Bleeder Entry Evaluation Using Condition Mapping and Numerical Modeling

Pittsburgh Mining Research Division, Pittsburgh, Pennsylvania

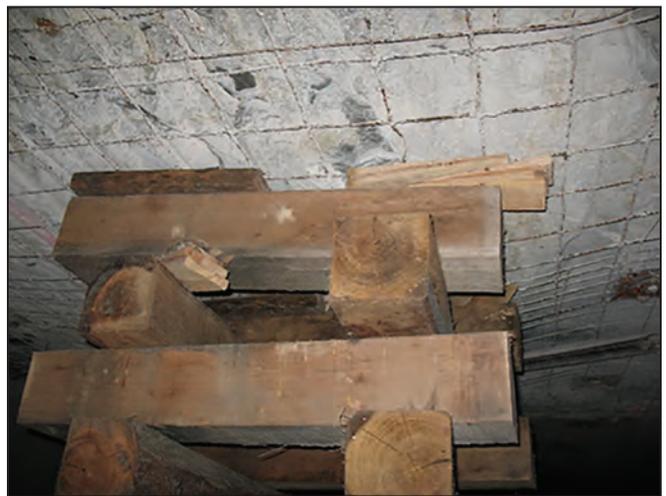
There were about five supports in the studied area where visible evidence of loading was noted. The supports were Propsetters installed in the crosscut between the travelway and the gob to act as a barrier to stop any loading or failure from migrating to the crosscut and beyond. The visual evidence on the Propsetters manifested in two different ways: (1) buckling of the cuts at the bottom of the support and (2) compaction of the bottom plates between the floor and the

Propsetter as can be seen in Figure 17. These loaded Propsetters were evidence of the effective design of the support to interrupt the progression of failure from the gob to the nearby entries.

Figure 17. Images of the two types of observed loading on the Propsetters.
