DEPARTMENT OF HEALTH & HUMAN SERVICES

Centers for Disease Control  
and Prevention (CDC)  
National Institute for Occupational  
Safety and Health (NIOSH)  
1095 Willowdale Road  
Morgantown, WV 26505-2888  
PHONE: (304) 285-5894  
FAX: (304) 285-6046  
July 2008

## Career Fire Fighter Dies and Chief is Injured When Struck by 130-Foot Awning that Collapses during a Commercial Building Fire – Texas

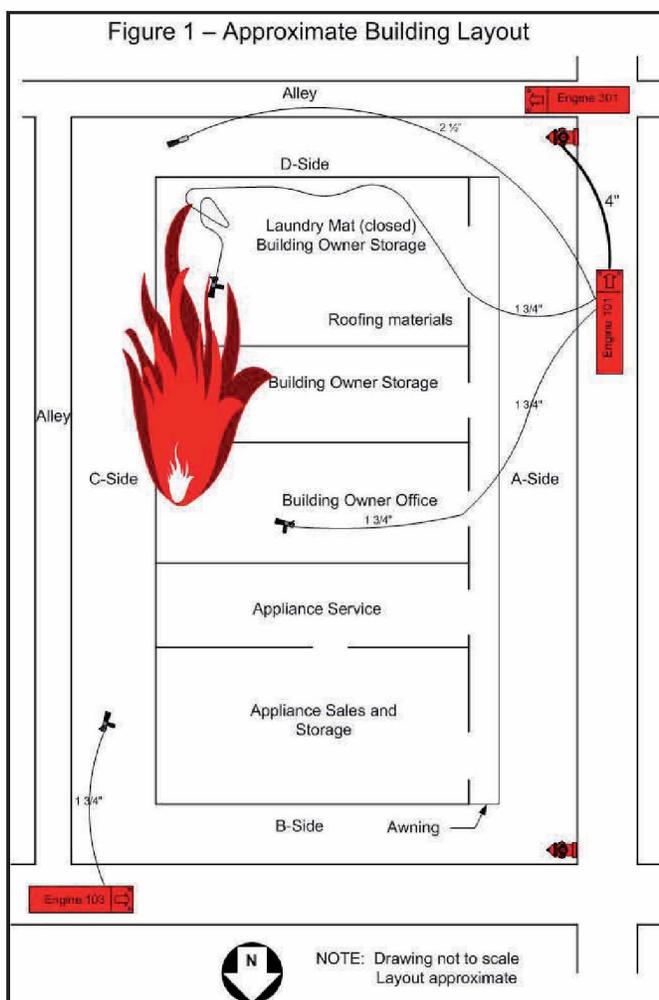
the roof was an air-conditioning condenser unit located near the rear wall at the north end of the structure that serviced the retail facilities at the north end. The bottom side of the trusses supported a suspended ceiling system and electrical junction boxes. There were no fire walls in place separating the different businesses and the structure had a common truss void above the suspended ceiling. At the time of the incident, the building was divided into three separate areas (see Figure 1). The northern end of the building contained a large-appliance sales business and an appliance repair business. The center area was used by the building owner as office and storage space for a number of businesses operated by the owner. The south end of the building contained a laundry that was closed at the time of the incident and was used by the owner to store roofing materials and supplies. *Note: It is believed the fire originated somewhere above the suspended ceiling in the center office area. Falling burning ceiling material ignited materials stored in the structure which contributed to the fire load and may have accelerated the roof collapse.*

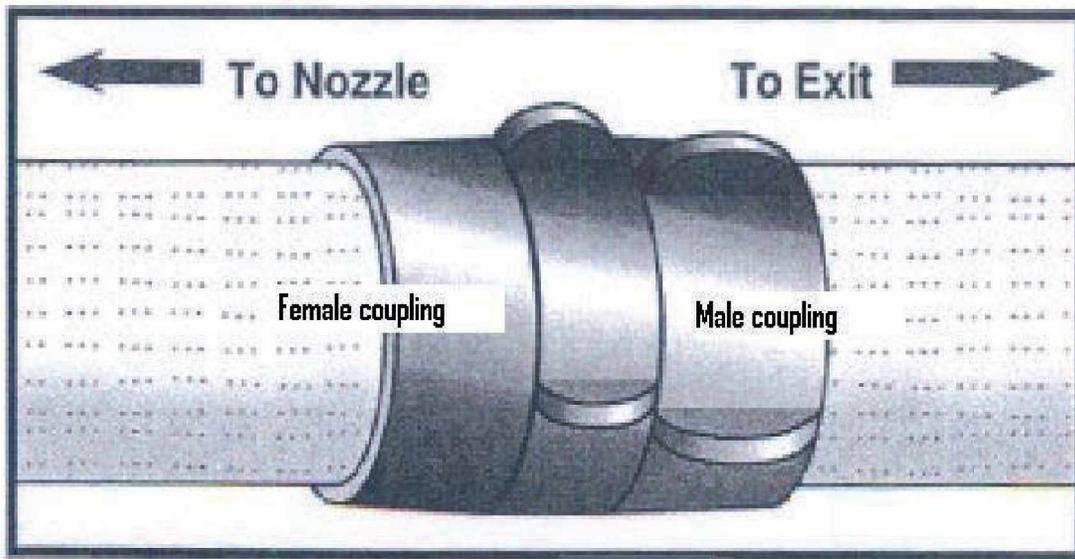
Diagram #3. Hose couplings will indicate the direction toward the exit. Adapted from IFSTA Essentials of Fire Fighting, 4<sup>th</sup> Edition.

In this incident, the truck crew went into the master bedroom doing a search without a hoseline. The engine crew with the hoseline was still at the front door when the truck crew went into the bedroom. Seconds later heavy smoke and flames blew through the upstairs hallway. The fire department's SOGs allow for the primary search and rescue crew not to have a hoseline as long as they are within sight of a crew with a hoseline. However, situations arise where conditions change in seconds preventing a fire fighter from following the hoseline to safety unless it is immediately available.

conditions while wearing gloves, the hose entangled, and with various obstructions present. This procedure should be incorporated into SOPs, trained upon, and enforced on the fireground.

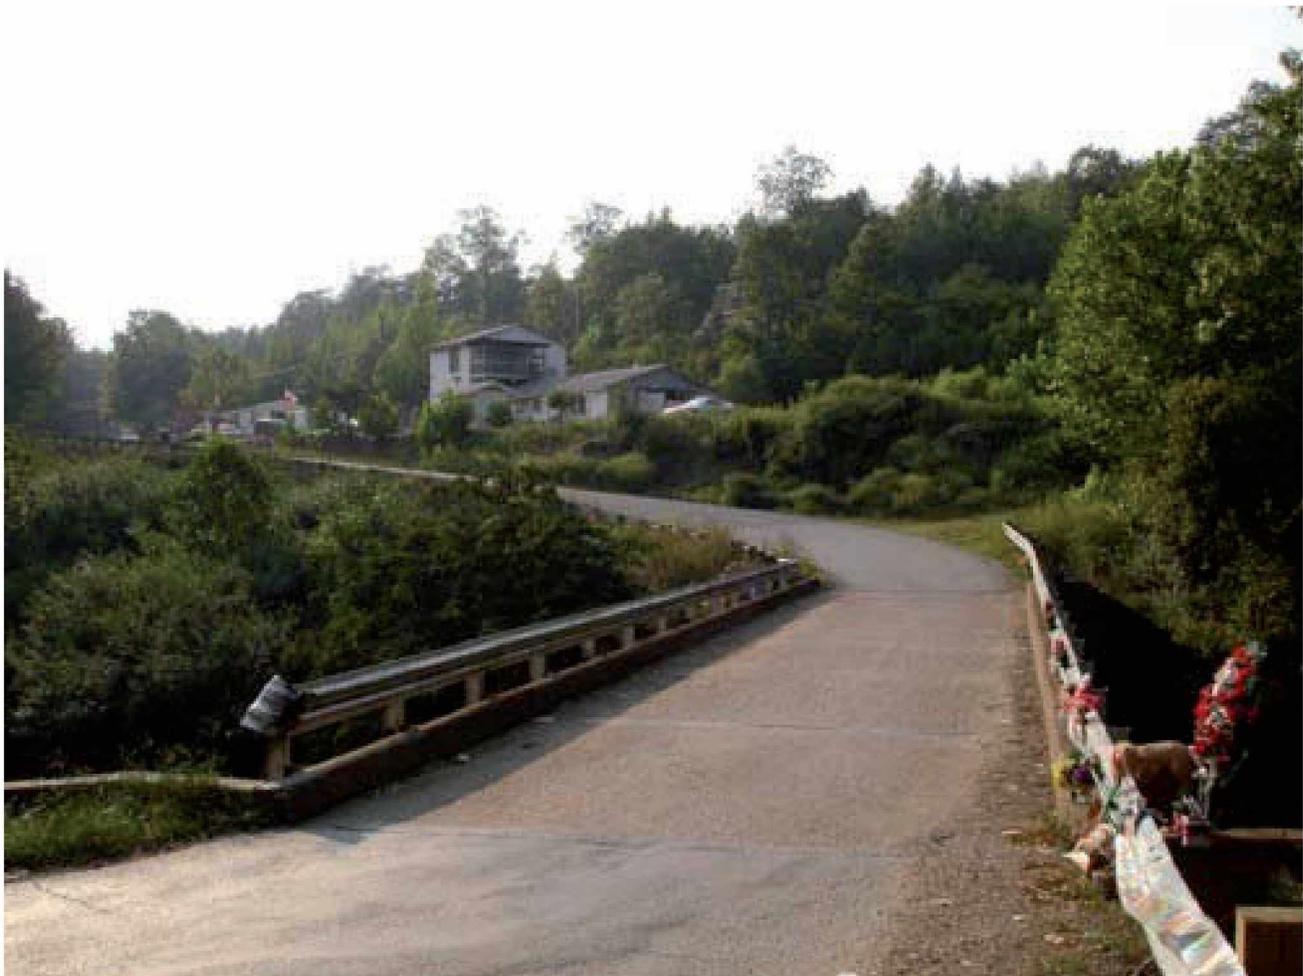
**Photo 1. Crash Location**

The incident occurred on a one-lane bridge located at the bottom of a downgrade on a horseshoe curve (see Photo 1) approximately 4 miles from the fire station. The asphalt road leading to the bridge is approximately 23 feet wide and the road makes a very sharp right hand curve as it approaches the bridge. According to the fire department and County 911 dispatch, there have been several vehicular incidents (with one other fatality) at this location in the last three years.

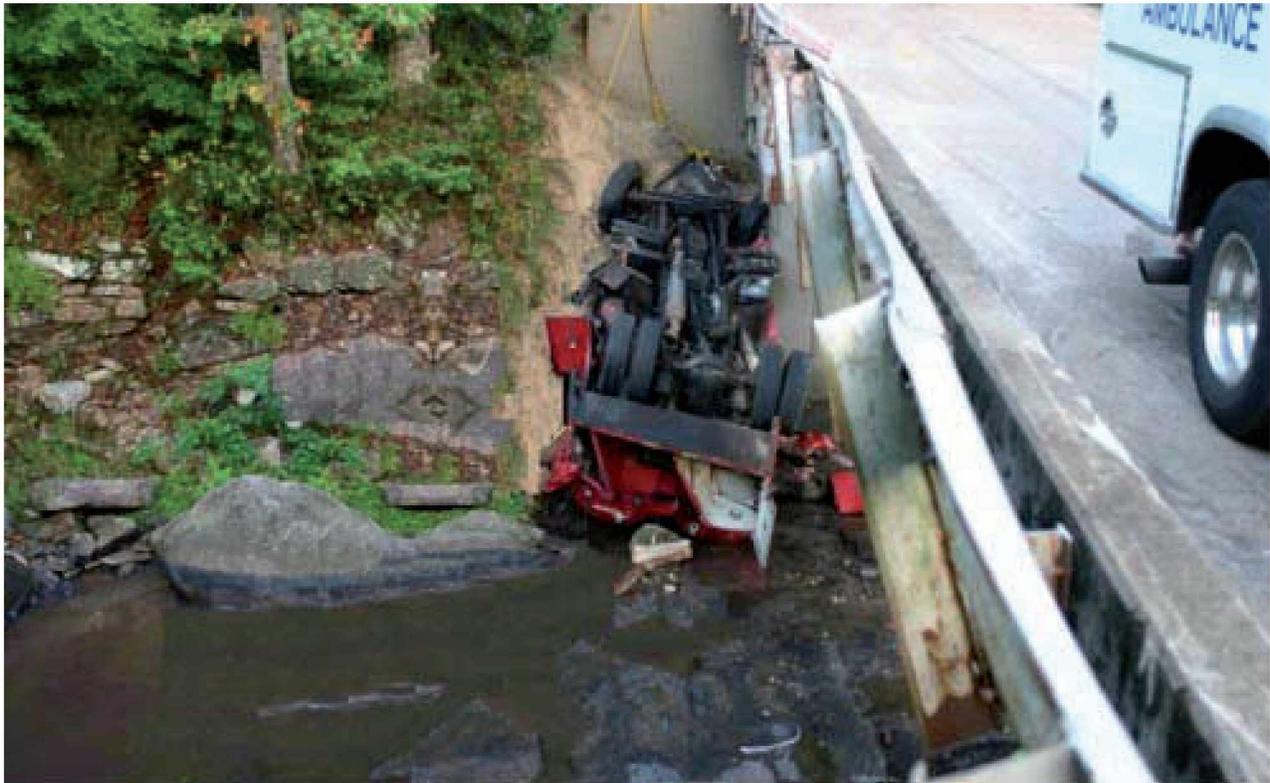
**Photo 4. Incident Scene**  
*(Photo Courtesy of Alabama State Troopers)*

The accident was reported to 911 dispatch by an area resident. Department vehicles enroute to the structure fire turned around *(Note: Just prior to their arrival to the fire ground, the structural fire was brought under control by the initial responding volunteer department)* and responded to the incident scene (see Photo 4). Fire Fighter #1 (the driver) was able to wiggle out of his turnout coat and free himself from the wreckage. He crawled out the broken driver's side window. The other three fire fighters were trapped upside down in the wreckage of the tanker's cab. Emergency responders used hydraulic rescue tools to free the trapped fire fighters in an extrication that lasted approximately one hour. Between 1919-1946 hours, three additional departments arrived on scene to assist with the extrication and set up a landing zone for a Medical Evacuation (MedEvac) helicopter. At 2019 hours, the MedEvac helicopter arrived on scene to transport the injured fire fighters. At 2035 hours, the MedEvac helicopter departed for the hospital with Fire Fighter #2 and Fire Fighter #3. The victim was the last to be extricated from the wreckage and was pronounced dead at the scene at 2105 hours by the county coroner.
