FLEXIBLE ROOF DRILL FOR LOW COAL

Final Technical Report
Contractor—Ingersoll-Rand Research, Inc.

July 1979

Contract No. U.S.D.O.E. AC01-74ET12196
(formerly U.S.B.M. HO242063)

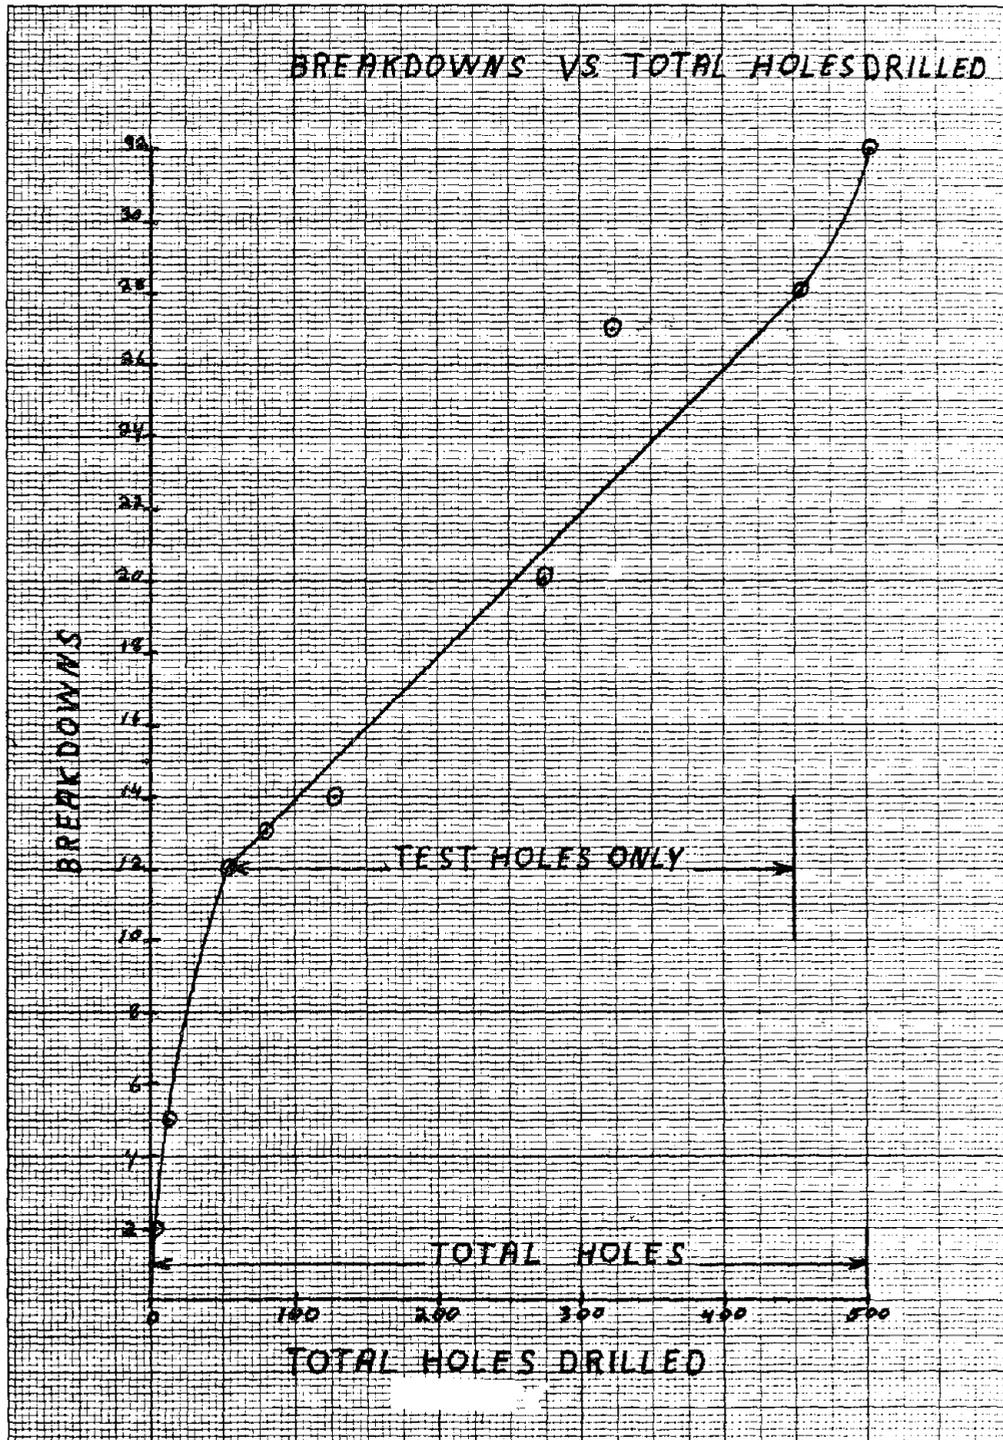
Figure 12: Graph - Breakdowns vs. Total Holes Drilled

When electrical power was available, only minor breakdowns affected the number of holes completed. Figure 12 represents the Breakdowns vs. the Total Holes Drilled for the field trial. The large number of breakdowns occurred away from the entrance in the side entry as shown by the steep slope of the line on the left side of the graph. Continuation of the line indicates the relationship between the number of breakdowns and the test holes completed. This line indicates four breakdowns for the completion of one hundred test holes and was consistent for the entire four hundred hole test. The increase in slope after the test section can be attributed to working directly at the face of the mine under different seam height conditions. Figure 13 represents the Holes Between Failures vs. Failure Days for the field trial. This graph indicates how the minor breakdowns reduced daily production and reduced the Flex Drill effectiveness.

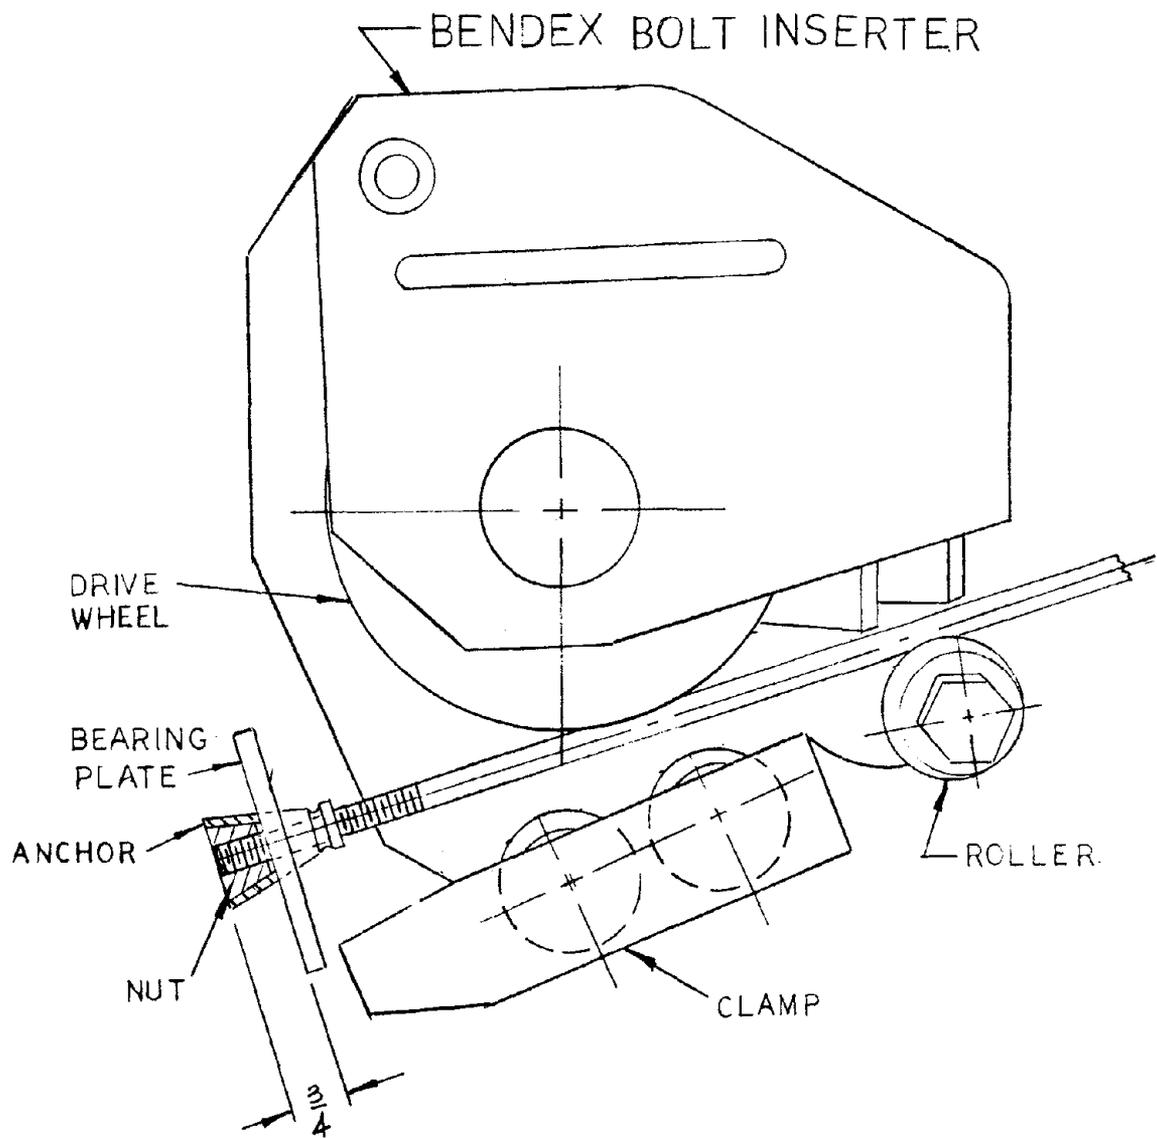
Figure 15: Bendix Bolt Inserter Loading Method No. 1

(1st attempt) The first method used to load the bolt inserter was that shown in Figure 15. With this method the anchor was flush with the end of the bolt. The bearing plate had a slight friction fit with the anchor which resulted in the plate being 3/4 of an inch from the end of the bolt. The bolt was also placed against the drive wheel as shown in the catalog. The problem encountered with these conditions was jamming the anchor between the drive wheel and swing arm clamp when starting the bolt. This was a result of the anchor and bearing plate being too close to the drive wheel. Consequently, the bolt was bent improperly and insertion in the roof was impossible.

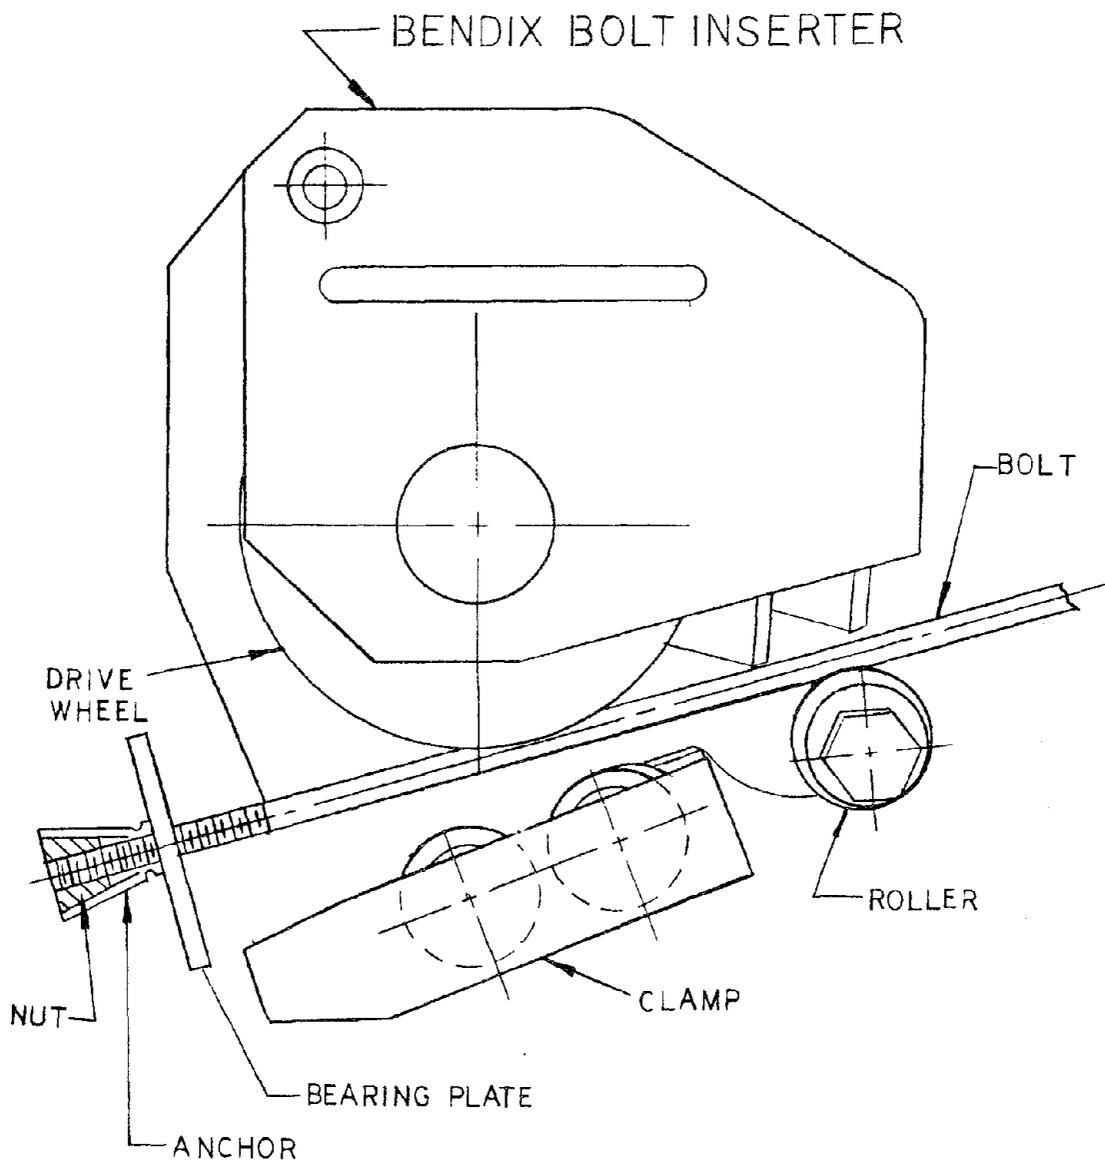
Figure 16: Bendix Bolt Inserter Loading Method No. 2

(2nd attempt) The second configuration attempted is shown in Figure 16. With this arrangement the anchor was passed through the bearing plate and the bearing plate was held with light pressure against the clamp arm swing. The bolt was fed through the bolt inserter properly, but missed the drilled hole and jammed against the roof, causing the drive wheel to slip and chatter on the bolt until the drive wheel was stopped. The safety arm was then lowered to free the bolt from the roof. The bolt was then manually aligned under the hole until it was properly inserted and successfully torqued to specifications.

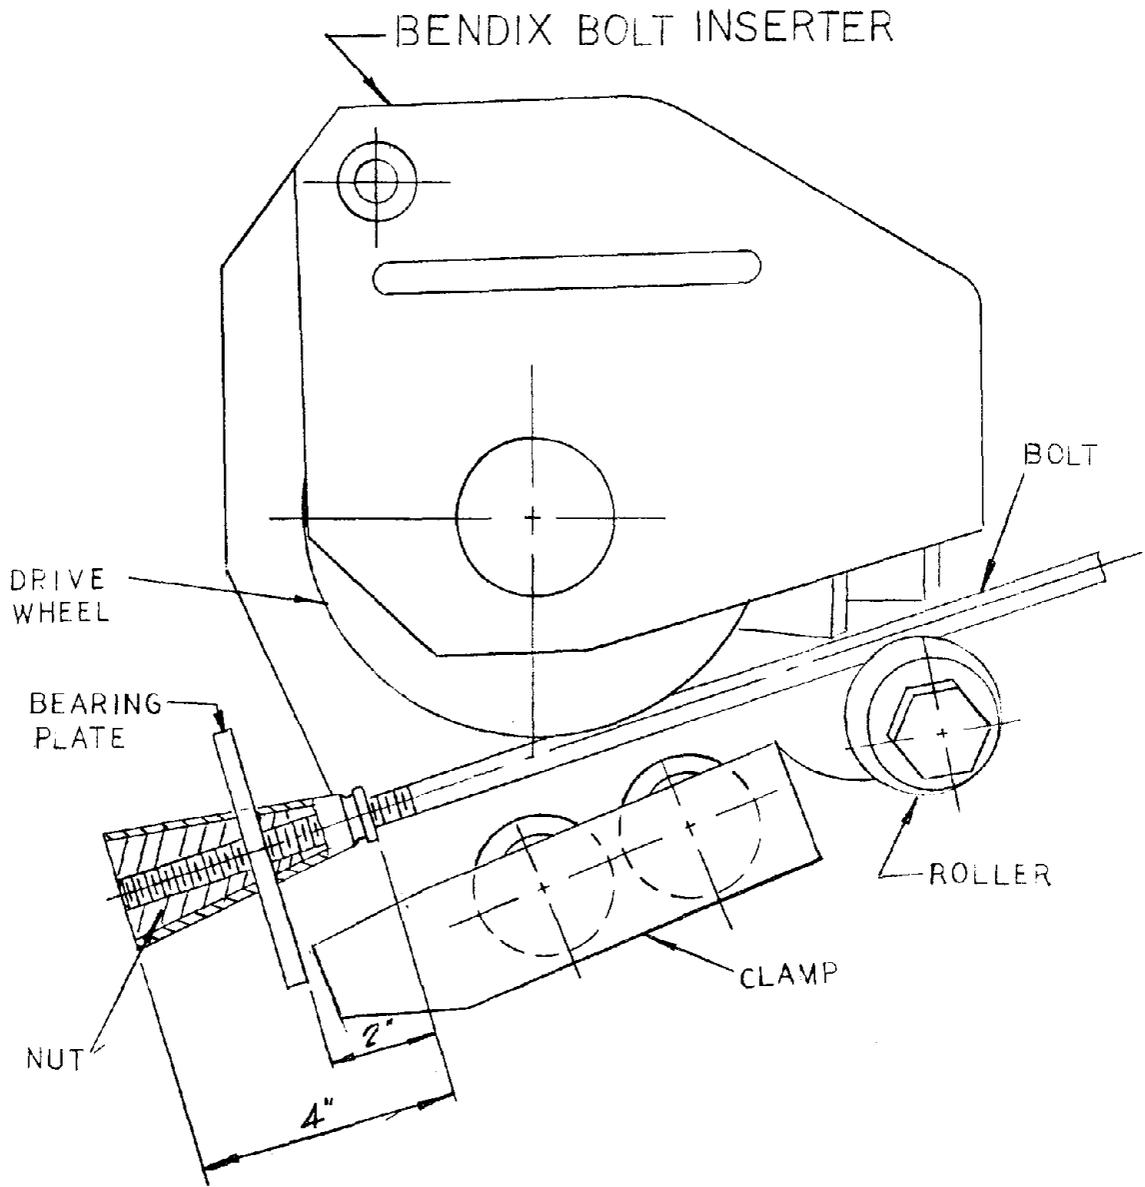
Figure 17: Bendix Bolt Inserter Loading Method No. 3

(2nd attempt) The second attempt failed when the bearing plate wedged between the drive wheel and swing arm clamp. This malfunction destroyed the bolt as it was being freed from the bolt inserter and the bolt was discarded.

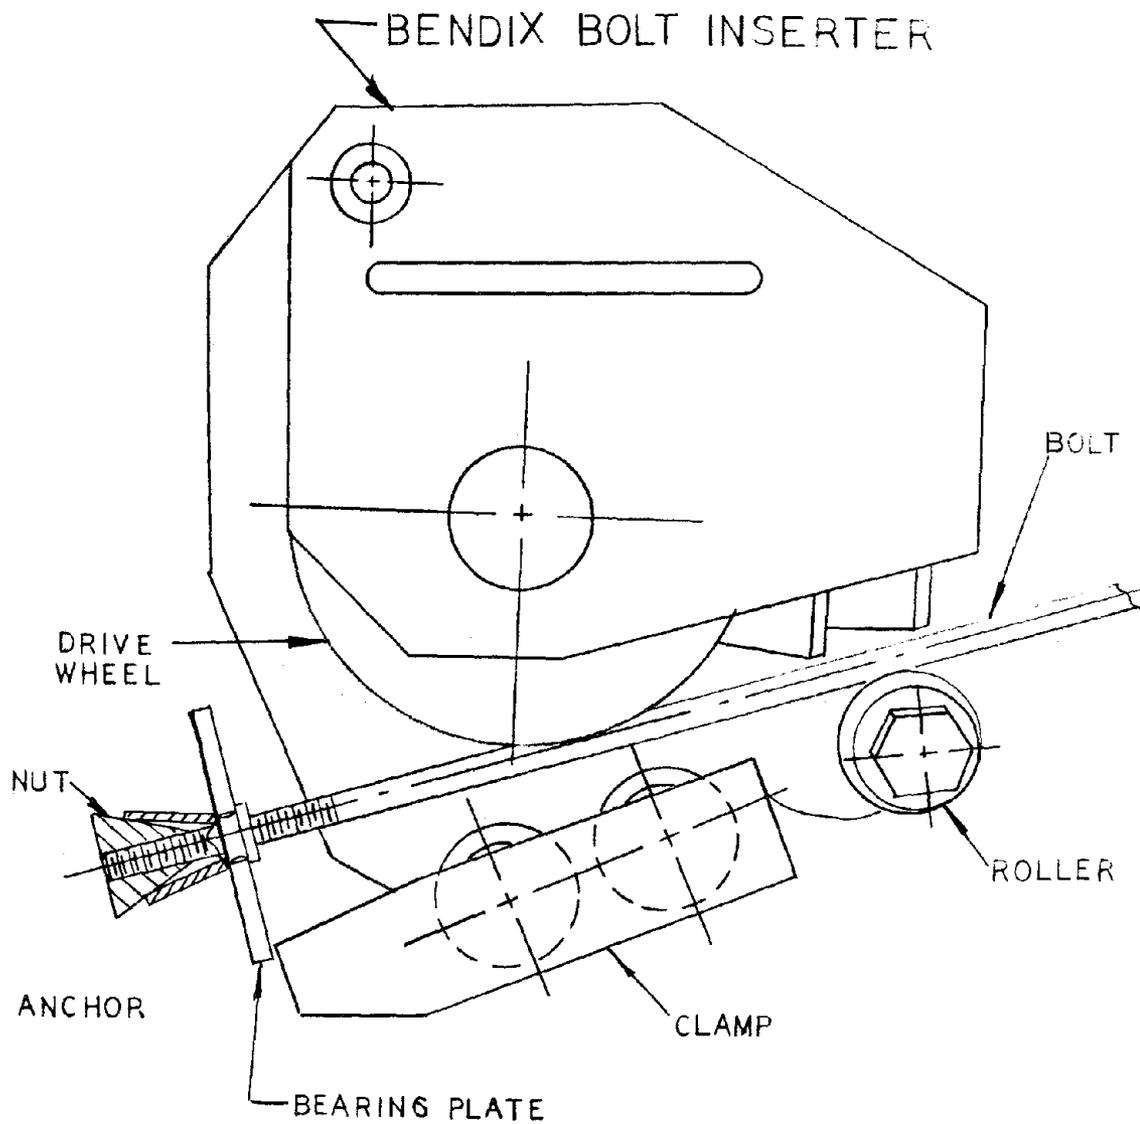
Figure 18: Bendix Bolt Inserter Loading Method No. 4

(3rd attempt) On the third attempt, the bolt was placed into the inserter as shown in Figure 18. The significant differences between Figure 17 and Figure 18 were the placement of the bearing plate in the notched area of the anchor and bringing the bearing plate flush back to the swing arm clamp. The nut was adjusted flush with the end of the bolt and the expandable section of the anchor slid back to the stops on the bolt. With this configuration the bolt found the drilled hole without problem and the bolt was secured in the prescribed manner.

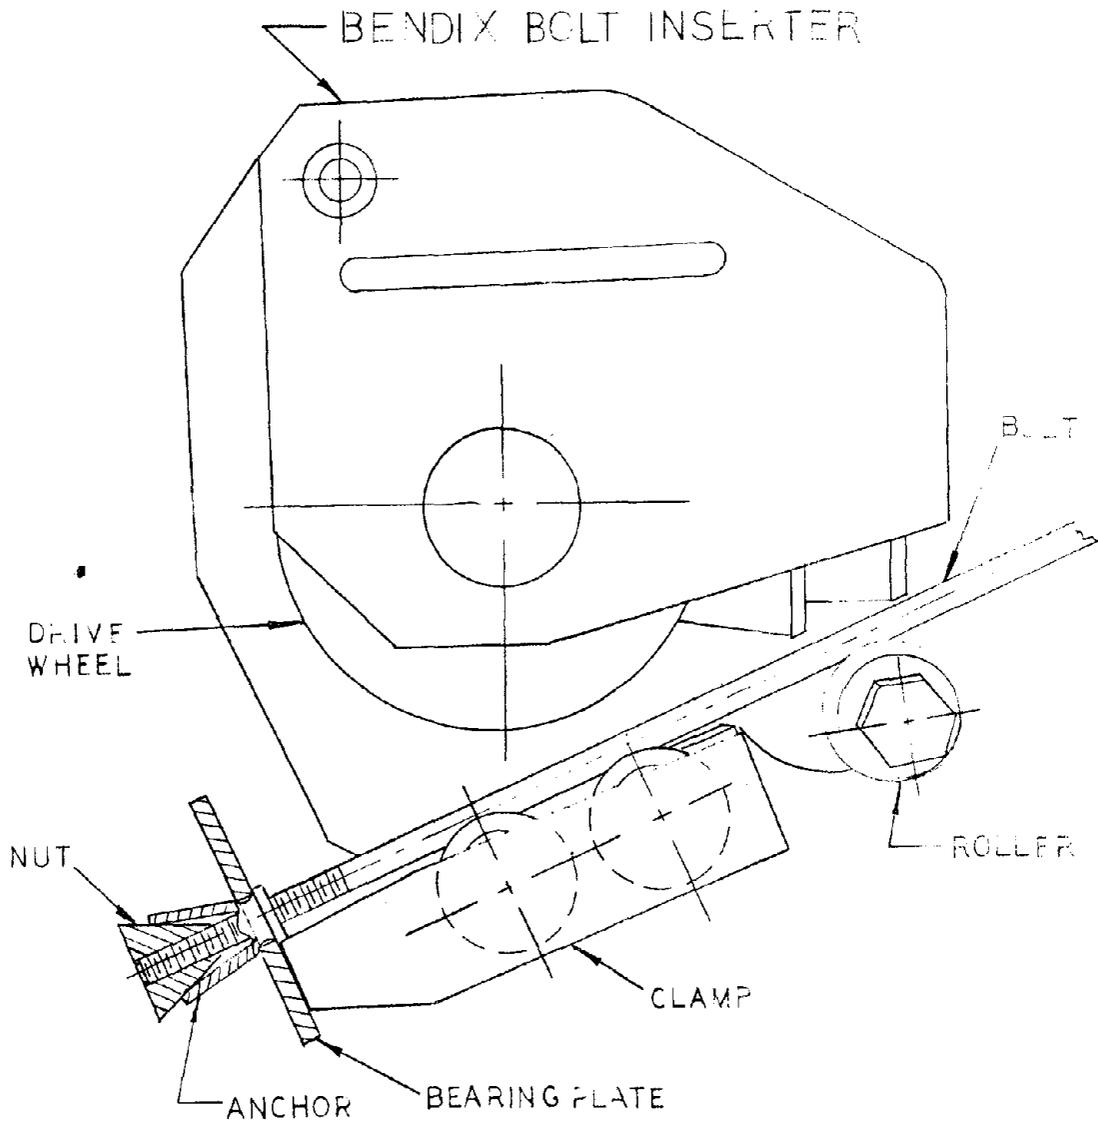
Figure 19: Bendix Bolt Inserter Loading Method No. 5

(1st attempt) For the fifth hole the configuration was changed into that of Figure 19. The significant difference was in placing the bolt on the swing arm rollers instead of the drive wheel. The bearing plate was placed in the notch of the anchor and the bolt was flush with the end of the nut. The bolt again missed the hole. The vehicle was repositioned until the bolt was under the hole. The bolt was then secured to the roof.

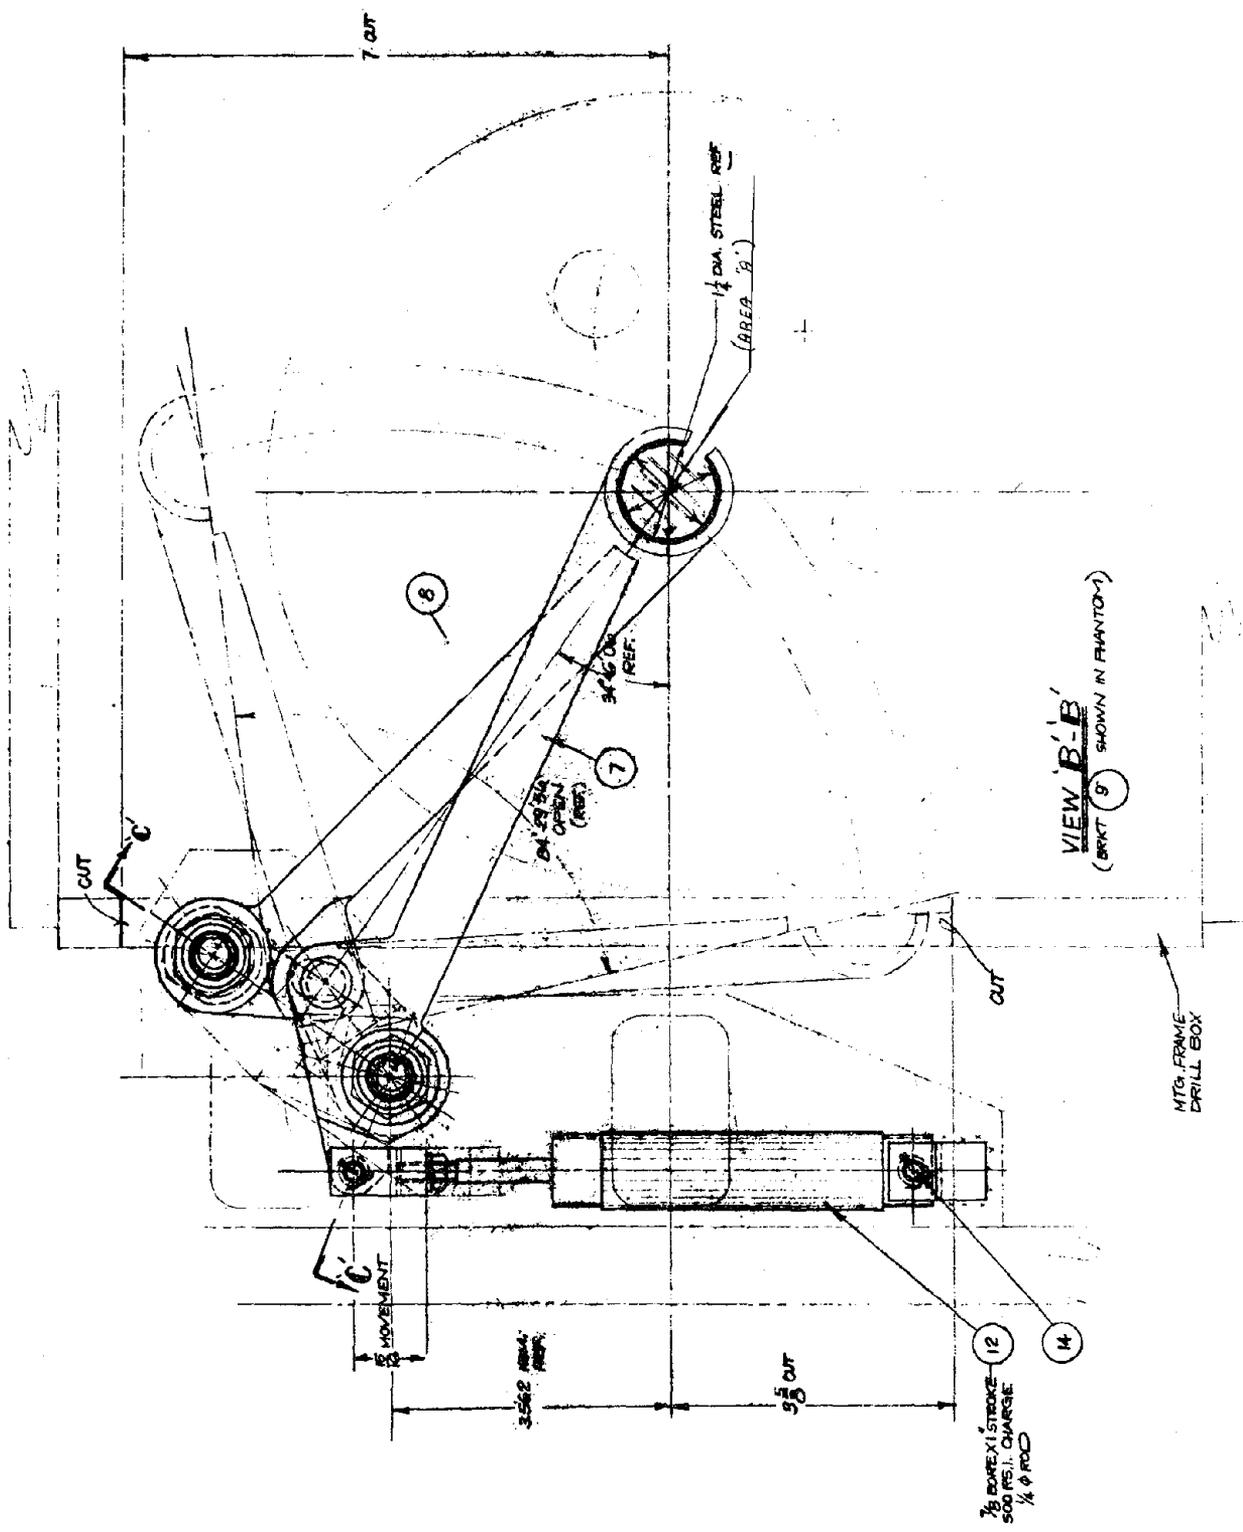
Figure 23: Centralizer - Top View

The centralizers became worn on the inside surface (area A, Figure 23) that contacted the drill steels during drill rotation. The wear on this surface was never sufficient to affect the operation of the arms, but could be eliminated with the proper heat treatment of the arms or with the selection of an alternate material. Maintenance on the centralizer arms consisted of tightening the arms (Area B, Figure 20) six times during the field trial. On one occasion during the field trial the centralizer arms were bent because of an interference with the boom. However, the arms were re-straightened on the vehicle with no associated downtime.

The operation of the arms was controlled through the moving part air logic actuated by air limit switch #5. On one occasion damage to the switch caused the centralizers to become inoperative until the switch could be replaced. The air logic circuit was designed to allow the centralizer arms to open in case of malfunction, preventing damage to the arms by boom movement.

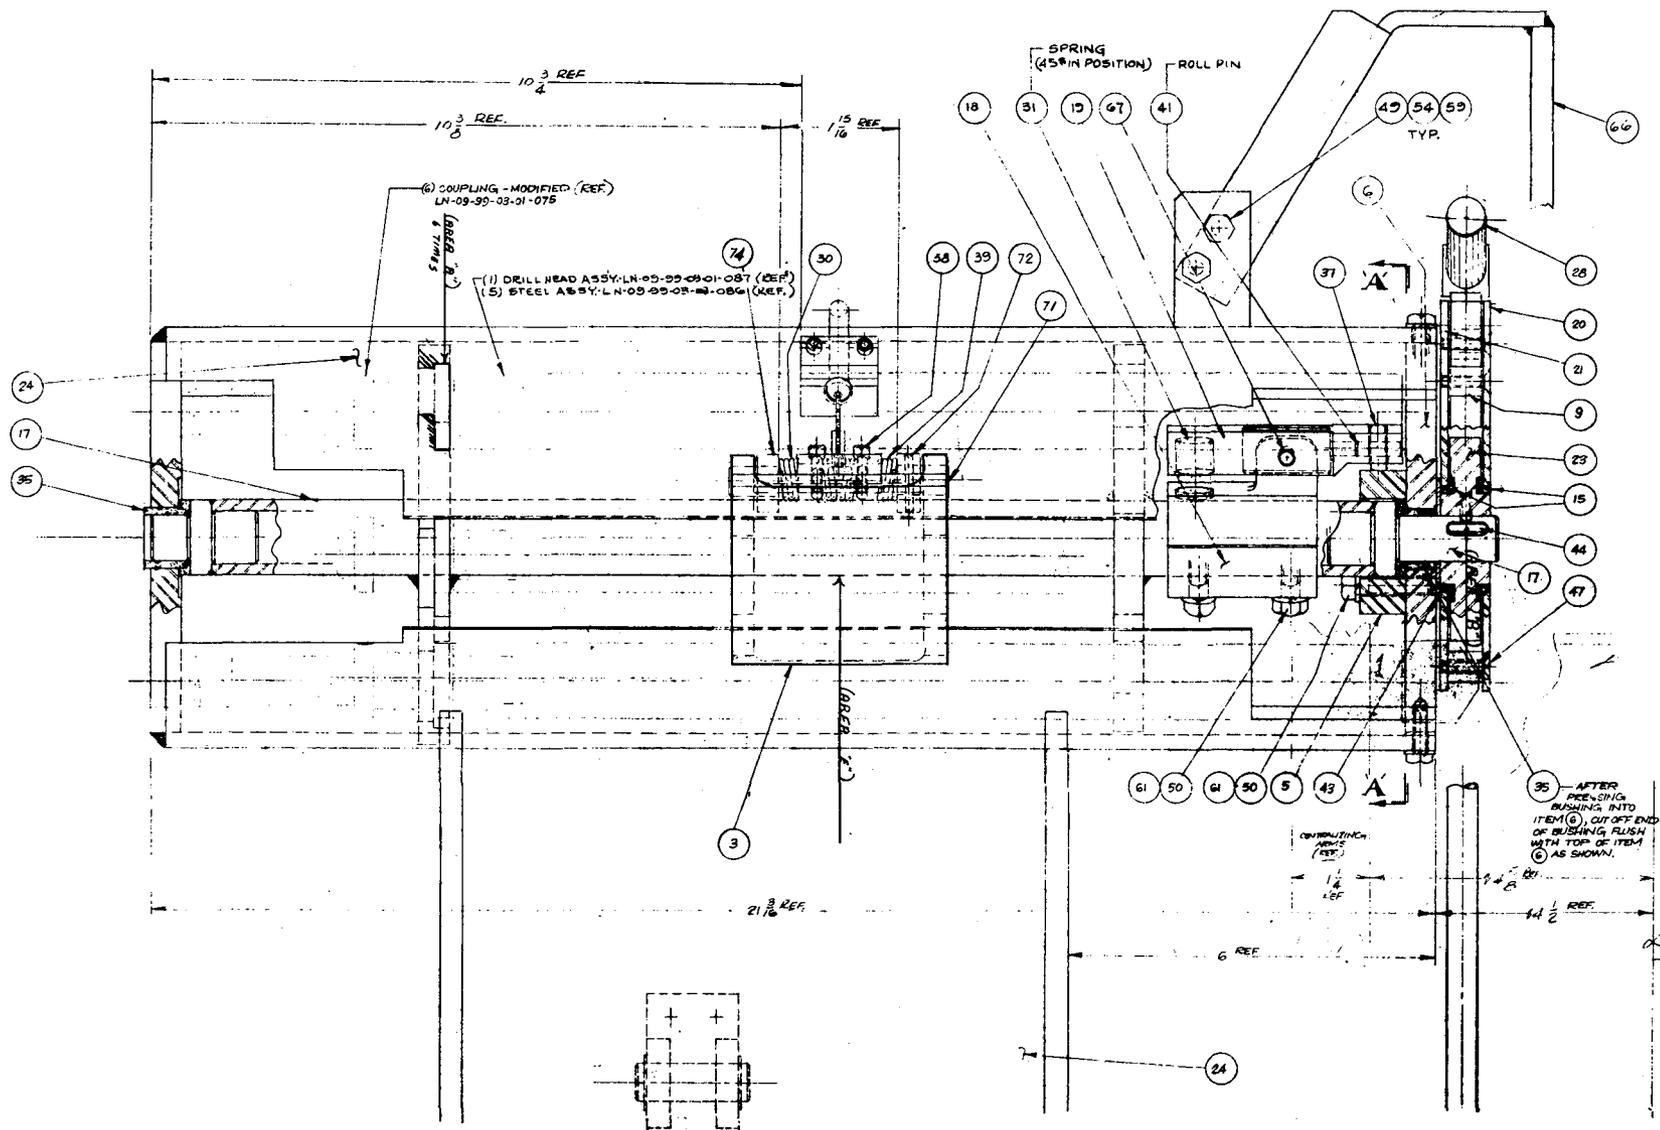
Figure 25: Carousel Assembly

The replacement of the carousel ratchet key was required throughout the field trial. The key was replaced fifteen times during the length of the field trial, and is shown in Area "B" of Figures 25 and 26. The shearing of the ratchet key was a result of a drill steel jamming between the housing weldment and the shaft and plate assembly. The possibility of jamming the carousel could never be totally eliminated. However, in a redesign, the frequency will be substantially reduced along with the associated lost drilling time. The time required to replace a sheared key was approximately thirty minutes in lost drilling time, but was very disruptive to the work schedule.

The ratchet cylinder was located in the upper portion of the carousel as shown in Figure 25, Area C. This cylinder was vulnerable to roof falls and was only slightly protected by the carousel cover. The ratchet cylinder was trunnion mounted to the carousel because of space and alignment design considerations. The cylinder was designed to engage the ratchet pawl mechanism to the ratchet for the load and unload modes of operation.

The failure of the cylinder occurred at the end of the cylinder rod. The cylinder rod failed at the threaded portion of the rod adjacent to the drilled hole for pinning the rod. The cylinder replacement time, had one been available at the mine, would have been approximately two

The areas of the carousel subject to wear were the lobes on the shaft and plate assembly shown in Figure 25, Area A. If the wear was allowed to continue, malfunctions caused by the drill steels jamming the carousel would become frequent. The wear in this area had no effect on the cycle time, but would ultimately increase the downtime. A simple heat treatment of this area would increase the wear resistance and reduce the problem.

3. Carousel Gates - The carousel gate as shown in Figure 25, Area E, is a system that worked flawlessly throughout the field trial. The cable actuation of the gates was positive and received preventive maintenance just twice during the field test.

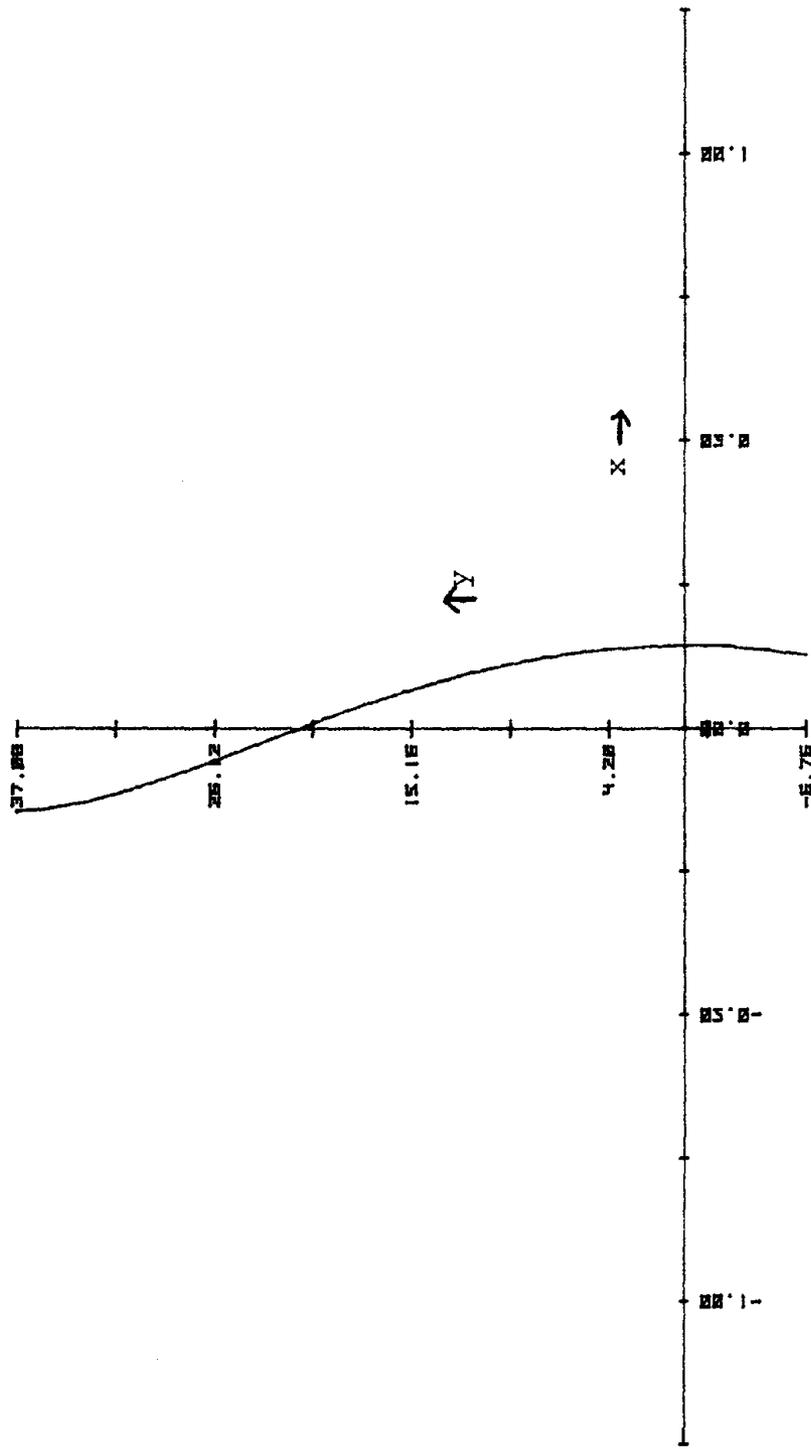
Figure 28: Point Curve Original Boom

The maximum variation of the coupler point curve (see Figure 28) from the x axis is .2883 inches. This deviation is too great for the rod changer mechanism, therefore a design modification to the boom is necessary.

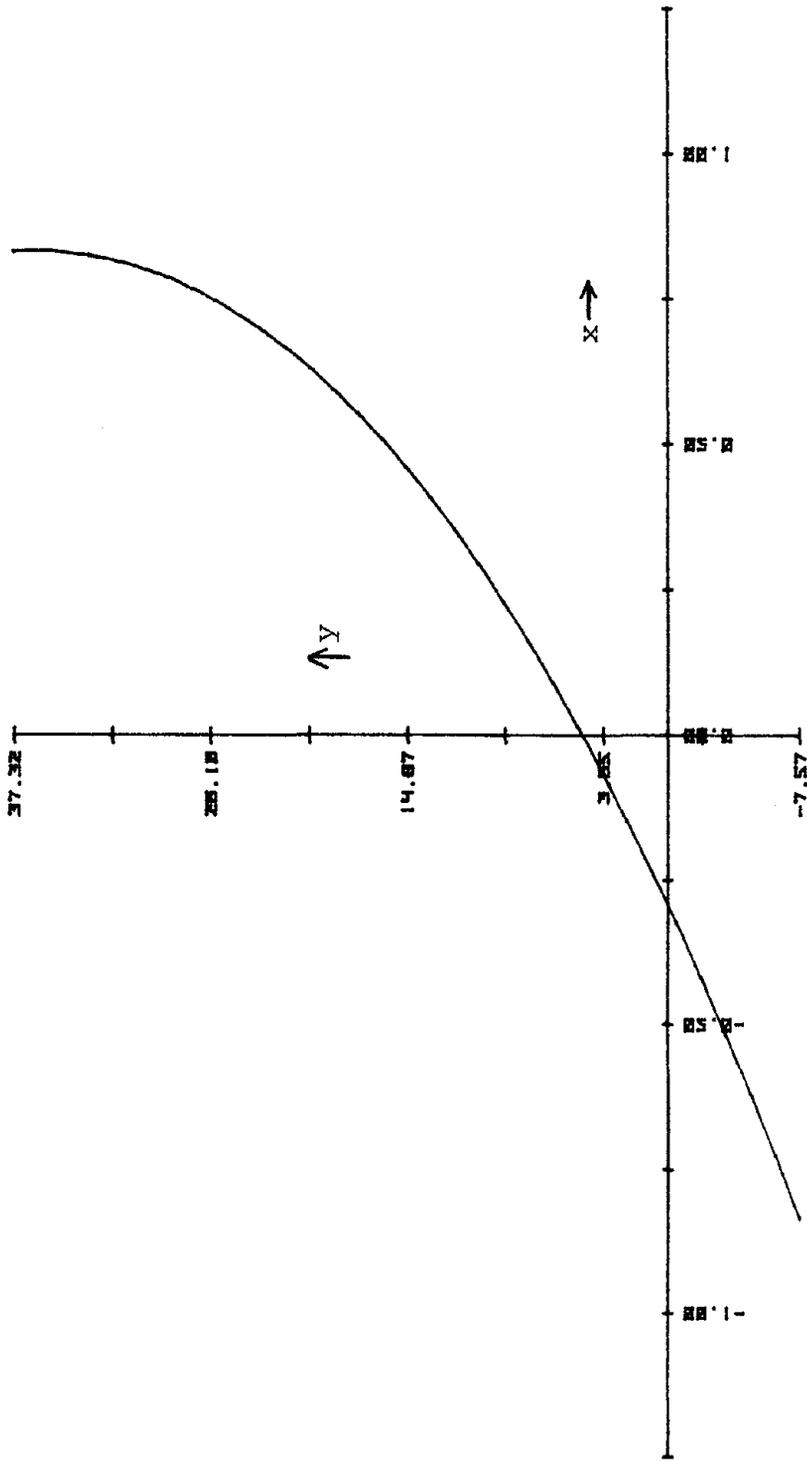
Figure 29: Point Curve Original Safety Arm

The variation of the coupler point curve (see Figure 29) from the x-axis is 1.1553 inches. This deviation is too great for the rod changer design so the safety arm must be re-designed.

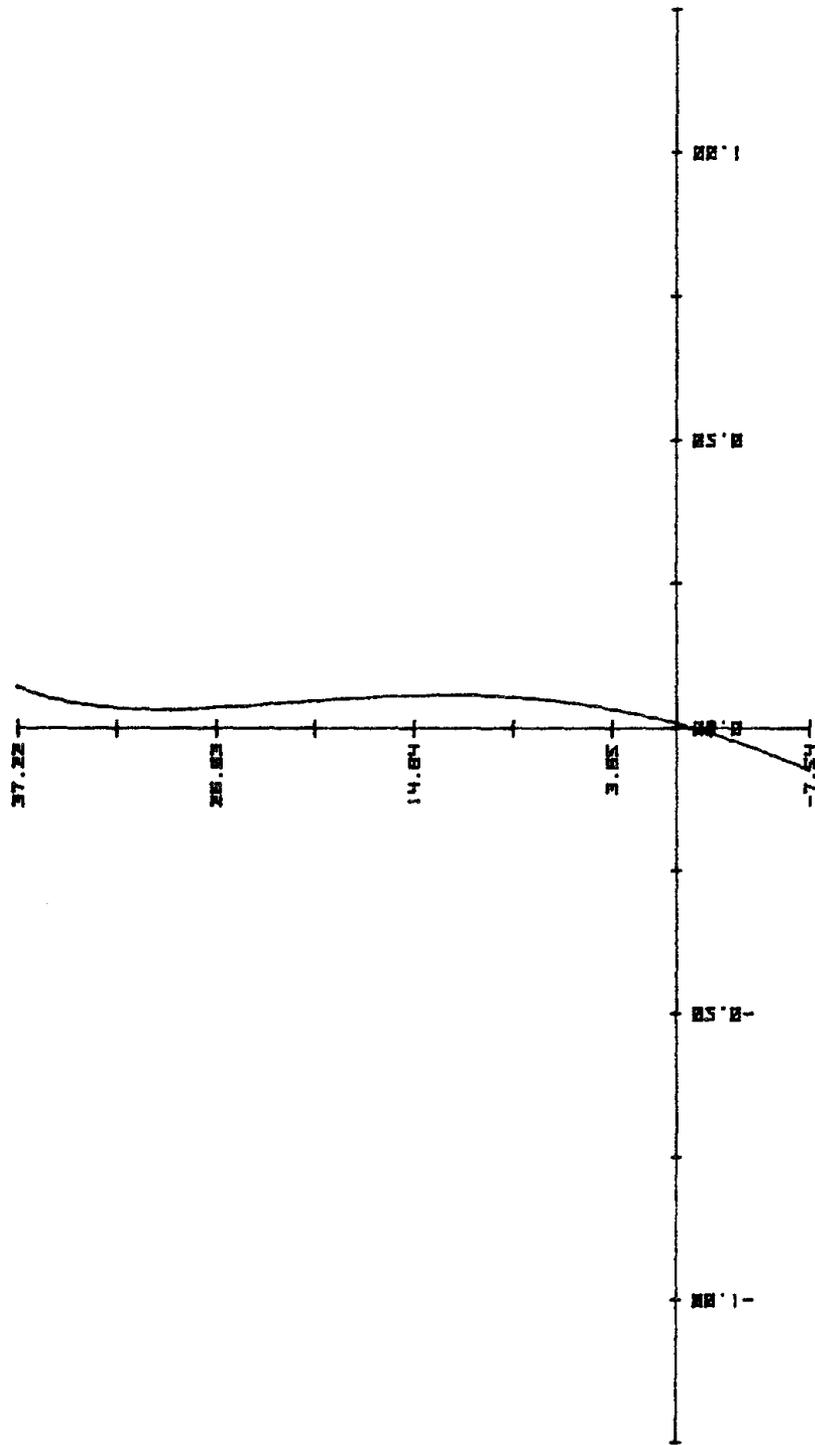
Figure 30: Point Curve Modified Mechanism

After many substitutions of the variables in the computer analysis a useable solution was found and is shown in Figure 30. The safety arm mechanism had the following dimensions:

This mechanism has only .0504 inches of deviation from the x-axis in the operating range of the rod changer drill. This is an acceptable variance from the straight line desired and can be used. The mechanism is identical to the existing boom mechanism with the exception of the .5 inch eccentricity. By making the safety arm identical to the boom and by lowering the point m (see Figure 27) on the TD-1-29 chassis by .5 inches the design change can easily be made.

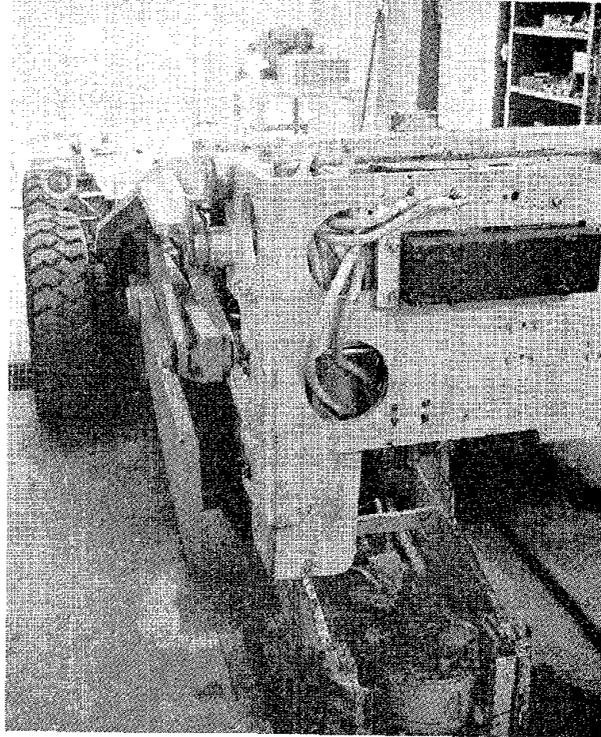
Figure 2. Chassis mounting changes.

In the course of the underground testing, several problems showed up which can be traced to this marriage. First, the chassis which carries the steel changer replaced the roof contact ring of the safety arm. The chassis was held in a vertical position by a parallelogram link which derived its orientation from the original safety arm slides of the roof bolter. The original design proved to be unable to maintain a consistent chassis orientation to the drill box during

The figures below show the changes as installed. Figure 2 shows a front view of the right hand side of the chassis installed on the safety arm. The drill box rests on the ground below the chassis. The lower extension of the chassis protects a limit switch which was modified for more reliable operation. The parallelogram link is in evidence to the left of the chassis extending back to the slide area. The link was strengthened to reduce flexing and now has a T-shaped cross-section.

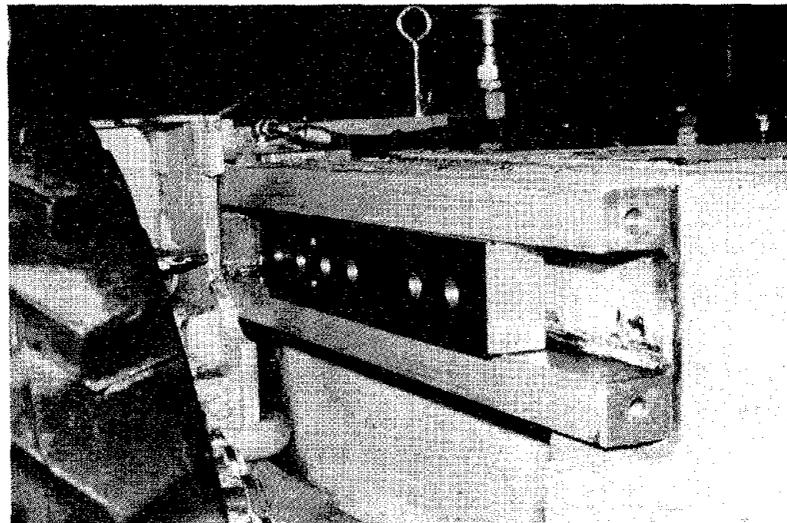
Figure 3. Slider block installation.

Figure 3 shows the slider block which replaced two rollers in the slide assembly orienting the chassis. The rollers were originally 8 inches apart and they have been replaced by a 15-inch slider block. The 15-inch block thus cuts the angular misalignment potential of the slide roughly in half for the same operating clearance. Reducing the slide's misalignment reduced the chassis' angular misalignment potential by the same amount.

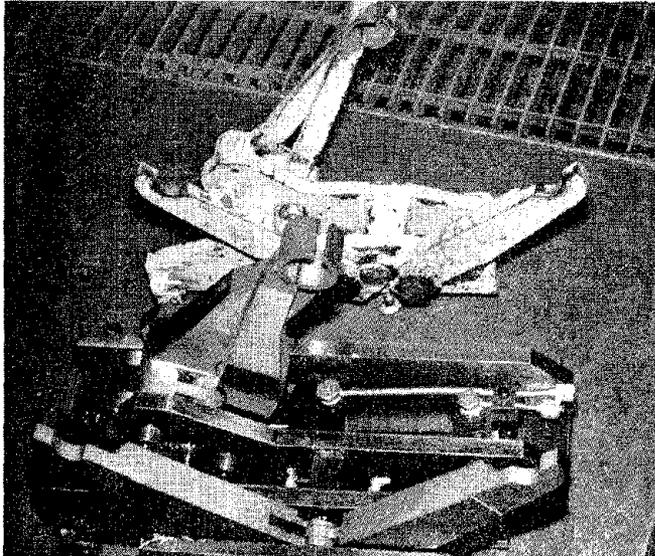
Figure 8. Upper clamp and centralizer assembly.

Two major areas improved were the centralizer and upper clamp designs. The two will be discussed together as they are inseparably linked in the machine. Underground experience with these parts revealed that the centralizer and upper clamp both opened up under drilling conditions. The centralizer's being unable to resist the sideloads of starting a hole resulted in off-axis holes, which was hard on drill steel couplings and made joining steels difficult. The upper clamp would score the drill couplings and perhaps cause a malfunction in the drill cycle when it was forced open during drilling. The centralizer also showed unacceptable wear rates on the surfaces that contacted the drill steel. Neither the centralizer nor upper clamp designs were capable of resisting the thrust of the drill box during an operating malfunction. The arms were originally pivoted on cantilevered pins which would not remain tight under repeated bumping by the drill box. In addition, the upper clamp arms broke under the strain.

Figures 8, 9, and 10 show the mechanical changes made to the upper clamp and centralizer assembly. In Figure 8, the new unpainted assembly is in the foreground, with the original assembly in the rear. The mount assembly is considerably strengthened. Provision has been made to hold the upper clamp and centralizer arms within a saddle, rather than carry them on cantilevered pins as before. Figure 9 shows the original mounting of the upper clamp and the new saddle mount quite clearly. The original mount could not take the loads encountered and had to be tightened up repeatedly. The special tube fittings that were fabricated for the new larger centralizer cylinder also show in the figure. These low-height fittings were needed to allow the drill box to pass the cylinder.

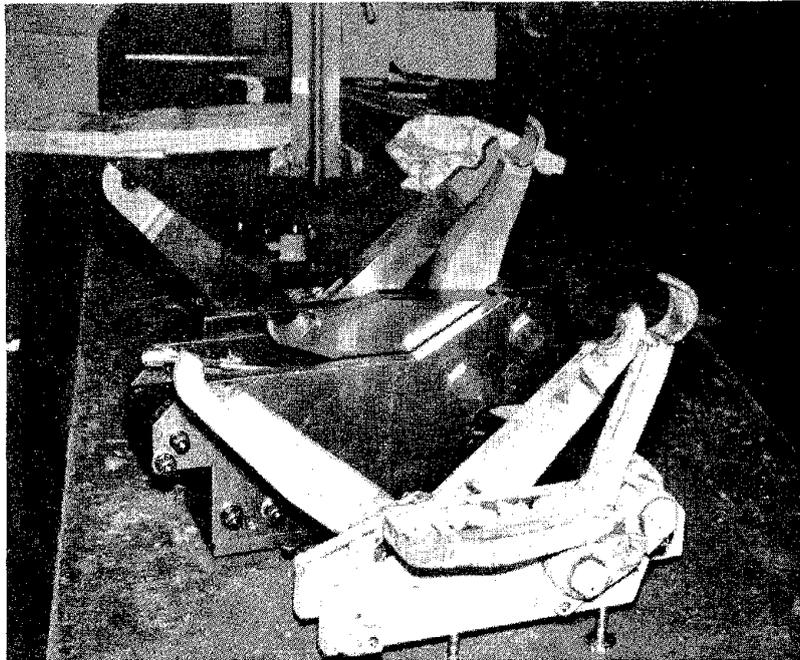
Figure 10. Bottom view of upper clamp and centralizer.

Figure 10 shows a view from the bottom of the two assemblies. The bottom edge of the original assembly corresponds to the notch in the new assembly. To increase the centralizer's lockup force, the mount assembly was extended through the Flex Drill chassis approximately 2-inches. This enabled a toggle link assembly to be included which materially increased the sideforce which the centralizer can resist.

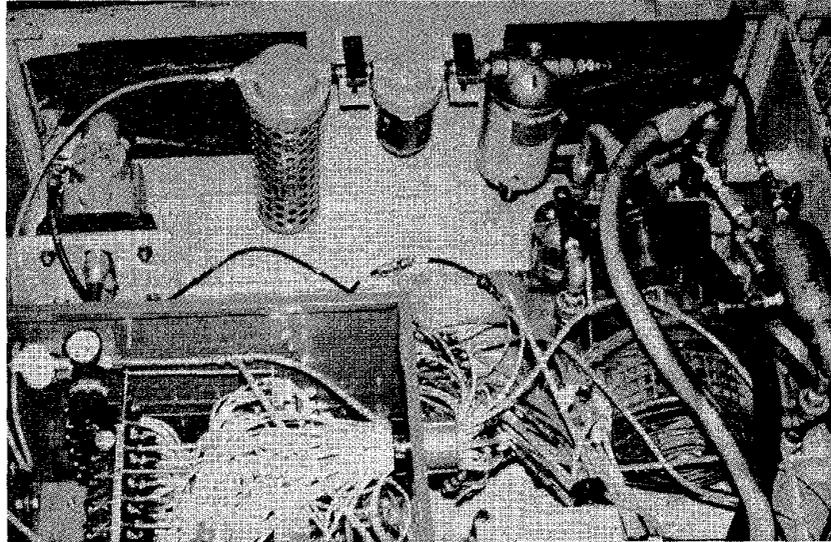
Figure 13. Air logic area.

The changes to the fluid power systems of Flex Drill will be discussed together. The work on the air system was mainly of a cleanup nature. No changes to the air logic were needed. Underground testing had revealed the need for a moisture disposal method more efficient than taking off a filter housing once a day. The hydraulic system was modified to utilize an unloader valve and accumulators in place of the relief valve originally used. The marriage of Flex Drill to an existing roof bolter had resulted in a fixed-volume gear pump feeding oil to a closed-center valvebank. A relief valve provided pressure control for the valve stack. The net result was an unnecessary heat load on the hydraulic oil.

Figures 13, 14, and 15 demonstrate the air logic area at the rear of the machine. This area was extensively modified during the rebuilding process. In Figure 13 several things are evident. To the left rear of the area is the unloader valve for the new accumulators which were installed in the machine. Next to that, in the center of the machine, is the new air filter assembly. This filter assembly consists of two particle entrapment filters and a microlescer filter designed to remove oil. All three of the filters are fitted with automatic float drains to prevent moisture accumulation. On the right of the area under the plumbing is the air compressor assembly. This assembly was not changed in the redesign. To the left lower corner of the figure is the new air logic box. This box is considerably reduced in size from the original assembly.

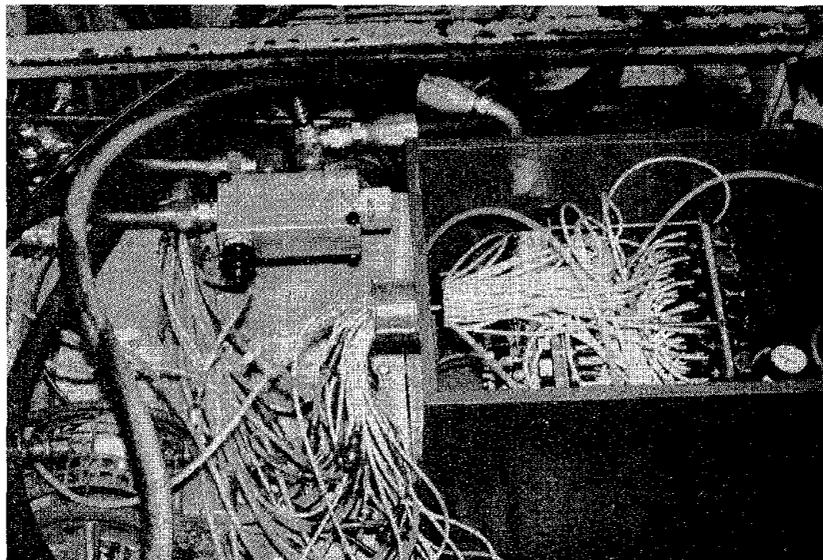
Figure 14. Air logic area.

Figure 14 is a view of the air logic area toward the front of the machine. On the right of the area is the air logic box. In the center of the picture is the flow control valve which was installed to control the drill rotary speed during automatic coupling.

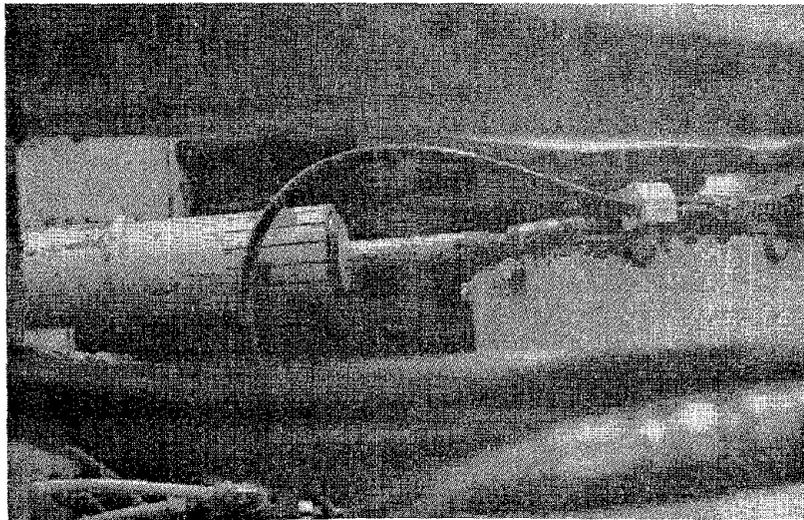
Figure 22. Linear clutch installed.

Several aspects of the carousel assembly caused trouble during the underground testing. The carousel was rotated by a two-directional ratchet mechanism. The hydraulic cylinder controlling the direction of rotation of the ratchet proved delicate in testing. A more rugged shifter design was needed. The ratchet rotator proved vulnerable to jams during steel changing. If a steel did not seat properly in the carousel it would block the rotation of the carousel and shear the key connecting the rotator to the carousel shaft. Repair was a time consuming operation requiring disassembly of the ratchet. The design of the carousel gate contributed to the likelihood of a steel jam occurring. It was short in length and allowed the steels to slip out of position easily.

Figures 21, 22, 23 and 24 show changes made to the carousel assembly in the redesign work. Figures 21 and 22 show two views of the linear clutch assembly added to the ratchet actuator arm of the carousel assembly. The function of these parts is to limit the force which can be applied to the ratchet assembly at the top of the carousel. In the original machine no provision for limited force was provided. Lacking this, a common occurrence was the shearing of the drive key holding the shaft and plates assembly in the carousel. In the new design the force which can be applied to the ratchet and ultimately to the drive key is limited by the linear clutch assembly.
