FLEXIBLE ROOF DRILL FOR LOW COAL

Final Technical Report
Contractor—Ingersoll-Rand Research, Inc.

July 1979

Contract No. U.S.D.O.E. AC01-74ET12196
(formerly U.S.B.M. HO242063)

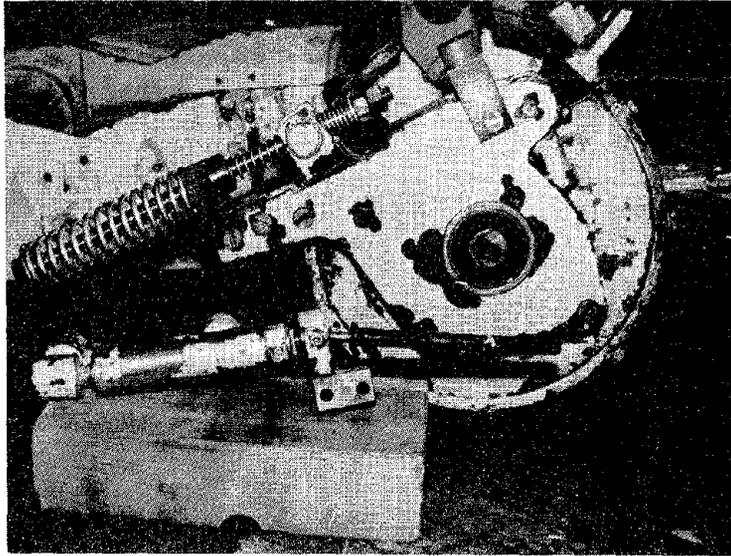
Figure 23. Ratchet shifter.

Figure 23 shows the new shifter for the ratchet assembly. The original ratchet shifter is shown at the bottom of the picture. It was a double-acting hydraulic cylinder which shifted the ratchet in either direction as required by the logic of the machine. This design proved fragile during the lifetime of the original Flex Drill assembly. The new assembly utilizes a spring to drive the ratchet to one position and a cylinder and cable arrangement to pull it back to the second of its two positions. One position is used to load the carousel and the other is used in unloading the carousel. The combination of a hydraulic cylinder operating through a flexible cable assembly was tested in the original Flex Drill as an actuator for the gate, and proved very satisfactory.

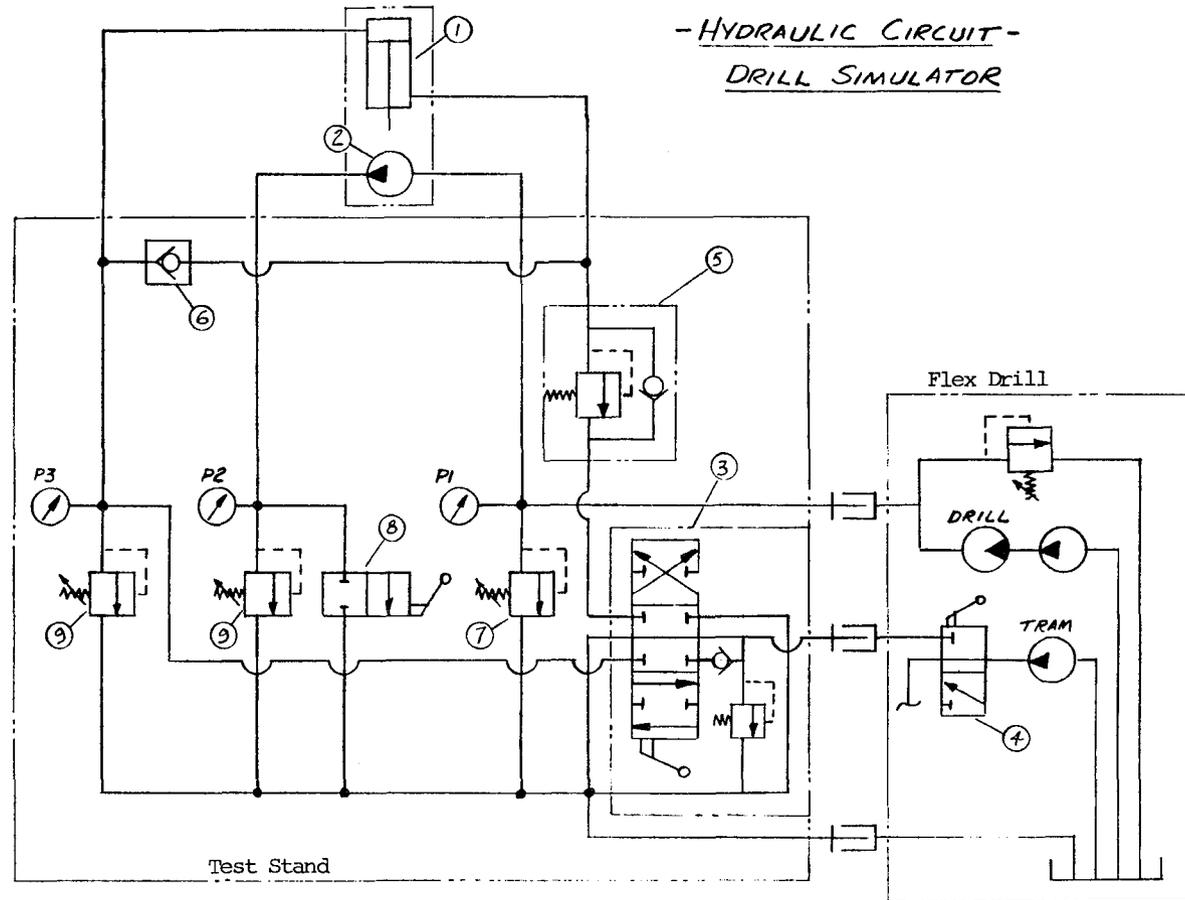
Figure 31. Drilling simulator hydraulic schematic.

Valve number 8 in Figure 31 is a refinement added after startup of the simulator. Because of the relief valve creating pressure P_2 , all coupling of drill steels was being done under full drilling torque. The drive sub or drill string already in the "hole" could not turn freely as is the case in a real drilling sequence during coupling. Valve 8 removes the restriction of the relief valve to approach the actual condition. This eliminated the premature coupling wear that was occurring with the simulator. The rounding off of the hex tip mentioned in the discussion of the drill steel couplings was extremely rapid before adding this valve. Couplings needed at least deburring after 5 to 10 holes. Sometimes the coupling was ruined. With the valve, the coupling problem disappeared.
