AN INVESTIGATION OF THE CAUSES OF CUTTER ROOF FAILURE IN A CENTRAL PENNSYLVANIA COAL MINE: A CASE STUDY

by John L. Hill, III and Eric R. Bauer

Proceedings Twenty-Fifth Symposium on Rock Mechanics

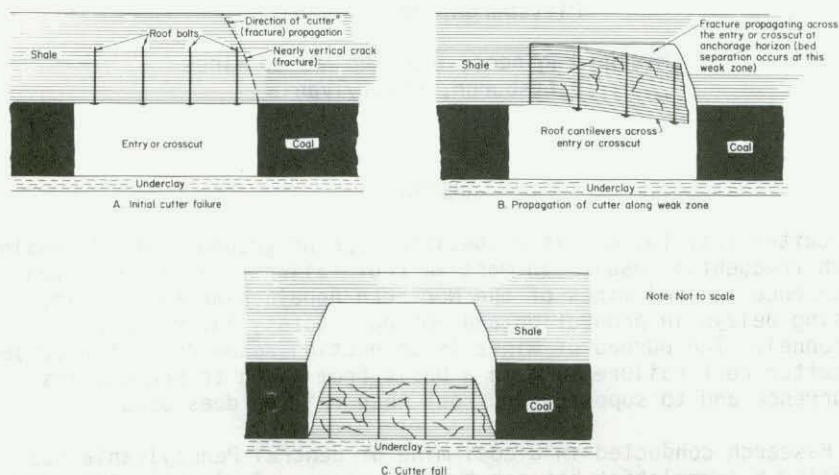
Cutter roof failure initially begins as a fracture along one or both roof-rib lines of an entry and propagates nearly vertically into the roof (fig. 1). When the fracture breaks to a height above the anchor horizon, or along a weak bedding plane, massive roof failure may occur. Figure 2 is an example of severe cutter failure and figure 3 illustrates the end result of such cutter development.

Fig. 1. Cutter roof failure diagram (modified from Kripakov, 1982; Nichols, 1978; Stefanko, 1983).

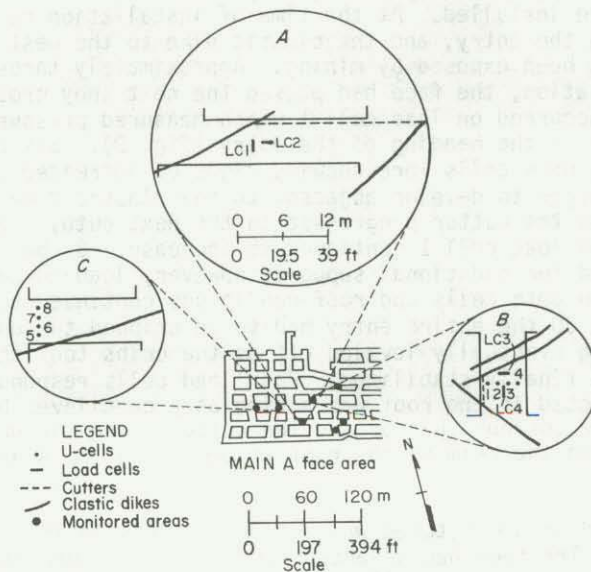
Fig. 8. Location map of monitored areas.

The first area monitored was in the L-1 entry of Main A; two load cells were installed (fig. 8, A). The entry had been advanced to a position approximately 3 m (10 ft) west of load cell 1 when the cells were installed. At the time of installation no cutter had formed in the entry, and the clastic dike to the west of the cells had not been exposed by mining. Approximately three days after installation, the face had passed the next inby crosscut, and loading occurred on load cell 1 which measured pressure changes perpendicular to the heading of the entry (fig. 9). Six days after installation, both cells were showing signs of increased loading as a cutter began to develop adjacent to the clastic dike just inby the cells. As the cutter progressed to the next outby clastic dike, the loading on load cell 1 continued to increase. By day 10 posts were installed for additional support; however, loading continued to increase on both cells and roof conditions continued to deteriorate. On day 30 the entire entry had to be cribbed to control the roof. Loading eventually leveled off as the cribs took the load, and the entry finally stabilized. Both load cells responded as would be expected if the roof was acting as a cantilever beam with support on the southern pillar and the cutter along the northern pillar allowing the beam of the roof to bend (fig. 8, A and fig. 9).

The second area monitored was a crosscut between the belt and track entry. The face had advanced to a position approximately 3 m (10 ft) north of load cell 3 (fig. 8, B). Based on the first experience of monitoring cutter development, it was decided that

U-cells would be installed on a row of bolts across the entry to measure bolt loading in addition to using load cells. The clastic dikes just north of the cells had not yet been exposed by mining when all of the U-cells and load cells were installed (fig. 8, B).

In the next area (fig. 8, C) trusses were being used on a regular basis and had been successful in deterring the formation of cutters. Shortly after this cut was mined, some rock did fall from the clastic dike in the roof, but this activity ceased once trusses were installed. Figure 13 shows the total loading seen by each U-cell across the entry. Very little total loading occurred on U-cells 6 and 8, and U-cells 5 and 7 actually bled off. Bleed off of loading on bolts is also natural if there is no new inducement of load (Roberts, 1980).
