GATE DESIGN KEY TO BUMP CONTROL

Bump-related fatalities in the Appalachian coalfields spur investigation by U.S. Bureau of Mines

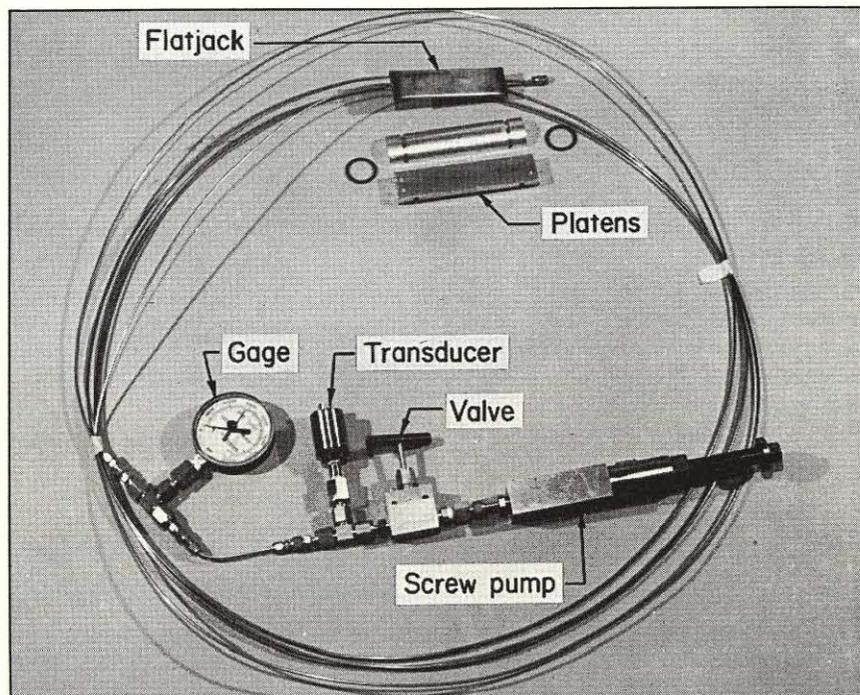
Fig. 1—Borehole platened flatjack configuration equipment that is used to monitor rock movements which proceed bumps.

seam on Island Creek Coal property, were evaluated using two detailed instrument arrays and in-mine observations. The state-of-the-art instrumentation arrays consisted of stainless-steel, borehole platened flatjacks used to indicate changes in pillar stress, coal extensometers for measuring pillar dilation, convergence stations for measuring roof-to-floor closure, a differential roof-sag indicator, and a differential floor-heave indicator. A permissible data acquisition system was employed to continuously monitor coalbed stress (Fig. 1) and roof-to-floor convergence in hazardous areas.
