# OCCURRENCE AND REMEDIATION OF COAL MINE BUMPS: A HISTORICAL REVIEW

By Anthony T. Iannacchione<sup>1</sup> and Joseph C. Zelanko<sup>2</sup>

Pittsburgh Research Center, U.S. Bureau of Mines, Pittsburgh, PA.

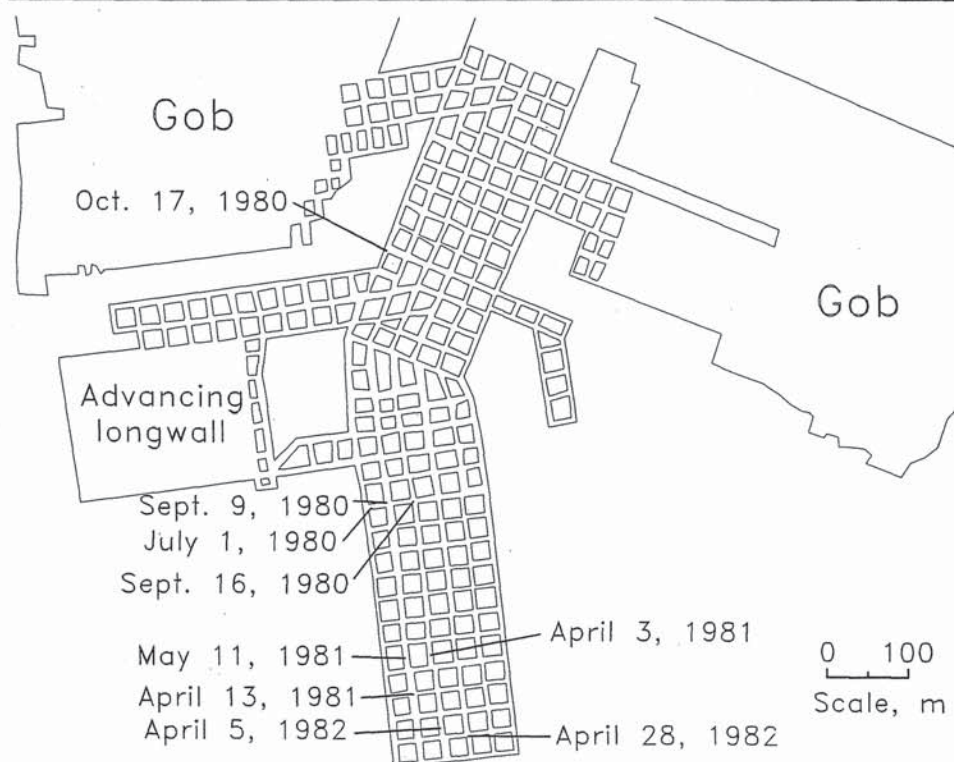
**Figure 2**

**Location and Dates of Bumps Reported at L. S. Wood Mine, Redstone, Pitkin County, CO.**

The L. S. Wood Mine experienced nine bumps during development of the Main Slope section between July 1980 and April 1982. All these bumps were associated with overburden greater than 600 m. Four bumps took place near one of two adjacent gobs (figure 2). Although the bumps exhibited tremendous force, the skilled work force at the mine was always able to avoid being "caught" by the bump so no miners were injured in any of these events. Eight bumps occurred during or shortly after mining and displaced large volumes of rib coal near the mining zone.

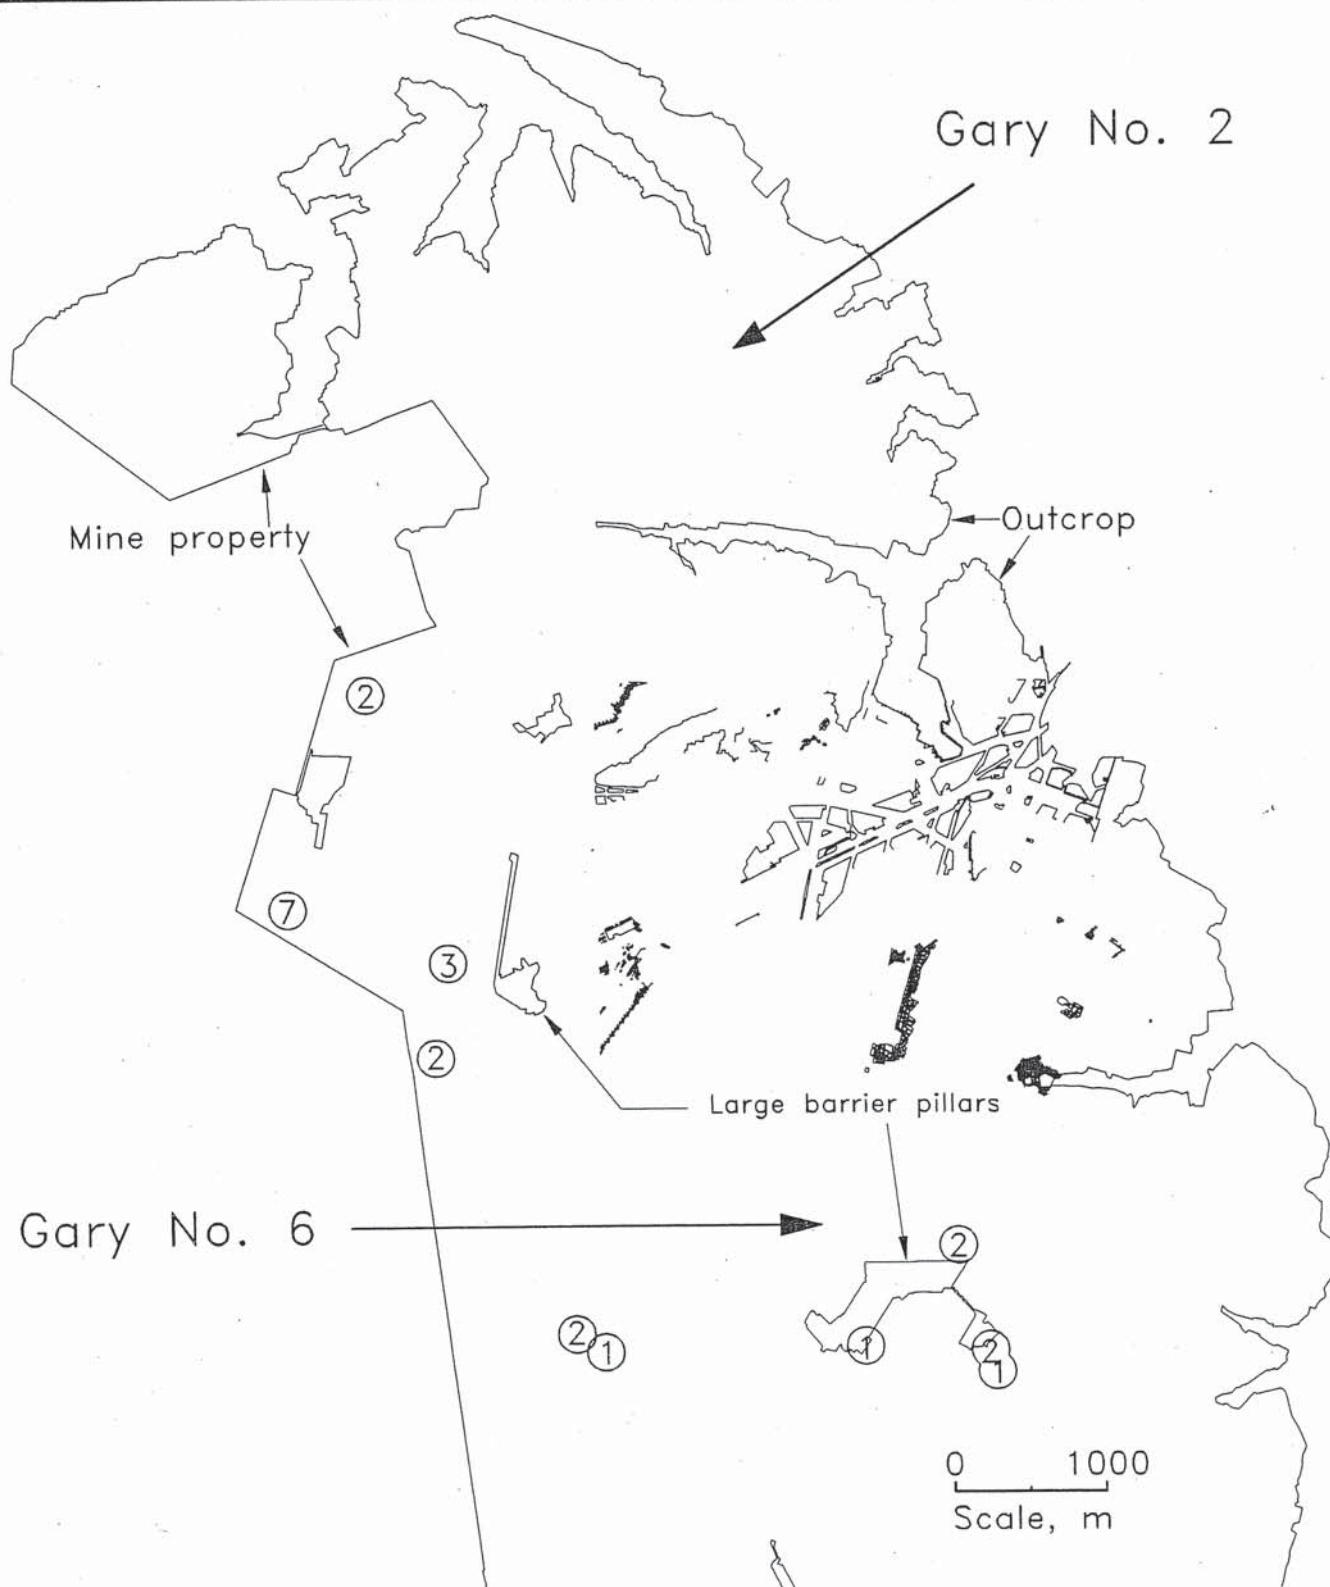
**Figure 3.**  
**Location of Bumps Reported at Gary No. 2 and 6 Mines, McDowell County, WV.**

Bumps at the Gary Mines in the 1950's were associated with a variety of factors (figure 3). Mining in the first half of the 20th century undoubtedly resulted in the bump-prone mining scenarios faced in the 1950's. For example, mining was conducted adjacent to gob areas created decades earlier, retreat sections operated on groups of pillars of irregular sizes and shapes, and much of the mining was directed to recovering barriers between old workings.

Circled numbers indicate number of bumps at various locations.

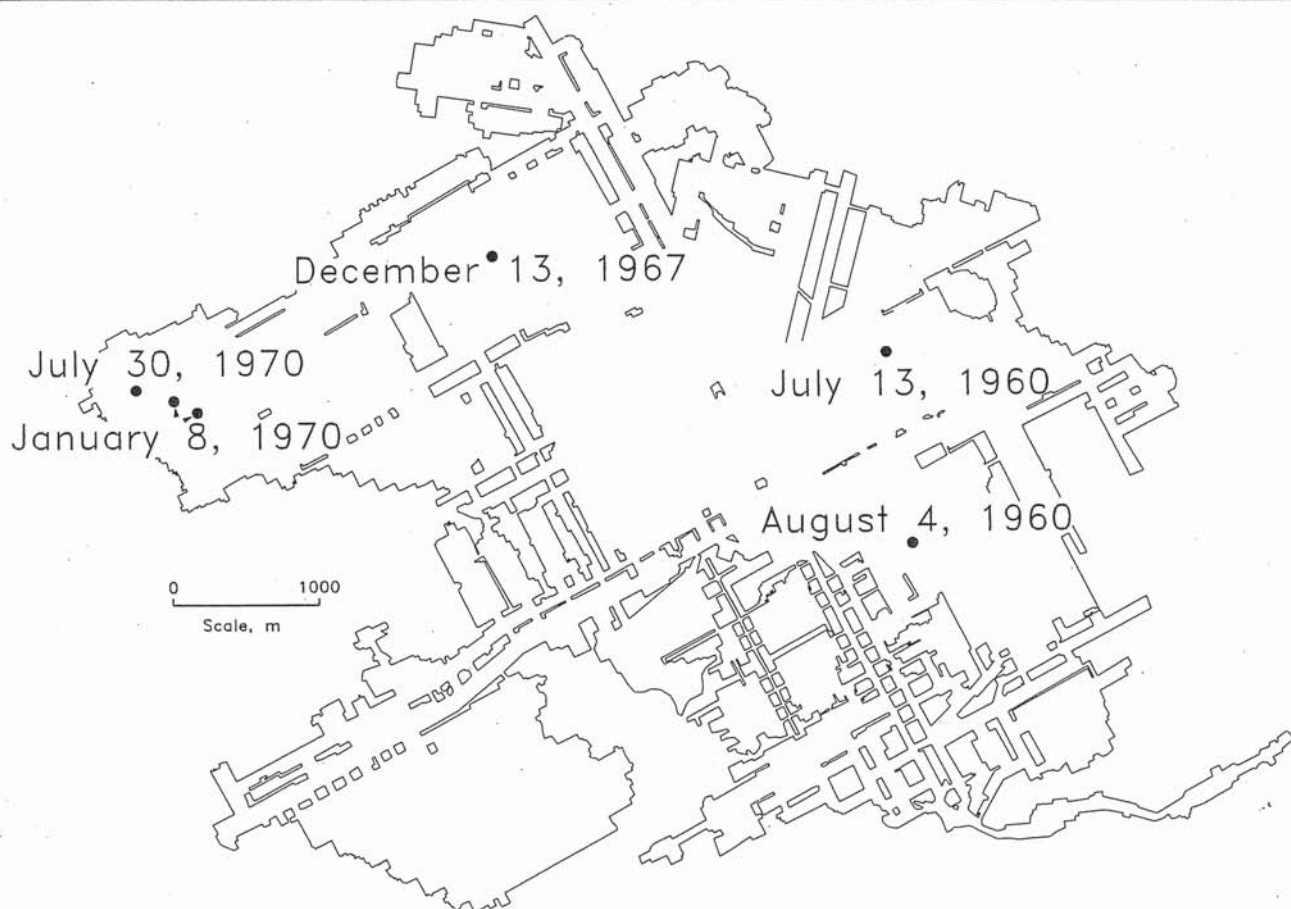
**Figure 4****Location and Dates of Bumps Reported at Moss No. 2 Mine, Russell County, VA.**

The Moss No. 2 Mine near Dante, VA, was extensively mined by Clinchfield Coal Co., from the 1950's to the 1970's in 1.2 m of the Tiller Coalbed. During this time, five bumps were recorded and are part of the USBM database (figure 4). The mine utilized a multientry development system, followed by room-and-pillar mining. Extraction of pillars was accomplished primarily by the split-and-fender method. Rooms were typically driven 23 m apart and 6 m wide with crosscuts every 23 m. More than 100 sections were developed and pillared using some variation of this method. One of the first longwall sections in the United States was employed at this site in the late 1960's and 1970's. Twenty-two longwall panels of varying length were extracted.

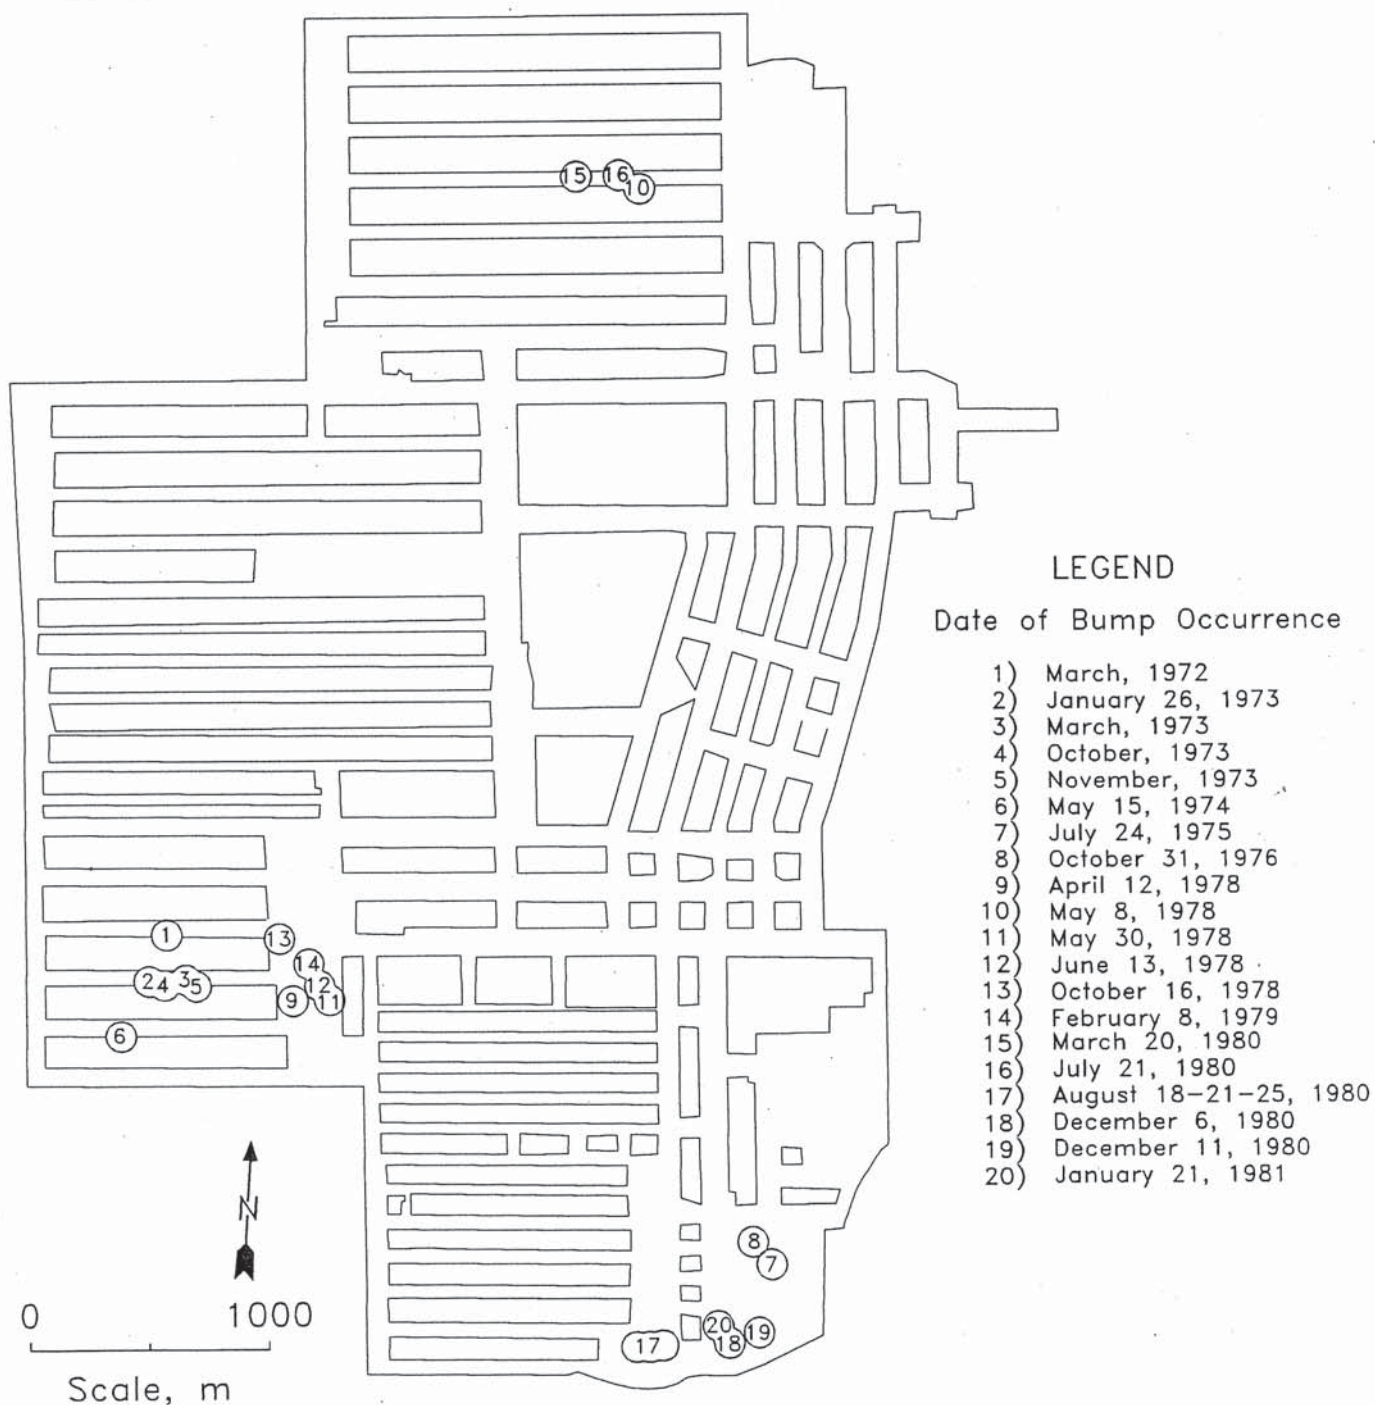
**Figure 5**  
**Location and Dates of Bumps Reported at Beatrice Mine, Buchanan County, VA.**

The Beatrice Mine near Keen Mountain, VA, reported 24 bumps between 1972 and 1981 (figure 5). This high

The Beatrice Mine had extensive experience with bumps during longwall mining in its southern portion during the early 1970's (figure 5). Early longwall equipment included a plow and 94 hydraulic legs and canopy units having a capacity of 127 t. Many of the same conditions responsible for bumps at the Moss No. 2 Mine were also found at the Beatrice Mine. Overburden in the south longwall district ranged from 700 to 760 m. Roof strata in these areas apparently changed from a laminated shale and sandstone sequence with coal streaks to predominately sandstone intermixed with siltstone layers. The gate entry design at the Beatrice Mine consisted of a yield-yield-abutment system. The pillars were 24 m long and none were offset. The yield and abutment pillars were 9 and 24 m wide, respectively.

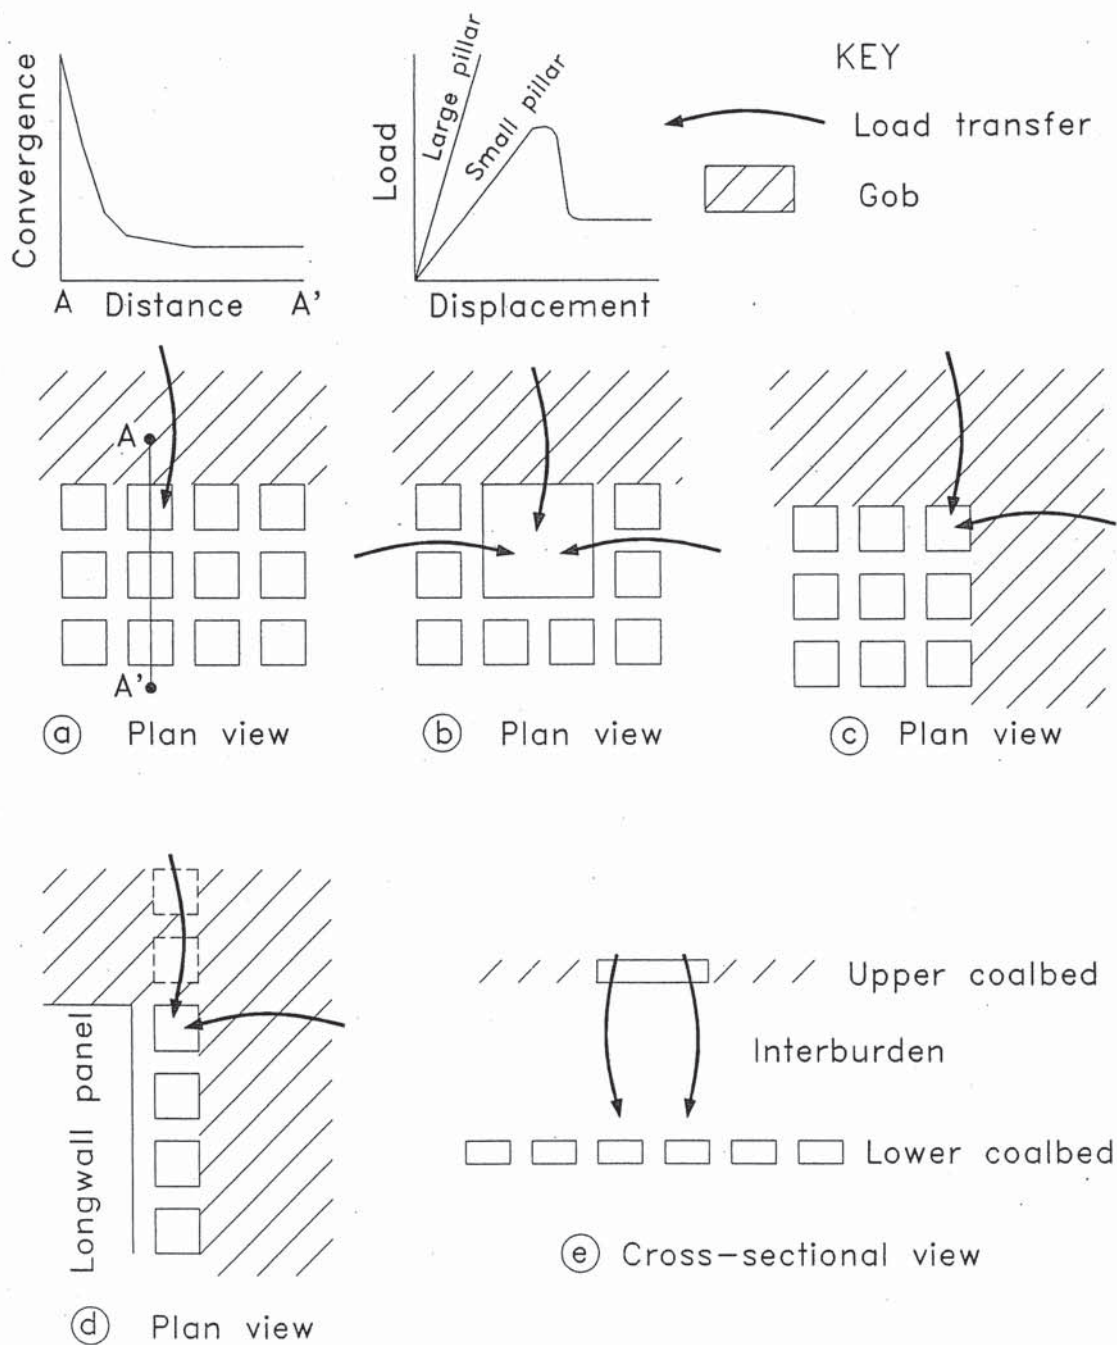
**Figure 8**  
**Generalized Examples Showing How Different Full-Extraction Mining Scenarios Transfer Load to Pillar Structures.**

Pillars adjacent to gob areas experience elevated loading conditions from the unsupported strata above the gob (figure 8A). Certain mining geometries, such as a large pillar surrounded by smaller pillars, can concentrate stress (figure 8B). Large pillars can be imagined as stiff structures that tend to deform or converge less than smaller, less stiff pillars. These larger structures tend to gather load, increasing the potential for violent failure as the smaller pillars are extracted within and around them.

(figures 8C and 8D) and overlying large pillars or barriers in multiple-seam mining operations can cause excessive pressures (figure 8E). Fortunately, all of the preceding conditions lend themselves to engineering solutions, many of which are discussed later with actual examples.

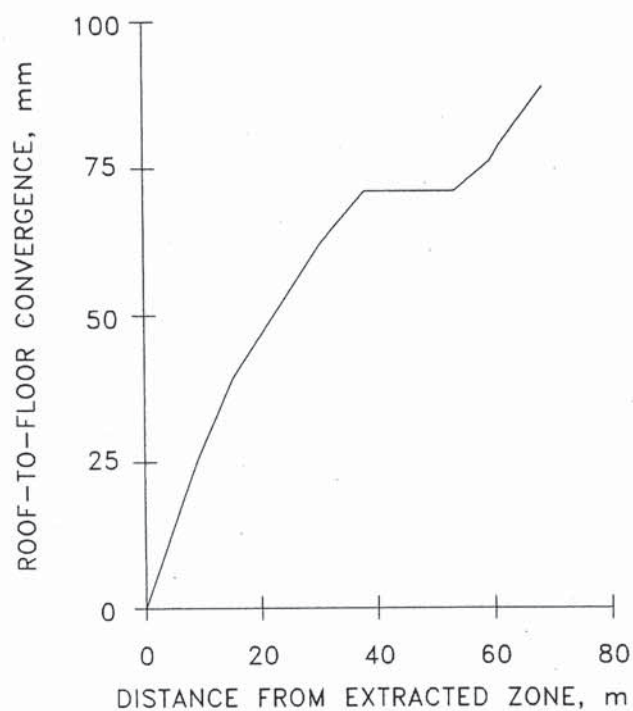
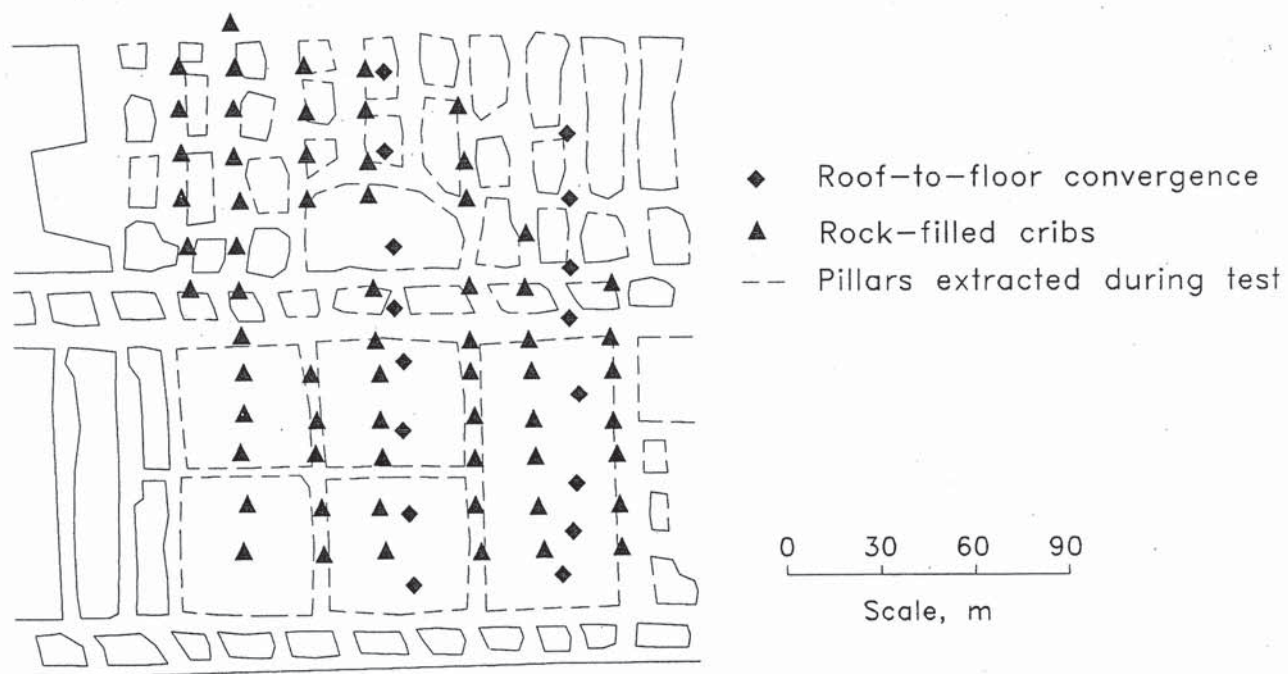
Bryson (3) described a detailed field test of this design method at a deep mine in the Harlan Coalbed, Cumberland Mining District, under 430 m of cover. Bumps had killed five miners at this particular site. Figure 25 shows the test area, which was approximately 210 m wide and adjacent to a large gob area. Rooms were driven approximately 91 m between the support entries, which were about 10.7 m wide. Prior to the extraction phase, the study area was composed of a series of narrow (10.7 m wide) and large (43 m wide) pillars. As the section was mined, 16 roof-to-floor convergence stations and 64 rock-filled cribs were installed.

6. Use the open-ended extraction technique with lifts of not more than 4.3 m.
7. Leave one or two rows of pillars adjacent to old gob areas.
8. Maintain pillars at the same size and shape.
9. Keep development entries narrow, approximately 4.3 m.
10. Note areas of rolls, changes in dip, and changes in coal thickness and hardness. Use this information in designing the mining system.
