Ground Failures in Coal Mines with Weak Roof

Greg Molinda, MS

Chris Mark, PhD

*Principal Research Engineer (cnm7@cdc.gov)
National Institute for Occupational Safety and Health (NIOSH)
P.O. Box 18070, Cochrans Mill Rd. Pgh., PA 15236*

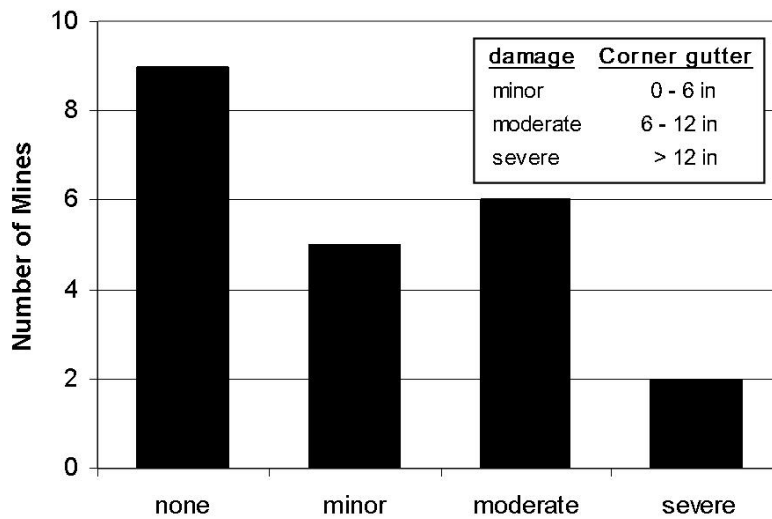
Six of the mines visited reported problems with stackrock in the roof. Three of the mines are in the Illinois Basin and three are in the Northern Appalachian Basin. Since stackrock is a relatively stable sequence in the absence of horizontal stress, roof falls related to stackrock may indicate an increased horizontal stress is attacking the roof. The average depth of cover over the 6 mines is 280 ft. This relatively shallow cover indicates that the horizontal stress is related to a regional, in situ stress field. Eight of 22 mines visited report moderate to severe horizontal stress damage to the roof (**Fig. 3**). Damage from horizontal stress can be difficult to control and require a reorientation of the mine workings to reduce damage.

Figure 3: Distribution of horizontal stress damage in study mines.

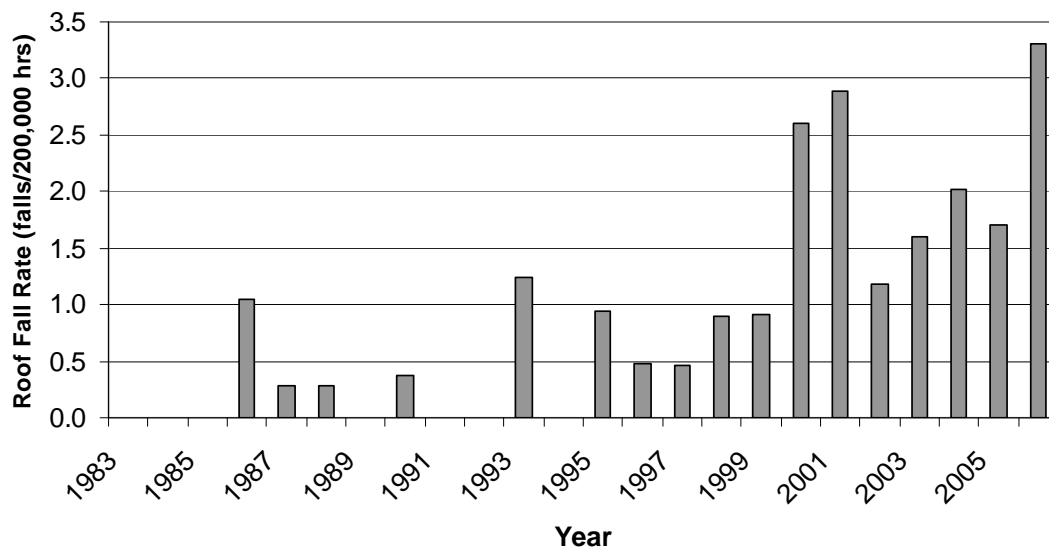
At the study mine roof deterioration and falls are time-dependant and much more frequent in the older workings (Fig. 28). More than 90% of the falls occur 2 or more years after mining. Roof falls are directly related to deterioration of rock between bolts. Roof and rib damage due to weathering steadily decreases when travelling away from the shaft from older workings into newer workings. Roof falls typically begin to occur 4-7 yrs after mining after rib guttering has severed the roof beam. In places where there is humidity roof conditions are extremely poor.

Figure 28: Reportable roof falls increase with time and roof deterioration at an Illinois mine.

Such extreme weakness and moisture-sensitivity forced the mine to reduce entry width to 16 ft, and use a dense 6 bolts per row roof pattern to cut down the spacing between roof bolts. Each row consists of four, 9 ft, point anchored, resin-assisted bolts, with two 4 ft “cutter” bolts angled over the rib to support the corner. The entire roof was screened with welded steel wire. Even though the roof is essentially rubbleized, the roof screen, supported by the dense roof bolt pattern, is effectively controlling it (Fig. 29).

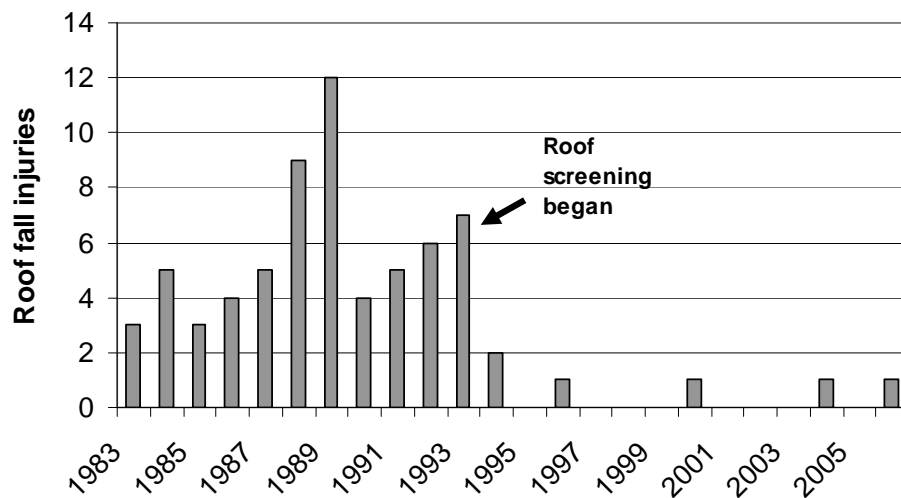
Figure 31: Roof fall injuries dropped dramatically with the use of roof screen at an Illinois coal mine.

The roof fall rate was calculated for those areas where roof screen was installed, and compared against those areas with no roof screen. The roof fall rate was 10.1 falls/10,000 ft of drivage for unscreened areas and was reduced to 2.5 roof falls/10,000 ft of drivage for areas with full screen. Roof fall injuries also decreased dramatically in the screened areas (Fig. 31).
