Determination of volumetric changes at an underground stone mine: a photogrammetry case study

Slaker Brent^{a,*}, Westman Erik^a, Ellenberger John^b, Murphy Michael^b

^b Office of Mine Safety and Health Research, NIOSH, Pittsburgh, PA 15236, USA

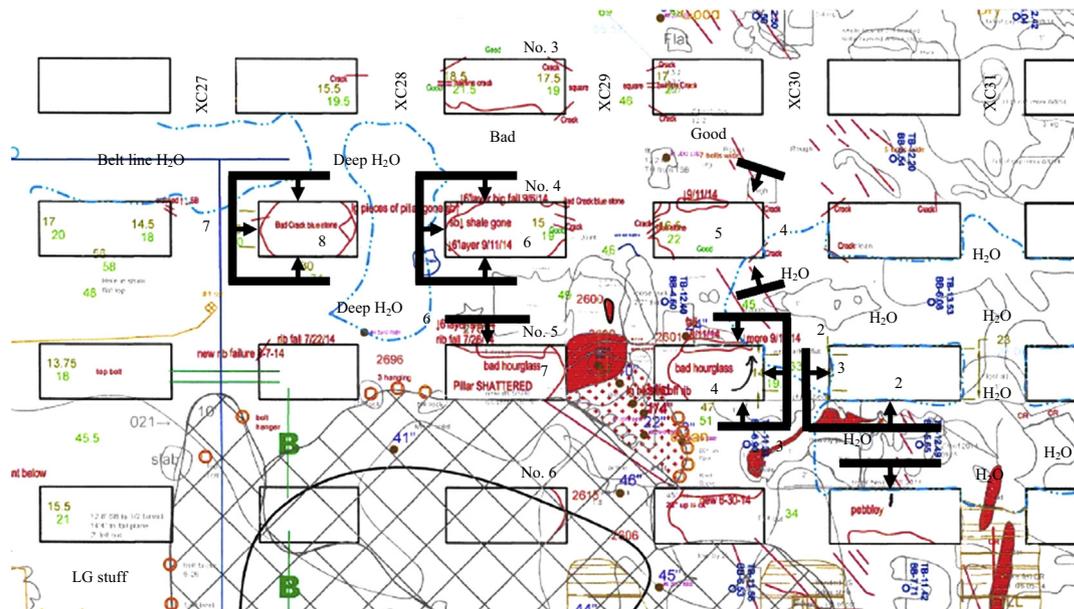
A map of the pillars that were photographed is shown in Fig. 1. The pillars are on the boundary of a collapsed area. The number of photographs taken of each pillar is listed in Table 2. With the need to move the light sources, the pictures were not taken continuously surrounding the pillar, but rather in distinct segments, fragmenting the pillar into “sides” instead of one contiguous object. Further displacement of material, through spalling, on these pillars was expected, but the magnitude of material being displaced was unknown.

Fig. 1. Map of the photographed areas of the mine with pillars numbered.
