# LINE OF DUTY DEATH REPORT

REPORT F2023-12 • March 2025

## ***Career Firefighter Dies After Falling into a Light/Air Shaft during a Fire in a Four-Story Mixed Occupancy Structure – Illinois***

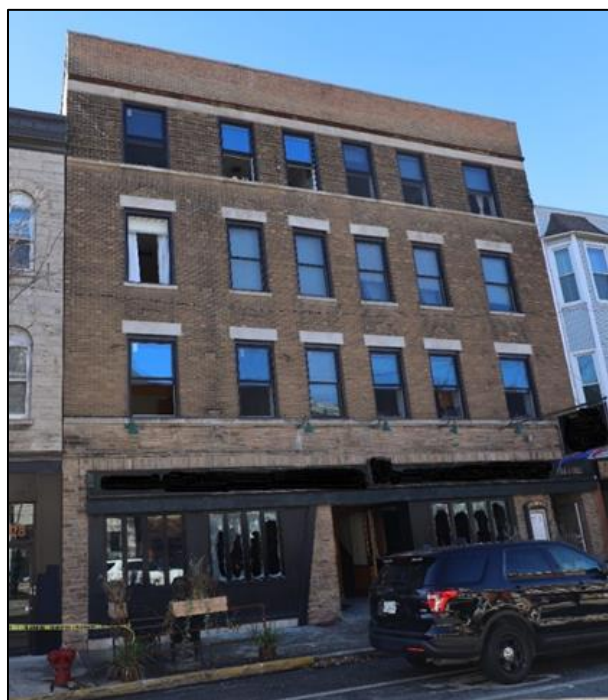
**A view of the structure from side Alpha.**  
*(Photo courtesy of the Fire Marshal's Office)*

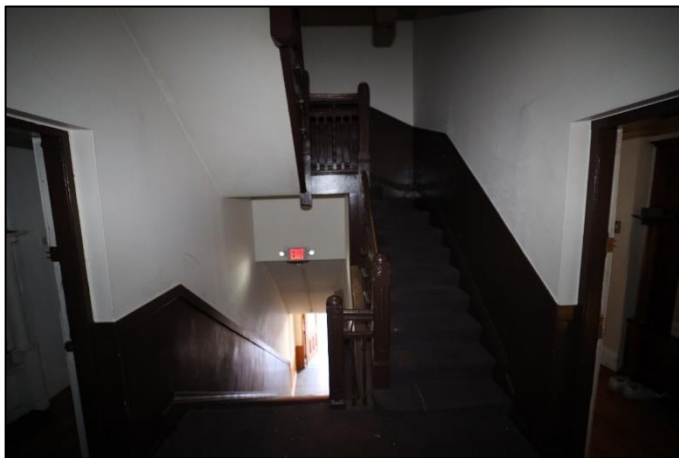
**Photo 1. View of stairway leading to upper floor apartments**  
*(Photo courtesy of Fire Marshal's Office)*

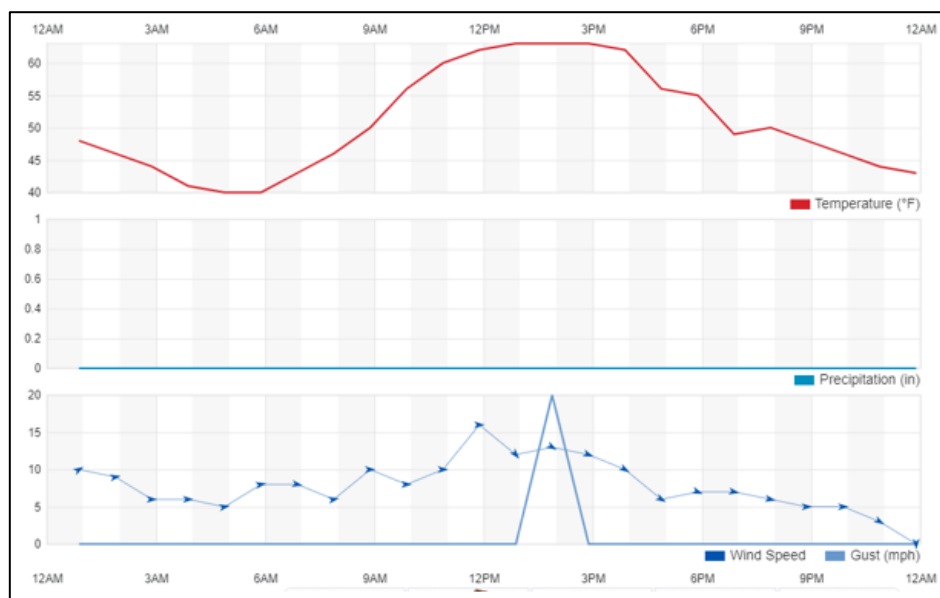
On November 13, 2023, at 05:53 hours, the weather was clear with winds out of the west at 8 mph with no reported wind gust. The temperature was 40°F, the dew point was 31°F, the humidity was 70%, and the barometric pressure was 29.63 inches. There had been no precipitation in the past 24 hours [Weather Underground 2023]. As detailed later, the temperature inversion shown in this graph impacted the smoke, preventing it from rising and impairing visibility. The sunrise time was at 06:31 hours.

**Graph 1. Weather conditions on November 13, 2023.**  
(Courtesy of Weather Underground)

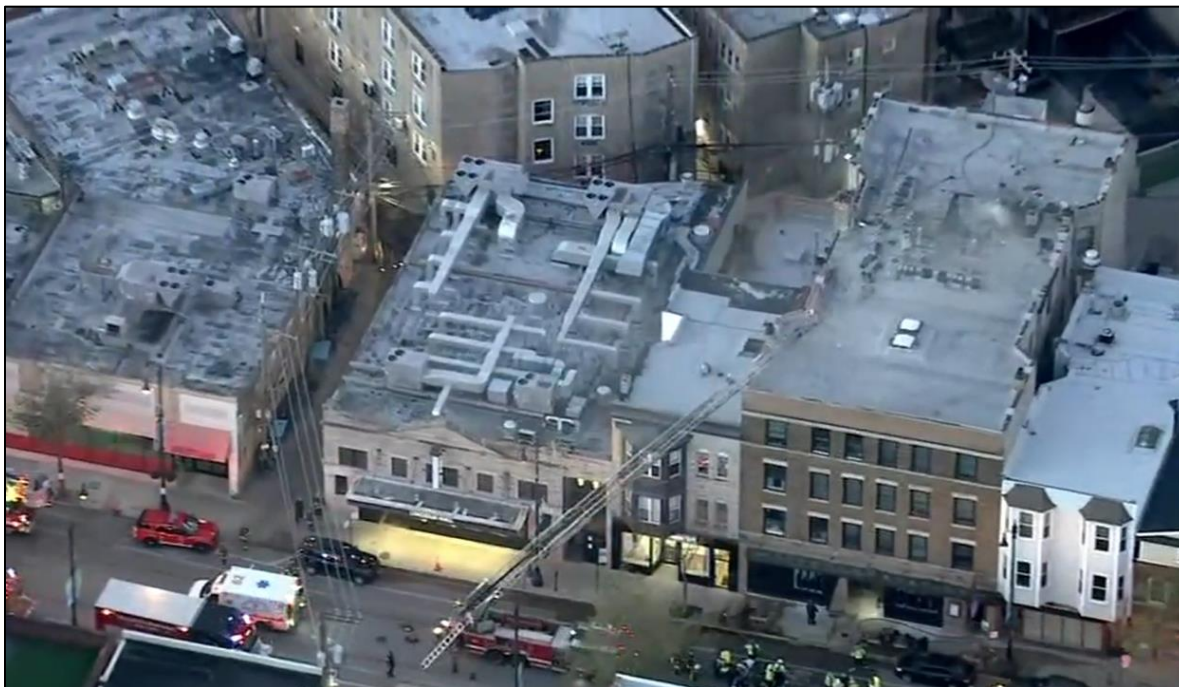
On November 13, 2023, a 39-year-old male career firefighter fell down a light/air shaft while conducting roof operations. The communications center received a 9-1-1 call at 05:27 hours from an employee who arrived to work at a restaurant, located in a four-story mixed occupancy building. She opened the front door and observed white smoke throughout the rear of the restaurant where the kitchen was located. At approximately 05:29 hours, the dispatch was issued for a “Still” alarm Box 103607. E55, T44, BC12, E22, and TL10 were dispatched for a structure fire. The first arriving unit was BC12, at 05:31:20 hours. He met with the caller who reported that the kitchen of the restaurant was on fire. Along with the caller, BC12 proceeded to the rear of the building where he observed smoke emanating from a north facing door in the alley on the west side of the structure. At 05:31:48 hours, E55 arrived on-scene simultaneously with T44 and was positioned northbound approximately two buildings past the fire location. T44 approached the building from the West, positioning the apparatus at the front of the building. T44’s aerial ladder was raised and placed on the Southeast corner of the roof (**see Photo 4**).

**Photo 4. View of Truck 44's position**  
*(Photo courtesy of fire department)*

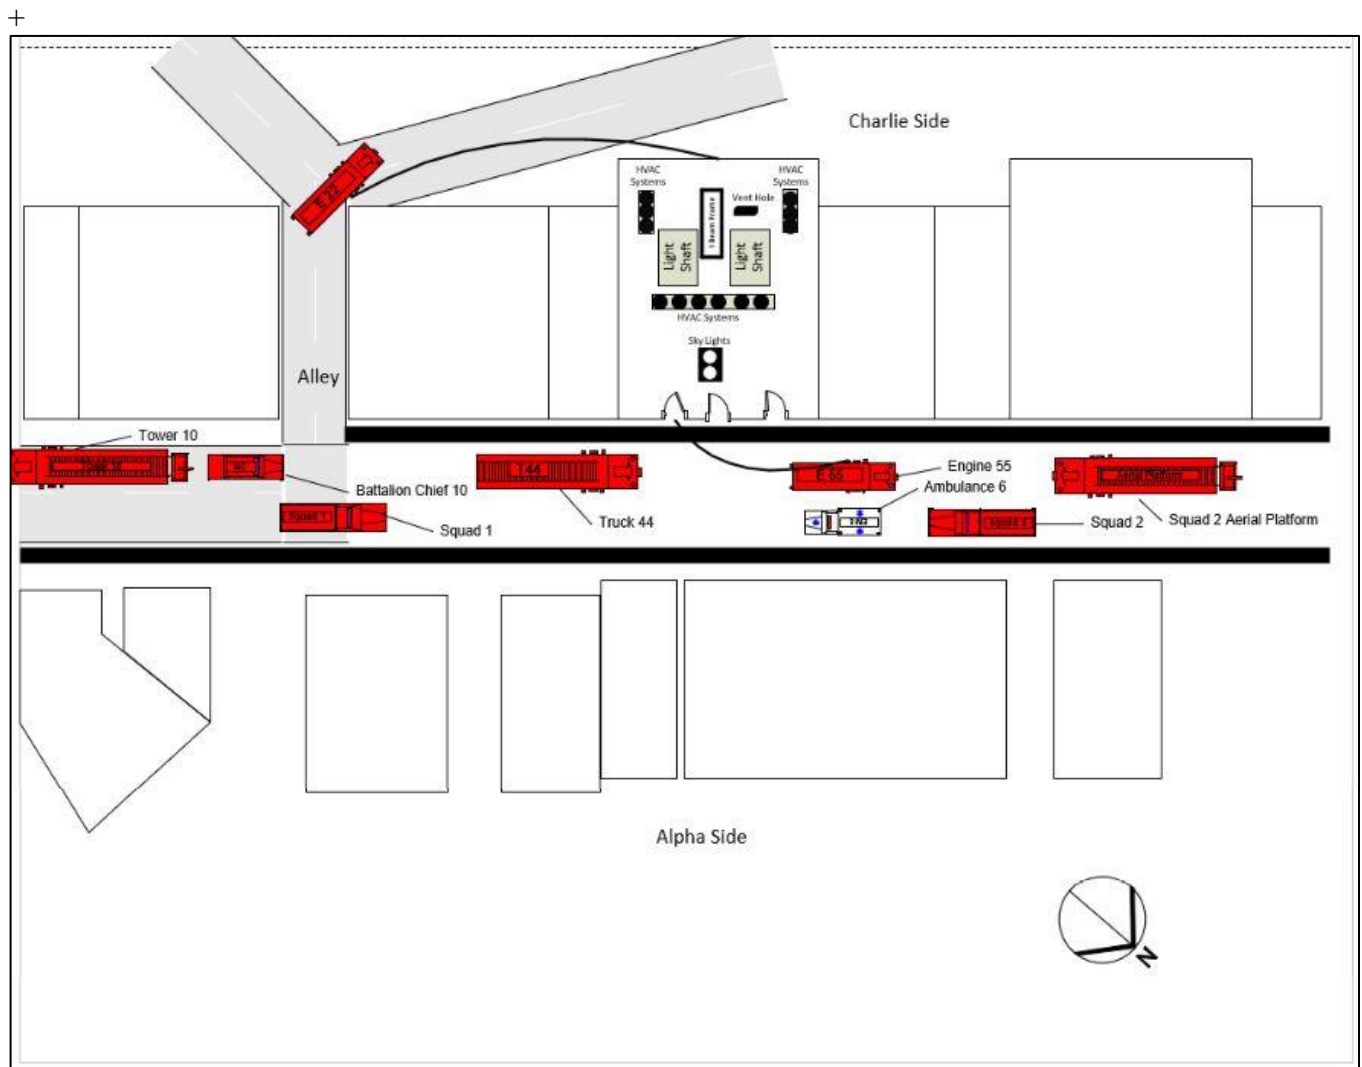
**Figure 1. Scene diagram showing apparatus and hose line placement**  
(Courtesy of NIOSH)

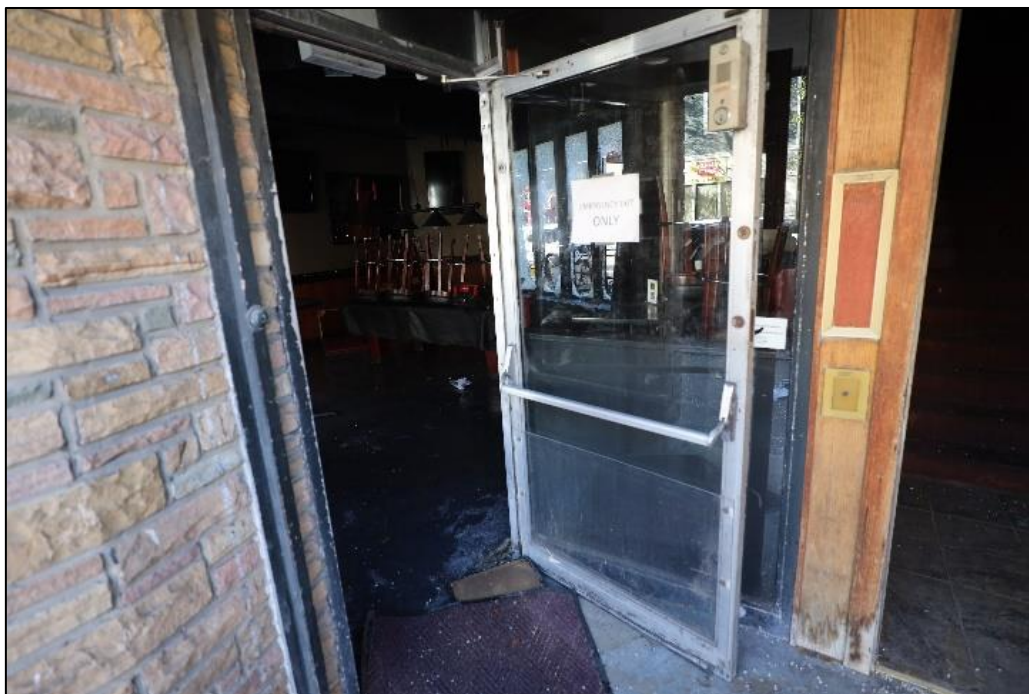
Initial size-up indicated a light haze was present along with the odor of smoke in the area. Units received notification over the radio from BC12 that the fire was located at the rear of the structure at 05:32:42 hours with E22 being directed to the rear alley. E55 stretched 550' of 2½" hose that supplied 150' of 1¾" attack hose through a wye, preparing to make an interior attack. The crew of E55 entered the building through a side Alpha glass door, followed by a wooden door that was forced open by T44 (see **Photo 5**).

**Photo 5. View of the attack crew's entry point to the restaurant on side Alpha.**  
*(Photo courtesy of Fire Marshal's Office)*

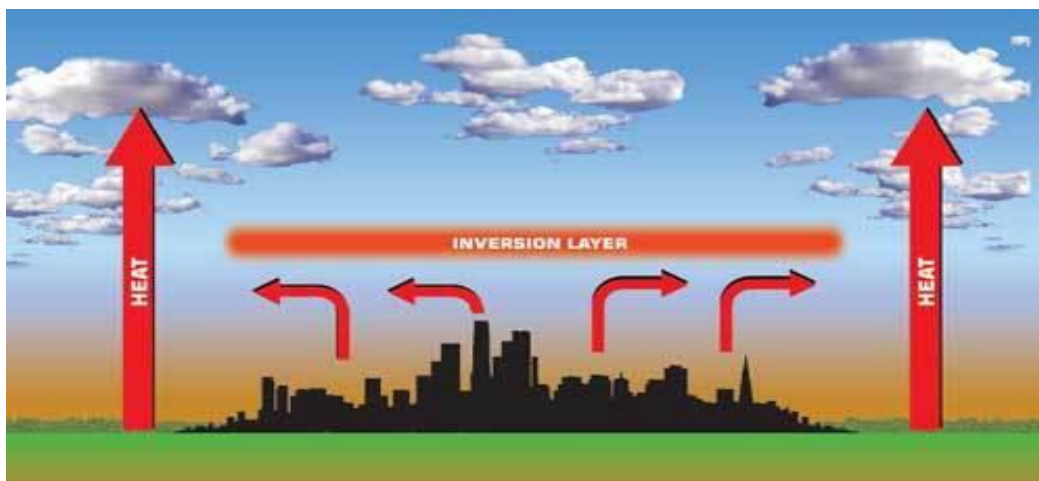
Surface inversion is a form of temperature inversion that usually takes place on a cloudless night with little or no wind present, creating the perfect conditions for heat to escape rapidly from the surface. As a result, the air at the surface cools down much more quickly than the air above it in the atmosphere, creating a low-lying temperature inversion. The temperature inversion causes the warm air to cap cooler air which can trap smoke in the cooler air under the warmer temperatures. This event combined with the darkness added to the reduced visibility for the personnel operating on the roof during this incident.

**Figure 2. Example of heat inversion affecting smoke movement.**  
(Photo courtesy of ownyourweather.com)
