**LINE OF DUTY
DEATH REPORT
REPORT SLIDES**

F2024-02

Career Engine Company Officer
Dies in Abandoned, Single-
Family Structure Fire – North
Carolina

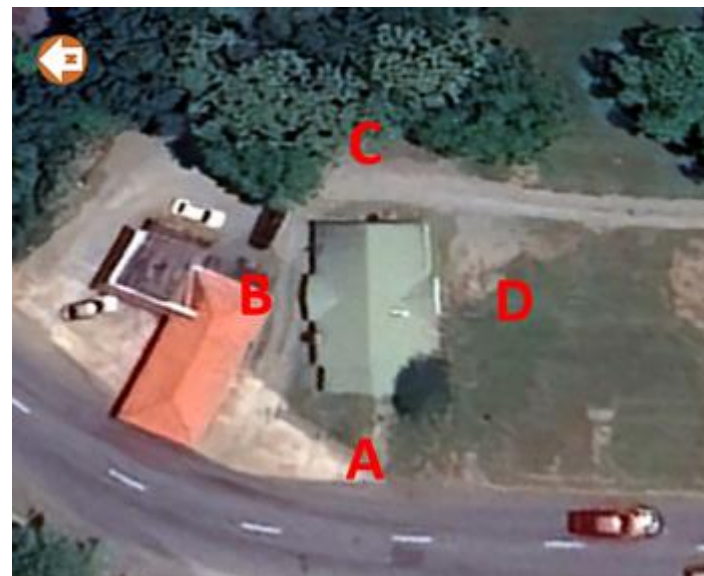
Aerial view of structure with sides of the structure labeled A (Alpha), B (Bravo), C (Charlie), and D (Delta) (Courtesy of: Google Earth)
