# SERIOUS INJURY REPORT

REPORT F2024-03 • April 2025

## ***Career Firefighter Seriously Injured During Search Operations in a Residential Structure Fire – Oregon***

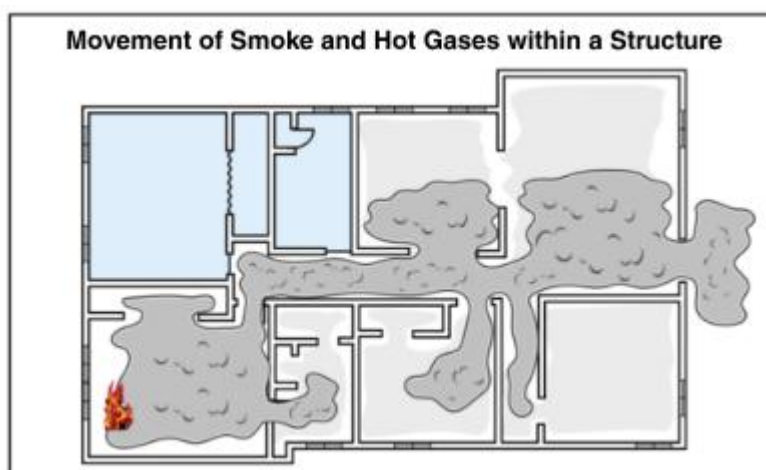
The International Fire Service Training Association (IFSTA) notes in the 7th Edition of the Essentials of Firefighting that, “when firefighters advance a hoseline or ventilate windows to make entry into a building, they establish new flow paths between the fire compartment (in this case the location) and exterior vents of the building” (see **Figure 1**) [IFSTA 2018].

**Figure 1. Movement of Smoke. (Courtesy of IFSTA)**
