Report of Investigations 8453

**Documentation and Analysis
of a Massive Rock Failure
at the Bautsch Mine, Galena, Ill.**

By Jack Touseull and Charles Rich, Jr.

**BUREAU OF MINES
Lindsay D. Norman, Acting Director**

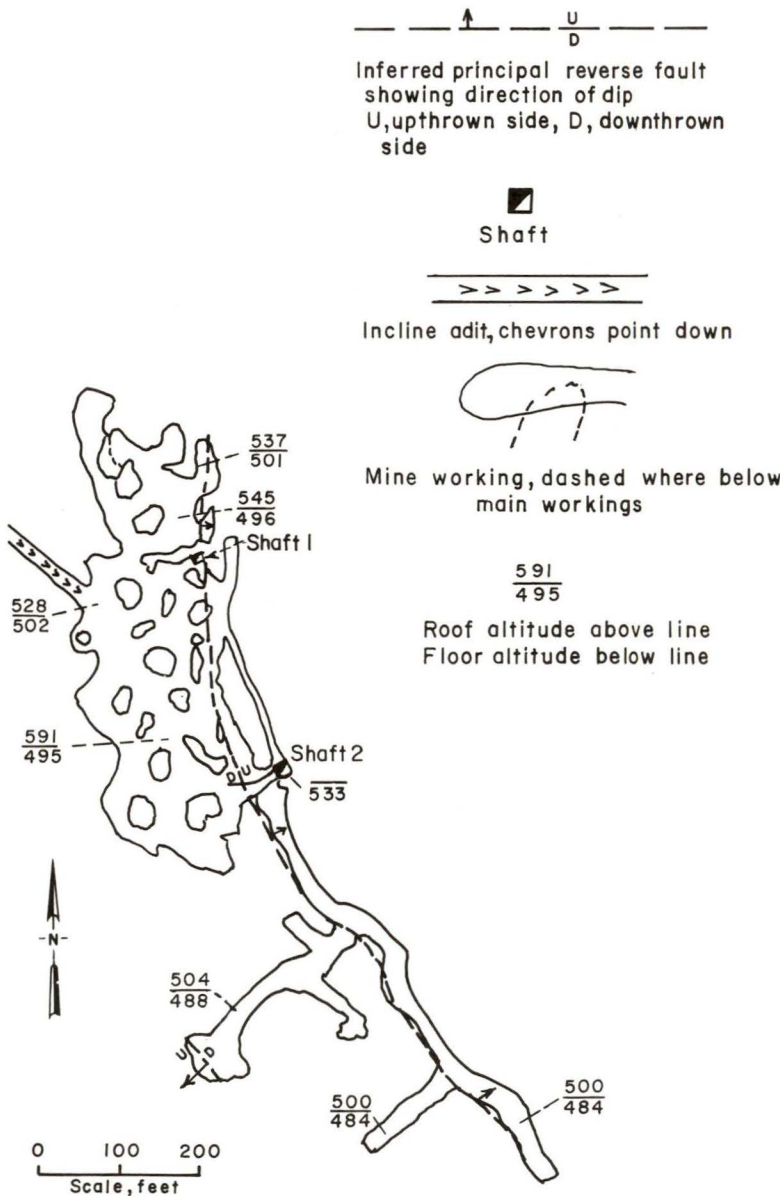
FIGURE 3. - Map of Bautsch mine.

In 1949, the mine comprised an area of over 2.56 acres (10,359 square meters) and consisted of two shafts and a truck incline (fig. 3). Water was being pumped from the mine at a rate of about 1,500 gal/min (5,677 liters/min).

From the onset of mining in 1949 until sometime late in the fifties, the size and extent of underground workings were not large enough to result in any massive failures (fig. 3). Most of the mining dimensions were small, and only pilot drifts were in the area that failed. Hence, the roof during this time period was adequately supported, and any adverse external effects, such as those caused by rainfall, were compensated for by a large safety factor.

For the first two weeks in October, there was either no observations of, or increase, in activity. However, on the 14th or 15th of October, the high brow sluffed off above where pillar F was removed (fig. 3). The removal of that pillar had created a large, unsupported span, 150 feet (45.7 meters) where a bentonite layer existed about 20 feet above the original back. Hence, a long, narrow beam of rock was outlined, and with sufficient saturation and span, the brow failed. Activity during the 16th through the 22d of October was mainly in the form of minor slabbing from pillars and small parts of the brow working loose.

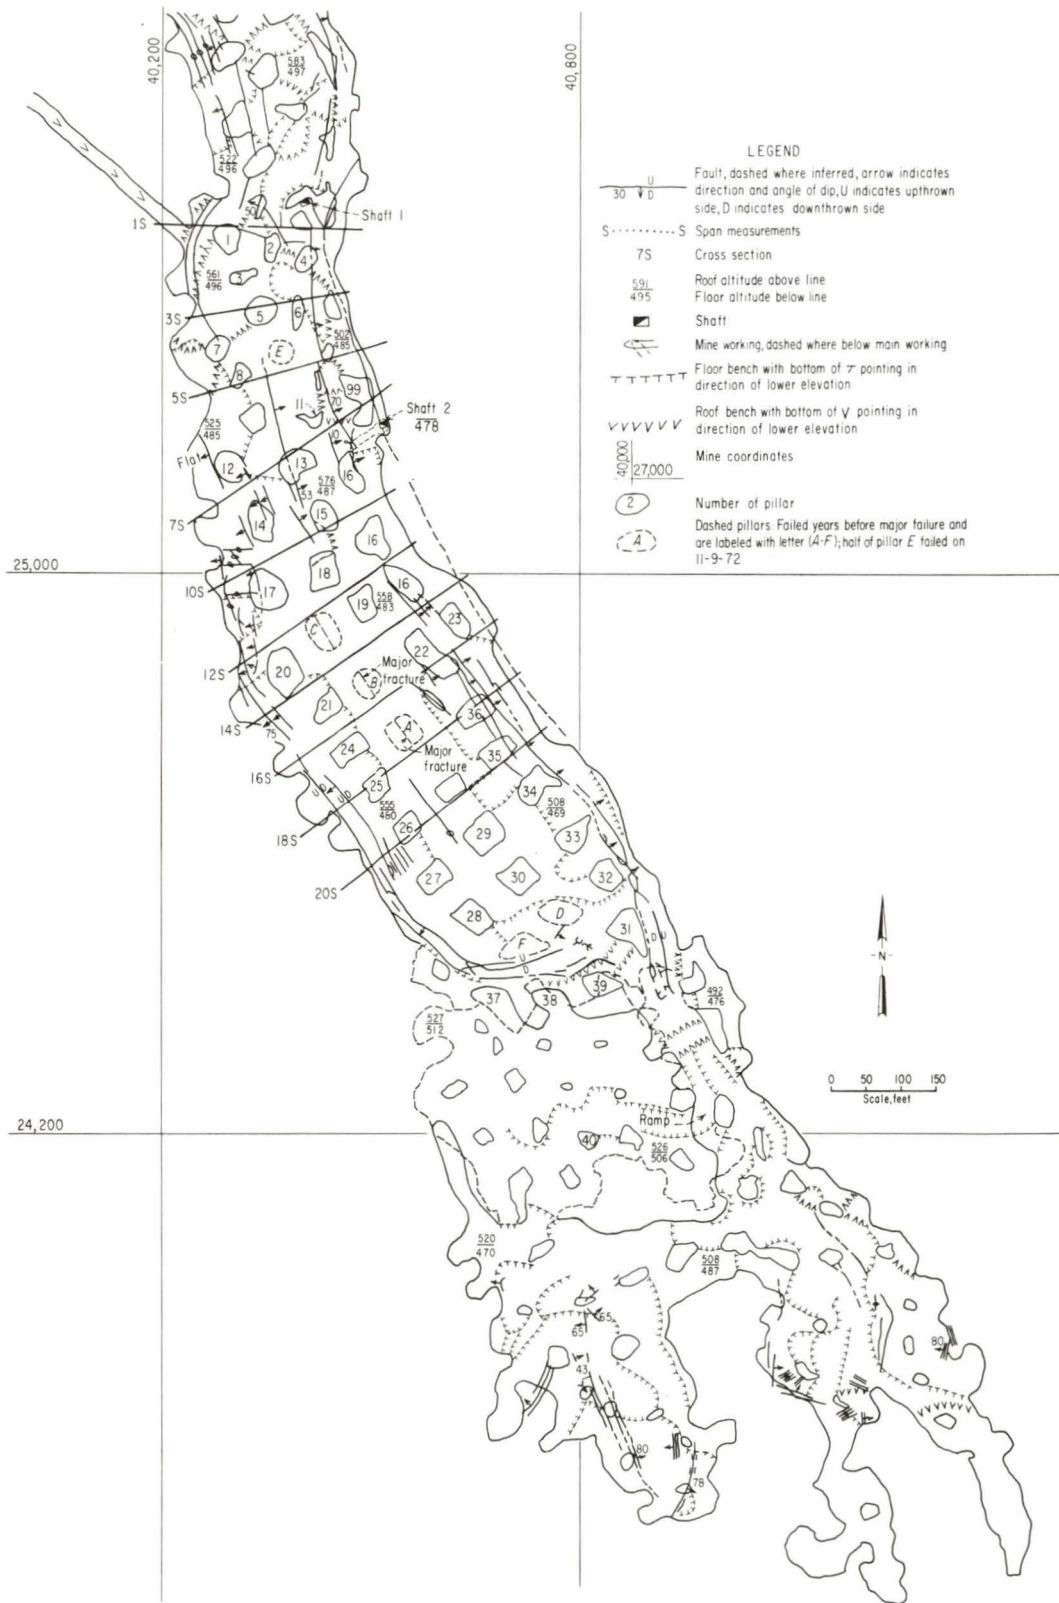
FIGURE 5. - Batsch mine geology—south.

Depending on the area of the mine, the pillars were irregular or rectangular in shape and randomly or regularly spaced. Pillar dimensions ranged from approximately 10 to 50 feet (3 to 15.2 meters) horizontally from 10 to 130 feet (3 to 39.6 meters) vertically. Unsupported spans ranged from approximately 20 to 130 feet (6.1 to 39.6 meters). Also, floor and back elevations are very irregular (figs. 5-6).

In the area of failure (fig. 4), the pillars were generally rectangular and regularly spaced; however, at the southern and northern ends, the pillars were rectangular and irregular in shape (figs. 5-6), respectively. Average dimensions of pillars in the failure area were 92 feet (28 meters) vertically and 36.75 feet (11.2 meters) horizontally. Average spans in the area were 75 feet (25.5 meters), with the mine's maximum span of 130 feet (39.6 meters) along section line U-U' in figure 4.

Reverse and bedding-plane faults, as described under the regional structure section, are common (figs 5 and 9, and appendix F). The cross sections in appendix F and in figure 9 show the contrast between the more steplike, weaker fault zone on the SW limb of the syncline, and the more numerous straighter reverse faults on the NE limb.

¹²23,790 N 41,320 E, figure 5.

September 9-10.--A large section fell off the third pillar from the base of the incline (between pillars 8 and 12) on the west side. For pillar numbers see figures 4 and 5.

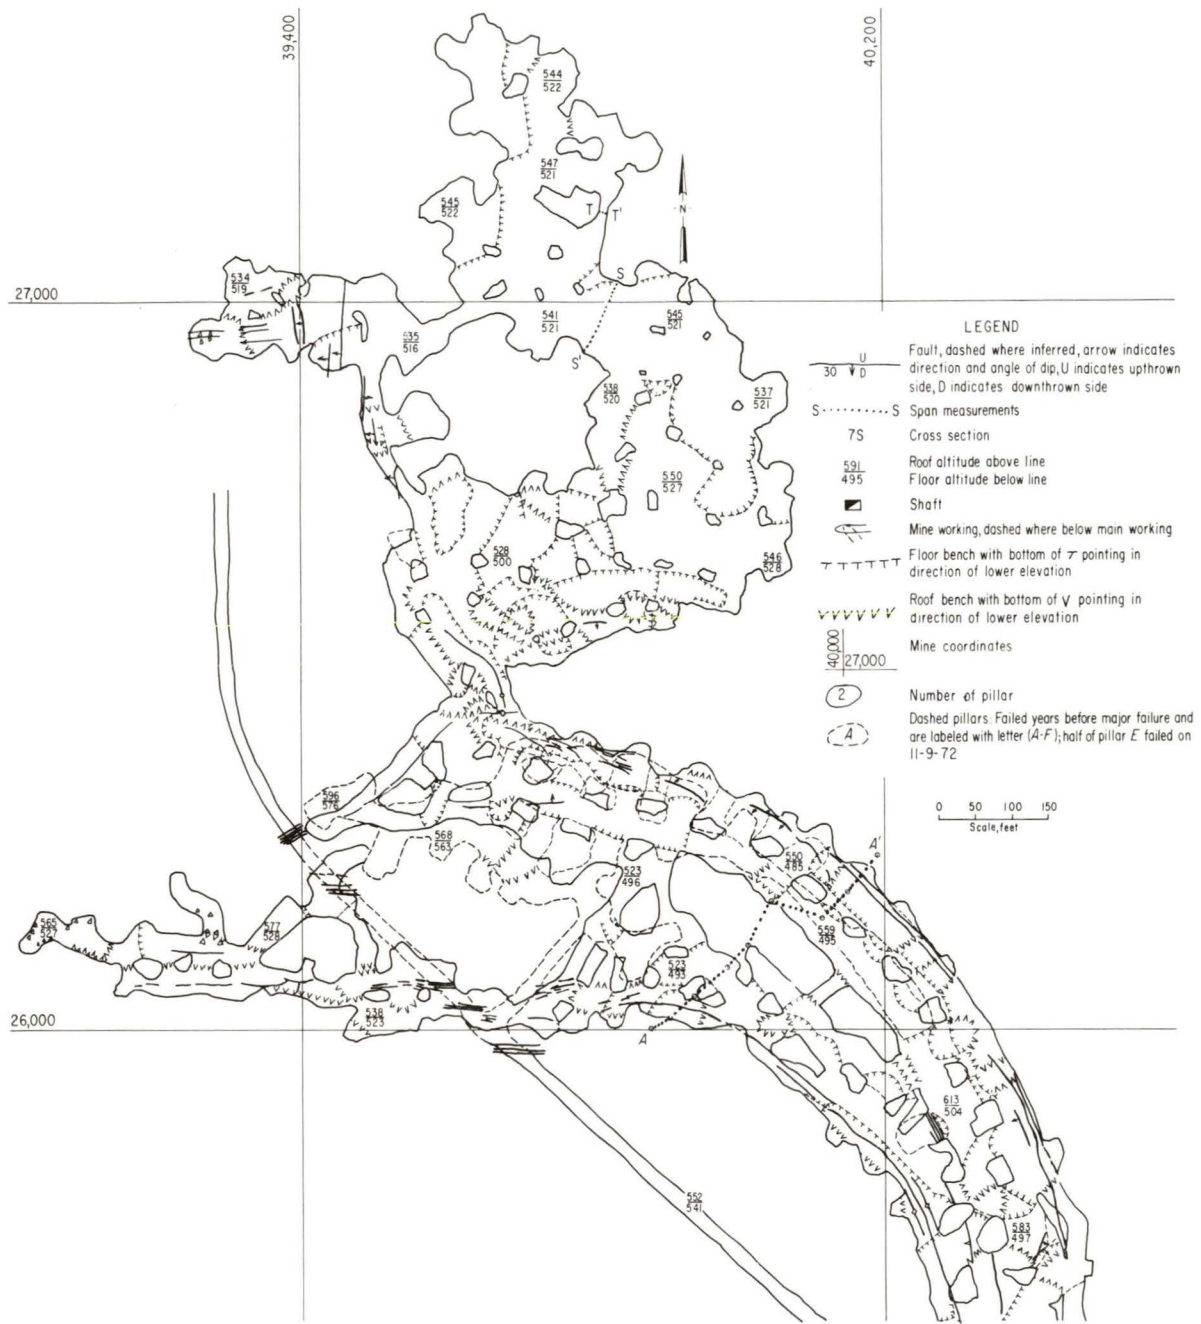
FIGURE 6. - Batsch mine geology—north.

²Section S-S', figure 6.

³Section T-T', figure 6.

⁵26,100 N 39,300 E, figure 6.

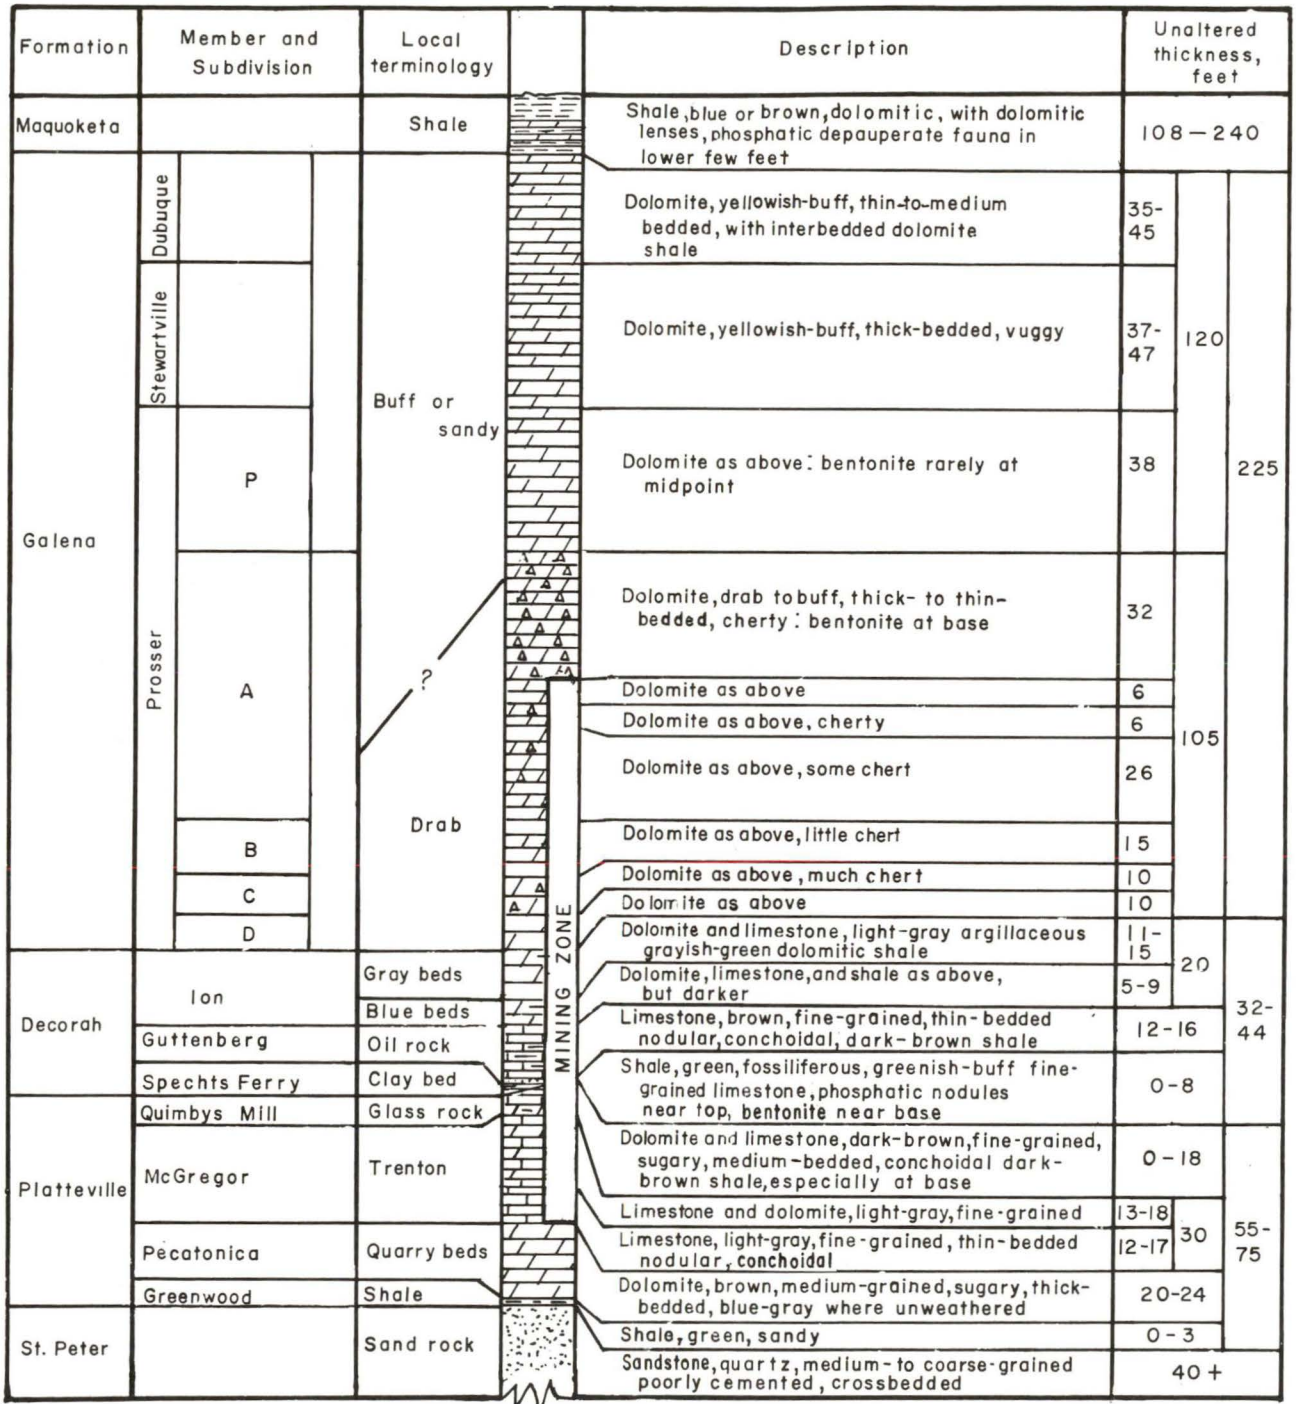
FIGURE 10. - Detailed stratigraphic column of the formations in the zinc-lead district.

The Maquoketa Shale and part of the Galena Dolomite comprise the overburden at the Bautsch mine. The mining zone encounters rocks from the McGregor Member of the Platteville Formation, up into the Galena Dolomite (fig. 10). In general, the mine stratigraphic section is composed of thin- to thick-bedded limestones, dolomites, shales and a thin clay bed (Spechts Ferry), with a significant bentonite content. (For a detailed lithologic description, see appendix E, and mine cross sections in appendix F.)

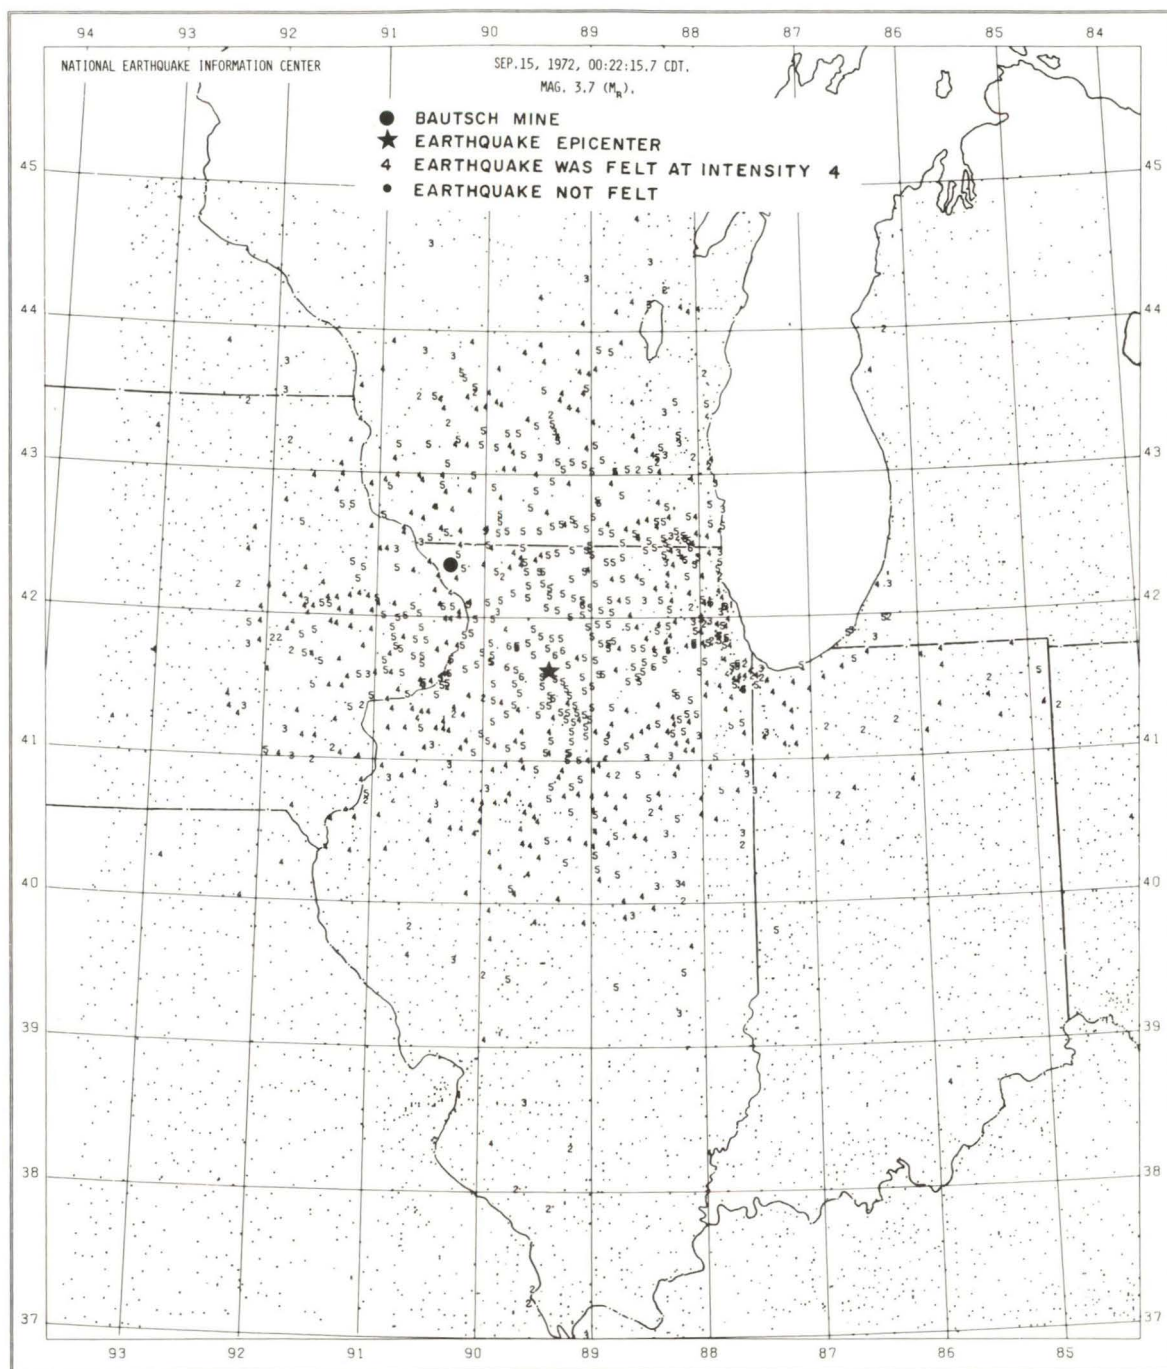
FIGURE 12. - Location and area affected by Illinois earthquake of September 15, 1972.

A possible, although remote, factor is an earth tremor that occurred on the morning of September 15, 1972. The epicenter registered 3.7 on the Richter scale (VI on the Modified Mercalli intensity scale) and occurred about 74 miles (118.4 kilometers) SE of the Bautsch mine (fig. 12), at a depth of 3.1 miles (5 kilometers). However, because of the small intensity (IV-V) felt at the mine and because no further progression of ground instability occurred until 2 weeks after, the conclusion was that any compression and dilation of water-bearing rock, as a result of the seismic waves, did not, in all probability, contribute significantly toward failure (6).

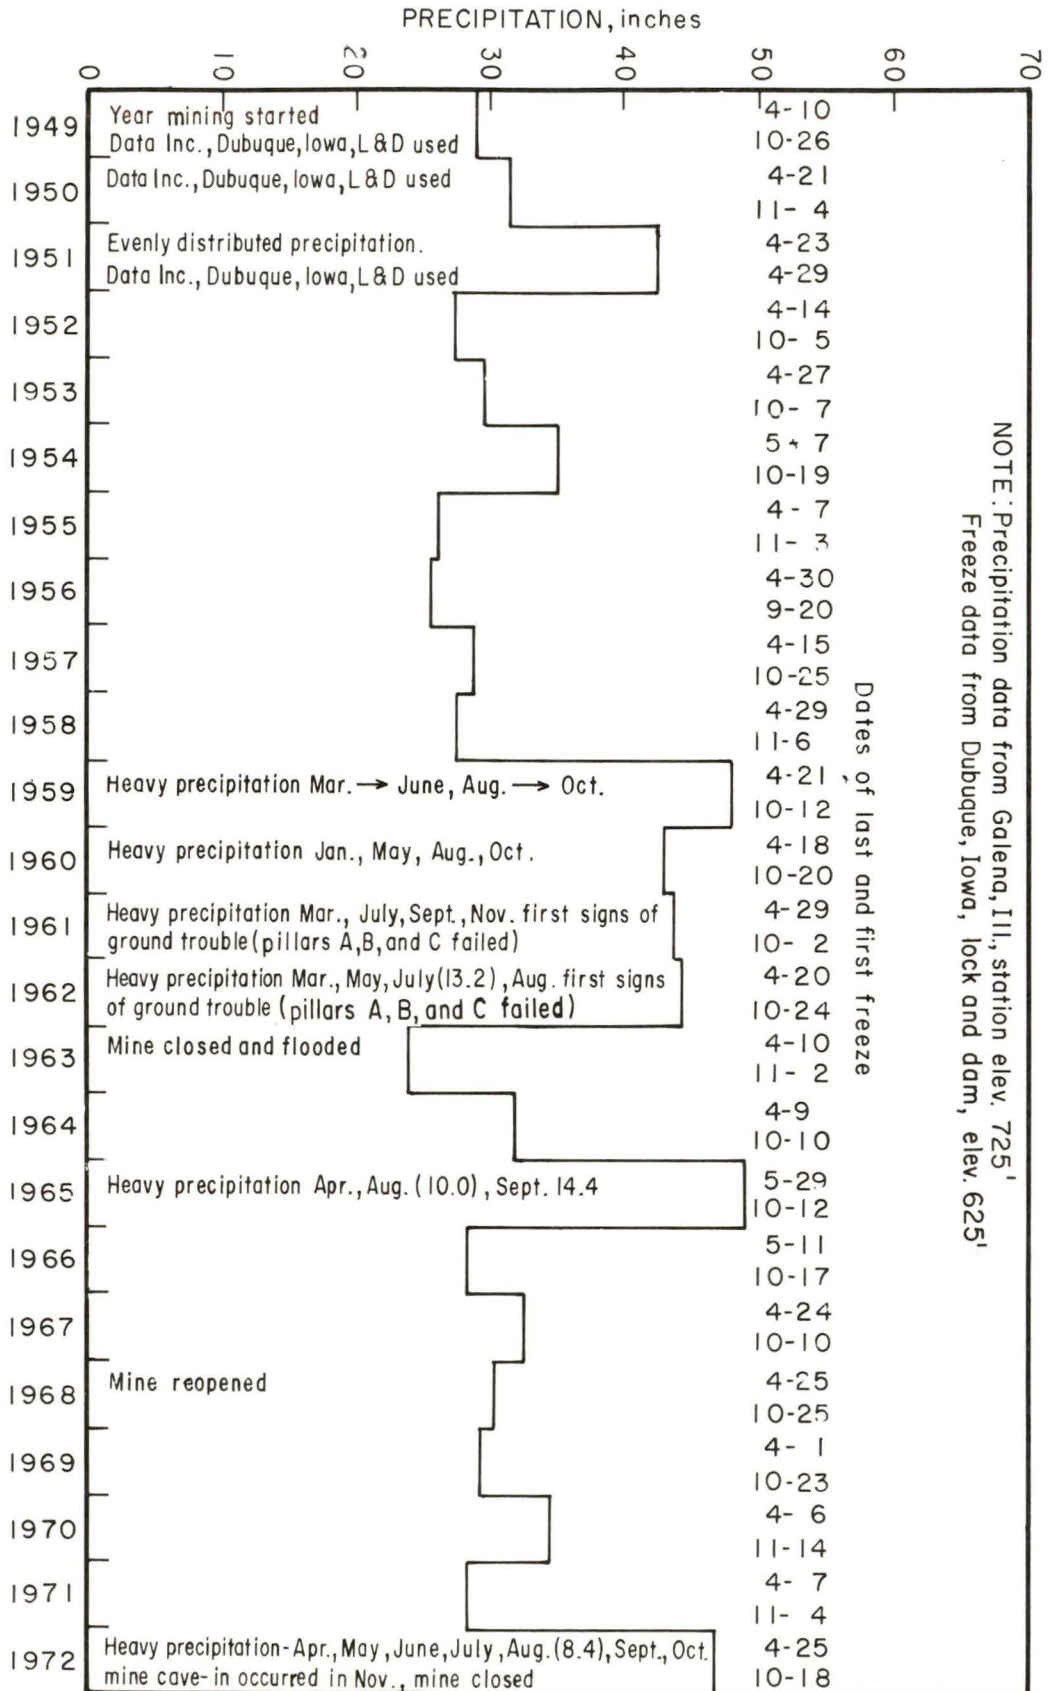
APPENDIX A.--ANNUAL PRECIPITATION CHART

Rainfall data (appendixes A and B) for the Bautsch mine, considering recharge and evapotranspiration (appendix G), show a direct correlation with failure activity and the time at which failure occurred. That is, times of increased failure activity or activation of failure activity occurred during

periods that showed unusually large amounts of precipitation being available for ground-water recharge (7). Periods of high recharge in general, were 1961, 1962, 1965, 1968, and 1972; 1961, 1962, and 1972 correspond to when failure activity was first noted and the final failure occurred. As for the high discharge periods during 1965 and 1968, no observations were possible because the

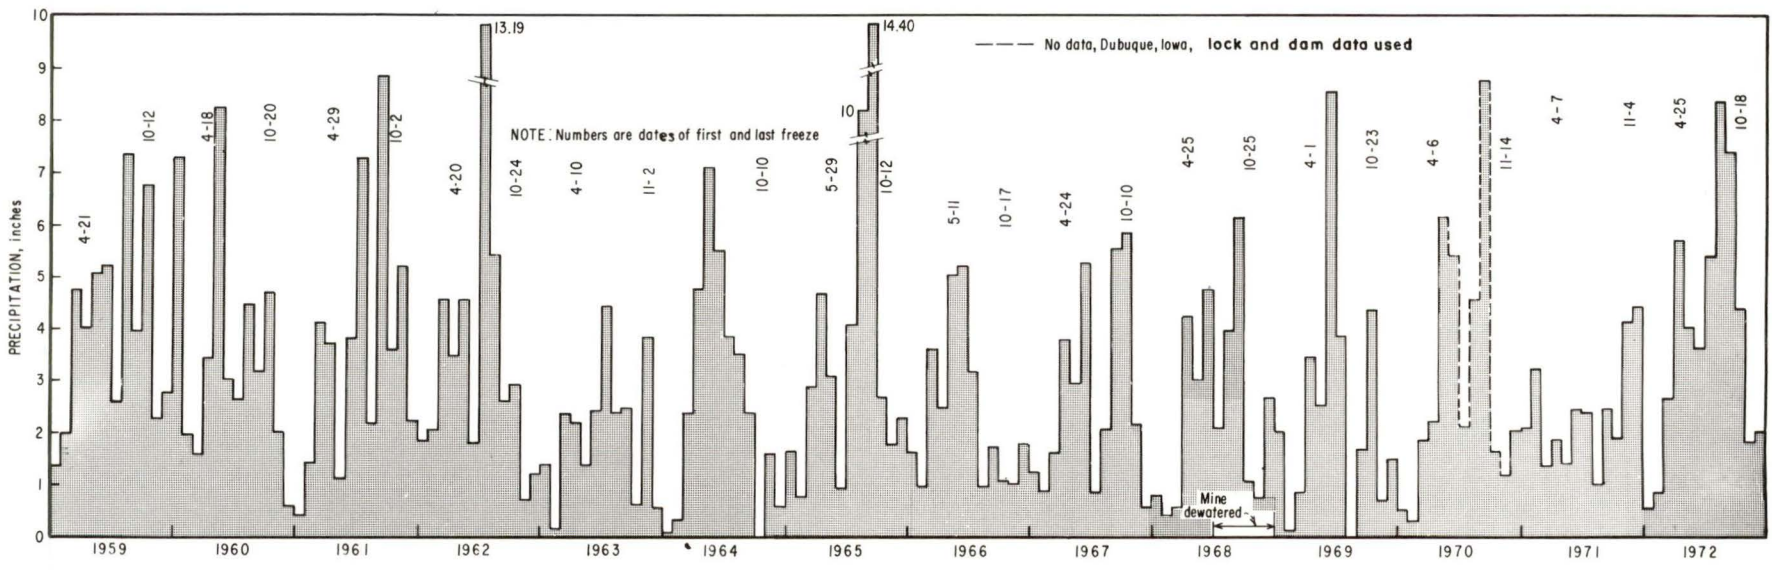
APPENDIX B.--MONTHLY PRECIPITATION CHART

The climate of the area is cool-temperate with heavy snows and considerable periods of subzero temperatures (14). Temperatures are usually 20° to 30° F (-7° to -1° C) in the winter and 65° to 75° F (18° to 24° C) in the summer. The first and last frost generally occur in late September and late April, respectively. Annual precipitation (appendix A) is about 34 inches (86.4 centimeters) and is usually well distributed, however, there are periods when rainfall greatly exceeds the monthly average (appendix B).
