**Demonstrating the Noise Control
of a Coal Preparation Plant
Volume I. Initial Installation and Treatment Evaluation**

**Contract No. USBM H0155155
Demonstrating the Noise Control of a Coal Preparation Plant
Volume I.**

1. Report No.	2.	3. Recipient's Accession No.	
4. Title and Subtitle DEMONSTRATING THE NOISE CONTROL OF A COAL PREPARATION PLANT - VOLUME I. INITIAL INSTALLATION AND TREATMENT EVALUATION		5. Report Date September 1977

7. Author(s) Matthew N. Rubin		8. Performing Organization Report No. BBN Report No. 3631	
9. Performing Organization Name and Address Bolt Beranek and Newman Inc. 50 Moulton Street Cambridge, MA 02138		10. Project/Task/Work Unit No.

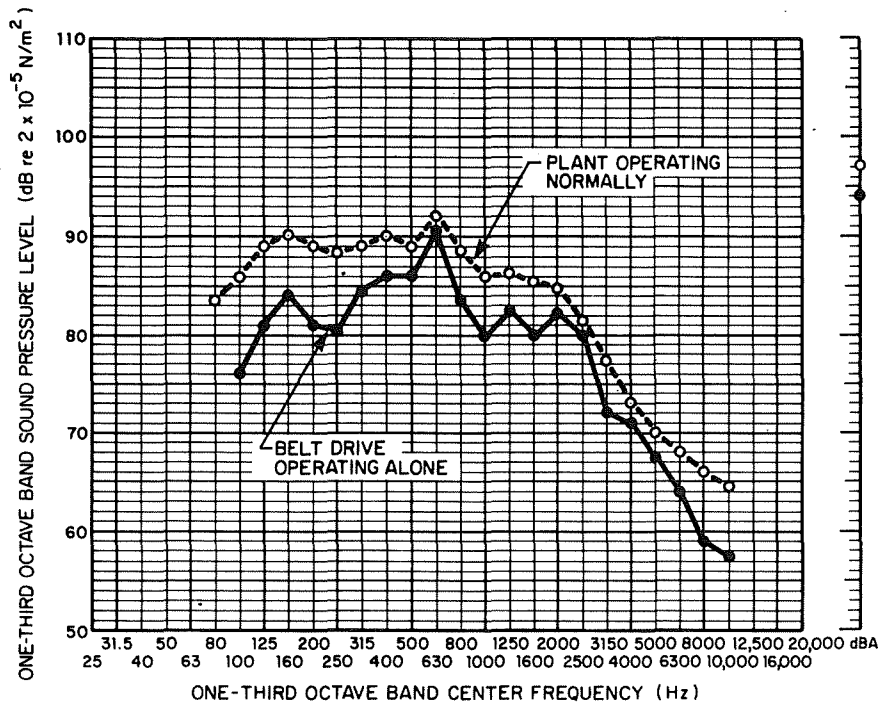
Preliminary measurements indicated that the ROM belt drive was 3 to 4 dB quieter than the Oak Park belt drive. Figure 12 shows the 1/3-octave band sound spectra measured 3 ft from the Oak Park belt drive with the plant at full capacity and with the belt drive operating alone. Even though the gear tone at 630 Hz was quite audible, the overall noise generated by the coal flow over the primary screens is approximately equivalent to the drive unit noise [94 dB(A)]. At the nearest worker position, A₃ (the picking table operator), the primary screen noise becomes more significant than the drive unit noise.

Because workers are not normally stationed in this area, it was classified as a limited-exposure (Type III) area. Since the

FIG. 12. OAK PARK BELT DRIVE UNIT NOISE.

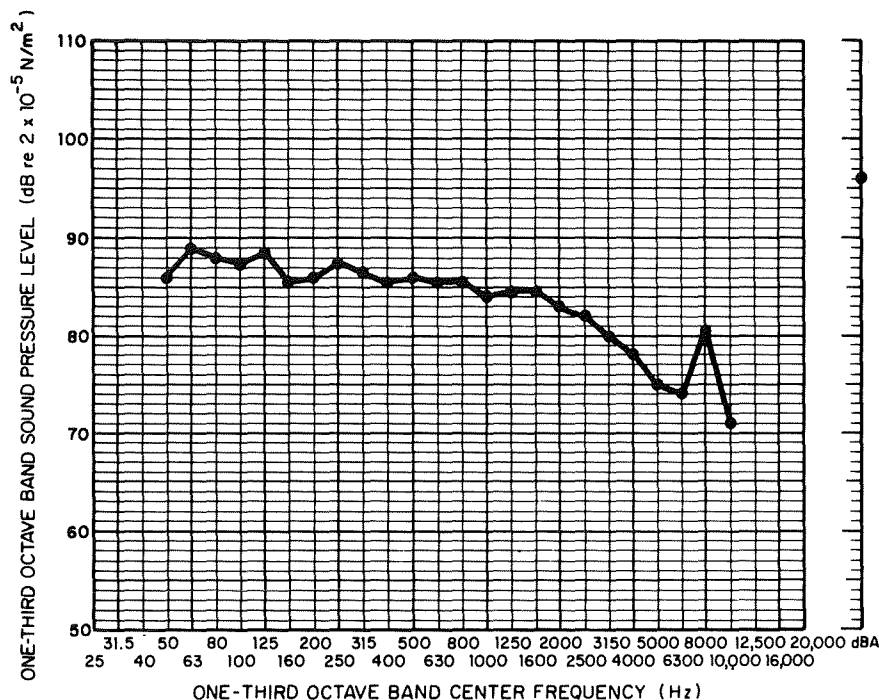
Figure 16 shows the spectrum measured 3 ft from the conveyor. The scraping of the steel flights against the conveyor bottom creates a screeching noise (not the 8000-Hz spike in the sound spectrum), which can generate up to 100 dB(A) at this position.

FIG. 16. RIPL-FLO SCREEN FEED CONVEYOR NOISE.

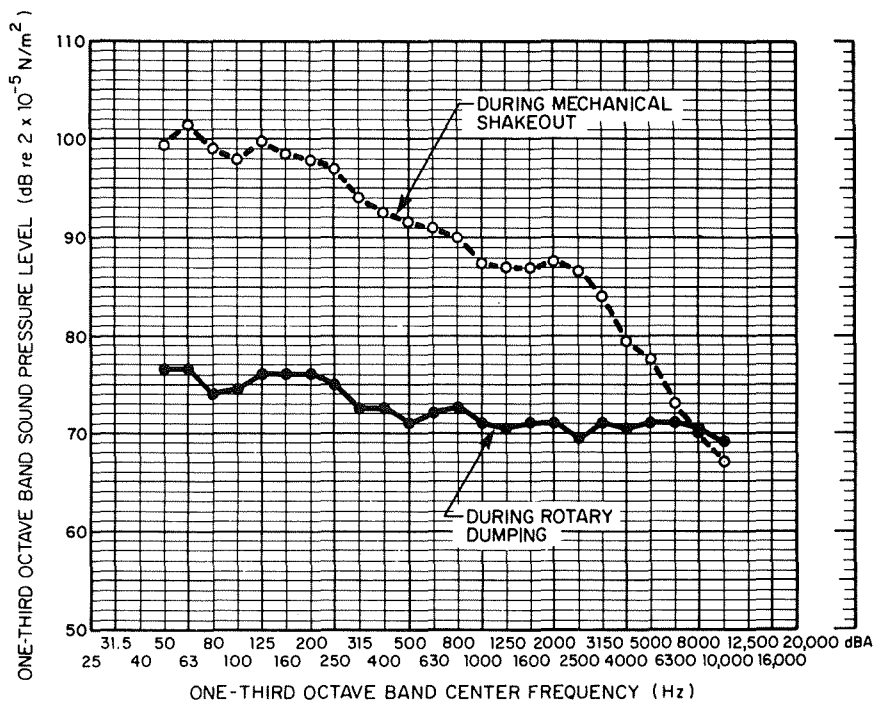
Figure 20 shows the 1/3-octave band sound spectrum measured alongside a rail car being unloaded (not in control booth) during the shakeout operation [105 dB(A)]. Also shown in this figure is the spectrum measured at the same location during the rotary dump operation. The A-weighted sound level during this operation was 85 dB(A).

The operator in this location was provided with a booth for hearing protection. The sound level in this booth was less than 90 dB(A) during either operation. Even though workers are stationed here for entire shifts, the unloading mechanisms (particularly the mechanical shakeout) do not operate continuously. Therefore, the area is classified as Type II.

FIG. 20. SOUND POWER LEVELS MEASURED AT OPERATOR'S POSITION IN RAIL CAR UNLOADING AREA.

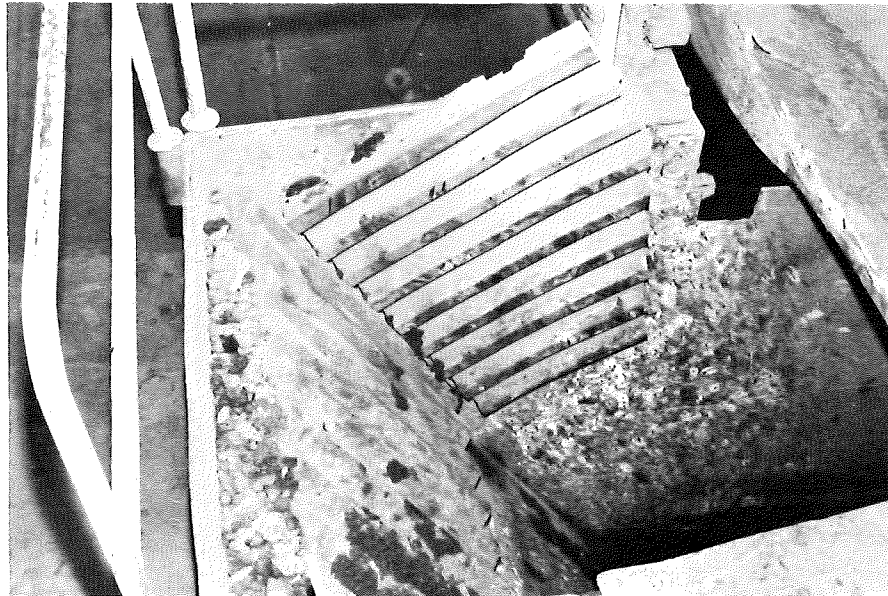
FIG. 31. PROFILED TRELLEBORG AT INFEED TO McLANAHAN ROCK CRUSHER.

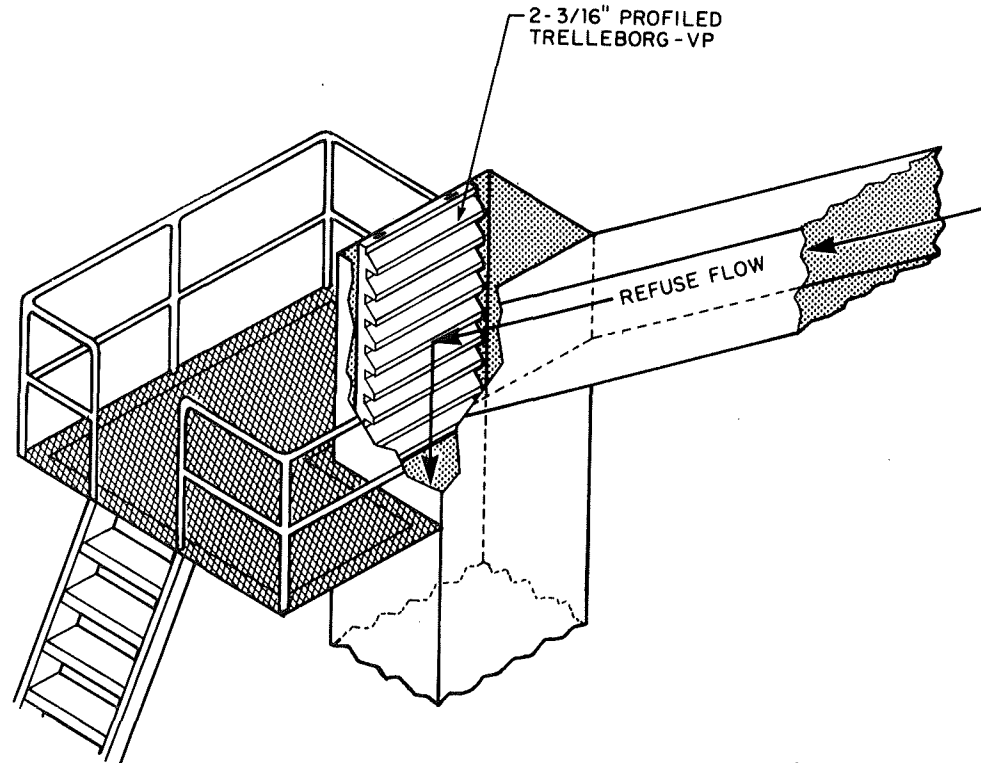
The second piece of profiled Trelleborg was installed on a vertical chute wall downstream of the piece described above (see Fig. 32). At this location, rocks strike the chute prior to dropping onto the refuse belt below. Installed on 21 August 1976, the pad was positioned incorrectly and had to be replaced on 27 November 1976. During an inspection on 13 April 1977, it was observed that the bolts had loosened under 4½ months of refuse impact and that the Trelleborg had slipped. It is recommended for future installations that either the top of the T-slots be welded closed or an angle iron be bolted below the Trelleborg to prevent sliding.

FIG. 32. PROFILED TRELLEBORG INSTALLATION IN REFUSE CHUTE, BELOW McLANAHAN ROCK CRUSHER.

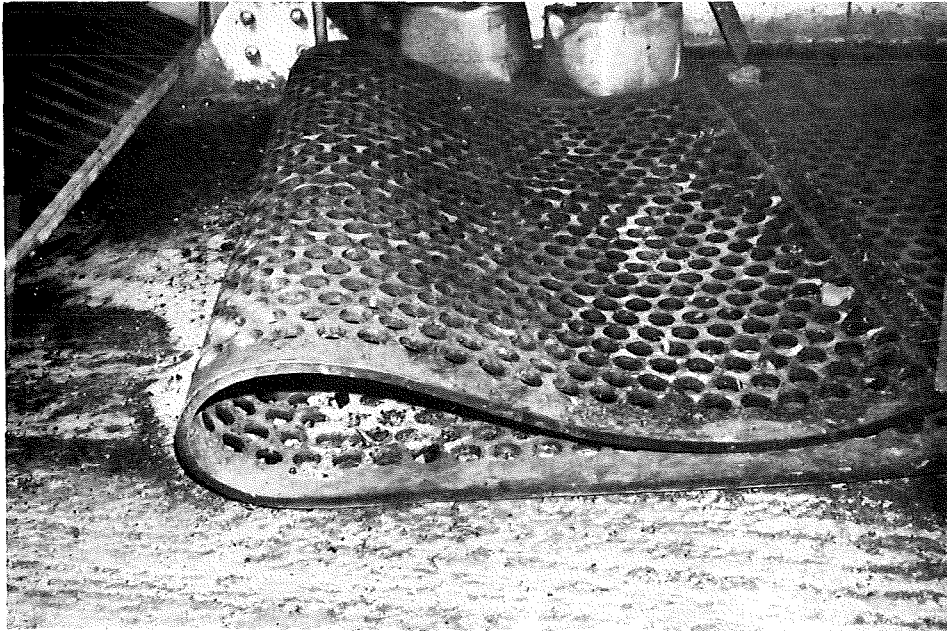
FIG. 33. TRELLEBORG ALL-RUBBER SCREEN.

composed of a resilient layer bonded to the top surface of the steel punch plate. Actually, the screen was composed of a top surface of Trellex-60 rubber and a lower surface of higher durometer rubber for support; this combination is referred to as Duenero rubber. The screen had $1\frac{1}{4}$ -in.-diameter holes, as in the steel deck, but was $\frac{3}{4}$ -in.-thick, as opposed to the $\frac{1}{4}$ -in.-thick steel screen. The single 95-in. \times 47 $\frac{1}{2}$ -in. screen cost \$1180.

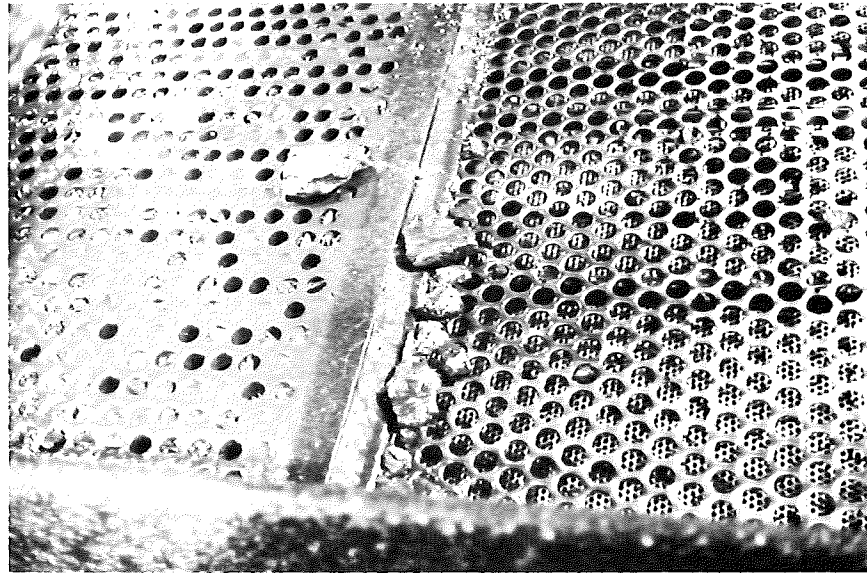
The test panel was installed on 18 November 1975. Within one week of operation, significant blinding had occurred (Figs. 34 and 35). The blinding became severe enough, with roughly 65% of the holes plugged, to require the removal of the screen on 17 December 1975. There was no actual maintenance required during this one month of service; the holes were not unclogged by hand at the end of the shift.

FIG. 34. EXCESSIVE BLINDING OF URETHANE SCREEN (UPSTREAM EDGE).

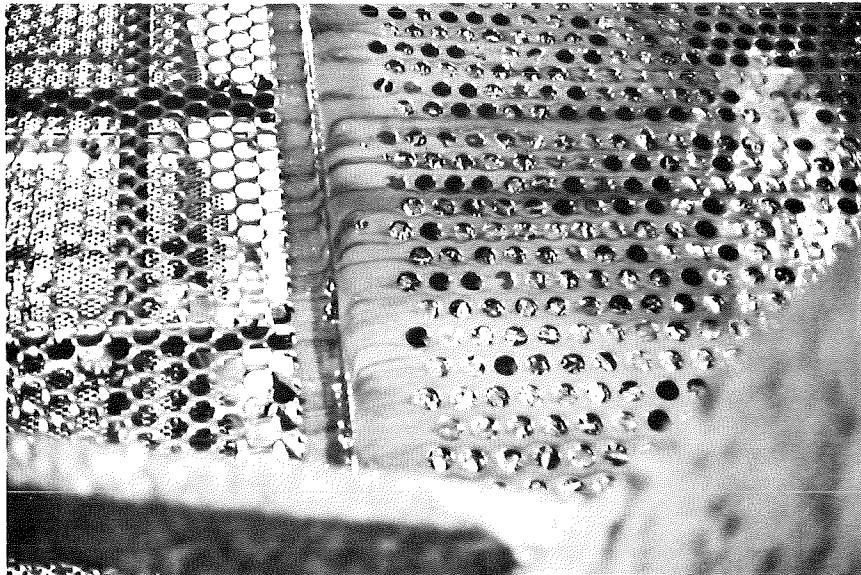
FIG. 35. BLINDING OF URETHANE SCREEN ON SECONDARY SHAKER AFTER ONE WEEK OF OPERATION (DOWNSTREAM EDGE).

Since only a single test panel was installed in one of the secondary shakers, no sound level data were obtained. Blinding reduced screening efficiency by roughly 65%, thereby necessitating removal of this panel. As a result, no wear-related service life data are available.

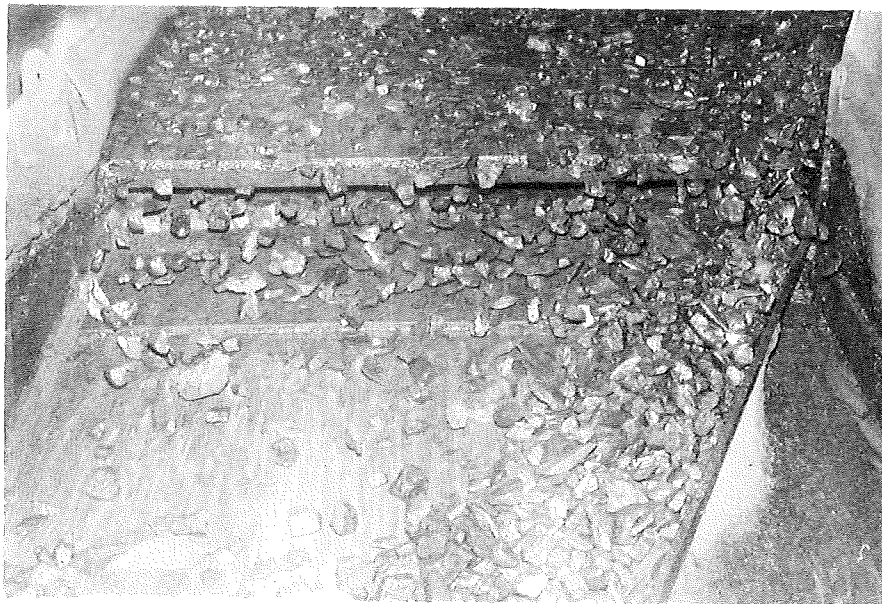
The open discharge chutes of the secondary screens carry 1½-in. × 7-in. material to the McNally jigs. The coal/coal and coal/chute impact noise of this flow contributed substantially to the noise both around the walkway and in the McNally jig area. Initially, a small impact pad of 1/2-in.-thick Goodyear Armaplate was installed in the bottom of the No. 2 chute to test its ability to absorb the impact of the material as it dropped off the end of the secondary screen without impeding material flow (Fig. 37). This pad performed successfully. It was therefore removed, and both chute bottoms were completely lined with 1/2-in. Armaplate.

FIG. 37. GOODYEAR ARMAPLATE TEST PAD AT DISCHARGE OF SECONDARY SCREEN.

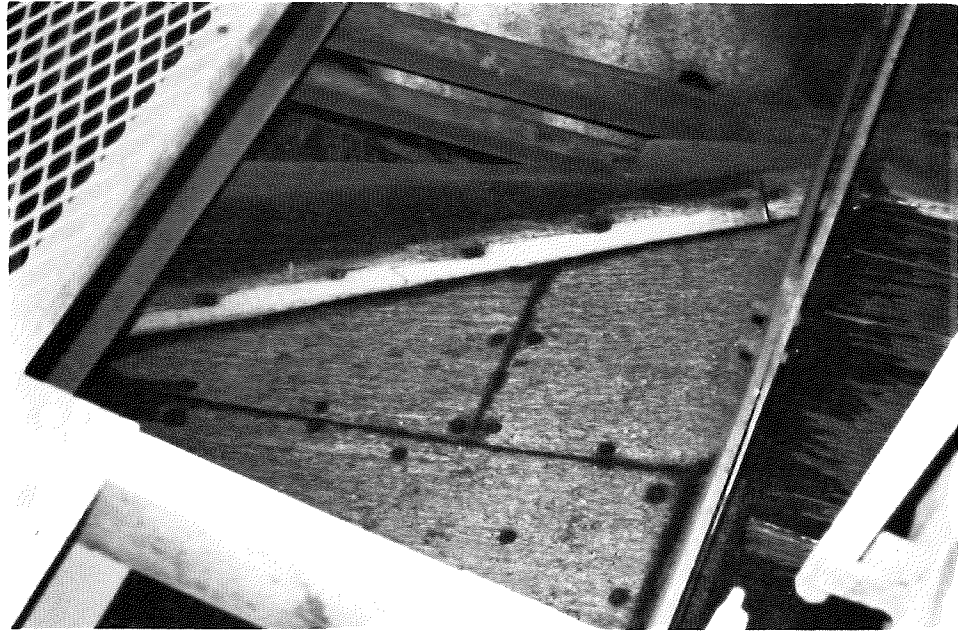
Figure 38 shows the general configuration of the installation. The Goodyear Armaplate was cut to size, and holes were countersunk in the center portion, as illustrated previously in Fig. 27. The Armaplate was bolted onto the bottom of the chute.

FIG. 38. LINING OF DISCHARGE CHUTES OF SECONDARY SCREEN.

The chute from the No. 2 secondary screen was lined on 25 September 1976; the chute from the No. 1 secondary screen, on 6 November 1976. The flow in these chutes averages 400 tph of 1½-in. to 7-in. raw coal with approximately 35% rock. The Armaplate began to show signs of significant wear within 4 months and was considered worn out within approximately 6 months after installation. This period is only about half the expected life of the steel chutes.

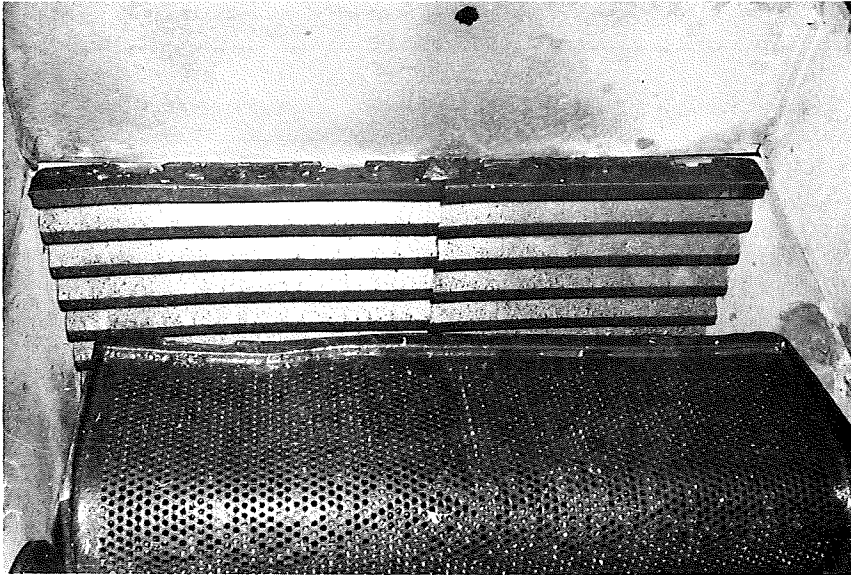
Profiled Trelleborg was installed 18 October 1975 and 19 June 1976 on the No. 2 and No. 1 refuse elevators, respectively (Fig. 44). As of 23 June 1977, the edges of the material in the No. 2 chute were showing some slight rounding at the impact point; however, the pads were still quite serviceable. No maintenance has been required since installation. The urethane pads were installed on 15 November 1975 and 4 September 1976 in the No. 2 and No. 1 refuse chutes, respectively. Inspection of the pad in No. 2 on 23 June 1977 indicated that the center of the pad, at the impact point, had worn through and that some refuse had pushed up under the pad. This loose material provides some

FIG. 44. PROFILED TRELLEBORG BOLTED TO CHUTE WALL OPPOSITE NO. 2 REFUSE ELEVATOR DISCHARGE. (ELEVATOR BASKET SHOWN AT TOP OF TRAVEL.)

cushioning of the impact of the falling refuse. Therefore, while the material technically has been worn through, it is still providing some indirect cushioning.

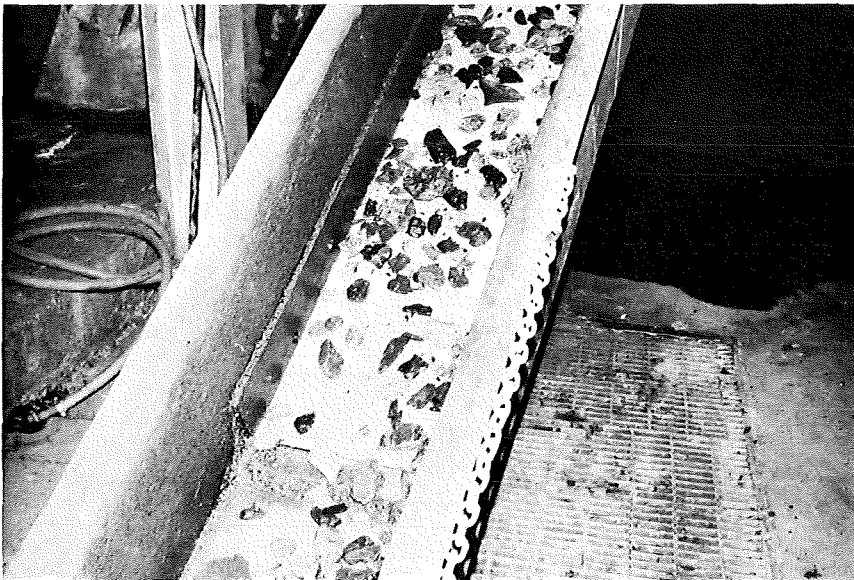
FIG. 45. MINALOY PLASTIC CHUTE LINER IN NO. 2 JIG REFUSE CHUTE.

The Minaloy chute liner was installed in the No. 2 jig refuse chute on 8 December 1975. Two and a half months later, on 20 February 1975, the Minaloy was removed because of excessive wear. Apparently, the coarse nature of the refuse (70 tph) and the tendency of the flow to bounce and impact the liner rather than slide over it caused severe gouging. The ceramic

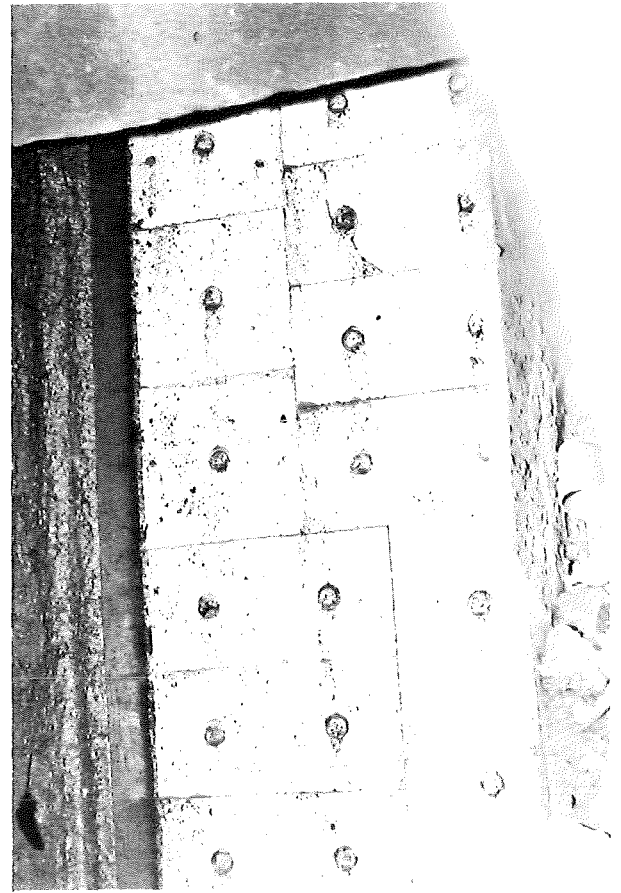
FIG. 46. DURAFLEX CERAMIC TILE INSTALLED IN JIG REFUSE CHUTE.

tile was installed in the No. 2 chute on 31 February 1976 and in the No. 1 chute on 25 September 1976. Between the time of installation and the final inspection date of 23 June 1977, a number of cracks and slight chipping of the tiles had become evident; however, actual wear did not yet appear to be significant. No maintenance was performed on either liner.

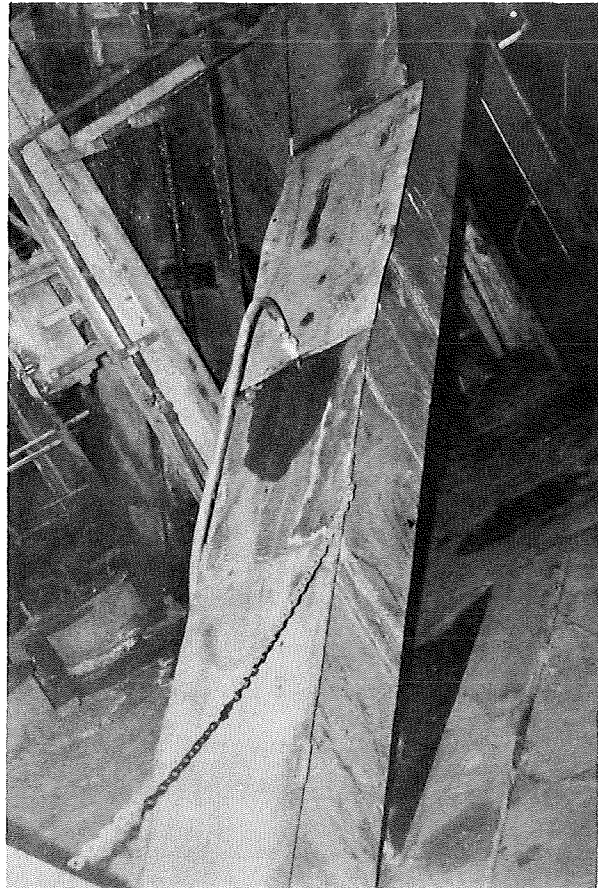
FIG. 48. STEEL COVERS ON NO. 2 JIG REFUSE CHUTE.

Neither liner impeded the flow in the chute; in fact, since neither rusted as would a steel chute when the plants shut down, there was actually less of a tendency for the material to "hang-up" when the jigs resumed operation. As of the final inspection date, the ceramic tile in the No. 2 chute had been in place for 2.3 times the service life of the original steel chute and was still serviceable.

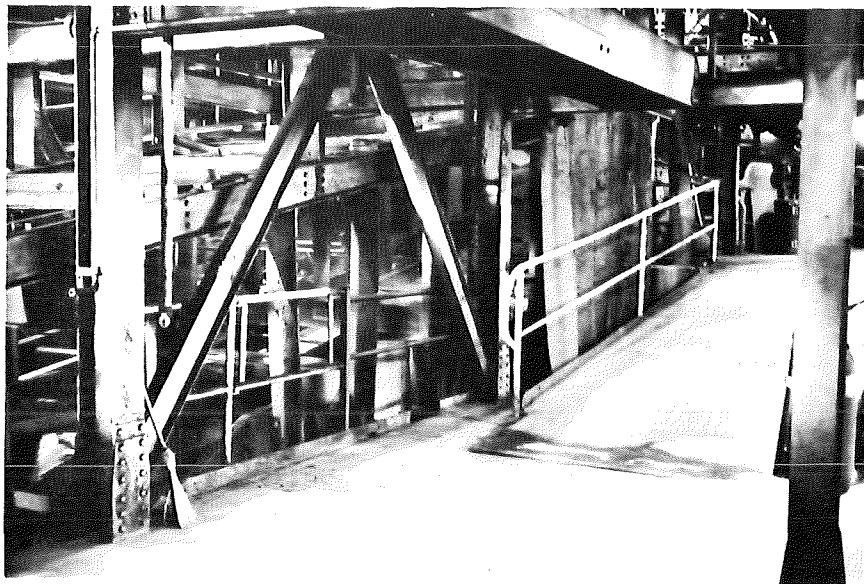
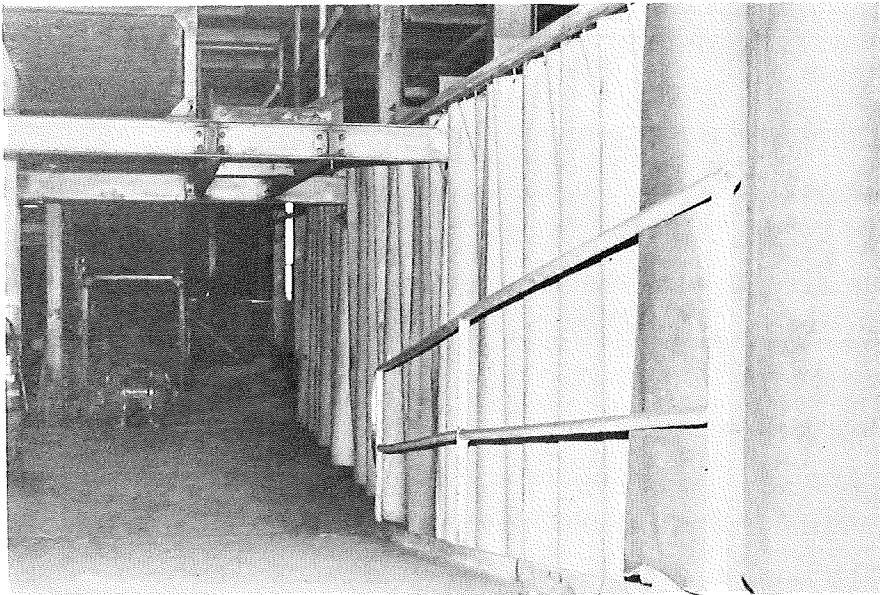
FIG. 55. CLEAN-COAL DESANDING SHAKERS BEFORE CURTAIN INSTALLATION (LOOKING TOWARD RAMP TO BUILDING A).

FIG. 56. CLEAN-COAL DESANDING SHAKER AREA AFTER INSTALLATION OF CURTAINS (LOOKING DOWN RAMP FROM BUILDING A).

The original sound levels alongside the shaker were 96 to 98 dB(A). After the installation of the movable curtain panels, the sound levels alongside the shaker were 93 to 94 dB(A) — a reduction of 3 to 4 dB(A). The limiting factor in the performance of the curtains is the opening over the top of the curtains (visible in Fig. 56), where sound escapes. Stationary curtain panels (sketched in Fig. 57) are planned for installation above the existing movable sections to seal this gap. The expected result is an additional 2 to 3 dB of noise reduction. While these curtains have not noticeably affected the production of these shakers nor interfered with their maintenance, the installation of observation windows in the curtain panels would enhance their acceptability by the workers.

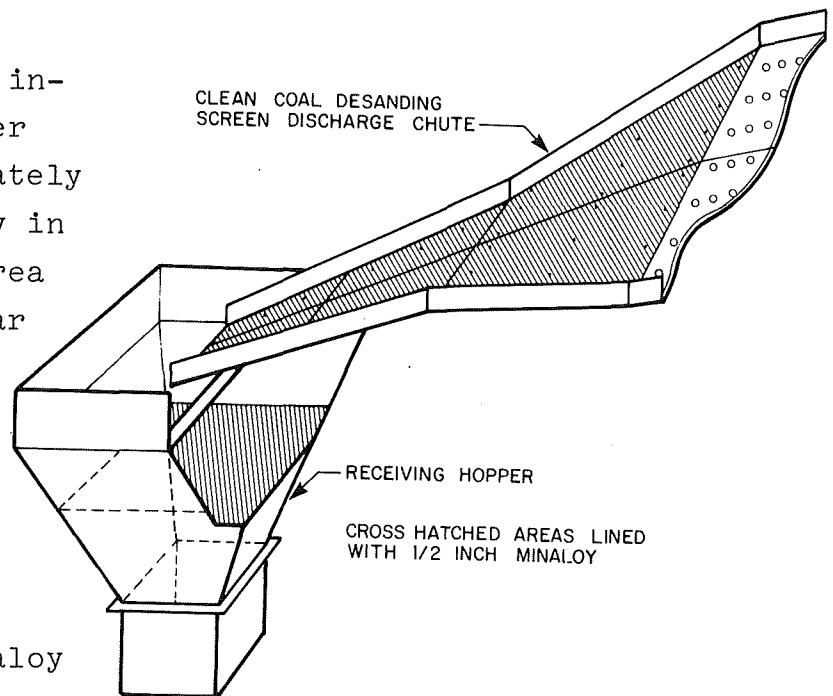
The material was installed on 22 September 1976. After approximately 2½ months, the Minaloy in the discharge chute area showed ripple-like wear patterns, which did not deteriorate significantly during the rest of the observation period.

Before installation of the Minaloy liners, the sound level over the discharge section of the clean-coal desanding screens was 96 dB(A). After installation, the sound level was 95 dB(A), a reduction of 1 dB. This small reduction indicates that at this measurement position, the noise radiating directly from the impact of the coal on itself and on the Minaloy liner is more

FIG. 58. DISCHARGE SECTION OF CLEAN-COAL DESANDING SHAKER.

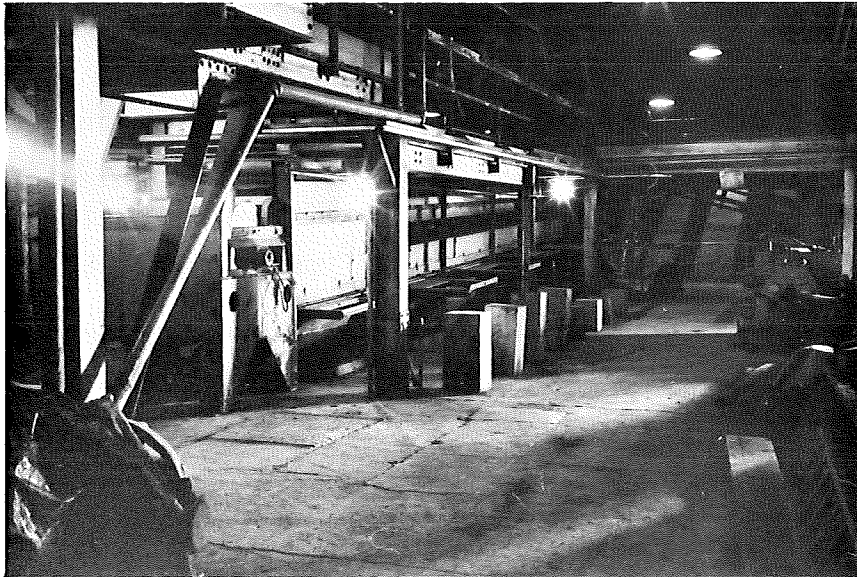
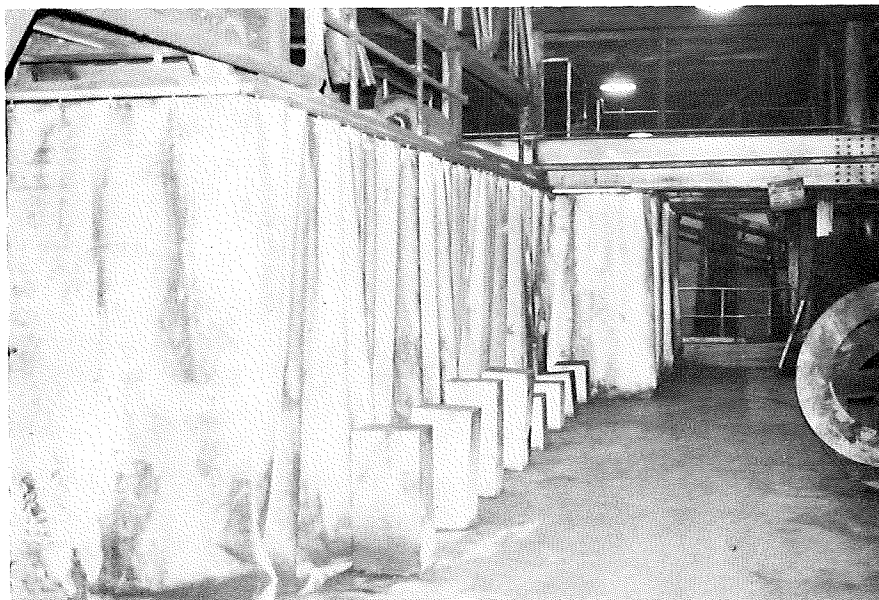
FIG. 60. RIPL-FLO SCREEN FEED CONVEYOR AREA BEFORE CURTAIN INSTALLATION.

FIG. 61. RIPL-FLO SCREEN FEED CONVEYOR AREA AFTER CURTAIN INSTALLATION.

flights rubbed against the conveyor structure, squeaks were measured well in excess of these levels [97 to 99 dB(A)]. After installation of the curtains, the sound levels at position No. 2 were typically 91 to 92 dB(A); they were heavily influenced by the noise of the clean-coal desanding shaker discharges, and somewhat by the sound propagating over the top of the curtain.

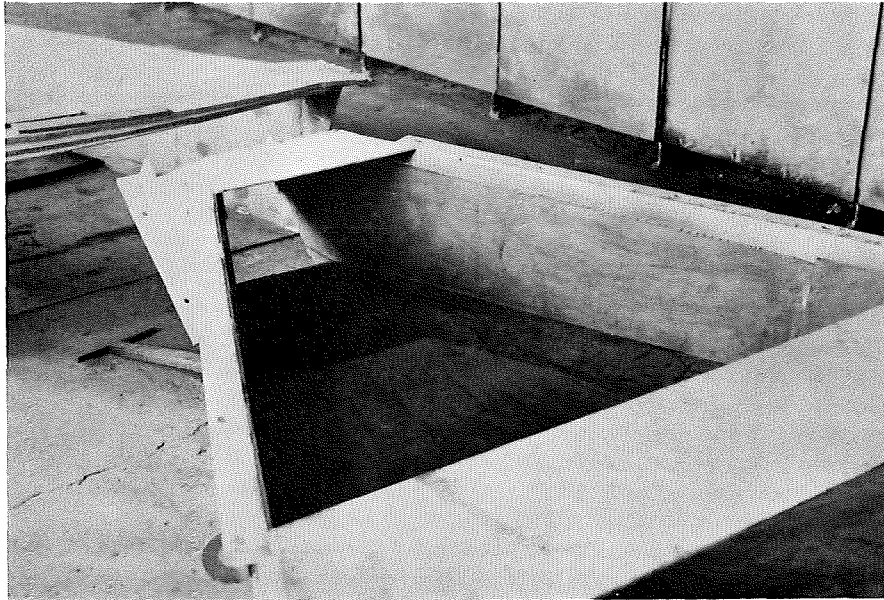
The Goodyear Jade Green Armabond was also installed in 2 new steel chutes. The Jade Green was cut with a knife and glued to the inside chute wall with the adhesive recommended by Goodyear

FIG. 67. GOODYEAR ARMABOND GLUED IN UPPER SECTION OF RIPL-FLO DISCHARGE CHUTE.

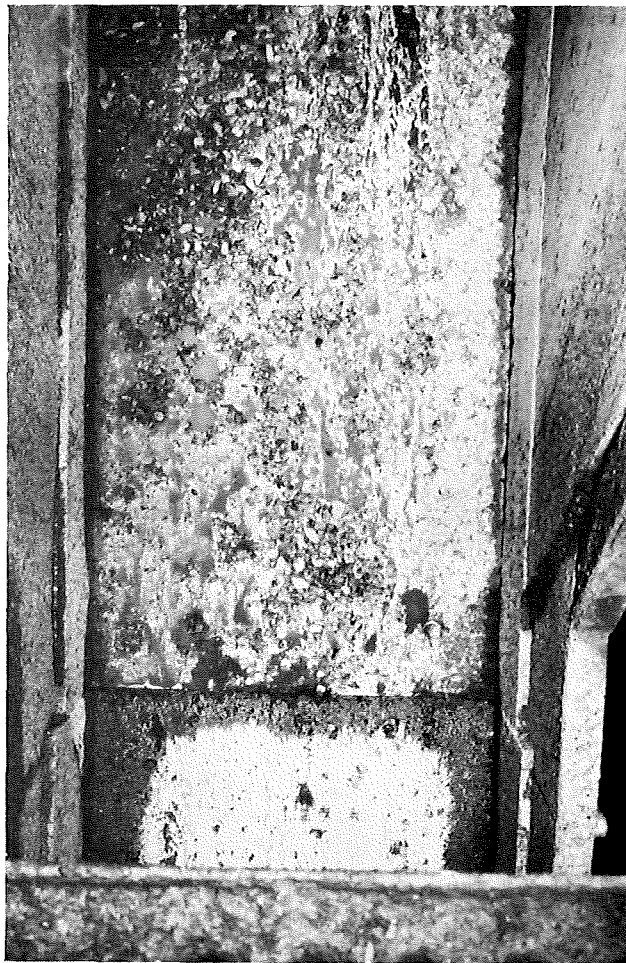
Two men installed the urethane in 3 hours. Installation involved bolting the material to the existing steel chute bottoms (Fig. 70) and welding steel wear plates to the chute walls to protect the edges of the urethane. (See "Service" under Ripl-Flo chutes for discussion of potential problems.)

The urethane sheet was installed on 8 December 1975, and, as of 23 June 1977, was still in service. No maintenance had been performed during this period, and the material did not show any badly worn areas.

As of the final inspection, the urethane pad had been in service over 18 months. In comparison, the original steel chute typically required repair after 6 months of service.

FIG. 70. URETHANE IMPACT PAD IN REFUSE DESANDING SHAKER DISCHARGE CHUTE.

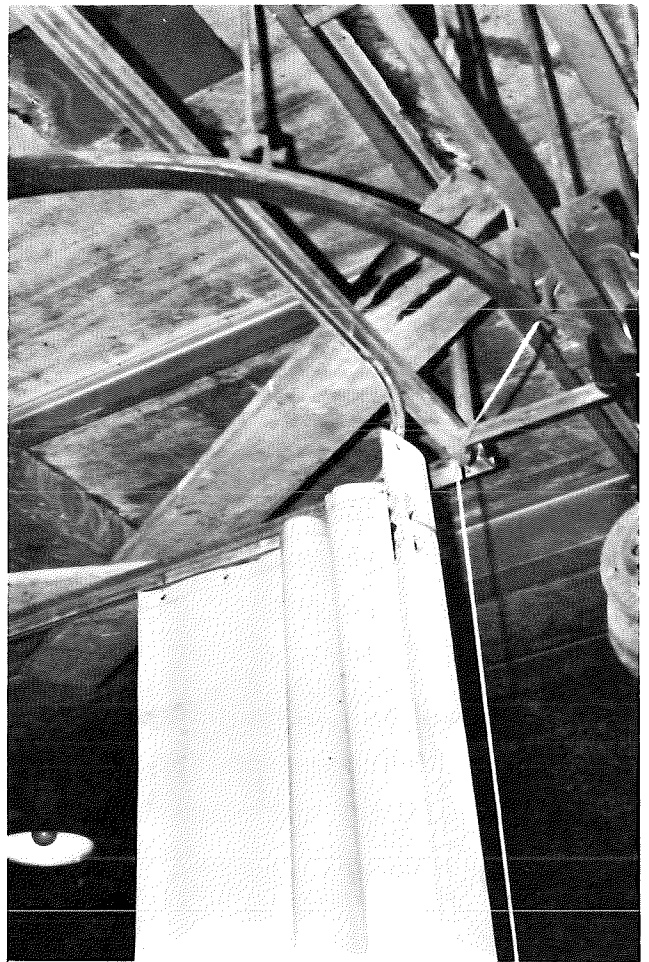
The movable curtain panels, precut and fitted with grommets by the supplier, were hung from the track and roller-hook setup described previously. The curtain track was installed on a steel U-channel that was positioned above the existing overhead hoist track (Fig. 71), used when the dryer covers are removed for basket replacement. The curtains parted at the point where the hoist track passes through the curtain wall, thus permitting dryer maintenance with a minimum of interference. Velco strips, sewn to the curtains, fastened the curtains during normal operation.

FIG. 71. INSTALLATION OF CURTAINS AND TRACK IN REINEVELD DRYER AREA (NOTE CURTAIN TRACK INSTALLED ABOVE OVERHEAD HOIST TRACK TO AVOID INTERFERENCE WITH DRYER MAINTENANCE.)

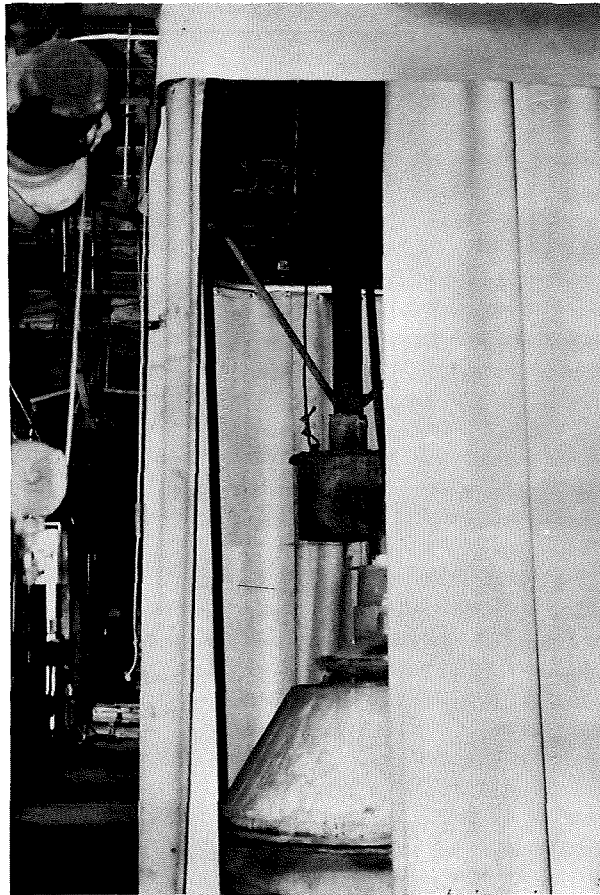
Figure 72 shows a completed installation for one of the dryers. Note how the track (15 ft. above the floor) encircles the individual dryer (the curtain panels between adjacent dryers were cut to allow for piping) and how the hoist track passes through the curtain wall. Also visible in Fig. 72 is the stationary curtain baffle, mounted from the ceiling, to reduce the noise that would escape through the opening between the top of the movable sections and the ceiling. The overlap between the movable and stationary panels is about 8 in. Figures 73 and 74 show the Reineveld area before and after the installation of the curtains.

FIG. 72. CURTAIN INSTALLATION AROUND SINGLE REINEVELD DRYER.

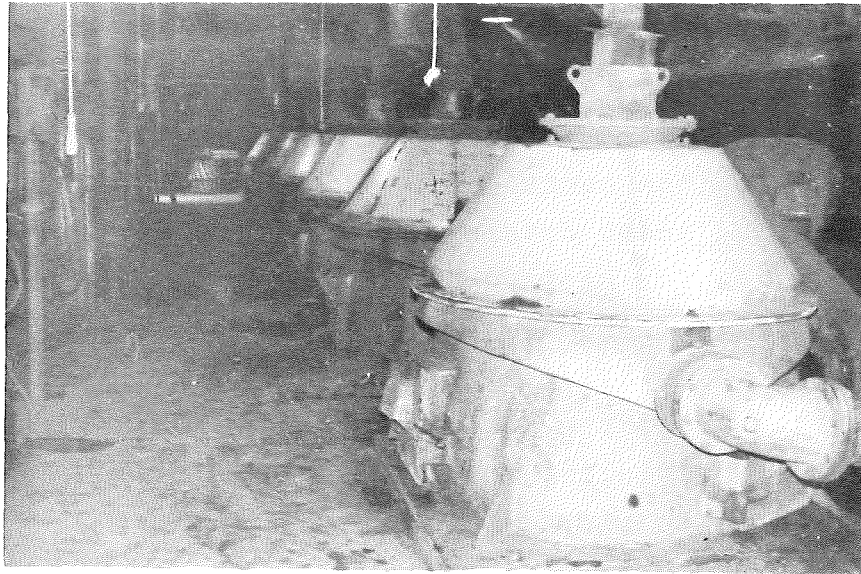
FIG. 73. REINEVELD DRYER AREA PRIOR TO INSTALLATION OF CURTAINS.

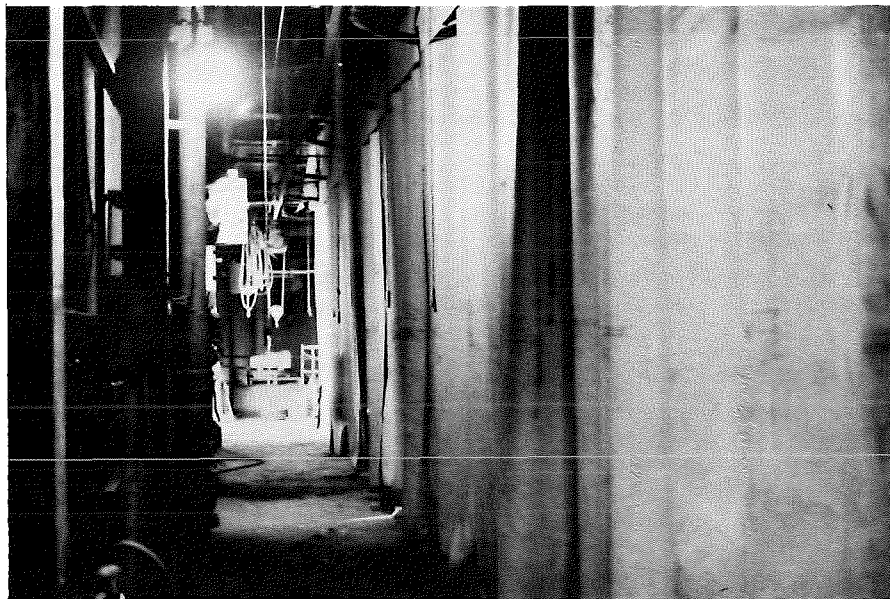
The curtains were completed on 15 November 1976, and as of the final inspection on 23 June 1977, they were still in good condition. The Velcro, which was sewn on, operated successfully throughout the observation period.

FIG. 74. REINEVELD DRYER AREA AFTER INSTALLATION OF CURTAINS.

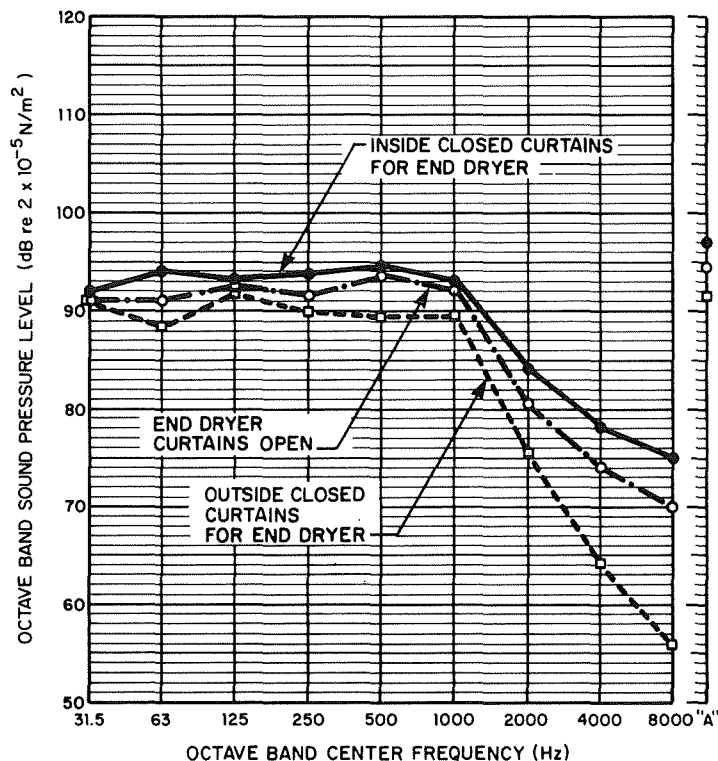
Because these curtains do not contain any sound-absorbing material, there was some sound buildup inside the curtains. Figure 75 shows the sound pressure level spectra measured inside and outside the curtains for the end dryer. Although the other dryers contribute to some extent, it is possible to see the effect of sound buildup in this figure.

FIG. 75. SOUND PRESSURE LEVELS MEASURED AT REINEVELD DRYER CURTAINS.

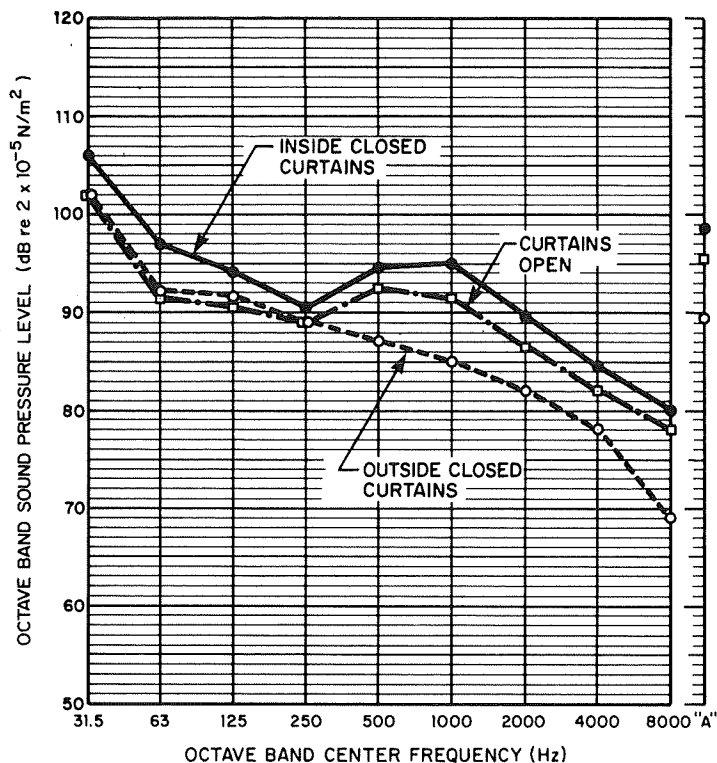
Figure 76 shows the effectiveness of the curtains, as well as the magnitude of the sound buildup within the curtains. No

FIG. 76. SOUND PRESSURE LEVELS MEASURED AT WEMCO DRYER CURTAINS.

acoustically absorptive material was used in this installation. The overall noise reduction from original to final sound levels in the aisle adjacent to the dryers was 6 dB(A).

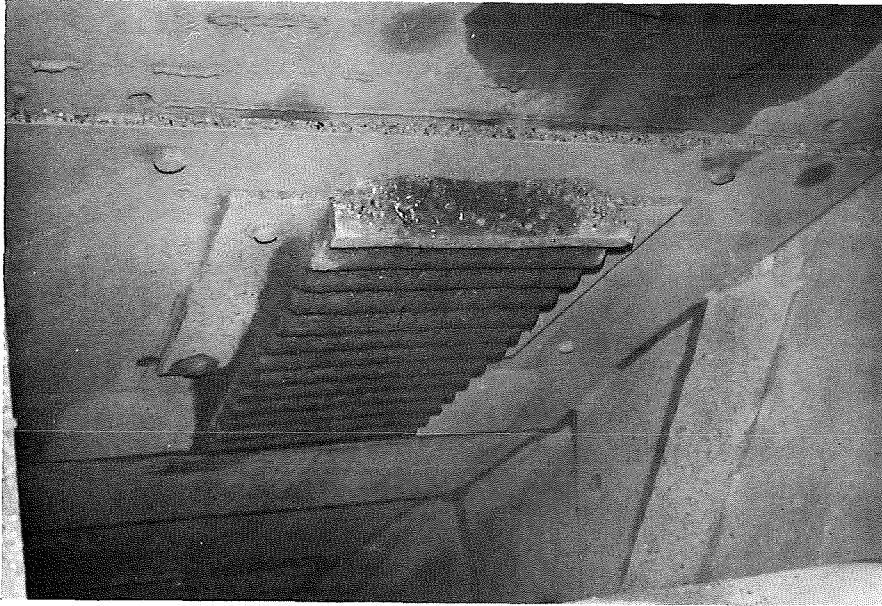
Installation was relatively straightforward because the location was within a couple of feet of the readily accessible open top of the chute (Fig. 77). The pad was bolted in with T-bolts in the usual manner (see discussion of picking table). Two men worked 2 hours to complete the installation.

The pad was installed on 9 September 1976. As of the last inspection on 23 June 1977, the Trelleborg was still in good condition, showing only a slight rounding of the edges.

FIG. 77. PROFILED TRELLEBORG INSTALLED AT HEAD END OF CRUSHED COAL BELT (INFEEED TO CLASSIFYING SHAKERS).

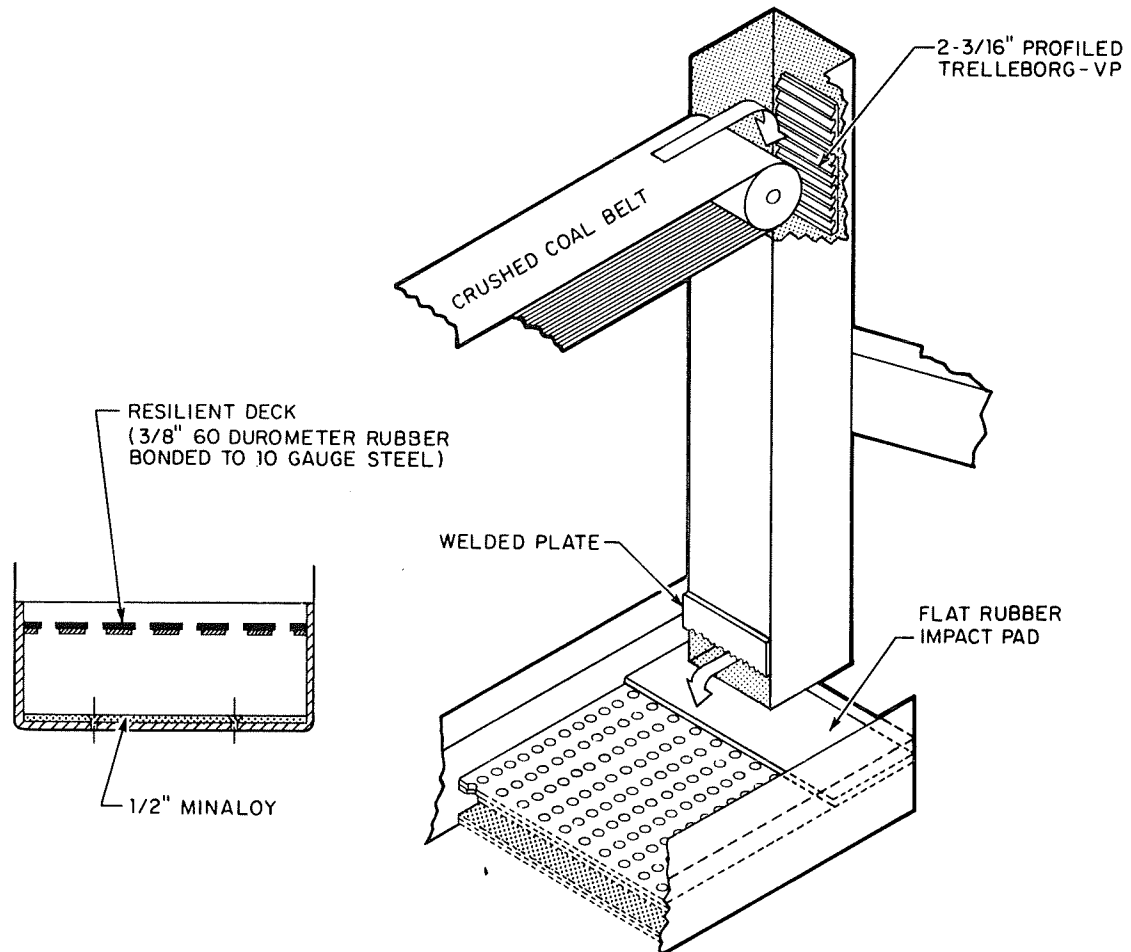
The remainder of the treatments on the classifying shaker are summarized in Fig. 78. The major components, the resilient

FIG. 78. CLASSIFYING SCREEN NOISE CONTROL TREATMENTS

decking, was a composite deck, with a top layer of 3/8-in. 60-durometer rubber bonded to a 10-gauge steel support plate. The diameter of the holes in the steel was $1\frac{3}{4}$ -in. vs $1\frac{1}{2}$ -in. for the rubber layer, to minimize an expected blinding problem. The resilient decks cost \$3650.

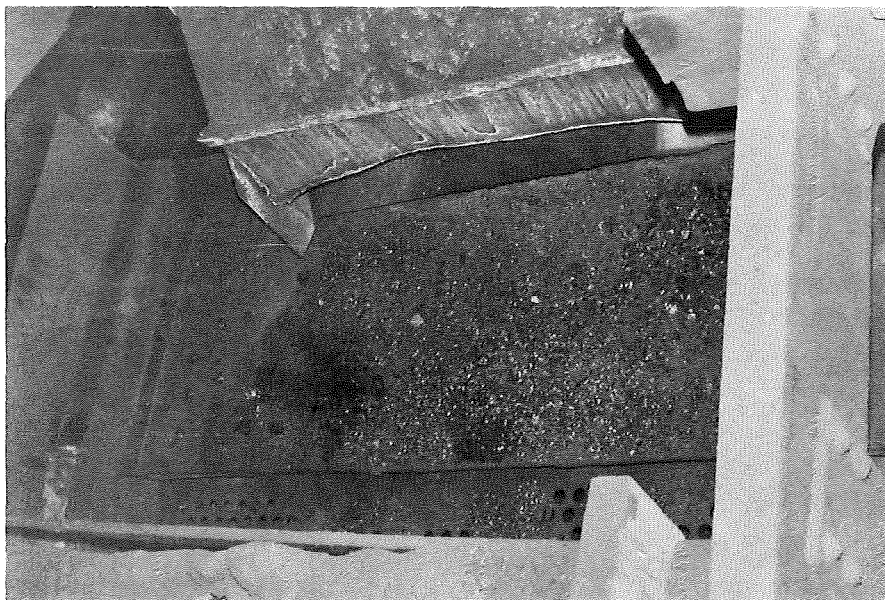
A piece of solid flat rubber was also installed at the head end of the shaker to absorb the impact and to protect the leading edge of the screens (Fig. 79).

FIG. 79. FLAT RUBBER IMPACT PAD AT INFEEED END OF CLASSIFYING SHAKER.

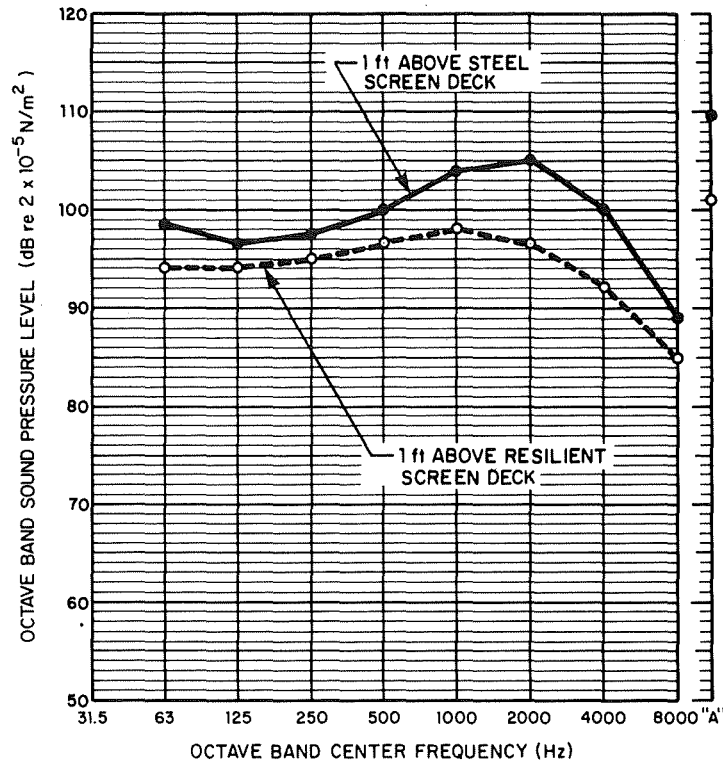
Figure 80 shows the sound pressure level spectrum measured close-in (12 in. above) to one of the remaining steel screens and one of the resilient decks. The overall difference is 8 to 9 dB(A). Alongside the shakers (position Q_2), the sound level was reduced from 102 dB(A) to 97 to 98 dB(A), a 4- to 5-dB(A) reduction.

FIG. 80. COMPARISON OF SPLs MEASURED OVER STEEL AND RESILIENT SCREEN DECKS.
