A mining research contract report  
December 1985

# GEOLOGIC CONDITIONS AFFECTING COAL MINE GROUND CONTROL IN THE WESTERN UNITED STATES

OFR 86-63

Contract J0145032  
Goodson & Associates, Inc.

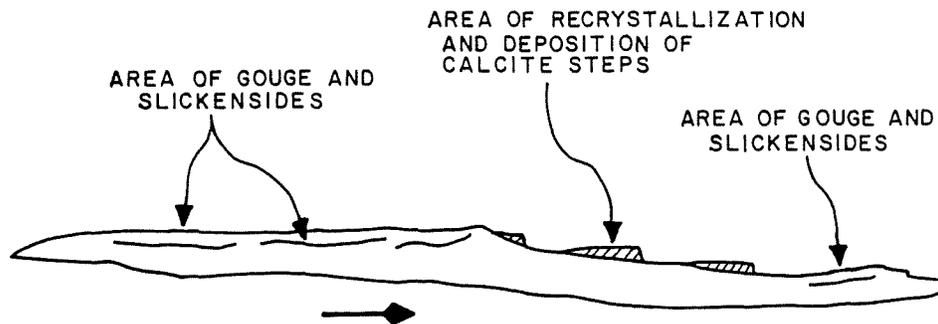
FIGURE 41. - Cross-section through structurally slickensided siltstone of Plate 9. Scale is actual. This perspective clearly shows locations of gouge and structural shortening and also the area of calcite recrystallization and deposition with structural lengthening. This siltstone is extremely brittle, and with respect to recrystallization, apparently has partially metamorphosed to slate. Arrow shows direction of movement.

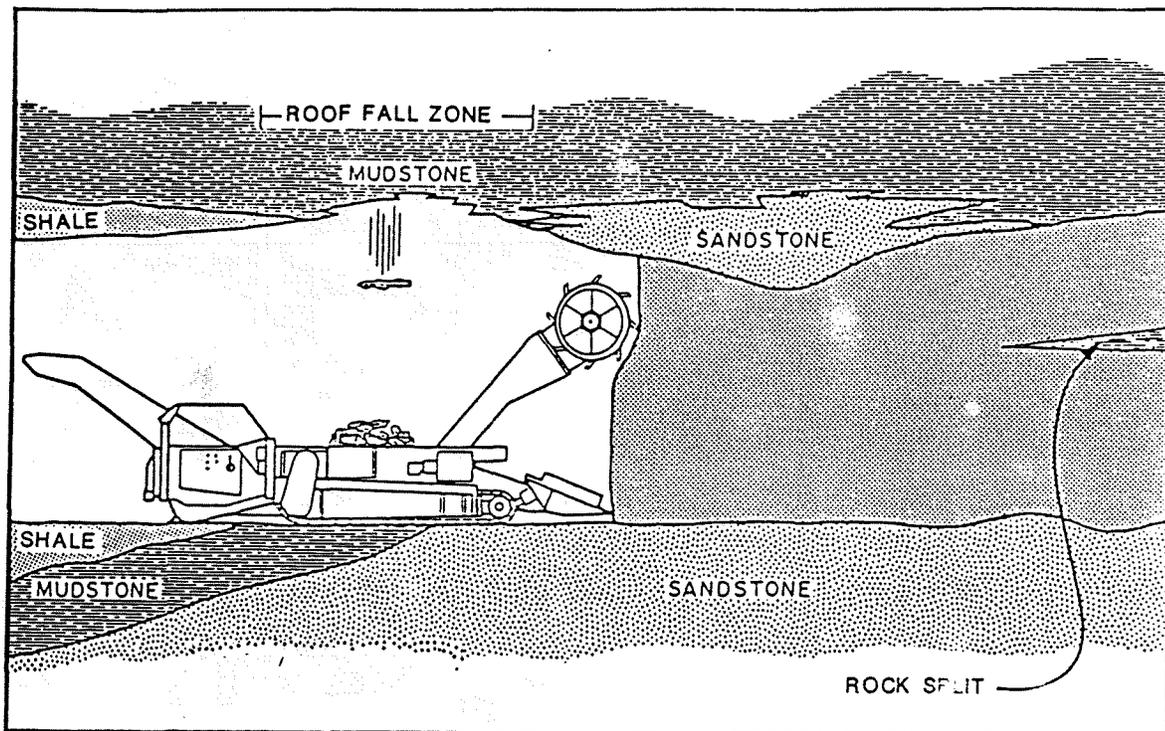
FIGURE 42. - Diagram showing the common location of roof falls that are associated with a sandstone channel. This zone of weakness in the roof may be caused by differential stress, slickensides, or by the weak, noncohesive contact between the sandstone of the channel and the surrounding lithology. Upon removal of the coal, differential stress between the two lithologies can cause severe roof failure (adapted from 38).

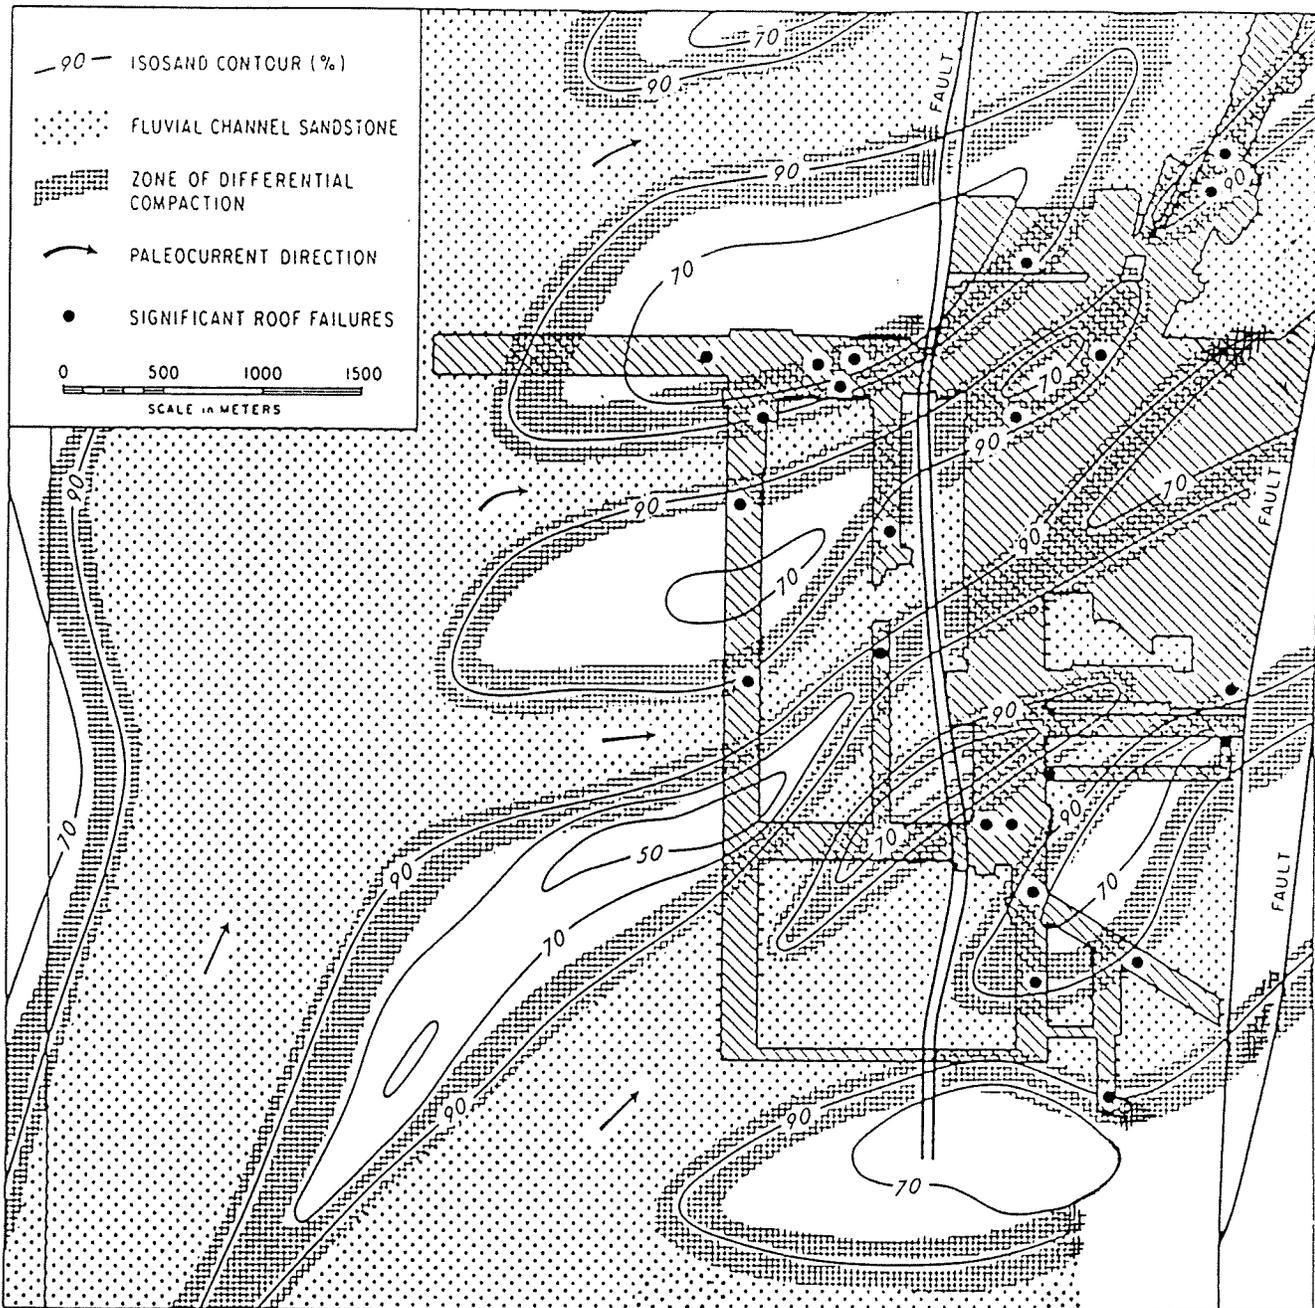
FIGURE 43. - Portion of a mine map showing sandstone channels, central Wasatch Plateau Coal Field. Mapping of sandstone channels shows paleocurrent directions and differential compaction zones producing slickensides. Map shows that location of most roof falls coincides with edge of sandstone channels, where differential stress and slickensides cause adverse roof conditions (adapted from 34).

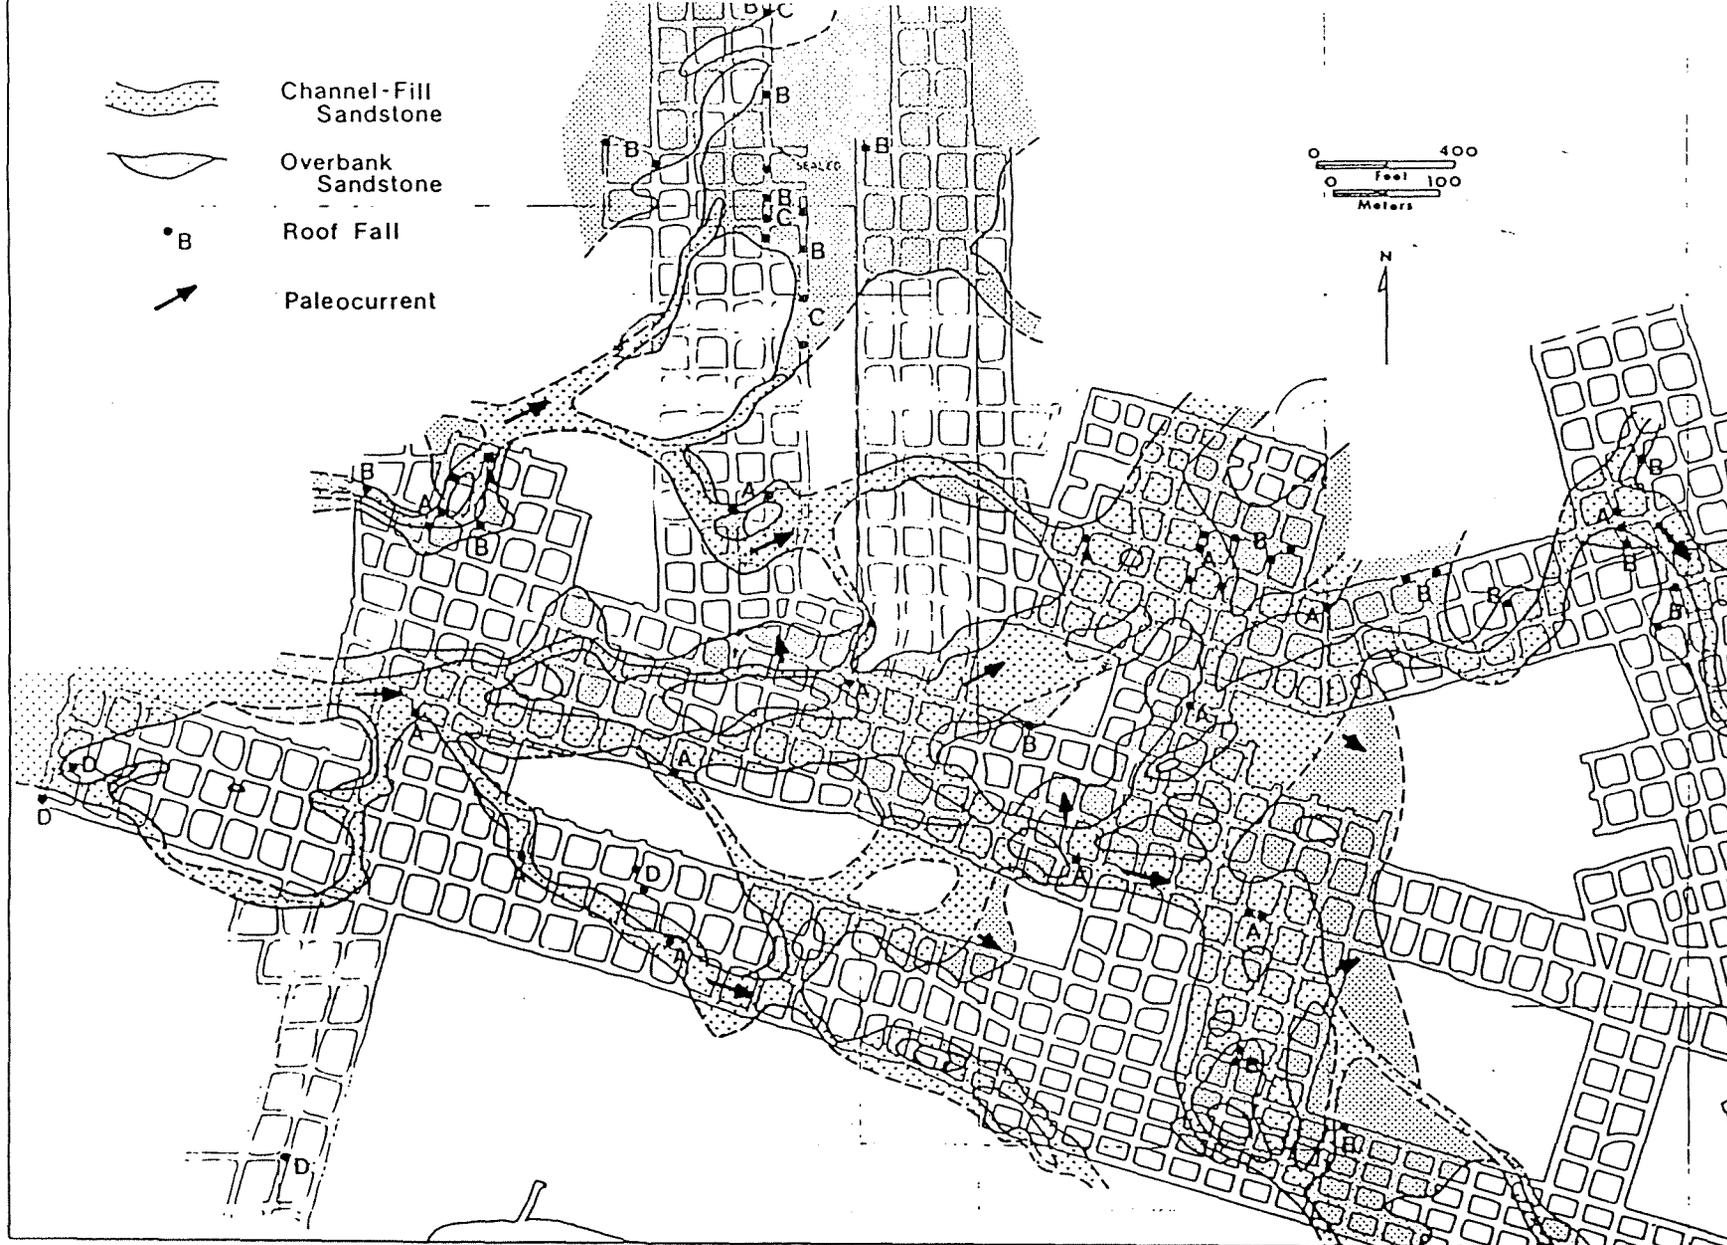
FIGURE 44. - Portion of a mine map, from a mine in the western Book Cliffs Coal Field, showing sandstone channel deposits. Majority of roof falls have occurred in crevasse-splay and overbank deposits (33).

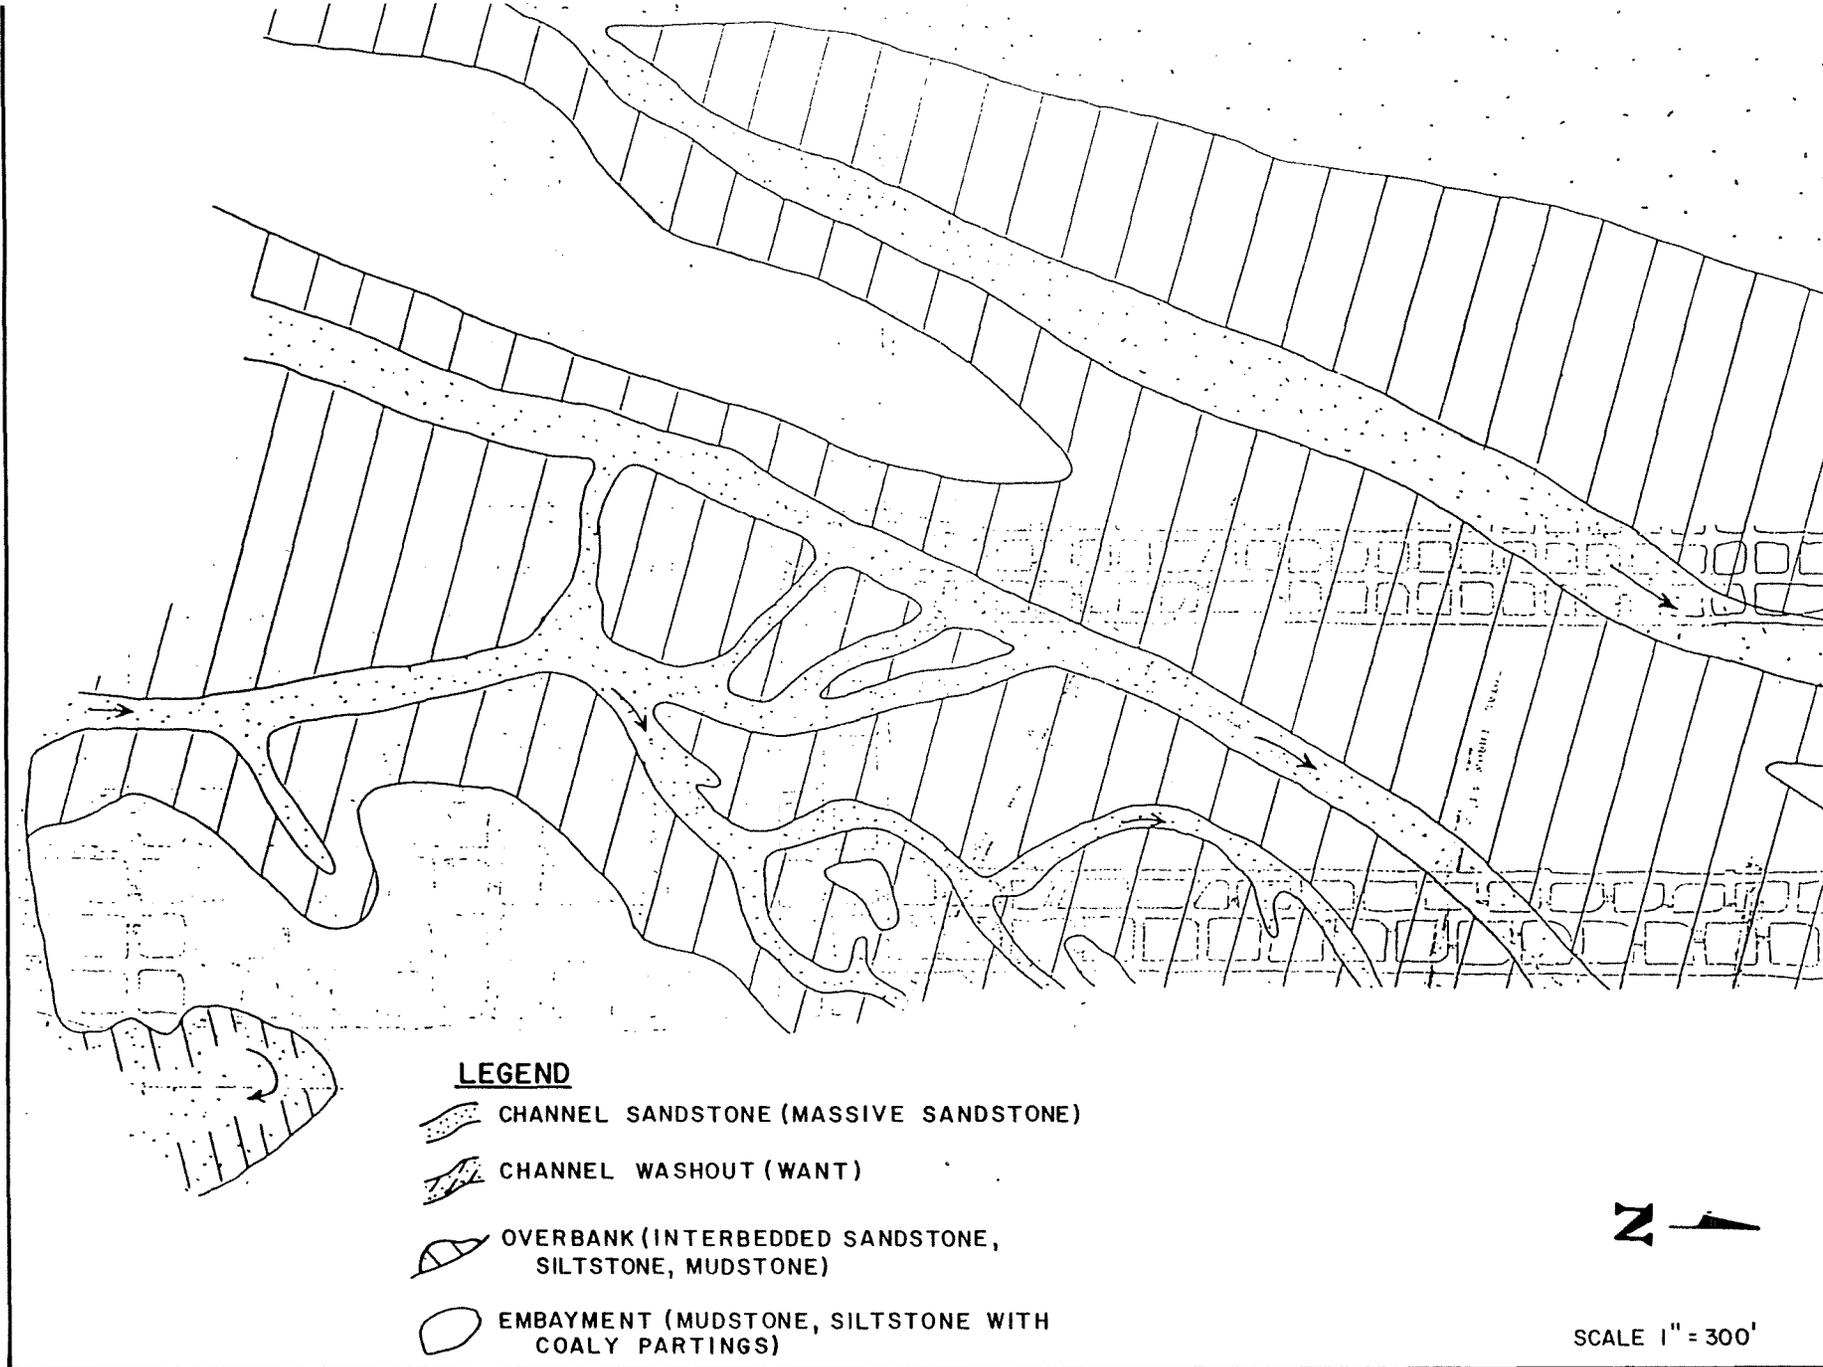
FIGURE 46. - Portion of a mine map, from a mine in the northern Wasatch Plateau Coal Field, showing roof lithology including a coal washout mapped in the lower left corner.

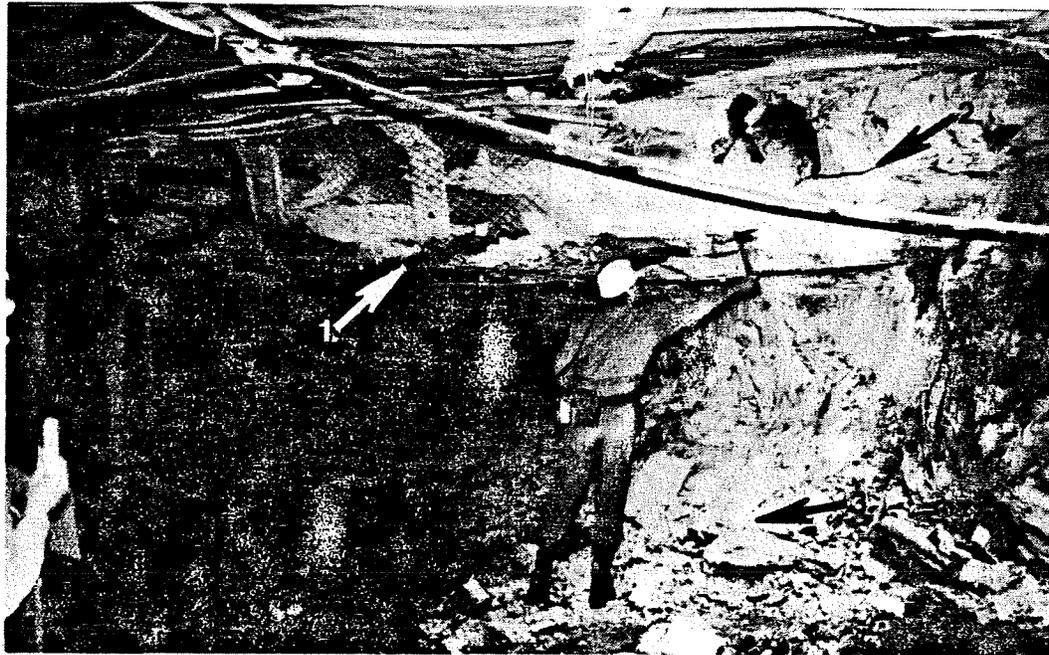
PLATE 18. - Fluvial sandstone channel and associated coal cut-out, central Wasatch Plateau Coal Field. Sandstone channel has removed approximately 4 ft. of the peat deposit. Channel has blocky splitting that causes much spalling. Arrow 1. points to mats and mesh needed to keep sandstone blocks from falling into entry; arrow 2. points to fracture causing blocky splitting; arrow 3. points to spalled sandstone blocks on mine floor.

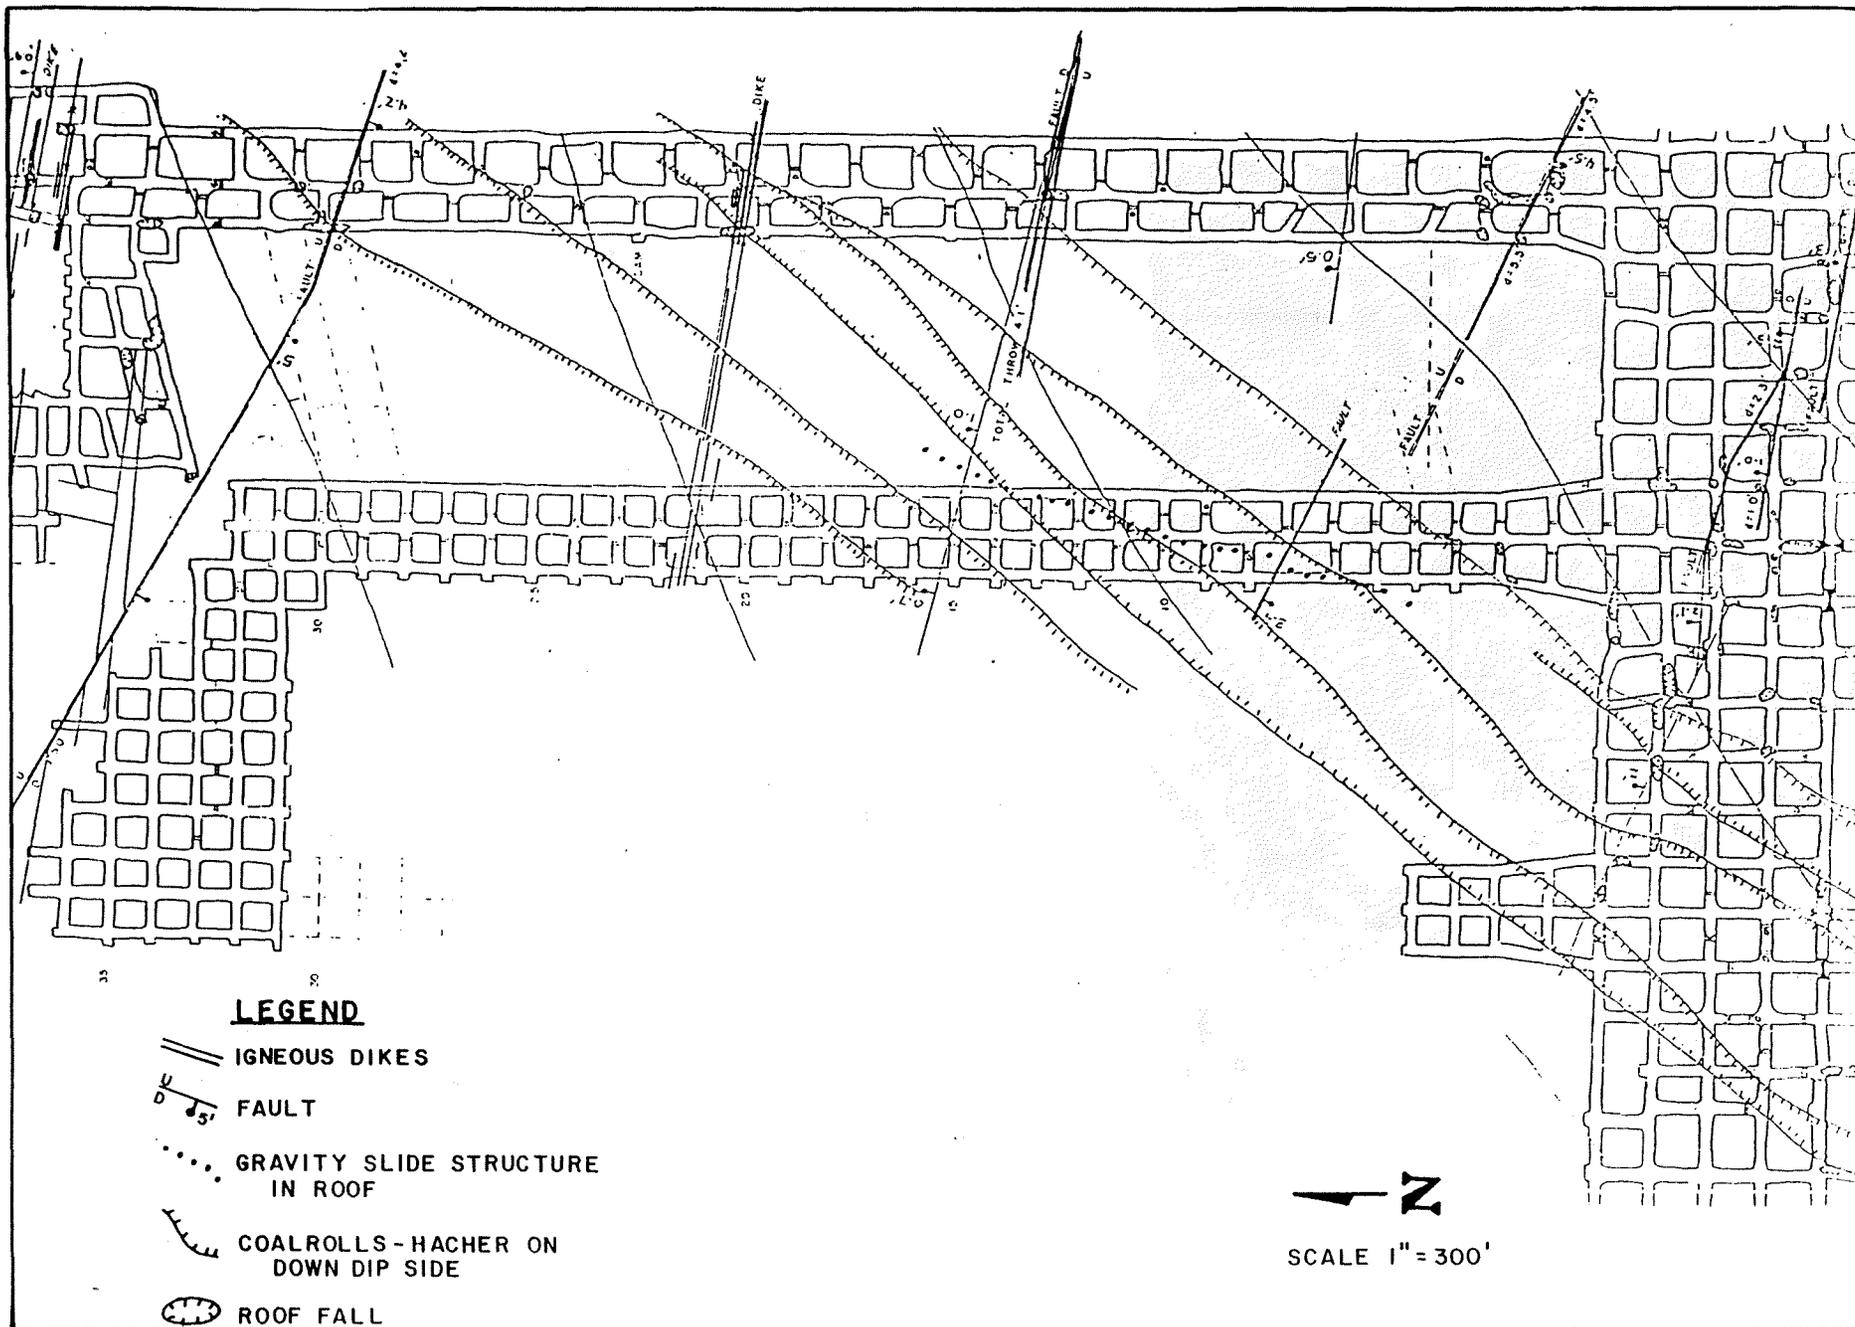
FIGURE 49. - Portion of a mine map, from a mine in the northern Wasatch Plateau Coal Field, showing structural geology including coal rolls.

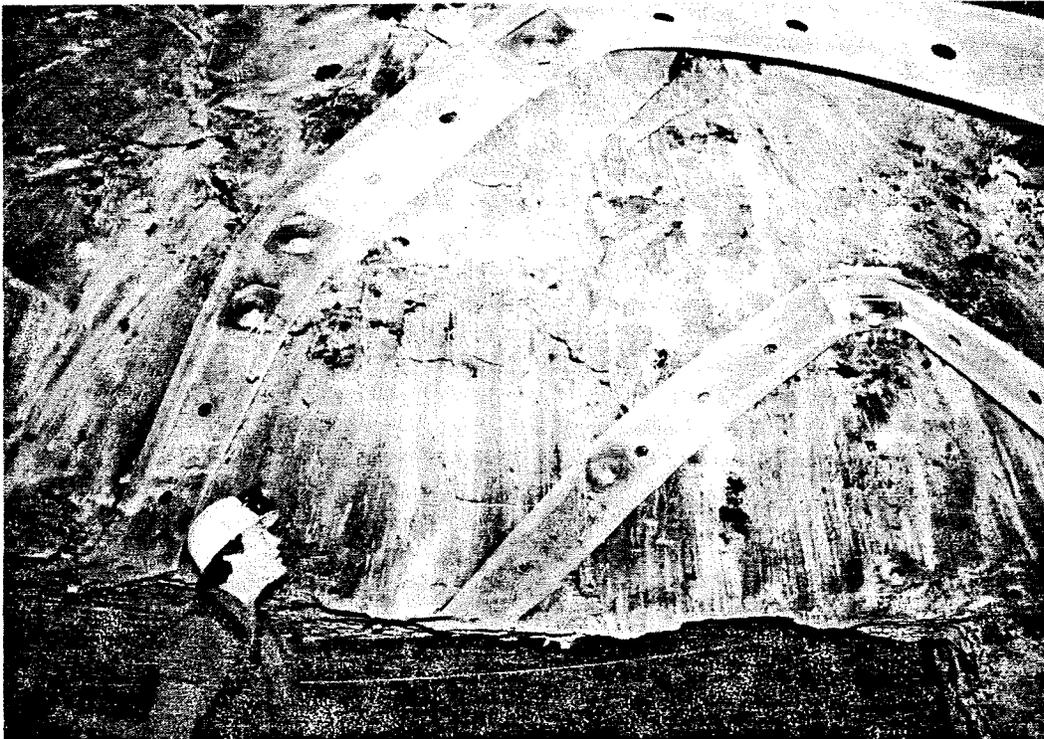
PLATE 29. - Large kettlebottom cave, Somerset Coal Field. This kettlebottom cave is 14 ft. in diameter and 6 ft. high. Sides are completely slickensided with imprints of root bark on the upper sides and top.

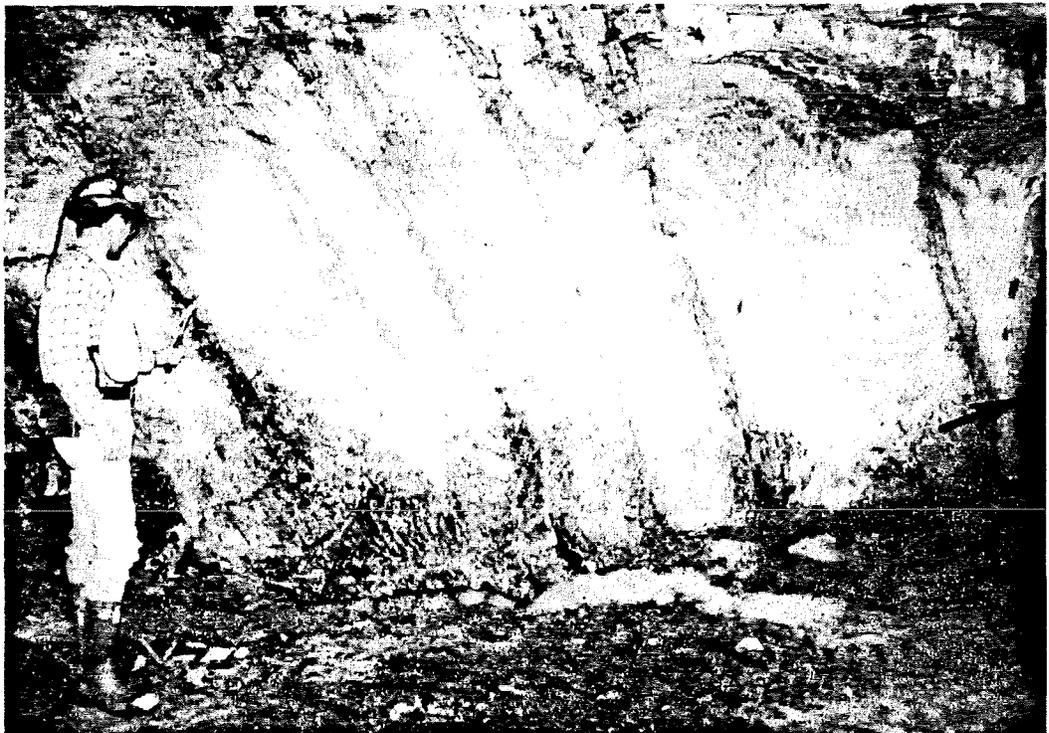
PLATE 33. - Joint set in a coal pillar, Yampa Coal Field. Observers hammer is on plane of joint. These joints strike at an angle to mine development. Arrow points to edge of coal pillar.

a pillar. This joint set has parallel fractures as little as 2.5 ft. apart that dip at approximately 65 degrees. However, the joints strike at an angle to mine development, similar to those depicted in Figure 52b. At an angle to mine development, joints do not usually cause hazardous pillar slabbing.

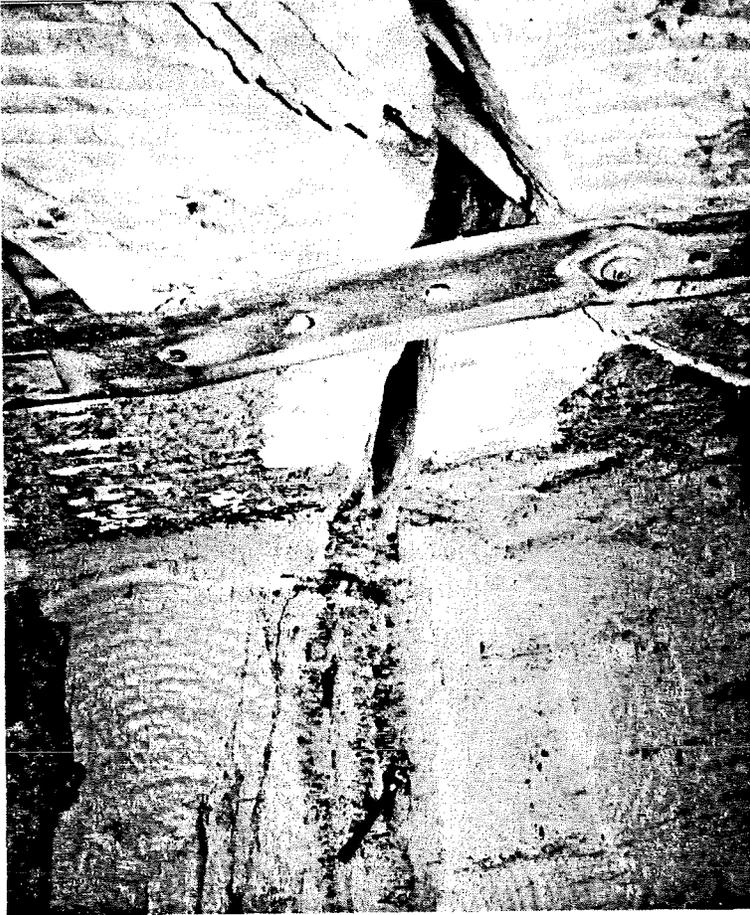
PLATE 36. - Large open joint, Paonia Coal Field. This joint is one of a set of four. Hammer provides scale. Joint has affected coal seam. These joints remain open to the surface, several hundred feet above. These joints parallel mine cross-cuts. However, there are only four joints spaced approximately 10 ft. apart and mine development circumvented this problem. No roof or rib control problems are associated with these joints.

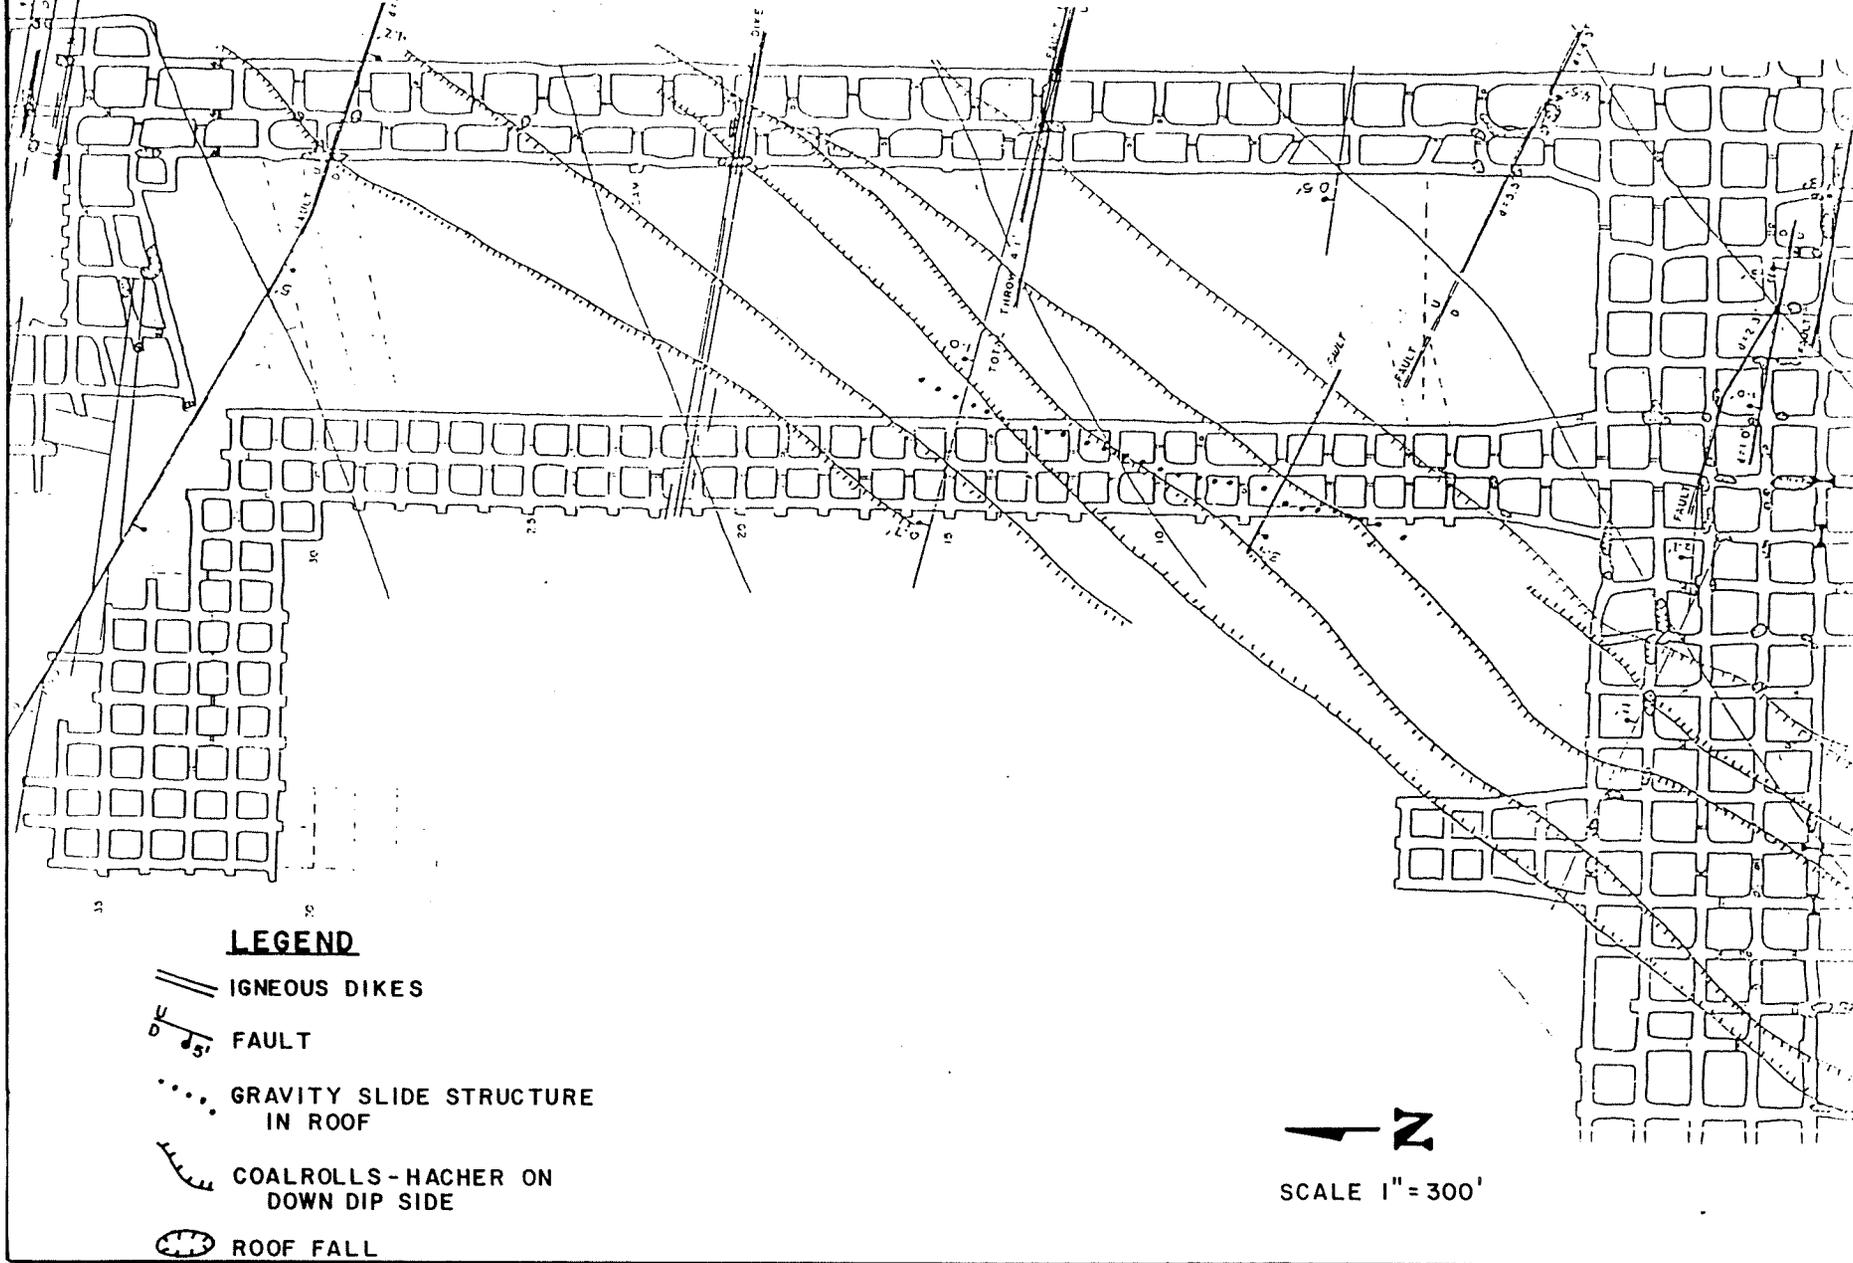
Figure 54. is a portion of a mine map, from a mine in the northern Wasatch Plateau, that shows mapped faults and associated roof falls. As can be seen on this figure, all faults mapped in this portion of the mine strike approximately N10-20E under the control of regional tectonic forces. Minor to major roof falls have occurred near these faults that have produced weak roof conditions. Several of the faults exhibit more than one direction of movement, due to repeated motion under changing regional stress through geologic time. These changes in stress and motion have significantly increased the fractured condition of rock adjacent to the faults. Figure 55. is a portion of another mine map, from a mine in the central Wasatch Plateau Field, showing structural and depositional geology. Several north-striking faults are

FIGURE 54. - Portion of a mine map, from a mine in the northern Wasatch Plateau Coal Field, showing structural geology. All faults are normal. Fault sets, splayed faults, and dike-injected faults are shown.

mapped. No roof falls are mapped on this figure, but faulting, in combination with the sandstone channel, has produced areas with very poor roof conditions. The faults shown in Figures 54. and 55. have small displacements, with only moderate amounts of gouge. However, these faults have weakened adjacent roof rock and have caused roof falls subsequent to undermining. Plate 37. shows one of the faults from Figure 55. This is a fairly clean fault with very little gouge. Minor roof control problems were associated with this normal fault, which displaced about 4.5 ft. of strata. Plate 38. is a photograph showing the plane of movement along a thrust fault in the Yampa Coal Field. This type of faulting was induced by powerful compressional forces. Plate 39. shows a major roof fall below one of these low-angle thrust faults. This fall, which occurred in an intersection, was approximately 11 ft. high. Figure 56. is a cross-section through this roof fall, showing the conditions that caused the fall. The low angle of the thrust-fault plane, which is a major plane of weakness, combined with water influx along the fault plane, caused this roof fall. Figure 57. is a portion of a mine map from a mine in the Carbondale Coal Field. This map shows a major fault zone, in this example termed a "shear zone", which strikes diagonally across the entries of the mine. This shear zone caused major roof falls during mine development. Figure 58. is a cross-section through this shear zone that shows the direction and amount of movement on the fault, as well as the rock slope that had to be constructed to cross through the shear zone to the coal seam on the opposite side. Plate 40. is a photograph showing the sheared condition of the rock within the fault zone shown in Figure 58. Technically, this entire zone of sheared rock is termed fault gouge. The extreme roof control procedures needed to support this weak rock are also shown. Plate 41. shows a fault set within the same mine in the Carbondale Field. Total offset on this fault set is approximately 4 ft.

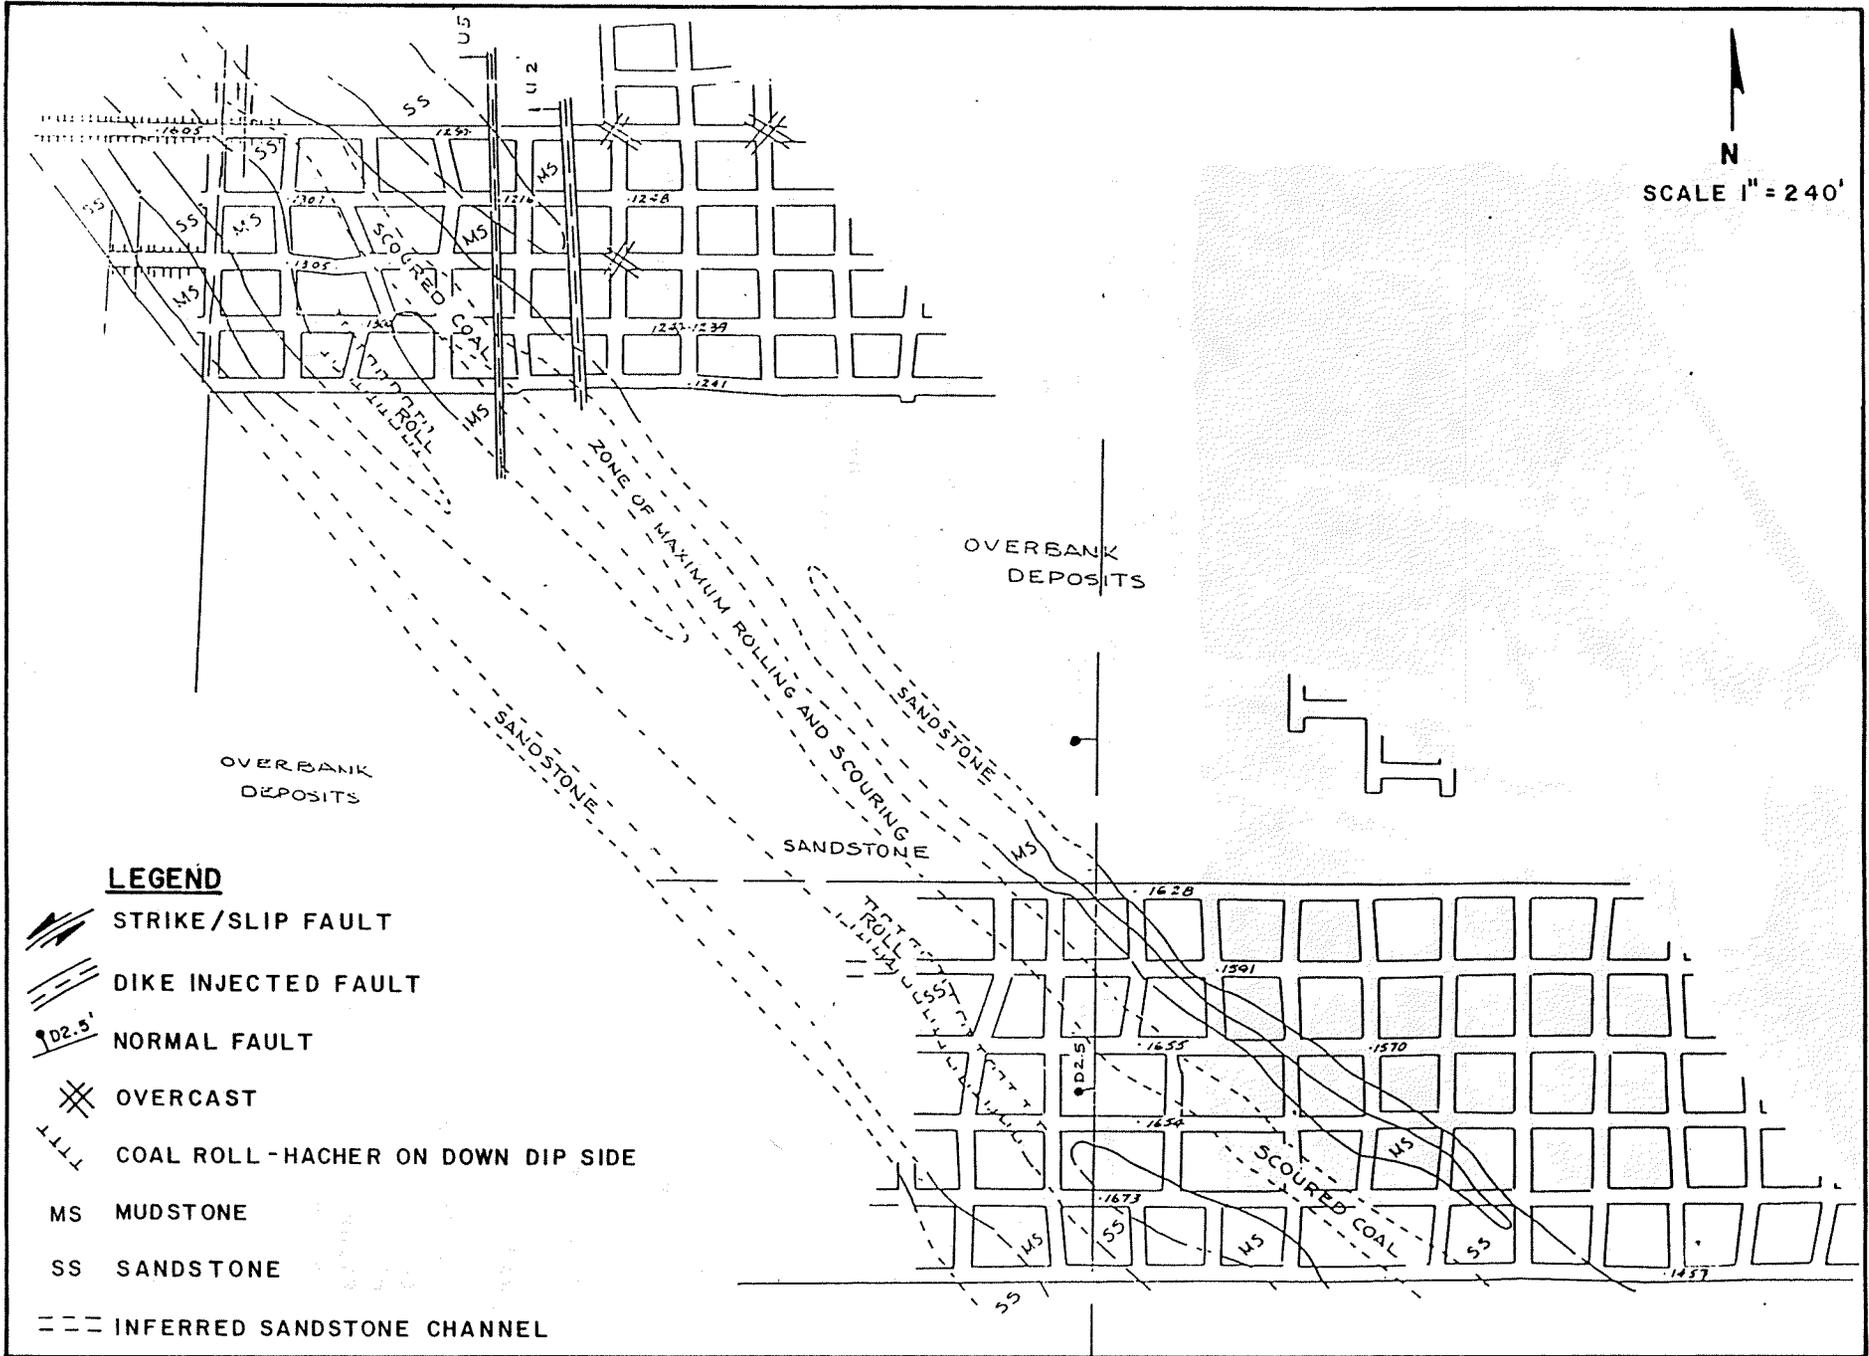
FIGURE 55. - Portion of a mine map, from a mine in the central Wasatch Plateau Coal Field, showing structural and depositional geology. Faults mapped show normal and strike-slip movement as well as dike injection.

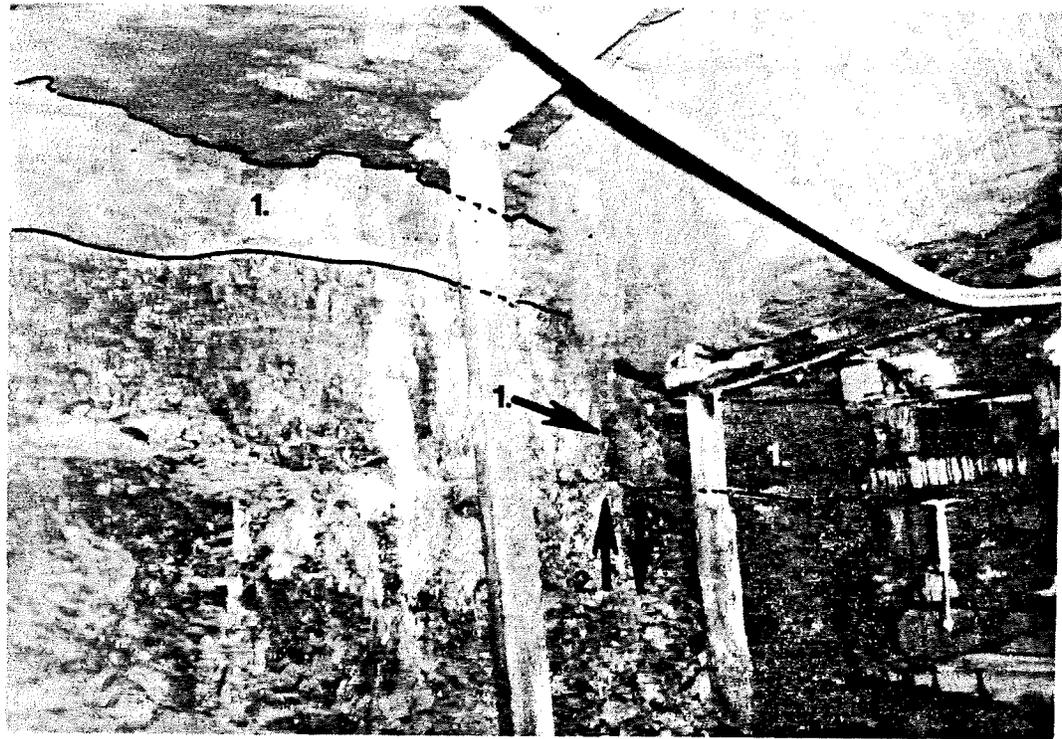
PLATE 37. - Photograph showing fault, central Wasatch Plateau Coal Field. Rock pick is approximately 3 ft. long. Fault has normal movement along a vertical plane. About 4.5 ft. of displacement has occurred. Unit 1. outlines displaced strata; arrow 1. points to plane of movement; arrows 2. show direction of movement.

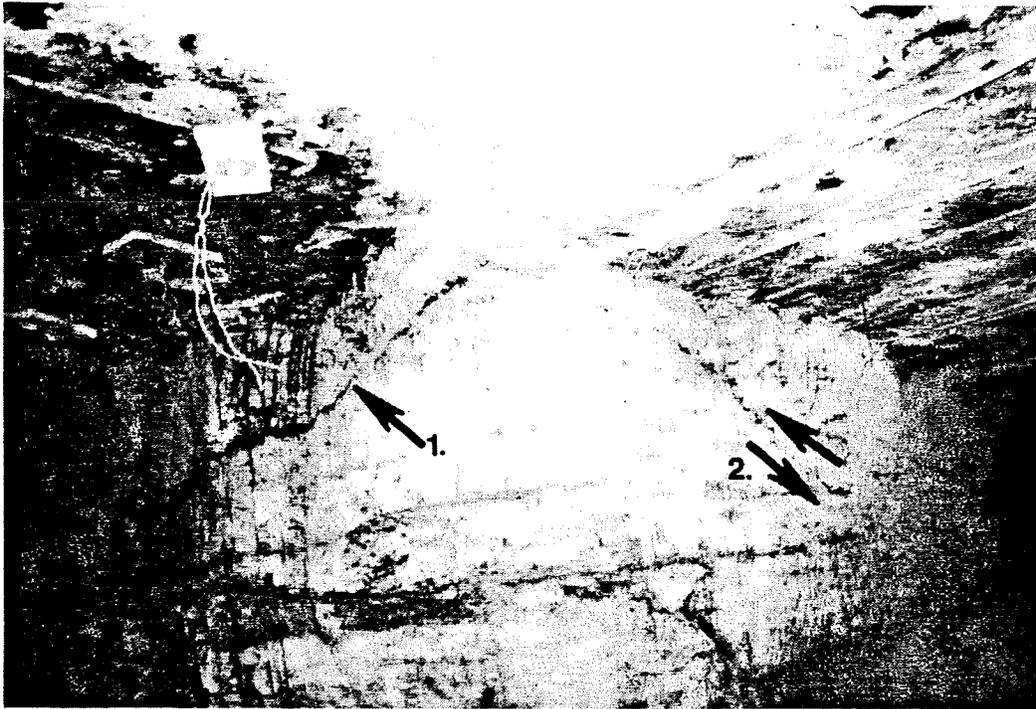
PLATE 38. - Photograph taken perpendicular to the plane of a thrust fault, Yampa Coal Field. Fault dips approximately 25 degrees. Arrow 1. points to plane of fault and arrows 2. point to direction of movement. Cap blocks are 8 in. wide.
