A mining research contract report  
December 1985

# GEOLOGIC CONDITIONS AFFECTING COAL MINE GROUND CONTROL IN THE WESTERN UNITED STATES

OFR 86-63

Contract J0145032  
Goodson & Associates, Inc.

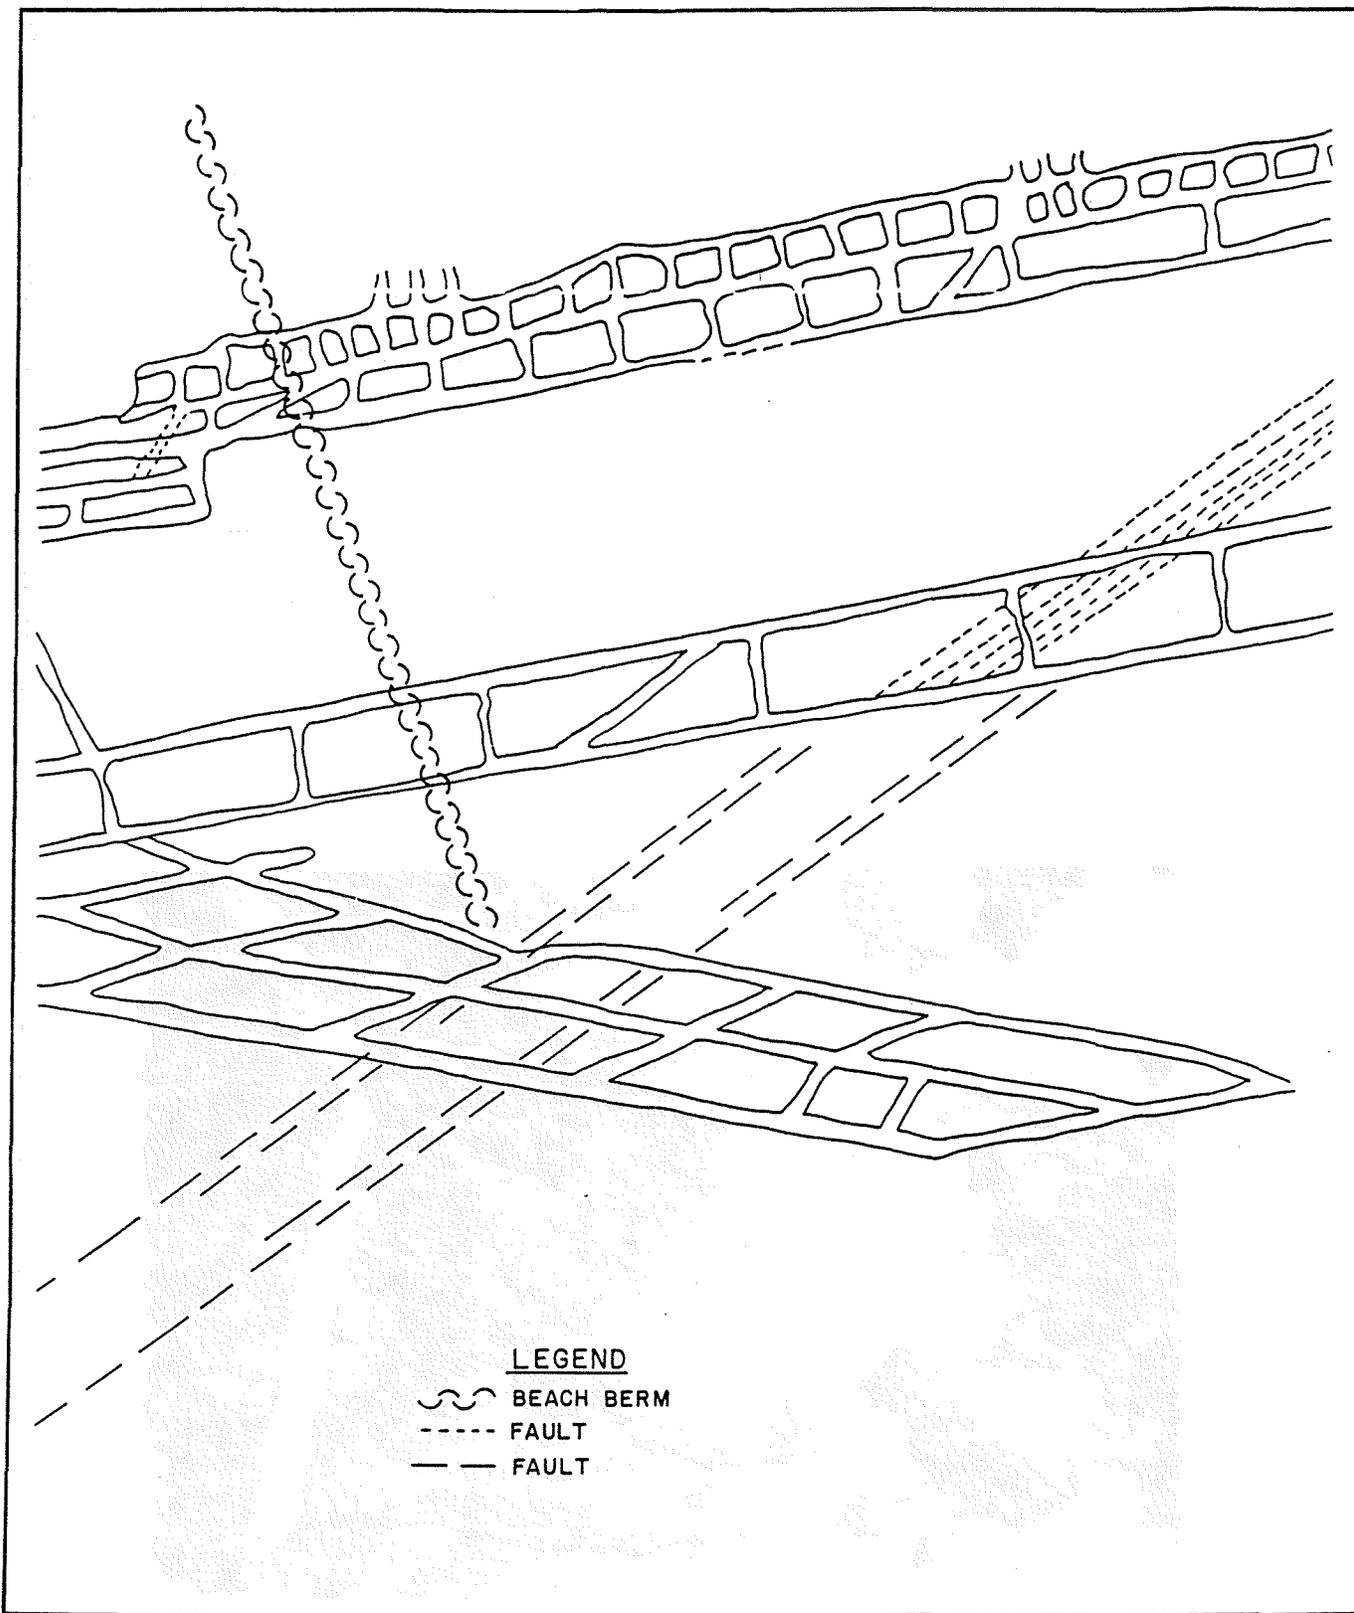
FIGURE 57. - Portion of a mine map, from a mine in the Carbondale Coal Field, showing the major faulted shear zone that transects this mine and caused significant problems in the development stage. No scale.

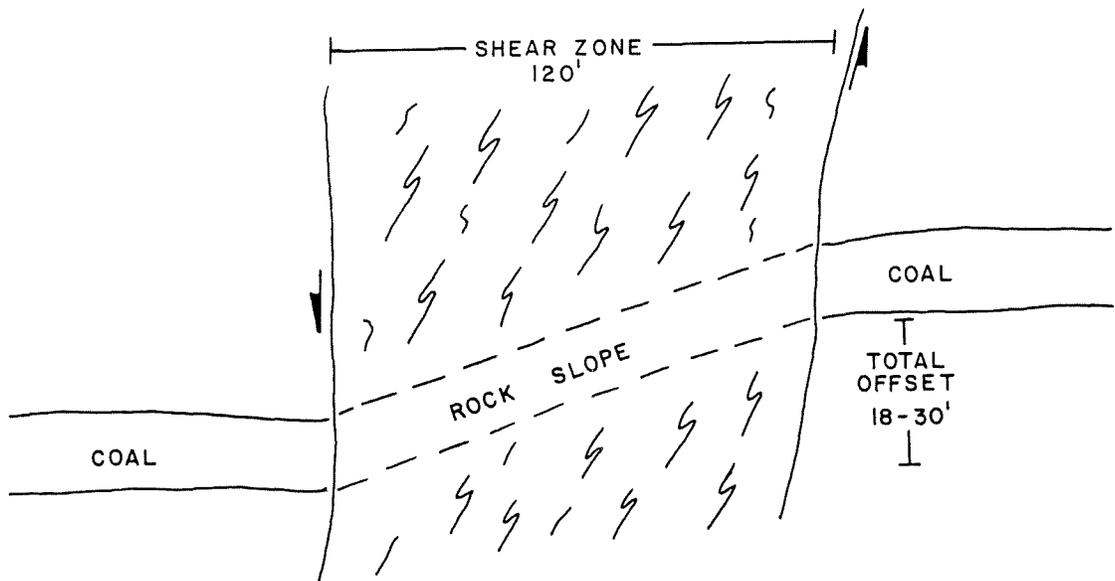
FIGURE 58. - Cross-section through faulted shear zone, Carbondale Coal Field. Shear zone is approximately 120 ft. wide. Fault shows oblique-slip with extensive strike-slip movement that produced sheared rock within fault plane boundaries.

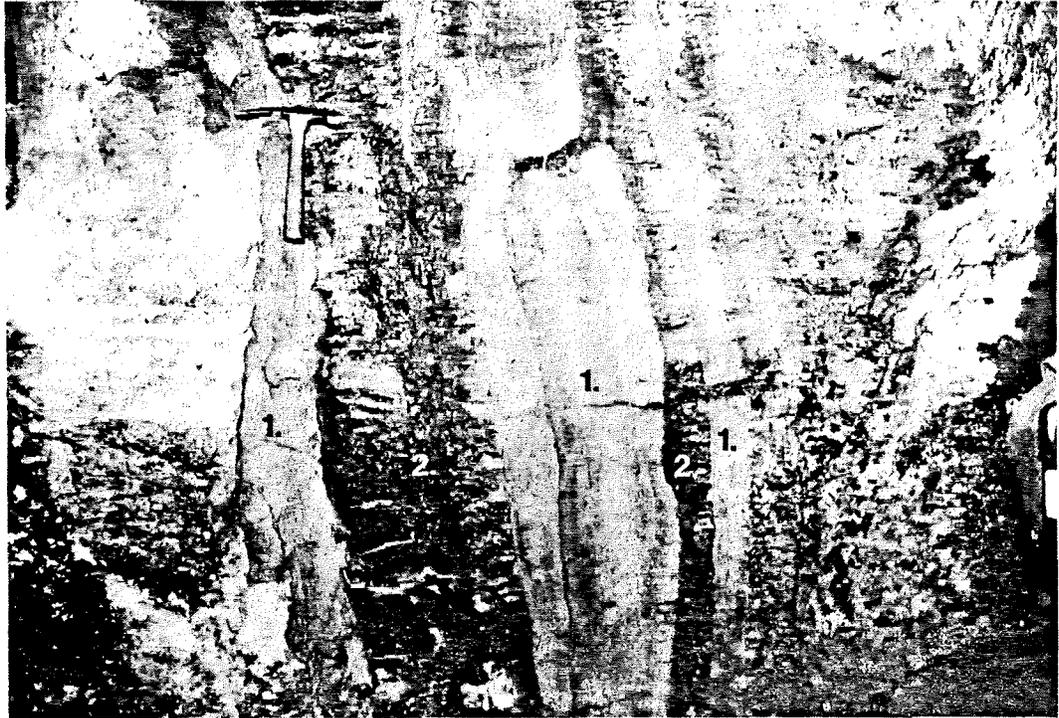
PLATE 42. - Photograph of an igneous dike, northern Wasatch Plateau Coal Field. Hammer provides scale. Rock units labeled 1. are dike injections; rock units labeled 2. are zones of coked coal.

Plate 42. is an excellent example of a small dike which has coked the surrounding coal in the northern Wasatch Plateau Field. Plate 43. is another photograph of an igneous dike intruding into a coal seam. Plate 44. shows a large igneous dike in the central Wasatch Plateau Field that has intruded the coal seam. This dike is composed of extremely friable igneous rock reported to be peridotite (45). The friable and noncohesive nature of this rock has required that extreme roof control measures be implemented, using steel sets.

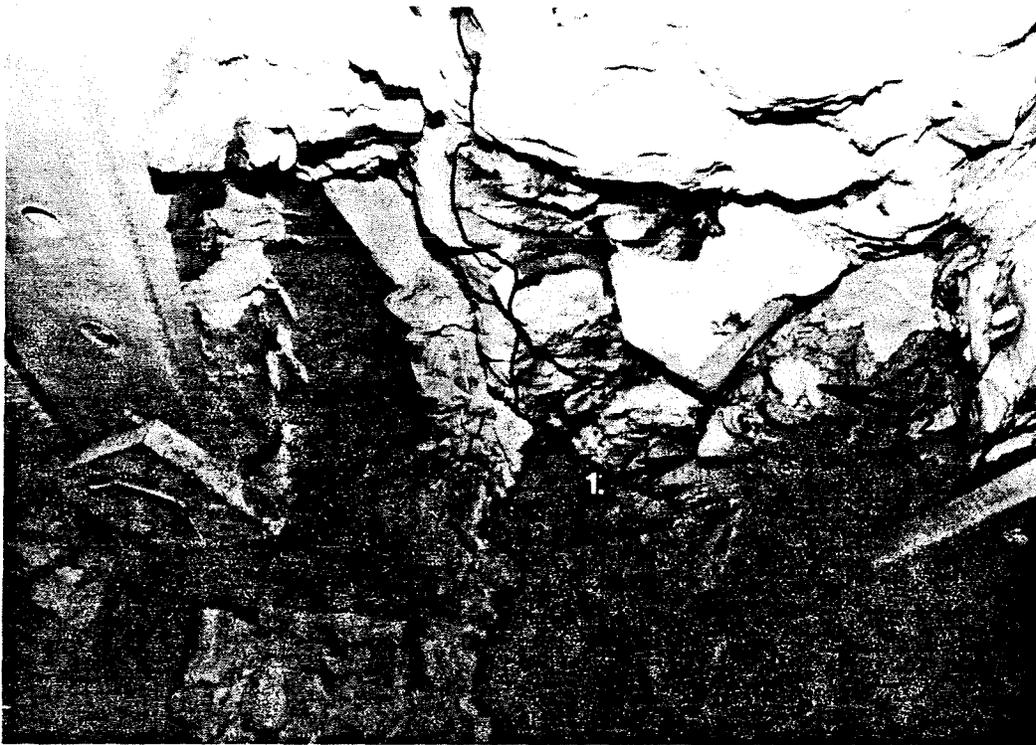
PLATE 43. - Igneous dike, northern Wasatch Plateau Coal Field. Igneous dike is outlined in the rib and the roof of this entry. Arrow 1. points to sand-filled cast of a claw from a three-toed dinosaur; arrow 2. points to a broken toe cast. Cap block is 8 in. wide.

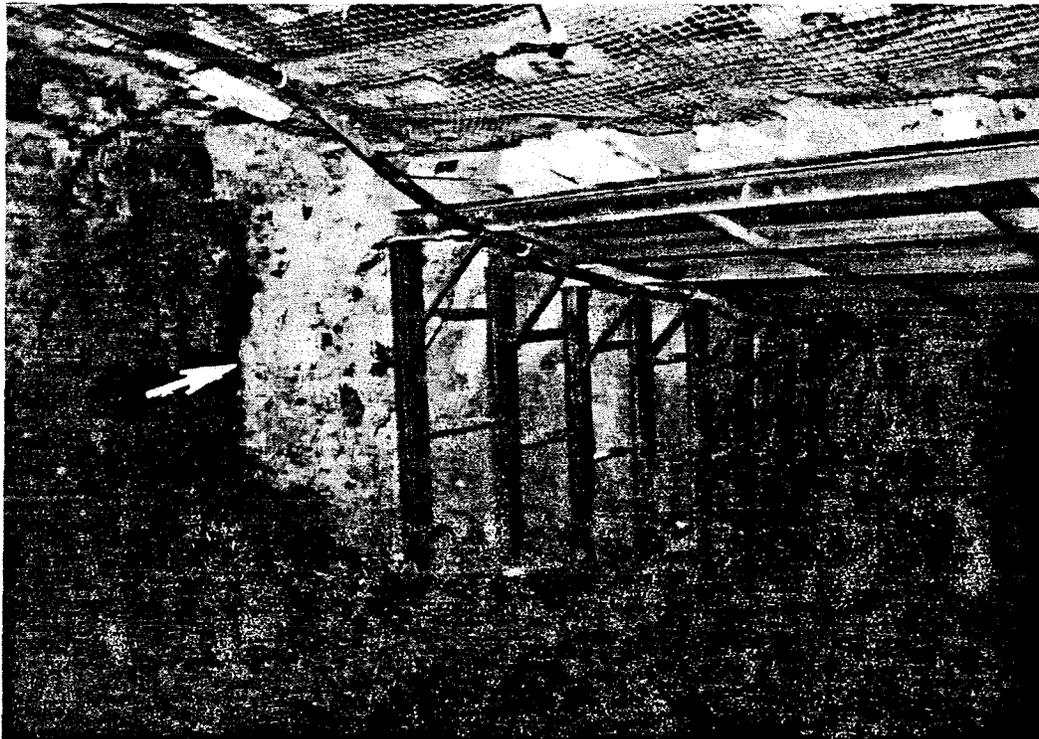
No coal mine reported any major problems with igneous dikes, although most coal mines encounter them. Where igneous dikes have intruded along faults, such as in the Wasatch Plateau Field, moderate ground control problems occur. The large dike pictured in Plate 44. is atypical in that it is approximately 30 ft. wide and contains many hard minerals and so is difficult to mine through.

PLATE 44. - Large (30 ft. wide) igneous dike, central Wasatch Plateau Coal Field. Dike is light-colored rock. Arrow points to contact between dike and coal seam. Dark-colored rocks within the dike are coked-coal xenoliths. Note the extensive roof support required to control caving of this friable dike.

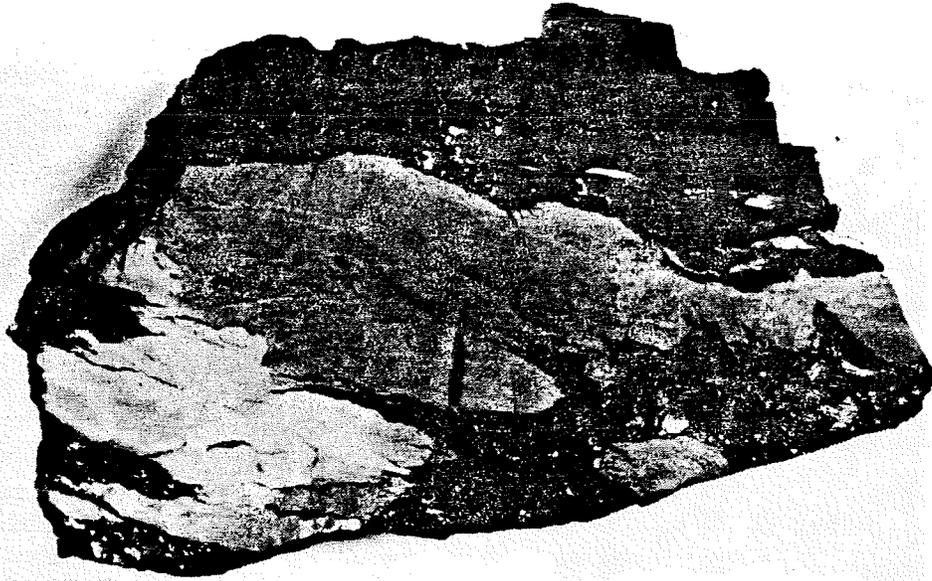
Plate 45. is a detailed photograph showing a piece of coal that has been intruded by a very fine-grained sandstone dike. The sandstone is well-sorted and cemented, and appears to be composed of the same sandstone that makes up thin laminations of related crevasse-splay deposits. Plate 46. shows the clastic dike in the rib of a coal mine in the northern Wasatch Plateau Field

PLATE 45. - Detailed photograph of clastic dike from the northern Wasatch Plateau Coal Field. Light-colored rock is very fine-grained and well-sorted sandstone; dark-colored rock is coal. Fragment is approximately 8 in. wide.

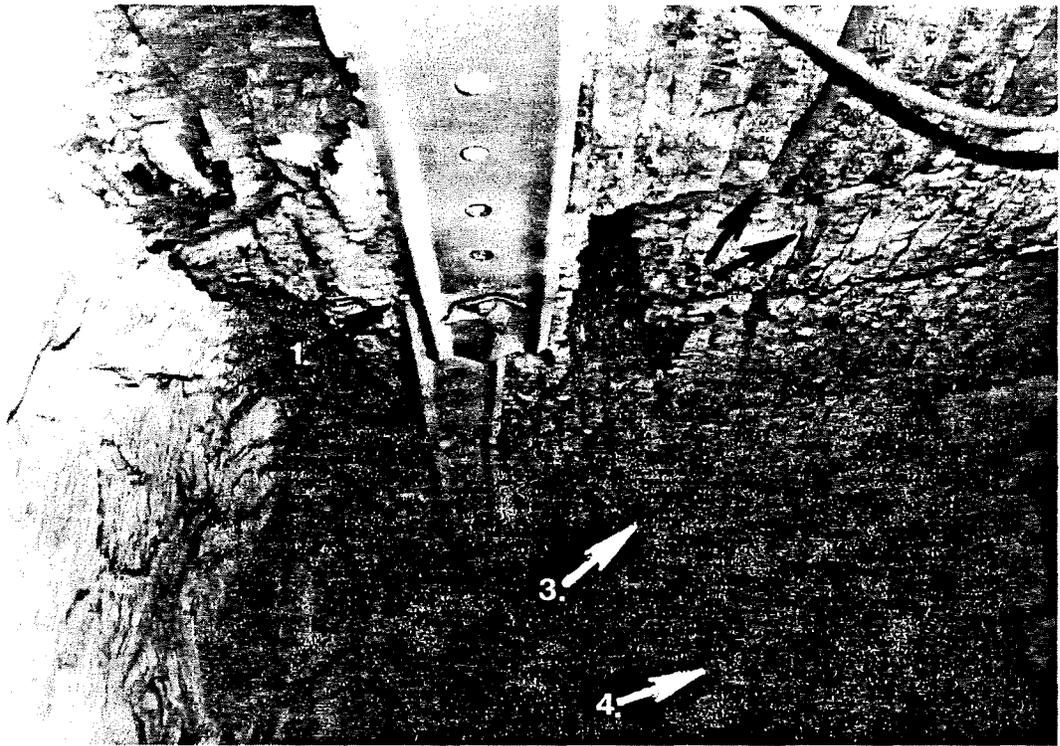
Plate 48. is a photograph, from a mine in the northern Wasatch Plateau Field, showing the effects of high horizontal stress. Roof mats, originally bolted in line with each other, have been offset. Extensive fractures have formed in the roof, and trusses, which originally were emplaced to compress the roof, have buckled in on themselves. Large cribs have shifted and are offset; they are no longer plumb with the roof and floor. Approximately 1600 ft. of overburden overlies this location.

PLATE 48. - Photograph showing adverse effects of high horizontal stress, northern Wasatch Plateau Coal Field. Arrow 1. points to offset roof mats; arrows 2. point to fractures in roof; arrow 3. points to ineffective, buckled roof truss; arrow 4. points to extensive cribbing.

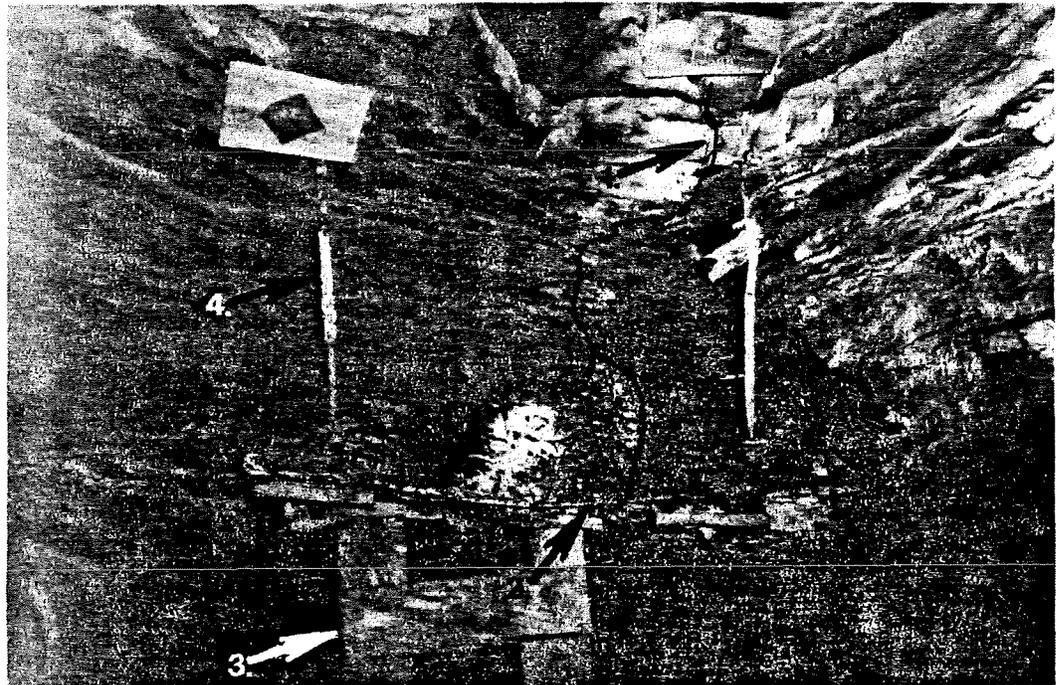
Plate 49. is a photograph taken near to the location shown in Plate 48. This plate also shows the extremely poor roof conditions that have been caused by high horizontal stress. A large roof fall is pictured that was caused by extreme fracturing in a siltstone roof. The roof is heavily timbered and cribbed in this location, with trusses that are not effectively pulling the roof together.

PLATE 49. - Photograph showing adverse effects of high horizontal stress, northern Wasatch Plateau Coal Field. High horizontal stress is causing siltstone roof to fracture and collapse. Arrow 1. points to highlighted fracture in roof; arrow 2. points to ineffective roof truss; arrow 3. points to crib; arrow 4. points to ineffective roof bolt that remained anchored subsequent to major roof fall.

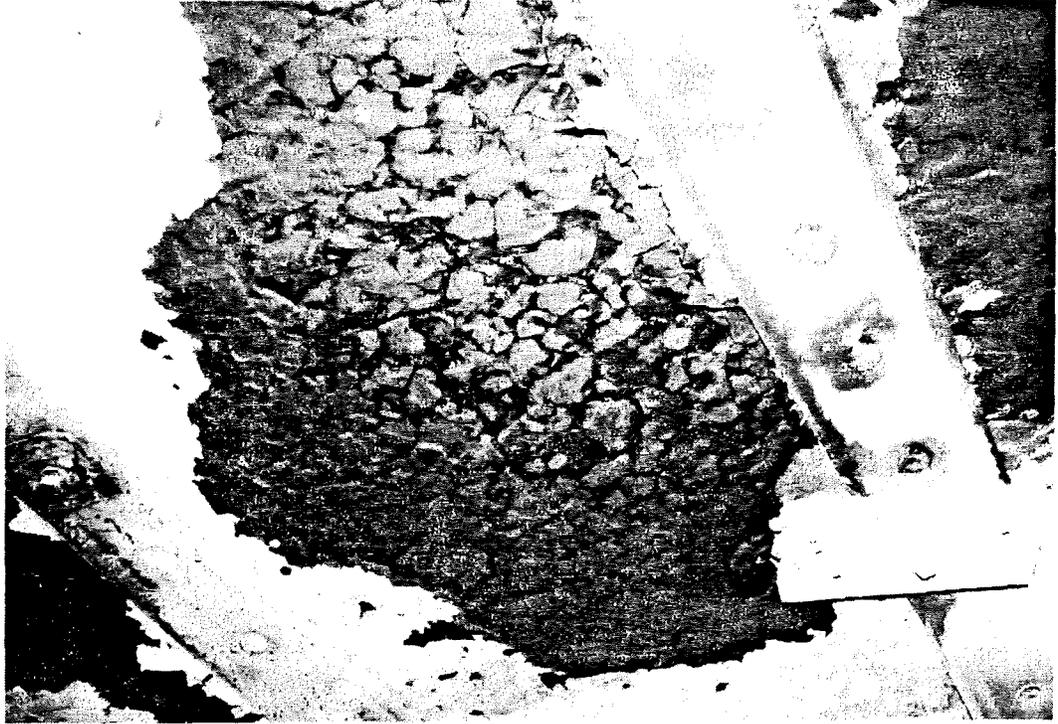
Dessication cracks can result in formation of a plane of weakness, and can cause roof rock separations up to several feet thick. Plate 50. is a photograph of dessication cracks in the Yampa Coal Field. In this case, 1 in. of roof rock has separated from the plane of weakness generated by the dessication cracks. Dessication cracks were only observed directly in the Yampa

PLATE 50. - Dessication cracks in mudstone mine roof, Yampa Coal Field. Approximately 1 in. of mudstone has separated from the weak bedding plane created by the casts of the cracks. Light-colored material is rock dust. Mats are 8 in. wide.

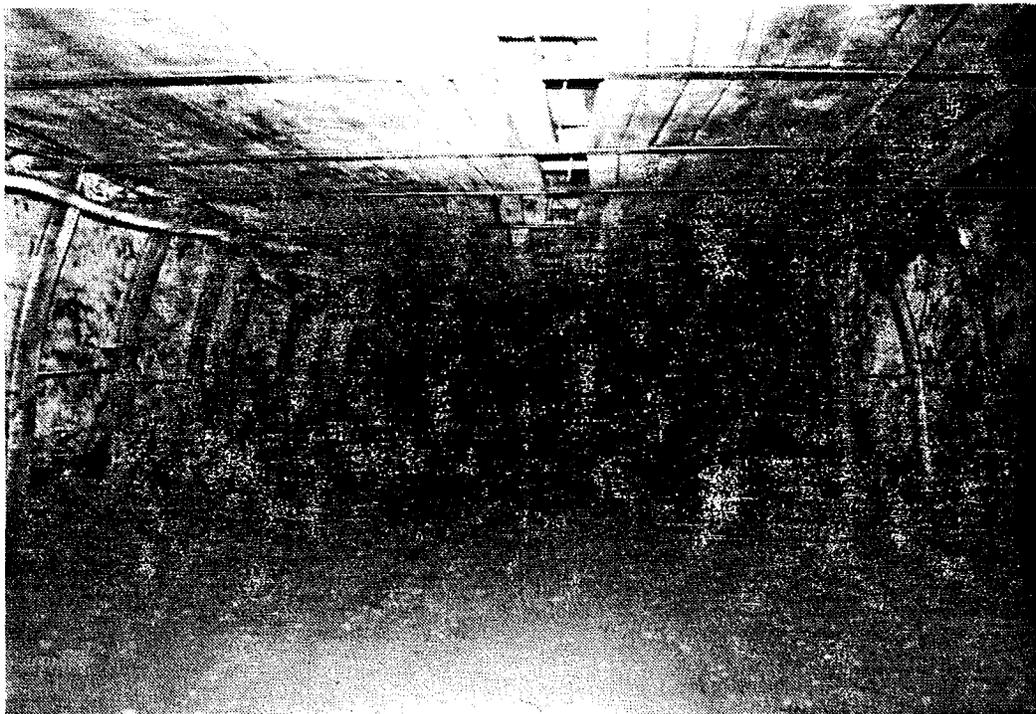
PLATE 63. - Main entry that is supported by steel sets, western Book Cliffs Coal Field, Utah. Steel sets control poor roof conditions caused by crevasse-splay deposits in conjunction with high horizontal stress under an overburden depth of approximately 2,000 ft. This entry is a main "roadway" that will carry much traffic.

In areas of poor roof conditions, where roof falls are expected to occur, conventional bolting and matting procedures are supplemented either by increased use of bolts and mats, or by additional roof support mechanisms. If the roof has deteriorated in a portion of a mine to a fractured or weakly bonded condition, increased use of bolts and mats may be all that is necessary. If the fractured and noncohesive roof rock extends above the height of the conventional bolts, longer bolts may be required. In mines, where the roof is fracturing due to weak roof rock, or high vertical stress, roof trusses may be used in place of mats. Roof trusses are designed to screw together in the center to tighten and compress the roof, as shown in Plates 48. and 49. In general, the type of roof control required is dictated by the condition of the lithologic structure in the roof rock. In areas of water infiltration, poorly bonded and weak strata (such as a lithofacies change roof type), high horizontal stress, vertically extensive slickensides, or overlying sandstone channels, extensive timbering, cribbing, or even steel sets may be required. Conventional bolting and matting in these areas may prove to be entirely ineffective. Plate 63. shows a main entry roof that is heavily supported with steel sets. This entry is supported in this way not only because of poor roof conditions caused by crevasse-splay deposits in conjunction with high horizontal stress, but also because this main entry will receive much traffic upon resumption of active mining.
