THE DEVELOPMENT OF GUIDELINES FOR
CLOSING UNDERGROUND MINES:
MICHIGAN CASE HISTORIES

Institute of Mineral Research
C.W. Schultz, Director
Michigan Technological University
Houghton, Michigan 49931

Allan M. Johnson
Research Leader

Date prepared June 28, 1984

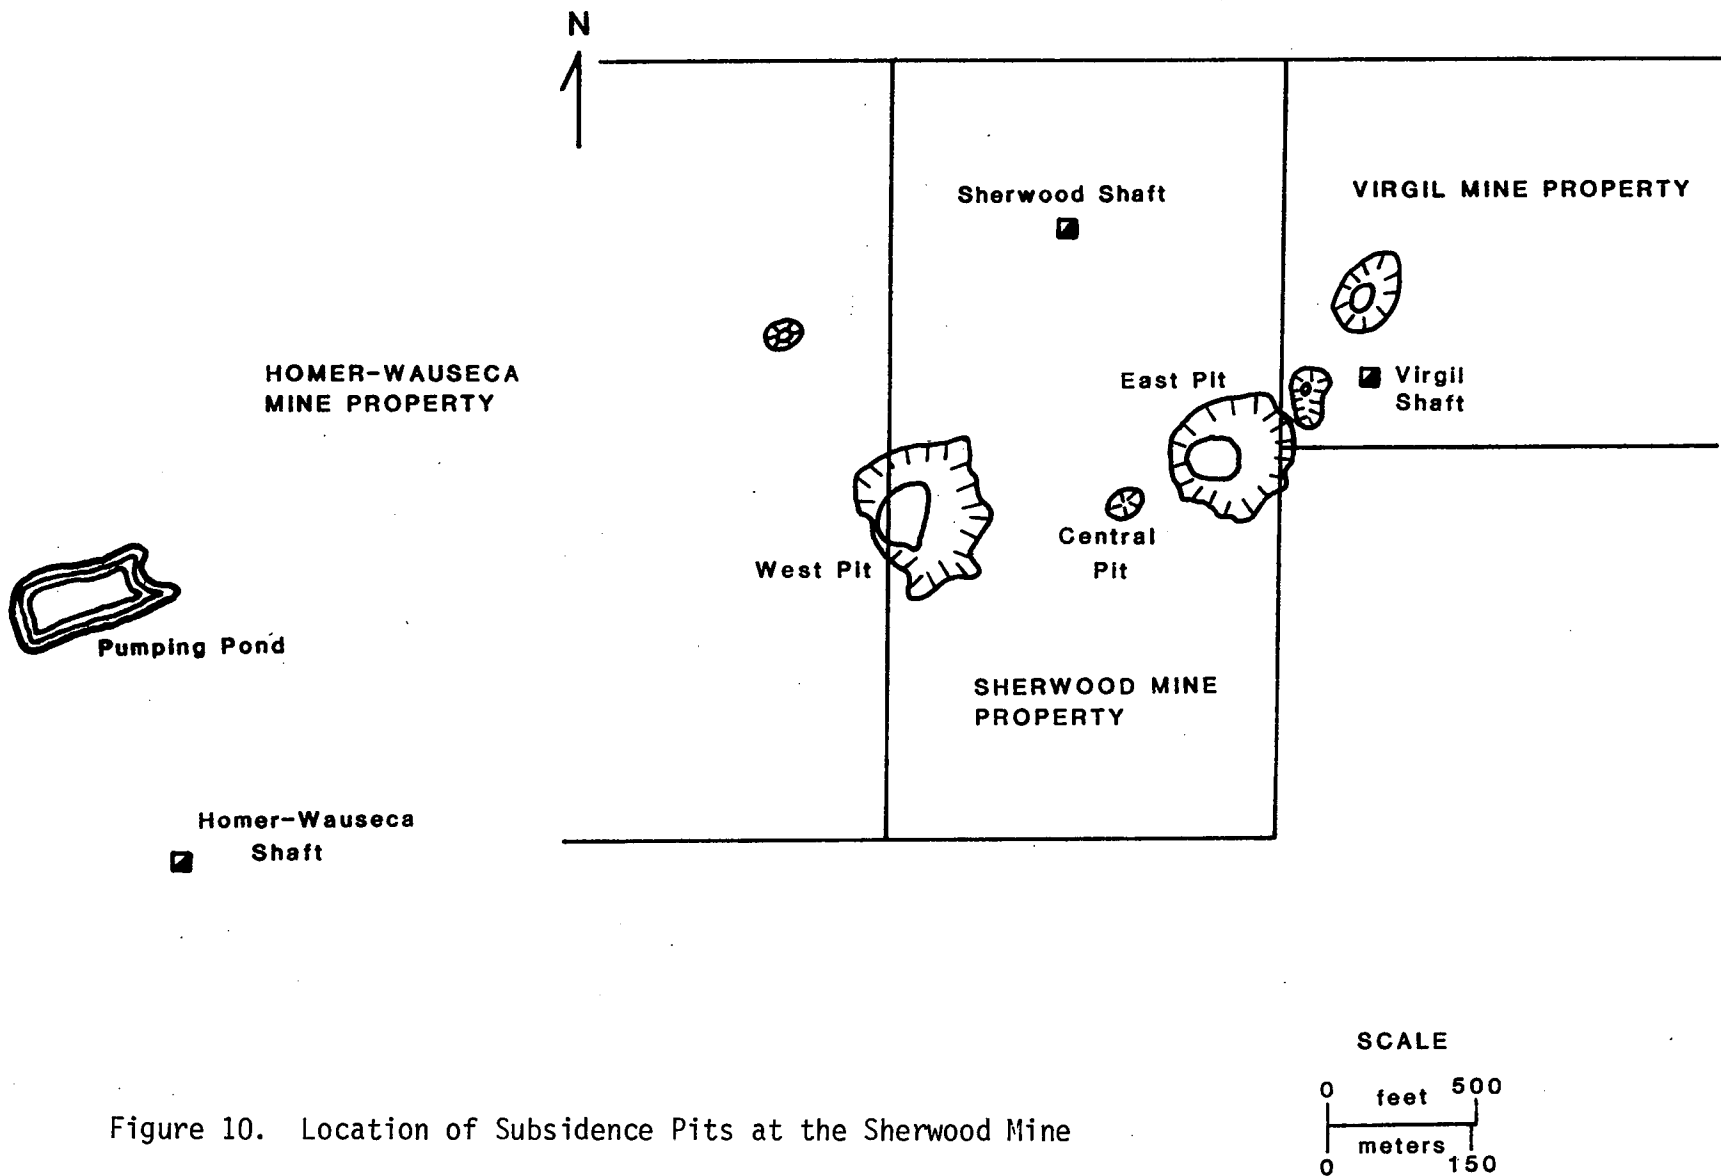
Figure 10. Location of Subsidence Pits at the Sherwood Mine

The Sherwood Mine has had a rather long history of subsidence. Major stopes in the upper levels of the Sherwood Mine on both the east and west margins of the Sherwood property had caved to the surface. These cave-ins resulted in large deep surface pits in the thick glacial overburden. The West Pit caved in February 1956 and the East Pit caved to the surface in August 1964. The pit locations are shown in Figure 10. Also shown is a small pit located between the East and West Pits, known as the Central Pit. This 100-foot diameter pit appeared suddenly in February of 1967 following an explosive blast used to break up consolidated overburden being used for stope filling operations. The blast apparently triggered the collapse of a soil capping over an existing cavity in the overburden. This void had probably been formed either by piping or running sands, but a plug-type failure of a shallow stope may also have been responsible. A steeply dipping (70° south) east-west fracture developed in the Sherwood Mine during the Spring of 1966. By November of 1966 the fracture was evident on the 400, 800, 1000 and 1200-foot levels plus on the surface. The maximum displacement was three feet on the 1000-foot level as observed in a major crosscut drift.

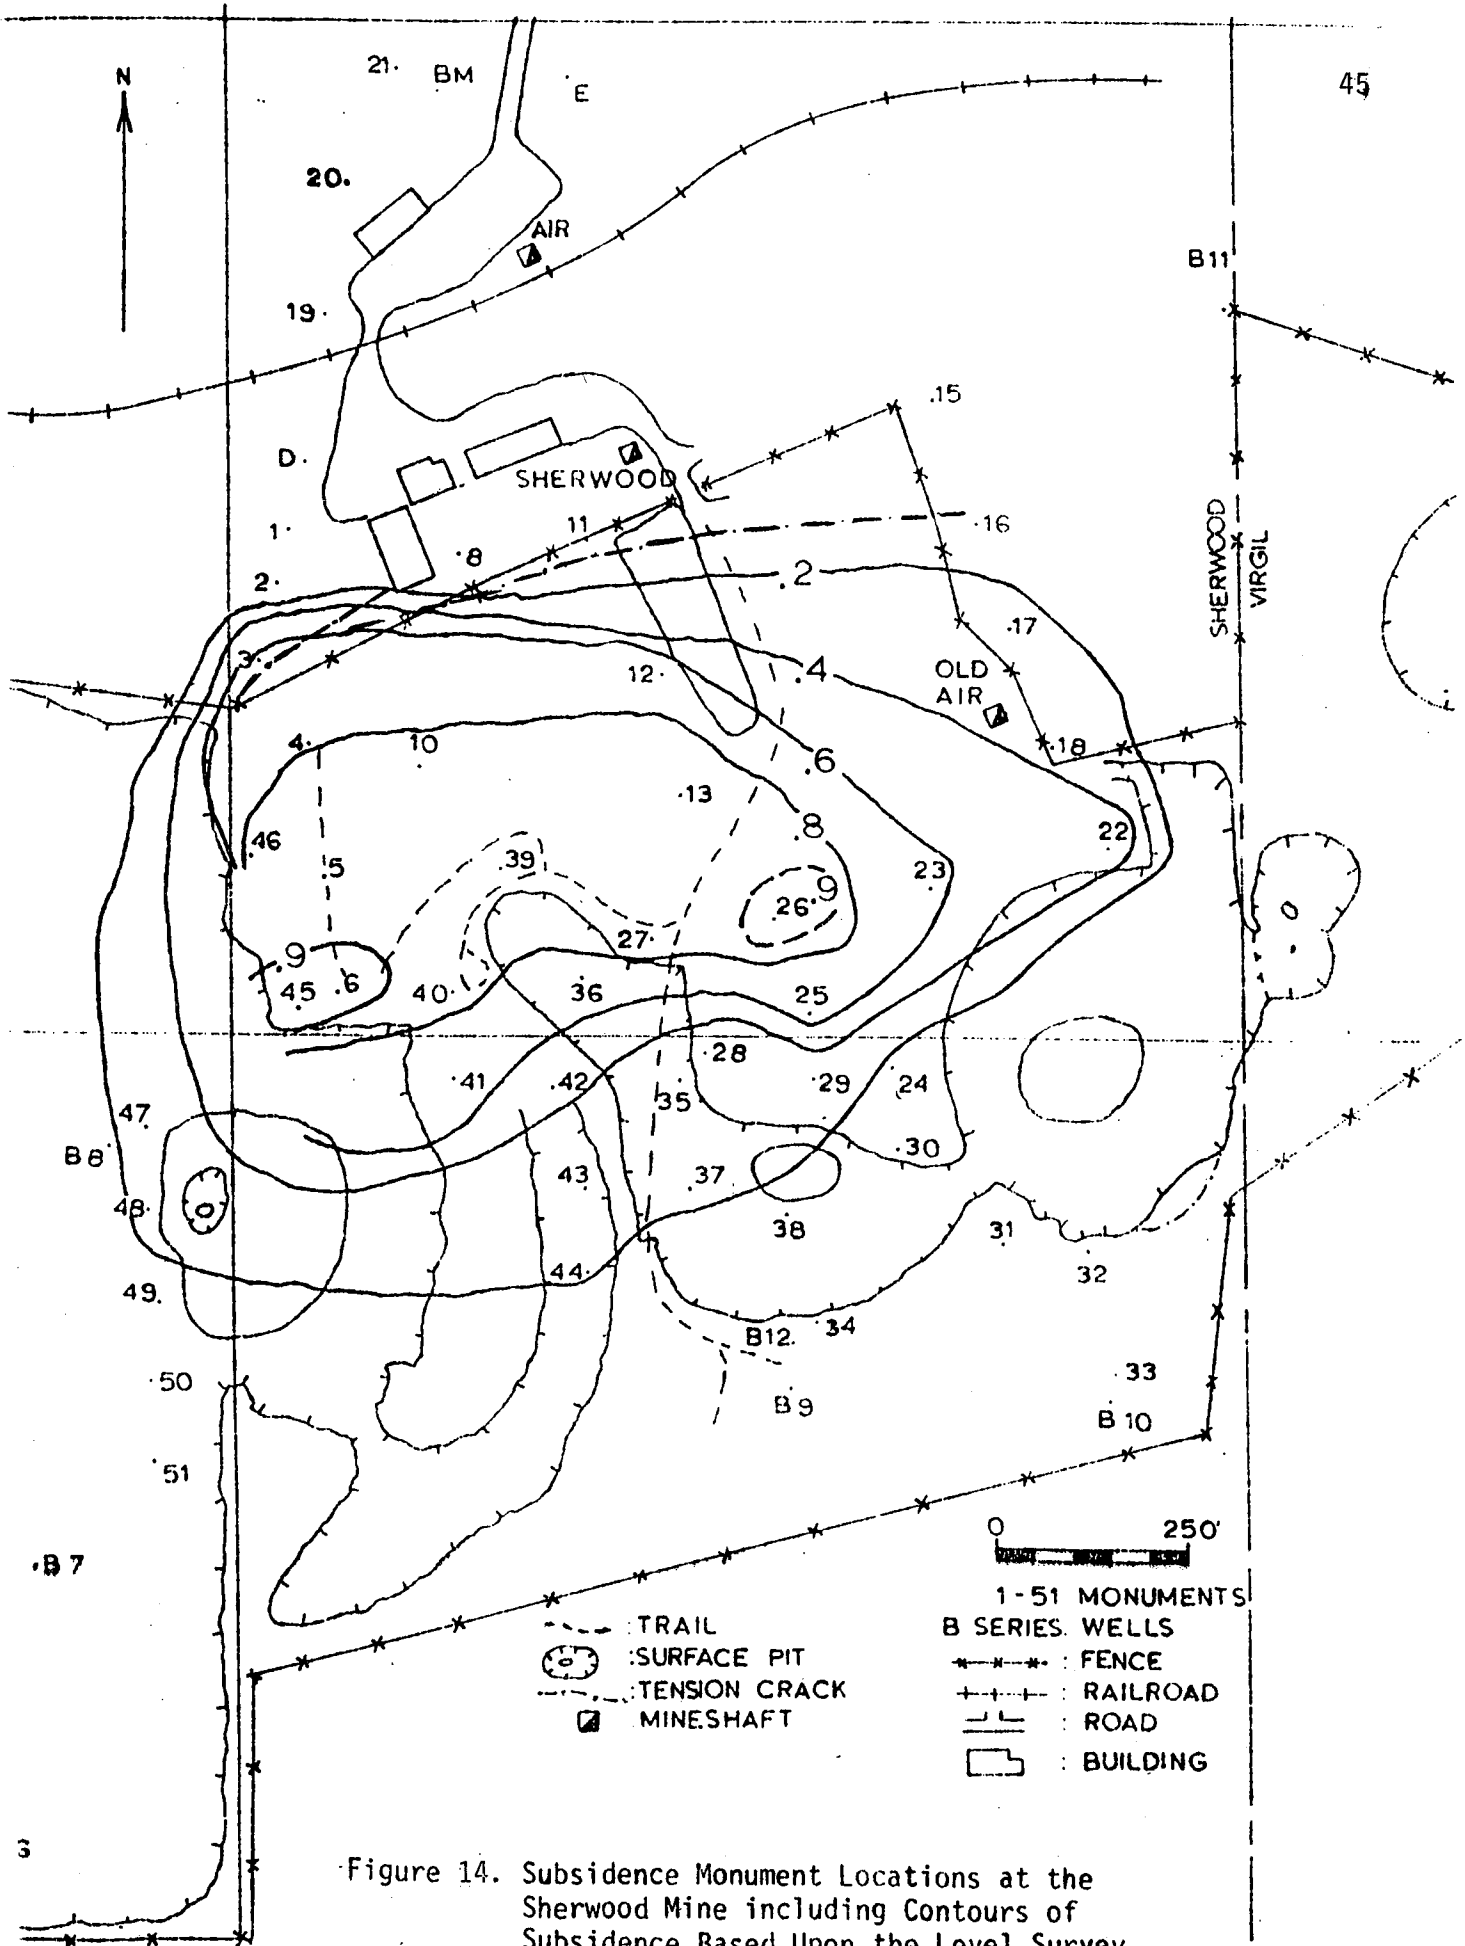
Figure 14. Subsidence Monument Locations at the Sherwood Mine including Contours of Subsidence Based Upon the Level Survey of December 9, 1980.

Surface subsidence resulting from rock mass movement. Leveling surveys of a 47-movement grid were performed periodically at the Sherwood Mine following its shut down. Surface subsidence over a broad area (25 acres) above the main ore body was first detected in late 1979. Surface subsidence continued throughout 1980 until the maximum downward displacement was 1.3 feet. The northern extent of the surface subsidence was marked by the surface trace of an east-west trending shear that was about 100 feet south of the main shaft. These features including the monument locations are shown on Figure 14. The contours of subsidence based upon a level survey in December 1980 are also shown.

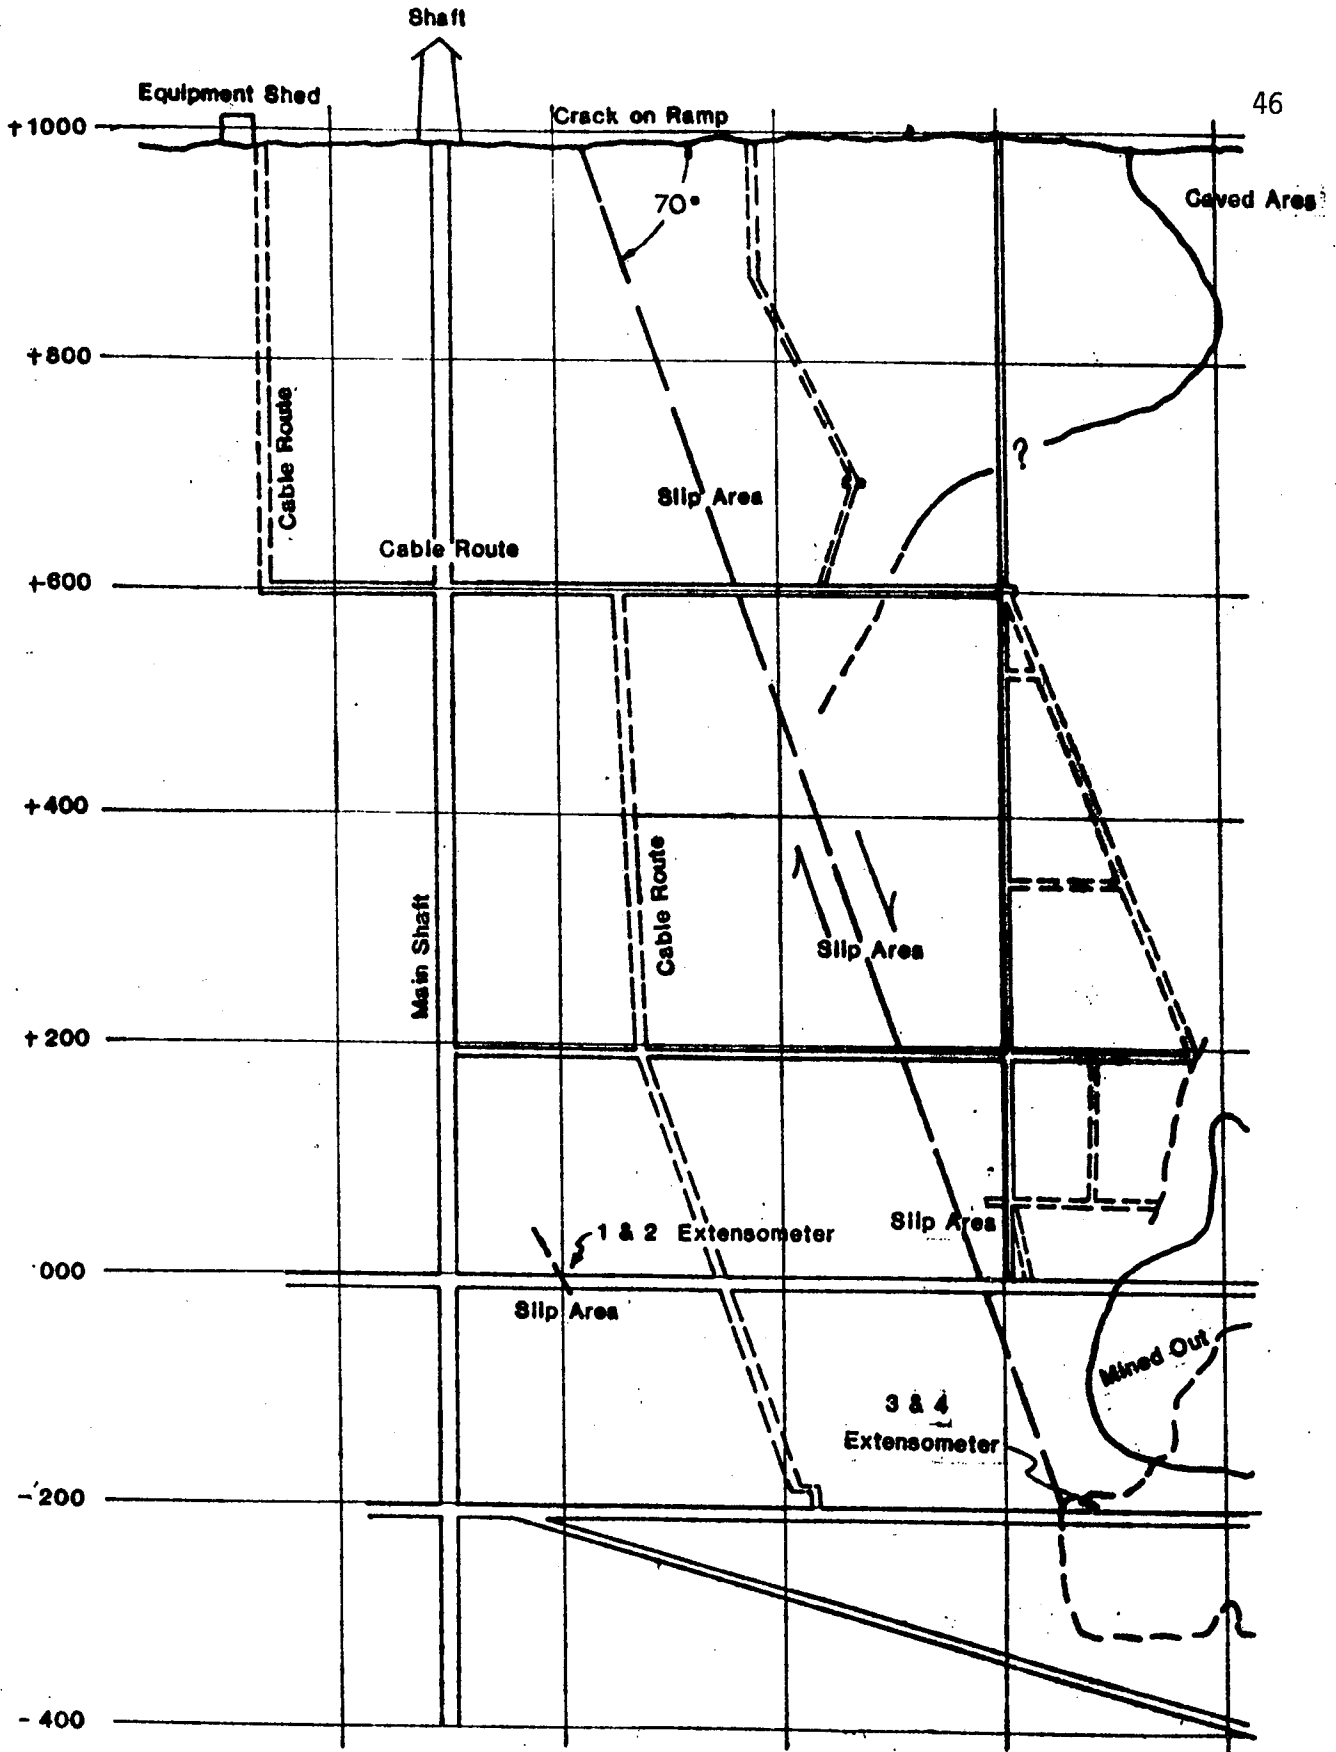
Figure 15 Location of Extensometer Installations in Shear Zones on the 1000 and 1200 Levels of the Sherwood Mine: Looking East

The surface subsidence described above developed in response to rock mass movement within the mine. The initial phases of this movement were detected and monitored by extensometers installed across the 70° south dipping shear plane. A cross section map of the mine in Figure 15 shows the location of the shear zone in relation to the mine workings and the extensometer installations. The relationship between the movement on the shear plane and the broad surface subsidence is shown in Figure 16.

It is hypothesized that renewed movement of the massive south block of the mine occurred as a result of mine flooding. It is likely that groundwater inflow into the shear zone reduced the frictional forces holding the block in position and perhaps loading of the sealed stopes within the block with water may have helped this movement. It is also possible that movement on the shear plane may have been partly responsible for initiating

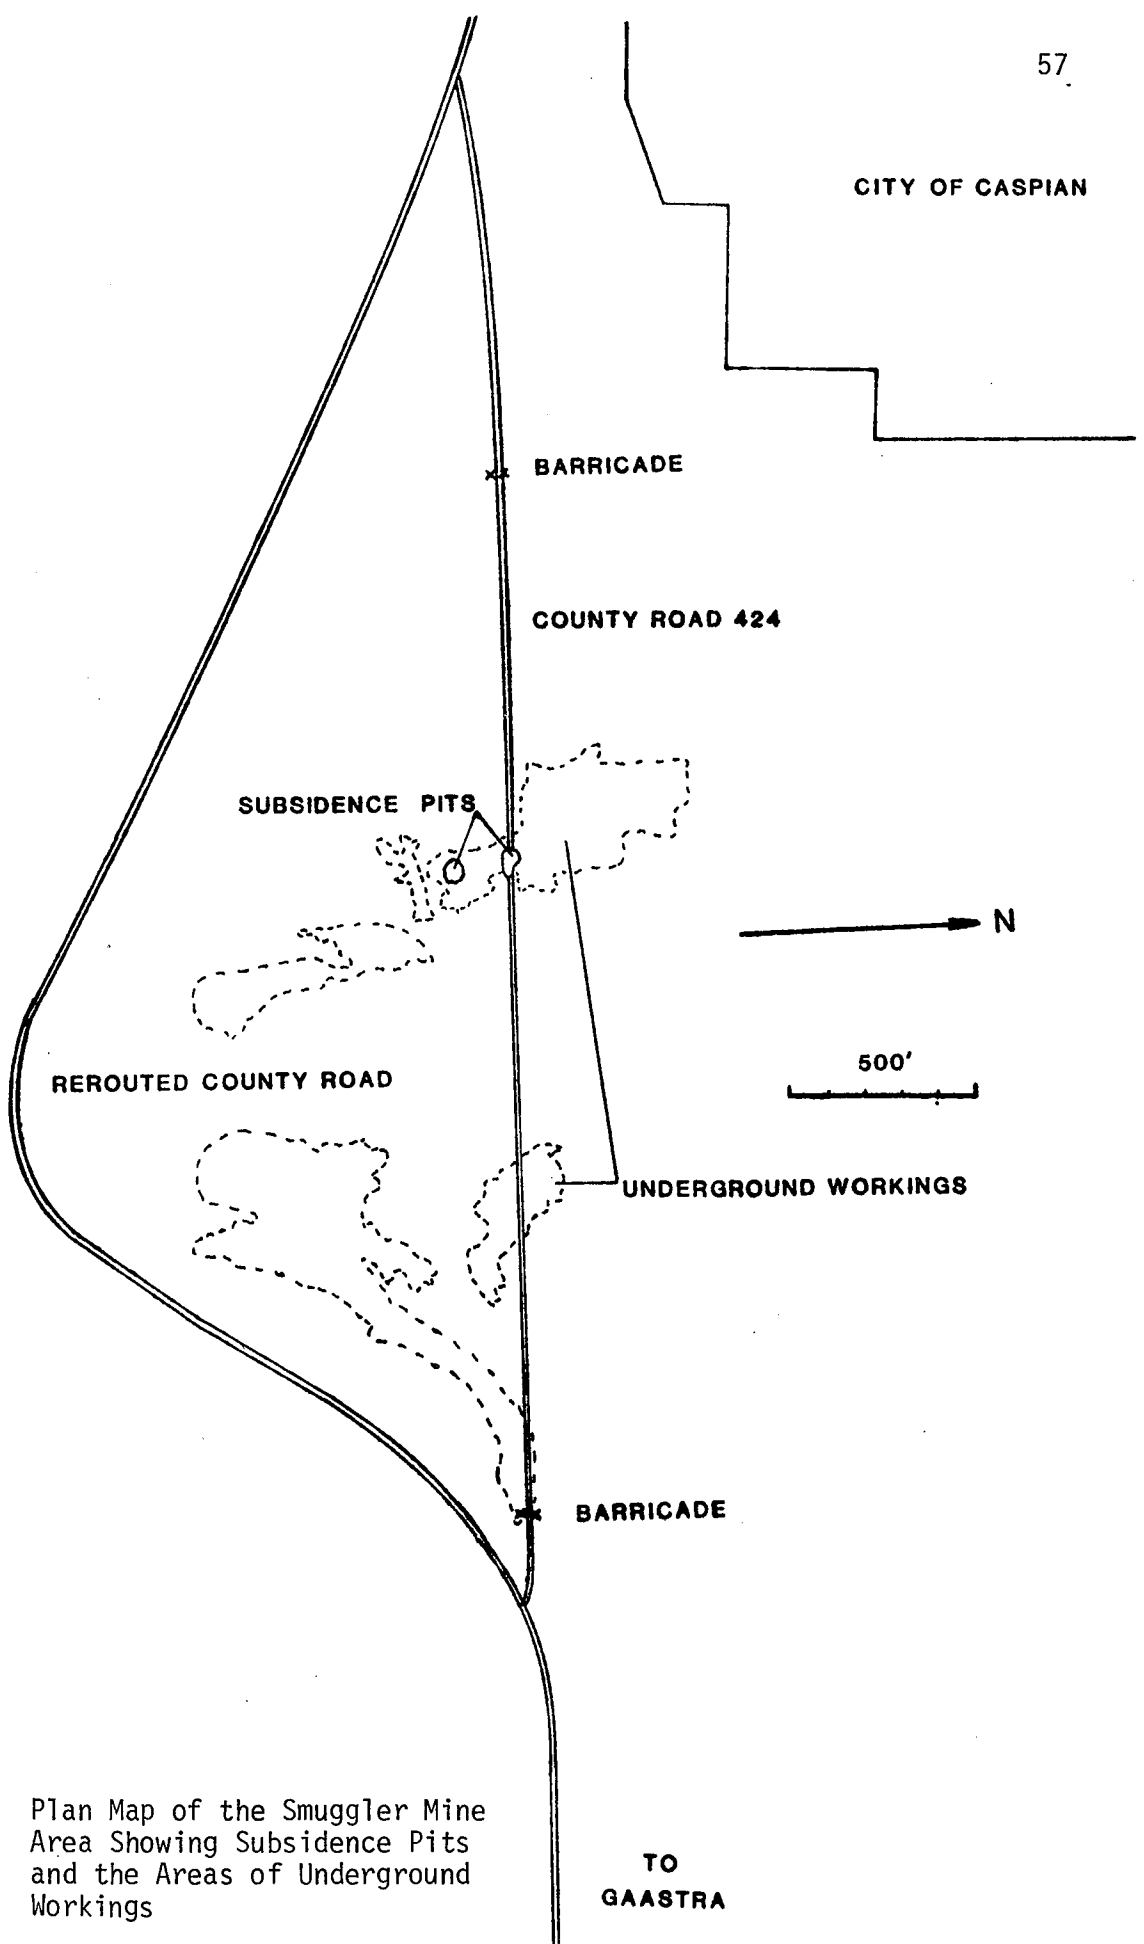
Figure 22. Plan Map of the Smuggler Mine Area Showing Subsidence Pits and the Areas of Underground Workings

The location of the subsided area is shown in the plan map of Figure 22 which was traced from an aerial photograph. Note the subsidence pit in the

road and a second one of similar size a short distance south of the road. A photograph of this second subsidence pit is shown in Figure 23. Both of these pits are underlain by the Smuggler Mine. Accurate mine maps of the Smuggler Mine are not available, however, two old maps were found which show section views of the Smuggler ore body. Figure 24 is a cross section view looking north and Figure 25 is a longitudinal section looking west.

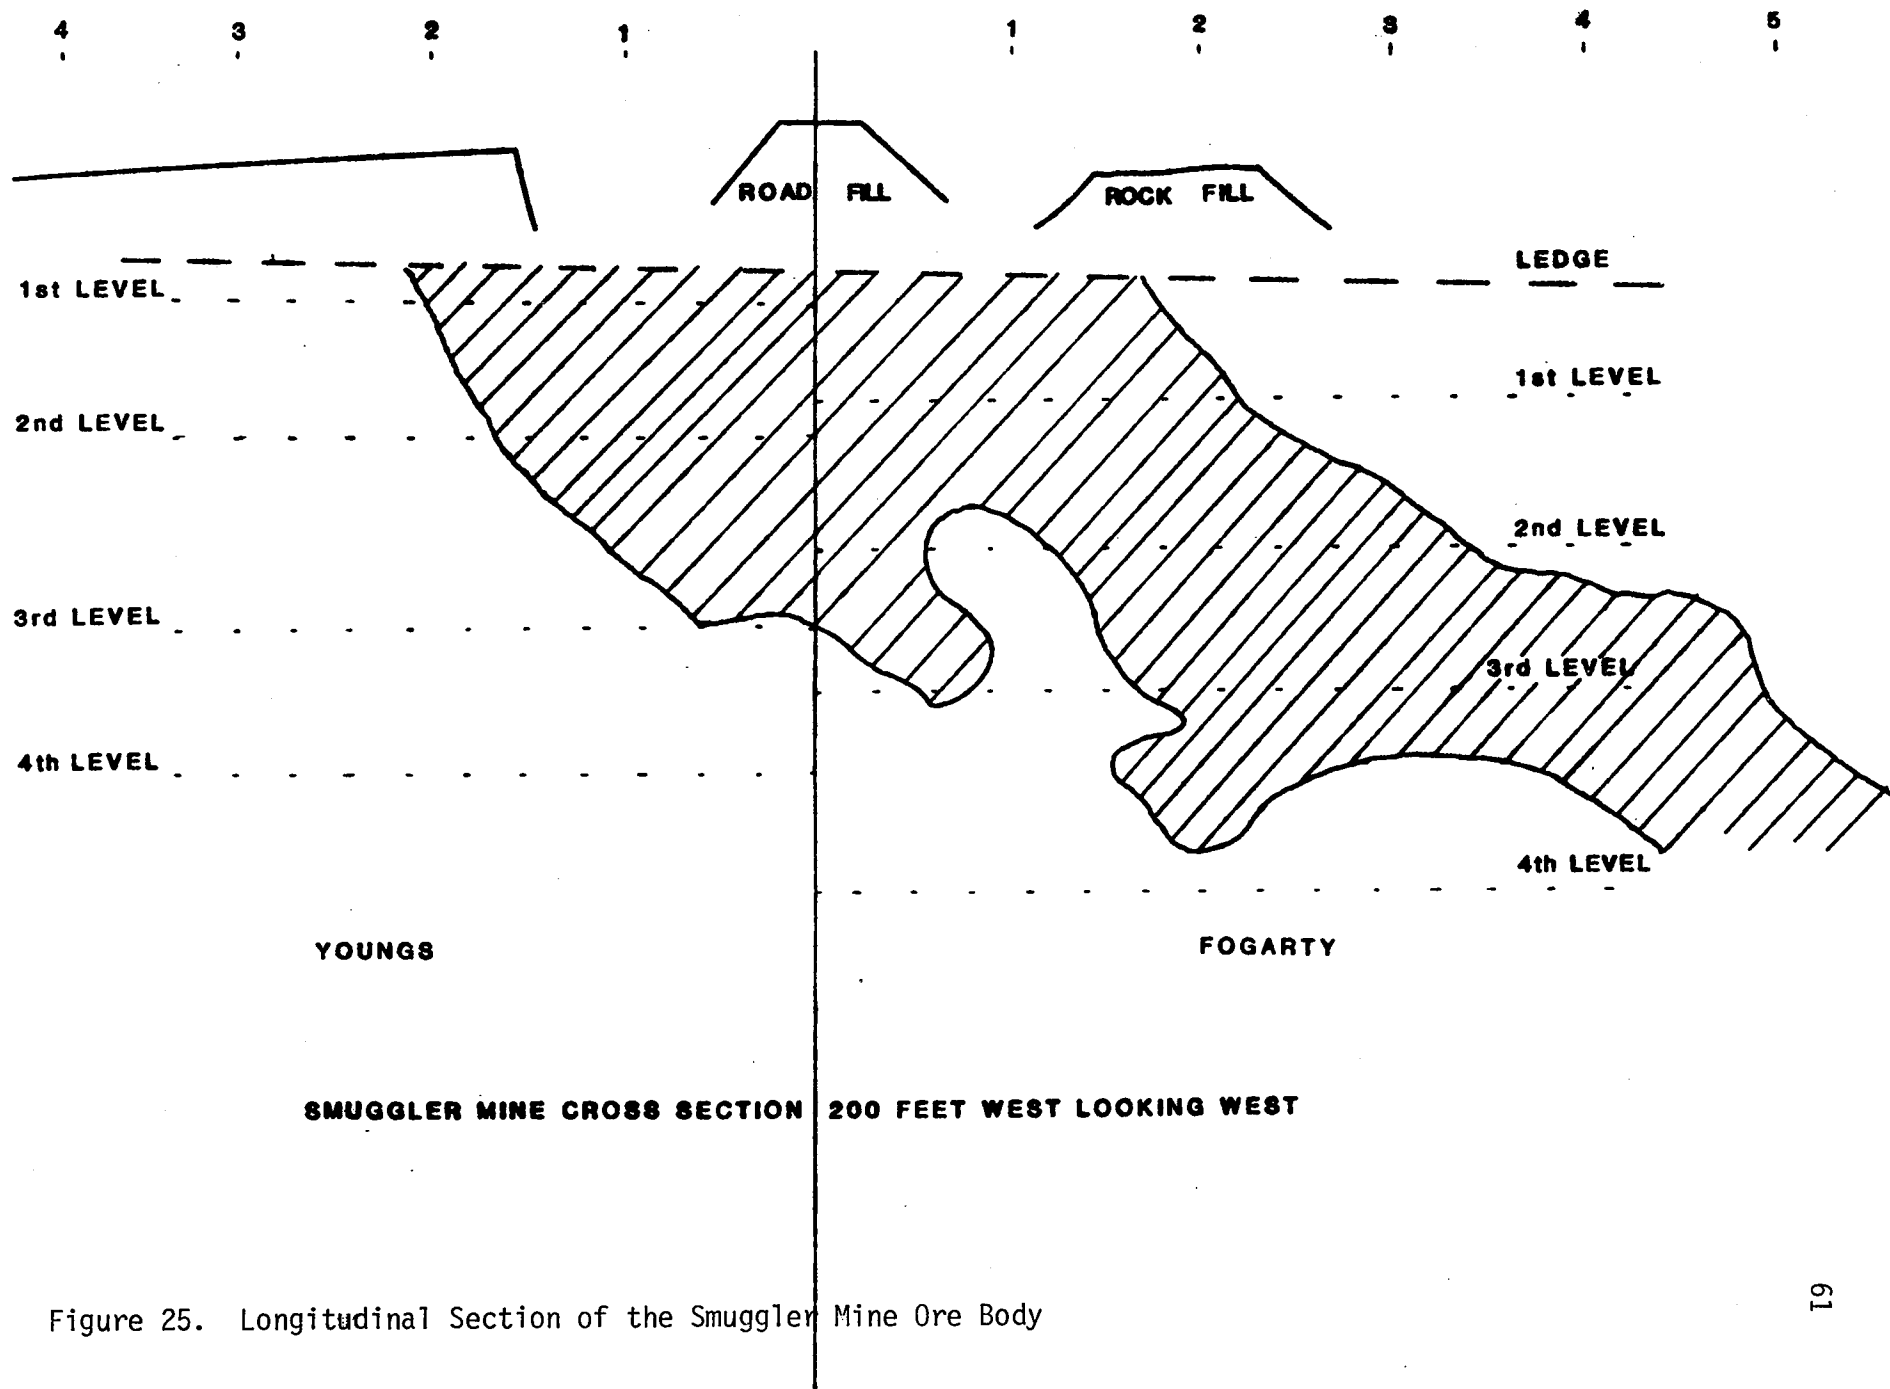
Figure 25. Longitudinal Section of the Smuggler Mine Ore Body

Perhaps at this time there was no road in this area, or perhaps it was only a trail. From information on the map shown in Figure 25, it is suggested that rock may have been used to fill the mine void. However, this is not known. What is clear, is that with County Road 424 over a mined-out and largely forgotten early mining operation, that the stage for eventual subsidence of the roadway was set. The unfortuitous timing of the subsidence event, on a foggy night, played a large role in causing the human fatality.

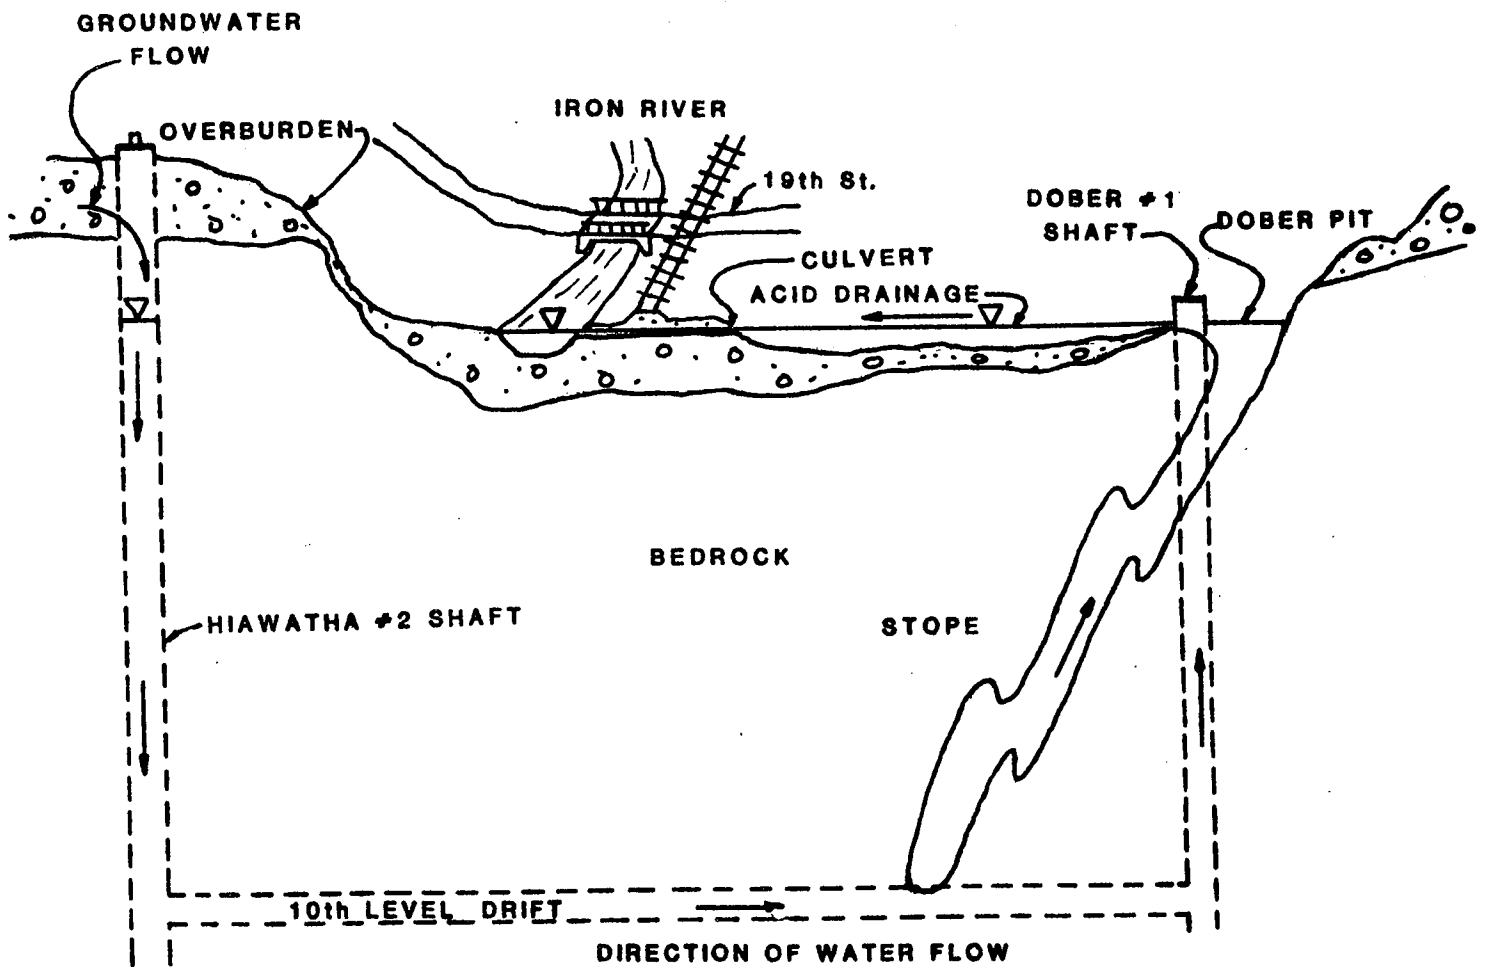
Figure 29. Schematic Diagram Showing Flow of Water in the Dober Mine Complex

Model for acid drainage from the Dober Mine complex. Simply stated, the model for acid drainage from the Dober Mine pit is one of recharging surface waters entering the mine complex above the Hiawatha workings on the west side of the Iron River to force acid waters through the interconnected mine workings into the Dober "leg" of the mine via a 10th level drift connecting the workings. Sufficient head exists in the Hiawatha workings to cause a flow of acid water from the Dober Mine into the Iron River. Flow occurs because of recharge and because the Dober Mine pit lies at a lower elevation in the Iron River Valley. These relationships are shown schematically in Figure 29.

dry. Following closure the mine complex was allowed to flood. Prior to flooding, oxygen and water reacted with pyrite-bearing slates wherever they were exposed in the hanging and footwall and in caved stopes, forming soluble ferrous sulfate compounds. These compounds dissolve readily to form sulfuric acid and soluble iron. As a result, nearly the entire volume of the mine complex was flooded with acid water, except perhaps for the very uppermost portion of the Hiawatha No. 1 workings where most of the surface water apparently entered. With the mine flooded, pyrite oxidation no longer occurred.

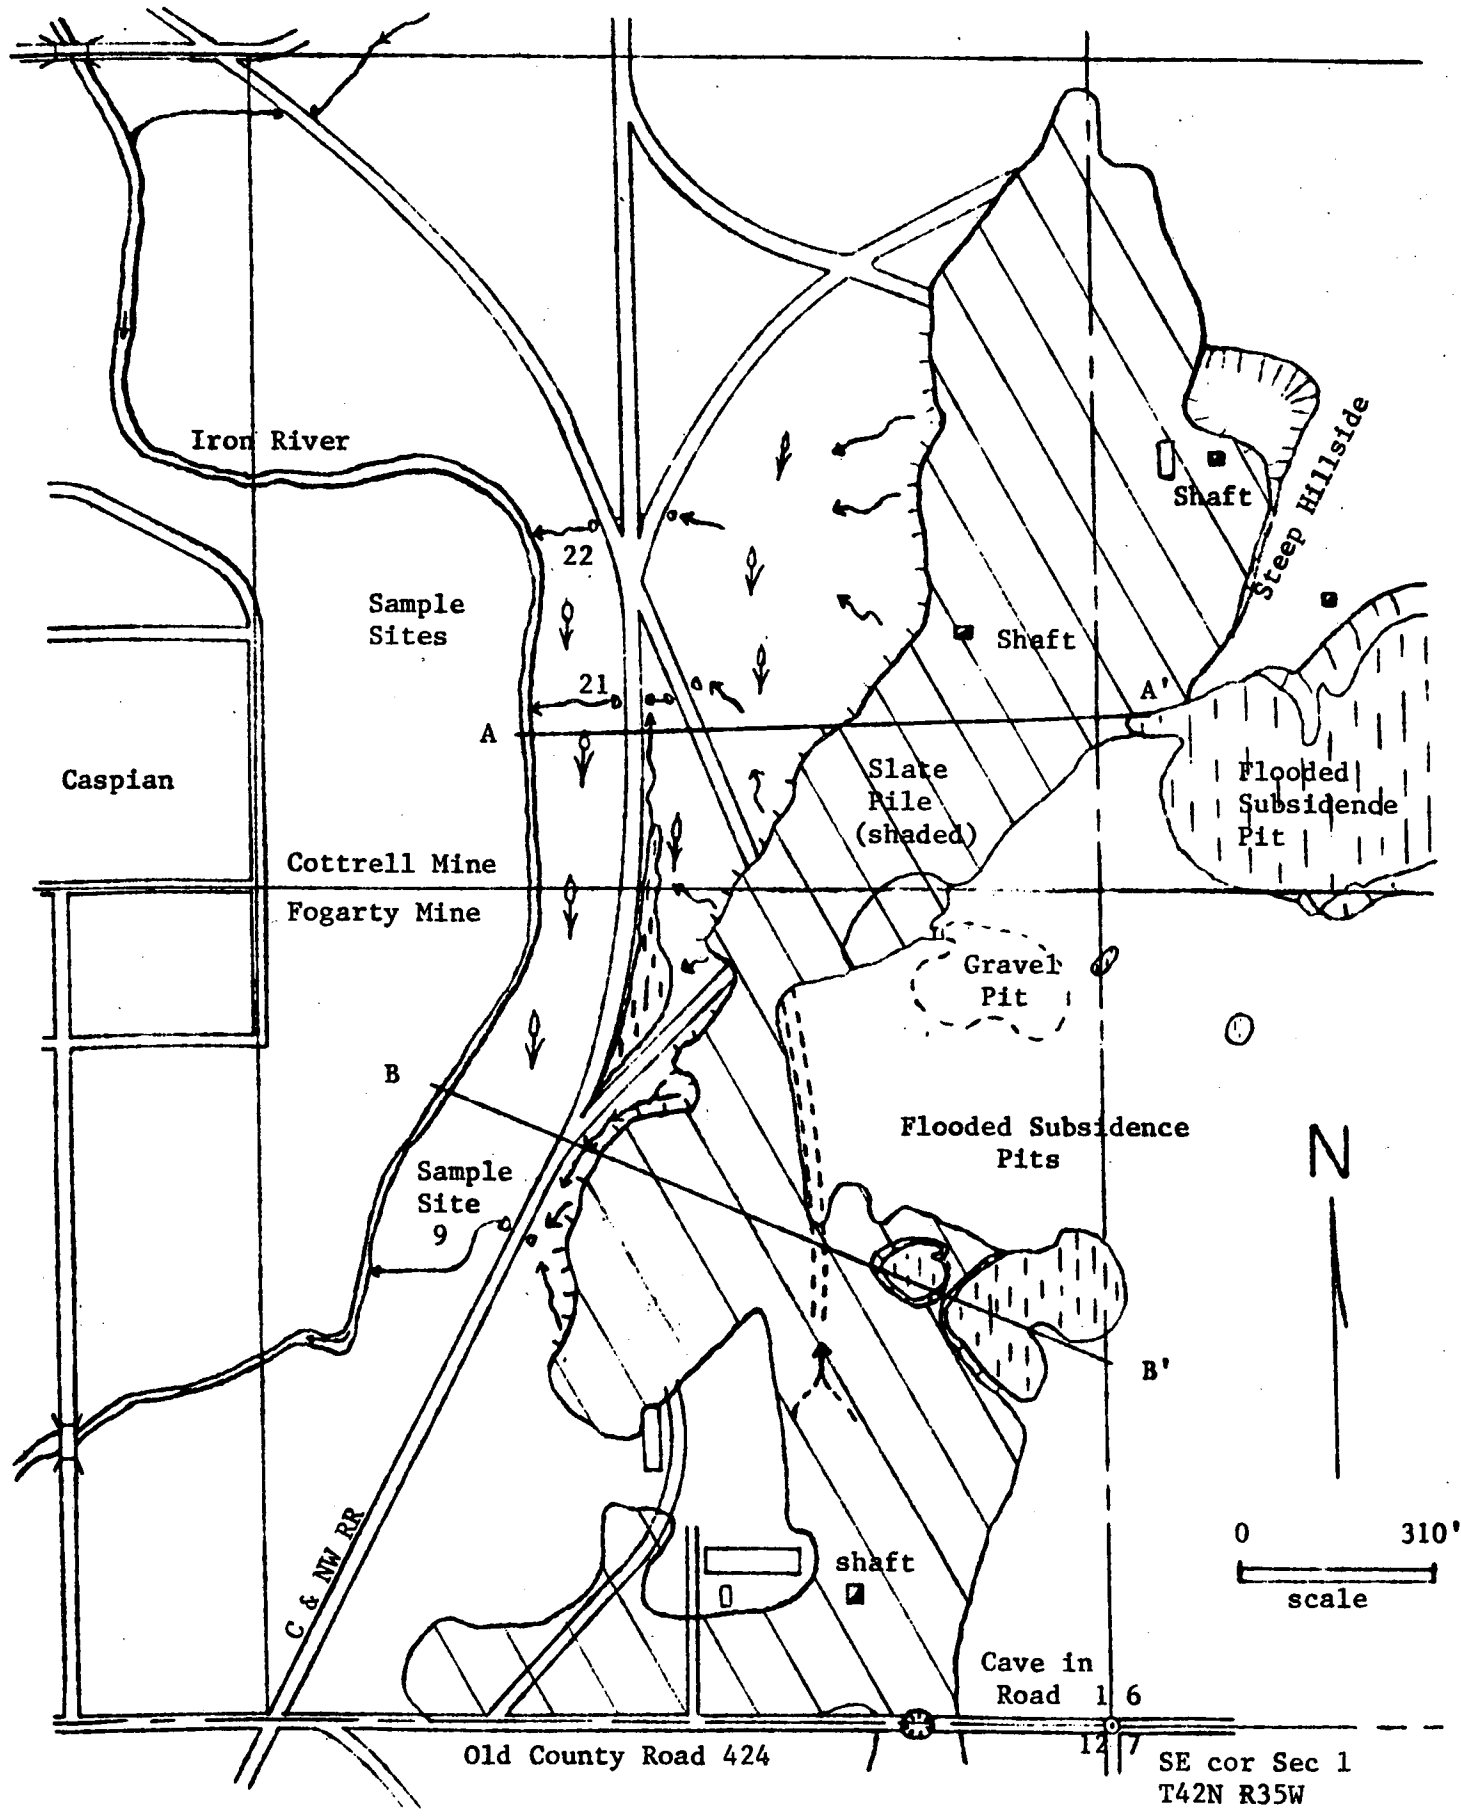
Figure 31. Map of the Buck Group Slate Piles

long and up to 600 feet wide. The black slate piles are flanked by higher ground on the east and by low marshy ground along the Iron River on the west. Numerous subsidence pits are present in the eastern area of the piles and several extend into the waste rock area. Many of the subsidence pits are flooded. Consequently both ground and surface waters flow from the elevated eastern edge of the black slate piles, through the piles and into the river flood plain along the lower western slope. These relationships are shown in Figures 31 and 32.

Analyses of samples augered from the slate piles from 14 locations showed that sulfur contents ranged from 0.21% to nearly 10%. This information combined with the drill hole depths and the area of the slate piles as determined by mapping was used to calculate the amount of sulfur remaining in the piles. Results showed that 10.2 million pounds of sulfur were present in the slate piles which had a volume of 129,000 cubic yards and occupied an area of 19 acres. These data are presented in Table 5. Based upon the sulfur being present in its reduced form as pyrite, it was calculated that 8.9 million pounds of iron and 31.1 million pounds of

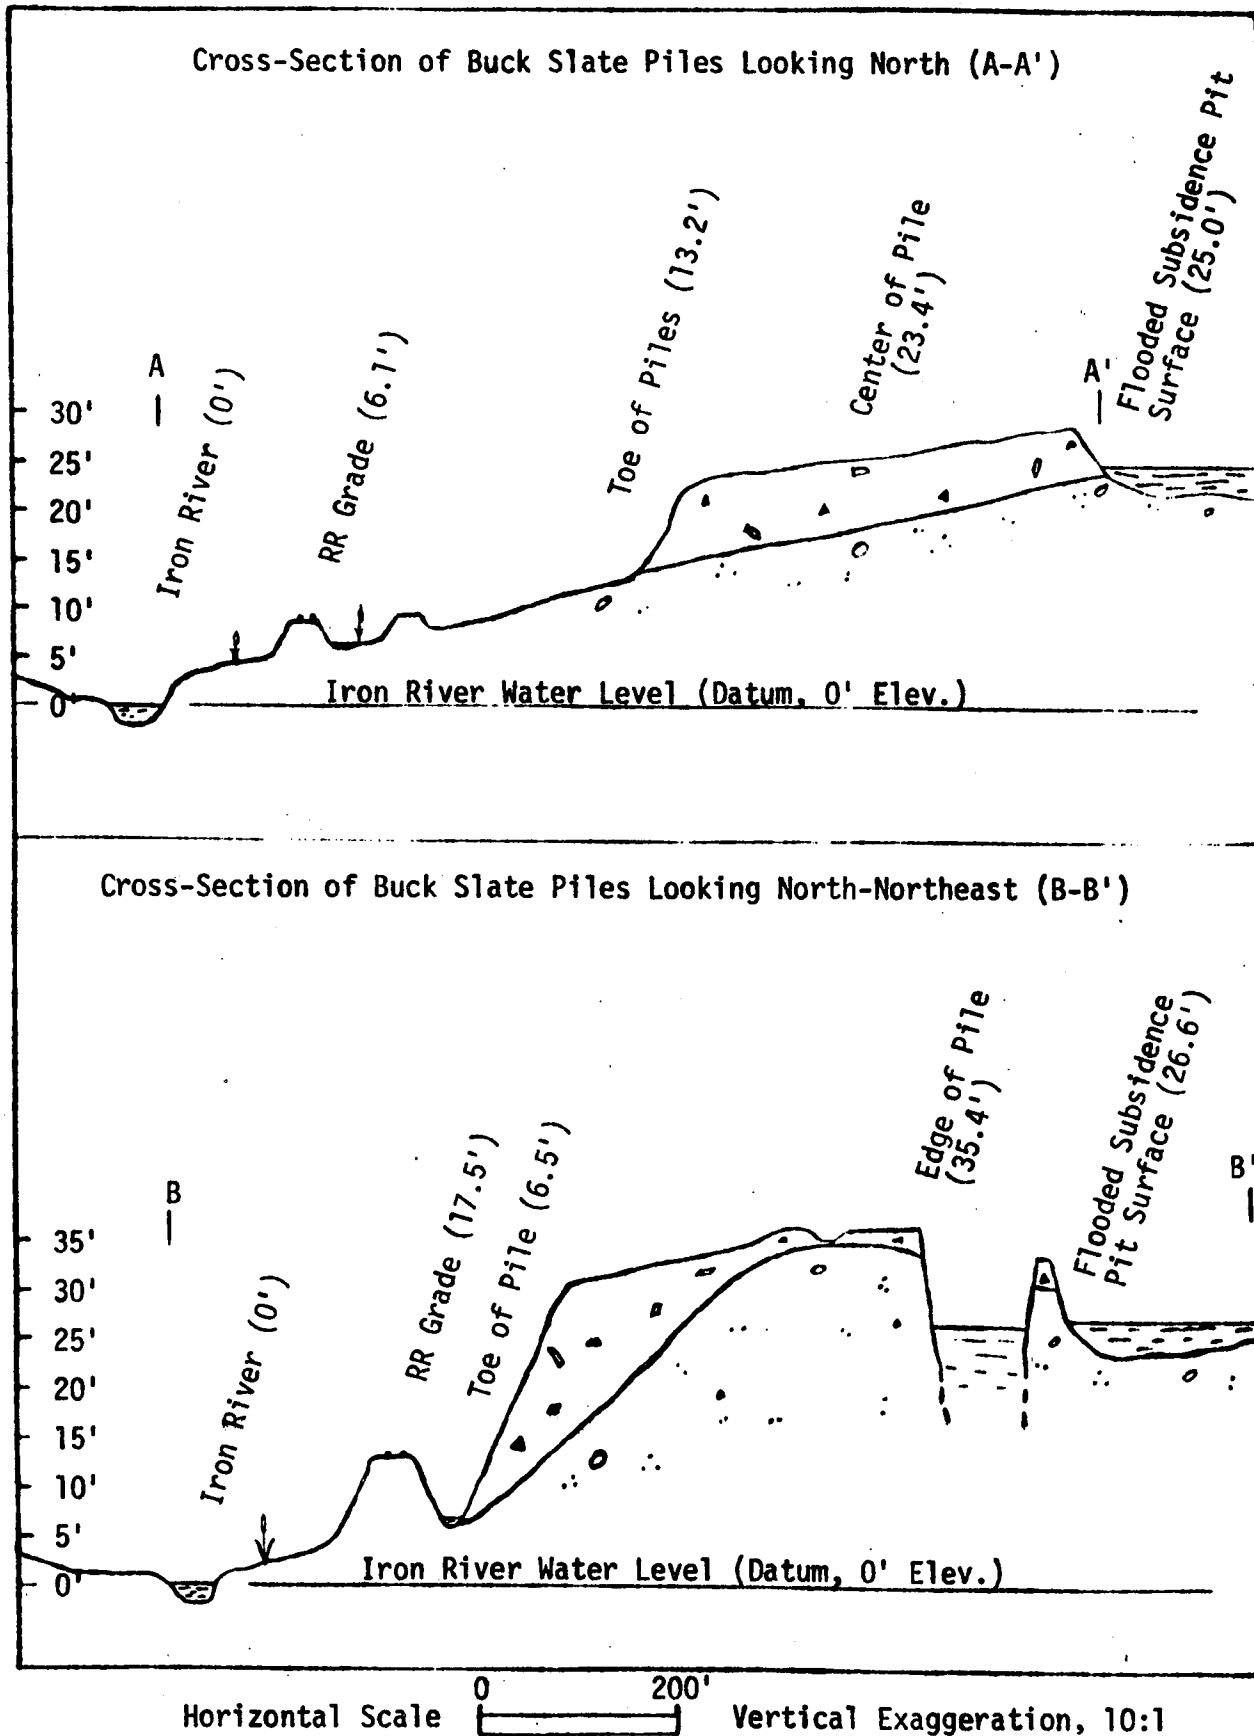
Figure 32. Cross-Sectional Views of Buck Slate Piles (see Figure 31)

concentrated sulfuric acid could be produced. Thus, it is obvious that a significant amount of acid drainage can be generated by leaching from the surface slate piles.

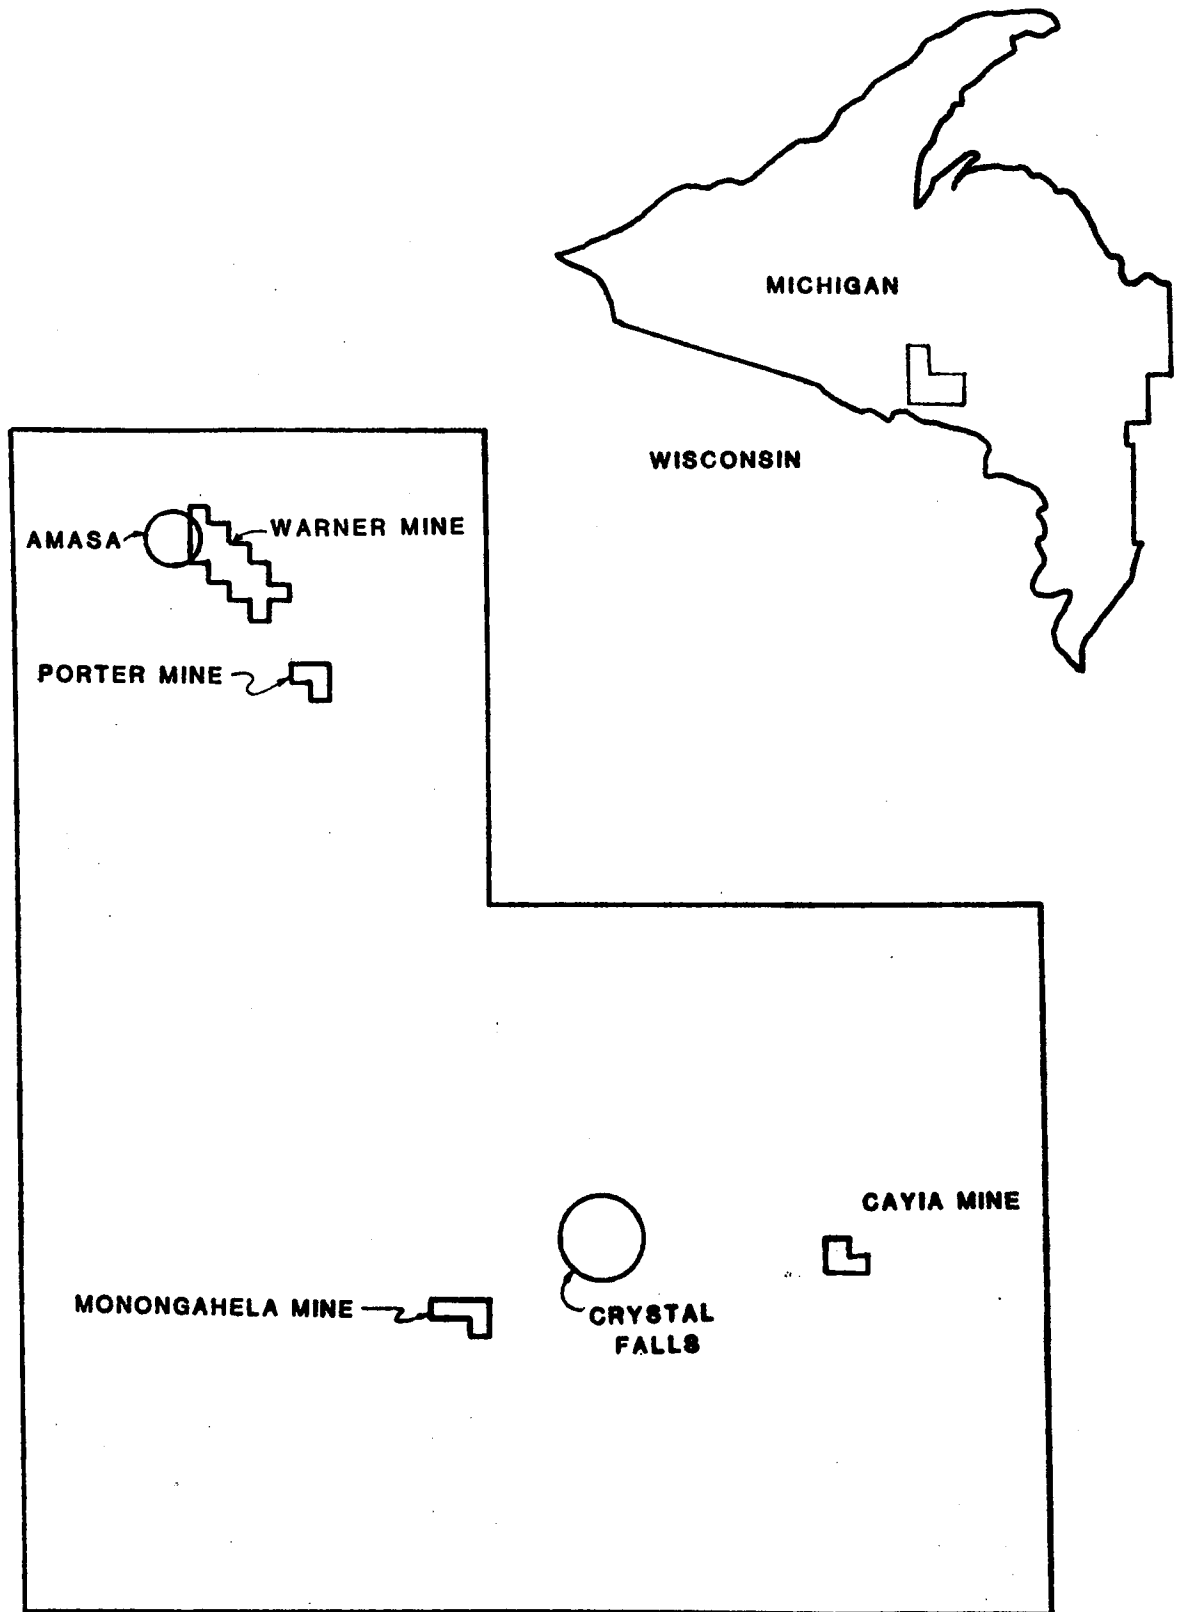
Figure 33. Mine Locations in the Crystal Falls District

The Warner Mine is located near Amasa, Michigan about 10 miles northwest of Crystal Falls (see Figure 33). The mine operated from 1915 until 1958, producing 3.4 million long tons of ore from a series of vertical shafts that were as deep as 1700 feet. The production shafts have apparently been backfilled from the surface, however, a wood timbered air shaft was found without any cap covering. The area is fenced with several loose strands of barbed wire. It is apparent that some type of wooden planking covered the shaft at one time, but it has either rotted or been removed by vandals or by someone curious enough to pry off the wooden cap. The shaft is located in an open field near a dirt trail road. The mine is flooded and the water level is near the ground surface. Several photographs are shown in Figure 34 which illustrate the setting and the condition of the shaft collar.

The Porter Mine is also located between Crystal Falls and Amasa, Michigan. It operated from 1914 until 1927, producing 733,000 tons of ore from seven levels. The main shaft was vertical, some 850 feet deep and was capped with heavy wood planking supported by two large steel I-beams. The I-beams have remained in position, but the wooden planking has rotted and collapsed. There is some subsidence around the shaft collar. A secure fence does limit access to the shaft. A photograph of the capping is shown in Figure 35.
