THE DEVELOPMENT OF GUIDELINES FOR
CLOSING UNDERGROUND MINES:
MICHIGAN CASE HISTORIES

Institute of Mineral Research
C.W. Schultz, Director
Michigan Technological University
Houghton, Michigan 49931

Allan M. Johnson
Research Leader

Date prepared June 28, 1984

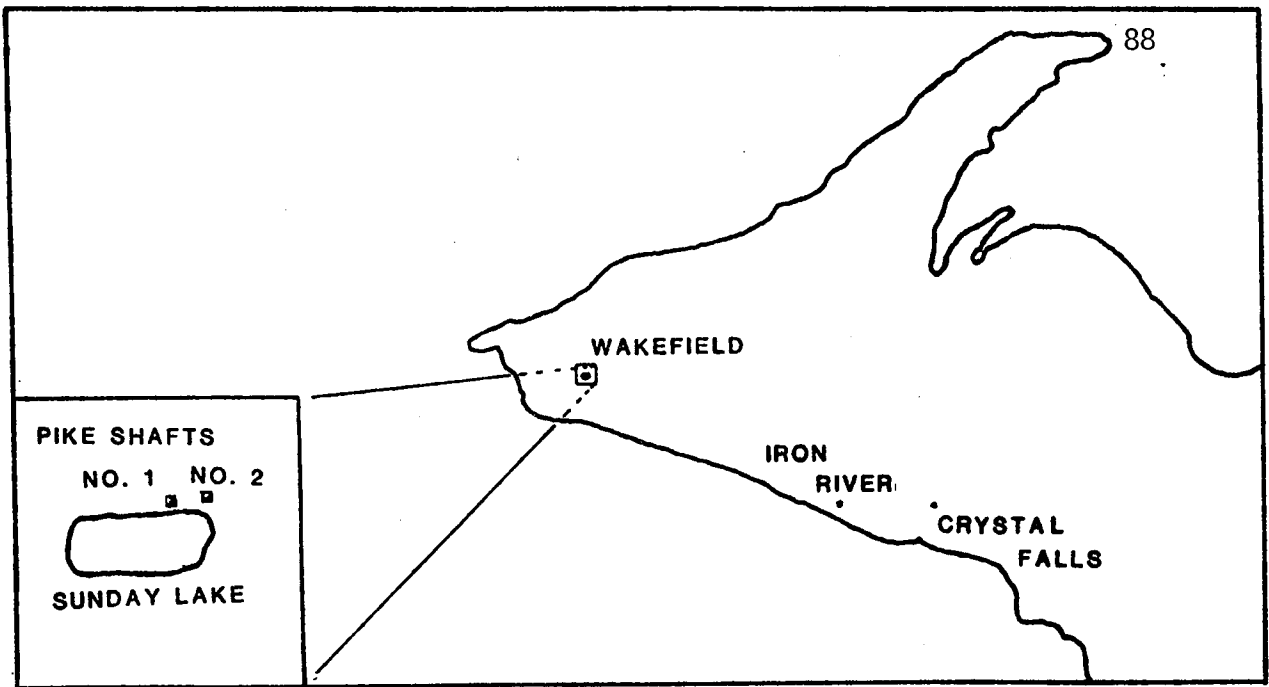
Figure 38a. Location of the Pike Mine

The Pike Mine is located in Wakefield, Michigan on the Gogebic Iron Range (see Figure 38). Records show that the Pike Mine operated from 1891 until 1910 producing a total of 105,000 tons of ore. The Pike Mine had two shafts, the No. 1 and the No. 2 which are shown on the section map of Figure 38.

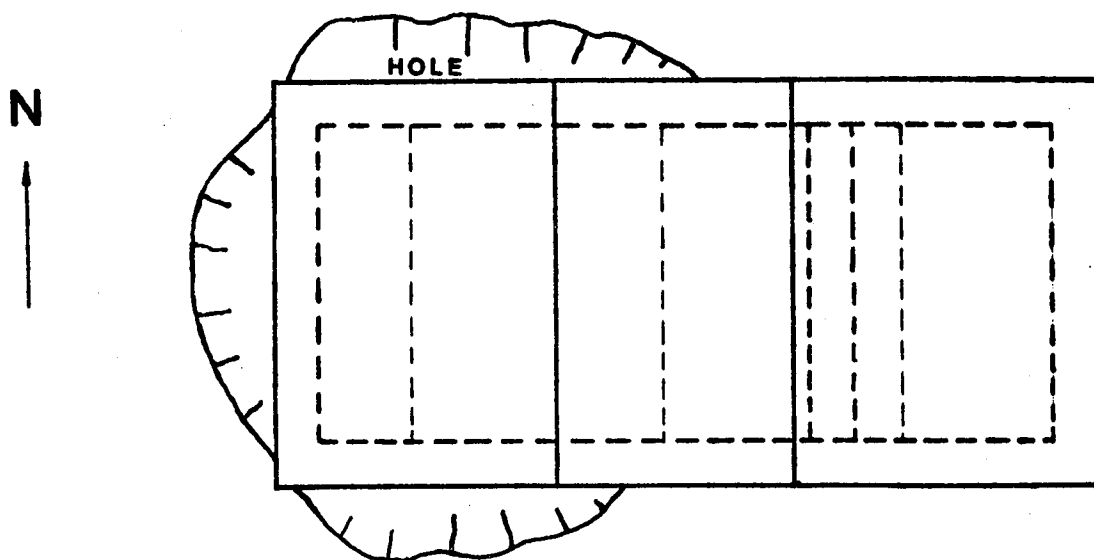
Figure 40. Plan and Section Views of the Zimmerman Mine No. 1 Shaft Capping

The Zimmerman No. 1 Mine shaft capping consists of steel plates of various thicknesses. Although the capping has not failed, the use of steel for a permanent capping is questionable. The mine shaft is located about 3/8 of a mile southwest of Gaastra, Michigan (see Figure 36). The mine operated from 1907 until 1950 producing 3.6 million tons of ore by caving and stoping methods. The vertical No. 1 shaft is 600 feet deep. Records indicate that the shaft has three compartments. From field investigations it was observed that the shaft is capped with three sizes of steel plates, 1/8-inch, 1/4-inch, and 1/2-inch thick. Although it was not possible to determine how the plates are supported, it is likely that steel stringers extend across the shortest dimension of the shaft. Sketches of the shaft and capping materials are shown in Figure 40. Initially, the steel plates would provide a very strong and secure capping except for perhaps the 1/8-inch thick plates on the east side of the shaft. However, with the passage of time, the plates rust and lose strength. A thin layer of soil and moss covering on the steel plates retains moisture which will hasten the rusting of the plates. It is apparent that with time the strength of the capping will deteriorate to the point that the weight of a person can no longer be supported by the thinner plates of the cap. An inadequate fence does little to restrict access to the cap and a serious accident could occur when the steel plates deteriorate sufficiently. The safety of the capping is also questionable from the standpoint of subsidence. Openings in the soil around the shaft indicate that the shaft liner may also be deteriorating.

B. PLAN SKETCH OF SHAFT

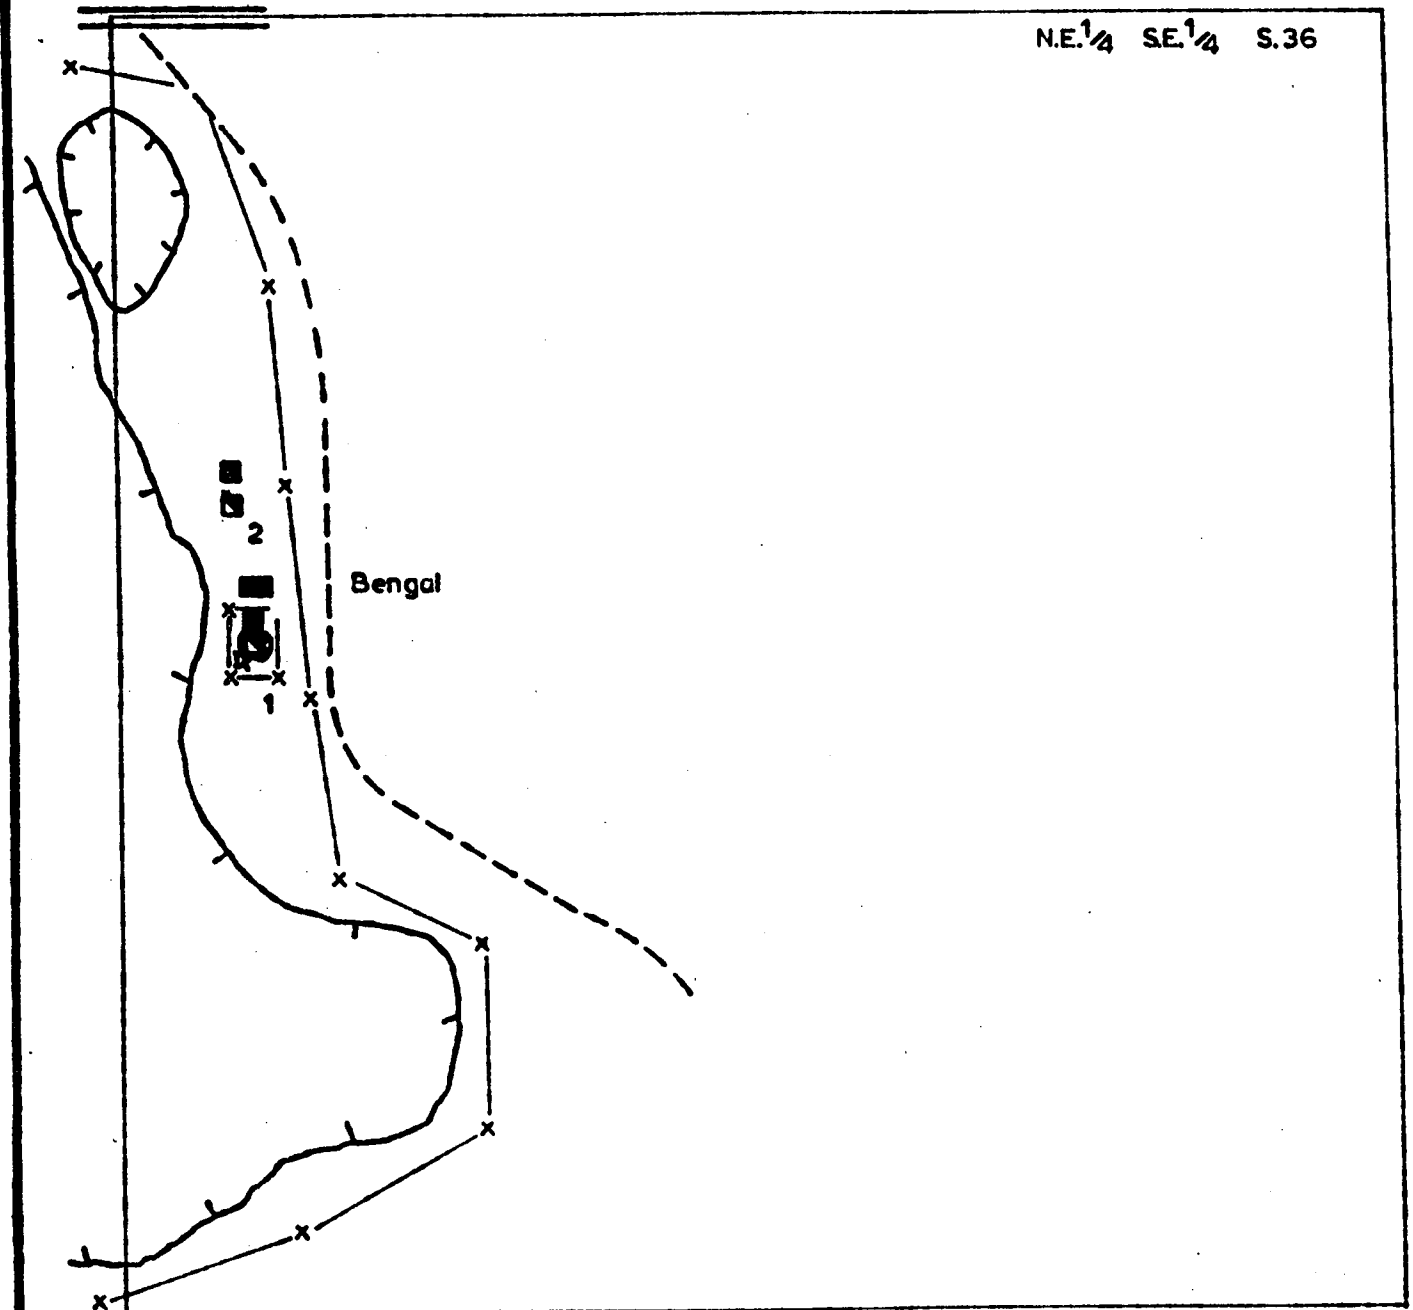
Bengal Mine

Following mining the 670-foot deep Number 1 or main shaft was capped at the surface with a massive two foot thick concrete cap. The shaft capping has since failed. Apparently, the three compartment shaft was timber lined through 150 feet of overburden. Failure of the shaft lining in the overburden has caused extensive surface subsidence around the shaft collar and has caused the concrete cap to fall into the shaft opening. Photographs of the shaft capping failure are shown in Figure 45.

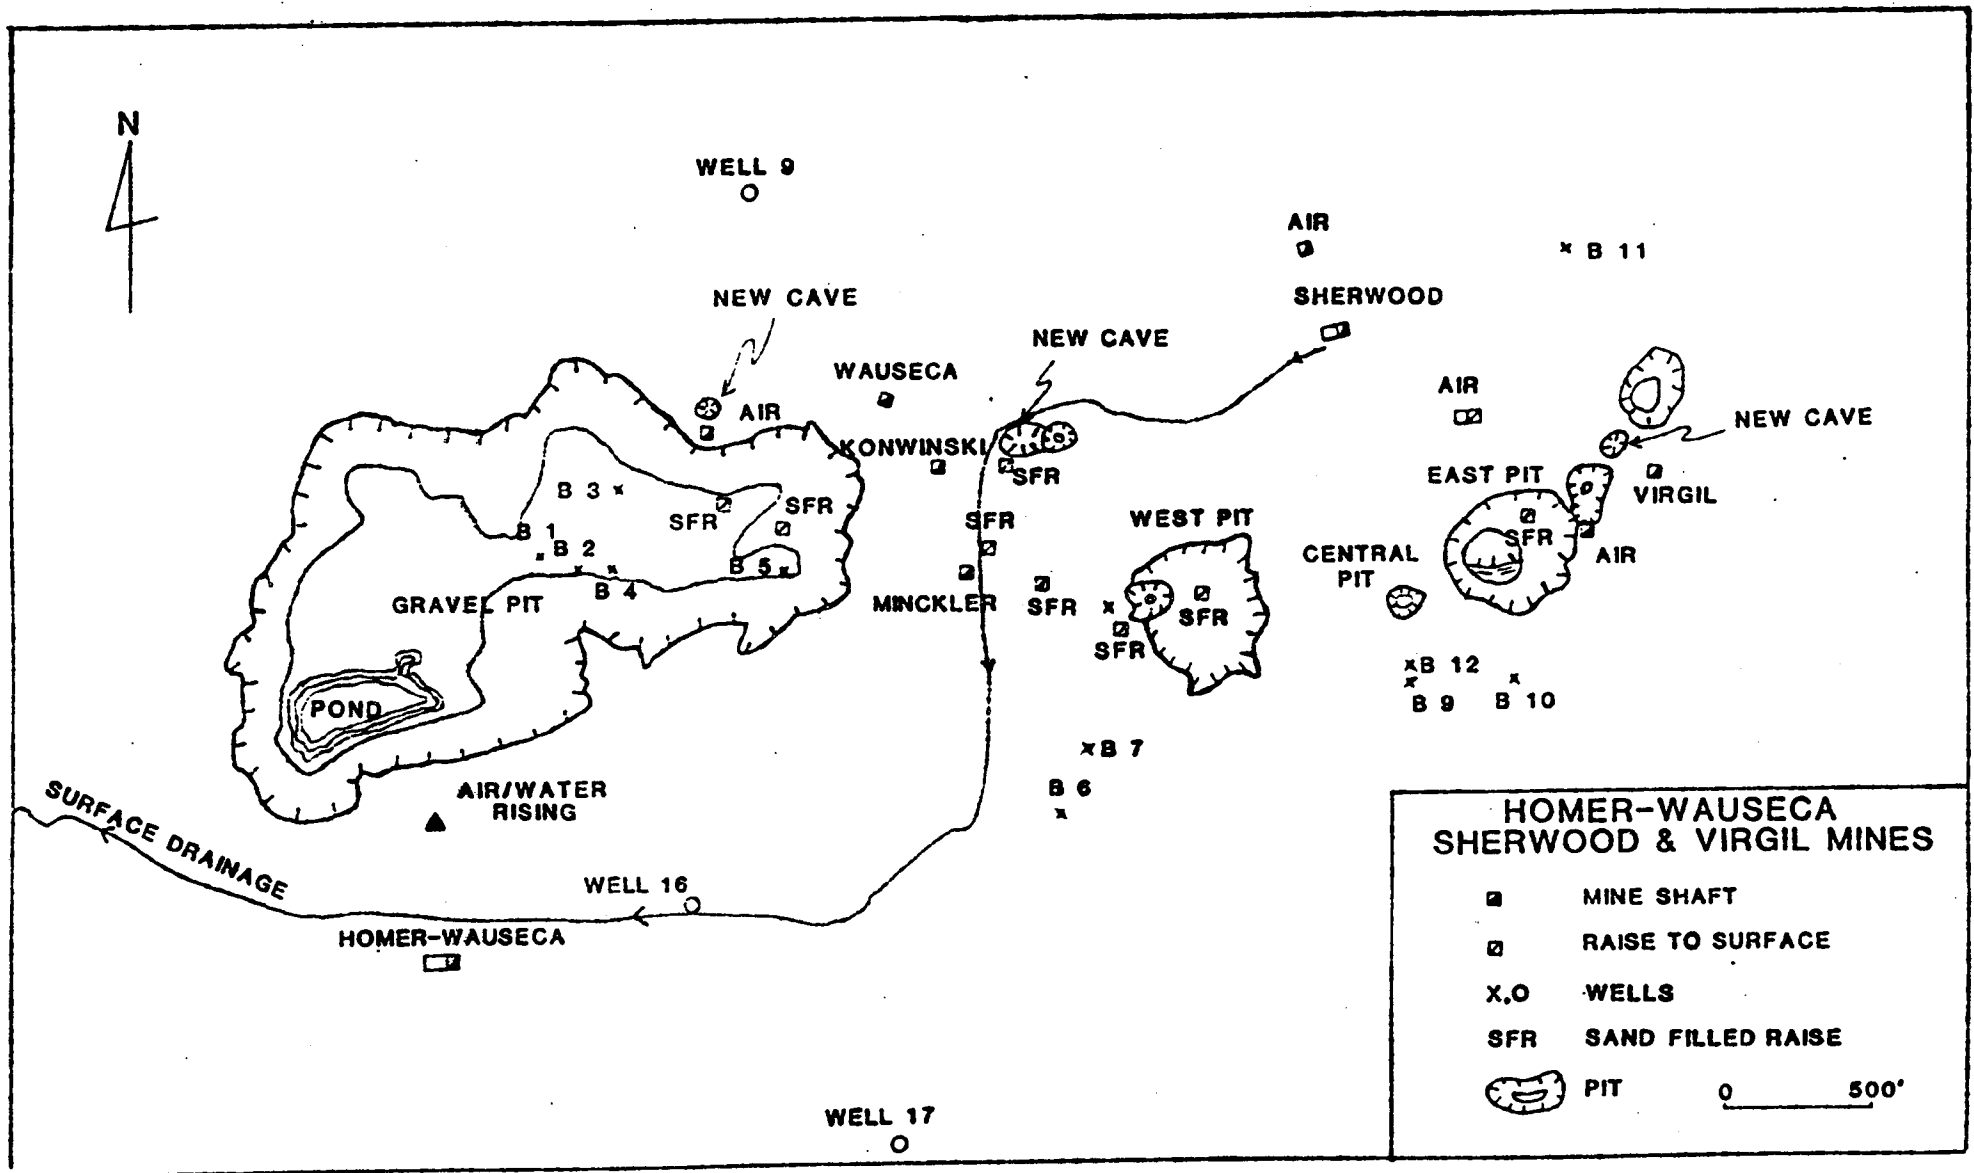
Figure 46. Locations of Surface Features at the Sherwood Mine Complex Including Subsidence Features Resulting From April 1, 1981 Event.

Sherwood Mine and associated mines of the complex were nearly flooded. An infall of surface overburden or rock is believed to have generated high pressures in the nearly flooded mine which caused surging waters and triggered other subsidence events throughout the mine. These surging waters disrupted or circumvented several shaft seals and caps. Details of the hydraulic event were presented in the earlier subsidence section of this report. More detailed documentation is available in a report prepared by Johnson and Frantti (1983b). The following case histories are extracted from that report largely as field notes made by Johnson. The affected shafts include the Homer-Wauseca, the Minkler and the Sherwood air and main shafts. Their locations are shown on the plan map of Figure 46.

Sherwood Mine air shaft. Extensive damage was done to the concrete capping over an air shaft at the Sherwood Mine. The air shaft is located about 300 feet north and slightly west of the Sherwood Shaft (Figure 46). The ground surface around the shaft had been visibly scoured and channeled by water forced from the mine. The surrounding area of about one to two acres was muddy and a large shallow pond of water covered the area north and east of the shaft.

Sherwood Mine shaft. No visible damage was done to the Sherwood Mine shaft excepting the water level measuring device which had been suspended in a 10-inch diameter pipe extending into the shaft. The pipe was used previously for mine water pumpage. The sensor leads were lying in a tangled pile on the concrete cap. A small wooden shed that had sheltered the water level sensor was lying on its side a short distance away. Abundant ferric hydroxide precipitate (yellow boy) scale was observed on and around the mine cap. A long plume of yellow boy stain was noticeable on the surface extending in a southeast direction from the cap. It contrasted sharply with the black slate waste rock present over much of the surface. It was apparent that a geyser of water had been forcibly ejected from the shaft through the pipe. The yellow boy scale was apparently from the pipe walls and was stripped by the high velocity flow of water. It is not known how high the water was forced, but an indication of great height was suggested by the length of the yellow boy plume. Local residents reported high northwest winds blowing during the night. Yellow boy mud was found on automobiles parked more than one eighth of a mile away downwind at the Virgil location (Figure 46).

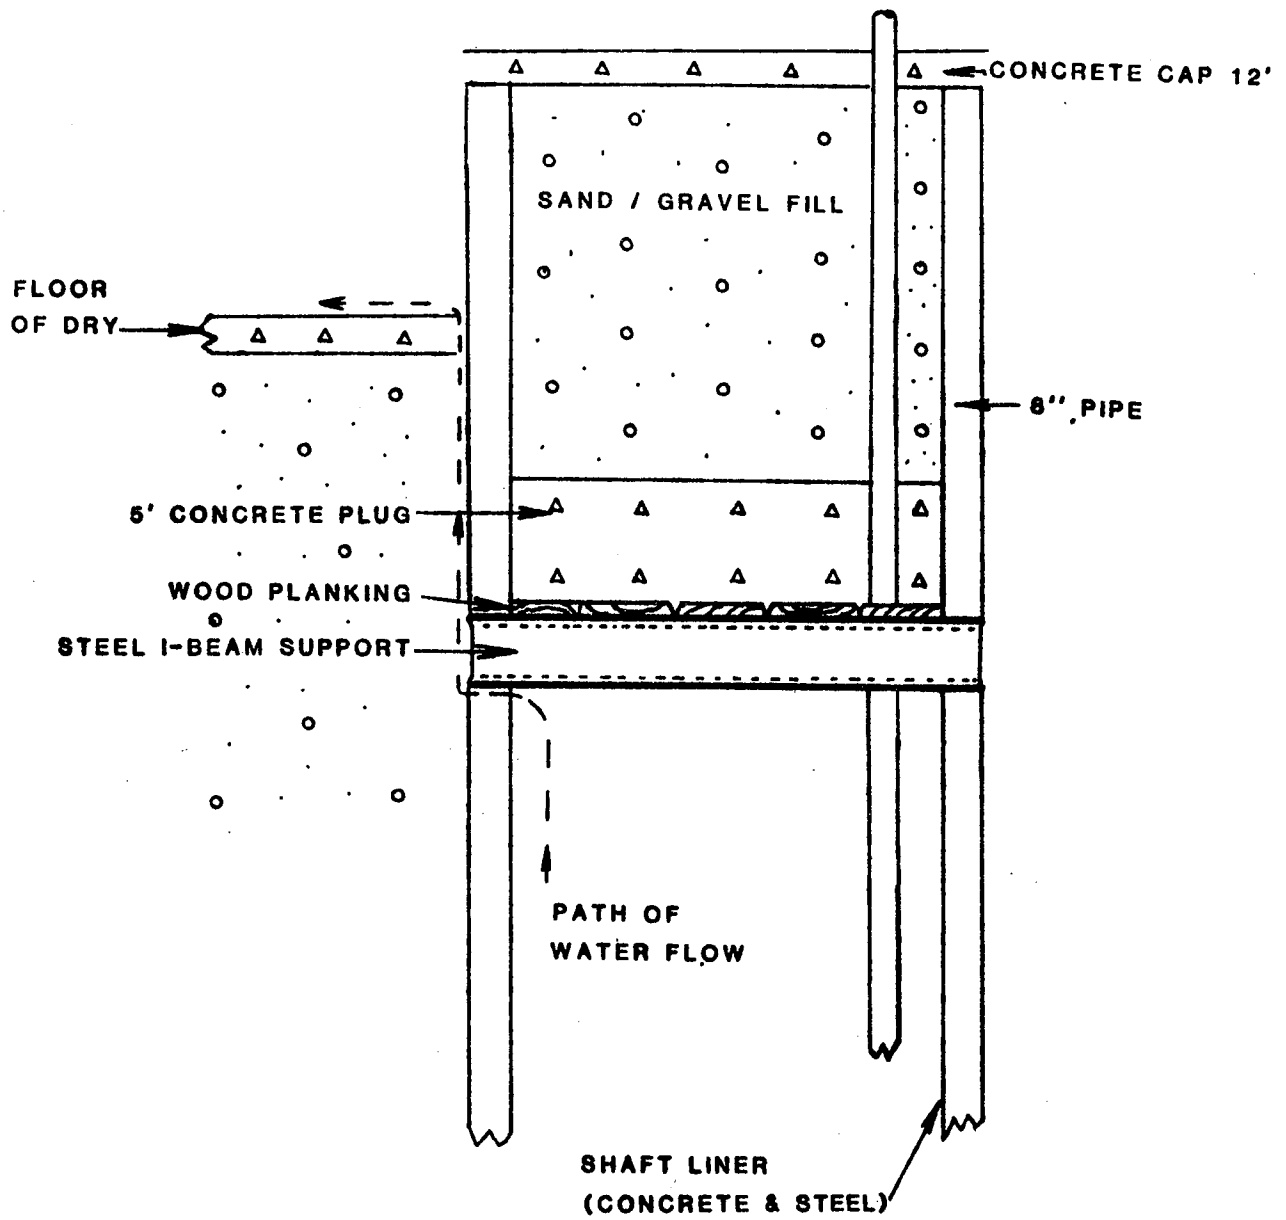
Figure 47. Cross-Section Sketch of Homer-Wauseca Shaft Seal

Homer-Wauseca Mine shaft. The Homer-Wauseca Mine shaft and associated dry and mine buildings are presently being used by McPhearson Company as offices and shops for diesel engine repair and servicing. During the evening of April 1 or the early morning hours of April 2, large quantities of muddy water issued from the periphery of the shaft collar at the dry level and partially flooded the old dry area which had been converted into shops. It appeared that mine water had been forced up the shaft circumventing a concrete seal which was emplaced about 30 feet below the shaft collar. Based upon a description of how the seal was constructed provided by Mr. David McPhearson, I concluded that water under very high pressure had forced its way to the outside periphery of the circular shaft and through the soil overburden next to the shaft to the surface of the dry level. The route through the shaft collar was presumably provided by holes cut into the concrete liner of the shaft for steel I-beam supports. According to Mr. McPhearson a 5-foot thick concrete seal was poured in place over the I-beam supports. A cross-sectional sketch of the seal and likely path of the water is shown in Figure 47.

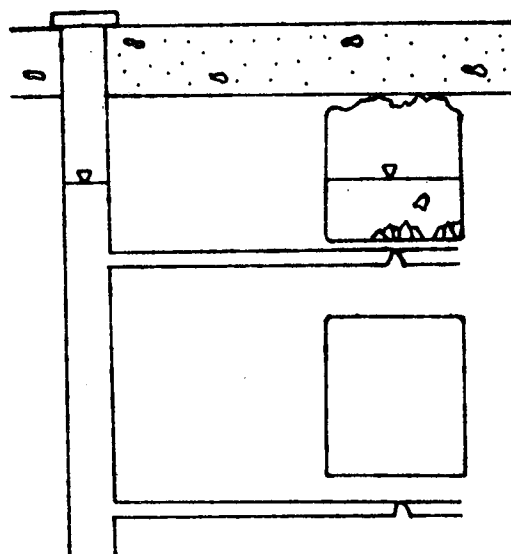
B. Mine nearly flooded, sloughing of back in upper stope implies imminent surface subsidence
