**Information Circular 9072**

# **Ground Subsidence and Structural Damage Over an Abandoned Room-and-Pillar Coal Mine at Hegeler, IL**

**By Gennaro G. Marino, James W. Mahar, Larry R. Powell,  
and Richard E. Thill**

**BUREAU OF MINES**

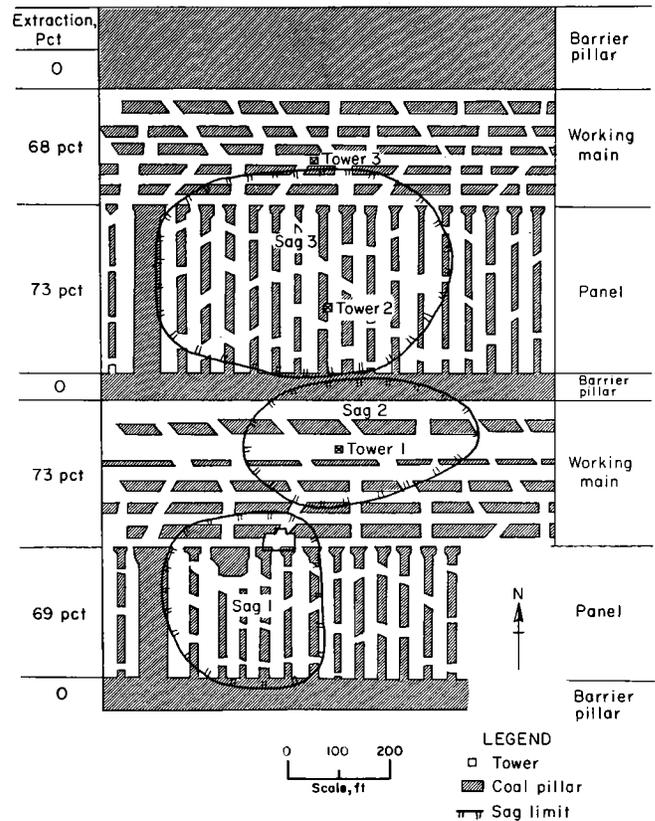
FIGURE 4. - Mine map showing location of subsidence sags.

Sag 1 started to develop in the vicinity of the radio station about noon on July 21, 1967. The subsidence eventually encompassed the access road and parking lot and the surrounding area. The ground movements damaged three houses, the radio station, and service utilities to these structures (26-29). In addition, the southern guy wires to tower 1 were tensioned. The maximum settlement (about 3.5 ft) occurred over an area west of the radio station parking lot and access road. Although most of the displacement occurred within 2 days, ground movements were reported as late as October 1967. Then, in May or June 1969, the northern portion of the radio station building sustained additional damage from residual movements in the northern portion of sag 1.

Sag 2 developed in the field north of the radio station building in May or June 1968. The center of the sag is located 40 ft northwest of tower 1. Most of the settlement (3 ft) occurred rapidly within 6 weeks. Tower 1 subsided 2.75 ft, which caused the guy wires supporting the tower to loosen, and they had to be retightened several times. Surface water collected in the sag around tower 1.

In November or December 1976, sag 3 developed under tower 2. The tower nearly failed when it settled and tilted 0.05 ft

to the east. In July 1978, residual subsidence of sag 3 produced settlement and lateral movement of the southwest guy wire anchors for tower 3. The upper 150 ft of the tower was bent in response to the ground movements. The maximum settlement was about 3 ft.

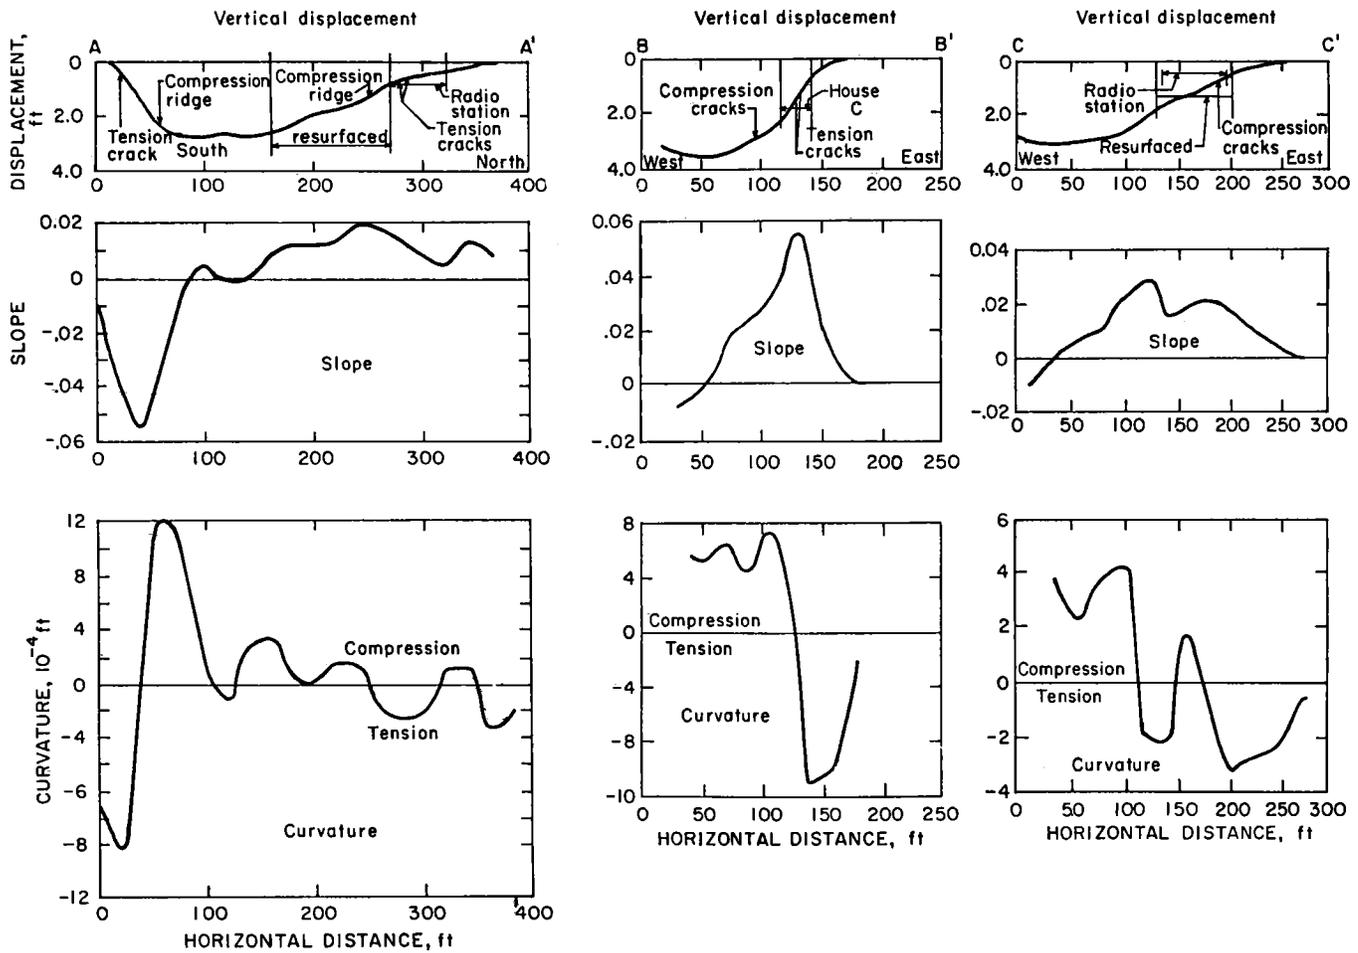
FIGURE 8. - Adjusted profiles, slopes, and curvatures for sag 1. Profile slopes and curvatures calculated on 40-ft lengths from survey data. Surveyed Nov. 11, 1978.

Sag 1 is a 290- by 350-ft semirectangular depression with rounded corners. The area of maximum settlement is approximately concentric to sag limits. A maximum settlement of 3.5 ft is located 100 ft west of profile A-A' (fig. 8). The ratio of settlement to extraction height, known as the subsidence factor, is 0.55.

house C was located (fig. 8, B-B'). Slopes decrease to the north. Around the radio station building, the maximum slope is roughly 0.02. Both structures are located in the tension zone but on opposite sides of the sag. Curvatures, corresponding to the maximum tension and compression, are  $1.2 \times 10^{-3} \text{ ft}^{-1}$  on the south side of the sag and 2.0 to  $4.0 \times 10^{-4} \text{ ft}^{-1}$  on the north side. Figure 11 shows tension cracks and compression ridges associated with sag 1.

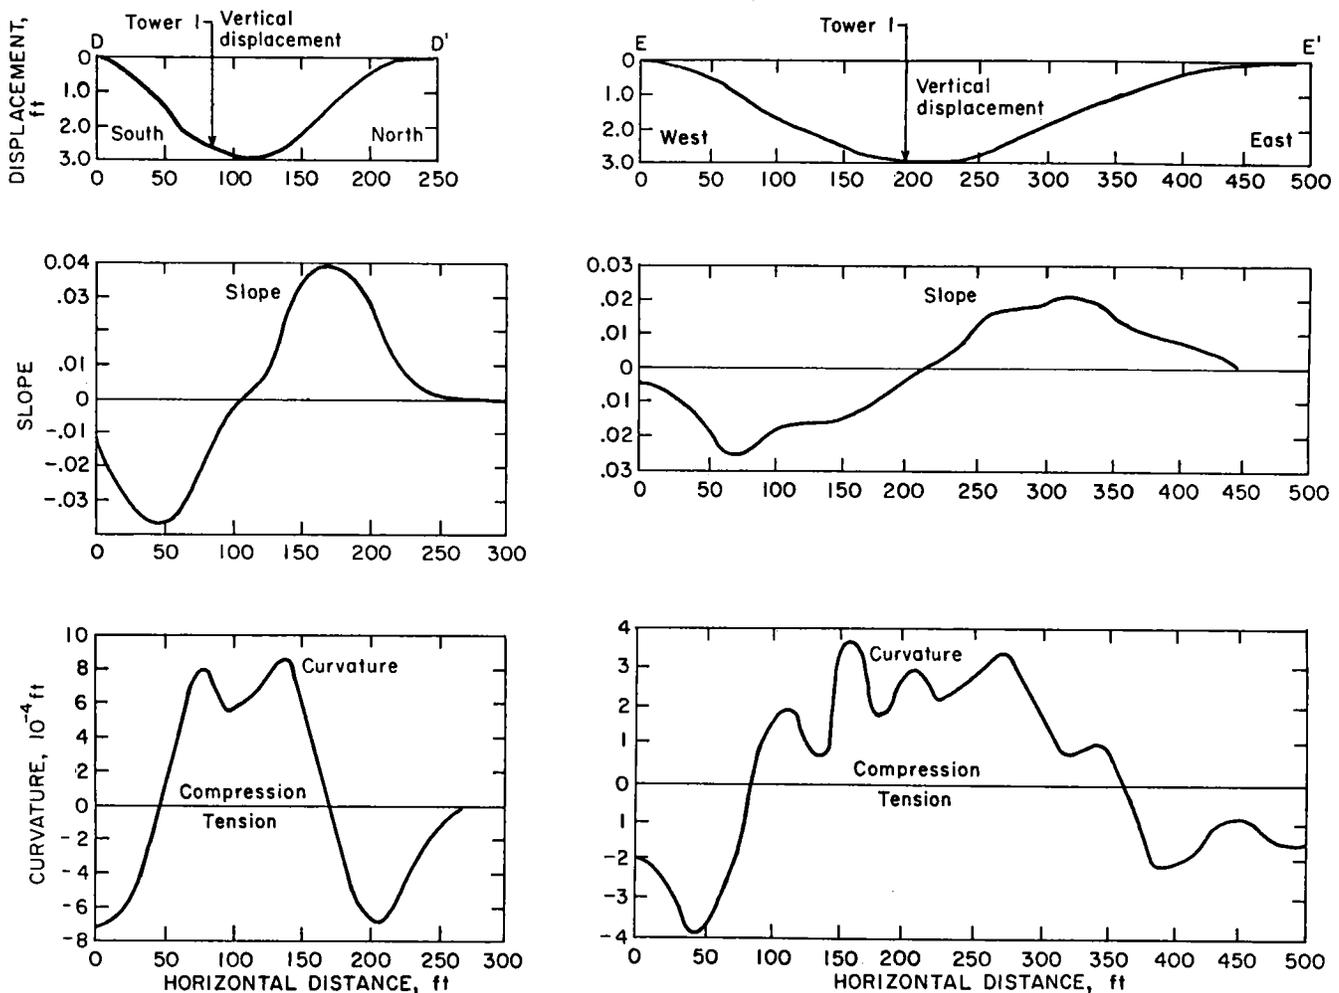
FIGURE 9. - Adjusted profiles, slopes, and curvatures for sag 2. Profile slopes and curvatures calculated on 40-ft lengths from survey data. Surveyed July 9, 1981.

Sag 2 is a 450- by 240-ft elliptical depression elongated in the east-west direction. The sag encompasses the base of tower 1 and most of its guy wire anchors. The adjusted displacement profiles (fig. 9) show the sag to be a bowl-shaped depression with a maximum settlement of about 3 ft.

Slopes for sag 2 are greatest along the north-south profile (fig. 9, D-D') where

the maximum slope is 0.038. This value is 1.5 times greater than the maximum slope in the east-west direction. The maximum curvatures are  $8.6 \times 10^{-4} \text{ ft}^{-1}$  in the compression zone and  $7.0 \times 10^{-4} \text{ ft}^{-1}$  in the tension zone. Both occur along the north-south profile and are about twice those in the east and west portions of the sag.

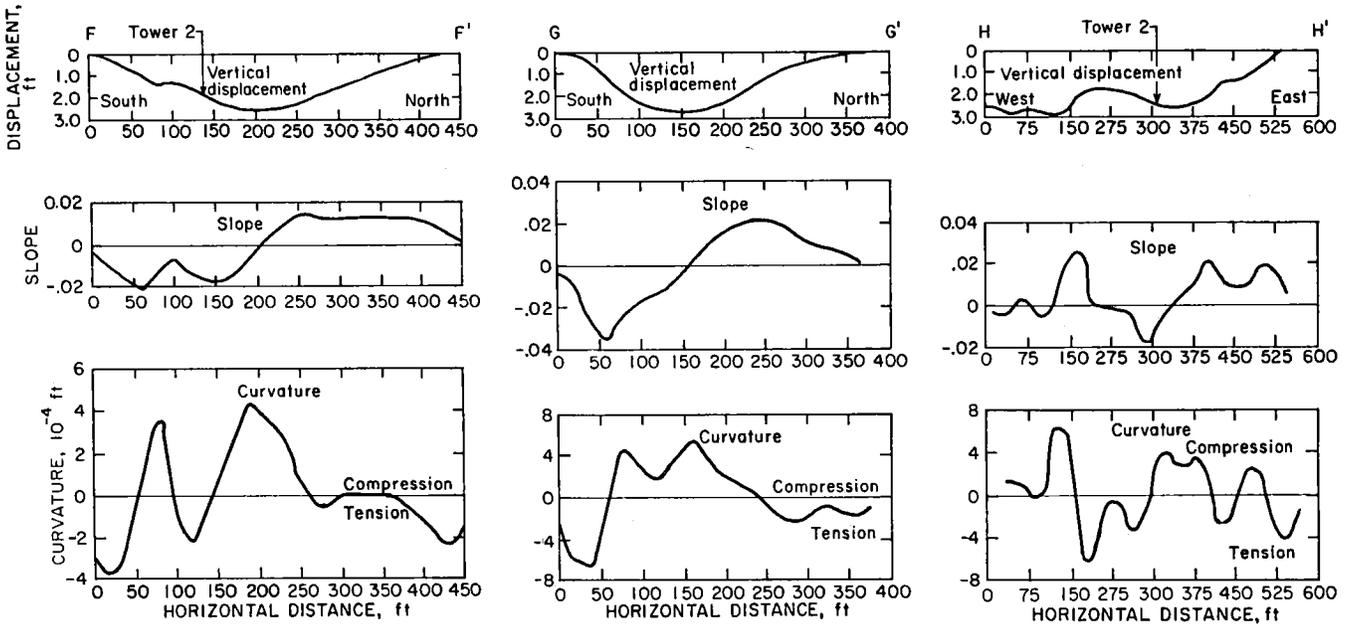
FIGURE 10. - Adjusted profiles, slopes, and curvatures for sag 3. Profile slopes and curvatures calculated on 40-ft lengths from survey data. Surveyed July 9, 1981.

Sag 3 is oval with a maximum east-west diameter of 570 ft and a minimum north-south diameter of 411 ft. The sag encompasses nearly all of tower 2 and the southern guy wire anchors of tower 3. Figure 10 shows that in the north-south direction, the sag has a uniform smooth profile (F-F' and G-G'), but in the east-west direction, the sag bottom varies by 1 ft or more (fig. 10, H-H'). The maximum settlement is 3.0 ft.

The maximum slope for sag 3 is 0.034, which occurs on the south side of profile G-G' (fig. 10); however, slopes greater than 0.02 exist in many other areas of the sag. Curvatures in the compression and tension zones are  $6.0 \times 10^{-4} \text{ ft}^{-1}$  and occur in the western part of the sag, but in the eastern part they are as great as  $4.0 \times 10^{-4} \text{ ft}^{-1}$ . Both slopes and curvatures are erratic in the east-west direction and reflect the nonuniform settlement profile across the bottom of the sag.

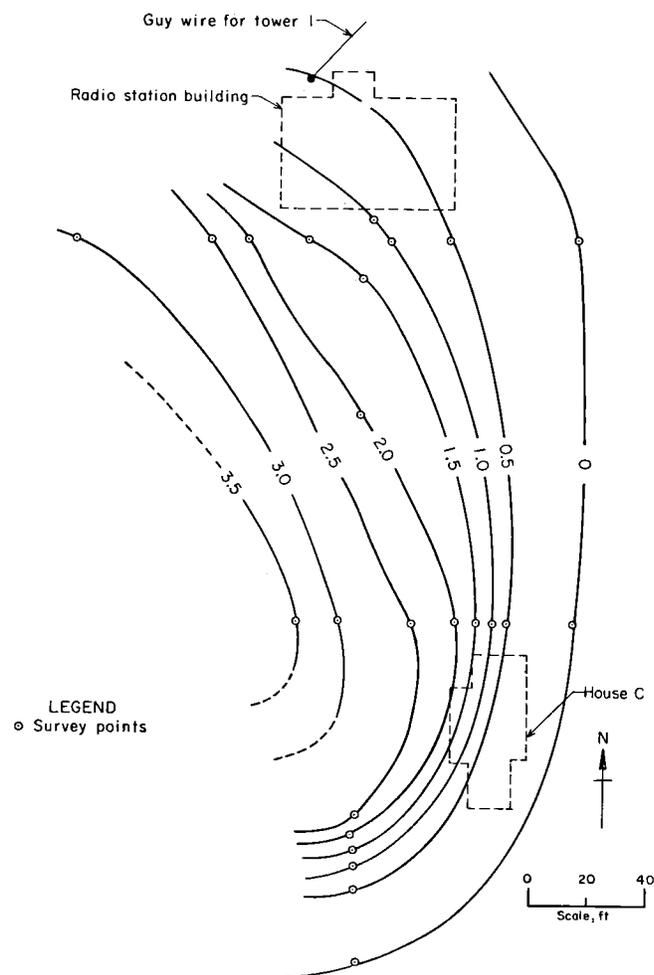
FIGURE 16. - Vertical-displacement contours for sag 1. Survey performed in November 1978.

The house was located in the tension zone just inside the southeast corner of sag 1 (fig. 6). Vertical-displacement contours related to sag 1 are shown in figure 16. The ground movements subjected the house to large horizontal strains, angular distortions, rigid body tilt, and translation. Profile B-B' in figure 8
