# SERIOUS INJURY REPORT

REPORT F2025-01 • March 2026

## ***Senior Captain and Two Firefighters of Ladder Company Burned During Primary Search in Garden Apartment Fire – Texas***

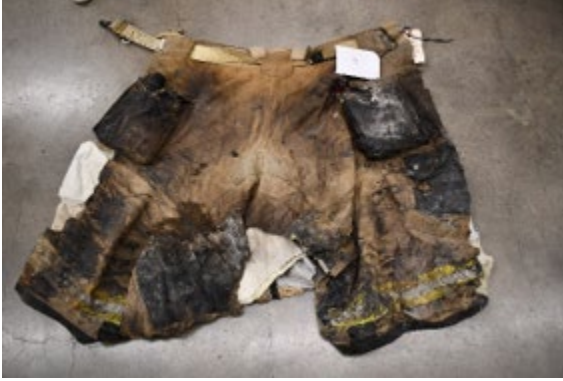
| L46A Outer Shell Exterior Side | | L46A Liner Interior Side | |

**Table 6:** Selected photographs for damaged protective pants worn by members of L46 entry team.

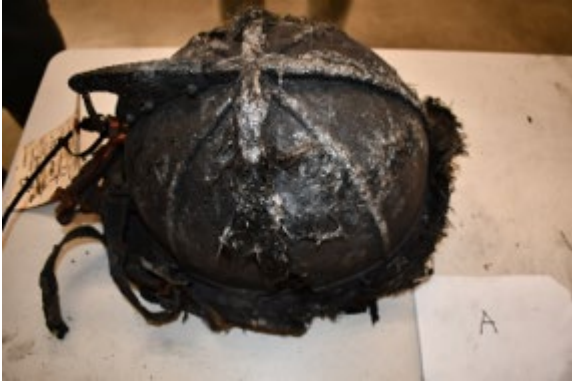
| L46A Helmet (Left Side) | | L46A Left Glove (Back View) | |

**Senior Captain and Two Firefighters of Ladder Company Burned During Primary Search in Garden Apartment Fire – Texas****Table 7:** Selected photographs for damaged protective helmets and gloves worn by members of L46 entry team.

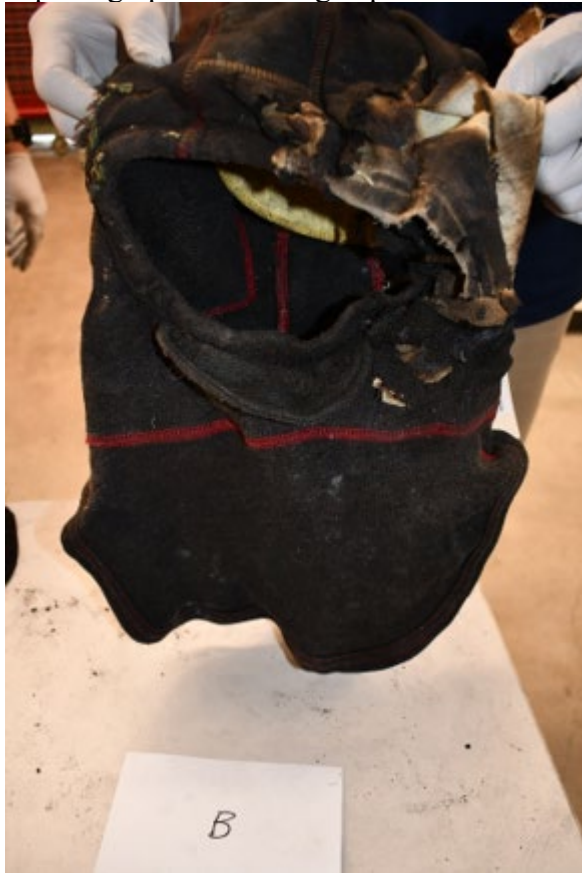
**Table 8:** Selected photographs for damaged protective hoods worn by members of L46 entry team.**L46B Hood (Front View)**

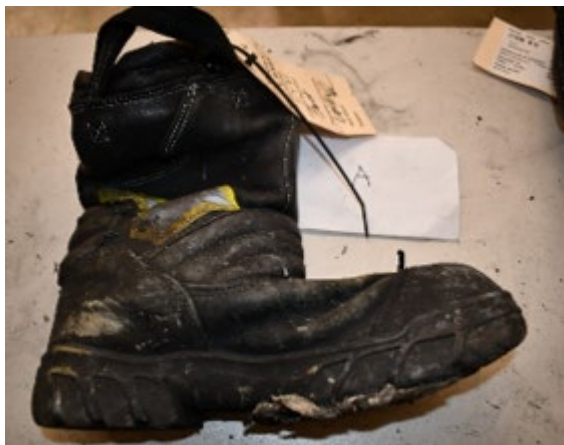
**L46A Right Boot (Outboard View)**

**Table 9:** Selected photograms for damaged protective footwear and SCBA facepieces worn by members of L46 entry team.

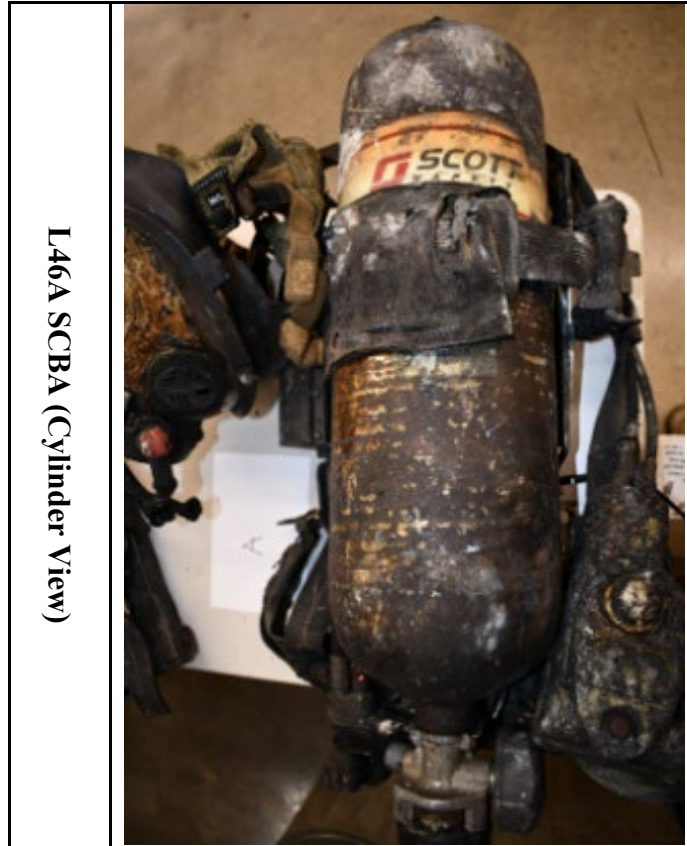
**Table 10:** Selected photographs for damaged protective SCBA back frames and cylinders worn by members of L46 entry team.
