Career Fire Captain Electrocuted After Contacting Overhead Powerline From the Platform of an Elevating Platform Fire Apparatus – Pennsylvania

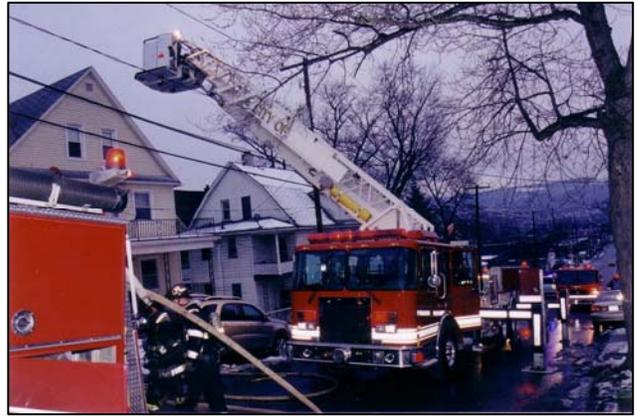
On January 6, 2008, a 40-year-old male career Fire Captain (the victim) was electrocuted after coming into contact with a 12,400-volt overhead powerline. The victim and a fire fighter had been assigned to ventilate the roof of an apartment building and were using an elevating platform fire apparatus to gain access to the roof. The victim was in the process of maneuvering the platform beneath a three-phase overhead powerline when he contacted one of the powerlines with his neck and back. The other fire fighter located on the platform had crouched down just before the contact. After realizing what had occurred, a fire fighter located on the turntable of the apparatus lowered the platform containing the victim and the fire fighter to the ground. The victim and fire fighter were removed from the platform and transported to a local hospital. The victim was pronounced dead on arrival at the hospital. The fire fighter received medical treatment and was later released. Two occupants of the apartment building died as a result of the fire. The following factors were identified as contributing to the incident: fire fighter proximity to energized powerlines; suboptimal incident command; an absence of relevant standard operating procedures; absence of specific periodic training; heightened sense of urgency given civilian occupants; and a lack of verification of the powerline energy state.
