Blasting-Related Carbon Monoxide Incident in Bristow, Virginia
By Marcia L. Harris, James H. Rowland III, and Richard J. Mainiero

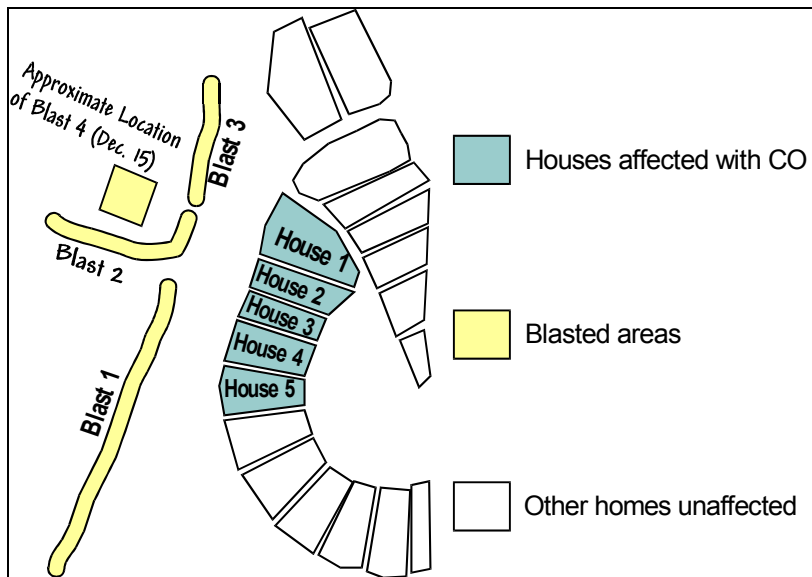
Figure 1 - Locations of houses and blasts.

During the evening of November 8, a CO monitor in a home located approximately 90 ft (27.4 m) from the blast (see Figure 1) alarmed. The residents called the gas company and the local fire department of Prince William County. The gas company measured in excess of 800 parts per million (ppm) of CO near the water sump in the basement of the house. The fire department also took CO readings on the first floor of the house and in the basement. The CO readings were 100 ppm on the first floor and more than 200 ppm in the basement. Exposures for long periods of time at these levels can be hazardous to a person's health. The NIOSH recommended exposure limit (REL) is 35 ppm time weighted average (TWA) for an 8-hour period.⁴ In the range of 200 ppm, slight headaches, tiredness, dizziness, and nausea (after 2-3 hours) may be experienced. A person could experience frontal headaches within 1-2 hours when the CO is in the 400 ppm range. In the 800 ppm range, dizziness, nausea and convulsions may occur within 45 minutes of exposure. If exposed to 800 ppm for 2-3 hours, death will occur.⁵

The second trench blast (see Figure 1) occurred on November 14, 2002. The blast consisted of 82.5 lbs (37.4 kg) of boosters and 770 lbs (349.3 kg) of packaged cap sensitive emulsion. To reduce the possibility of CO entering the four affected homes, the fire department covered the water sumps in the homes with plastic and sealed the plastic with duct tape. CO monitors were also purchased and placed in each of the homes. After the shot, the CO monitors did not alarm in any of the houses.

The third trench blast (Figure 1) was shot on December 3, 2002, at 11:30 a.m. The trench was 120 ft (36.6 m) long with boreholes 20 to 27 ft (6.1 to 8.2 m) deep. The shot consisted of 3,504 lbs (1,605.7 kg) of bulk emulsion blasting agent primed with 167.75 lbs (76.1 kg) of booster. Immediately after the shot, four venting pits approximately 6 ft x 6 ft x 5 ft (1.8 m x 1.8 m x 1.5 m) deep were excavated along the length of the shot to release the trapped gases into the atmosphere. Following the shot, the home CO monitor alarmed in house # 2. The fire department was called to take measurements. In the basement near the water sump, the CO reading was 370 ppm, while in the living area the CO reading was 55 ppm. The levels measured in the living areas of the other three homes ranged from 55 ppm to 182 ppm. The next day, CO readings taken in the living area of each home ranged from 27 ppm to 226 ppm. Every home except one was evacuated. Two days later on December 5, 2002, no CO could be detected at house #3. None of the other home owners were available for access to their homes. At this point, the fire department voided the blasting permit and would not reissue the permit until the department was confident that measures had been put in place to protect the homeowners from CO poisoning.

After submitting a revised blasting plan, a blasting permit was reissued. On December 13, 2002, a shot was fired to break up rock for excavation of a house foundation pad (Figure 1). The blast pattern consisted of about 120 holes, each 7 to 8 ft (2.1 to 2.4 m) deep, loaded with 4.6 lb (2.1 kg) of explosive primed with $\frac{3}{4}$ -lb (0.34 kg) boosters. The total 630 lbs (285.7 kg) of bulk emulsion blasting agent was primed with 101.5 lbs (46 kg) of boosters. To prevent migration of CO to the homes that were affected previously, the shot was excavated immediately following the blast as required in the new blasting permit. Additionally, the 15 to 25 ft (4.6 to 7.6 m) deep storm sewer trenches between the shot and the homes were left open to ventilate any CO to the atmosphere before it could migrate away from the blast.
