OCCURRENCE AND REMEDIATION OF COAL MINE BUMPS: A HISTORICAL REVIEW

By Anthony T. Iannacchione¹ and Joseph C. Zelanko²

Pittsburgh Research Center, U.S. Bureau of Mines, Pittsburgh, PA.

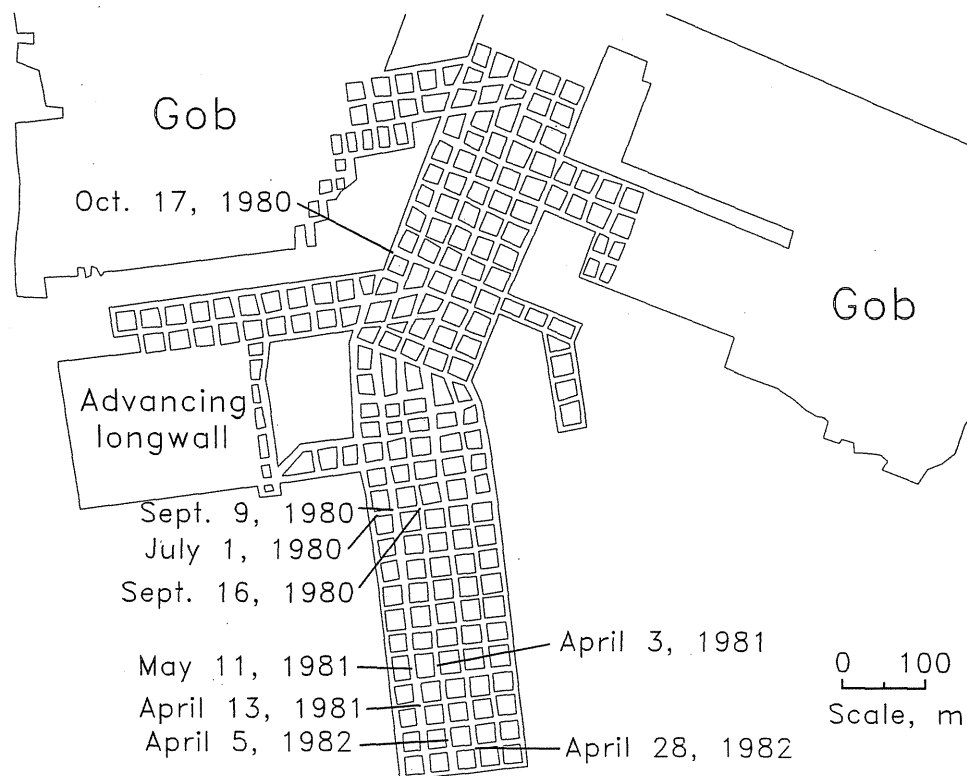
Figure 2
Location and Dates of Bumps Reported at L. S. Wood Mine, Redstone, Pitkin County, CO.

The L. S. Wood Mine experienced nine bumps during development of the Main Slope section between July 1980 and April 1982. All these bumps were associated with overburden greater than 600 m. Four bumps took place near one of two adjacent gobbs (figure 2). Although the bumps exhibited tremendous force, the skilled work force at the mine was always able to avoid being "caught" by the bump so no miners were injured in any of these events. Eight bumps occurred during or shortly after mining and displaced large volumes of rib coal near the mining zone.

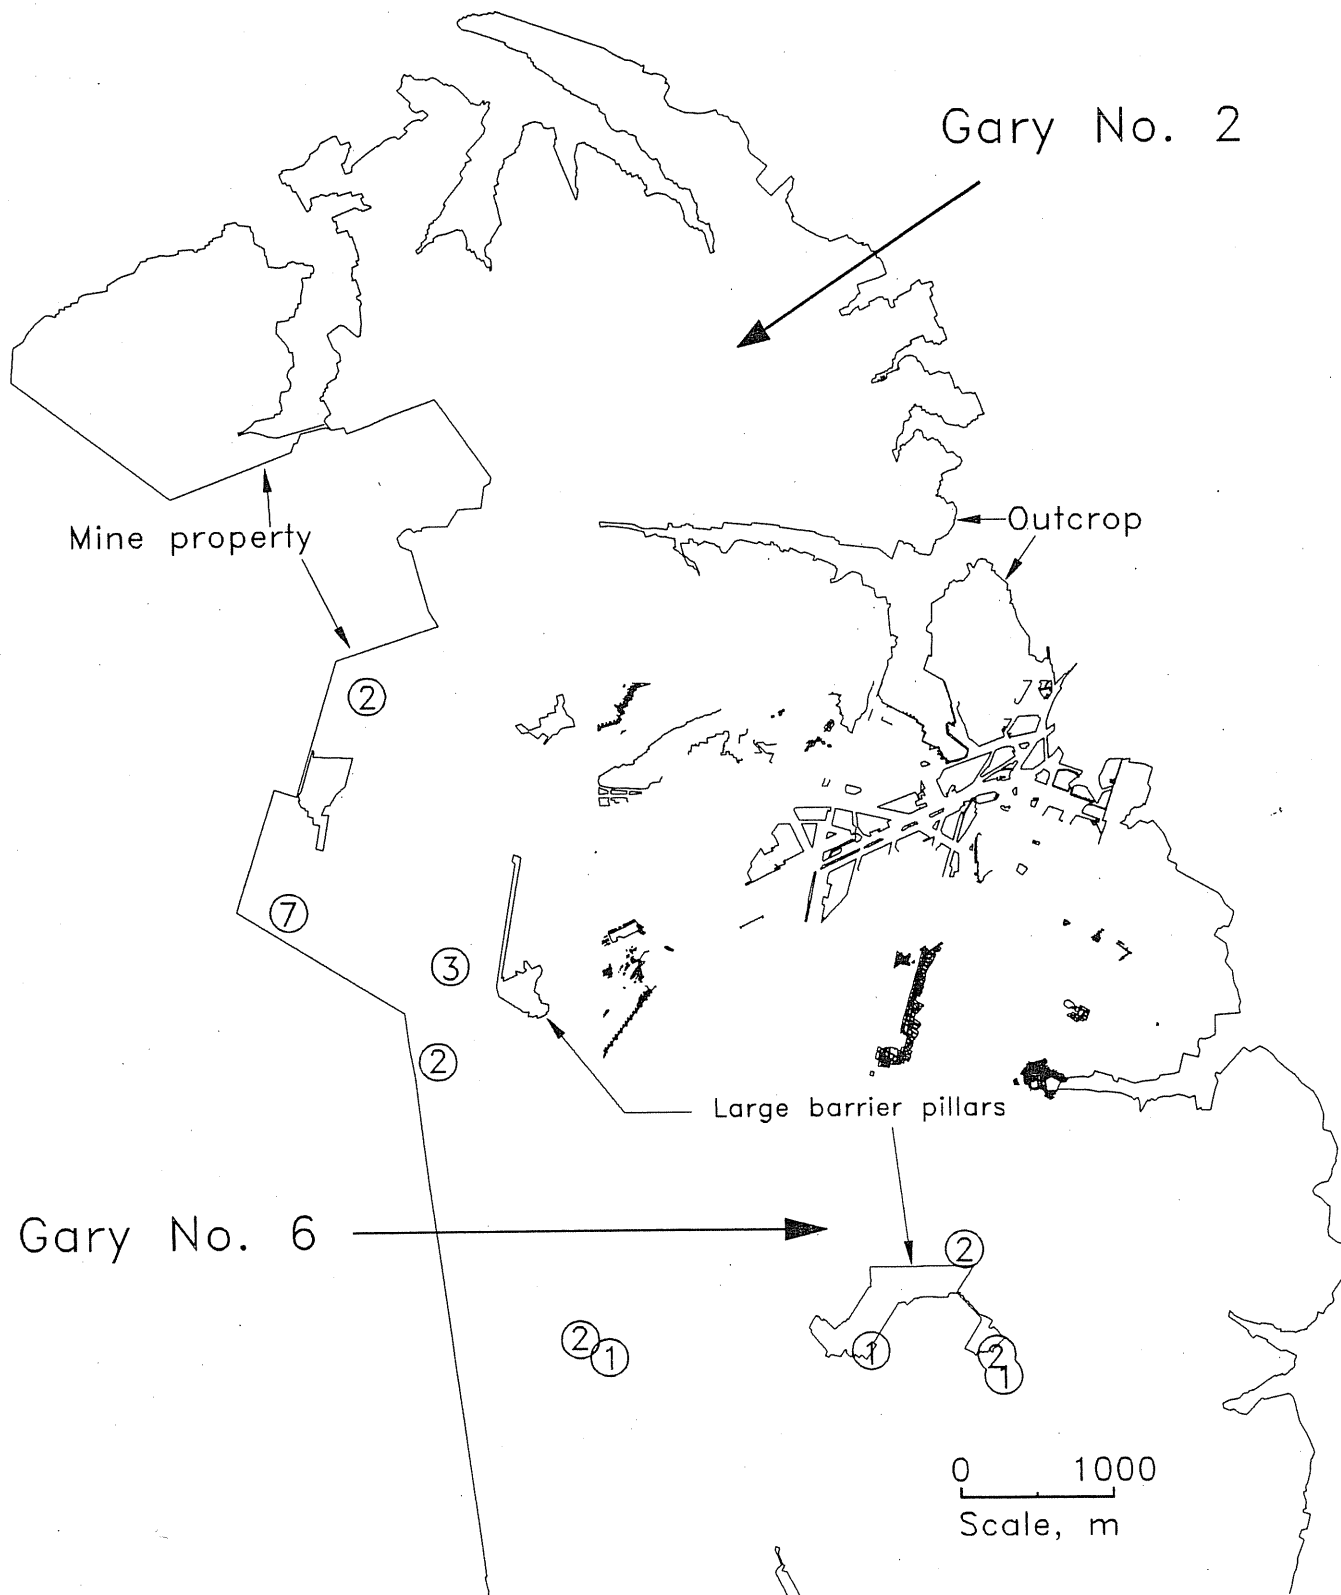
Figure 3.
Location of Bumps Reported at Gary No. 2 and 6 Mines, McDowell County, WV.

Bumps at the Gary Mines in the 1950's were associated with a variety of factors (figure 3). Mining in the first half of the 20th century undoubtedly resulted in the bump-prone mining scenarios faced in the 1950's. For example, mining was conducted adjacent to gob areas created decades earlier, retreat sections operated on groups of pillars of irregular sizes and shapes, and much of the mining was directed to recovering barriers between old workings.

Circled numbers indicate number of bumps at various locations.

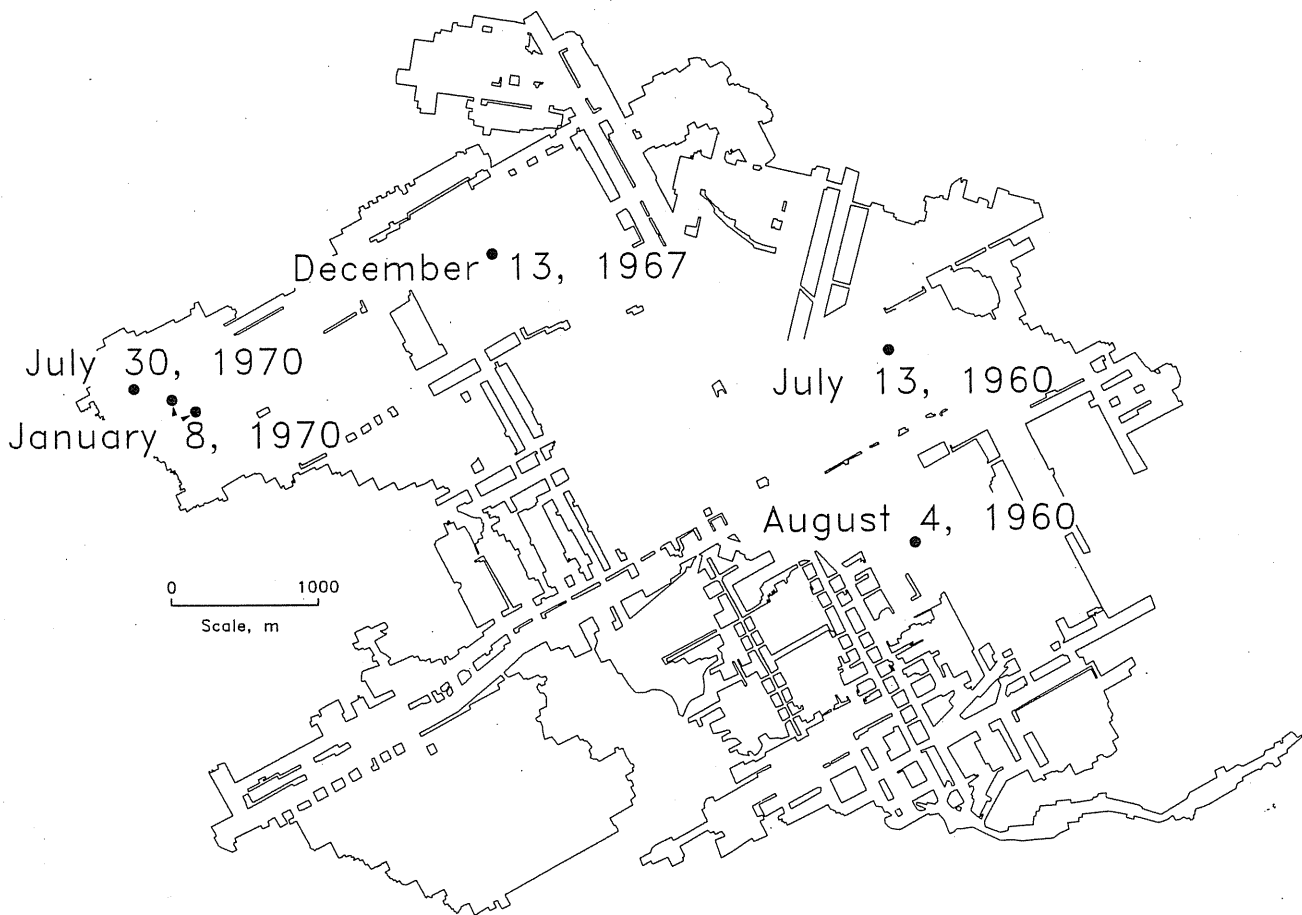
Figure 4**Location and Dates of Bumps Reported at Moss No. 2 Mine, Russell County, VA.**

The Moss No. 2 Mine near Dante, VA, was extensively mined by Clinchfield Coal Co., from the 1950's to the 1970's in 1.2 m of the Tiller Coalbed. During this time, five bumps were recorded and are part of the USBM database (figure 4). The mine utilized a multientry development system, followed by room-and-pillar mining. Extraction of pillars was accomplished primarily by the split-and-fender method. Rooms were typically driven 23 m apart and 6 m wide with crosscuts every 23 m. More than 100 sections were developed and pillared using some variation of this method. One of the first longwall sections in the United States was employed at this site in the late 1960's and 1970's. Twenty-two longwall panels of varying length were extracted.

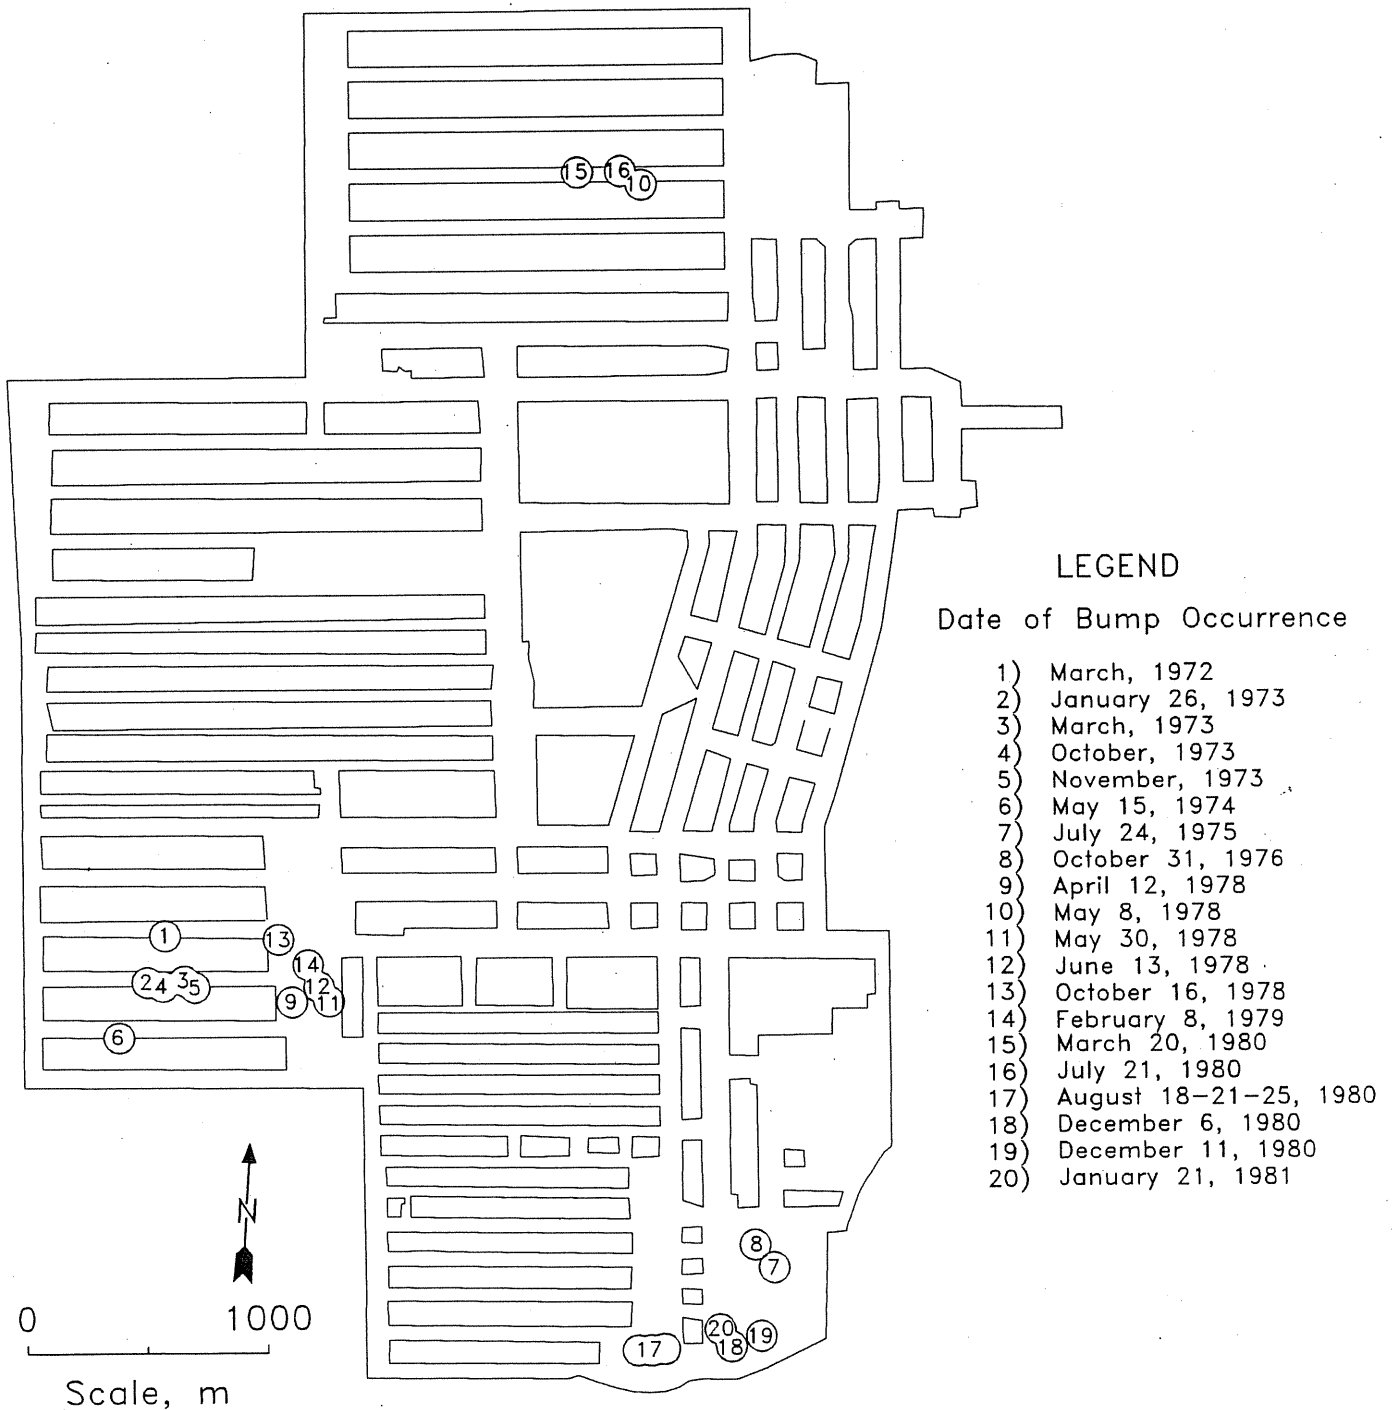
Figure 5
Location and Dates of Bumps Reported at Beatrice Mine, Buchanan County, VA.

The Beatrice Mine near Keen Mountain, VA, reported 24 bumps between 1972 and 1981 (figure 5). This high

The Beatrice Mine had extensive experience with bumps during longwall mining in its southern portion during the early 1970's (figure 5). Early longwall equipment included a plow and 94 hydraulic legs and canopy units having a capacity of 127 t. Many of the same conditions responsible for bumps at the Moss No. 2 Mine were also found at the Beatrice Mine. Overburden in the south longwall district ranged from 700 to 760 m. Roof strata in these areas apparently changed from a laminated shale and sandstone sequence with coal streaks to predominately sandstone intermixed with siltstone layers. The gate entry design at the Beatrice Mine consisted of a yield-yield-abutment system. The pillars were 24 m long and none were offset. The yield and abutment pillars were 9 and 24 m wide, respectively.

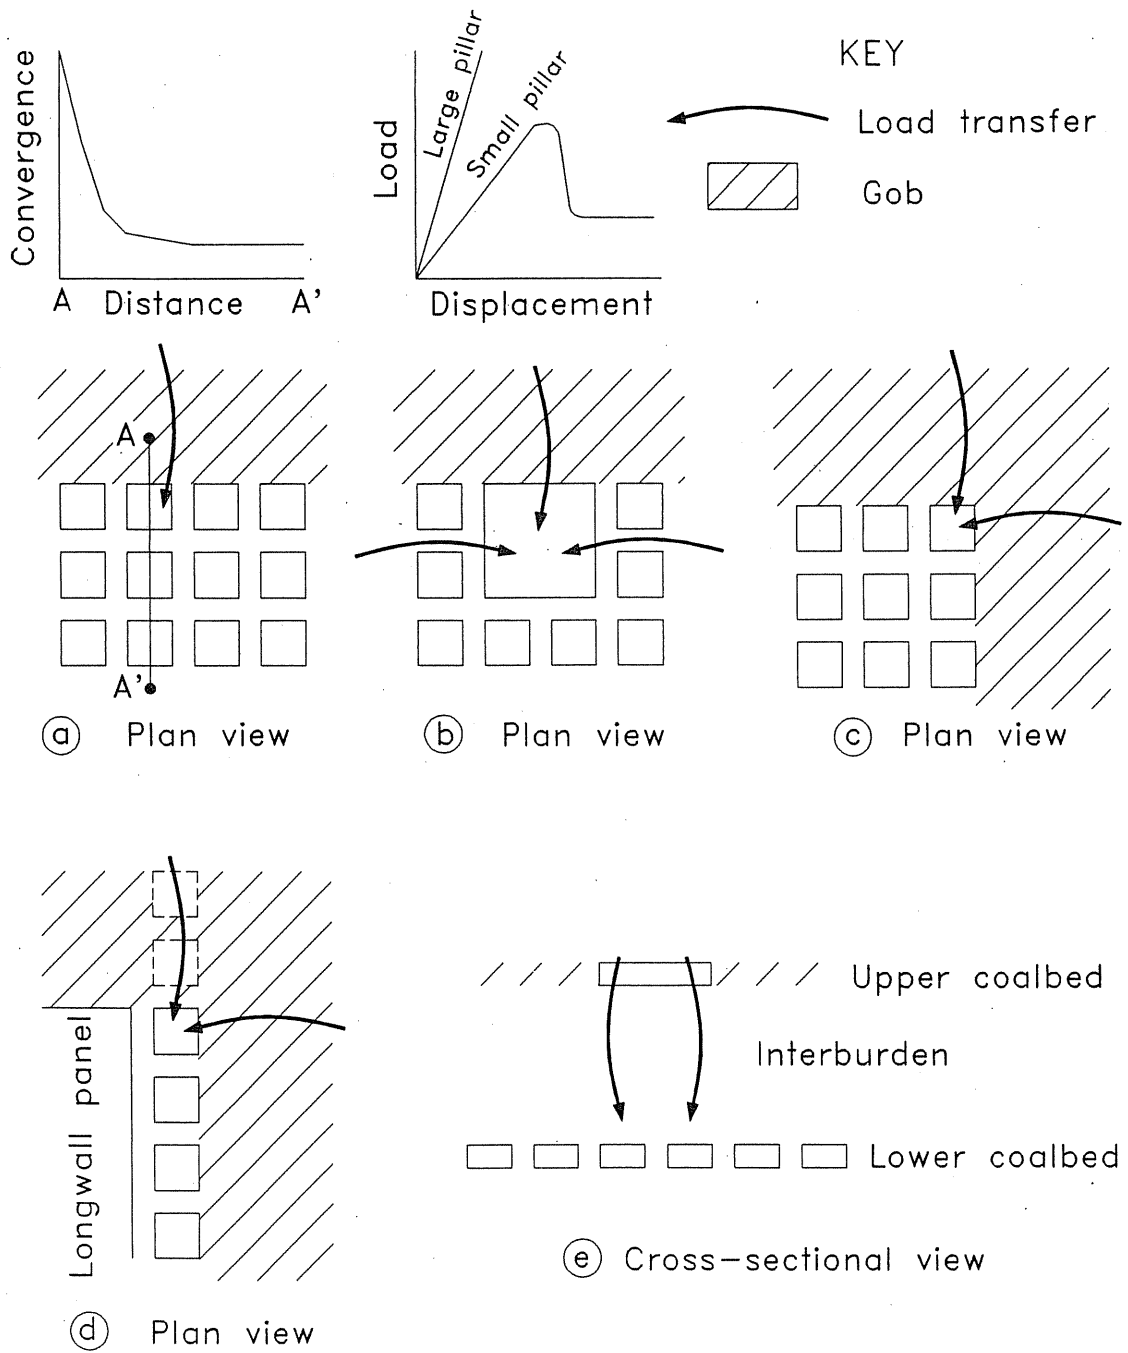
Figure 8
Generalized Examples Showing How Different Full-Extraction Mining Scenarios Transfer Load to Pillar Structures.

Pillars adjacent to gob areas experience elevated loading conditions from the unsupported strata above the gob (figure 8A). Certain mining geometries, such as a large pillar surrounded by smaller pillars, can concentrate stress (figure 8B). Large pillars can be imagined as stiff structures that tend to deform or converge less than smaller, less stiff pillars. These larger structures tend to gather load, increasing the potential for violent failure as the smaller pillars are extracted within and around them.

(figures 8C and 8D) and overlying large pillars or barriers in multiple-seam mining operations can cause excessive pressures (figure 8E). Fortunately, all of the preceding conditions lend themselves to engineering solutions, many of which are discussed later with actual examples.

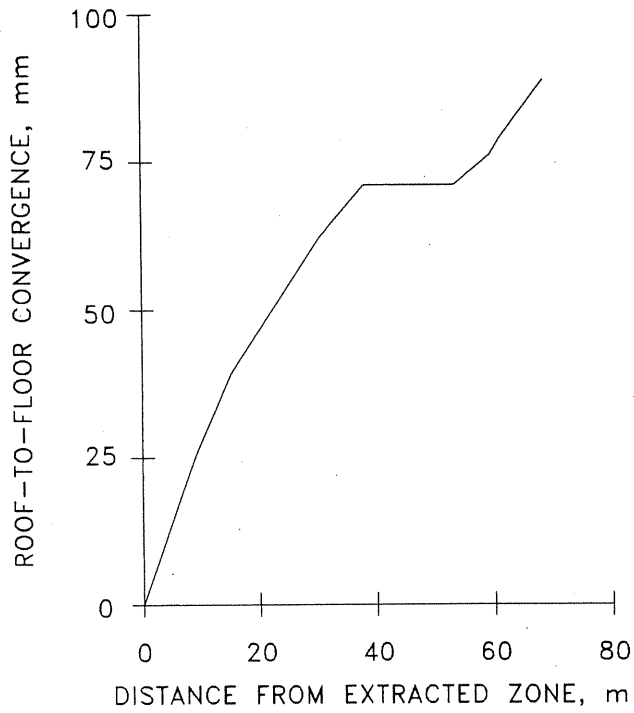
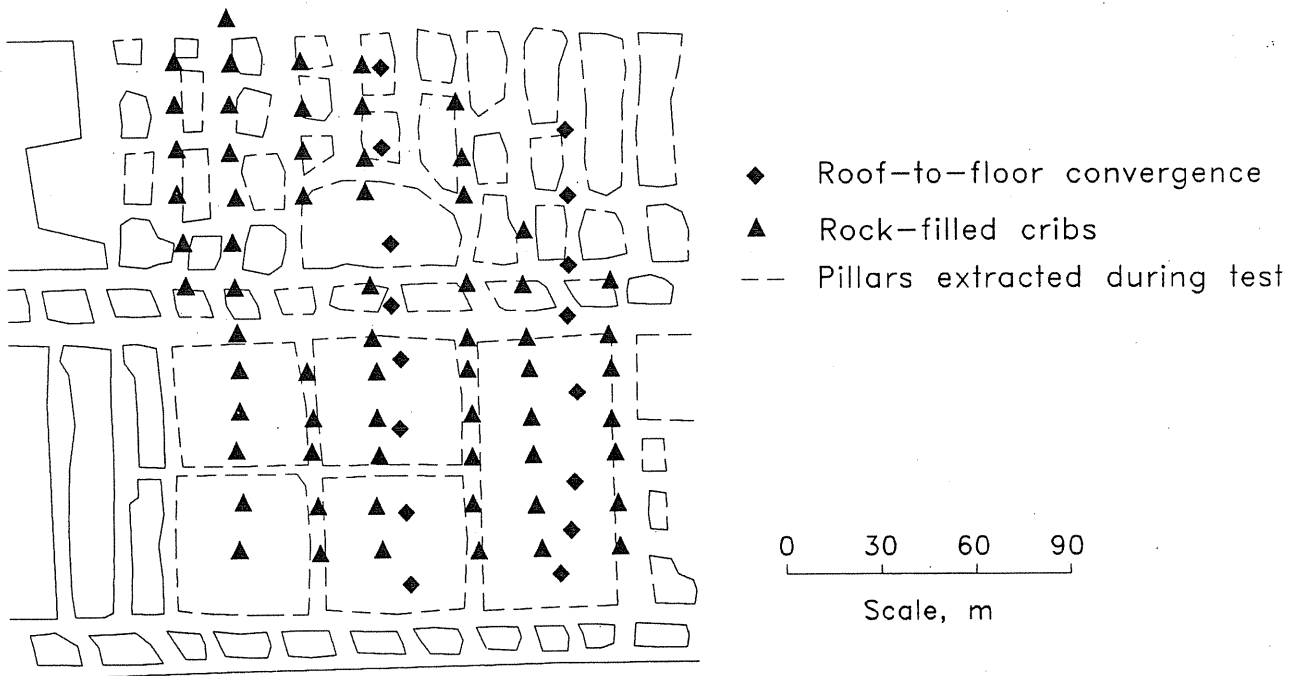
Figure 25
Suggested Plan of Pillar Extraction Under Deep Cover Using Rock-Filled Cribs (After 17).

Bryson (3) described a detailed field test of this design method at a deep mine in the Harlan Coalbed, Cumberland Mining District, under 430 m of cover. Bumps had killed five miners at this particular site. Figure 25 shows the test area, which was approximately 210 m wide and adjacent to a large gob area. Rooms were driven approximately 91 m between the support entries, which were about 10.7 m wide. Prior to the extraction phase, the study area was composed of a series of narrow (10.7 m wide) and large (43 m wide) pillars. As the section was mined, 16 roof-to-floor convergence stations and 64 rock-filled cribs were installed.

1. Recover all coal in a pillar operation.
2. Avoid pillar line points.
3. Keep the roof spans projecting over the gob as short as possible or provide support so that the roof beds do not fracture.
4. Do not conduct development work in abutment areas.
5. Do not split pillars on or near the extraction line.

6. Use the open-ended extraction technique with lifts of not more than 4.3 m.
7. Leave one or two rows of pillars adjacent to old gob areas.
8. Maintain pillars at the same size and shape.
9. Keep development entries narrow, approximately 4.3 m.
10. Note areas of rolls, changes in dip, and changes in coal thickness and hardness. Use this information in designing the mining system.
