Geologic Investigations of Underground Coal Mining Problems

RI 8022

Bureau of Mines Report of Investigations/1975

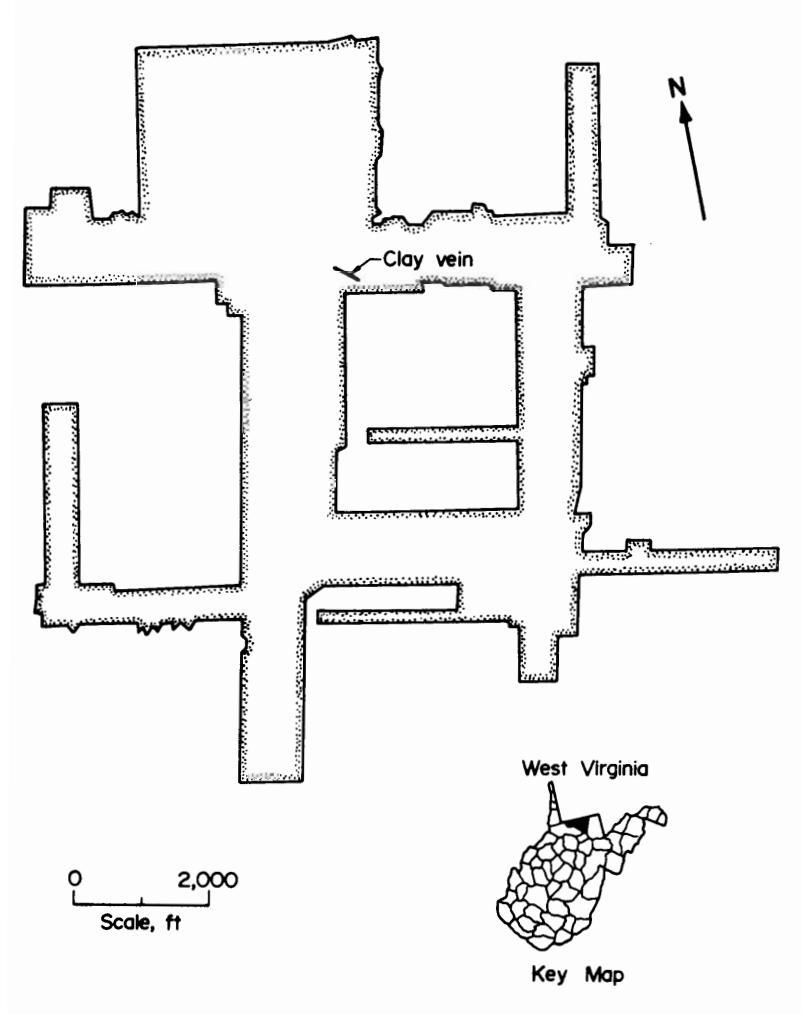
FIGURE 16. - Outline of the Federal No. 2 mine.

Analysis of the cleat data showed uniformity within the present mine development. The face cleat strikes N68°W, the butt cleat strikes N22°E, and the dip is essentially vertical. A series of slump fractures were observed in the East Bleeder, and one clay vein (fig. 16) approximately 150 feet long extends from the roof 2 feet into the coalbed near the mouth of the East Mains. The slump feature may be due to some local channel erosion or to differential compaction. Geologically related mining problems are methane emissions and roof instability, which go hand-in-hand in many instances. Driving north-south tends to develop high gas by intersecting face cleats. Roof control problems are probably due to bolting into the incompetent alternating coals and shales (draw slate interval).

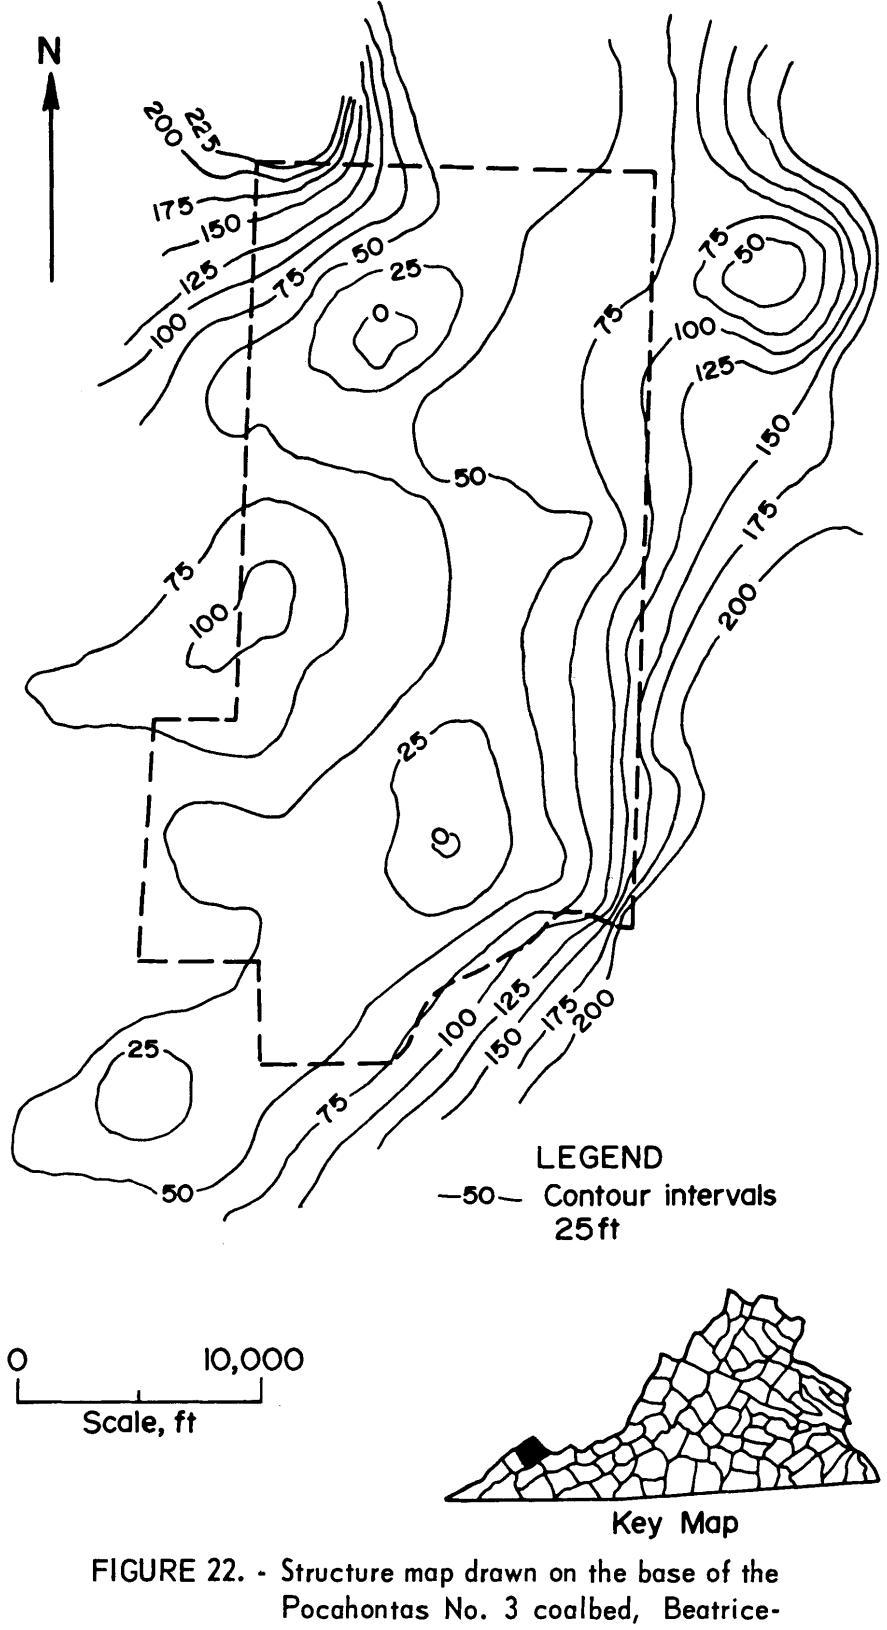
Pocahontas mine.

According to a structure map (fig. 22), the mine is located on the flank of a monocline with a west-southwest dip. A fence diagram (fig. 23) showed two possible sandstone channels, one running southeast and the other northeast. The one trending southeast has already been encountered in mining and did cut out the coal. The one trending northeast has not yet been reached, but it is expected to cause much the same type of problem as the first one.
