Effects of Hydraulic Stimulation on Coalbeds and Associated Strata

Report of Investigations 8260

By Curtis H. Elder

BUREAU OF MINES

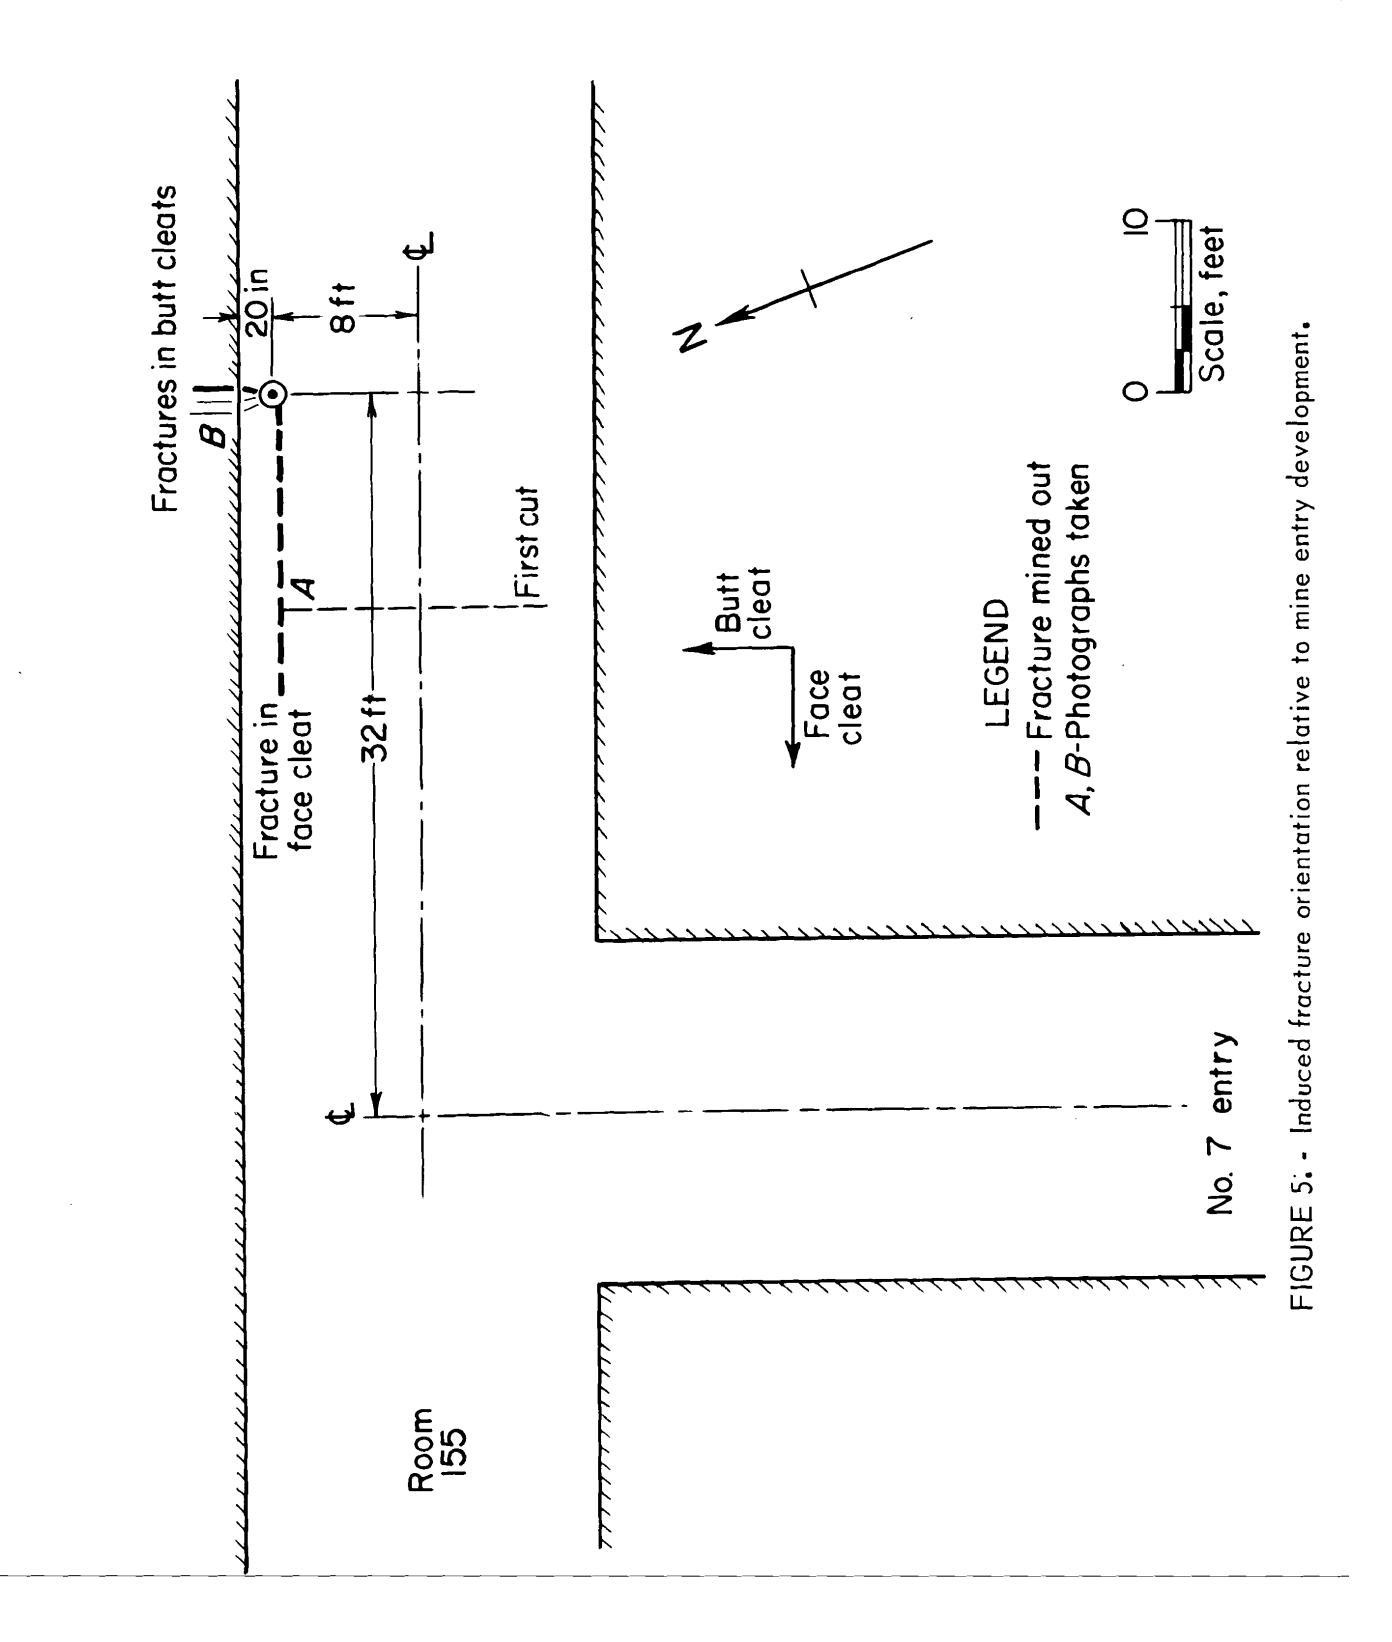
On June 12, 1974, the induced fractures were intercepted by mining. Twenty feet of vertical sand-propped fracture was mapped along the face cleat direction west of the borehole. The sand-filled fracture ranged from oneeighth to one-half inch in width, extending from the draw slate at the top of the coalbed to the mine floor. There was no evidence that the fracture extended into the roof or floor rock (figs. 4-6). Wide vertical fractures were propagated to the north of the borehole along the butt cleat direction. These fractures were 1/2 to 2-1/2 inches in width and were packed with the propping sand (figs. 7-8). They extended from the base of the draw slate to the floor. Again, no evidence was found to indicate that the induced fractures along the butt cleat direction penetrated the roof (fig. 9) or floor rock.

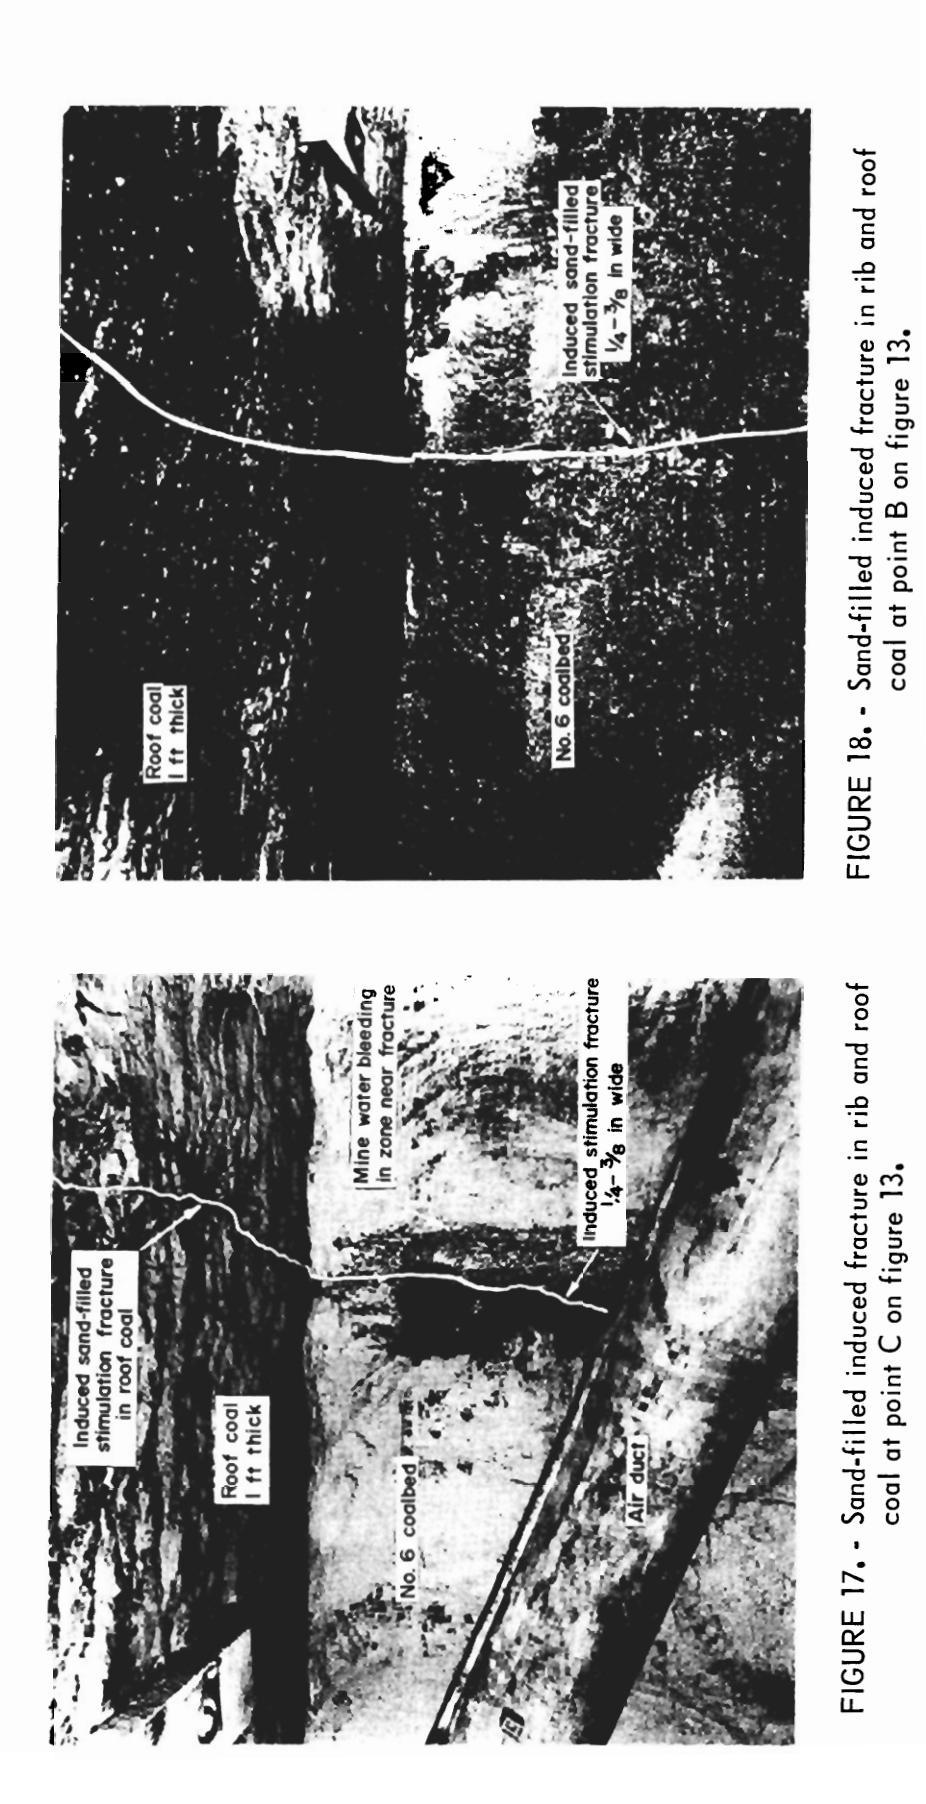
The fracture could be readily traced across the entries of the roof coal. It ranged from one-eighth to three-eighths inch in width, averaging approximately one-quarter inch (figs. 15-18). The sand-propped fracture did not extend into the roof or floor. The roof coal and rock remained stable in all the entries intersecting the fracture. Mining developed normally through the stimulated areas. Mine engineers noted a reduction in gas emission into the mine in the test area resulting from a long period of degasification prior to mining. Approximately 61 cu ft of fracture volume was created which was filled with sand. Sixty-four cubic feet of sand was used during the treatment. The 3-cu-ft difference can be attributed to sand that settled in the borehole. The excess sand was removed from the borehole immediately after treatment.

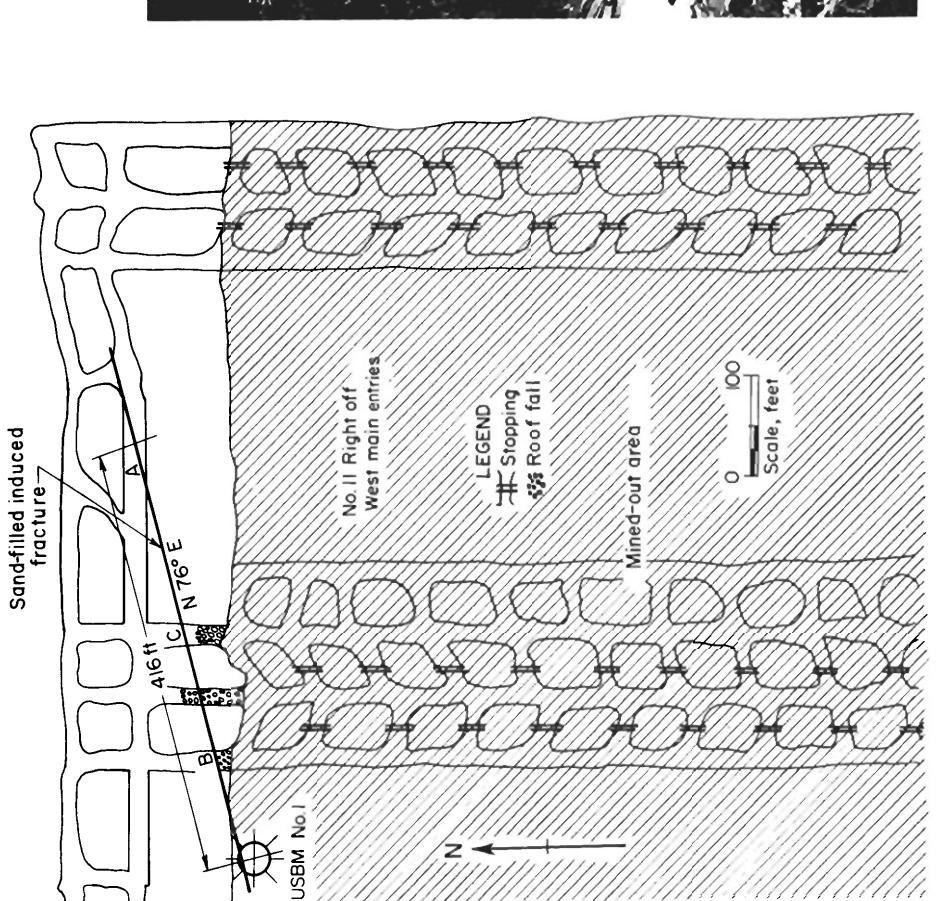
FIGURE 20. - Induced fracture after 2-1/2 years of exposure to mine atmosphere at point A on figure 19.

The roof along the east-west bleeder entry at point A (fig. 19) had remained stable. There had been no spalling of roof or coal rib along the trace of the induced fracture (fig. 20).
