Bureau of Mines Report of Investigations/1987

Effects of Stimulation Treatments on Coalbeds and Surrounding Strata

Evidence From Underground Observations

By William P. Diamond and David C. Oyster

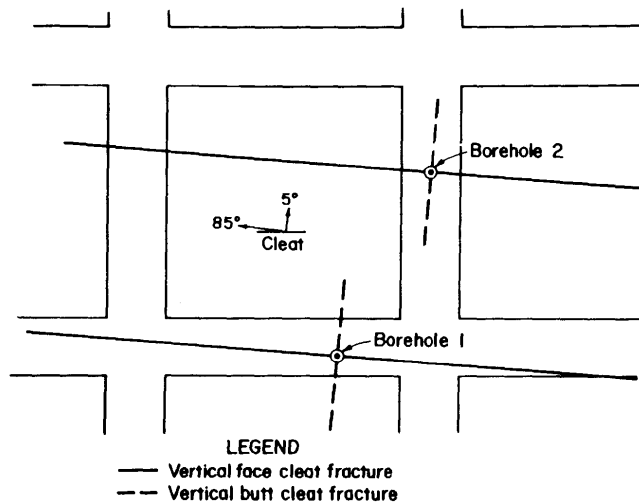
Figure 1.—Relationship of mine entry orientation and interception of vertical fracture wings parallel to coal cleat.

A hydraulic fracture trending in the face cleat direction perpendicular to the long axis of an entry would presumably be contained in the ribs adjacent to the borehole (borehole 2, figure 1) and would be available for observation as long as the pillar remained. Butt cleat fractures, if present, would have been intercepted head on. Since butt cleat fractures are often relatively short, they would often be completely mined by a single mining cut and never observed.

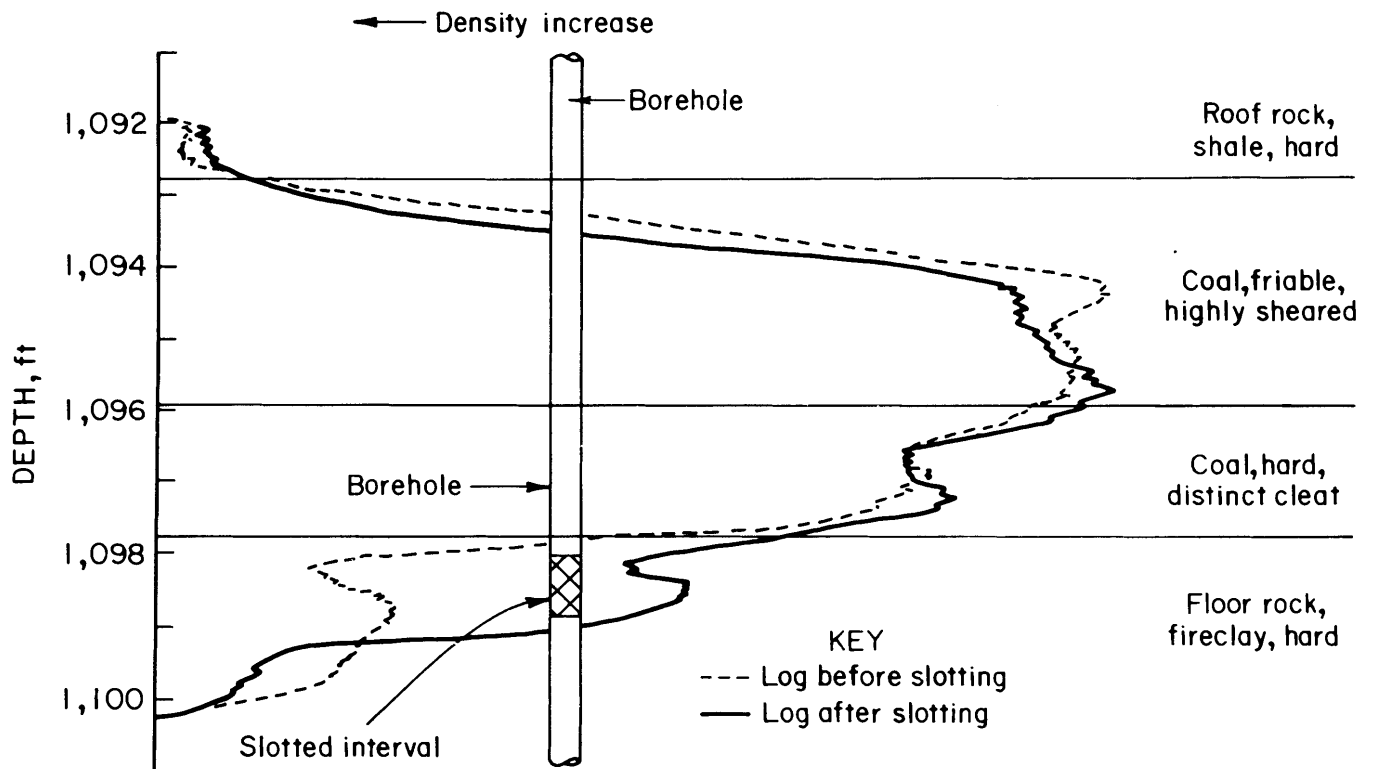
Figure 8.—Comparison of gamma density logs before and after jet slotting, borehole TW-2. (Modified from Lambert (20))

In addition to the common orthogonal vertical cleat system found in most coalbeds, the coal section at the Oak Grove Mine and other mines in the area displays secondary vertical and inclined fracture systems that intersect at various angles and with a variety of orientations (16). These complicated fracture systems are the result of the complex geological history of the area, and they can apparently influence the character of the induced fractures. Lambert (20) pointed out that the vertical fractures were contained in the lower, hard, distinctly cleated coal zone (correlated to the denser interval on the density log, figure 8) and that horizontal and inclined fractures were contained in the upper, friable, highly sheared portion of the coalbed (correlatable to less dense interval on the density log).

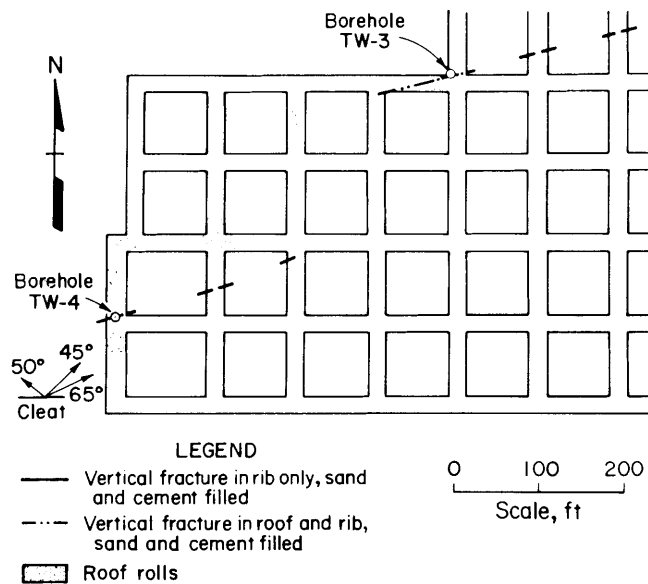
Figure 10.—Mine map, boreholes TW-3 and TW-4, with fracture orientations. (Modified from Lambert (21))

A fracture from borehole TW-3 was intercepted in the Blue Creek Coalbed on October 6, 1977, approximately 10½ months after stimulation. The initial interception and underground observation of the fracture from borehole TW-3 did not include the mine-through of the borehole itself. Subsequently, entries were developed to the north of the borehole revealing the borehole and an extension of the earlier observed fractures (fig. 10). The fracture seen near the borehole was described by Lambert (21) as a single vertical sand-filled fracture, beginning as a hairline crack about 3 ft above the base of the coalbed, and gradually widening to approximately 3/16 in at the top of the coalbed. The total observed lateral extent of this fracture to the southwest of the borehole was 80 ft.

The entry nearest TW-3 is also shown (fig. 10) to be a location of natural roof disturbances. Geologists also noted the presence of many wet roof joints in this area. Except for the single sand-filled crack leading from TW-3 (fig. 10), no evidence could be found to indicate that these wet roof joints had been created by stimulation. Unusually large amounts of seepage from roof openings near TW-3 could, however, be due to the borehole's presence, since it is an accumulation point for water within a coal unit only 7 ft above the open entry.

Previous geologic inspection of the mine near TW-4 showed the well to be nearly surrounded by minor deformation and dislocations in the coal associated with lenticular shale ridges projecting from the roof. Areas of the mine where these features, called "rolls", were observed are shown in figure 10. Because inherent rock weaknesses develop near such features, these areas generally require some degree of additional roof support. The necessity for more roof support near TW-4 than used

in many other portions of the mine, as reported by mine management, may be attributed to this geologic phenomenon rather than stimulation of the test well. The fact that additional roof support was not required at the base of TW-4 nor was it required along the fracture wings indicates borehole stimulation was not the cause for providing additional roof support.

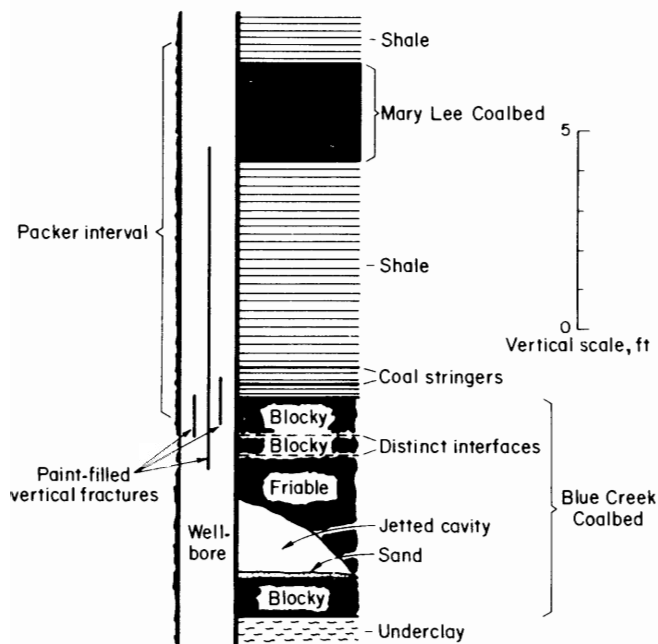
Figure 12.—Stratigraphic section and near-wellbore underground observations in the Mary Lee-Blue Creek Coalbed intervals, borehole TW-5. (Modified from Lambert (9) and Mahoney (22))

was intercepted very close to the southeast corner of a pillar (fig. 14). A large cavity eroded by the jet slotting procedure was observed near the base of the borehole. The cavity appeared to be conical in shape with its base approximately 1 ft above the bottom of the Blue Creek Coalbed (fig. 12). Sand from the slotting procedures covered the bottom of the cavity. The height of the cavity was 23 in and the radius of the base was approximately 36 in.

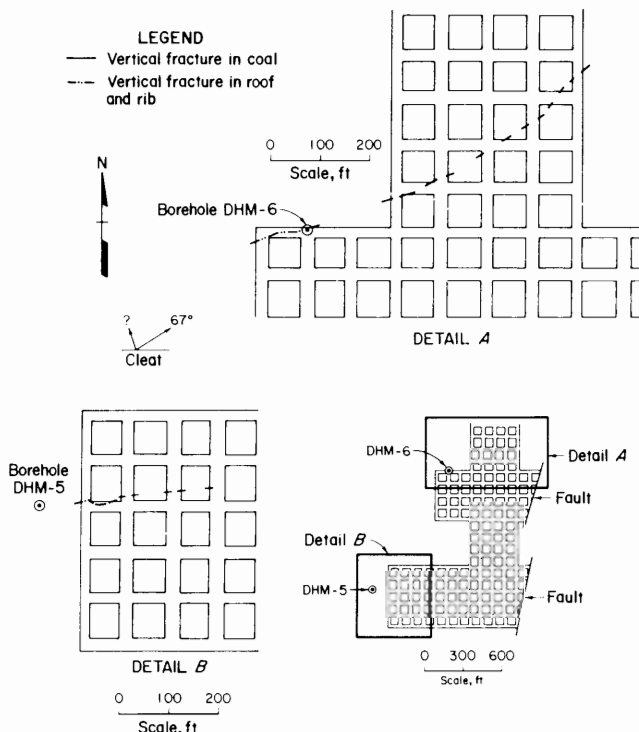
Figure 15.—Mine map, boreholes DHM-5 and DHM-6, with fracture orientations. (Modified from Boyer (17))

Inspection of the well casing exposed by mining of the Blue Creek Coalbed revealed two vertical slots, 180° apart, cut in a northeast-southwest direction. A vertical fracture zone, 1 to 2 in. in width and confined to the upper 3 ft of the coalbed, was observed on the rib 2 ft to the northeast of the borehole. The fracture zone consisted of multiple vertical planes, a maximum of 1/16 in wide, propped with sand and coated with fluorescent paint. A single vertical sand-and-paint-coated fracture was also observed in the 2 ft of exposed roof rock at this location. Boyer (17) commented that it was “difficult to ascertain if the roof fracture was produced by the hydraulic stimulation or if the hydraulic stimulation opened a pre-existing roof joint.” The northeast wing of the fracture was next observed on the rib around the corner from the previous exposure, and 180 ft from the borehole (fig. 15). The fracture was still confined to the upper 3 ft of the coalbed, but consisted of a 10- to 12-in-wide zone of multiple vertical paint-coated face cleat surfaces with no sand proppant. The fracture terminated at the characteristically smooth, mirrorlike slickensided surface at the top of the coalbed. No penetration of the roof was observed at this

location or any further along this fracture wing. The fracture could be traced an additional 450 ft across the five entries to the northeast, finally entering the barrier pillar 630 ft from the borehole, the longest vertical fracture traced underground to date. The fracture was generally uniform in character across the five entries, consisting of multiple paint-coated vertical cleat surfaces in a narrow zone at the top of the coalbed. At the last observation point the fracture consisted of a 1- to 2-in-wide zone in the upper 1 ft of the coalbed. The northeast fracture wing varied slightly in orientation through its 630-ft traceable length, but generally followed an orientation of N 67° E, essentially the same orientation measured for face cleat at the mine site. No horizontal component was observed at any location along or in the vicinity of this fracture wing.

The vertical fracture wing to the southwest was observed on the rib 95 ft from the borehole (fig. 15). The

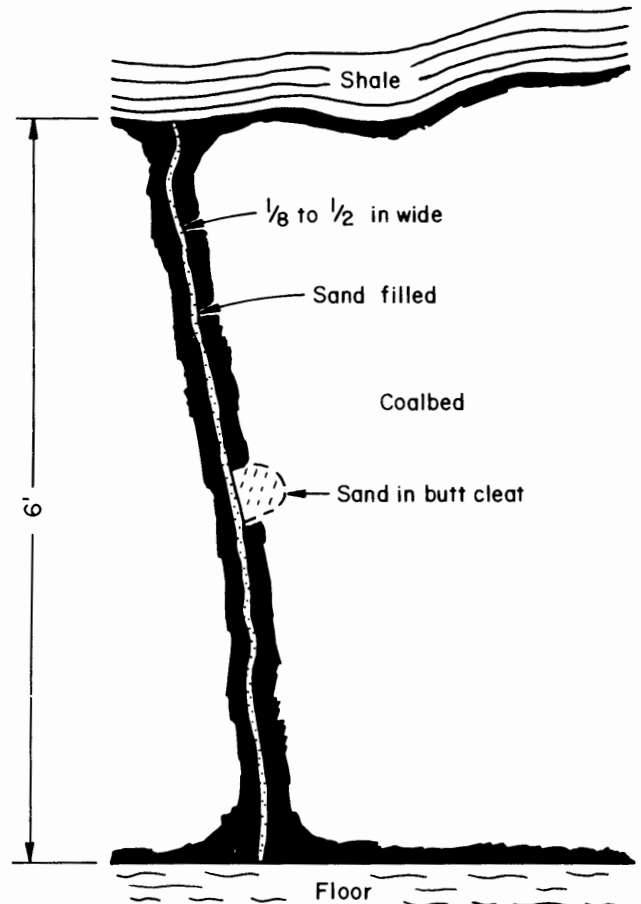
Figure 19.—Cross section of face cleat fracture in entry at location 1 near borehole USBM-4. (Modified from Elder (8))

Borehole USBM-4 was mined through on June 12, 1974, approximately 2 months after stimulation. The area of the borehole intercept is shown in map view on figure 18. Elder (8) reported that approximately 20 ft of sand-filled vertical fracture was followed head-on as mining progressed to the east and then intercepted the borehole (location 1, figure 18). The fracture extended from the roof to floor and ranged from 1/8 to 1/2 in. in width (fig. 19). The fracture appeared to have propagated along face cleats with an orientation of N 70° W. The fracture was essentially vertical, but several small offsets where the fracture was diverted laterally along bedding planes in the coal gave an apparent inclination to the fracture. Three vertical sand-filled fractures invading butt cleats on a N 20° E azimuth were observed on the north rib approximately 2 ft from the borehole (location 2, figure 18). These fractures deviated short distances laterally on bedding planes, producing a stairstepping pathway that resulted in an arcuate pattern in gross appearance (fig. 20). The primary vertical fracture in the butt cleat direction was a maximum of 2 1/2 in wide, and the two thinner fractures averaged approximately 1/2 in wide. The primary butt cleat fracture extended from roof to floor and the two thinner fractures extended from the roof and terminated before reaching the floor.

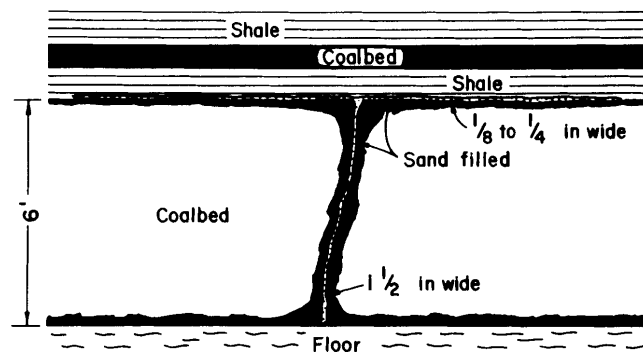
Figure 23.—Cross section of fractures on rib closest to borehole EM-5. (Modified from Lambert (9))

A fracture wing from borehole EM-5 was intercepted by mining on July 21, 1978, approximately 2 yr after stimulation. The borehole location itself was not exposed by mining. The area of the fracture interception is shown in map view on figure 22. At the rib closest to the borehole, a single vertical sand-filled fracture up to 1½ in wide was observed extending from the floor to the roof (fig. 23). At the interface between the top of the coalbed and the overlying hard shale, the vertical fracture became horizontal. The sand-filled horizontal fracture was ⅛ to ¼ in wide, and at its maximum lateral extent was observed 50 ft from the presumed borehole location. The sand-filled vertical fracture could be traced across two entries of the mine, and at its maximum observed extent, it was approximately 140 ft from the presumed borehole location. The vertical fractures were propagated along face cleats, which averaged N 68° W in orientation. The width of the vertical sand-filled fracture varied from 1½ in at the exposure nearest the borehole to only a hairline at its maximum extent, where it was only partially filled with sand. No evidence of penetration of the roof strata was observed associated with the stimulation treatment at borehole EM-5.

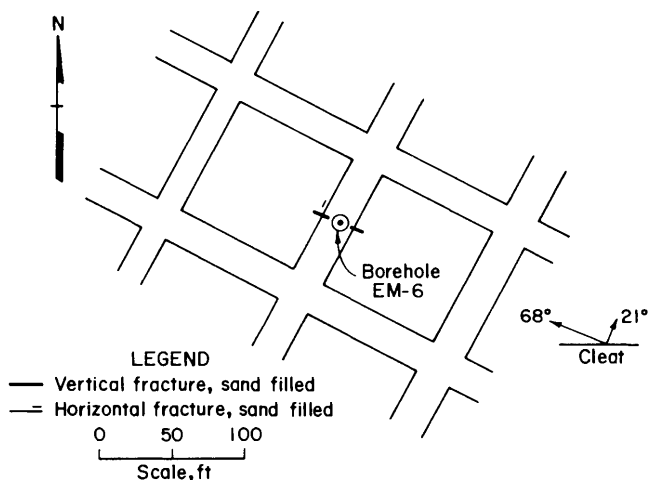
Figure 25.—Mine map, borehole EM-6, with fracture orientations. (Modified from Lambert (9))

Borehole EM-6 was mined through on November 9, 1978, approximately 2½ yr after stimulation. The area of the borehole interception is shown in map view in figure 25. A single vertical sand-filled fracture, approximately 2½ in wide and extending from the base of the coalbed to a point about 3 ft above the base was observed on the west rib, 10 ft away from the intercepted borehole (fig. 26). The vertical fracture was propagated along face cleats and several discontinuous sand-filled fractures extended to the top of the main coal bench. Several additional thin discontinuous sand-filled vertical fractures paralleled the main fracture and were also developed in face cleats. The average orientation was N 68° W. One of the short vertical fractures penetrated the thin roof shale above the main coal bench and terminated at the base of the rider coal.

An inclined fracture split off from the main vertical fracture and stairstepped its way up to the top of the coalbed where it became horizontal for a short distance before inclining through the thin (8-10 in) roof shale and finally becoming horizontal at the base of the rider coal. The sand-filled horizontal fracture on top of the main coal bench was about ½ in thick and the horizontal fracture at the base of the rider coal was ¼ to ½ in thick. No additional exposures were observed for the fractures seen on the ribs adjacent to the borehole. The extent of the fractures into the ribs is unknown. No adverse mining conditions were encountered due to the penetration of the

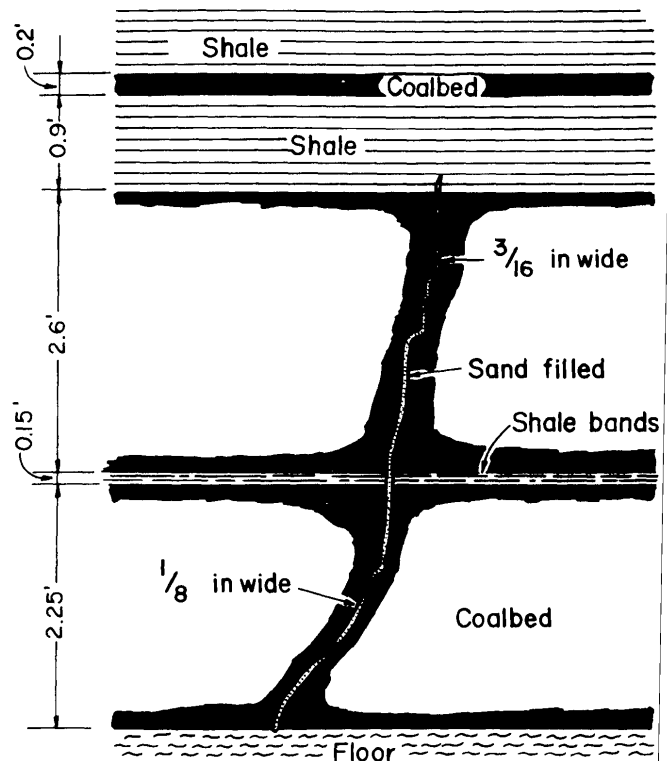
Figure 32.—Cross section of fracture on rib at location 4 near borehole EM-8.

At location 4, a sand-filled fracture was essentially vertical but did stairstep short distances on horizontal bedding planes in the coal (fig. 32). Above the distinct shale bands the fracture was about ⅜ in wide, and narrowed slightly to ¼ in below the shale bands. The fracture extended from the floor to the top of the coalbed, and penetrated 0.15 ft into the overlying shale. No adverse mining conditions were experienced as a result of this minor penetration of the thin shale bed. The fracture at this location was predominately propagated along face cleats with an orientation of N 67° W. Short sand-filled butt cleat fractures were also observed. This location, at 55

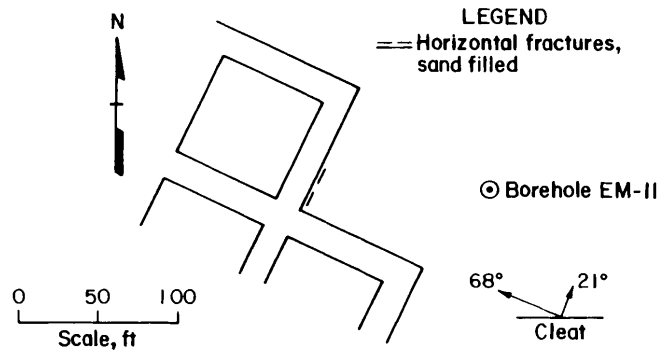
Figure 33.—Mine map, borehole EM-11, with fracture orientations. (Modified from Lambert (9))

Sand-filled fractures from borehole EM-11 were intercepted in June of 1978, approximately 1 yr after stimulation. The borehole was not mined through. The area of the fracture interception is shown in map view in figure 33. The only observed fractures were horizontal to slightly inclined and were located in the rider coal above the main bench of the Pittsburgh Coalbed (fig. 34). One of the fractures curved up into the shale overlying the rider coal.

The penetration of the upper shale bed at this location may have been influenced by the presence of a clay vein. Clay veins are commonly characterized by planes of weakness at their interface with surrounding strata. The location of the exposures of horizontal fractures was approximately 110 ft from the presumed location of the borehole. No other exposure of sand-filled fractures was observed, and no adverse mining conditions were reported related to the presence of the horizontal fractures in the rider coal, which is commonly mined along with the main bench. Since borehole EM-11 was not completely mined around, additional sand-filled fractures may have been created, but not mined through. Vertical fractures that would have extended from the borehole in the face cleat direction could have been intercepted by the mine

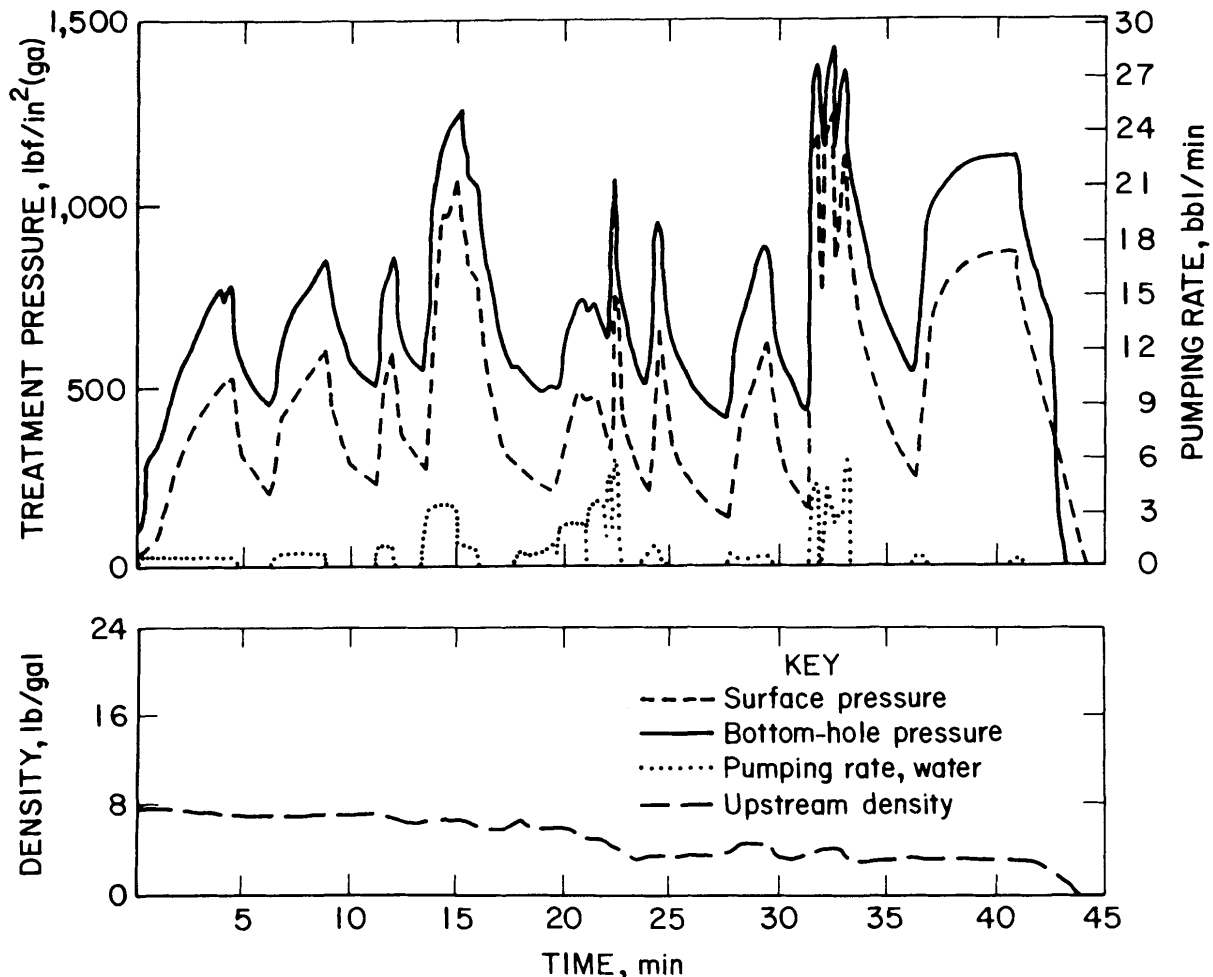
Figure 36.—Treatment record, borehole RP-1.

During the initial stage of the treatment, while using clear water to initiate a fracture in the coal, treatment pressures steadily climbed and remained high. The continuous stimulation treatment record is shown on figure 36. Several cycles of pressure buildup and release

were made in an attempt to initiate a fracture, without success. A total of 1,600 gal of clear water containing green fluorescent paint was injected into the coalbed at rates ranging from 0.4 to 7.4 bbl/min. No sand proppant was included in the injected fluid. Maximum treatment pressures of 1,450 lbf/in²(ga) bottom hole and 1,260 lbf/in²(ga) surface were reached. Table 7 summarizes parameters for the stimulation.

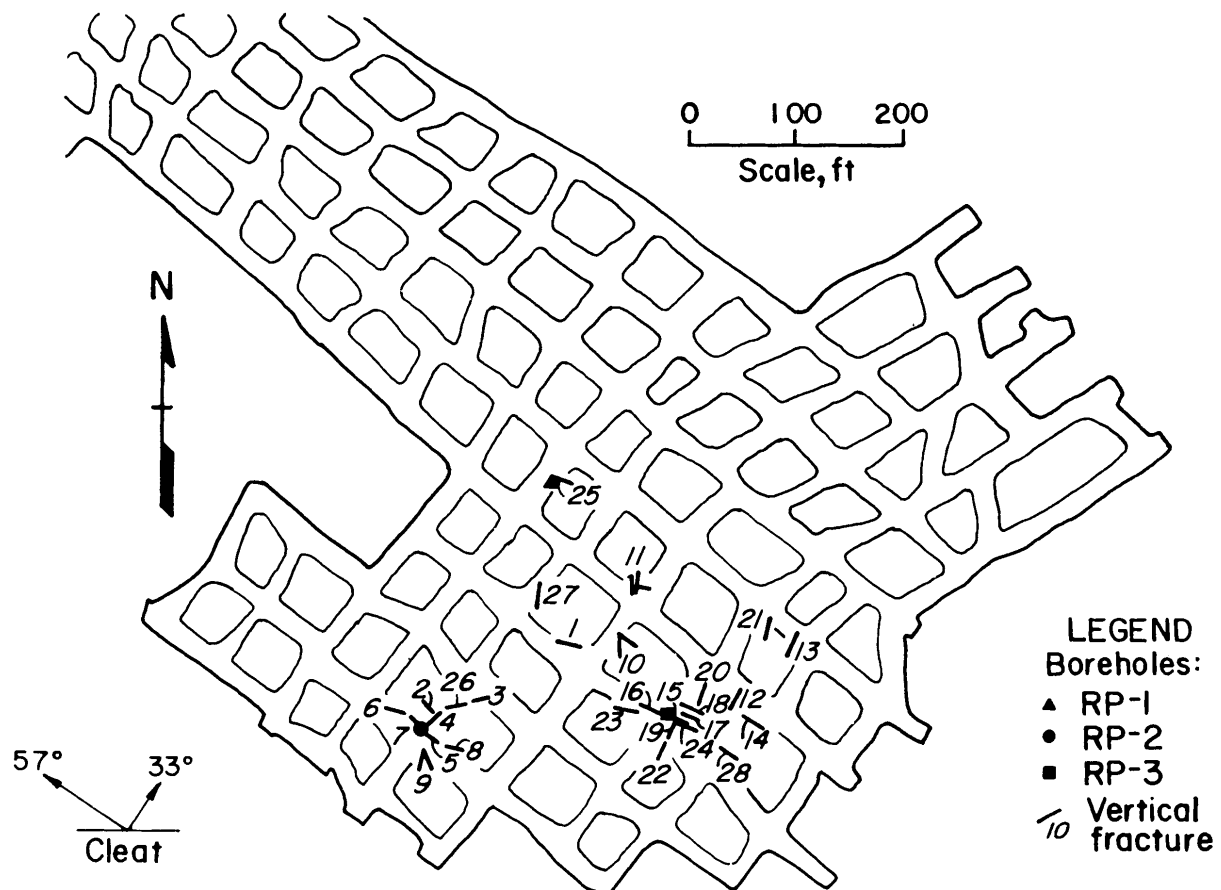
Figure 37.—Mine map, boreholes RP-1 through RP-3, with fracture orientations (12).

Vertical fractures (25)⁵ from borehole RP-1 were found in the southeast rib adjacent to the intercepted borehole (fig. 37). Nine vertical fractures in a zone 8½ in

wide were present in the lower bench of coal below the shale parting (fig. 38). Two fractures contained sand that is assumed to have come from the sand placed at the bottom of the hole to protect the coalbed from cement invasion during the casing and cementing operation, since no sand was injected as part of the treatment.

Several of the vertical fractures extended through the shale parting and into the upper bench. Pink-paint-tagged grout that had been used to plug the hole for abandonment was found in the upper portion of fractures whose lower portion contained sand. All of the fractures were aligned parallel to the face cleat (N76°W) and were coated with green paint. Fractures that contained only paint were visible using the ultraviolet light. They appeared to be no wider than the face cleat itself. The sand-filled fractures were approximately $\frac{1}{16}$ in wide. The most prominent vertical fracture could be traced with the ultraviolet light laterally across a small patch of roof coal remaining around the borehole. The fracture in the roof coal extended laterally from the borehole approximately 6 in to the nearby rib and 19 in into the entry in the opposite direction. The fluids followed a stairstep path alternating along the face and butt cleat in the roof coal, and did not travel along a single face cleat for more than 1 or 2 in. A summary of the orientation and fracture observations is given in table 8.

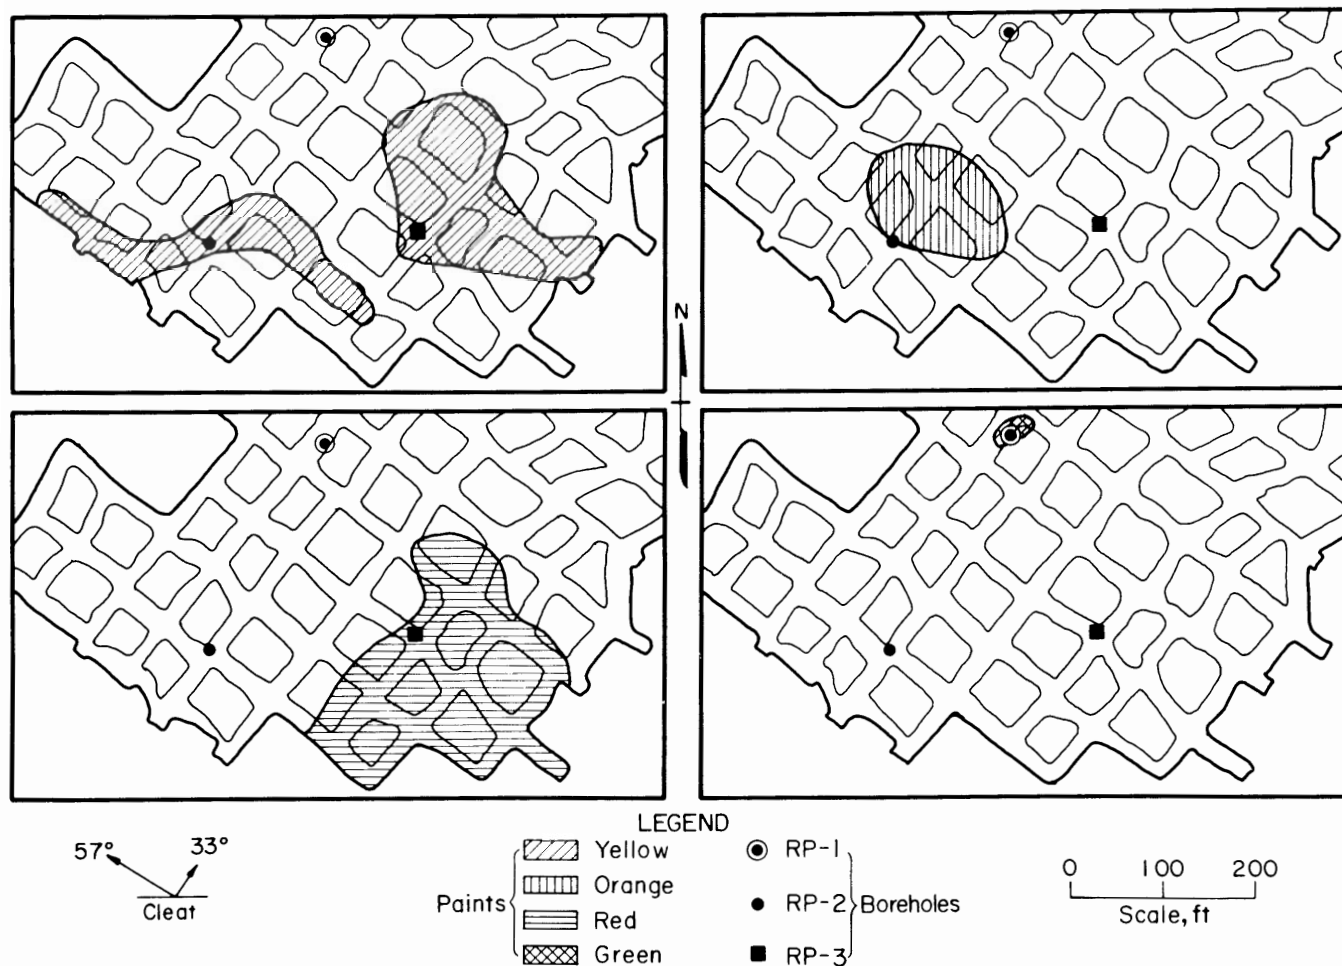
Figure 39.—Mine map, boreholes RP-1 through RP-3, with horizontal distribution of paint on roof (12).

No evidence of horizontal fracturing was found close to borehole RP-1, but traces of the green paint were found on the roof shale at several points in the entry. The inferred horizontal extent of the paint pigment is shown in figure 39.

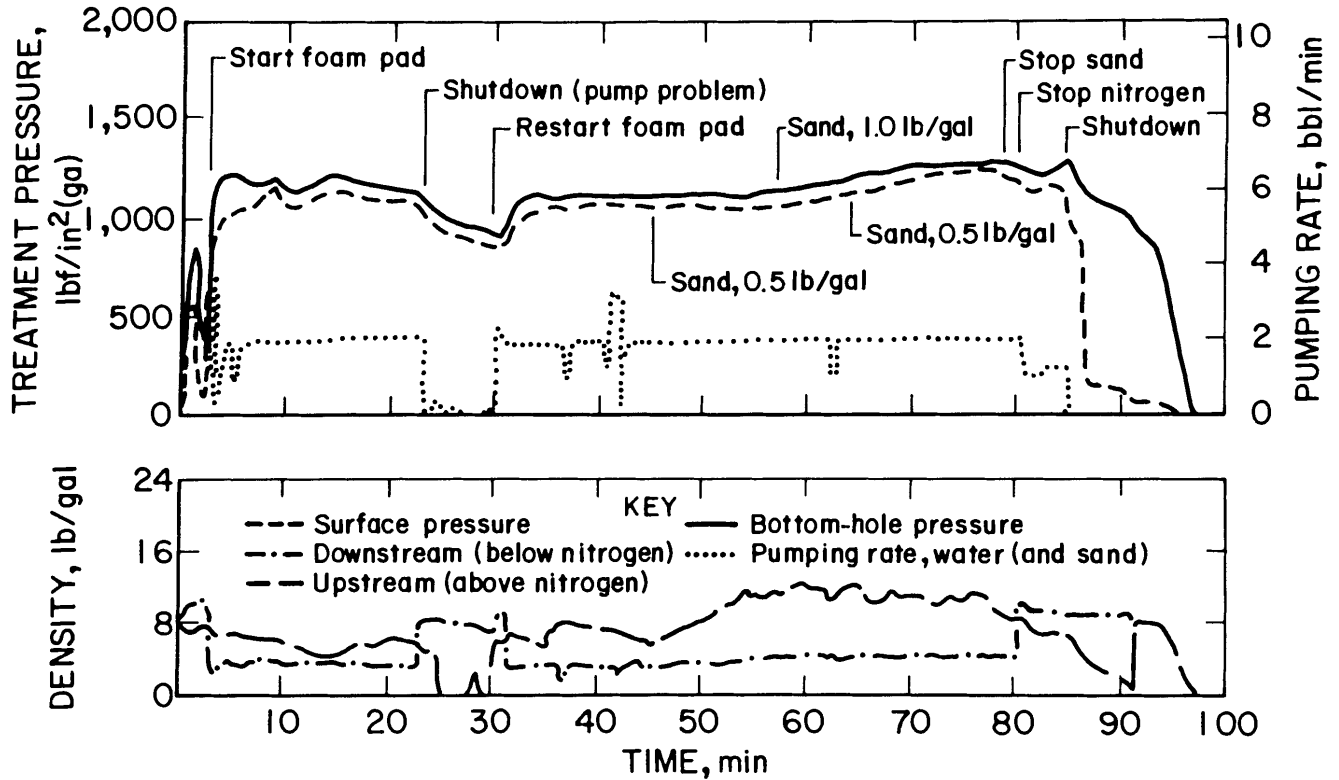
Figure 40.—Treatment record, borehole RP-2.

Breakdown pressures in borehole RP-2 were 1,170 lbf/in²(ga) bottom hole and 945 lbf/in²(ga) surface, using clear water. The continuous stimulation treatment record is shown in figure 40. Blue fluorescent paint was added to the foam pad. A summary of the paint colors, sand rates, and fluid volumes used in the treatment is given in table 7. Pump problems and time restrictions placed on the stimulation by the mine operator precluded pumping the scheduled 20,000-gal foam pad, which was reduced to 10,000 gal.

Treatment pressures declined from 1,210 to 1,105 lbf/in²(ga) bottom hole and 1,150 to 1,060 lbf/in²(ga) surface before problems with the fracturing pumps began. The initial sand concentration was 0.5 lb/gal of foam with orange fluorescent paint. After 13 min the sand concentration was increased to 1.0 lb/gal of foam with yellow fluorescent paint. The treatment pressure began a gradual increase almost immediately after increasing the sand

concentration, indicating either the inability of the induced fractures to accept, or inability of the foam to carry, the higher sand load. If the pressure had continued to increase unchecked, a point might have been reached where the foam could not have carried the suspended sand load, and a screenout or dropping of the sand in the wellbore would have occurred, prematurely terminating the treatment.

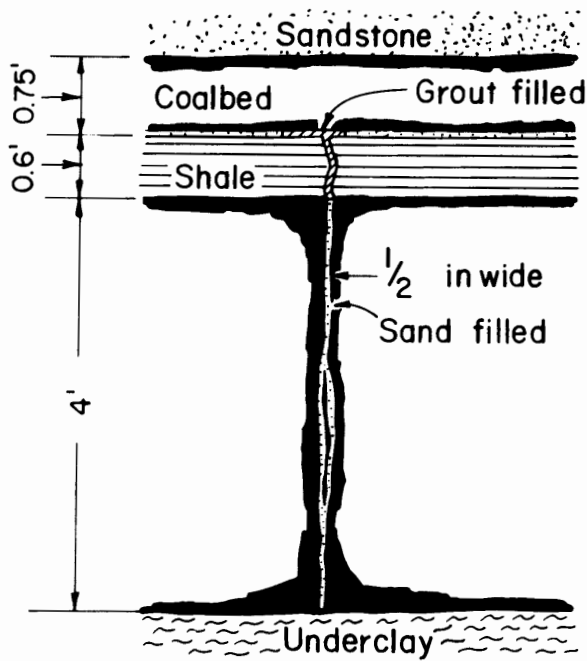
Figure 41.—Cross section of fractures at location 7 on the northwest rib near borehole RP-2. (Modified from Murrie (12))

Vertical fractures in the face cleat direction were observed as the borehole was mined through. One fracture (7) on the northwest rib (fig. 41) and one (5) to the southeast contained sand. The fracture on the northwest rib was closest to the borehole and was approximately ½ in wide and filled with sand proppant to the bottom of the parting. A second vertical fracture split off the main fracture approximately midway in the main bench of coal and rejoined near the base. Yellow and orange paint were found in the sand. The upper section of the fracture through the shale parting was filled with grout tagged with pink paint used to plug the hole for abandonment. The grout also extended a few inches horizontally along the interface between the shale parting and the upper bench of coal (fig. 41). Sand was found beyond the grout on the same horizontal plane in the rib for a maximum distance of 17 ft from the borehole to the northeast (fig. 42). The vertical sand-filled portion of the fracture narrowed to approximately ¼ to ⅛ in where it extended to the southeast rib (5). Grout from the plugging operation was again found in the vertical fracture through the shale parting. Sand was present for a short distance horizontally at the interface between the top of the shale parting and the upper coal bench. A summary of the vertical fracture observations is given in table 8.

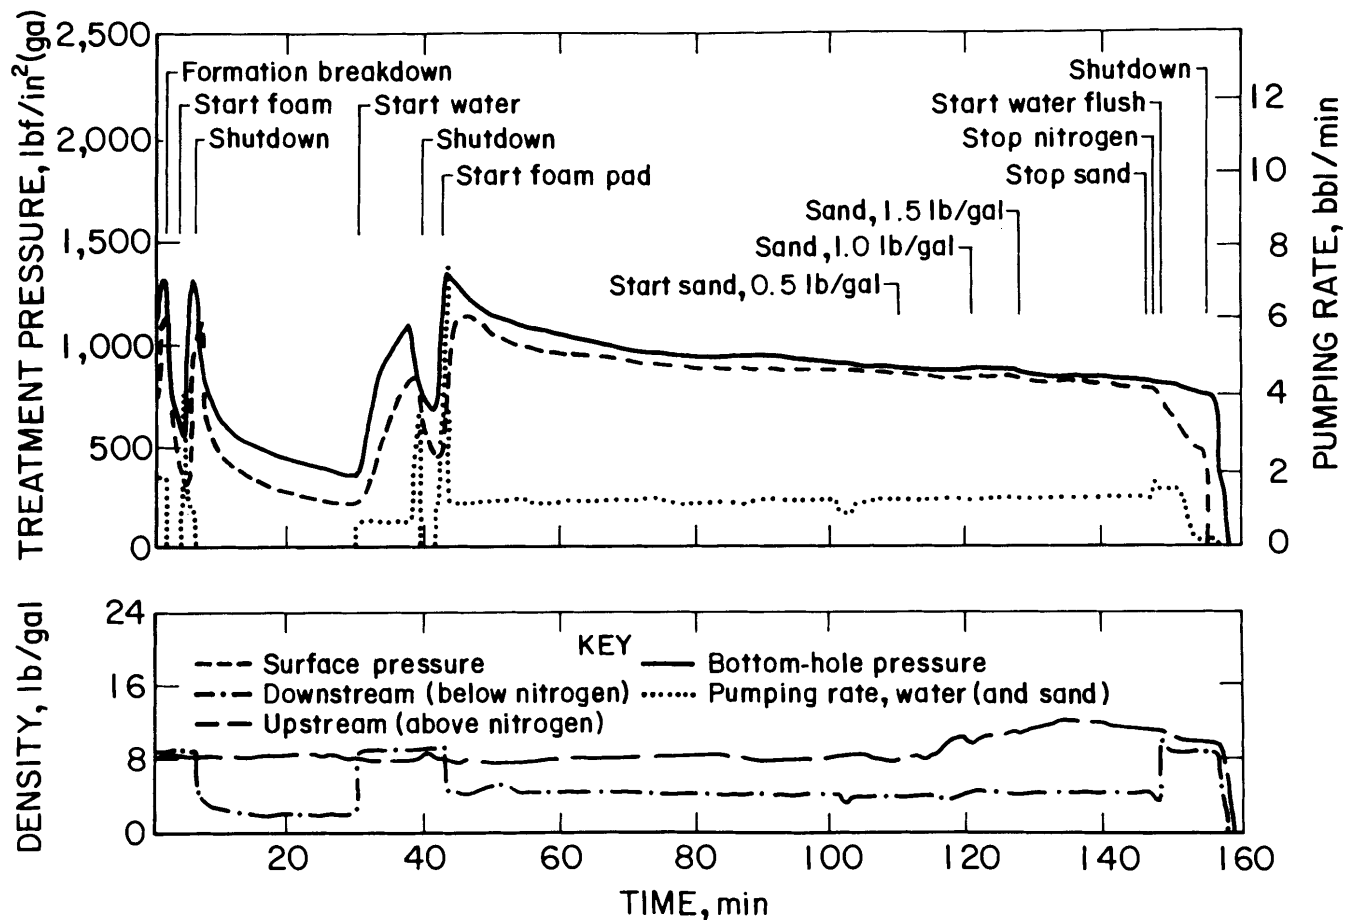
Figure 43.—Treatment record, borehole RP-3.

The stimulation of borehole RP-3 began with a small volume of clear water to break down the coalbed. The continuous stimulation treatment record is shown in figure 43. Breakdown pressures were 1,320 lbf/in²(ga) bottom hole and 1,080 lbf/in²(ga) surface. A 20,000-gal foam pad with red fluorescent paint was injected at a rate of 6 bbl/min. At the end of the pad, sand proppant was added to the treatment in concentrations that were gradually increased from 0.5 to 1.5 lb/gal of foam in increments of 0.5 lb/gal. At each increase in sand concentration a different paint color was introduced as shown in table 7. A total of 11,500 lb of sand was injected with 10,200 gal of foam during stage 2. Pressures declined from 1,365 lbf/in²(ga) bottom hole and 1,110 lbf/in²(ga) surface at the beginning of the foam pad to 815 lbf/in²(ga) bottom hole and 750 lbf/in²(ga) surface at the end of the treatment with no apparent increase in pressures as sand was introduced or its concentration increased. Average surface treatment pressure was about 850 lbf/in²(ga).

During the latter portion of the stimulation treatment of borehole RP-3, communication was observed with borehole RP-2, where small amounts of foam were detected bubbling from the casing. The two boreholes are approximately 225 ft apart and on a line that is oriented 25° from the face cleat direction. It is possible that the decrease in treatment pressure resulted in part from the fractures created in the stimulation of borehole RP-3 entering the area previously affected by the treatment of borehole RP-2.

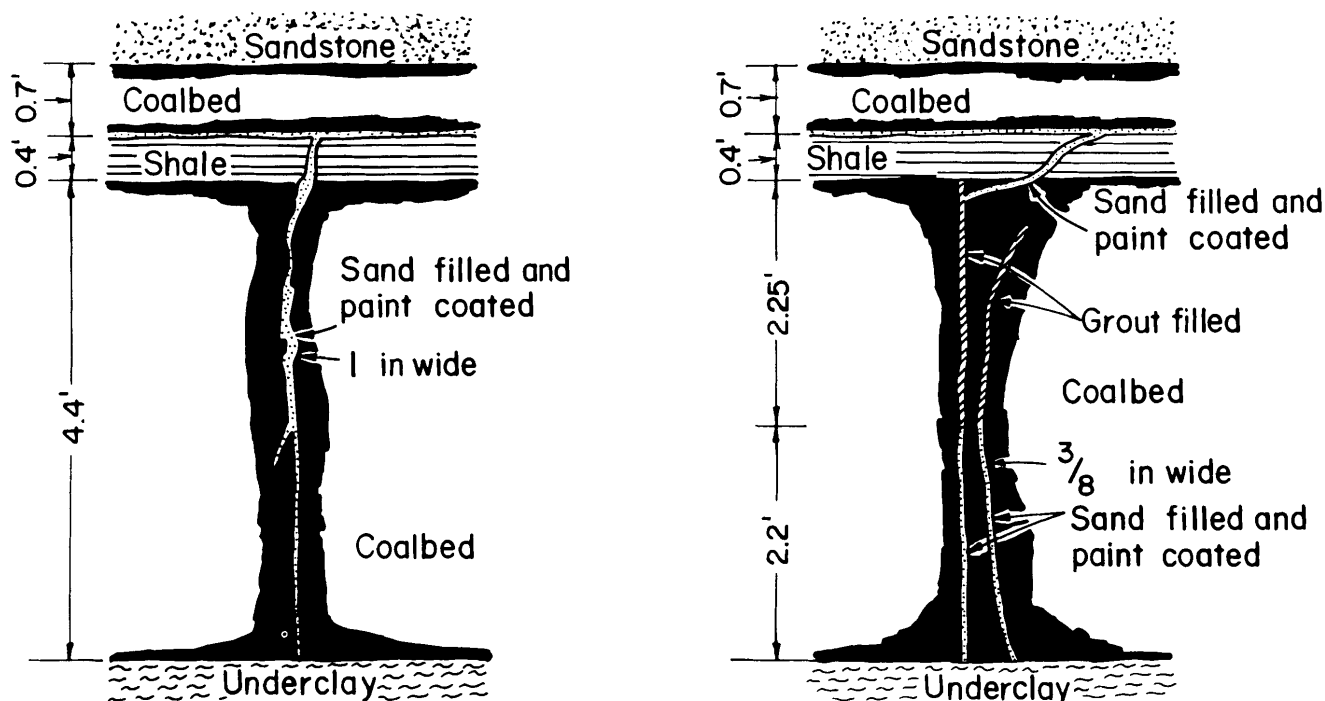
Figure 44.—Cross section of fractures at location 15 on southeast rib (right) and location 16 on northwest rib (left) near borehole RP-3. (Modified from Murrie (12))

The vertical fracture on the northwest rib (16) was filled with sand, had a maximum width of approximately 1 in, and tapered to the width of a cleat at the base. This sand-filled fracture extended upward through the shale parting and became horizontal on top of the parting. Orange and yellow paint were found in the fracture (16) nearest the hole in the northwest direction and only red was found further out (23) in this direction. The sand-filled wing of this major fracture (15) on the southeast rib (fig. 44) was slightly more complex than that on the northwest rib. Two nearly parallel vertical sand- and grout-filled (from the plugging operation) fractures were present. The sand filling extended from the floor to about halfway up the main coal bench, and the grout filled

the remainder of each fracture up to its maximum vertical extent. Maximum width was $\frac{3}{8}$ in. The shorter vertical fracture terminated approximately 2 in below the parting. The other fracture terminated at the bottom of the shale parting, but a horizontal sand-filled fracture split off from it 2 in below the parting. This split intercepted the parting at a shallow angle and then cut through it at approximately 45° and became horizontal on top of the parting. Orange and yellow fluorescent paint were found in the fractures (15) closest to the borehole in this direction, red only slightly further away (24), and finally yellow only at the furthest extent of this fracture on the next rib (28). A summary of the vertical fracture observations is given in table 8.

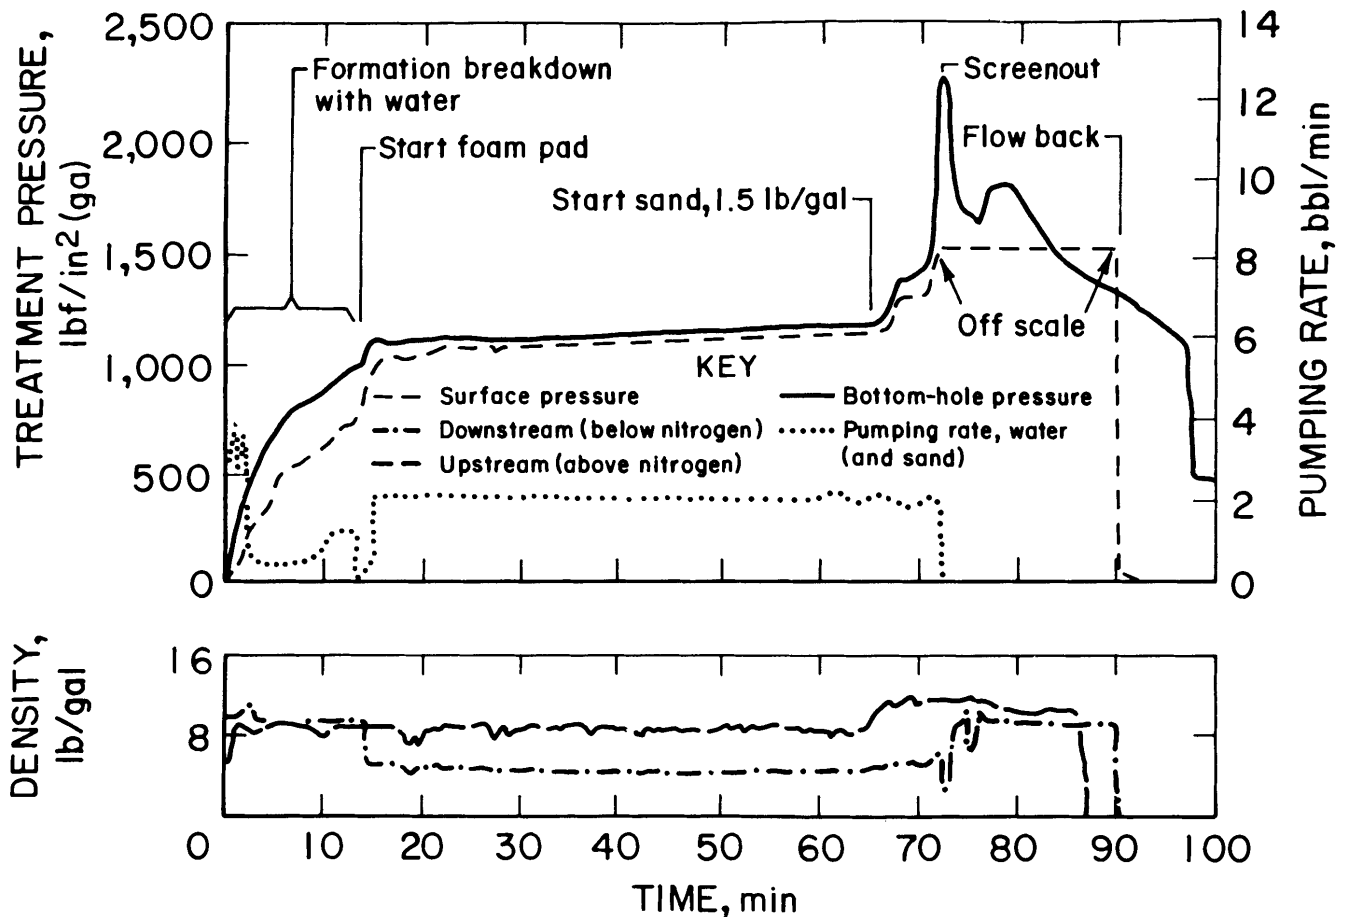
Figure 45.—Treatment record, borehole KE-2.

Borehole KE-2 was stimulated with 75-pct-quality nitrogen-generated foam and sand proppant. The continuous stimulation treatment record is shown in figure 45. The coalbed was broken down using a small volume of water. Pressures were 1,050 lbf/in²(ga) bottom hole and 1,000 lbf/in²(ga) surface. The 20,000-gal foam pad with red fluorescent paint was injected into the coalbed at a rate of 8 bbl/min. Treatment pressures gradually increased from 1,050 to 1,130 lbf/in²(ga) bottom hole and 1,000 to 1,090 lbf/in²(ga) surface at the end of the foam pad. Stage 2 began with the introduction of sand proppant at a concentration of 1.5 lb/gal along with the yellow fluorescent paint. Treatment pressure increased to 1,340 lbf/in²(ga) bottom hole and 1,290 lbf/in²(ga) surface, leveled off, then rapidly rose to 2,300 lbf/in²(ga) bottom hole and 2,000 lbf/in²(ga) surface. The rise in treatment pressure was so rapid that the sand injection could not be stopped quickly enough to prevent a screenout and

termination of the treatment. Only 3,500 gal of the scheduled 7,000 gal of foam and 3,300 lb of the scheduled 10,000 lb of sand proppant were injected during stage 2. A review of the treatment record after the job indicated that the calculated foam quality was 54 to 60 pct, not the required 75-pct quality necessary to carry the sand concentration specified, thereby contributing to the screenout.

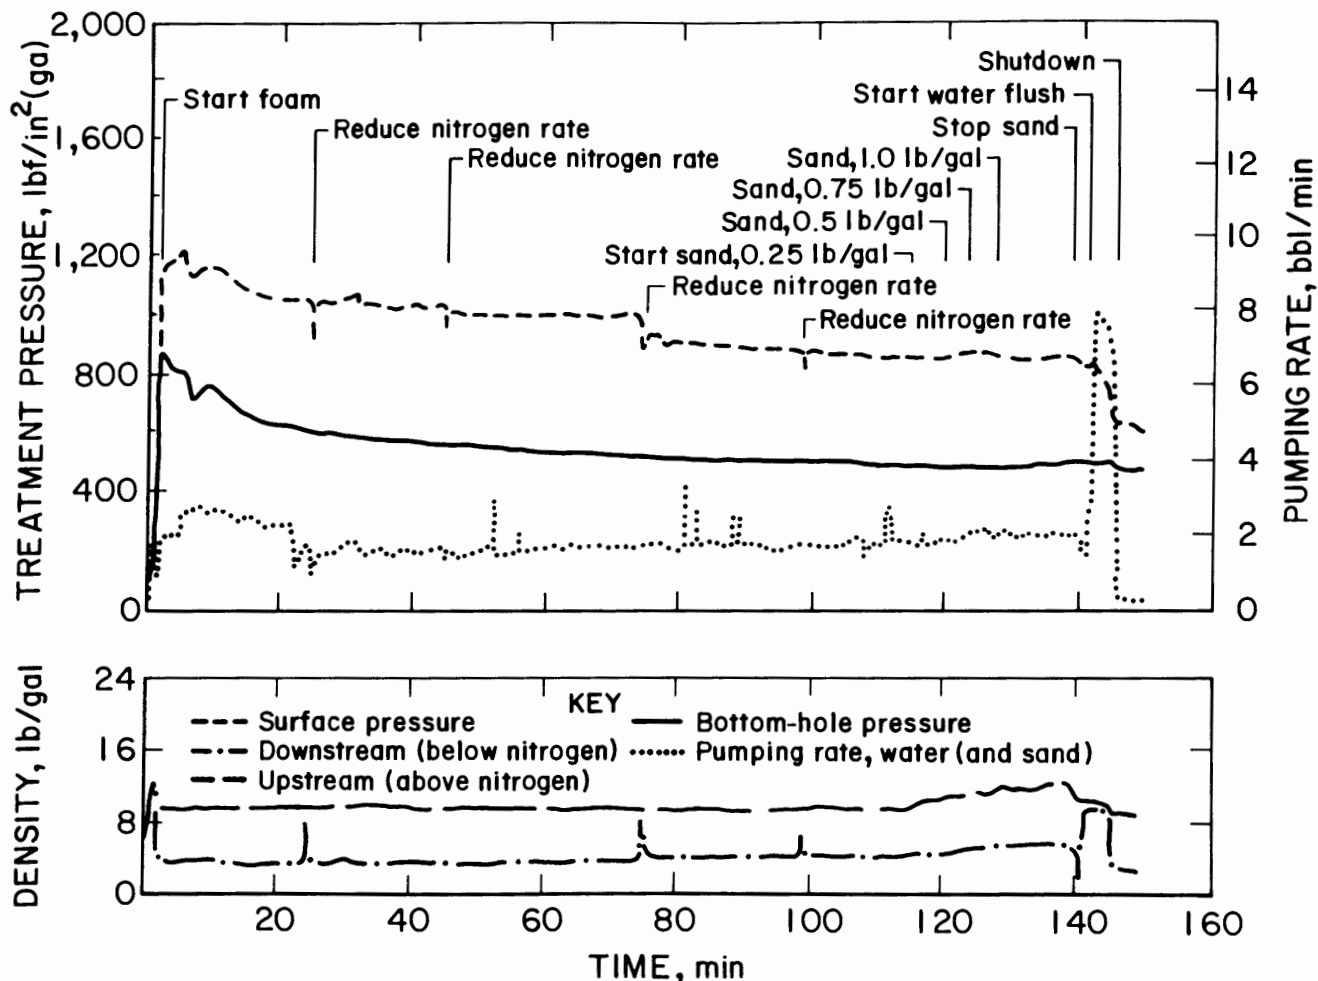
Figure 47.—Treatment record, borehole DGBH-5.

Prestimulation strata characterization tests on this borehole included caliper, gamma ray, and density wireline geophysical logs. The treatment for borehole DGBH-5 consisted of two stages, the first being a 40,320-gal foam pad and the second 10,080 gal of foam with 11,800 lb of 20/50-mesh sand proppant. The treatment was conducted through the annulus between the casing and the tubing used to obtain bottom hole pressure. The coalbed was first broken down with a small volume of clear water at pressures of 860 lbf/in²(ga) bottom hole and 1,210 lbf/in²(ga) surface. A continuous stimulation record for the treatment is shown in figure 47. Treatment pressures gradually declined to 490 lbf/in²(ga) bottom and 1,140 lbf/in²(ga) surface at injection rates of 8 bbl/min. Average surface treatment pressure was about 950 lbf/in²(ga). Sand proppant was introduced at the end of the foam pad in concentrations that were gradually increased from 0.25 to 1.5 lb/gal in increments of 0.25 lb/gal. Because of mechanical problems with the methane engines used to power the pumping unit on this borehole, continuous water and gas production were never achieved.

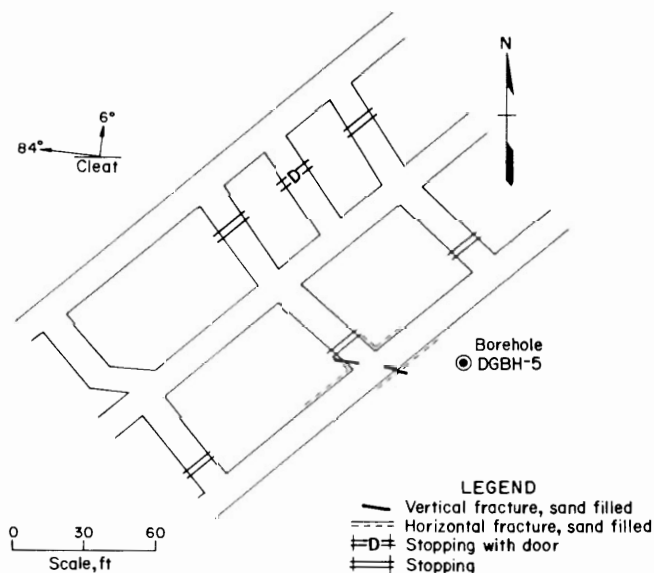
Figure 48.—Mine map, borehole DGBH-5, with fracture orientations.

Sand-filled fractures from borehole DGBH-5 were intercepted by mining in August 1984, approximately 2½ yr after stimulation. A sand-filled vertical fracture was intercepted in the entry closest to the borehole (fig. 48). The fracture was approximately ½ in wide on the east rib closest to the borehole. The fracture paralleled the face cleat, but followed a sinuous path as shown in figure 49. The fracture extended from the floor to the roof, but did not penetrate the roof. The mine operator reported a flow of water and gas from the fracture for some period of time after interception. The flow of water and gas was probably due to the inability to produce the borehole prior to interception.
