Bureau of Mines Report of Investigations/1987

Effects of Stimulation Treatments on Coalbeds and Surrounding Strata

Evidence From Underground Observations

By William P. Diamond and David C. Oyster

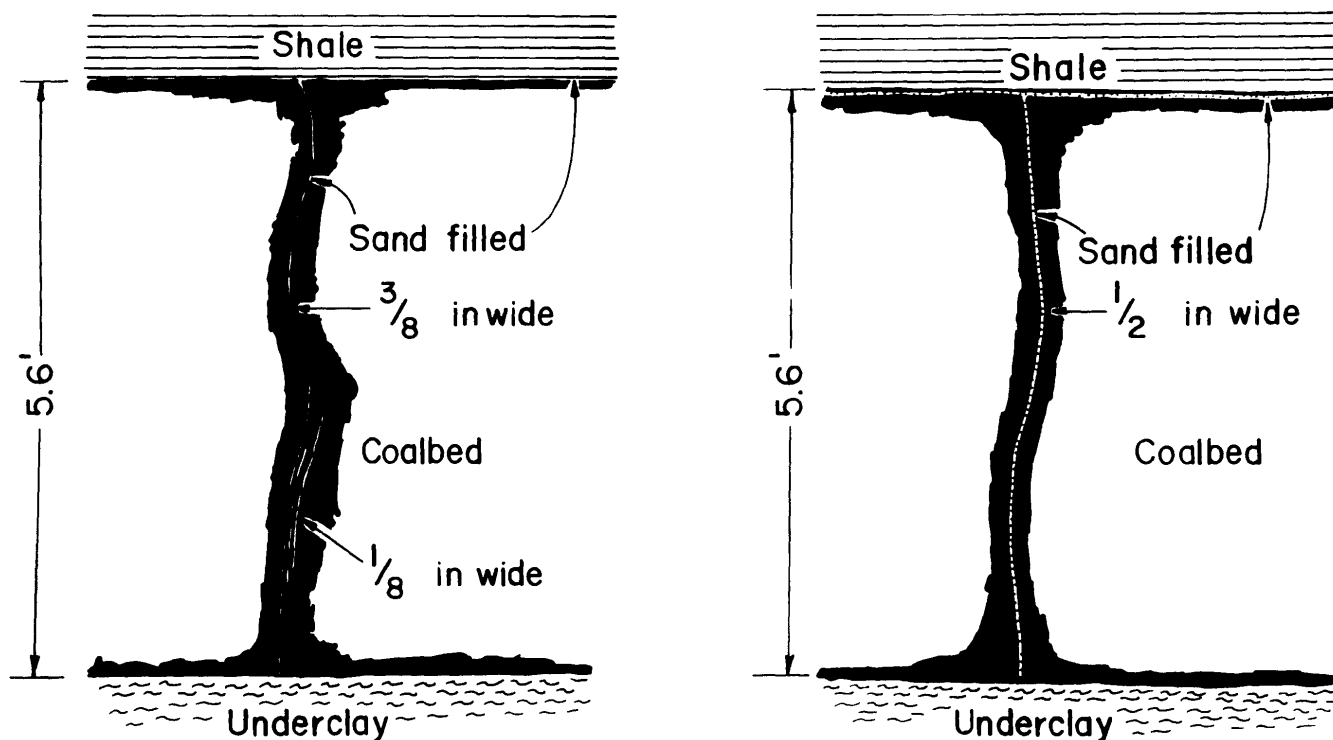
Figure 49.—Cross section of fractures on east (right) and west (left) ribs near borehole DGBH-5.

The fracture became horizontal at the interface between the top of the coalbed and the roof where it was generally only a few sand grains thick. Sand could be traced horizontally along the east rib a maximum of 29 ft from the vertical fracture.

The vertical fracture was also found on the opposite side of the entry on the west rib. The fracture was $\frac{3}{8}$ in wide and extended from floor to roof (fig. 49). The fracture was parallel to the face cleat along a sinuous path similar to that on the east rib. There were several thin (several sand grains wide) vertical fractures in the lower section of the coalbed parallel to the primary fracture. The fracture became horizontal at the interface between the top of the coalbed and the roof, and sand could be traced a maximum of 51 ft from the position of the vertical fracture on the west rib. The distance from the presumed location of the borehole to the vertical trace on the west rib was 72 ft and the maximum distance that sand on the horizontal surface was found from the presumed location of the borehole was 105 ft. No penetration of the roof was observed at the west rib or across the roof of the entry between the two vertical exposures. A thorough inspection of the coalbed on both sides of the entry on the opposite side of the west pillar failed to reveal any sand-filled vertical or horizontal extension of the fracture.

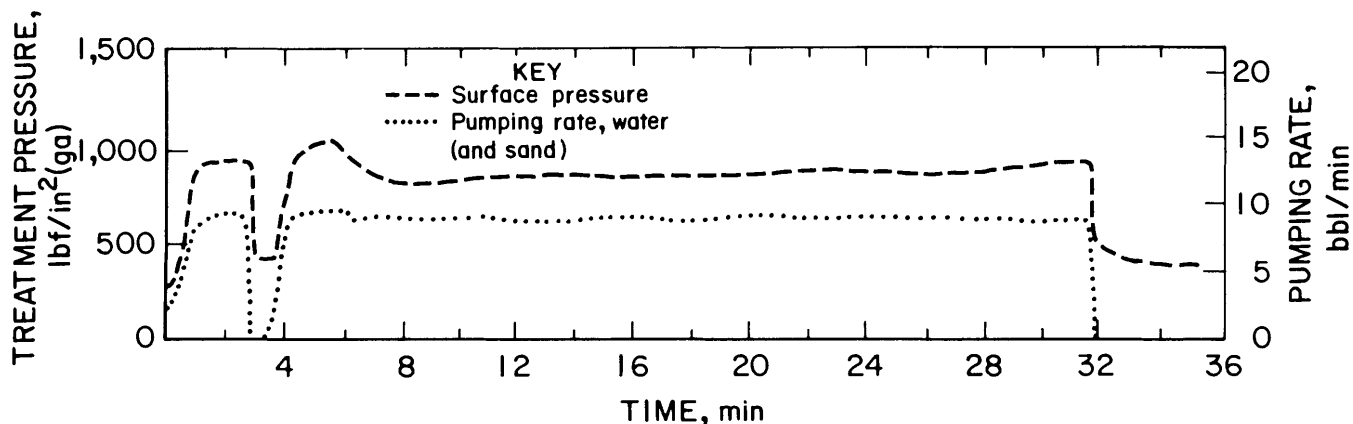
Figure 50.—Treatment record, borehole 1-NE. (Modified from Elder (8))

Borehole 1-NE was treated through 2³/₈-in.-diameter tubing with a packer set in the casing at a depth of 720 ft, and the open end of the tubing extending to the middle of the coalbed at a depth of 733 ft. The treatment design to be implemented was to use gelled water (20 lb of guar gum per 1,000 gal of water) and sand to create two fracture wings, each 431 ft long, of which 305 ft would be propped by sand, 6.9 ft high and 0.2 in wide. A 2,000-gal gelled water pad was first injected into the coalbed to control leakoff. The continuous stimulation treatment record is shown on figure 50. Formation break was reported at 1,050 lbf/in²(ga) surface. A pumping rate of 10 bbl/min was maintained throughout the treatment. Following the pad, an additional 10,000 gal of gelled water and 6,400 lb of 10/20-mesh sand was injected into the coalbed according to the schedule shown in table 9. The average injection pressure was 850 lbf/in²(ga) surface. Gas flows during the

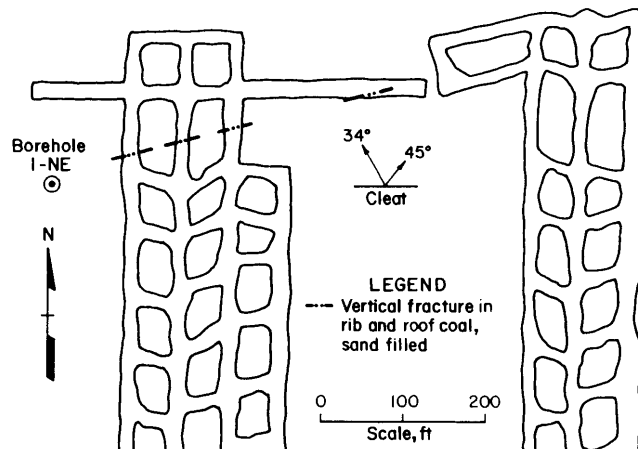
Figure 51.—Mine map, borehole 1-NE, with fracture orientations. (Modified from Elder (8))

Fractures from the treatment were intercepted by mining in May 1974, approximately 3 months after stimulation. A single sand-filled vertical fracture was observed in four entries northeast of the presumed location of the borehole (fig. 51). The fracture extended from the roof to a hard shale parting approximately 2 ft from the bottom of the 9-ft-thick coalbed. The width of the fracture ranged from 1/8 to 3/8 in, averaging approximately 1/4 in. A small amount of water drained from the fracture at the time of the mine-through. The sand-filled fracture could be traced across several entries in the 1 ft of roof coal generally left to protect the overlying shale from deterioration. The fracture in the roof coal was essentially the same width as the vertical exposures on the rib.

The orientation of the vertical fracture (N 76° E) did not coincide with either the face (N 34° W) or butt (N 45° E) cleat, but was closest to the butt cleat orientation (fig. 51). It is possible that the induced fracture orientation was influenced by the horizontal stress field in the area. The major horizontal stress axis in south-central Illinois has generally been reported (26-27) to be east to east-northeast, which would correspond quite well to the N 76° E fracture orientation. The reported fracture orientation could also be the result of unobserved stairstepping along face and butt cleat, which could give an apparent orientation for the fracture(s) oblique to the cleat orientation.

At its maximum lateral extent, the vertical fracture was observed 416 ft from the presumed location of the borehole. This is the greatest length observed to date for a sand-filled vertical fracture wing. There was essentially no penetration of the roof rock except at one point where Elder (8) reported "there was some evidence of fluid and sand intruding a few inches into a rock joint that crossed the induced fracture." No adverse mining conditions were reported as a result of the stimulation treatment, and even at a follow-up visit 2.5 yr after the stimulation there was still no deterioration. No horizontal fracture component was noted at this mine site.

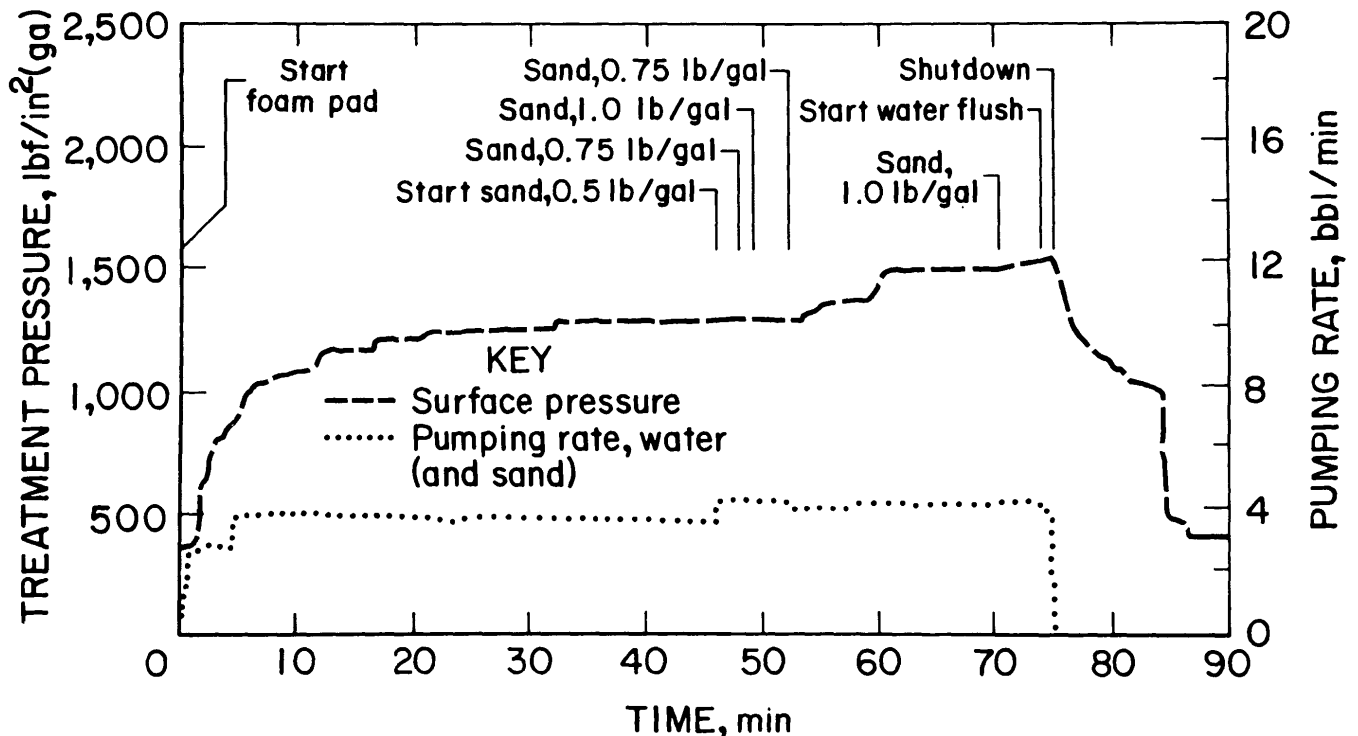
Figure 52.—Treatment record, borehole SC-1.

in the fluid returns indicated that the tool had been placed in the coal interval. The stimulation treatment utilized 75-pct-quality nitrogen-generated foam, sand proppant, and green fluorescent paint. A 30,000-gal foam pad was injected first to control leakoff, followed by 20,000 gal of foam containing 15,000 lb of 20/40-mesh sand proppant. There was some evidence that the foam quality was lower than the specified 75 pct, therefore the actual foam volumes may be significantly less than reported by the service company. Foam treatment rates were maintained at approximately 16 bbl/min. Surface pressures during the injection of the foam pad quickly reached 1,000 $\text{lb}/\text{in}^2(\text{ga})$ then gradually increased to about 1,250 $\text{lb}/\text{in}^2(\text{ga})$. No obvious formation break was observed. The surface treatment pressure during sand injection reached a maximum of 1,500 $\text{lb}/\text{in}^2(\text{ga})$. The average surface treatment pressure was about 1,350 $\text{lb}/\text{in}^2(\text{ga})$. The continuous treatment record for this stimulation is shown in figure 52. The borehole was not completed for production since the project goals were to only stimulate and evaluate the effect of the stimulation treatment on the coalbed and surrounding strata.

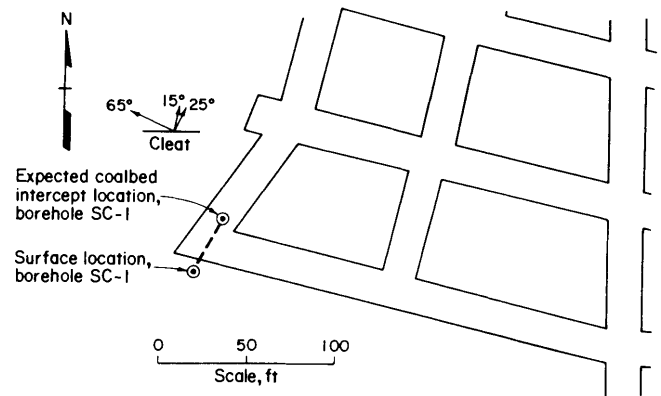
Figure 53.—Mine map, borehole SC-1.

The area around the presumed location of the borehole was mined through in April 1985. A directional survey run on the borehole was used to plot the coalbed intercept point, which was calculated to be approximately 35 ft north-northeast of the surface location and near the center of an entry (fig. 53). A thorough examination of the roof and ribs at the expected underground borehole location and all accessible entries in the area failed to reveal the borehole or any of the sand proppant used in the stimulation.

If the borehole was located within the general area expected, and if the stimulation generally followed the face cleat orientation (N 65° W) as would be assumed, then a wing of the fracture would have a high probability of being intercepted by the available entries at the time of observation (fig. 53). The obvious incorrect presumed location of borehole SC-1 points out the need for accurate surveys (surface, underground, and borehole deviation) and the advantages of actually mining through the borehole in interpreting underground observations.

naturally occurring fluorescent material at this location, or that it was more noticeable because of the fresh, unweathered exposures. In any case, it would be advisable to check for any naturally occurring fluorescence before selecting a paint color for use in a stimulation treatment.
