# Evaluation of Devices to Prevent Construction Equipment Backing Incidents

Todd M. Ruff

Spokane Research Laboratory, National Institute for Occupational Safety and Health,  
Spokane, WA USA

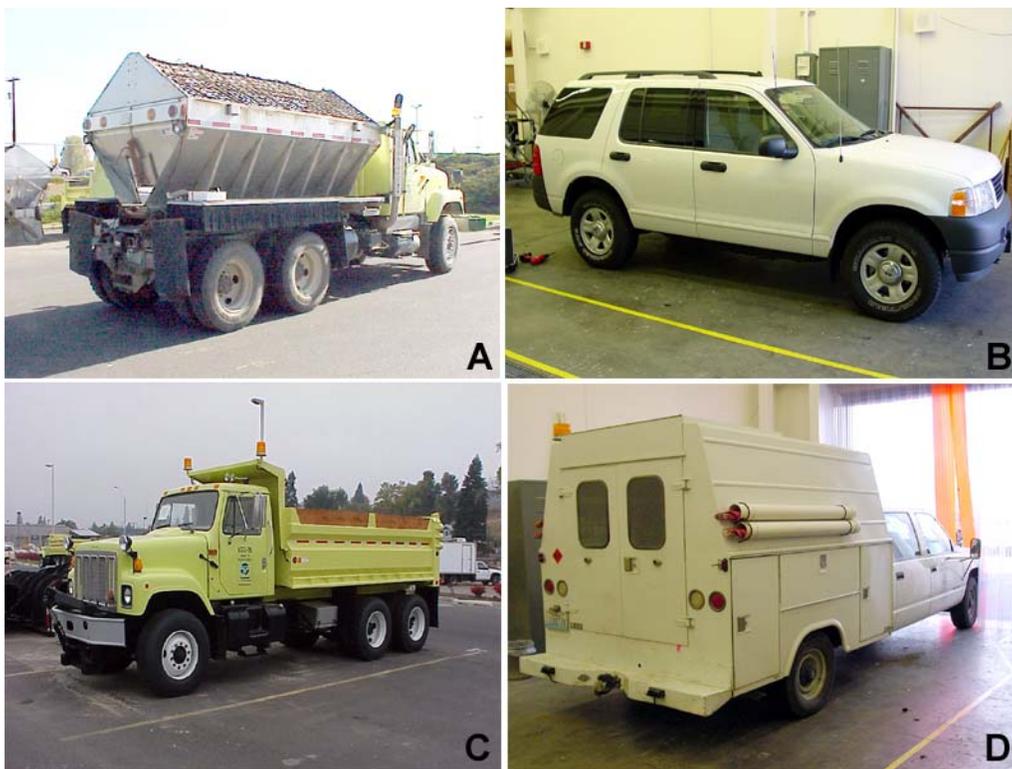
Figure 1.—WSDOT test vehicles. A, Sanding/plowing truck; B, sport utility vehicle; C, dump truck; D, pickup truck.

**Test Results-Dump Truck:** Tests were conducted on a tandem-axle dump truck (figure 1C). Several positions for the radar antenna were tried; the best results were obtained when the antenna was mounted on the hitch plate at a height of 89 cm (35 in) and slightly off-center (figure 3). The antenna could not be mounted closer to the center of the truck because the system may detect the hitch, causing false alarms, or be crushed when the truck is backed up to a trailer tongue. The alarm display was mounted on top of the dashboard in the cab.

Test Results-Sanding/Plow Truck: Tests of the radar system through the winter were conducted on a sanding truck (figure 1A) to determine the system’s effectiveness in harsh weather conditions. Radar mounting was the same as described above for the dump truck. Only driver interviews and a researcher’s direct observation were used to obtain feedback on the system’s operation.

A single sensor system (HS100) was mounted on the receiver hitch of the Ford Explorer (figure 1B) at a height of 50 cm (20 in) at the center of the vehicle. The alarm display was mounted in the rear cargo area of the cabin and near the upper right corner of the rear window. This was the recommended mounting position and allowed the driver to see the warning lights when looking over the right shoulder while reversing. Power for the system was taken from the reverse lights. The detection area for a person covered the width of the vehicle and extended to 2 m (6.6 ft) from the bumper in a rectangular shape.

On the pickup truck (figure 1D), a two-sensor system was tested (HS300). This vehicle was wider than the Ford Explorer and required two sensors for adequate detection. The sensors were mounted near the ends of the rear bumper at a height of 46 cm (18 in) and a spacing of 1 m (39 in), as shown in figure 14. The alarm display was mounted in the cab on the dashboard. The sensor configuration resulted in a detection area for a person that was similar to that in figure 13. It covered the width of the truck and extended 2.5 m (8.2 ft). Early in the tests the system generated false alarms when the truck was moved in reverse in a clear area on asphalt or gravel surfaces. The sensor mounting brackets were modified so the sensors had an upward angle of approximately 5 degrees. This eliminated false alarms on flat ground, but still allowed a 13 cm (5 in) high curb to be detected.

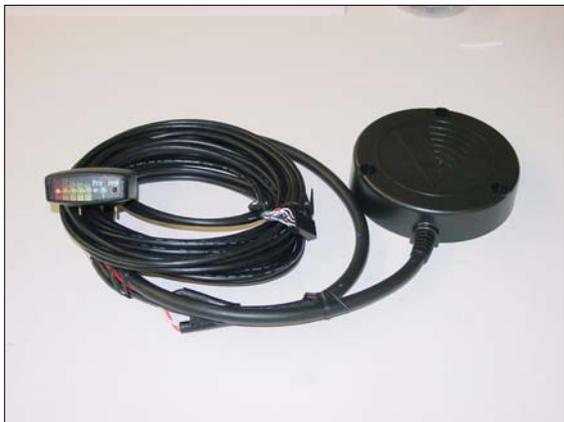
**System Description:** This radar system uses pulsed microwave signal techniques to detect an object in the radar beam. It consists of a radar antenna and processing electronics, an alarm display, and cables (figure 2). No motion of the object or vehicle is needed for detection. The alarm display indicates distance in 1-m increments using a series of LED's. An audible alarm that changes in frequency as the distance to an object changes is generated. The radar system is designed to monitor the rear blind area and is activated when the vehicle is in reverse. This model has no user-adjustable settings.

Figure 2.—Preco's Preview radar system

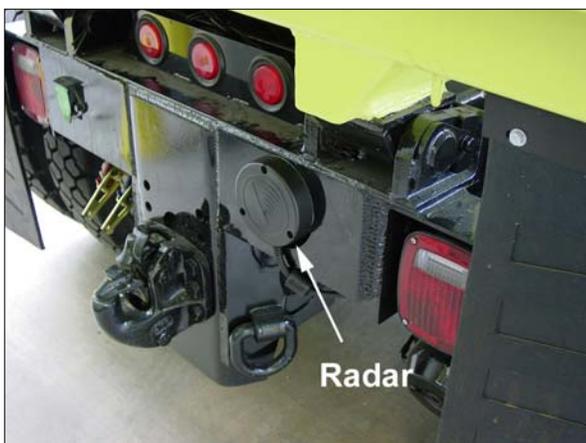
Figure 3.—Preview radar antenna mounted on hitch plate.

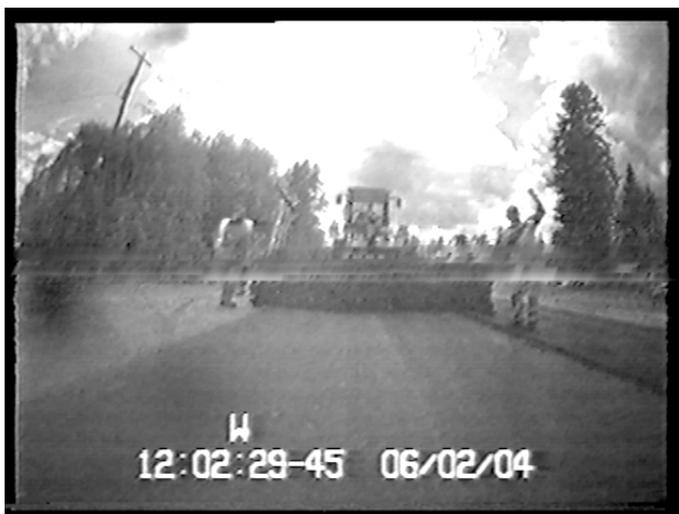
Figure 5.—Screen shot of video from rear camera view. Note that the “W” indicates a radar alarm.

Figure 5 shows an example of a video obtained from the camera and radar combination. Note that a “W” appears on screen whenever the radar system alarms. Since the radar detection zone is entirely contained within the camera’s field of view (FOV), any object that causes an alarm can be seen in the video. This allows researchers to determine when alarms occur and what causes them. In this case, the radar system correctly detected the nearby equipment and workers.

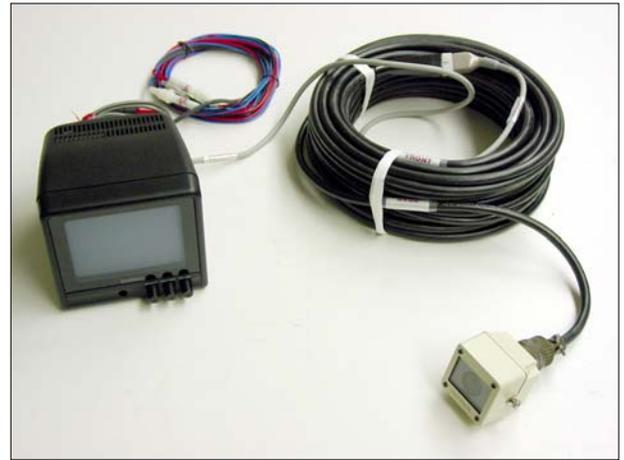
Figure 6.—Intec camera system

**System Description:** The Intec camera system consists of a small camera the size of a 5-cm (2-in) cube (model CVC210XL), an 11.4-cm (4.5-in) video monitor (model CVM450LPP), and cables (figure 6).

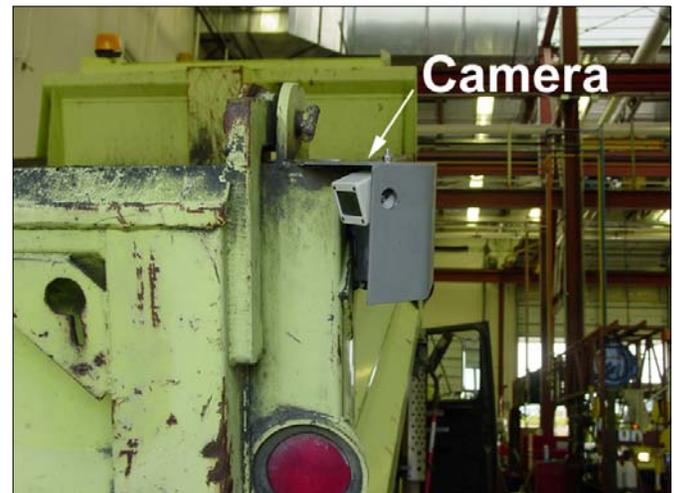
Figure 7.—Initial mounting position for Intec camera on dump box.

**Test Results-Dump Truck:** Initially the camera was mounted on the right side of the dump box, above the rear taillights that are integrated into the box (figure 7). Tests showed that this was an acceptable mounting position and provided an acceptable FOV for the driver. However, a crouching person near the back of the truck might not be in view because of the camera's high position. It might also be of more benefit to mount the camera on the left side of the box, pointing to the right, so that the larger blind spot to the right would be covered more adequately.

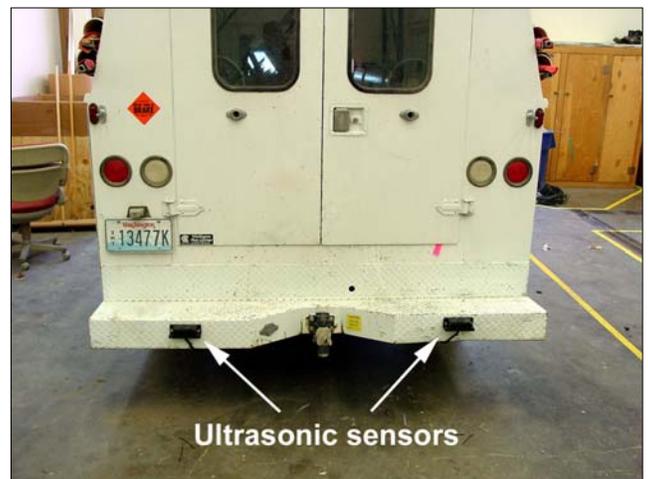
Figure 14.—Hindsight system sensors mounted on pickup.
