Rapid Response Pneumatic Fire Detection for Multilevel Metal Mines: System Design and In-Mine Testing

By W. H. Pomroy, R. E. Griffin, and M. A. Ackerson

Report of Investigations 9305

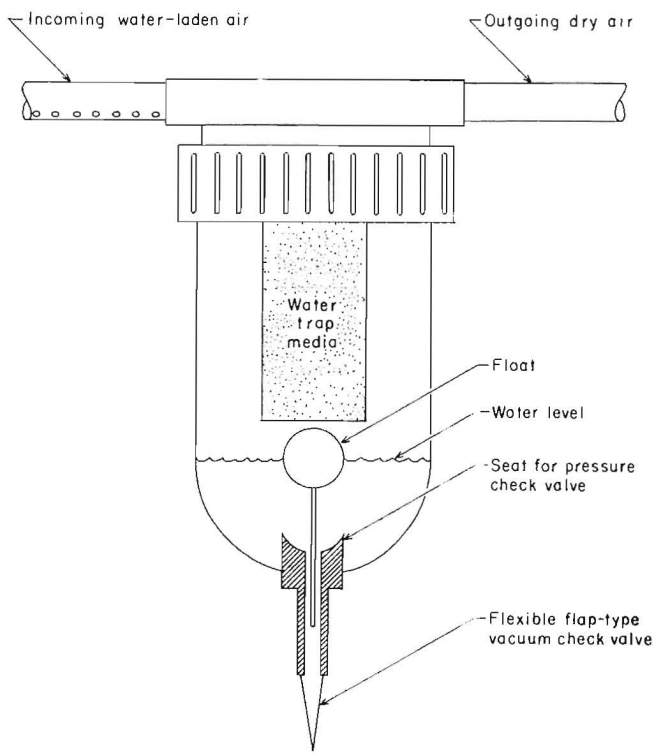
Standard water traps were modified for this system using a specially designed two-way check valve assembly. During normal operation (i.e., under vacuum), a vacuum check valve prevented air leakage into the water trap and, hence, dilution of the sample. To empty the traps, the system was periodically cycled into a pressure mode, wherein the entire tubing network was pressurized with compressed air. The water traps were equipped with float-type check valves that permitted accumulated water to be blown out by the compressed air pressure but then sealed against further pressure loss once the trap was empty (fig. 1). Laboratory testing of the modified water traps was performed prior to in-mine installation to ensure proper, maintenance-free operation.

Figure 1.–Water trap

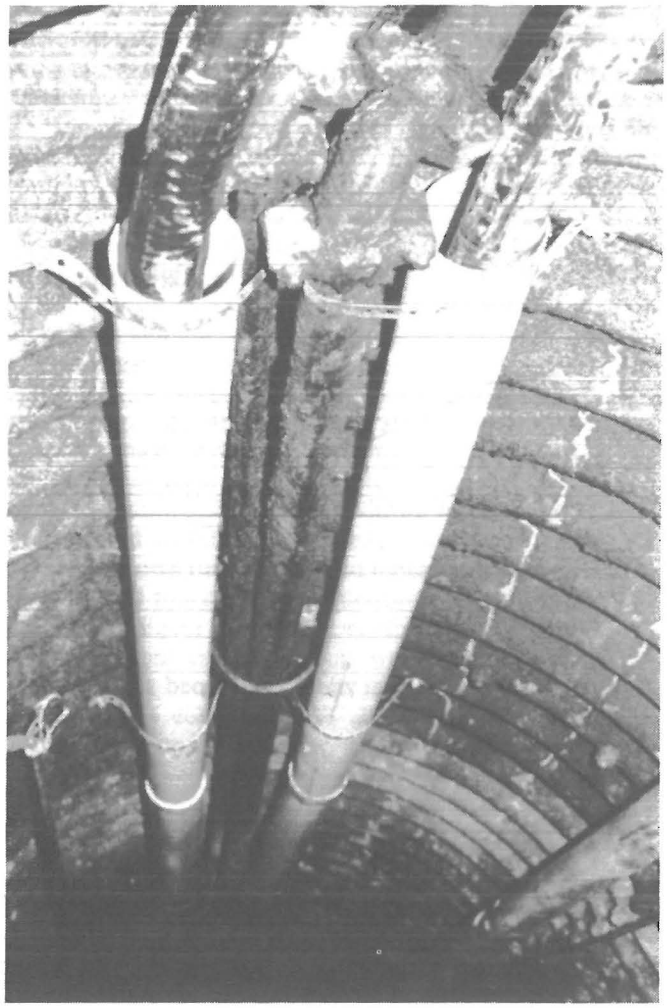
Figure 6.–Routing of main bundles through pipe in narrow drifts.

be prevented from becoming entangled with passing equipment. In those areas, pipes were mounted flush with the drift walls and the bundle was run through the pipes (fig. 6).

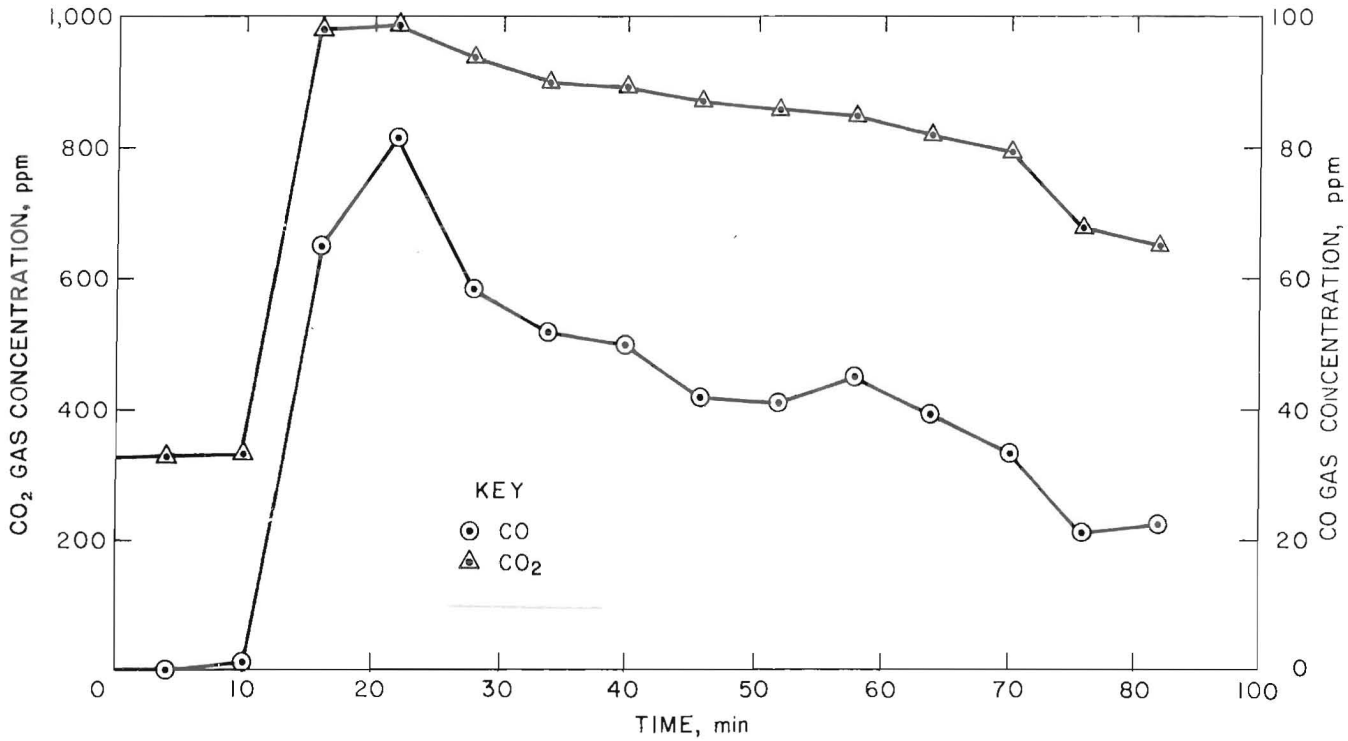
System operation was closely monitored throughout the 3-year evaluation period. No fires were detected by the system, and aside from late afternoon excursions in both the CO and CO_2 levels corresponding to end-of-shift blasting operations (fig. 7), no alarms occurred during the evaluation. A background level of 1 to 3 ppm CO was observed, probably due to diesel operations; however, no adjustment to the CO alarm level was made.

Figure 7.–Elevated CO and CO_2 levels following end-of-shift blasting.

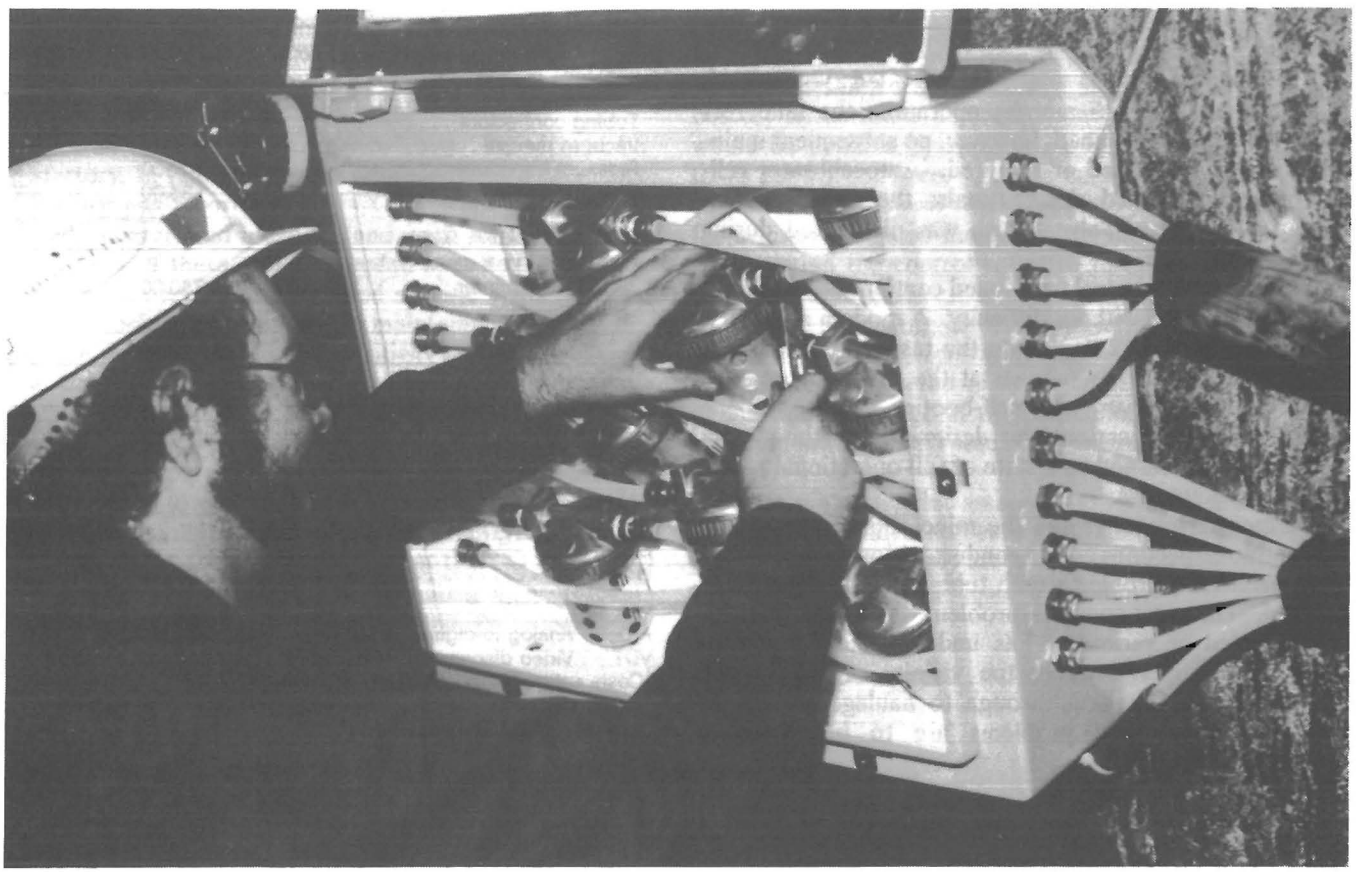
The provision for blowing water from the sample tubes proved to be quite effective. Inspection of the tubes shortly after the system was commissioned, but prior to the installation of the water traps, revealed accumulations of water at low points where the tubes sagged. Following installation of the traps (fig. 9), such accumulations were not completely eliminated; however, enough of the water was

Figure 9.–Water traps installed in main tube bundle.

removed by the traps that system performance was not impaired by accumulated water. Purging the tubes with high-pressure (80 psi) compressed air cleared both the traps and other water accumulations.
