RI 9451

REPORT OF INVESTIGATIONS/1993

Effect of Pressure on Leakage of Automatic Sprinklers

BUREAU OF MINES
T S Ary, Director

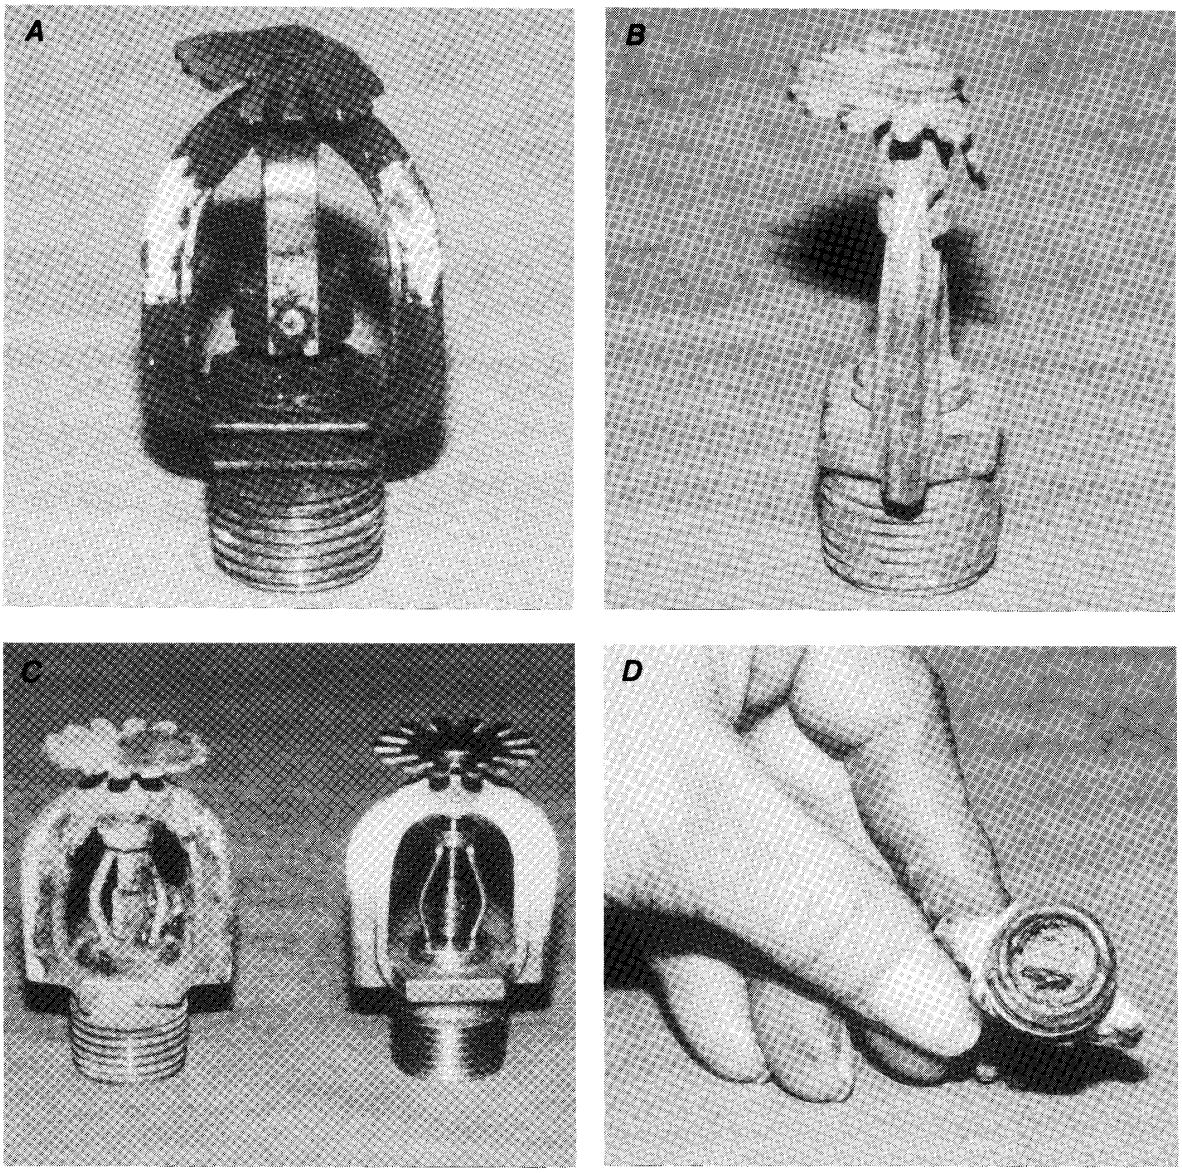
The exposed sprinklers from mine 1 were 135° F standard-response sprinklers from manufacturer A. These sprinklers were in service in the mine for approximately 3 years. Three of the five sprinklers had deflectors that were slightly damaged. This was probably the result of being struck by a hard object, which could have also jarred one of the linkage components that hold down the orifice cap. The average leak pressure for the new sprinklers was 1,825 ± 140 psig. The confidence interval for the new sprinklers was from 1,700 to 1,950 psig. None of the leak pressures of the exposed sprinklers fell into this range. The leak pressures of the exposed sprinklers ranged from 1,000 to 1,500 psig. They were all mildly corroded and all of the fusible elements were coated with a layer of caked rock dust. The leak pressures of four of the five exposed sprinklers were at least 40% lower than the average leak pressure of the new sprinklers. This shows that exposure to the environment at this particular mine had a significant effect on the ability of these sprinklers to withstand high static water pressure.

Mines 2 and 3 sent sets of exposed sprinklers that were 212° F rated from manufacturer A. The set of exposed sprinklers from mine 2 had been in service in the mine about 3 years and had a range of leak pressures from <100 to 2,000 psig. The deflector of the exposed sprinkler that leaked before 100 psig could be applied was slightly damaged but there was no other visual damage that would indicate that the sprinkler could not hold 100 psig. The sprinkler that held only 300 psig had no visual damage and the sprinkler that held 500 psig had corroded to the point where a reddish rust had started to form on the metal surface. The two sprinklers that held 1,500 and 2,000 psig were in the best condition of the sprinklers received from this mine. The confidence interval for the new 212° F sprinklers from manufacturer A was from 1,925 to 2,175 psig. Only the sprinkler that held 2,000 psig fell in the confidence interval for the corresponding new sprinklers. Three of the five exposed sprinklers were able to withstand less than 25% of the average leak pressure of the corresponding new sprinklers. The mine environment had a significant effect on the ability of these sprinklers to withstand static pressure.

Figure 4.—Examples of exposed sprinklers. *A*, Damaged sprinkler; *B*, damaged sprinkler; *C*, exposed sprinkler (left) versus new sprinkler (right); *D*, sprinkler plugged with pipe scale, stones, and/or other foreign material.

In the set from mine 9, one of the sprinklers fell in the confidence interval; however, one of the other four sprinklers was able to withstand only 600 psig. The deflector on this sprinkler was severely damaged, which could be the reason for its poor performance. The mine environment was definitely a factor in the performance of this sprinkler, although the effect on the rest of sprinklers was not as obvious.

In several cases, the exposed sprinklers that did not withstand high static pressures were physically damaged, while in other cases the sprinklers looked no different than the other sprinklers from that mine. Because of the poor visibility and cramped conditions in an underground coal mine, sprinklers installed in mines are more susceptible to being struck by various objects. Sprinkler guards are available and should be used where this is a problem. Also, the sprinklers may be subjected to large water hammers in an underground water system. This may reduce their ability to withstand high static pressures while causing no visible physical damage to the sprinkler. If the sprinklers are physically damaged, they should be replaced as soon as possible. For some of the exposed sprinklers, in addition to the poor performance in the leak pressure experiment, the physical damage of the deflector would have adversely affected the discharge pattern of the sprinkler.
