FINAL REPORT OF INVESTIGATION

TO THE DIESEL EMISSIONS EVALUATION PROGRAM (DEEP)

NORANDA INC. - BRUNSWICK MINE DIESEL PARTICULATE FILTER (DPF) FIELD STUDY

OCTOBER 2004

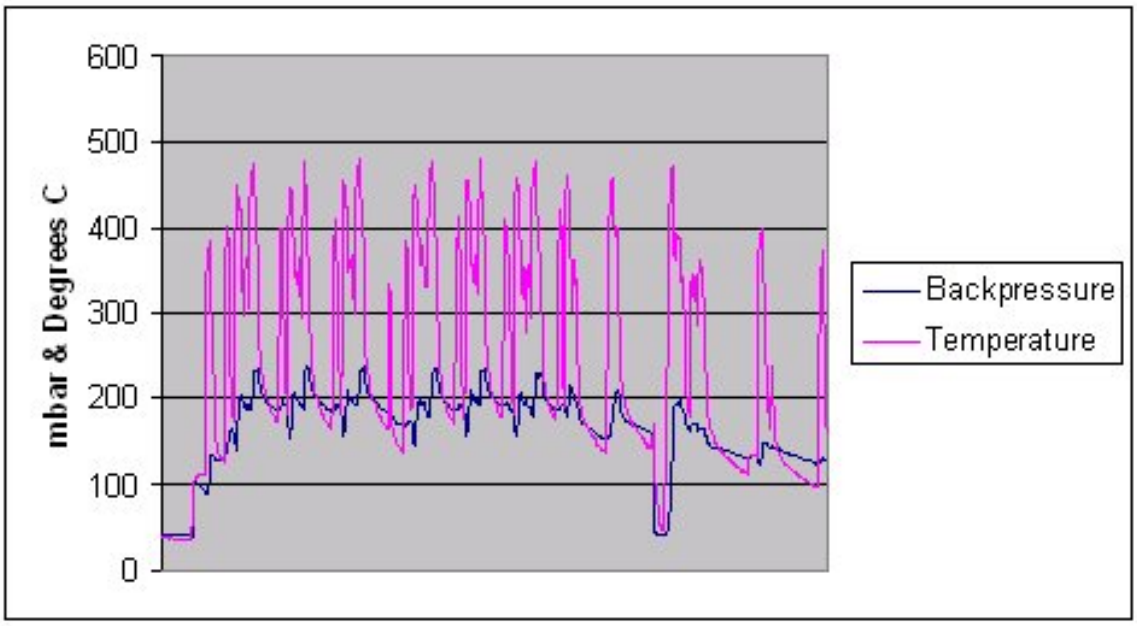
Figure 18 - Exhaust Temperature and Backpressure Traces for First Oberland Mangold DPF

High exhaust backpressure problems eventually forced the decision to replace the original Oberland Mangold system with a larger volume unit. A new system was delivered to the mine and installed within two months Figures 19 and 20 show the two Oberland Mangold systems.

The original DPF system accumulated 300 operating hours before removal and replacement with the larger volume unit. Figure 18 shows exhaust temperature (red line) and backpressure (blue line) traces for the first four days of operation. The exhaust backpressure was exceeding 200 mbar(80 in. wc) or twice the engine manufacturers limit of 100 mbar (40 in. wc)in the first days of operation.

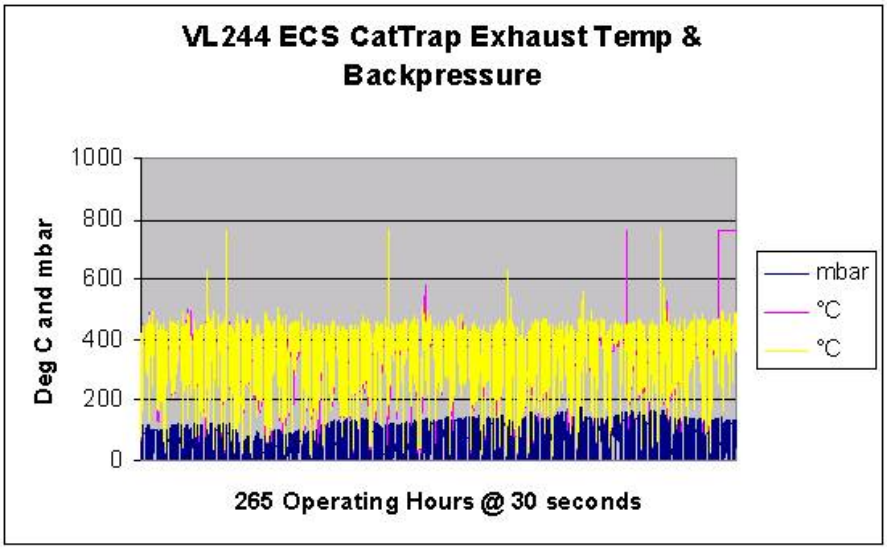
Figure 23 - ECS CatTrap Exhaust Temperature and Backpressure

The typical exhaust temperature and backpressure trace for LHD VL244 is shown in Figure 23. Temperature peaked between 375° and 400°C. The system manufacturer expected that the filter would be successfully regenerating at those temperatures for 30% or more of the total duty cycle. Backpressure reached a plateau of around 120 mbar or 50 inches of water. The backpressure values measured by mechanics at monthly PM inspections were consistent with those measured by the loggers.

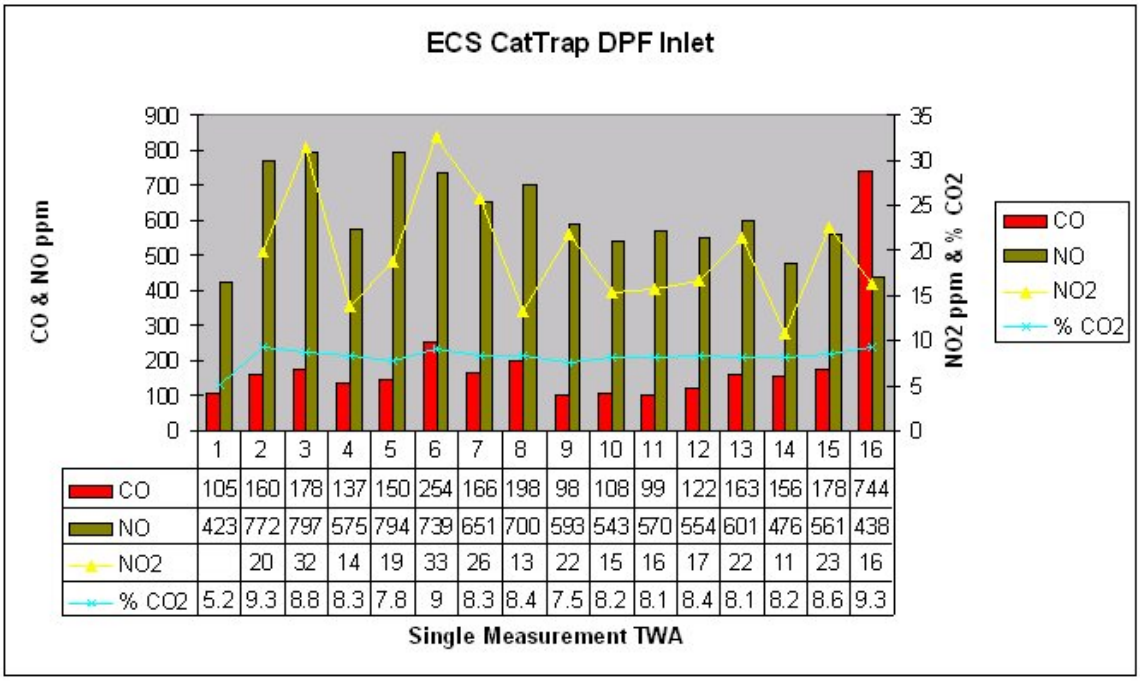
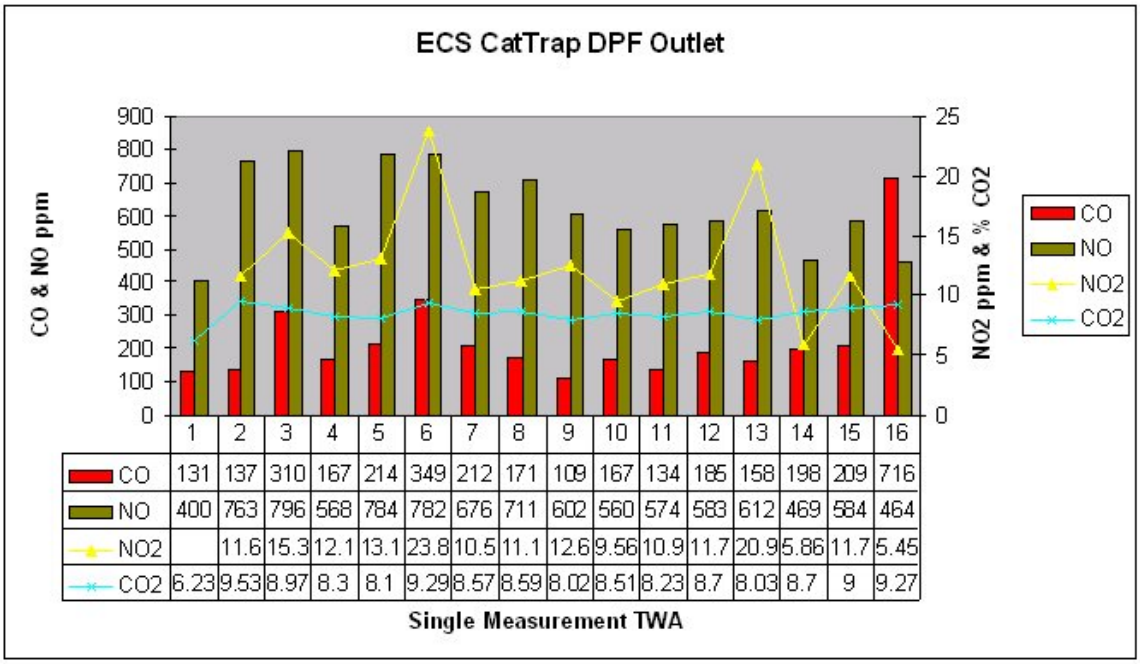
Figure 24 – Gaseous Emissions For VL244 With ECS CatTrap

Over the course of the project a total of 16 emissions tests were performed using UGAS at both the inlet and outlet of the DPF. The results are shown in Figure 24. The results showed that nitrogen dioxide emissions were not substantially affected by the base metal catalyst. Carbon monoxide emissions were consistent and correlating well to small fluctuations in carbon dioxide. All measured CO_2 emissions were near 8 to 9% indicating good tests at full engine stall condition.

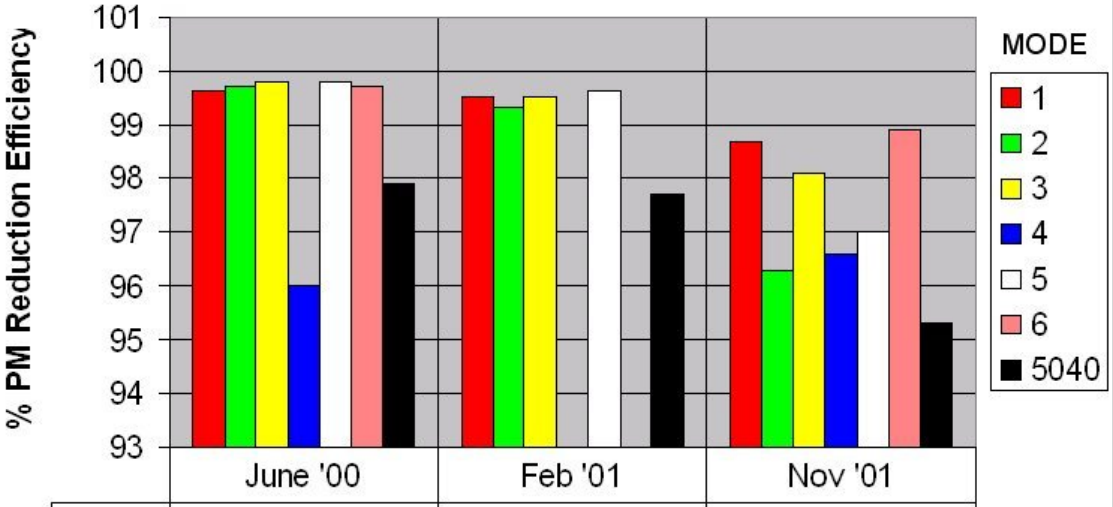
Figure 25 – DPM Filtration Efficiencies For ECS CatTrap DPF System

The emissions from VH244 equipped with ECS CatTrap were measured at only three out of the four in-depth performance evaluation sessions. During the third session the vehicle was out of service for overhaul needed after vehicle burial. Results of the three sets of tests, shown in Figure 25, showed that filtration efficiencies of the system are higher than

95%. The final set of tests conducted in November, 2001 with 3700 hours of operation accumulated by the system showed a noticeable decline in filtration efficiency.

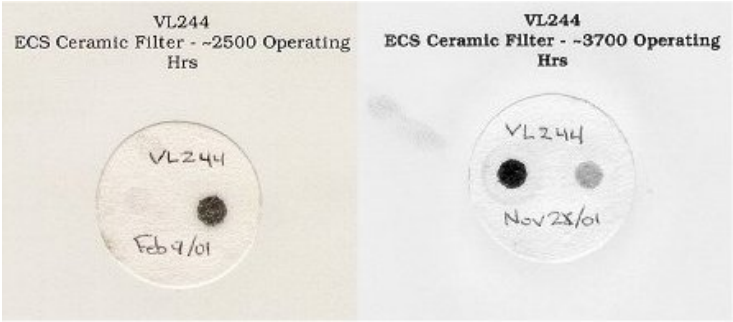
Figure 26 – Bacharach Smoke Index Measured for ECS CatTrap DPF System

The Figure 26 shows the filter sample taken by mechanics with the UGAS using Bacharach smoke index (BSI) option.. The black dot represents the DPM sample collected from the inlet side of the filter and the light gray dot represents the sample collected at the outlet side of the filter. The samples collected at the final tests in November 2001 indicate the reduced efficiencies observed with other methods (see Figure 25).

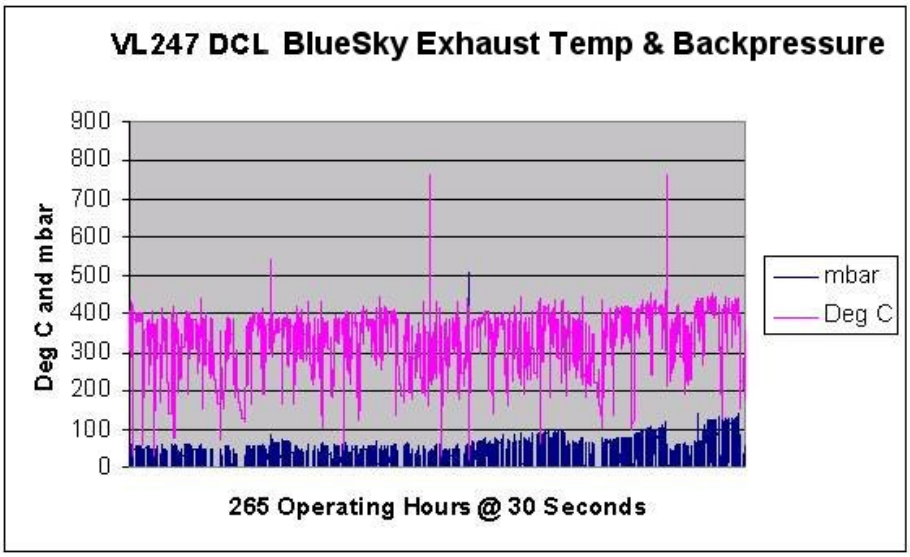
Figure 27 - Exhaust temperatures and engine backpressures recorded for LHD VH247 equipped with DCL Bluesky DPF system

The Nothiger datalogger and sensor system used on VL247 to establish time traces of exhaust temperature and backpressure was prone to technical problems throughout the study. The RTD temperature sensors used at the DPF inlet side were particularly prone to failures due to their proximity to the electrical regeneration unit that generated the additional heat. Figure 27 shows temporal distribution of exhaust temperature and engine backpressure. This data is fairly consistent with corresponding data obtained for the LHD VL244. Exhaust temperatures at peak engine load were between 350° and 400° C, These temperatures were theoretically within the range of temperatures needed for passive regeneration of this system. Backpressures observed with this system were slightly lower than those observed for the ECS system on LHD VL244. The backpressure reached a plateau at approximately 100 mbar or 40 inches of water. This indicates that regeneration was occurring frequently enough during the duty cycle to sustain continuous operation of the system. This was verified by the additional measurements of engine backpressure done by mechanics during monthly PM inspections.

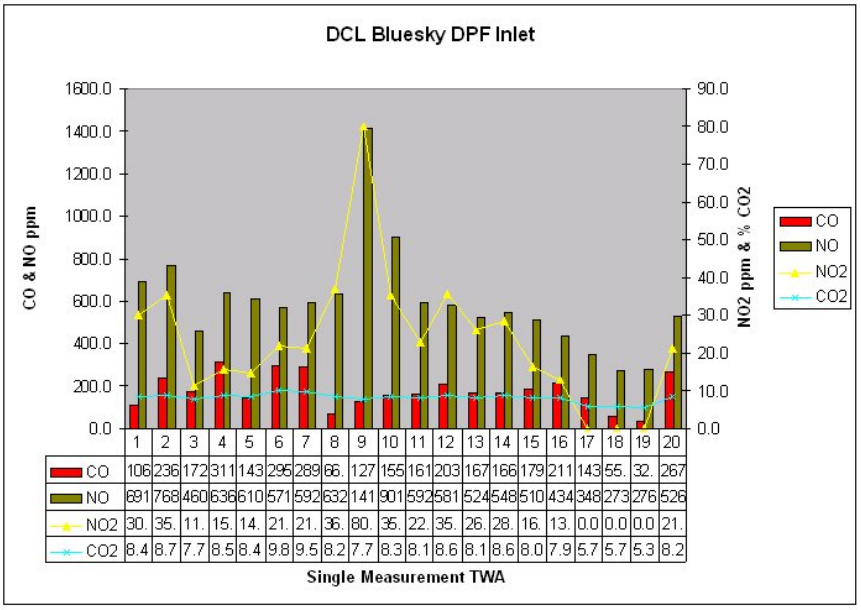
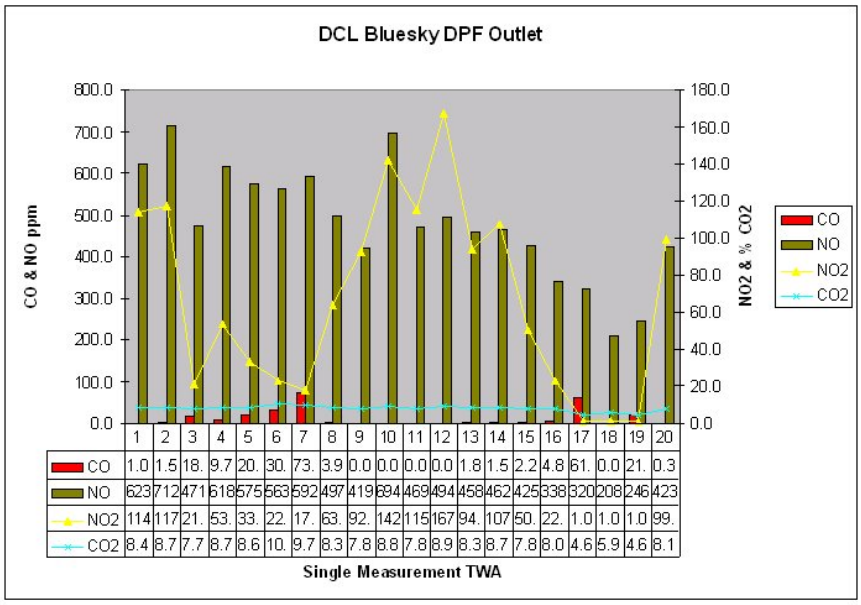
Figure 28 - Gaseous Emissions For VL247 With DCL Bluesky DPF System

Results of the emissions measurements conducted during 20 tests are shown in Figure 28. The measurements were conducted at the inlet and outlet sides of the DPF using the UGAS system. The CO was converted almost completely across the platinum catalyzed filter (see Figure 28). In some cases measurements showed that the concentrations of NO_2 at the outlet of the DPF were four fold higher than corresponding concentrations on the inlet side of the DPF. These results emphasized the importance of including gaseous emissions measurements in tests designed for evaluation of the effects of DPF systems on the particulate matter emissions.

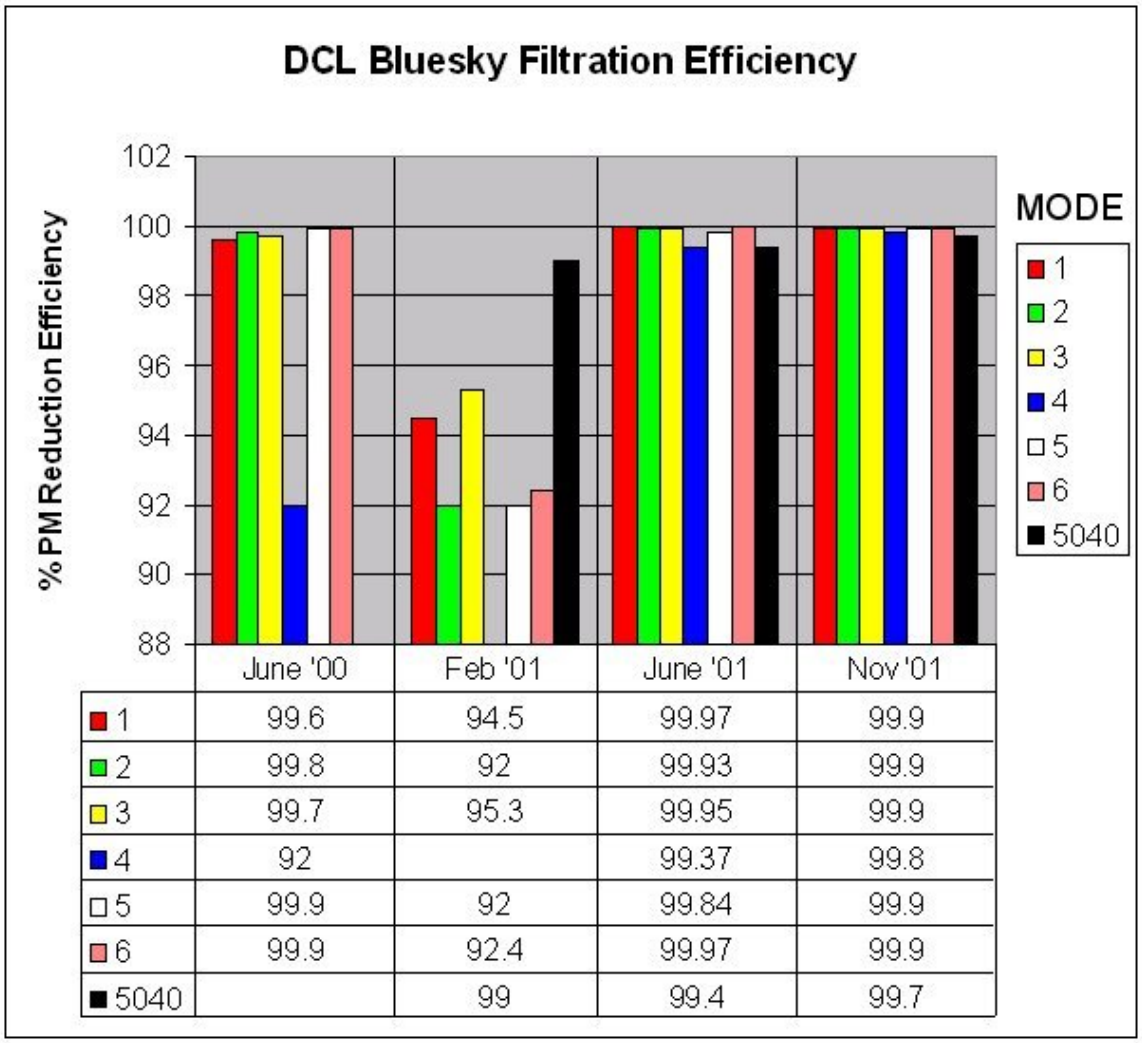
Figure 29 - DPM Filtration Efficiencies For DCL Bluesky DPF System

The results of particulate matter emissions measurements conducted during four detailed performance evaluations are shown in Figure 29. In terms of filtration efficiency, this system was the best performer of all systems tested in the project. The results were consistently indicating filtration efficiencies in excess of 99 percent. The results obtained with NanoMet during tests conducted in February of 2001 were found to be inconsistent due to instrumentation problems but are presented nonetheless. It is important to note that these tests were conducted during the isolated zone study in a drift at ambient air temperature just above the freezing point. We believe that the NIOSH 5040 method provided accurate results.

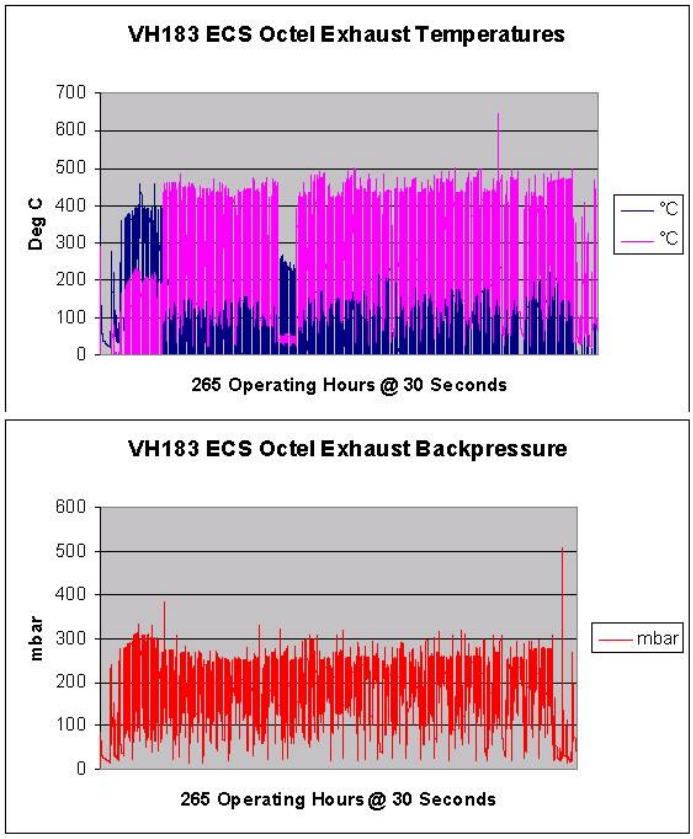
Figure 31 - ECS Octel Exhaust Temperature and Backpressure

lower DPF regeneration temperatures to approximately 300° C. Therefore, regeneration should have occurred more frequently than it was observed.. Figure 31 also shows that the backpressures were for a substantial time above 200 mbar and reaching periodically even 300 mbar. This high backpressure indicates that the regeneration process was slow and insufficient. The Octel representative offered the hypothesis that regeneration did not occur over the duty cycle since the moisture content of the soot buildup inside the filter monolith was less than expected. Low organic carbon content was hypothesized to be the result of efficient combustion inside the electronically controlled engine and operating conditions. These factors in combination with excessive engine idle times contributed to the insufficient DPF regeneration.

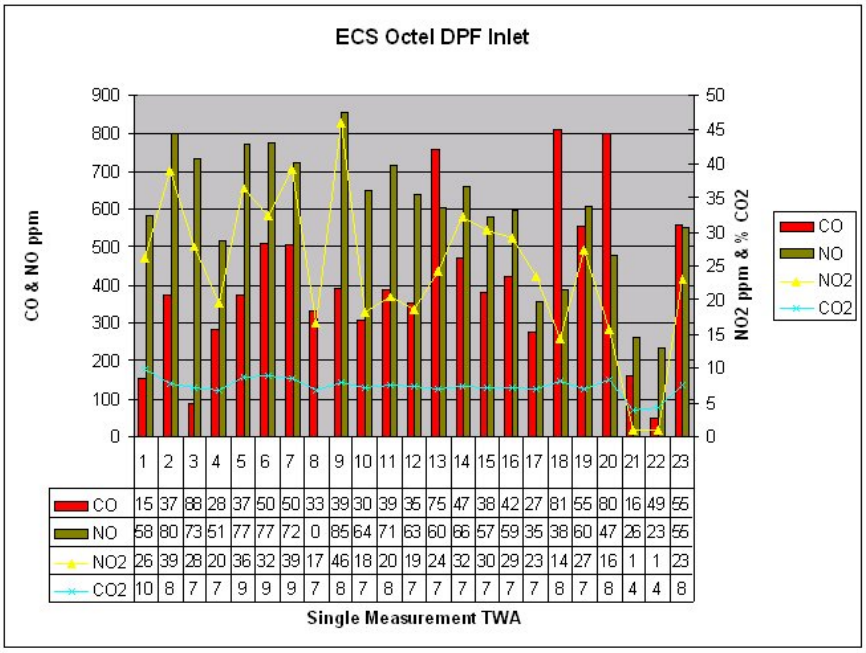
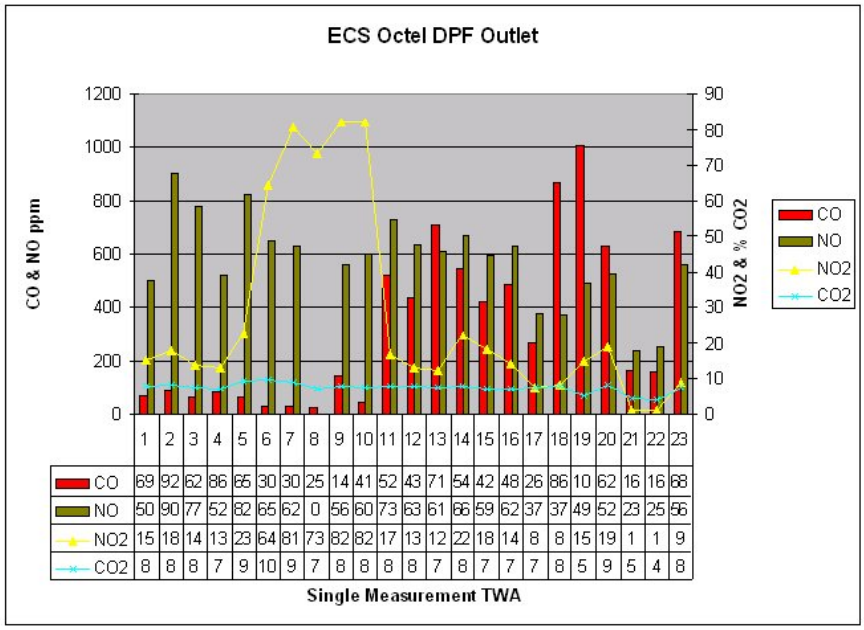
Figure 32 - Gaseous Emissions For VH183 ECS Octel DPF System

The results of gaseous emissions in the tailpipe of VH183 equipped with the ECS Octel DPF system indicate the problems with this unit. The concentrations of carbon monoxide measured in untreated exhaust at the initial stages of the project were ranging between 300 and 400 ppm. Those concentrations were somewhat higher than those observed for the smaller engines used in tested LHDs. As the DPF system was accumulating hours in operation and engine backpressure was gradually increasing, CO emissions were climbing. Measurements of the inlet to outlet CO emissions through the first ten tests

while the diesel oxidation catalyst was in place showed the CO conversion and reduction (see Figure 32). Once the diesel oxidation catalyst was removed, CO emissions at the outlet were often higher than those at the inlet due to combustion of DPM inside the filter while the engine was under full stall testing conditions. Measurable conversion of nitrogen oxide to nitrogen dioxide was taking place in the system while the oxidation catalyst was in place, but when the catalyst was removed conversion was not measurable.

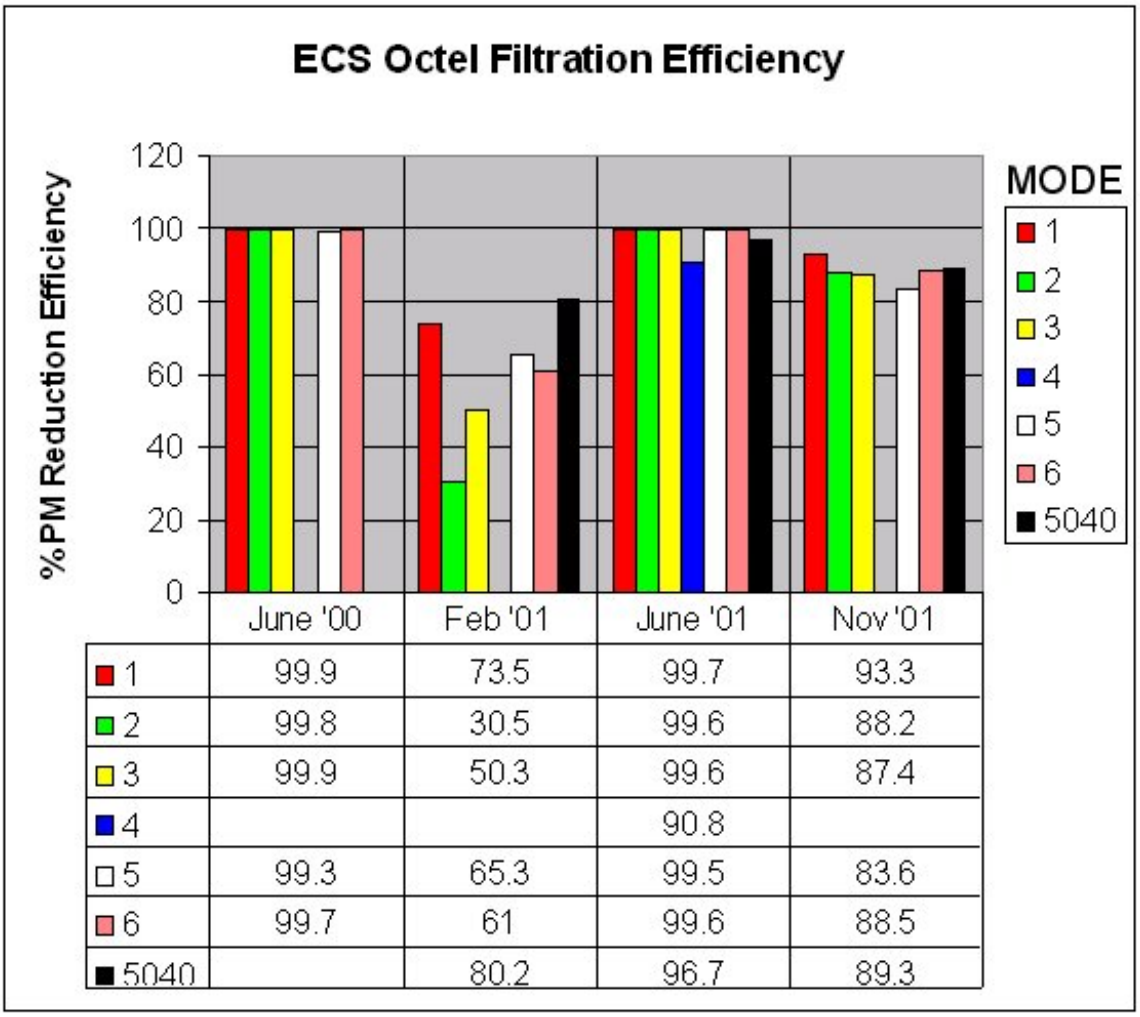
The filtration efficiency test results, shown in Figure 33, illustrate the high efficiencies of the newly installed system. The tests in February 2001 show a severely failed filter and the final tests in November 2001 show a partially failed filter. The results of the 5040 method carbon content analysis on the samples collected during the last three sets of tests correlate very well with the filtration efficiency measured by the NanoMet instrument. Test results showed that the new filters had efficiencies of approximately 98%, similar to the other tested DPFs. The severely damaged filter system had efficiency as low as 30%, and the partially damaged system had efficiency as low as 82% depending on which test mode was used for analysis.

June '00	Feb '01	June '01	Nov '01
1	99.9	73.5	99.7	93.3
2	99.8	30.5	99.6	88.2
3	99.9	50.3	99.6	87.4
4			90.8	
5	99.3	65.3	99.5	83.6
6	99.7	61	99.6	88.5
5040		80.2	96.7	89.3

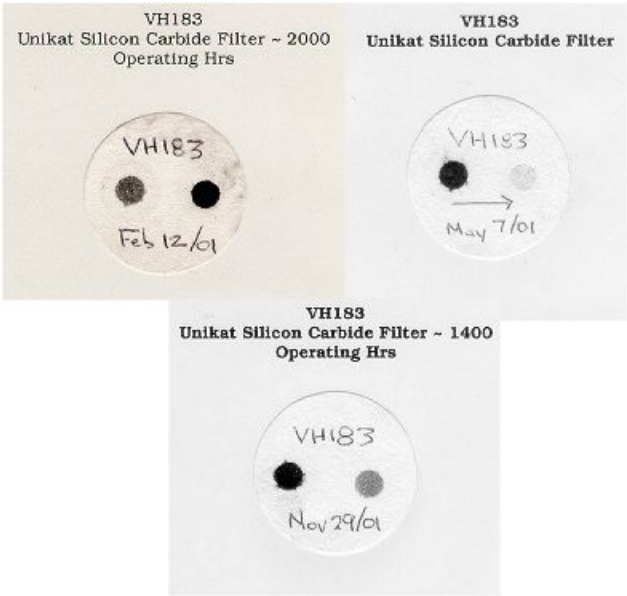
Figure 34 - Bacharach Smoke Density Results on VH183 with ECS Octel DPF System

The results of the Bacharach Smoke measurements are shown in Figure 34. The BSI measurements showed that DPF systems on VH183 failed in two instances. The first set of filters failed after 2000 operating hours and the second set of filters failed after 1400 operating hours. At other test instances when the DPF system was not compromised the efficiency was relatively high. These results are in direct correlation with results obtained using other more sophisticated methods. Therefore this method is suitable for quick and inexpensive verifications of DPF system performance.

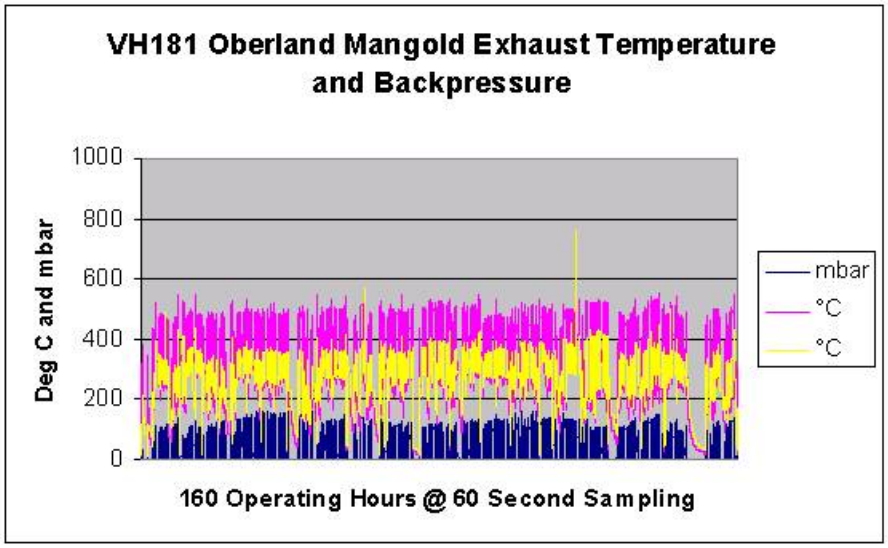
Figure 35 - Oberland Mangold Exhaust Temperature and Backpressure

The data that was retrieved from the datalogger was backed up by measurements of backpressure performed by mine mechanics at monthly intervals. The backpressure reached a plateau of approximately 120 mbar or 50 inches of water. The data presented in Figure 35 shows backpressure values increasing and decreasing in a regular pattern, which indicates at least partial regeneration occurring during the duty cycle. The exhaust temperature traces show temperatures at the inlet to the system well above 400° C. The temperature profile compares well to one for the other truck used in the project but the backpressures and apparent regeneration profiles are drastically different. The glass fiber filter media appear to have captured less particulate than silicon carbide monolith media used in the other system. The lower loading inside the filter media made it easier to regenerate when temperatures reached high enough levels to ignite the trapped soot.

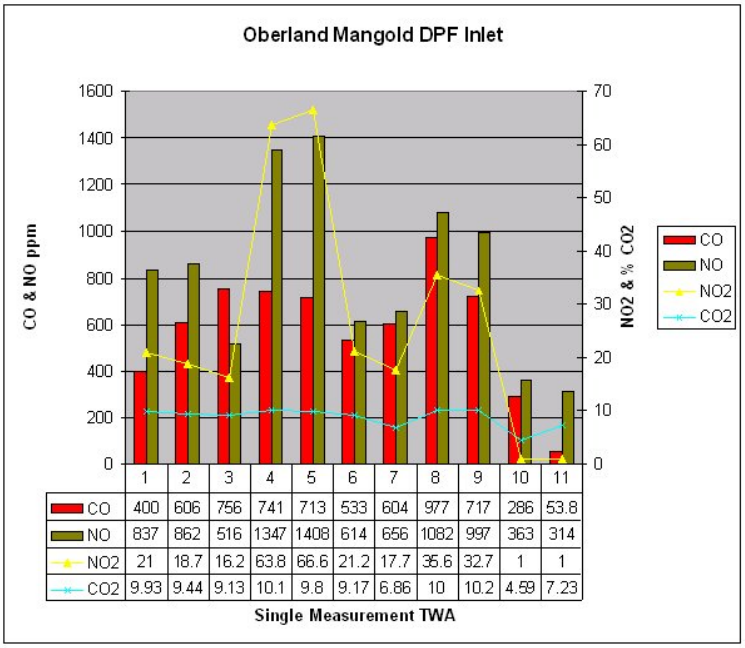
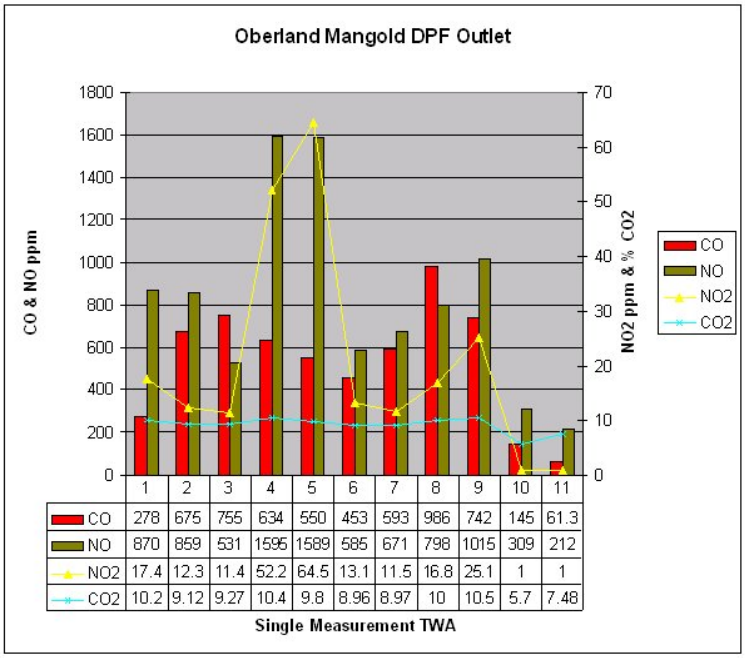
Figure 36 – Gaseous Emissions For VH181 With Oberland Mangold DPF

The results of gaseous emissions measurements made on VH181 truck equipped with the Oberland Mangold DPF system are shown in Figure 36. The non-catalyzed DPF with glass fiber media did not affect either carbon monoxide or nitrogen dioxide emissions. Carbon dioxide emissions and exhaust temperatures were consistent throughout the tests with the exception of the final test indicating that proper testing protocol was followed with full engine stall.

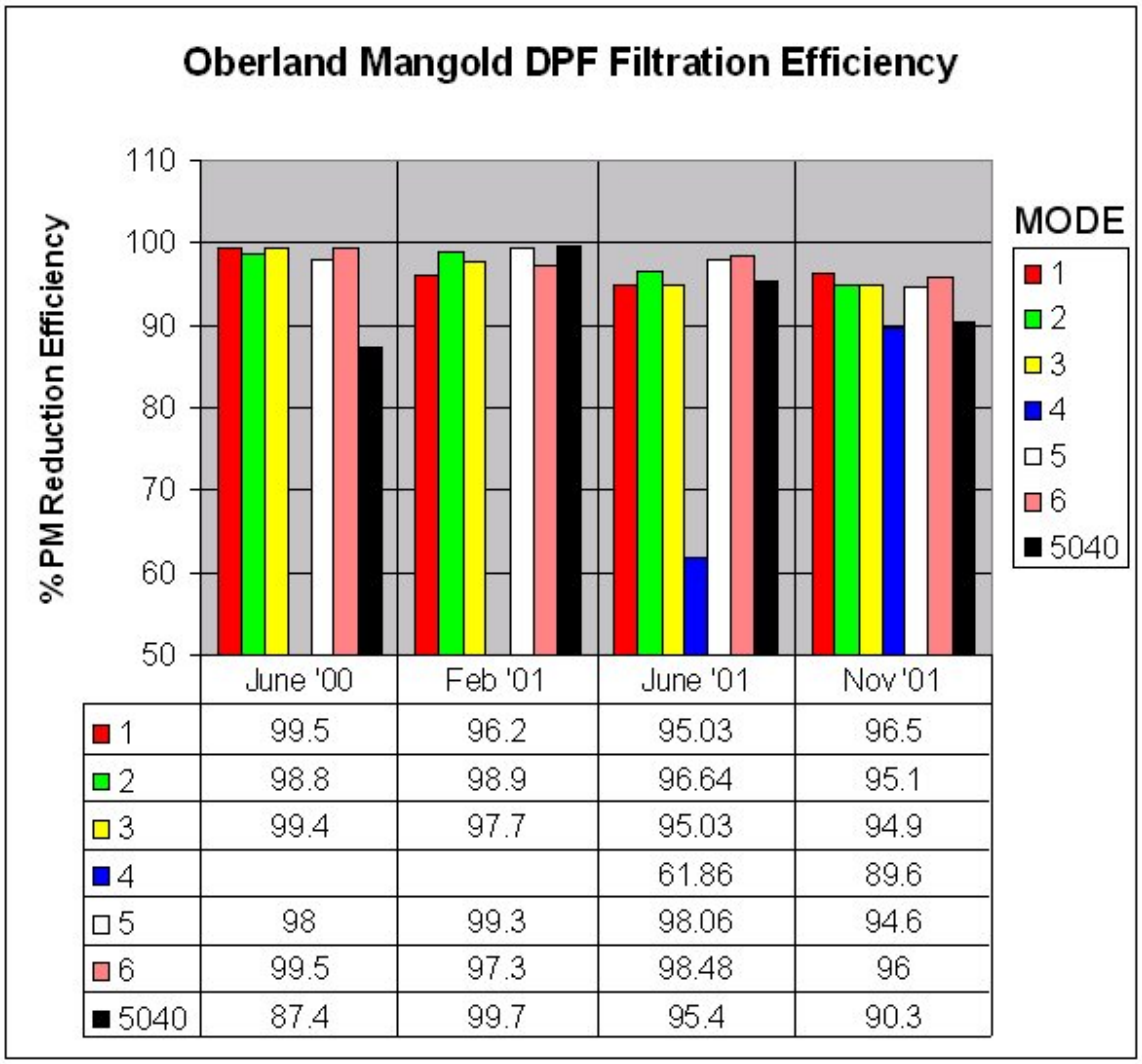
Figure 37 – DPM Filtration Efficiencies For Oberland Mangold DPF System on VH181 Truck

The results of particulate matter emissions measurements, shown in Figure 37, indicate that fiber knitted filter consistently exhibited lower filtration efficiency than the other three wall flow monolith DPF systems tested in this study. The first set of results was generated in June 2000 during the tests involving the original DPF with 25 filter cartridges. The other three tests were performed with the larger, 52 cartridge DPF system. The efficiency of the system was found to be lowest when particulate matter emissions obtained for tests at mode 4 (idle) were used for calculation. The PM emissions measurements obtained for remaining modes were providing consistent results and showed as low as 90% or slightly below. The NIOSH 5040 method analyses agreed very closely with NanoMet results in the 2nd and 3rd sets of tests but were 5 to 10% below NanoMet results in the 1st and 4th sets.

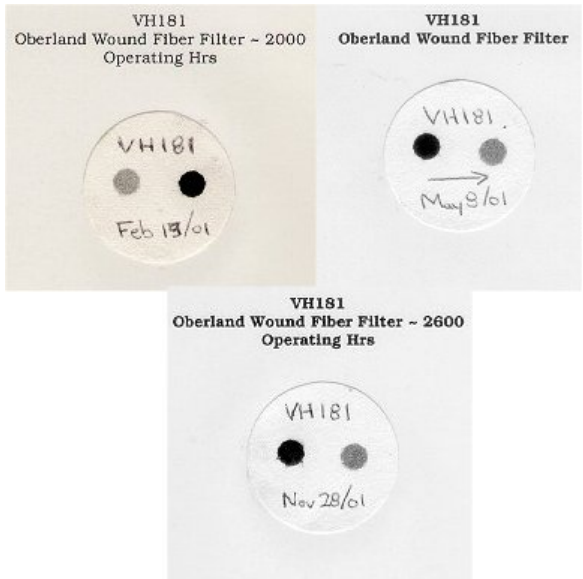
Figure 38 - Oberland Mangold Octel Bacharach Smoke Density Results

The results of Bacharach smoke index (BSI) tests shown in Figure 38 agree better with the NIOSH 5040 method results than with the NanoMet results. Whereas the BSIs observed for the other three tested DPF systems that are using wallflow monolith technologies were consistently between 0 or 1 at the outlet, the BSIs for Oberland Mangold System that utilize fiber cartridges were closer to 4 or 5 on 0 to 9 scale. Bacharach testing results were consistent throughout the project.

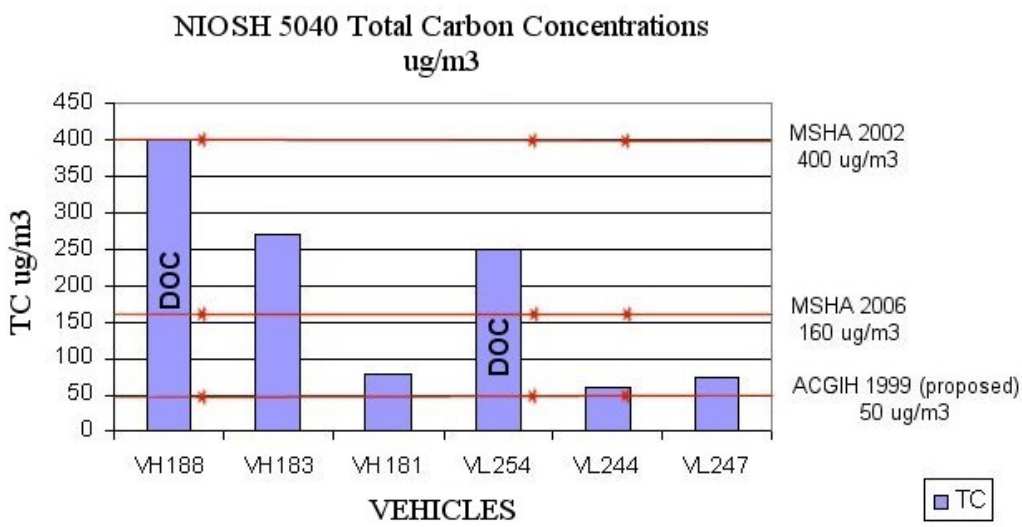
Figure 40 – Total Carbon Concentrations in Isolated Zone for Different Test Vehicles

Both LHDs retrofitted with DPFs emitted significantly less TC and EC than the LHD equipped with a DOC, although the observed concentrations at the exhaust station were slightly higher than proposed ACGIH limits of 0.05 mg/m^3 of TC or 0.02 mg/m^3 of EC.

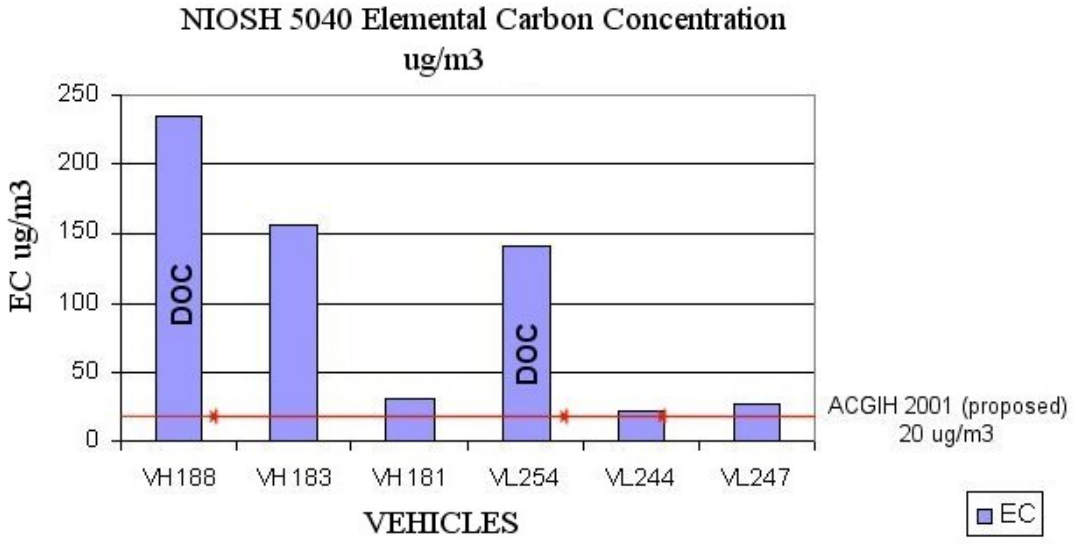
Figure 41 - Elemental Carbon Concentrations in Isolated Zone for Different Test Vehicles

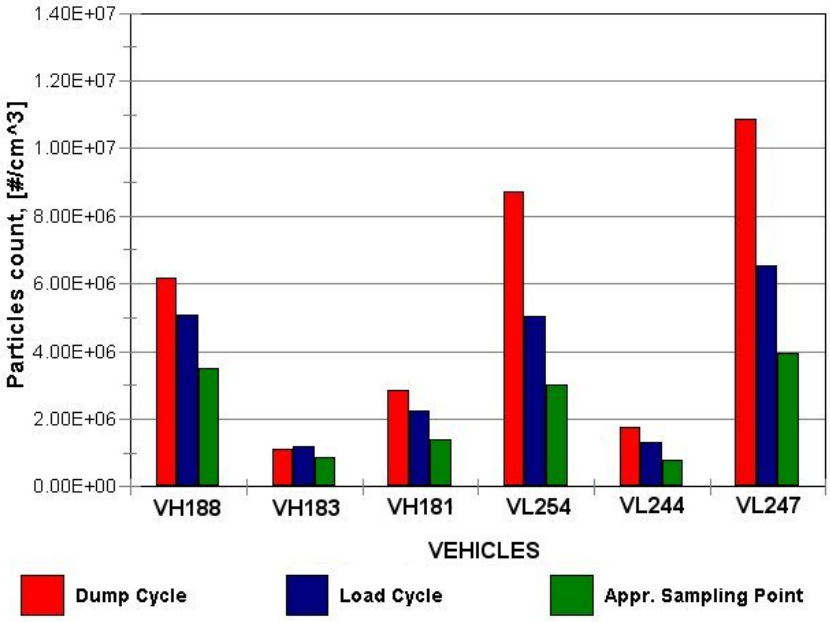
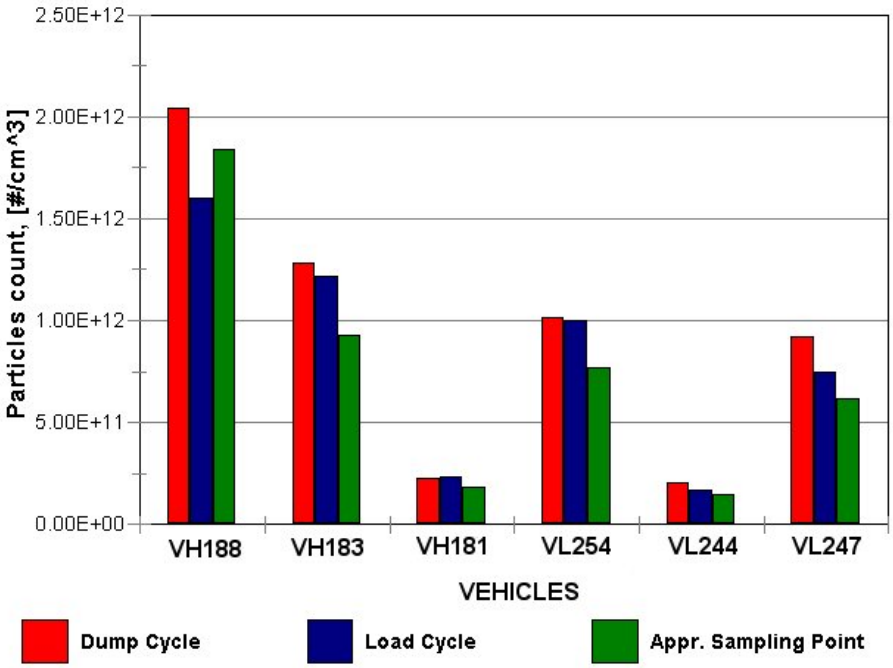
enough data to distinguish results between DPFs with leaks but the SMPS data results did show that VL247 with the DCL Bluesky DPF which had the largest and most visible leaks, had a distinguishing difference from the others with respect to particle size and number.

Figure 42 - Particle Concentrations by Number Measured in Isolated Zone for Different Test Vehicles

Figure 43 - Particle Concentrations by Volume Measured in Isolated Zone for Different Test Vehicles

All filtration systems except the DCL Bluesky filter installed on VL247 demonstrated high efficiency in reducing the number of particles emitted. (See figures 42 and 43.) For the DCL Bluesky system, the concentrations of particles by number were even higher than for the LHD equipped only with the DOC. Neither the DCL Bluesky system nor the ECS Octel system offered expected reductions in particle volume. The relatively low efficiency of the DCL Bluesky system was attributed to sizeable exhaust leaks between the turbocharger and filter. The results showing poor performance of the ECS Octel system are in good agreement with the results of carbon analysis.

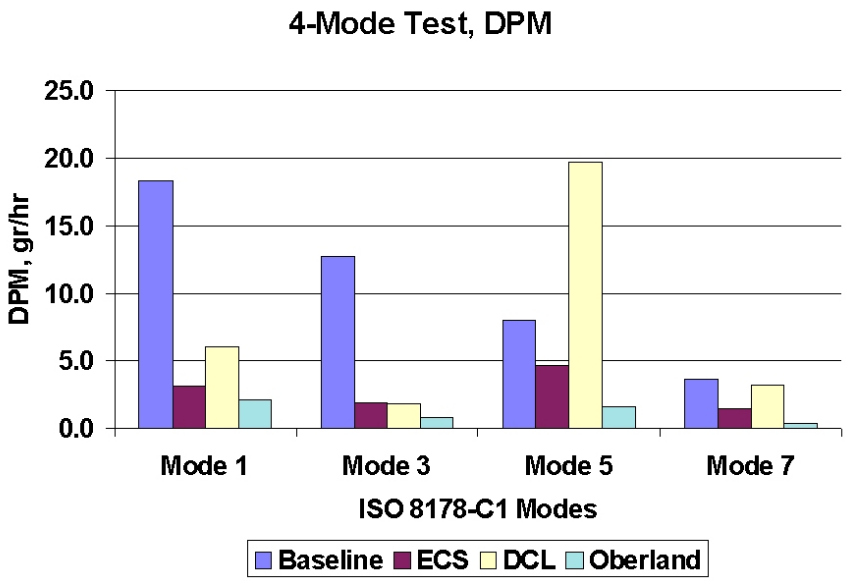
over mode 5 relatively high DPM emissions were recorded. This was most likely caused by the platinum catalyst washcoat employed with the DCL system, which depending on catalyst formulation and potency and exhaust temperatures tend to increase sulphate formation and therefore increase total DPM emissions. While the sensitivity of sulphate creation to exhaust temperature is quite evident in mode 5, there is no way of making this determination with absolute certainty. This finding is significant because until the post-field bench tests, all results for DPM and filtration efficiency indicated that the DCL Bluesky had a slightly higher efficiency than the other systems. The concentrations of carbon monoxide for all four test conditions were found to be fairly unaffected by DPF systems with the exception of the DCL Bluesky system. This system greatly reduced CO concentrations. These reductions can be attributed to the activity of the platinum catalyst used in the DCL system.. Similarly, the hydrocarbon emissions measurements shown in figure 49 indicate a larger reduction in HC emissions in the case of the DCL system again due to the activity of the platinum catalyst. The other systems also reduced hydrocarbon emissions but not to the extent observed with the DCL system. The platinum catalyst in the DCL system also increased conversion of NO to NO_2 as seen in Figure 50. The concentrations of NO_2 downstream of the Oberland Mangold Octel system were much lower than concentrations established during baseline and ECS CatTrap tests.

Figure 47 – Average Total DPM Emissions Over Four-Mode Tests

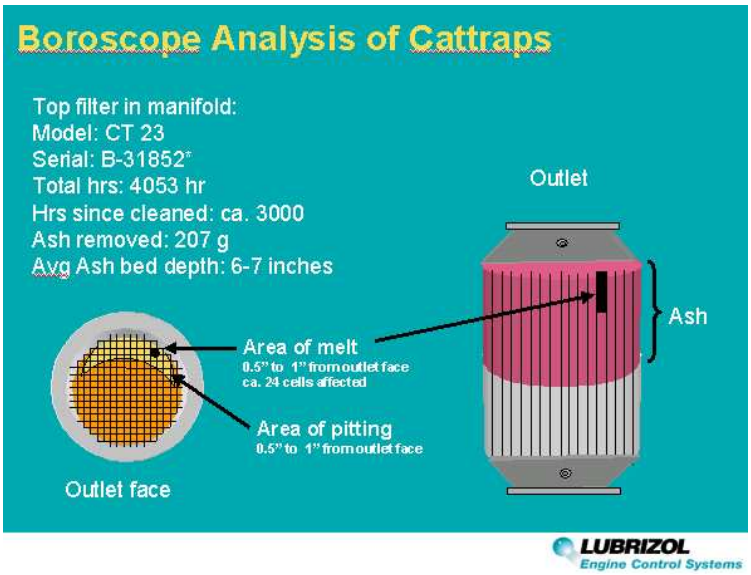
Figure 51 - Non-Destructive Testing of ECS CatTrap

top filter in the DPF. In light of these findings the manufacturer ECS recommended a cleaning frequency of 1000 hours. Frequent cleaning should minimize the buildup of accumulated ash. Since cleaning with compressed air alone was insufficient ECS recommended cleaning in a kiln where the filter element can be heated while ash is removed by compressed air.
