**Bureau of Mines Report of Investigations/1984**

## **Effects of Repeated Blasting on a Wood-Frame House**

**By Mark S. Stagg, David E. Siskind,  
Michael G. Stevens, and Charles H. Dowding**

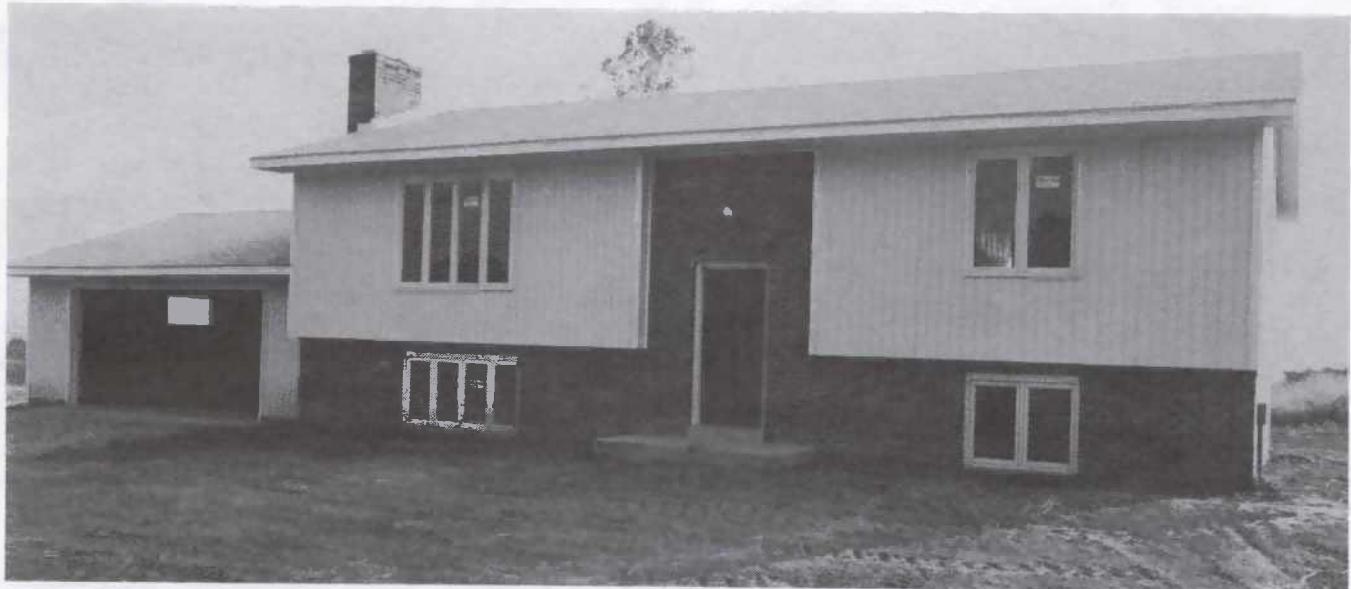
FIGURE 6. - Front view of test house.

After site selection, the Bureau contacted the local carpenters' union to establish the typical house design, then chose a split-level model. The 1,144-ft<sup>2</sup> test house (fig. 6) had a concrete block basement, brick veneer, and a brick fireplace. Interior walls were 1/2-in wallboard with taped and plastered joints. The kitchen-dining room area received an additional 3/16-in coat of veneer plaster. Plumbing, cupboards, finish molding, and interior doors were not installed, but 75 concrete blocks were used to simulate normal household loads. Design details are shown in appendix B. Ed Scheesele & Sons, a local contractor, built the structure between June and October 1979. As a cost-saving measure, the Bureau arranged for a local engineering firm, VME-Nitro Consult, Inc. (VME), to conduct construction inspections at the completion of the following stages: (1) footings--before pouring, (2) foundation, (3) frame and masonry, (4) electrical, and (5) finish.

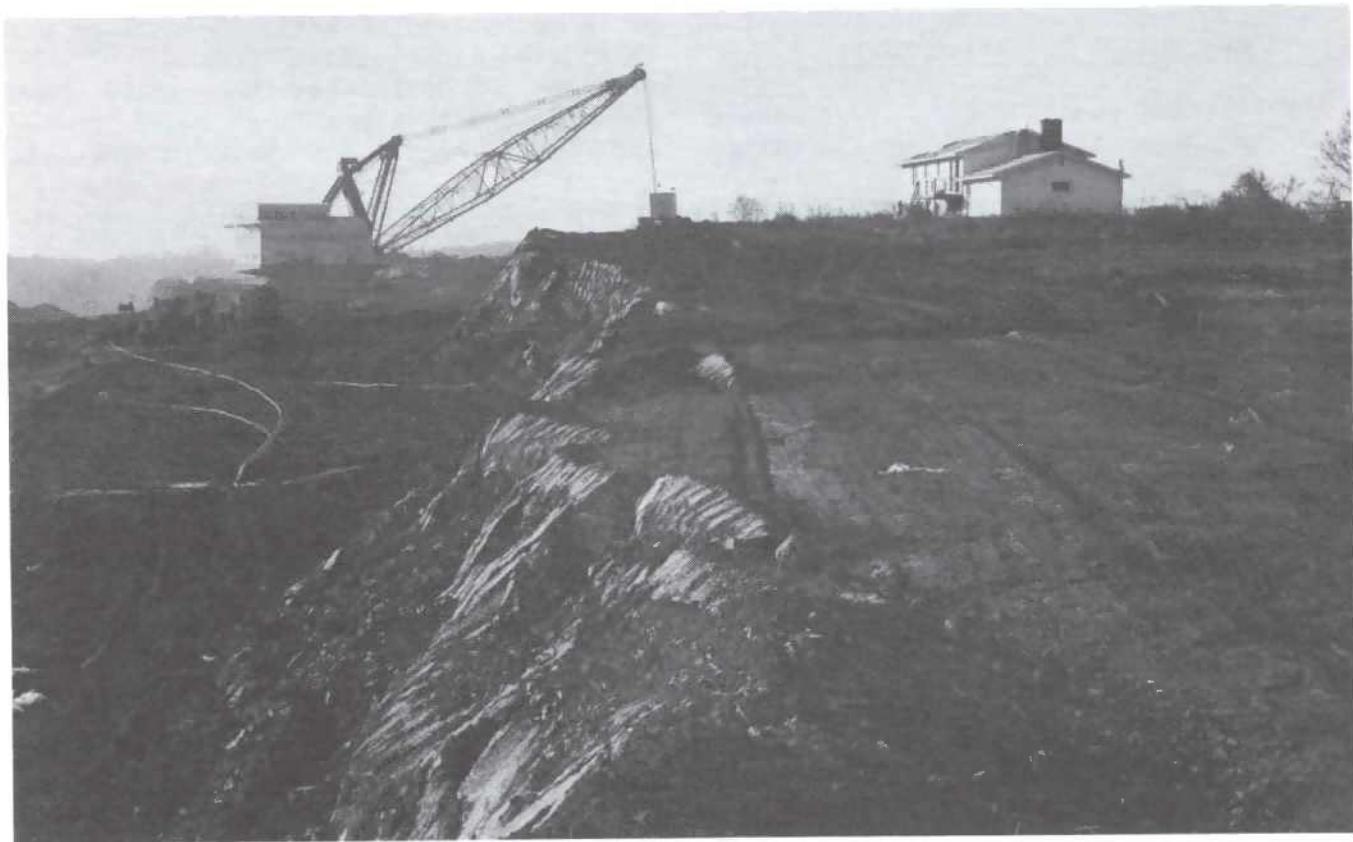
FIGURE 7. - House relationship to pit (south view).

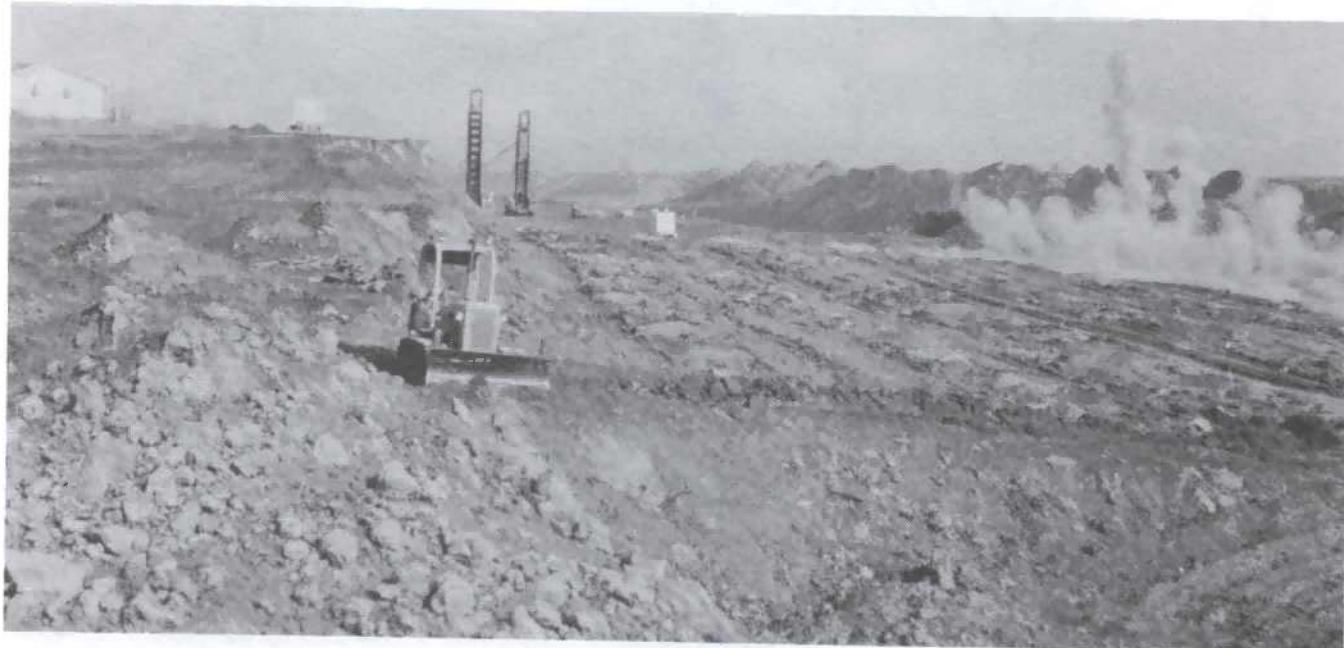
FIGURE 8. - House relationship to pit (north view).

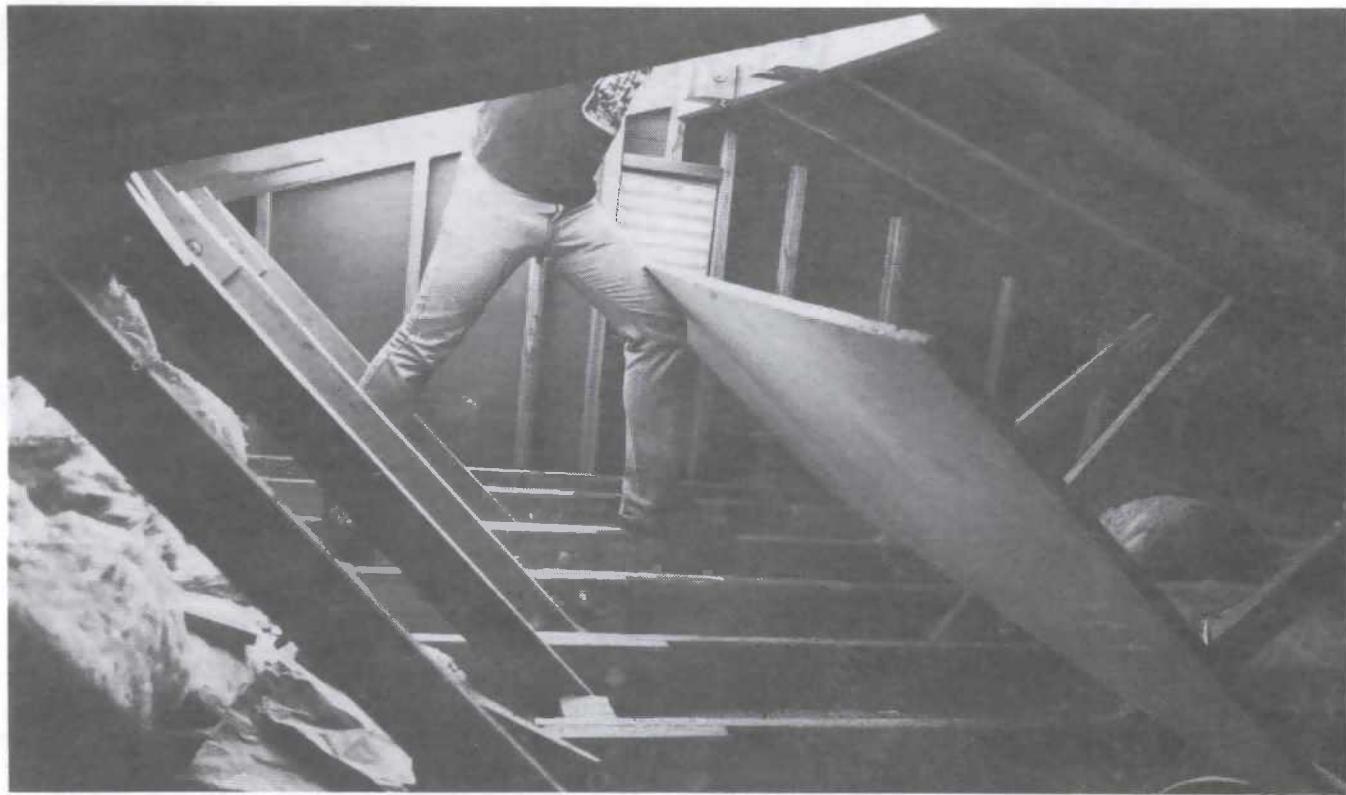
FIGURE 9. - Roof joist preparation for mechanical shaker installation.

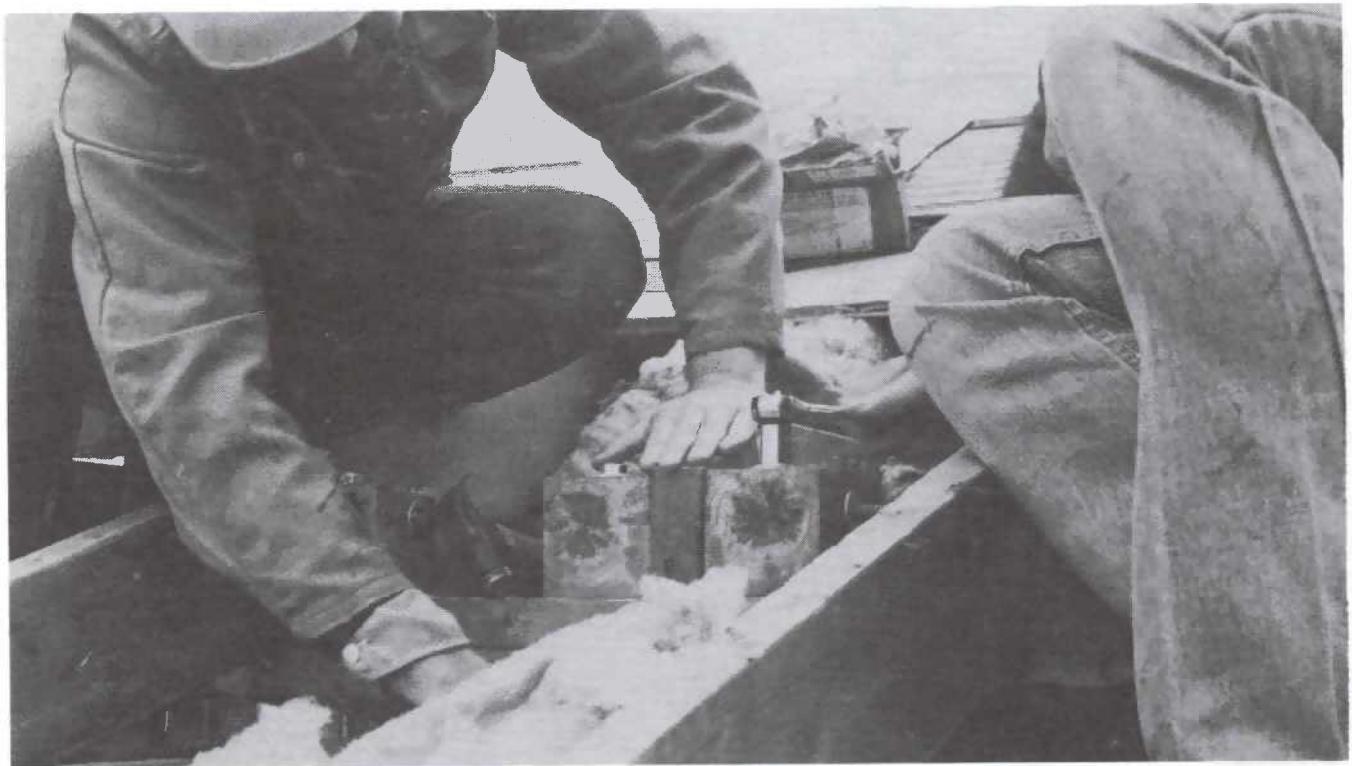
FIGURE 12. - Ceiling joists being bolted to wall studs.

were bolted (fig. 12) to ensure efficient horizontal load transmission during the more than 100,000 loading cycles. The tests involved inducing equivalent structure response until fatigue cracking was observed in the wallboard or until 100,000 cycles was reached at each level of vibration.

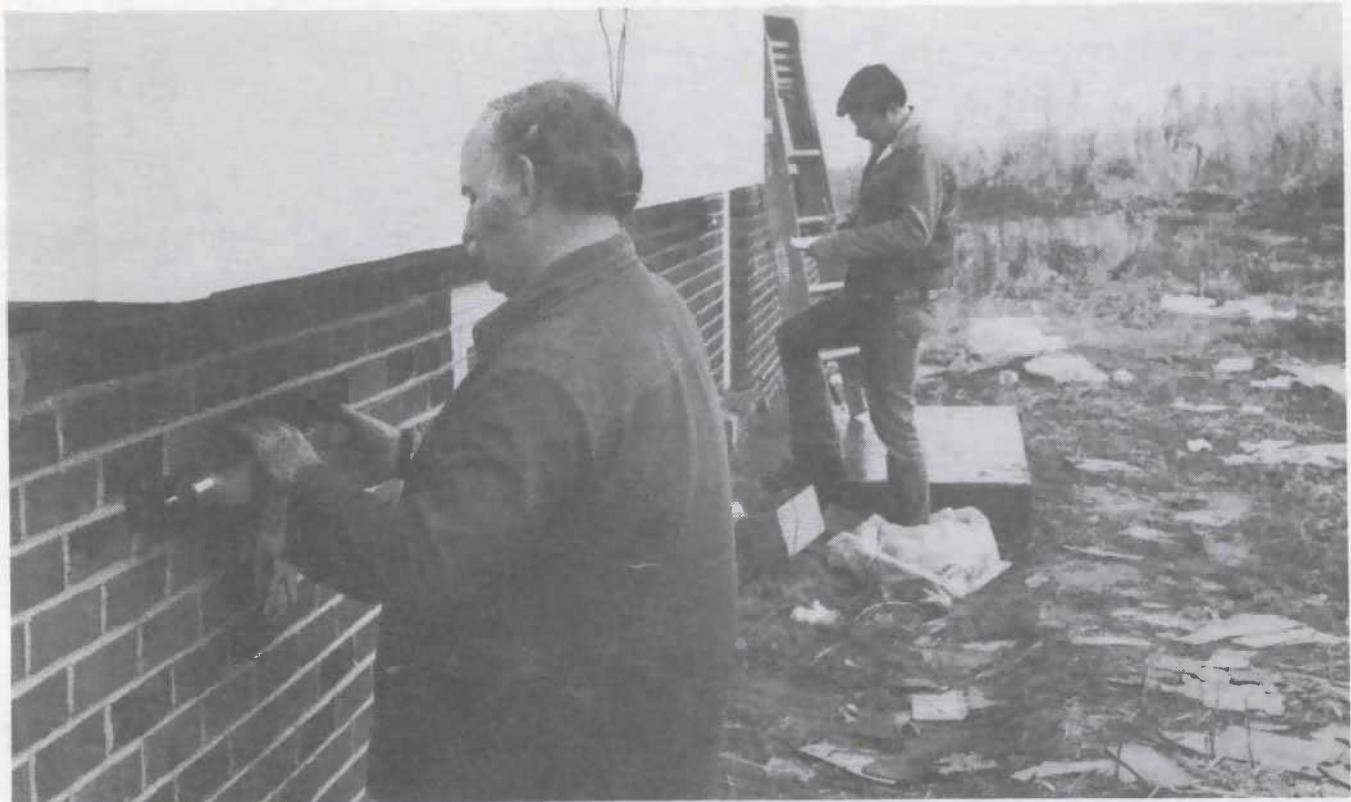
FIGURE 17. - Extensometer.

The extensometer (fig. 17) and groove comparitor (fig. 18) measured the distance between set reference points  $\sim 10$  to 30 ft apart and  $\sim 3$  in apart, respectively. The reference points for these two devices were permanently mounted stainless steel spheres and dimpled steel blocks. They were installed over critical areas of interest as detailed in figures 15 and 16 (points  $G_1$ ,  $G_2$ ,  $G_3$ , etc.). Differences in length, between that measured initially and at any later time, were divided by the initial length to obtain the strain values. A  $45^\circ$  rosette was employed at each groove comparitor location on wallboard; and for masonry joints, both the vertical and horizontal axes of the block or brick were instrumented. (Sites  $G_{13}$ - $G_{16}$  (masonry locations) are not shown because the reference blocks dislodged after 2 months; however, these sites were promptly replaced by sites  $G_{17}$ - $G_{20}$ .  $G_{21}$ - $G_{23}$  were additional sites instrumented during installation of the replacement sites.) In all, a total of 49 groove comparitor measurements and 17 extensometer measurements were made each semimonthly data collection period. (Use of site  $E_{14}$  was discontinued after 3 months due to loosening of the reference sphere.) Readings were corrected for temperature differences as determined with Invar-bar standards.

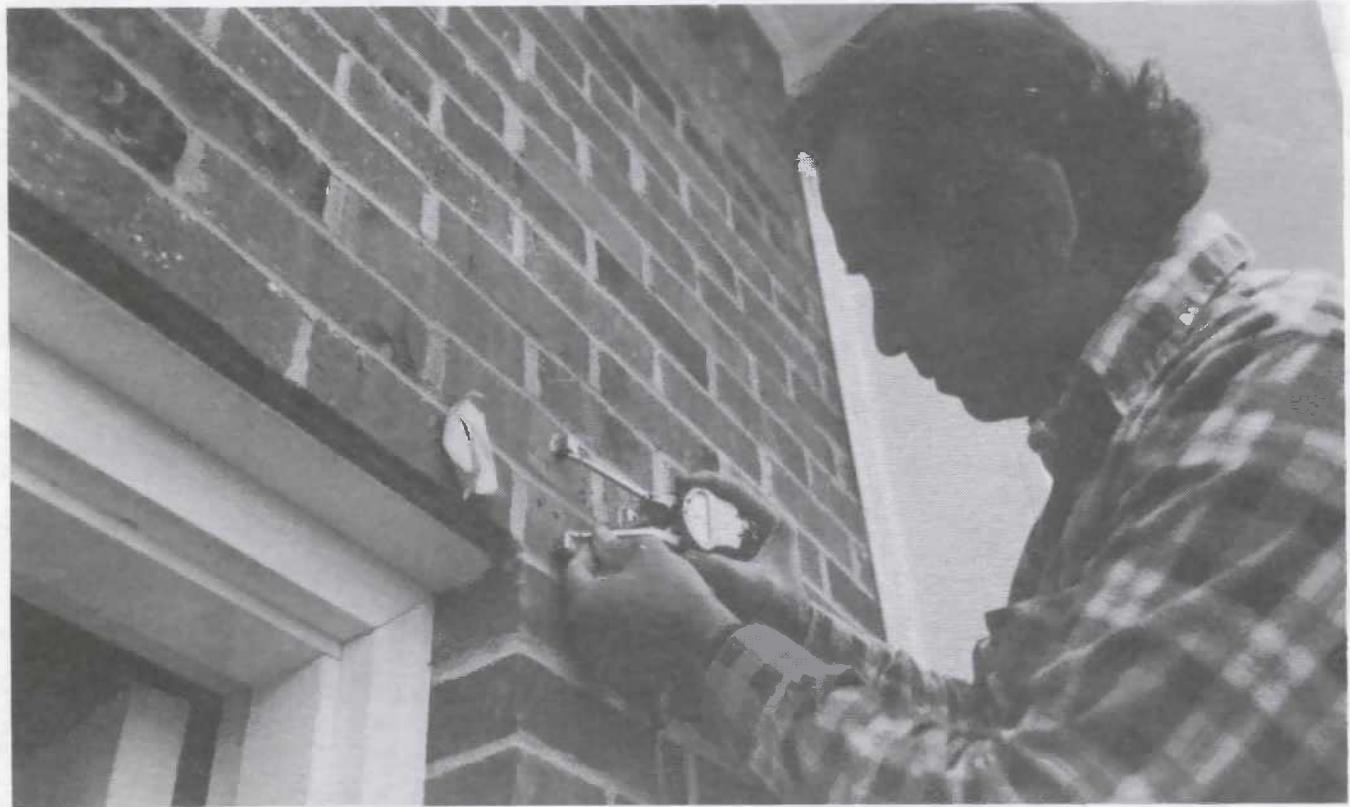
FIGURE 18. - Groove comparitor.

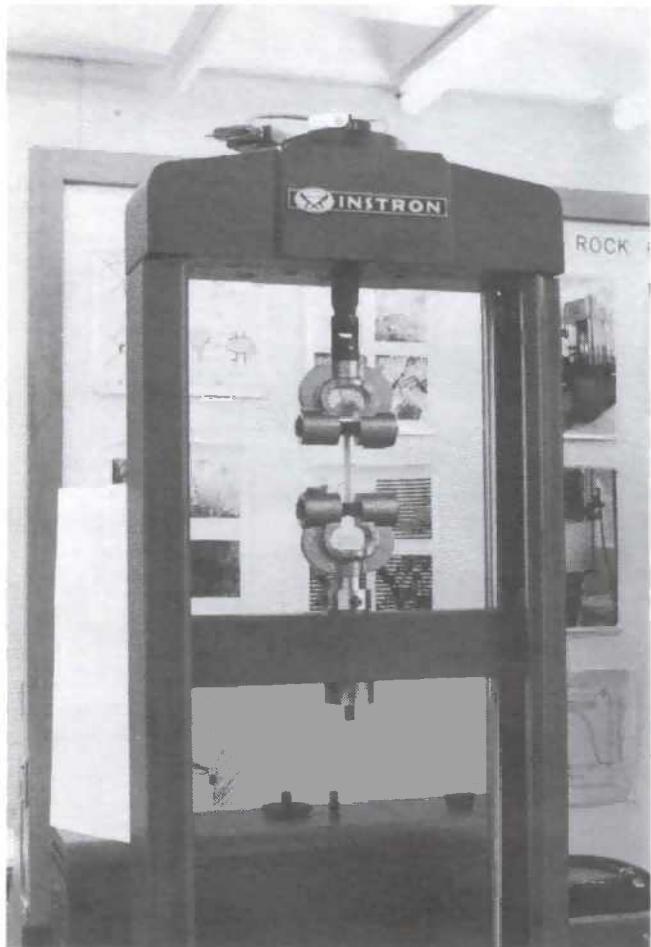
FIGURE A-1. - Instron TM 100-kg universal testing machine with test specimen.
