Analysis of Safety Aspects and Mining Practices for Effective Ground Control in Surface Mining

Suresh K. Bhatt, Mining Engineer
Christopher Mark, Rock Mechanics Team Leader
NIOSH - Pittsburgh Research Laboratory
Pittsburgh, PA

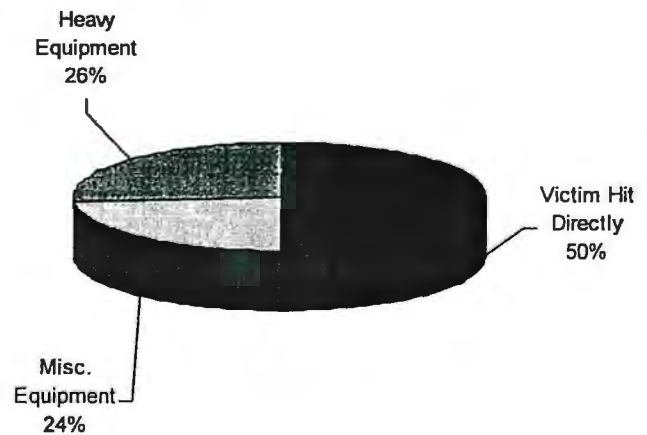
Approximately 26% of all accidents caused by highwall failure involved heavy earth moving equipment, such as the drill, front-end loader, dozer, shovel/dragline, and trucks. Approximately half of the injuries were caused when the failed material hit the victim directly. The remaining 24% involved miscellaneous equipment items (over 40). Figure 1 shows this breakdown.

Figure 1. Accidents by worker involvement

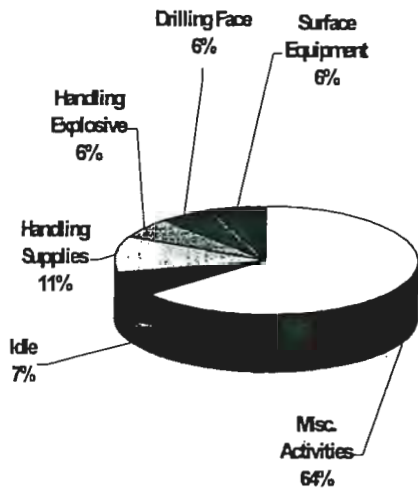
Handling supplies or material was found to be the single most frequent (11%) worker activity when injured, followed by idle category (7%). Handling explosives, drilling face, and surface equipment (not elsewhere classified) each represent about 6% of all accidents (18% total). The remaining 64% are distributed over 80 mine worker activities. Figure 2 shows this breakdown.

Figure 2. Accidents by worker activity

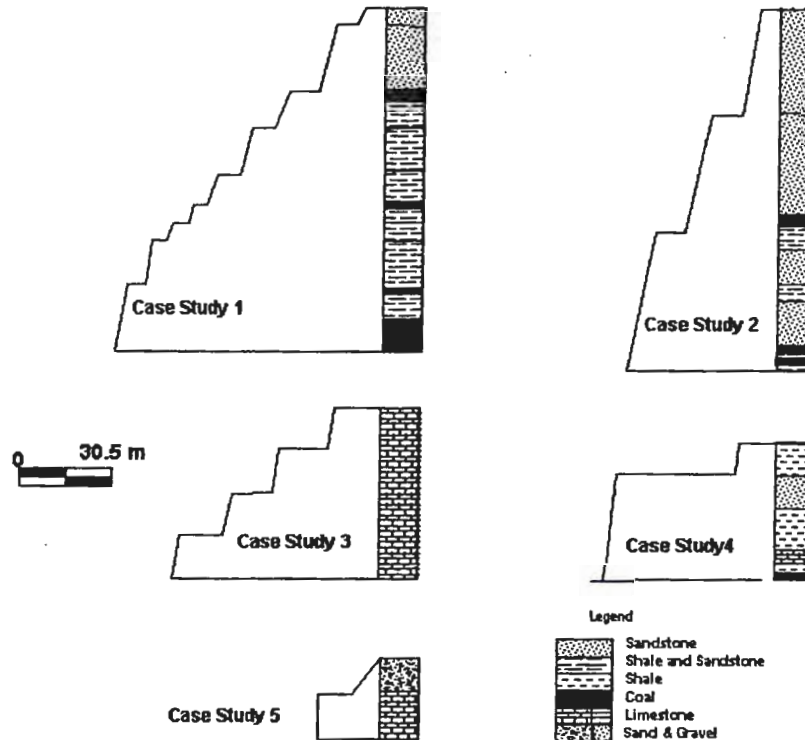
Figure 4. Geological settings and operational parameters

In addition to gathering information from the mine personnel, an operating surface mine was visited at each location. The mine visits covered parts of West Virginia, Pennsylvania, and Ohio. Materials mined include coal (anthracite and bituminous), limestone, and sandstone. Of the eleven mines, eight are coal, two limestone, and one sandstone. Figure 3 shows the general location of these mines in the eastern United States. Five case studies are provided to represent the mining practices and safety aspects of the study area. Typically, a case study addresses the geological setting and operational parameters (bench width, height, and slope angle) in a mining area for effective ground control. Figure 4 shows the geological settings and operational parameters for the five case studies.
