## GATE ROAD DESIGN CONSIDERATIONS FOR MITIGATION OF COAL BUMPS IN WESTERN U.S. LONGWALL OPERATIONS

By Matthew J. DeMarco,<sup>1</sup> J. R. Koehler,<sup>1</sup> and Hamid Maleki<sup>2</sup>

### ABSTRACT

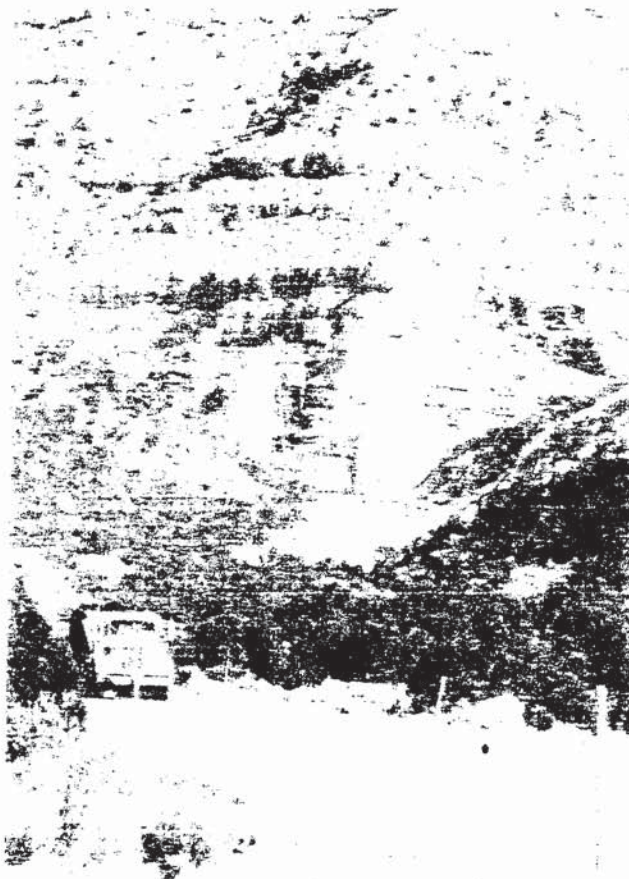
**Figure 5**  
Exposure of Star Point Sandstone at Cottonwood Mine Loading Facility.

Upper portion of unit is below Hiawatha Seam located even with small cubical building above concrete silo. Numerous strong sandstone and siltstone units can be seen to overlie seam workings as well.

within the Blackhawk; numerous smaller sandstone units and exceptionally strong siltstones make up much of the main roof overburden in the region (figure 5).
