## NOISE AND VIBRATION REDUCTION OF A VIBRATING SCREEN

David S. Yantek, NIOSH, Pittsburgh, PA  
Paul Jurovcik, NIOSH, Pittsburgh, PA  
Eric R. Bauer, NIOSH, Pittsburgh, PA

### Abstract

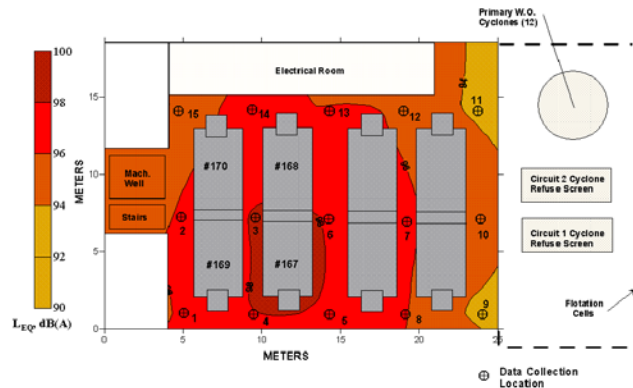
Figure 1. Contour plot of the A-weighted sound levels around a group of eight clean coal screens.

The consortium selected a coal preparation plant for the study based on its proximity to all of the involved researchers. In the selected plant, preliminary measurements were made in the area surrounding a group of eight horizontal vibrating screens used to process clean coal. These measurements indicated that the sound levels ranged from 94 to 98 dB(A) with the plant processing coal (see Figure 1) and from 89 to 97 dB(A) without the plant processing coal and the screens operating with vibration only. The sound levels decrease significantly with increasing distance from the screens, indicating that the screens dominate the overall A-weighted sound level in this area of the preparation plant. In order to reduce the

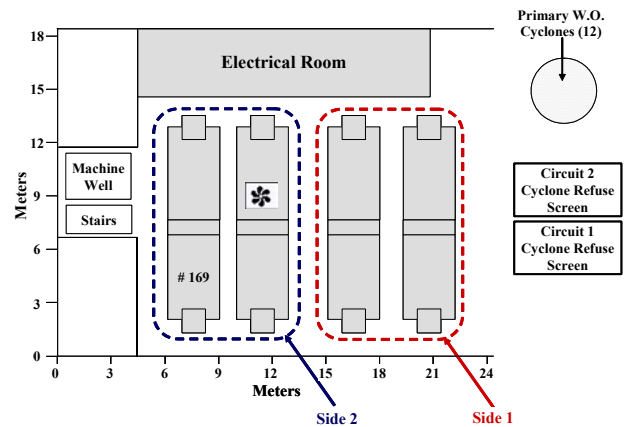
Figure 2. Overhead view of test area.

After the plant operation, test options, and available screens were discussed, a single 2.4 m x 4.9 m horizontal vibrating screen used to drain and rinse a 1 x 10 mesh cyclone clean coal product was selected as the test screen. The test screen, Screen #169, operates within a group of eight similar screens as shown in Figure 2. The plant is designed such that the eight screens are split into two groups of four screens, referred to as Side 1 and Side 2. The sound levels at any location within the test area are influenced by each of the eight screens. Ideally, the sound level around the test screen could be measured with only the test screen processing coal. However, the seven other screens cannot be turned off while processing coal on only the test screen. All of the screens from either Side 1 or Side 2 can be turned off while processing coal. In addition, one screen from Side 1 or Side 2 can be turned off while processing coal with the remaining screens. Therefore, without some means of reducing the contribution of the other screens to the sound level around the test screen, evaluating the sound levels due to the test screen and the noise reductions due to installing engineering controls would be impossible.

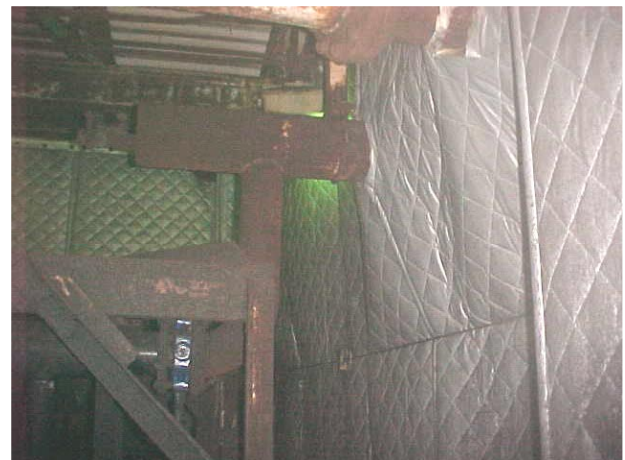
Figure 3. Barrier-absorber curtain between screen numbers 169 and 167 showing tight seal around piping.

In order to reduce the background sound levels around the test screen due to the nearby plant machinery, quilted barrier-absorbers consisting of two fiberglass layers with a loaded vinyl septum and covered in a nylon material were hung from the plant support beams around the test screen (see Figure 3). The barriers were attached to the support beams of the above floor with bolts through grommets. The barriers were sized such that they touched the floor when installed. The seams between individual barrier strips were sealed with Velcro, and gaps around pipe penetrations were kept to a minimum. The above steps were necessary to achieve the maximal reduction in the background noise near the test screen.

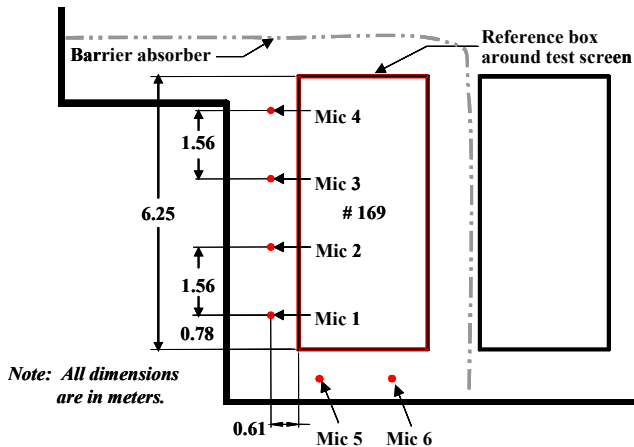
Figure 4. Overhead view of microphone positions around test screen (169) showing barrier-absorber curtain location.

Six microphones were positioned at a height of 1.5 meters and a distance of 0.6 meters from a reference box surrounding the test screen (see Figure 4). Four microphones were positioned along the left side of the test screen with two microphones behind the feed chute. Due

to the proximity of the barrier to the right side of the test screen, it was not possible to position microphones along the right side of the screen. Microphones could not be positioned at the discharge end of the screen between the test screen and Screen #170 due to the screen design. The data acquisition equipment was positioned in the corner of the building as shown in Figure 5.

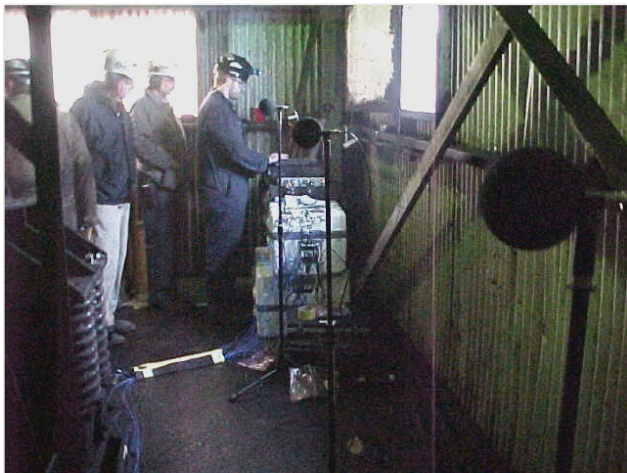
Figure 5. Data acquisition equipment location and microphones along left side of screen 169.

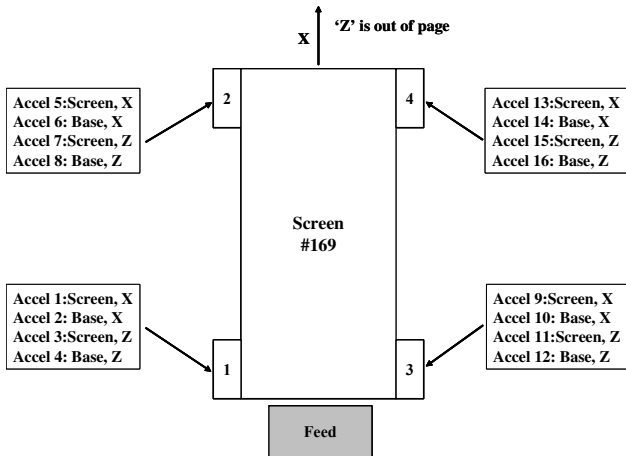
Figure 6. Accelerometer locations used during steel coil spring and rubber isolator testing.

After the barrier-absorber curtain was in place, sound level measurements were performed with new steel coil springs installed. To determine the effect of switching to rubber isolators on building vibration, accelerometers were attached to the screen at the steel coil spring locations on both the screen side and building side of the springs to measure accelerations in both the fore/aft (x) and vertical (z) directions as shown in Figure 6. Figure 7 shows the accelerometers at one mounting location with the steel coil springs (upper picture) and rubber isolators (lower picture).

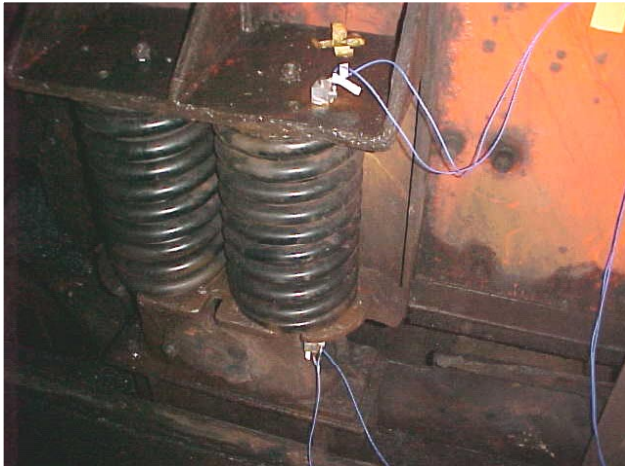
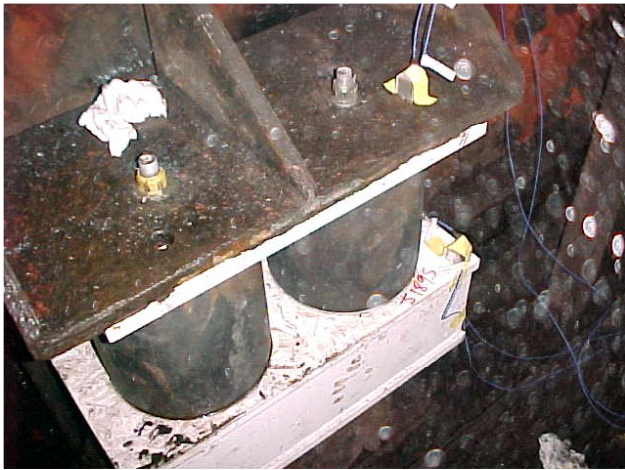
Figure 7. Accelerometers affixed to screen and base at isolator mount locations.

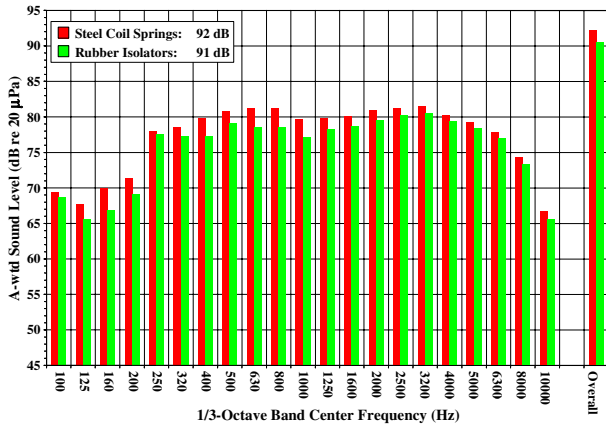
Figure 8. A-wtd 1/3-octave band sound levels for steel coil springs vs. rubber isolators, full operation.

Figures 8 and 9 show the background-noise-corrected A-weighted, 1/3-octave band sound levels due to the test screen for full operation and vibration only, respectively. The figures show that using rubber isolators reduced the overall sound level by 1 dB(A) for full operation and 2 dB(A) for vibration only operation. The figures show that small reductions occur throughout the 100 Hz to 10 kHz frequency range.

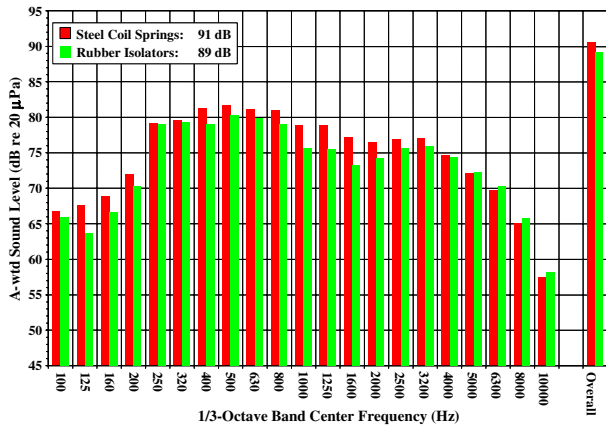
Figure 9. A-wtd 1/3-octave band sound levels for steel coil springs vs. rubber isolators, vibration only.

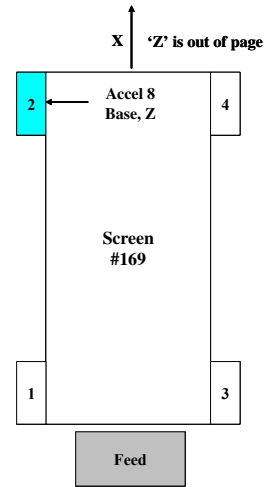
Figure 10. Location used to compare the acceleration time history with steel coil springs and rubber isolators.

To examine the vibration associated with noise radiation, the time waveform of the accelerometer signal on the building side of the mounting location highlighted in Figure 10 was compared for the steel coil springs and rubber isolators. Figure 11 shows the time waveform with the steel coil springs and with the rubber isolators. The figure shows that 15 impacts per second occurred with the

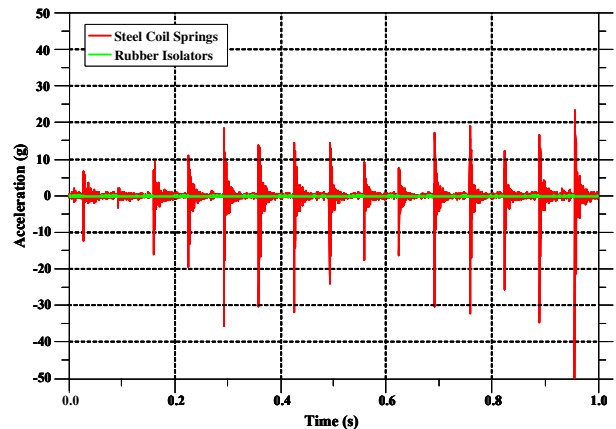
Figure 11. Acceleration in Z-direction at mount 2 with steel coil springs and rubber isolators.

steel coil springs. This impact rate corresponds with the rotation frequency of the vibration mechanisms. The impacts cause peak to peak high frequency vibrations on the order of 75 g at this location. Similar results were observed at the other mounting locations. The impacts could be due to contact between an inner and outer coil spring, a coil spring and its positioning disk, a friction check and the screen, or the screen and a fixed object such as a chute, pipe, or support structure. These impacts cause the screen and its support structure to vibrate and radiate noise. Therefore, these impacts must be eliminated to reduce screen noise in the most efficient manner.

Upon the re-installation of the steel coil springs, vibration measurements were taken at the spring mounting locations to determine the cause of the steel-on-steel impacts observed in the original data (refer to Figure 11). The steel-on-steel impacts were not observed at this time. It is possible that the original test data were influenced by an installation problem with the springs, which would increase the sound level around the screen. It is also possible that during the year that had passed any high spots on the gears in the rebuilt mechanisms had worn away resulting in smoother tooth engagement. In addition, with the rubber isolators, more vibration was transmitted to the building which could have increased the drive noise. Proper installation of the steel coil springs may have eliminated the steel-on-steel impacts and reduced the vibration transmitted to the building, thus decreasing the noise radiated by the screen and the building.

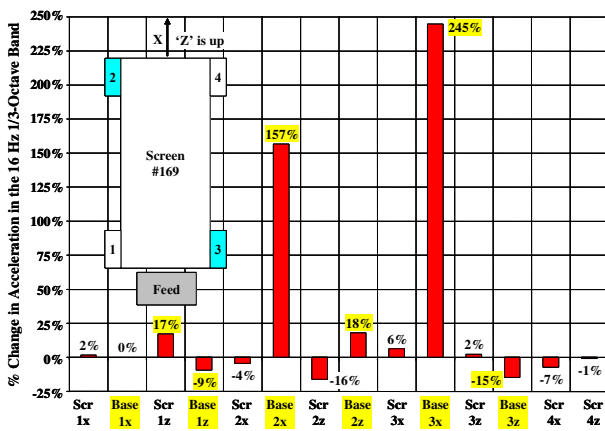
**Figure 12. Percentage change in the acceleration in the 16 Hz 1/3-octave band due to replacing steel coil springs with rubber isolators.**

rotation frequency. These low frequency vibrations can be a concern with respect to building vibration. Figure 12 shows the percentage change in the accelerations in the 16 Hz 1/3-octave band for the fore/aft (x) and vertical (z) directions on both the building (base) and screen side of each mount. The figure shows that the building vibration at the left mount on the discharge end and the right mount on the feed end of the screen increased substantially. Subjectively, an increase in the building vibration could be felt in the corner of the building where the acquisition equipment was located. The low frequency vibration with the rubber isolators was significantly higher than with the steel coil springs, even though the high frequency vibrations were lower with the rubber isolators.

The increase in building vibration is probably due to a difference between the system spring rates with the rubber isolators and the steel coil springs. With the steel coil springs, two sets of inner and outer springs are used at each mount at the discharge end whereas one inner and outer spring and a third spring are used at each mount on the feed end. However, with this arrangement, the product of the feed end spring rate with the distance from the feed end mounting location to the screen center of gravity is equal to the product of the discharge end screen rate with the distance from the discharge end mounting location to the screen center of gravity. In this case, the translational and rotational motions of the screen are decoupled so the screen motion is primarily translational in the direction of the force applied by the eccentric mechanisms.

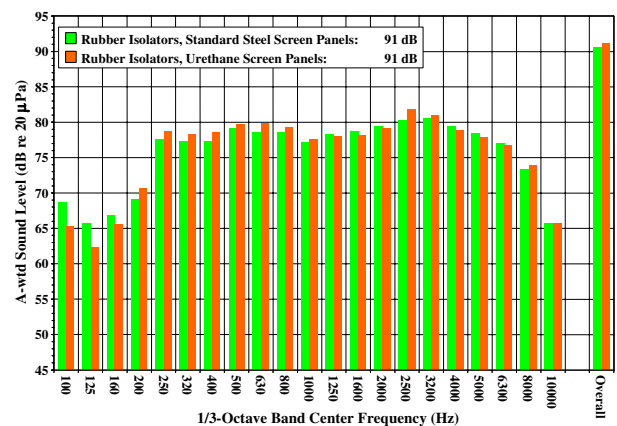
**Figure 13. A-wtd 1/3-octave band sound levels for standard steel screen panels vs. urethane screen panels with rubber isolators, processing coal.**

Following the tests with the rubber isolators, the steel screen panels were replaced with urethane screen panels. Sound level measurements were then performed with the screens processing coal. Figure 13 shows the background-noise-corrected A-weighted 1/3-octave band sound levels with the standard and urethane screen panels. A slight increase in sound level was observed. However, the increase was only a few tenths of a decibel, which is within measurement error. The figure indicates that the urethane screen panels did not reduce the sound level around the test screen in this case. These results are consistent with the findings of a 1977 report to the Bureau of Mines which states that particle size must ordinarily be greater than 12 mm diameter before coal impact noise exceeds 90 dB(A) near a screen (Rubin, 1997). Generally, coal flow noise is dominant in screens handling coarse coal, while noise due to the drive mechanism, which may be radiated by the screen body or mechanism housings, is the most significant noise source in screens handling finer coal (Ungar et al., 1976).

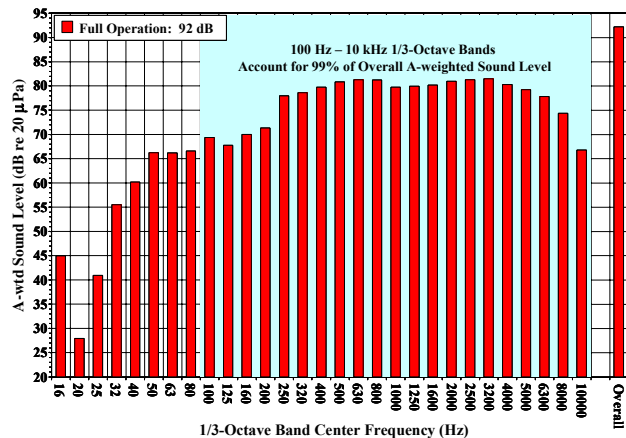
Figure 14. A-wtd 1/3-octave band sound levels for test screen while processing coal.

Figure 14 shows the A-weighted 1/3-octave band sound levels for the test screen with the steel coil springs and standard steel return deck while processing coal. The figure shows that the sound level in the 16 Hz 1/3-octave band, which contains the mechanism rotation frequency, is unimportant in terms of the overall A-weighted sound level. The 100 Hz through 10 kHz 1/3-octave bands, however, account for 99% of the overall A-weighted sound level under full operation. Therefore, emphasis was placed on this frequency range in determining the contributions of each noise source on the screen.

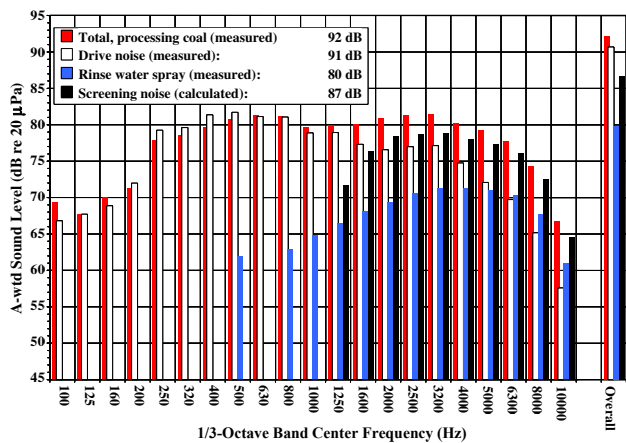
**Figure 15. A-wtd 1/3-octave band sound levels for the total screen noise, drive noise, rinse water spray noise, and screening noise.**

The A-weighted 1/3-octave band sound levels for the total screen noise, drive noise, rinse water spray noise, and screening noise are shown in Figure 15. The figure shows that drive noise is dominant in the 100 Hz through 1600 Hz 1/3-octave bands, whereas screening noise is dominant above the 1600 Hz 1/3-octave band. Therefore, the most effective approach to reduce the sound level around the screen would be to first address the drive noise in the 100 Hz through 1600 Hz 1/3-octave bands. Once the sound level due to drive noise is reduced to 87 dB(A), drive noise and screening noise would be equal contributors to the sound level around the screen during full operation. At this time, a decision would have to be made regarding which of these two noise sources would be most easily addressed to further reduce sound levels, if necessary.

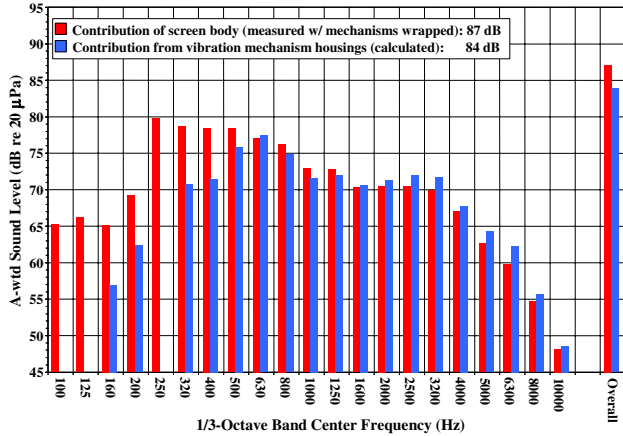
Figure 16. A-wtd 1/3-octave band sound levels for noise radiated by screen body and mechanism housings.

Figure 16 shows the A-weighted 1/3-octave band sound levels due to screen body and mechanism housing vibration. The sound levels due to screen body and mechanism housing vibration were found to be 87 dB(A) and 84 dB(A), respectively. Since a 3-dB difference in levels indicates a doubling of energy, screen side vibration can be said to have twice the significance of mechanism housing vibration in terms of drive noise. The spectra indicate that the noise radiated by the screen body is dominant in the 100 through 500 Hz 1/3-octave bands. The screen sides account for 83% of the sound energy for this band. In the 630 Hz through 1600 Hz 1/3-octave bands, the figure shows that the screen sides and mechanism housings generate similar sound levels with each contributing approximately 50% to the drive noise in this frequency range. In the 2 kHz through 10 kHz 1/3-octave bands, the sound levels due to mechanism housing

vibration are higher than those associated with screen side vibration. Mechanism housing vibration accounts for 58% of the drive noise sound level in this frequency range.

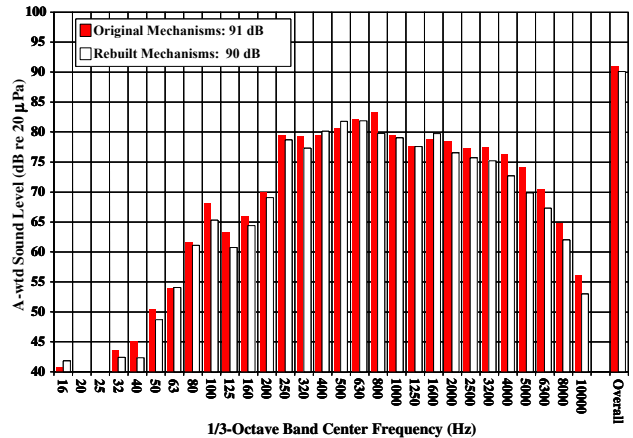
Figure 17. A-wtd 1/3-octave band sound levels for vibration only operation with original and rebuilt mechanisms.

Figure 17 shows the 1/3-octave band sound levels with the original and rebuilt mechanisms. The figure indicates that installing the rebuilt mechanisms reduced the overall A-weighted sound level by 1 dB. According to the screen manufacturer and the coal company, installing rebuilt mechanisms costs approximately \$10,000. The results suggest that the cost associated with installing a set of rebuilt mechanisms is high relative to the observed sound level reduction.

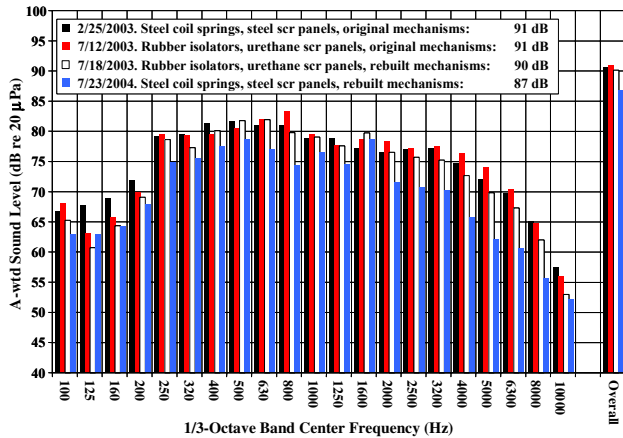
**Figure 18. Comparison of sound levels with original or rebuilt mechanisms, steel coil springs or rubber isolators, and steel or urethane screen panels for several test dates.**

Due to the increased building vibration with the rubber isolators, the mounts were switched back to the steel coil springs. In addition, the urethane screen panels were removed and standard steel screen panels were installed since the urethane screen panels did not reduce the sound levels and were prone to plugging. After approximately one year, a new set of measurements was performed to establish the baseline sound levels for the screen operating with vibration only with the steel coil springs and steel deck. The measurements were performed on a maintenance day with the plant shut down. At this time, an unexpected result was observed. The vibration only sound levels for the test screen with the steel coil springs and rebuilt mechanism decreased to 87 dB(A), a 4-dB reduction compared to the original measurements from February 25, 2003. Figure 18 shows a comparison of the vibration only sound levels with (1) steel coil springs, steel screen panels, and the original mechanisms, (2) rubber isolators, urethane screen panels, and the original mechanisms, (3) rubber isolators, urethane screen panels, and the rebuilt mechanisms, and (4) steel coil springs, steel screen panels, and the rebuilt mechanisms. The test dates for these data were February 25, 2003, July 12, 2003, July 18, 2003, and July 23, 2004, respectively.

The figure shows that the average sound level measured on February 25, 2003, with new coil springs, the steel return deck, and the original mechanisms was 91 dB(A). When testing was conducted within a 1-week period (July 12, 2003, and July 18, 2003) with the original versus rebuilt mechanisms with rubber isolators and urethane screen panels, the sound levels were 91 and 90 dB(A), respectively. However, after the steel coil springs replaced the rubber isolators and the steel screen panels replaced the urethane screen panels and one year had passed since the installation of the rebuilt mechanisms, the sound level for vibration only operation was 87 dB(A).

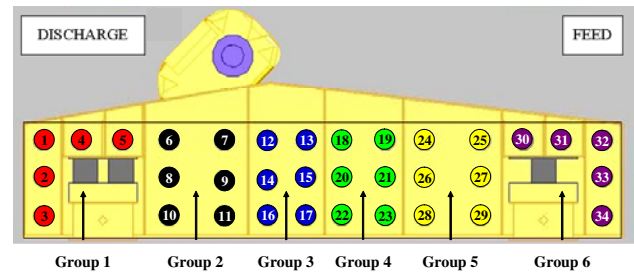
**Figure 19. Approximate accelerometer locations used for vibration measurements on the left side of the screen.**

Prior to constructing the damped side plates, a series of vibration measurements was performed on the left side of the screen to determine the relative vibration levels along the side of the screen. The goal was to determine if constrained layer damping was necessary on the entire side plate or if some areas, which had insignificant vibration levels, could be left untreated. The left side was divided into six areas and a group of accelerometers was attached to each area as shown in Figure 19.

The test screen was operated with vibration and without coal. Since noise radiation is directly related to the surface-averaged velocity, the resulting 1/3-octave band accelerations were integrated to yield vibratory velocities, and the surface-averaged A-weighted velocity levels for the six areas were calculated (see Figure 20). A-weighting was applied to the vibratory velocities to deemphasize low frequency vibration, which is not a significant contributor to the A-weighted sound level in this case. The figure shows that the velocity levels are highest in the 100 Hz through 400 Hz 1/3-octave bands for the Group 2 and Group 5 accelerometers. However, above the 500 Hz 1/3-octave band, the variation in vibration levels from group to group is generally less than 10 dB. Therefore, each area is a significant contributor to the drive noise radiated by the screen sides and should be treated.

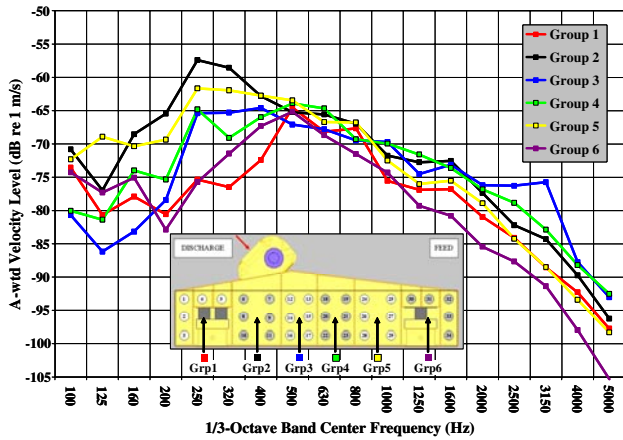
Figure 20. A-weighted surface-averaged velocity levels.

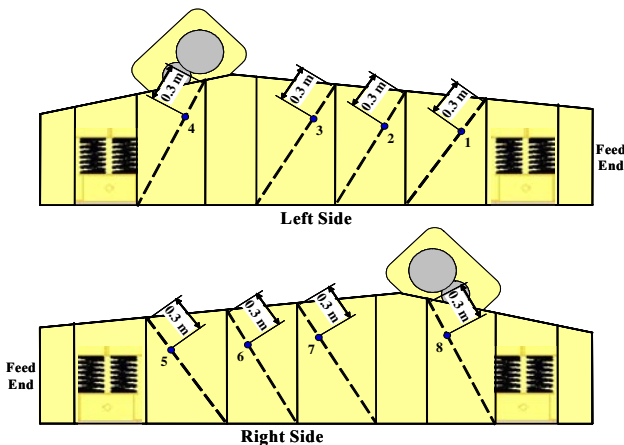
Constrained layer damped side plates were constructed by bonding a layer of viscoelastic damping material to new side plates using epoxy. A 1/8-inch-thick layer of steel was then attached to the viscoelastic material with epoxy to complete the construction. Mechanism covers were fabricated from a barrier-absorber material similar to the material used to exclude background noise from the test area during the initial tests. Prior to installing the damped side plates, baseline sound level measurements were taken during miner's vacation with the plant shut down and the test screen operating with vibration only. In addition, acceleration measurements were taken on the sides of the screen at the locations shown in Figure 21.

Figure 21. Accelerometer locations used to evaluate the effects of installing constrained layer damped side plates.

mechanism covers and damped screen sides installed with the plant shut down and the test screen operating with vibration only. The mechanism covers were then removed and the measurements were repeated. In addition, acceleration measurements were performed at the locations shown in Figure 21 for comparison with the baseline vibration measurements collected in July.

To evaluate the effects of the damping treatment on the screen side vibration, the average A-weighted vibration velocity levels for the left and right sides of the screen were calculated from the measured accelerations at the locations shown in Figure 21. Although the aforementioned problems with the screen installation would tend to increase the radiated noise, it was thought that the damping treatment would still reduce the screen side vibration. This is because both of the installation problems would tend to cause additional noise to be radiated from the building and from local areas more than from the screen sides. Figures 23 and 24 show the A-weighted 1/3-octave band vibration levels on the left and right sides of the screen, respectively. Figure 23 shows reductions in the A-weighted velocity levels on the left screen side ranging from 2 to 7 dB in the 200 Hz through 5 kHz 1/3-octave bands with the damped sides. For the right screen side, Figure 24 indicates reductions of 1 to 6 dB in the 200 Hz through 5 kHz 1/3-octave bands. In the 200 Hz through 630 Hz 1/3-octave bands, the A-weighted vibration levels were reduced by 3 dB on the left side and 4 dB on the right side. The A-weighted vibration levels in the 800 Hz through 5 kHz 1/3-octave bands were reduced by 6 dB on the left side and 3 dB on the right side. With these substantial reductions, the A-weighted sound levels should have been reduced by 3 dB or more. More research should be performed to evaluate the effects of mechanism covers and the damped sides on the radiated sound levels.

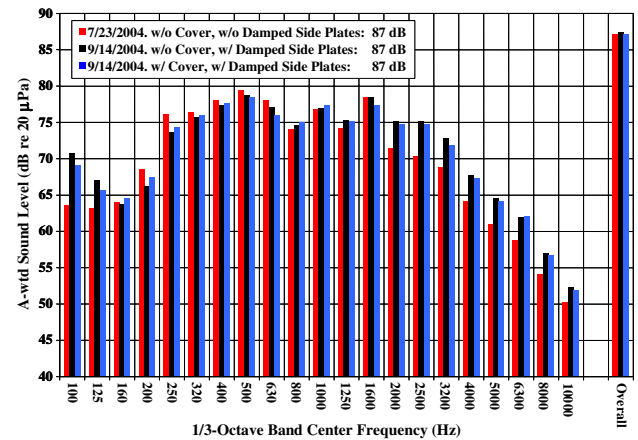
Figure 22 shows the A-weighted 1/3-octave band sound levels for baseline conditions and with the engineering noise controls installed. As the figure shows, neither the damped side plates alone nor the damped side plates and mechanism covers reduced the overall A-weighted sound level. It was expected that the sound level would be reduced by 3 dB or more. The figure shows that the sound levels in the 200 Hz through 630 Hz 1/3-octave bands were reduced by 1 to 2 dB with the damped side plates. With the damped sides and mechanism covers, the reductions in this band were again 1 to 2 dB. In the 800 Hz through 10 kHz 1/3-octave bands, the sound levels measured with the engineering controls installed increased from 83 dB(A) to 84 dB(A). Since it is unlikely that installing these noise controls would increase the sound levels in these bands, something must have changed with the vibrating screen during the period between baseline testing in July, 2004, and the testing with the noise controls in September, 2004.

Figure 22. A-wtd 1/3-octave band sound levels with vibration only operation for mechanism cover and damped side plate tests.

Further investigation of the screen revealed a possible cause for the increase in sound levels. One of the inner springs on the discharge end of the screen was broken when the damped side plates were installed. As a result, only three springs were installed on the right side of the discharge end when the damped side plates were installed. With three springs at this location, it is likely that the screen would undergo a pitching/rolling motion that could

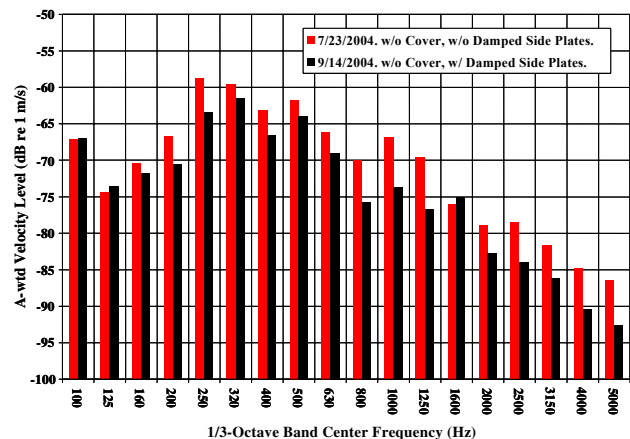
Figure 23. A-weighted average velocity on left side of the screen without and with damped sides.

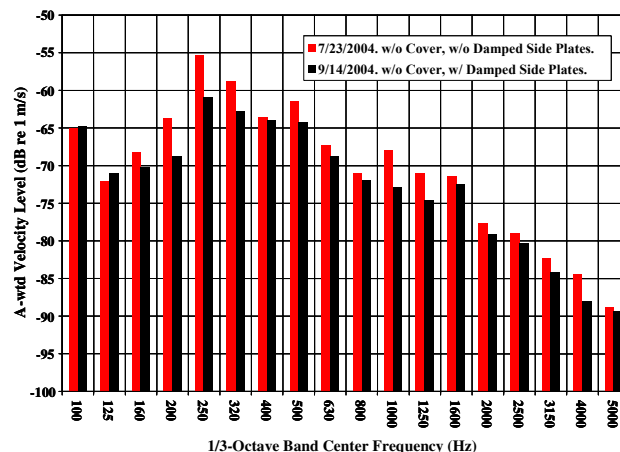
Figure 24. A-weighted average velocity on right side of the screen without and with damped sides.
