Asbestos exposure from the overhaul of a Pratt & Whitney R2800 engine

This study assessed the asbestos exposures of airplane piston engine mechanics while performing overhaul work on a Pratt & Whitney R2800 radial engine, with tools and practices in use since the time these engines were manufactured. Approximately 40% of the bulk samples collected during this test were found to contain chrysotile. Air samples were collected during the overhaul and were analyzed by phase contrast microscopy (PCM) and transmission electron microscopy (TEM). The average worker exposure during disassembly was 0.0272 f/ml (PCM) and ranged from 0.0013 to 0.1240 f/ml (PCM) during an average sample collection time of 188 min. The average worker exposure during reassembly was 0.0198 f/ml (PCM) and ranged from 0.0055 to 0.0913 f/ml (PCM) during an average sample collection time of 222 min. Only one worker sample (during reassembly) was found to contain asbestos at a concentration of 0.0012 f/ml (PCME). Similar results should be found in other aircraft piston engines that use metal clad and non-friable asbestos gaskets, which are the current standard in aircraft piston engines.

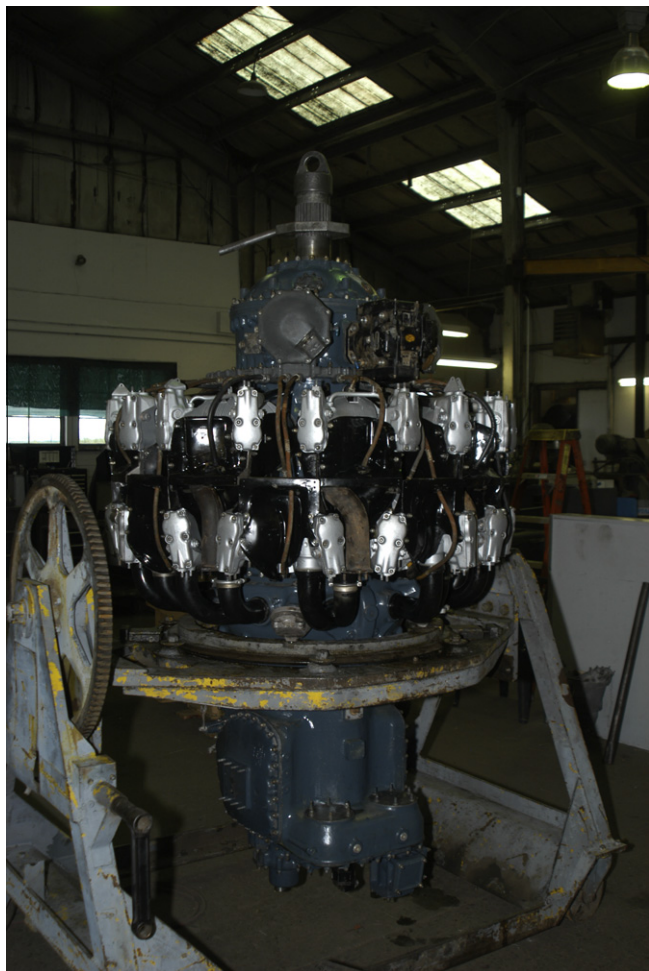
Fig. 1. Pratt & Whitney R2800-30W engine used in the present study. The engine is pictured at the completion of the study supported in a maintenance frame.

The airplane piston engine type used for this study was the Pratt & Whitney R2800 model, produced from approximately 1939 until 1960. Over 125,000 of this engine type were manufactured during this time period. The R2800 model was selected for this study because it was the main airplane engine produced by Pratt & Whitney during World War II. The right to produce this engine was granted by Pratt & Whitney to other companies, including Nash, Kelvinator, Ford, and Chevrolet. The R2800 airplane piston engine used in this study had not been overhauled since 1960 and had a complete use and service series of log books. The particular engine used in this project was an R2800-30W, Serial Number P28335. The suffix denotes the type of supercharger (blower) unit attached, and this, in turn, depends on the particular aircraft that used the engine, and that aircraft's purpose. A photograph of the engine used is presented as Fig. 1.
