Noise and vibration reduction of a vibrating screen

D.S. Yantek, P. Jurovcik and E.R. Bauer

Mechanical Engineer, general engineer and mining engineer, respectively,
NIOSH, Pittsburgh, Pennsylvania

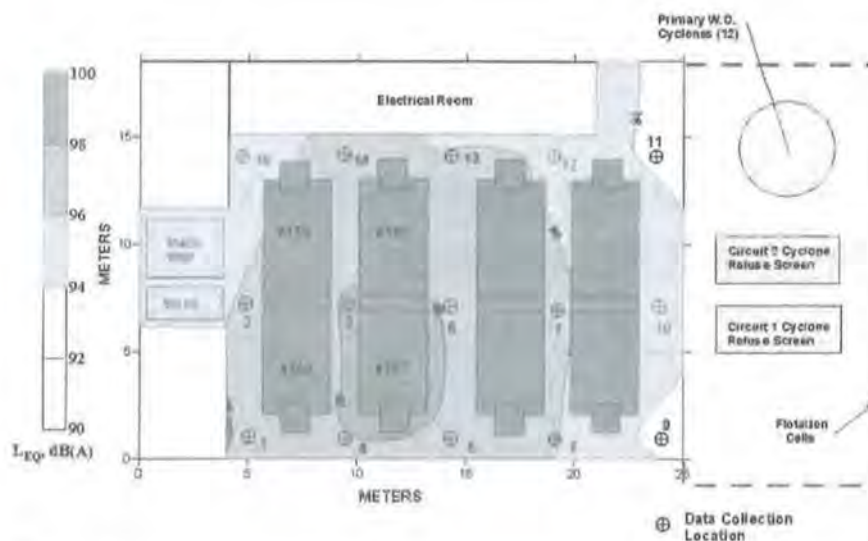
Figure 1 — Contour plot of the A-weighted sound levels around a group of eight clean coal screens.

The consortium selected a coal preparation plant for the study based on its proximity to all of the involved researchers. In the selected plant, preliminary measurements were made in the area surrounding a group of eight horizontal vibrating screens used to process clean coal. These measurements indicated that the sound levels ranged from 94 to 98 dB(A) with the plant processing coal (see Fig. 1) and from 89 to 97 dB(A) without the plant processing coal and the screens operating with vibration only. The sound levels decrease significantly with increasing distance from the screens, indicating that the screens dominate the overall A-weighted sound level in this area of the preparation plant. To reduce the potential for overexposing preparation-plant workers to noise, the collaborators agreed to test several commonly used engineering noise controls for vibrating screens. In addition, the collaborators initiated a research effort to rank the noise sources on one of the horizontal vibrating screens and to develop engineering noise controls to address the dominant noise sources.

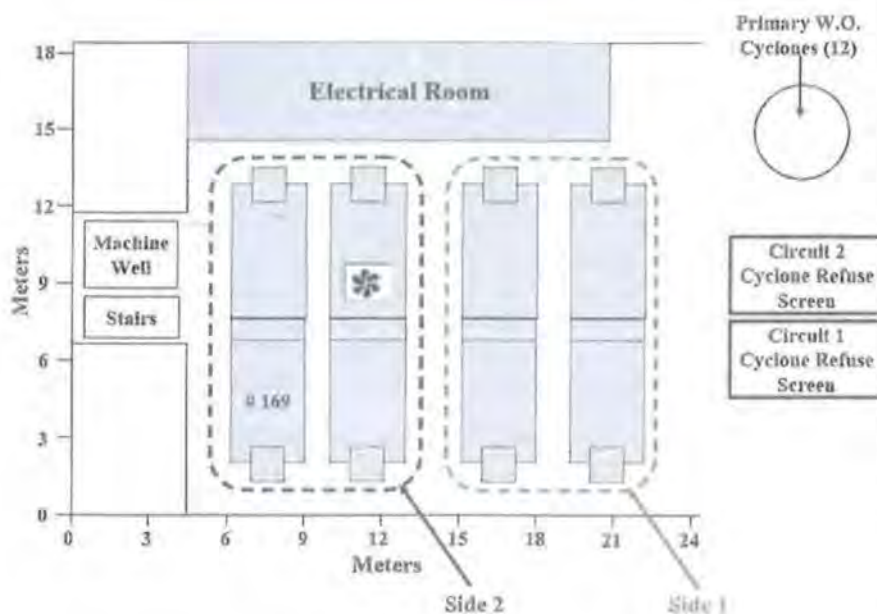
Figure 2 — Overhead view of test area.

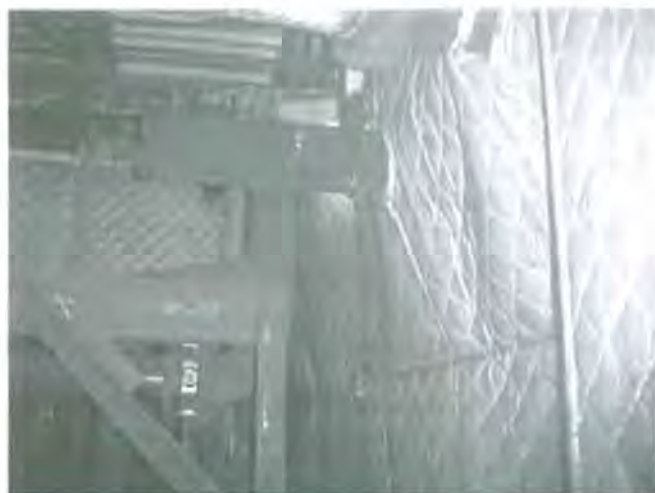
Figure 3 — Barrier-absorber curtain between Screens 169 and 167 showing tight seal around piping.

To reduce the background sound levels around the test screen due to the nearby plant machinery, quilted barrier-absorbers consisting of two fiberglass layers with a loaded vinyl septum and covered in a nylon material were hung from the plant support beams around the test screen (see Fig. 3). The barriers were attached to the support beams of the above floor with bolts through grommets. The barriers were sized such that they touched the floor when installed. The seams between individual barrier strips were sealed with Velcro, and gaps around pipe penetrations were kept to a minimum. The above steps were necessary to achieve the maximal reduction in the background noise near the test screen.

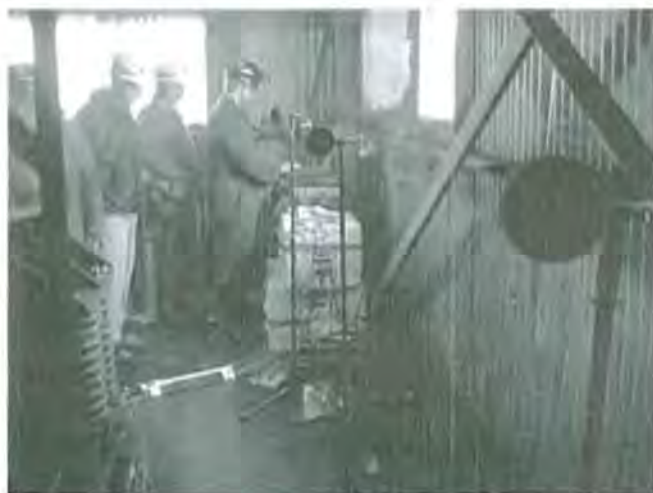
Figure 5 — Data acquisition equipment location and microphones along left side of Screen 169.

Six microphones were positioned at a height of 1.5 m (5 ft) and a distance of 0.6 m (2 ft) from a reference box surrounding the test screen (see Fig. 4). Four microphones were positioned along the left side of the test screen with two microphones behind the feed chute. Due to the proximity of the barrier to the right side of the test screen, it was not possible to position microphones along the right side of the screen. Microphones could not be positioned at the discharge end of the screen between the test screen and Screen 170 due to the screen design. The data-acquisition equipment was positioned in the corner of the building as shown in Fig. 5.

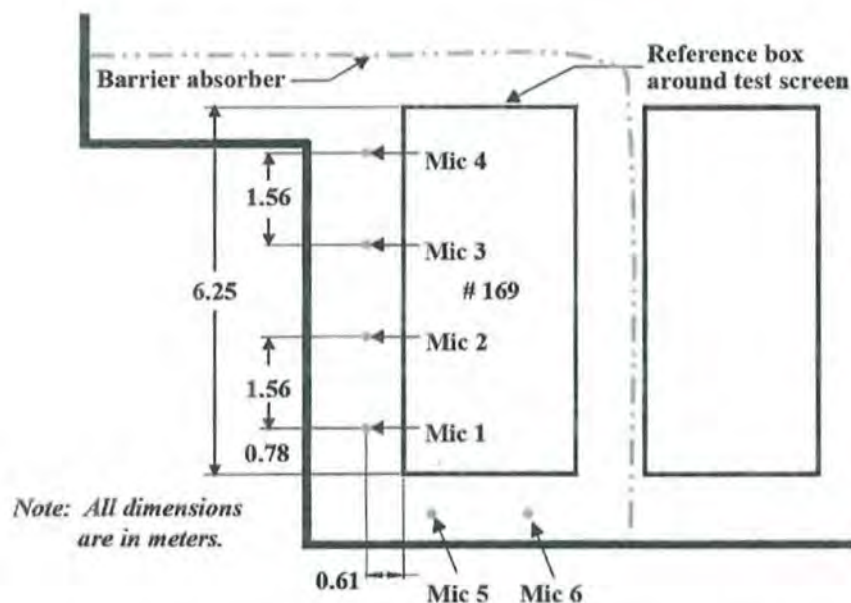
Figure 4 — Overhead view of microphone positions around test Screen 169 showing barrier-absorber curtain location.

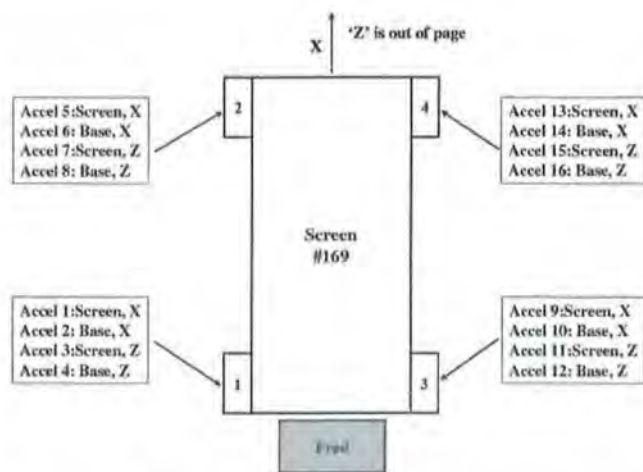
Figure 6 — Accelerometer locations used during steel coil spring and rubber isolator testing.

Steel coil springs vs. rubber isolators. After the barrier-absorber curtain was in place, sound-level measurements were performed with new steel coil springs installed. To determine the effect of switching to rubber isolators on building vibration, accelerometers were attached to the screen at the steel coil spring locations on both the screen side and building side of the springs to measure accelerations in both the fore/aft (x) and vertical (z) directions as shown in Fig. 6. Figure 7 shows the accelerometers at one mounting location with the steel coil springs (upper picture) and rubber isolators (lower picture).

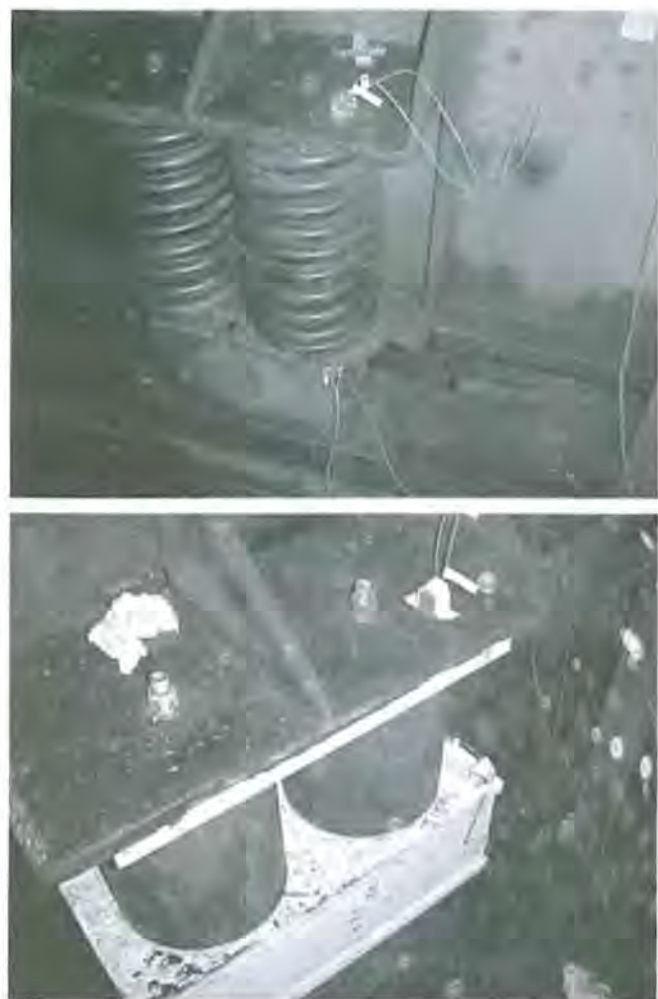
Figure 7 — Accelerometers affixed to screen and base at isolator mount locations.

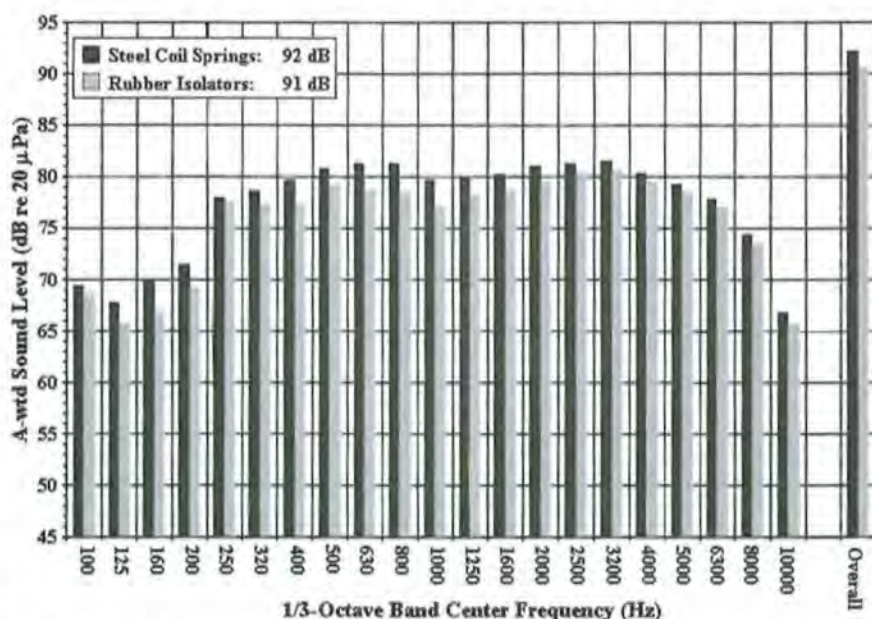
Figure 8 — A-weighted 1/3-octave band sound levels for steel coil springs vs. rubber isolators, full operation.

Figures 8 and 9 show the background-noise-corrected A-weighted 1/3-octave band sound levels due to the test screen for full operation and vibration only, respectively. The figures show that using rubber isolators reduced the overall sound level by 1 dB(A) for full operation and 2 dB(A) for vibration only operation. The figures show that small reductions occur throughout the 100 to 10 kHz frequency range.

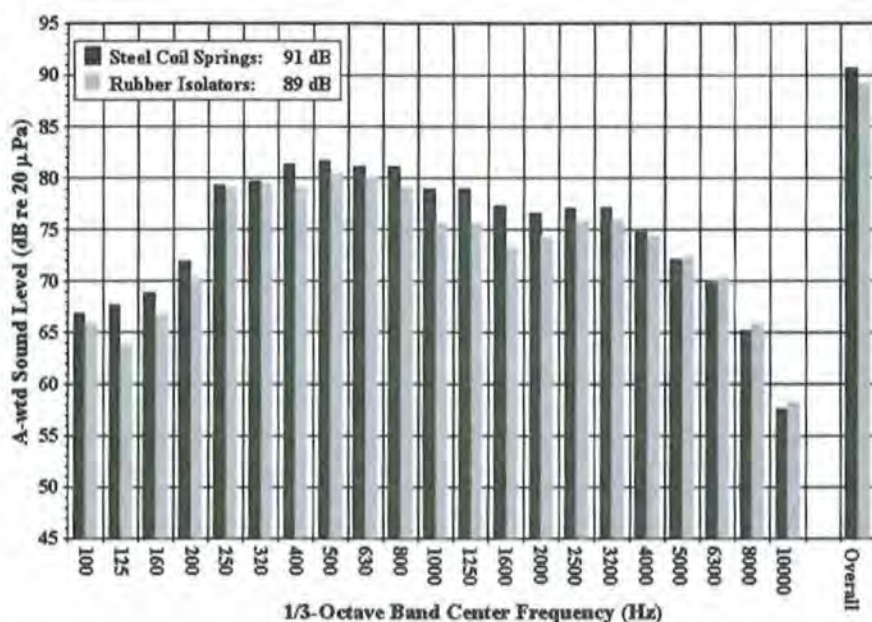
Figure 9 — A-weighted 1/3-octave band sound levels for steel coil springs vs. rubber isolators, vibration only.

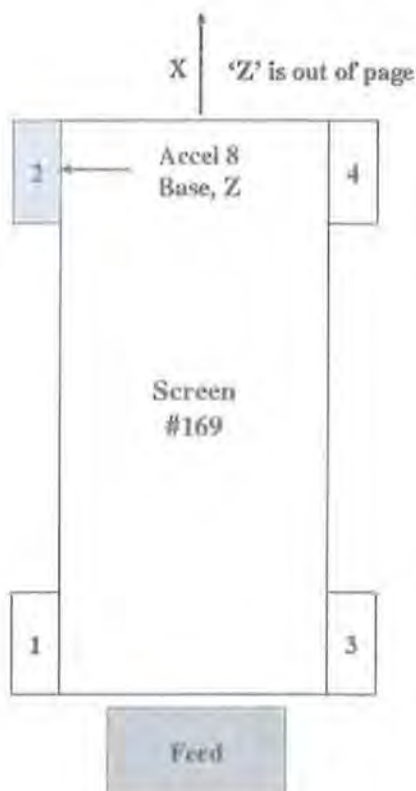
Figure 10 — Location used to compare the acceleration time history with steel coil springs and rubber isolators.

To examine the vibration associated with noise radiation, the time waveform of the accelerometer signal on the building side of the mounting location highlighted in Fig. 10 was compared for the steel coil springs and rubber isolators.

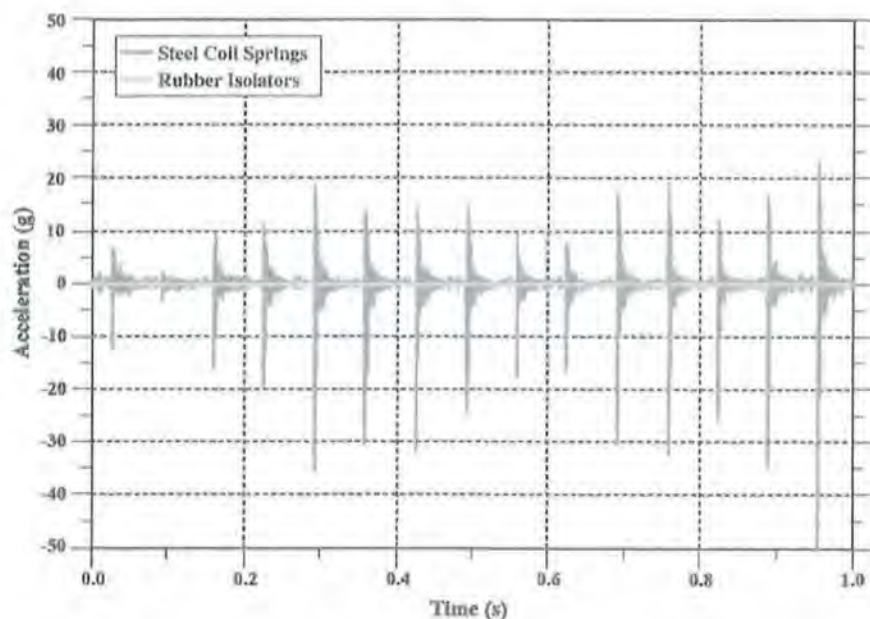
Figure 11 — Acceleration in Z-direction at Mount 2 with steel coil springs and rubber isolators.

Figure 11 shows the time waveform with the steel coil springs and with the rubber isolators. The figure shows that 15 impacts per second occurred with the steel coil springs. This impact rate corresponds with the rotation frequency of the vibration mechanisms. The impacts cause peak-to-peak high-frequency vibrations on the order of 75 g at this location. Similar results were observed at the other mounting locations.

The impacts could be due to contact between an inner and outer coil spring, a coil spring and its positioning disk, a friction check and the screen, or the screen and a fixed object such as a chute, pipe, or support structure. These impacts cause the screen and its support structure to vibrate and radiate noise. Therefore, these impacts must be eliminated to reduce screen noise in the most efficient manner.

On the reinstallation of the steel coil springs, vibration measurements were taken at the spring mounting locations to determine the cause of the steel-on-steel impacts observed in the original data (refer to Fig. 11). The steel-on-steel impacts were not observed at this time. It is possible that the original test data were influenced by an installation problem with the springs, which would increase the sound level around the screen. It is also possible that during the year that had passed, any high spots on the gears in the rebuilt mechanisms had worn away resulting in smoother tooth engagement. In addition, with the rubber isolators, more vibration was transmitted to the building, which could have increased the drive noise. Proper installation of the steel coil springs may have eliminated the steel-on-steel impacts and reduced the vibration transmitted to the building, thus decreasing the noise radiated by the screen and the building.

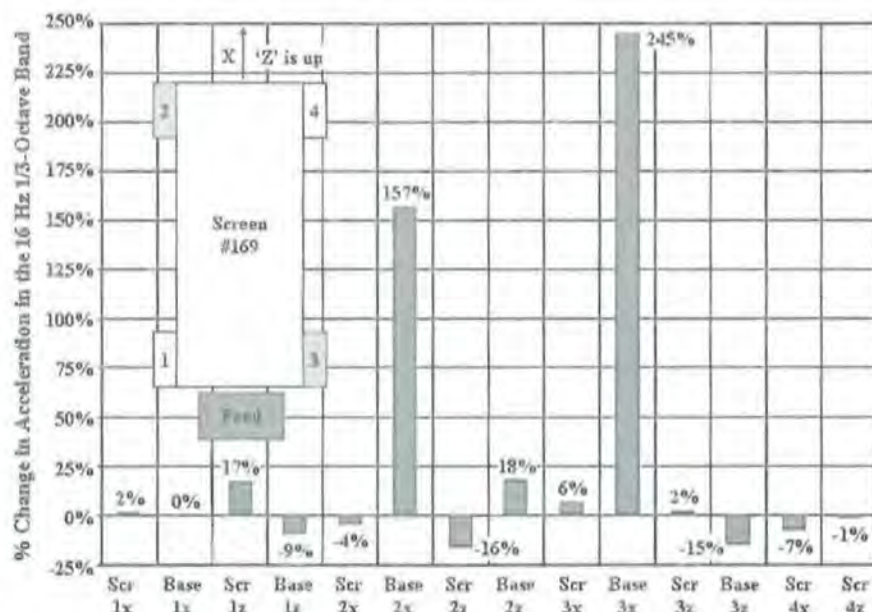
Figure 12 — Percentage change in the acceleration in the 16 Hz 1/3-octave band due to replacing steel coil springs with rubber isolators.

Figure 12 shows the percentage change in the accelerations in the 16 Hz 1/3-octave band for the fore/aft (x) and vertical (z) directions on both the building (base) and screen side of each mount. The figure shows that the building vibration at the left mount on the discharge end and the right mount on the feed end of the screen increased substantially. Subjectively, an increase in the building vibration could be felt in the corner of the building where the acquisition equipment was located. The low-frequency vibration with the rubber isolators was significantly higher than with the steel coil springs, even though the high-frequency vibrations were lower with the rubber isolators.

The increase in building vibration is probably due to a difference between the system spring rates with the rubber isolators and the steel coil springs. With the steel coil springs, two sets of inner and outer springs are used at each mount at the discharge end whereas one inner and outer spring and a third spring are used at each mount on the feed end. However, with this arrangement, the product of the feed end spring rate with the distance from the feed end mounting location to the screen center of gravity is equal to the product of the discharge end screen rate with the distance from the discharge end mounting location to the screen center of gravity. In this case, the translational and rotational motions of the screen are decoupled so the screen motion is primarily translational in the direction of the force applied by the eccentric mechanisms.

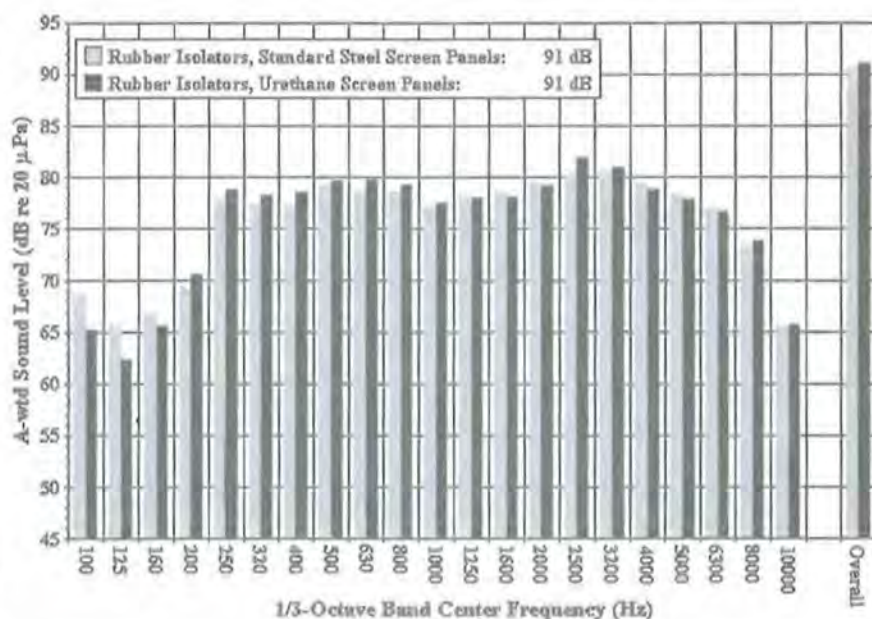
Figure 13 — A-weighted 1/3-octave band sound levels while processing coal with standard steel screen panels or urethane screen panels and rubber isolators coal.

ing coal. Figure 13 shows the background-noise-corrected A-weighted 1/3-octave band sound levels with the standard and urethane screen panels. A slight increase in sound level was observed. However, the increase was only a few tenths of a decibel, which is within measurement error. The figure indicates that the urethane screen panels did not reduce the sound level around the test screen in this case. These results

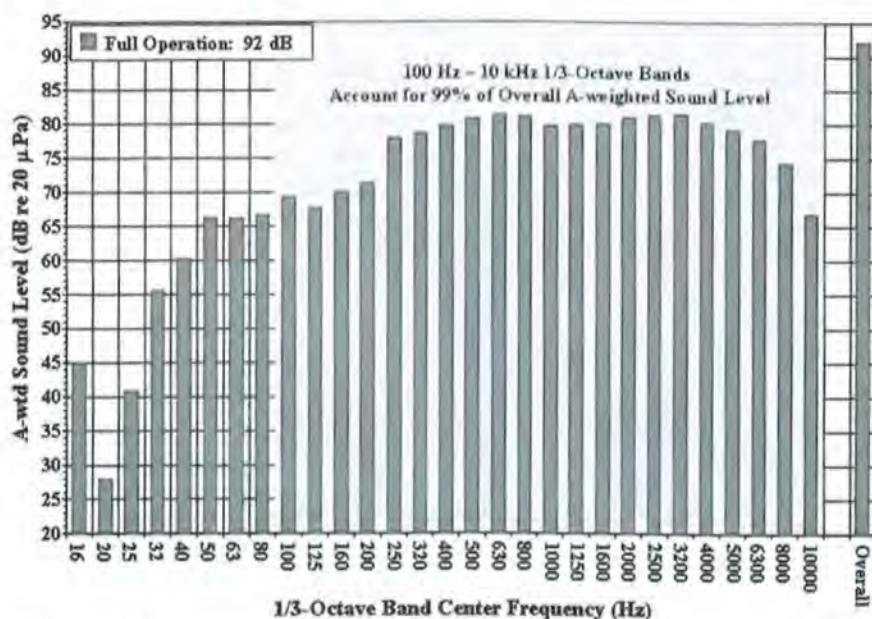
Figure 14 — A-weighted 1/3-octave band sound levels for test screen while processing coal.

Contributions of major noise sources. Figure 14 shows the A-weighted 1/3-octave band sound levels for the test screen with the steel coil springs and standard steel return deck while processing coal. The figure shows that the sound level in the 16 Hz 1/3-octave band, which contains the mechanism rotation frequency, is unimportant in terms of the overall A-weighted sound level. The 100 Hz through 10 kHz 1/3-octave bands, however, account for 99% of the overall A-weighted sound level under full operation. Therefore, emphasis was placed on this frequency range in determining the contributions of each noise source on the screen.

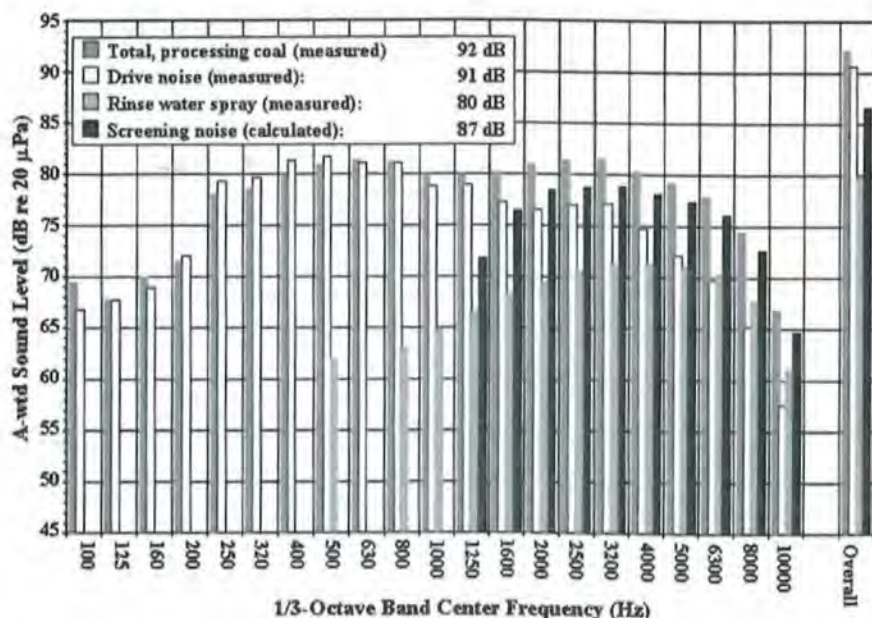
Figure 15 — A-weighted 1/3-octave band sound levels for the total screen noise, drive noise, rinse water spray noise, and screening noise.

The A-weighted 1/3-octave band sound levels for the total screen noise, drive noise, rinse-water spray noise and screening noise are shown in Fig. 15. The figure shows that drive noise is dominant in the 100 through 1,600 Hz 1/3-octave bands, whereas screening noise is dominant above the 1,600 Hz 1/3-octave band. Therefore, the most effective approach to reduce the sound level around the screen would be to first address the drive noise in the 100 through 1,600 Hz 1/3-octave bands. Once the sound level due to drive noise is reduced to 87 dB(A), drive noise and screening noise would be equal contributors to the sound level around the screen during full operation. At this time, a decision would have to be made regarding which of these two noise sources would be most easily addressed to further reduce sound levels, if necessary.

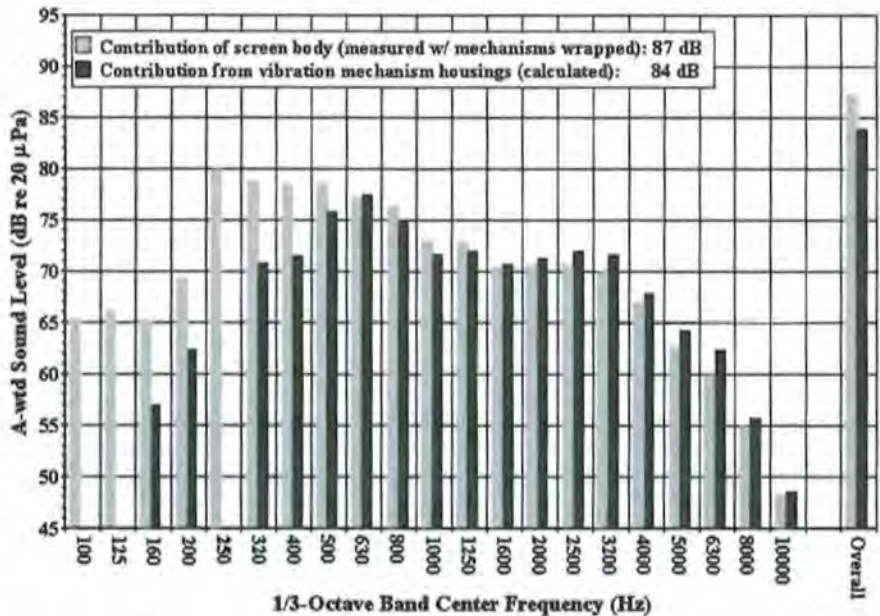
Figure 16 — A-weighted 1/3-octave band sound levels for noise radiated by screen body and vibration mechanism housings.

Figure 16 shows the A-weighted 1/3-octave band sound levels due to screen body and mechanism housing vibration. The sound levels due to screen body and mechanism housing vibration were found to be 87 and 84 dB(A), respectively. Because a 3-dB difference in levels indicates a doubling of energy, screen side vibration can be said to have twice the significance of mechanism housing vibration in terms of drive noise. The spectra indicate that the noise radiated by the screen body is dominant in the 100 through 500 Hz 1/3-octave bands. The screen sides account for 83% of the sound energy for this band. In the 630 through 1,600 Hz 1/3-octave bands, the figure shows that the screen

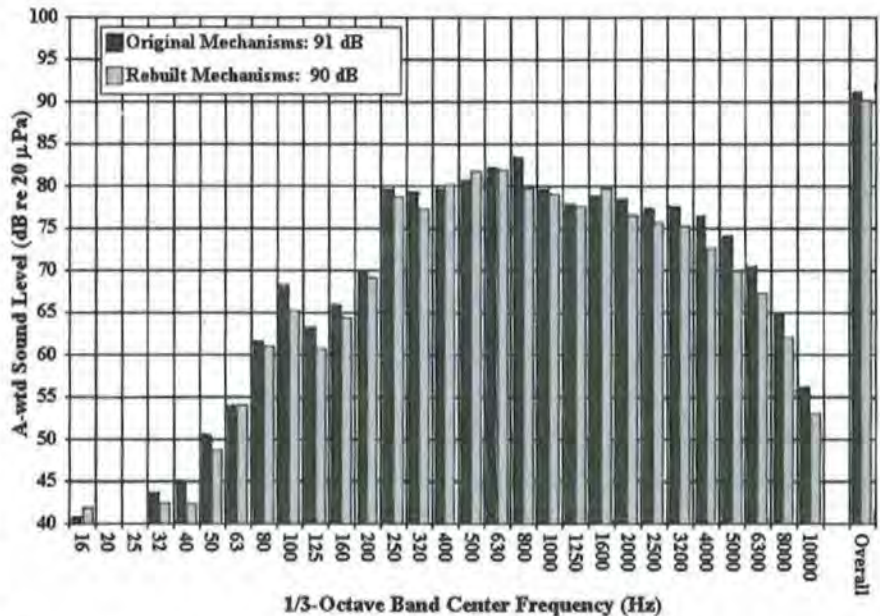
Figure 17 — A-weighted 1/3-octave band sound levels for vibration only operation with original and rebuilt mechanisms.

Baseline sound levels were measured with the existing set of mechanisms, the rubber isolators and the urethane screen panels installed on the test screen with the plant shut down and the test screen operating with vibration only. The mechanisms were then replaced with rebuilt mechanisms and the measurements were repeated. Figure 17 shows the 1/3-octave band sound levels with the original and rebuilt mechanisms. The figure indicates that installing the rebuilt mechanisms reduced the overall A-weighted sound level by 1 dB. According to the screen manufacturer and the coal company, installing rebuilt mechanisms costs approximately \$10,000. The results suggest that the cost associated with installing a set of rebuilt mechanisms is high relative to the observed sound level reduction.

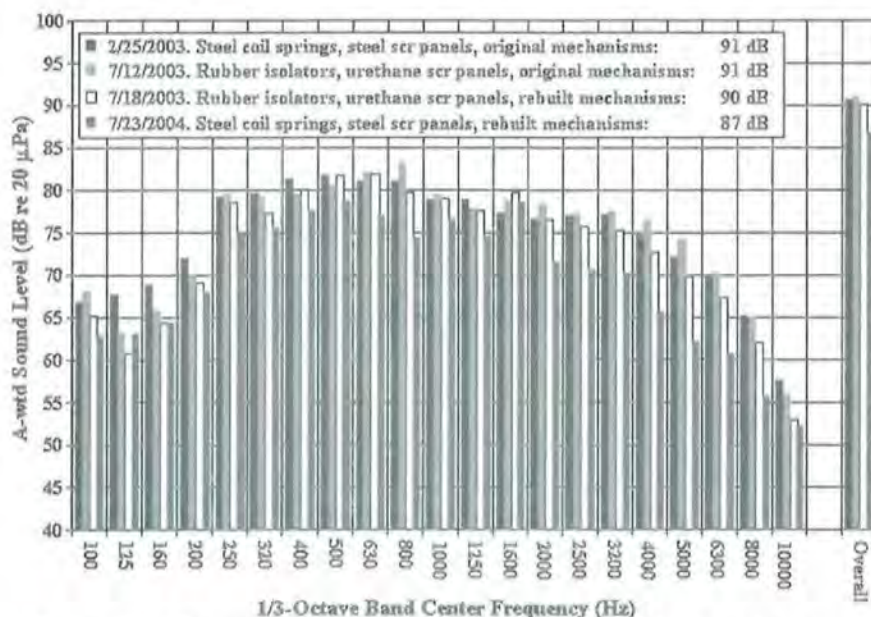
Figure 18 — Comparison of sound levels with original or rebuilt mechanisms, steel coil springs or rubber isolators, and steel or urethane screen panels for several test dates.

original mechanisms; rubber isolators, urethane screen panels and the original mechanisms; rubber isolators, urethane screen panels and the rebuilt mechanisms; and steel coil springs, steel screen panels and the rebuilt mechanisms. The test dates for these data were Feb. 25, 2003, July 12, 2003, July 18, 2003, and July 23, 2004, respectively.

The figure shows that the average sound level measured on Feb. 25, 2003, with new coil springs, the steel return deck and the original mechanisms was 91 dB(A). When testing was conducted within a one-week period (July 12, 2003, and July 18, 2003) with the original versus rebuilt mechanisms with

rubber isolators and urethane screen panels, the sound levels were 91 and 90 dB(A), respectively. However, after the steel coil springs replaced the rubber isolators and the steel screen panels replaced the urethane screen panels and one year had passed since the installation of the rebuilt mechanisms, the sound level for vibration only operation was 87 dB(A).

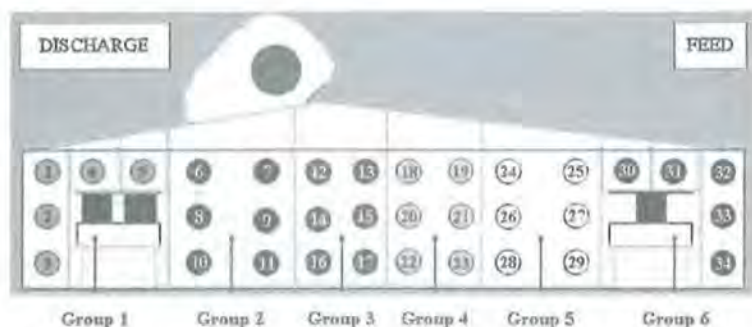
Figure 19 — Approximate accelerometer locations used for vibration measurements on the left side of the screen.

Prior to constructing the damped side plates, a series of vibration measurements was performed on the left side of the screen to determine the relative vibration levels along the side of the screen. The goal was to determine if constrained layer damping was necessary on the entire side plate or if some areas, which had insignificant vibration levels, could be left untreated. The left side was divided into six areas and a group of accelerometers was attached to each area as shown in Fig. 19.

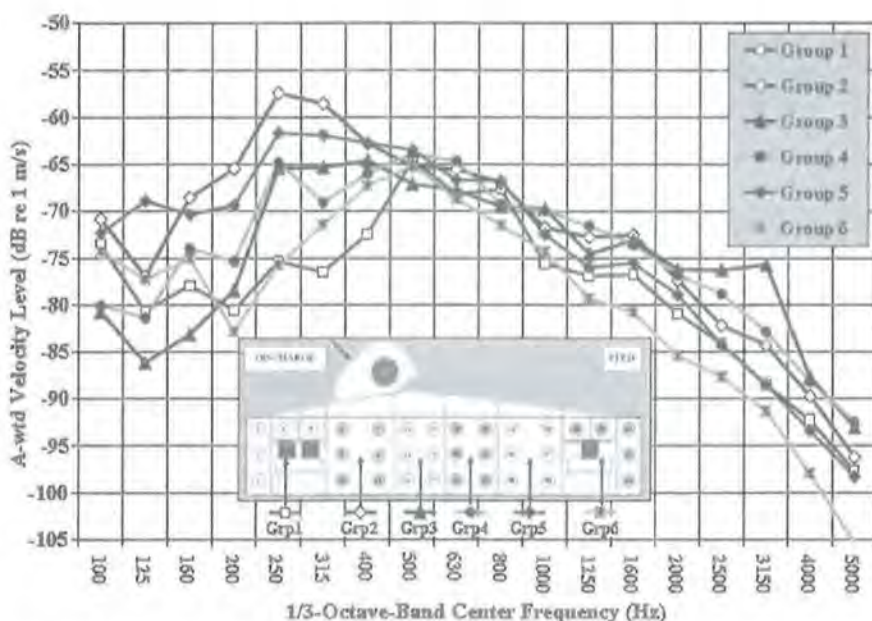
Figure 20 — A-weighted surface-averaged velocity levels.

averaged velocity, the resulting 1/3-octave band accelerations were integrated to yield vibratory velocities, and the surface-averaged A-weighted velocity levels for the six areas were calculated (see Fig. 20). A-weighting was applied to the vibratory velocities to deemphasize low frequency vibration, which is not a significant contributor to the A-weighted sound level in this case. The figure shows that the velocity levels are highest in the 100 through 400 Hz 1/3-octave bands for the Group 2 and Group 5 accelerometers. However, above the 500 Hz 1/3-octave band, the variation in vibration levels from group to group is generally less than 10 dB. Therefore, each area is a significant contributor to the drive noise radiated by the screen sides and should be treated.

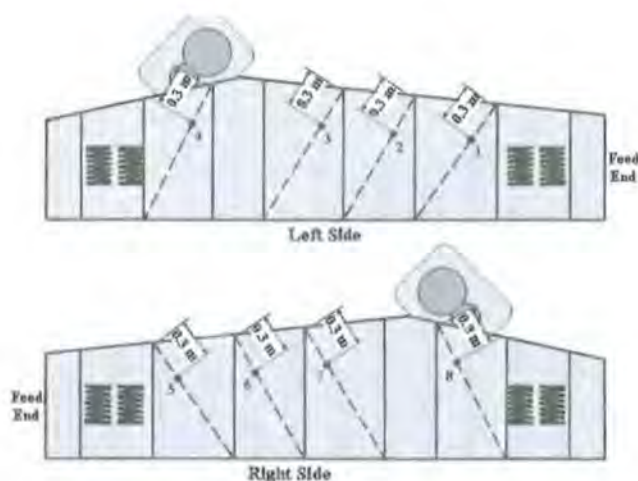
Figure 21 — Accelerometer locations used to evaluate the effects of installing constrained layer damped side plates.

Constrained layer damped side plates were constructed by bonding a layer of viscoelastic damping material to new side plates using epoxy. A 3.2-mm- (1/8-in.-) thick layer of steel was then attached to the viscoelastic material with epoxy to complete the construction. Mechanism covers were fabricated from a barrier-absorber material similar to the material used to exclude background noise from the test area during the initial tests. Prior to installing the damped side plates, baseline sound level measurements were taken during miner's vacation with the plant shut down and the test screen operating with vibration only. In addition, acceleration measurements were taken on the sides of the screen at the locations shown in Fig. 21.

The damped side plates were installed during the first week of September 2004, and sound-level measurements were collected on Sept. 14, 2004, with the mechanism covers and damped screen sides installed with the plant shut down and the test screen operating with vibration only. The mechanism covers were then removed and the measurements were repeated. In addition, acceleration measurements were performed at the locations shown in Fig. 21 for comparison with the baseline vibration measurements collected in July.

To evaluate the effects of the damping treatment on the screen side vibration, the average A-weighted vibration velocity levels for the left and right sides of the screen were calculated from the measured accelerations at the locations shown in Fig. 21. Although the aforementioned problems with the screen installation would tend to increase the radiated noise, it was thought that the damping treatment would still reduce the screen side vibration. This is because both of the installation problems would tend to cause additional noise to be radiated from the building and from local areas more than from the screen sides. Figures 23 and 24 show the A-weighted 1/3-octave band vibration levels on the left and right sides of

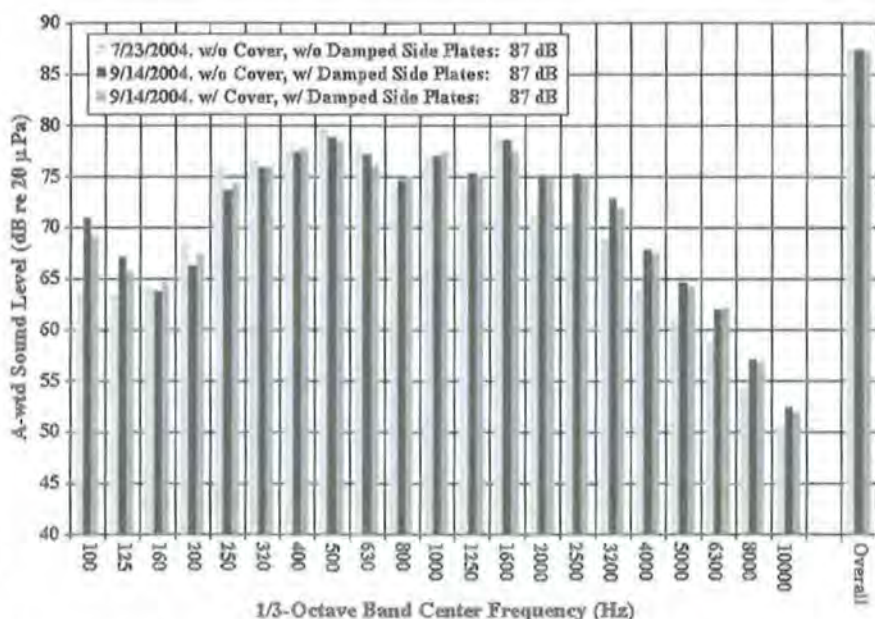
Figure 22 — A-weighted 1/3-octave band sound levels for vibration only operation for mechanism cover and damped side plate tests.

Figure 22 shows the A-weighted 1/3-octave band sound levels for baseline conditions and with the engineering noise controls installed. As the figure shows, neither the damped side plates alone nor the damped side plates and mechanism covers reduced the overall A-weighted sound level. It was expected that the sound level would be reduced by 3 dB or more. The figure shows that the sound levels in the 200 through 630 Hz 1/3-octave bands were reduced by 1 to 2 dB with the damped side plates. With the damped sides and mechanism covers, the reductions in this band were again 1 to 2 dB. In the 800 through 10 kHz 1/3-octave bands, the sound levels measured with the engineering controls installed increased from 83 to 84 dB(A). Because it is unlikely that installing these noise controls would increase the sound levels

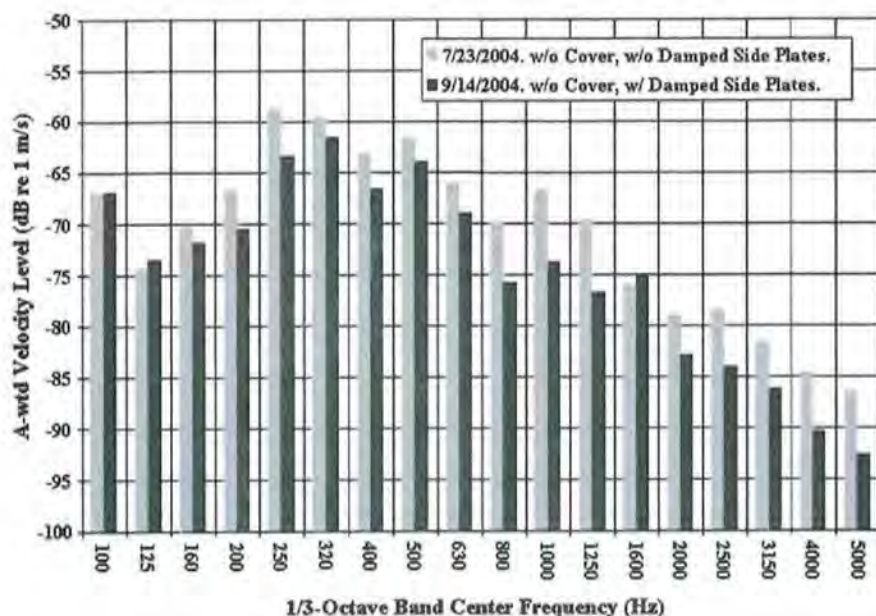
Figure 23 — A-weighted average velocity level on left side of the screen without and with damped sides.

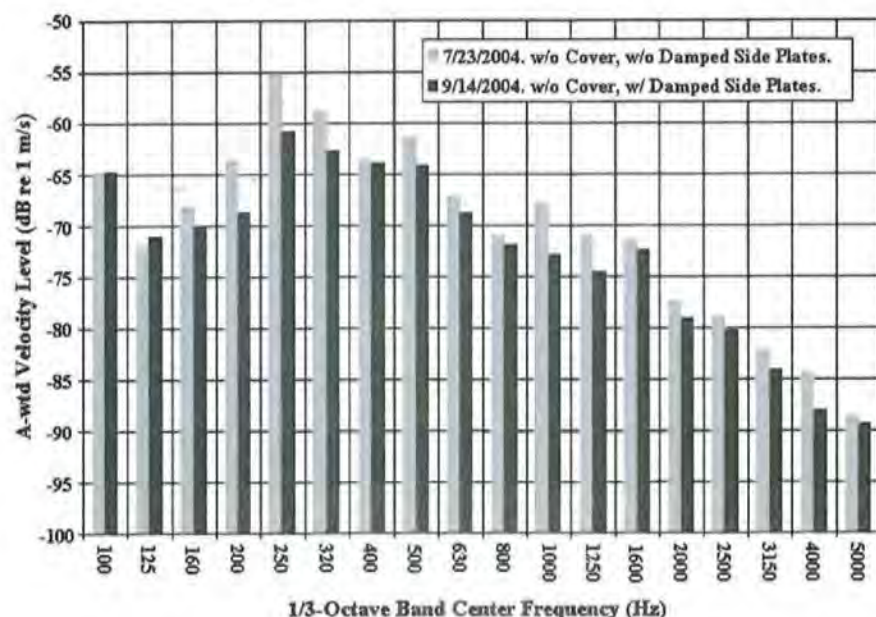
Figure 24 — A-weighted average velocity level on right side of the screen without and with damped sides.
