DEMONSTRATION OF LONGWALL MINING IN A STEEPLY DIPPING COAL SEAM

Contract J0233923
Snowmass Coal Company

OFR
87-37

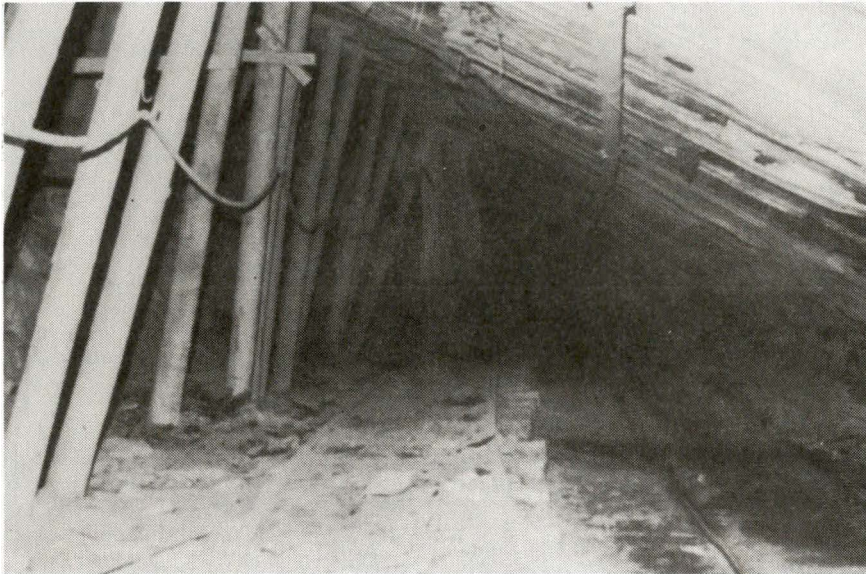
Track Entry

Track parting in the tailgate entry (looking south). Note the higher track level on the left to reduce the volume of rock that had to be cut.

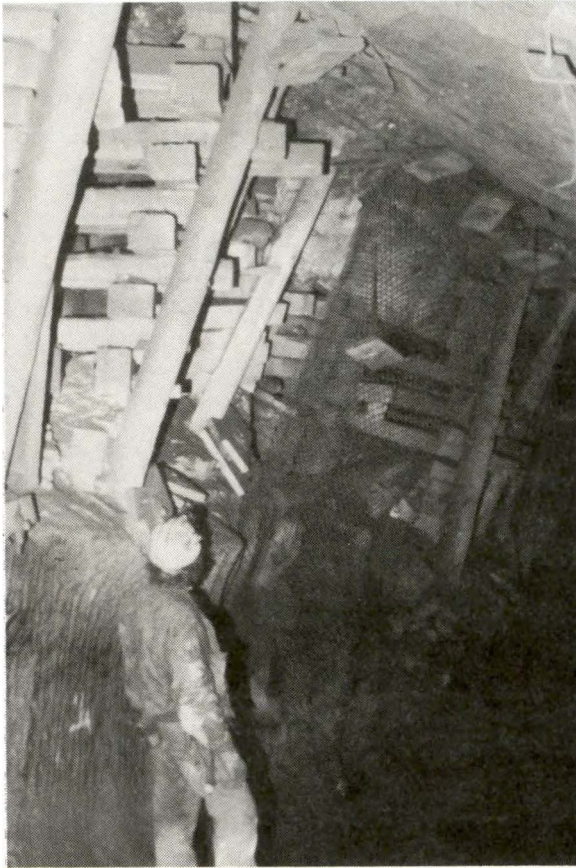
Top left. Rib control in the tailgate entry. Timber and lagging installed when mining. Chainlink fence and roof mats installed as secondary support when rehabilitating the entry.

During the normal development of entries and slopes the high rib was susceptible to sloughage. This rib in the panel entries was timbered and lagged. When the slope was started below the first panel, attempts were made to use chainlink fence bolted to the rib to control sloughage. Conventional bolts would not hold in the coal seam, therefore split set bolts were tried and found suitable. Figure IX.A.-1 shows a typical bolting pattern on the rib. The split set bolts were installed on five foot centers down the entry. Figure IX.A.-3 shows photos of timber and lagging rib control and chainlink fence rib control.
