A mining research contract report
OCTOBER 1983

DESIGN, FABRICATION, AND TESTING OF A BIDIRECTIONAL AUGER

ESD Corporation

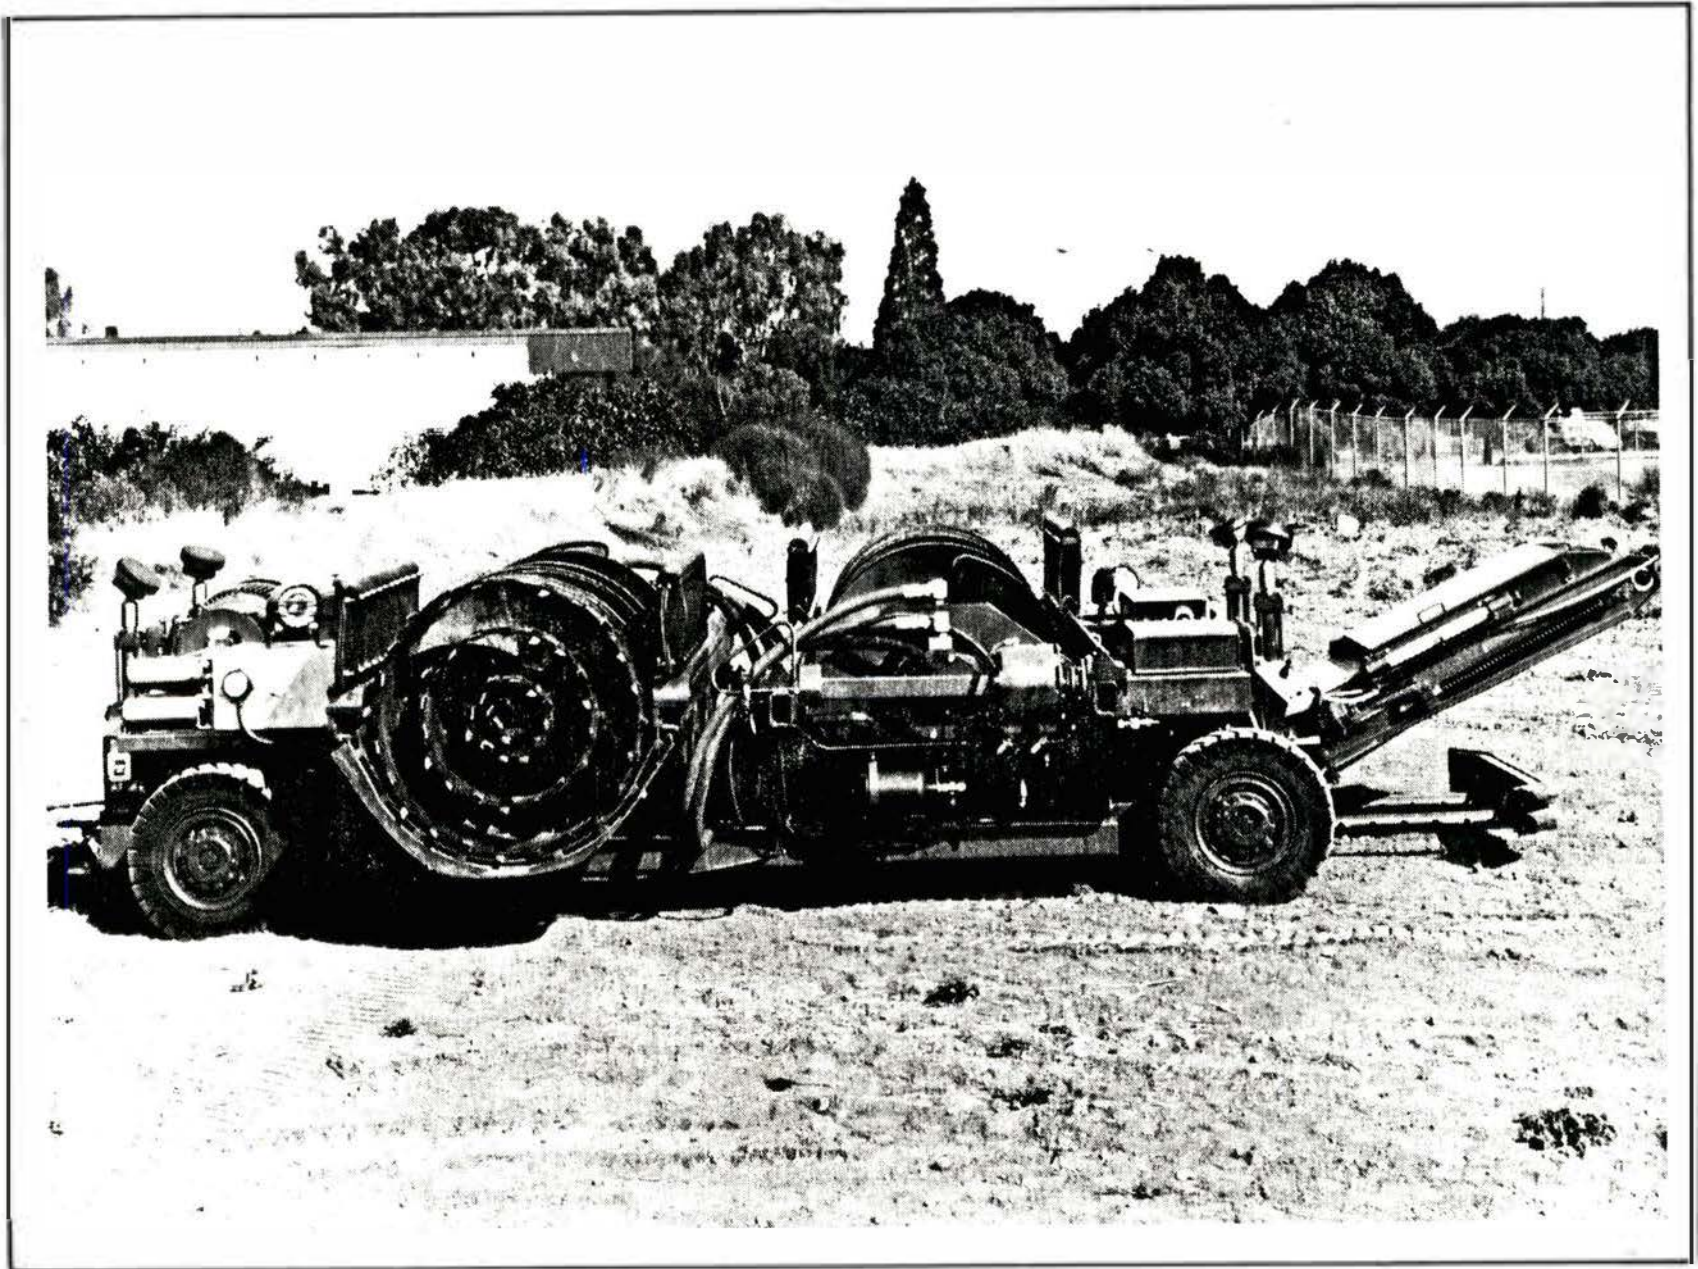
Figure 1 BIDIRECTIONAL AUGER

Department of Energy Contract ET-78-C-01-3150, "Design, Fabrication, and Test of a Bidirectional Auger," was awarded FMC Corporation on September 30, 1978. The objective of the program was to develop an underground auger miner (see Figure 1) for removal of coal from pillars in previously developed sections of a mine.

The general arrangement of the auger is shown in Figure 1. It is a single-chassis unit supported by four steerable driving wheels. Two auger sections, each integral with a cutting head, are positioned across the auger miner frame. Each auger sump and rotates individually (never simultaneously) into the nearest rib. Figure 2 lists the auger miner dimensions and performance data.

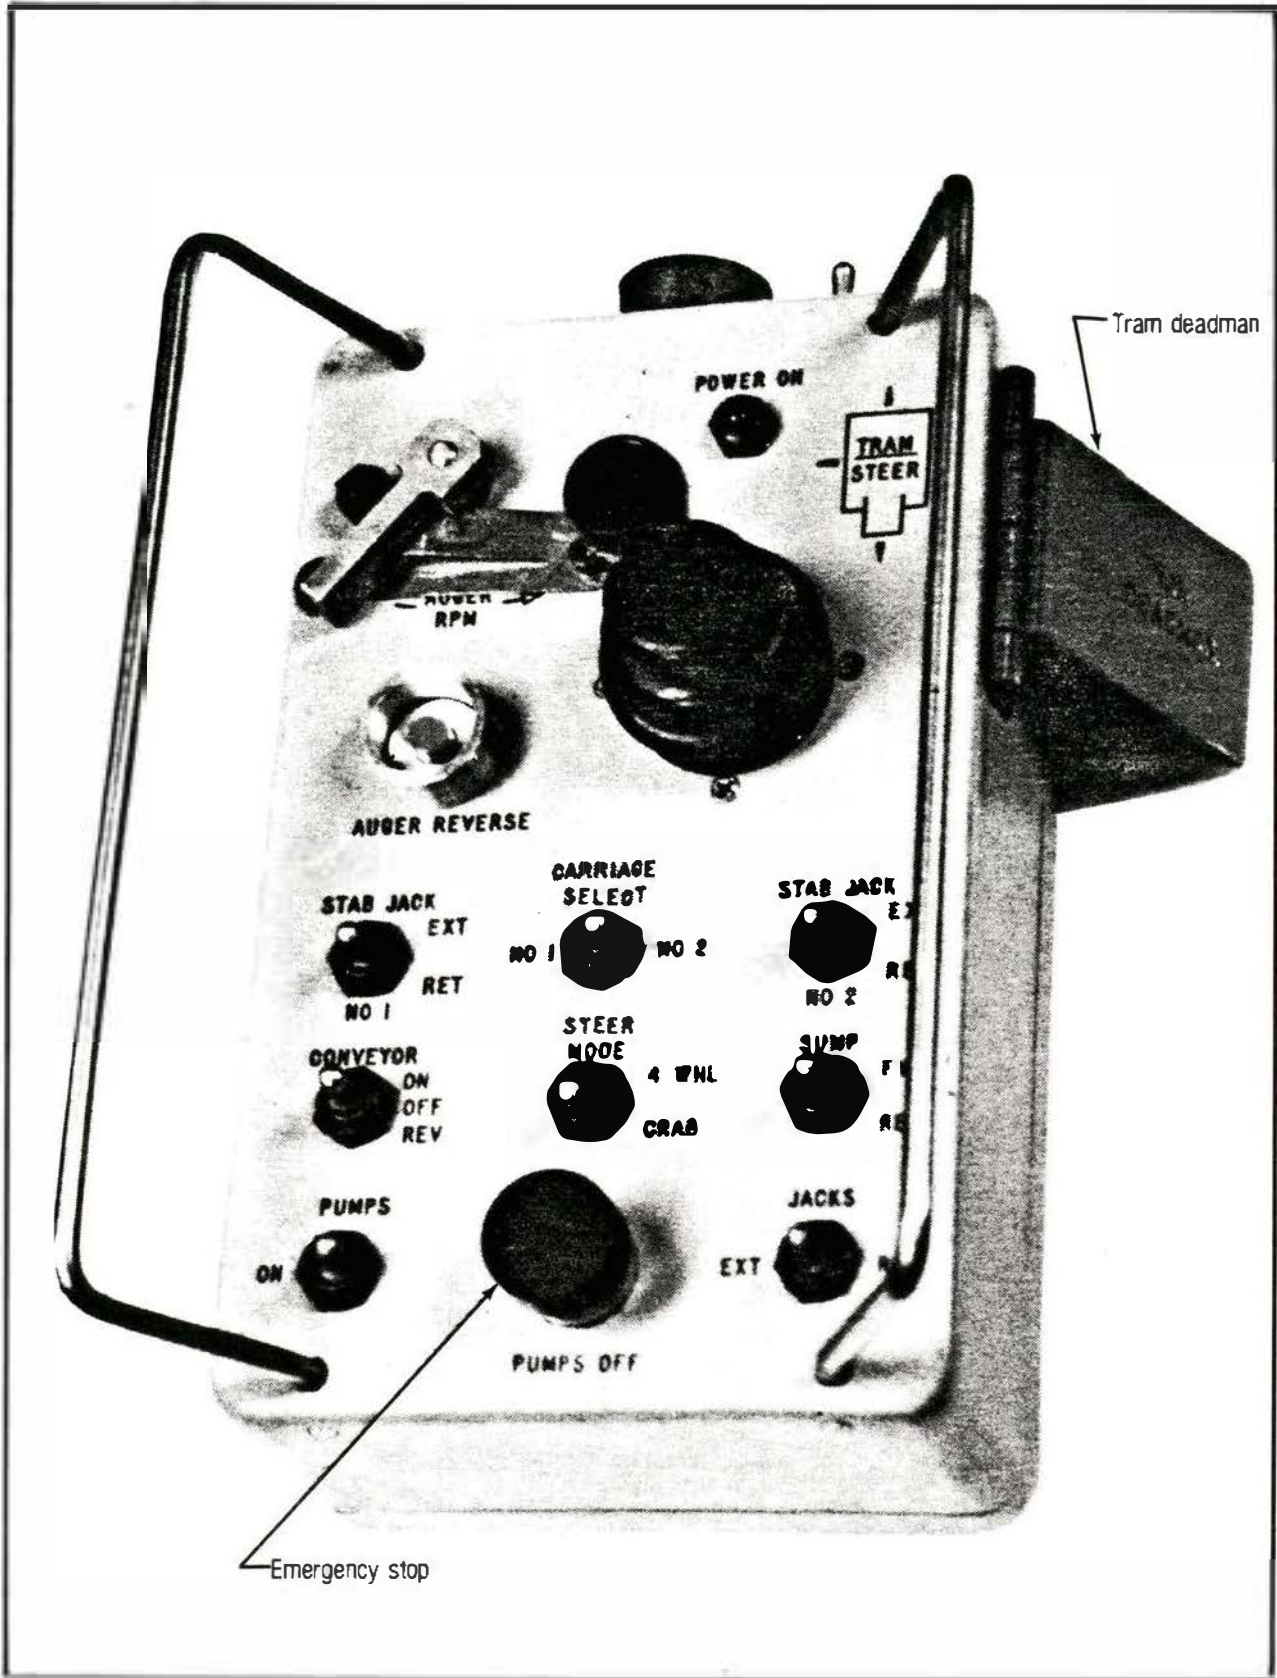
Figure 3 BIDIRECTIONAL AUGER REMOTE CONTROL UNIT

All functions of the auger miner, except the lights and fire extinguishing system, are controlled from the remote controller (see Figure 3). The remote controller is connected to the auger miner electrical system at any one of three connectors located at three corners of the machine.

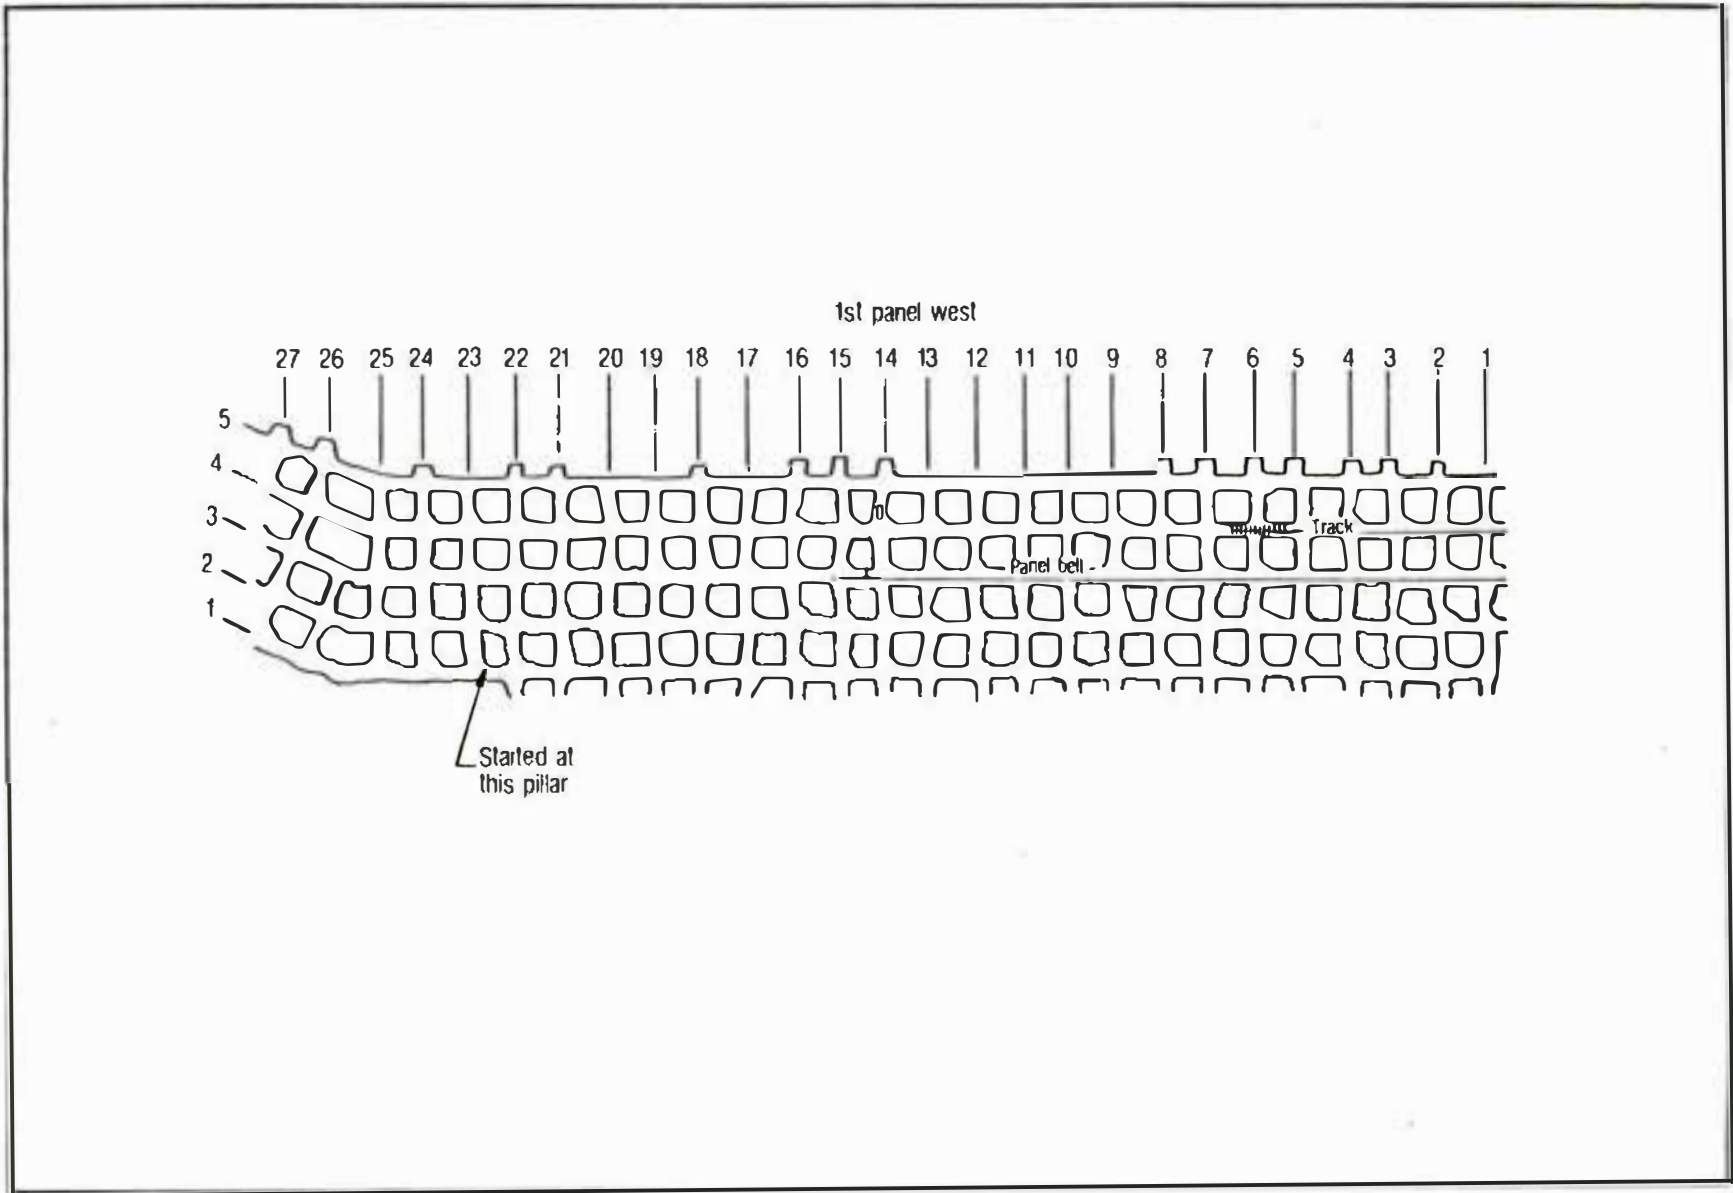
Figure 4 MINE SECTION WHERE DEMONSTRATION TOOK PLACE

The area in the Marissa Mine selected for the demonstration was at the First Panel West (see Figure 4). Pillars in Entries 2, 3, and 4 were drilled from Crosscut 23 outby to Crosscut 9.

Drilling of pillars began in Entry 2 at Crosscut 23 and proceeded outby to Entry 16. (The tail pulley of the panel belt was located between Crosscuts 15 and 16.) The auger miner was then moved to Entry 3 and Crosscut 23 for a repeat of the cycle. When Entry 4 was drilled to Crosscut 16, the panel belt was shortened to place the tail pulley between Crosscuts 8 and 9. The whole cycle was then repeated.

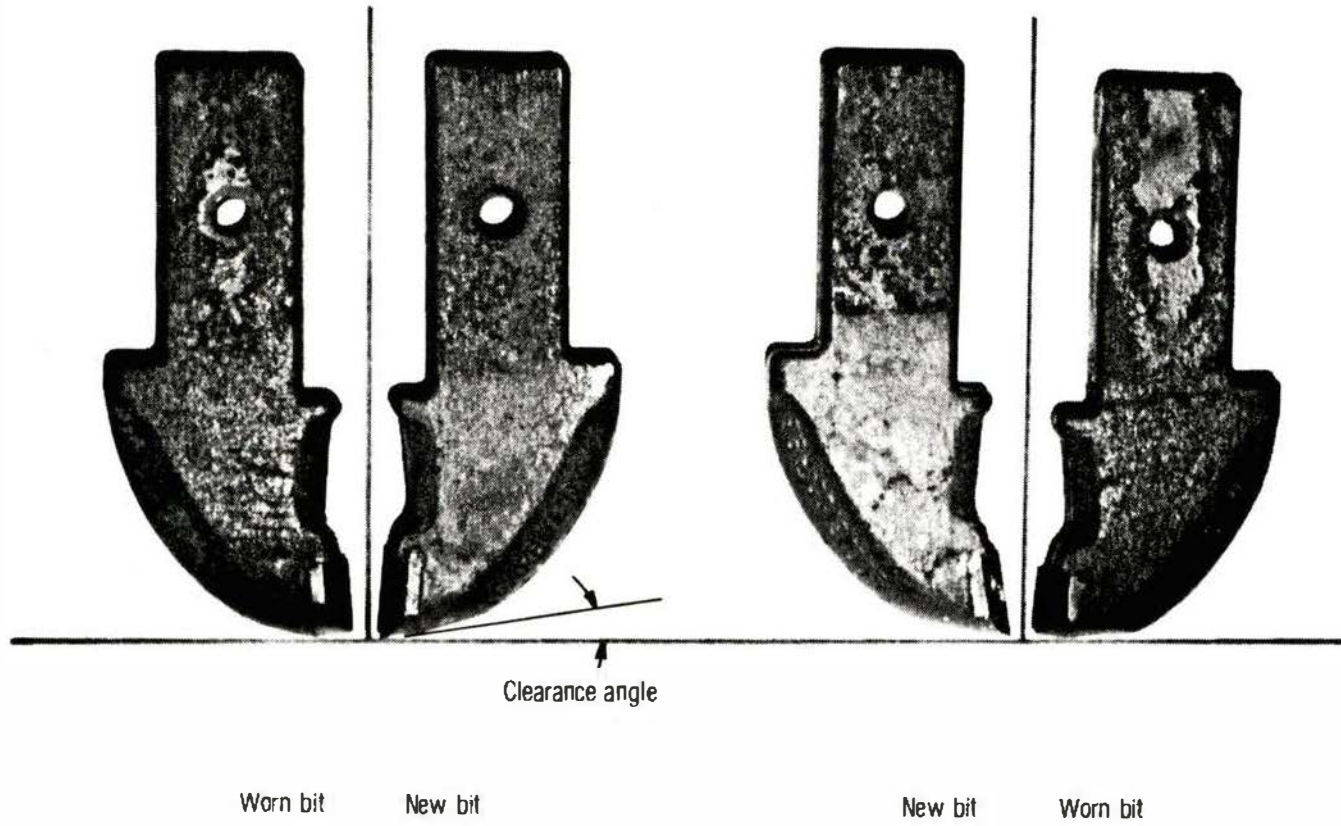
Figure 6 CUTTER BIT WEAR

With new cutting bits, the auger miner drilled 9- to 10-foot-deep holes in 3-1/2 to 4 minutes, but once the clearance angle on the carbide tip (see Figure 6) was reduced to zero by wearing action, the tip no longer cut effectively. Loss of clearance angle caused a noticeable increase in the time required to drill a hole.

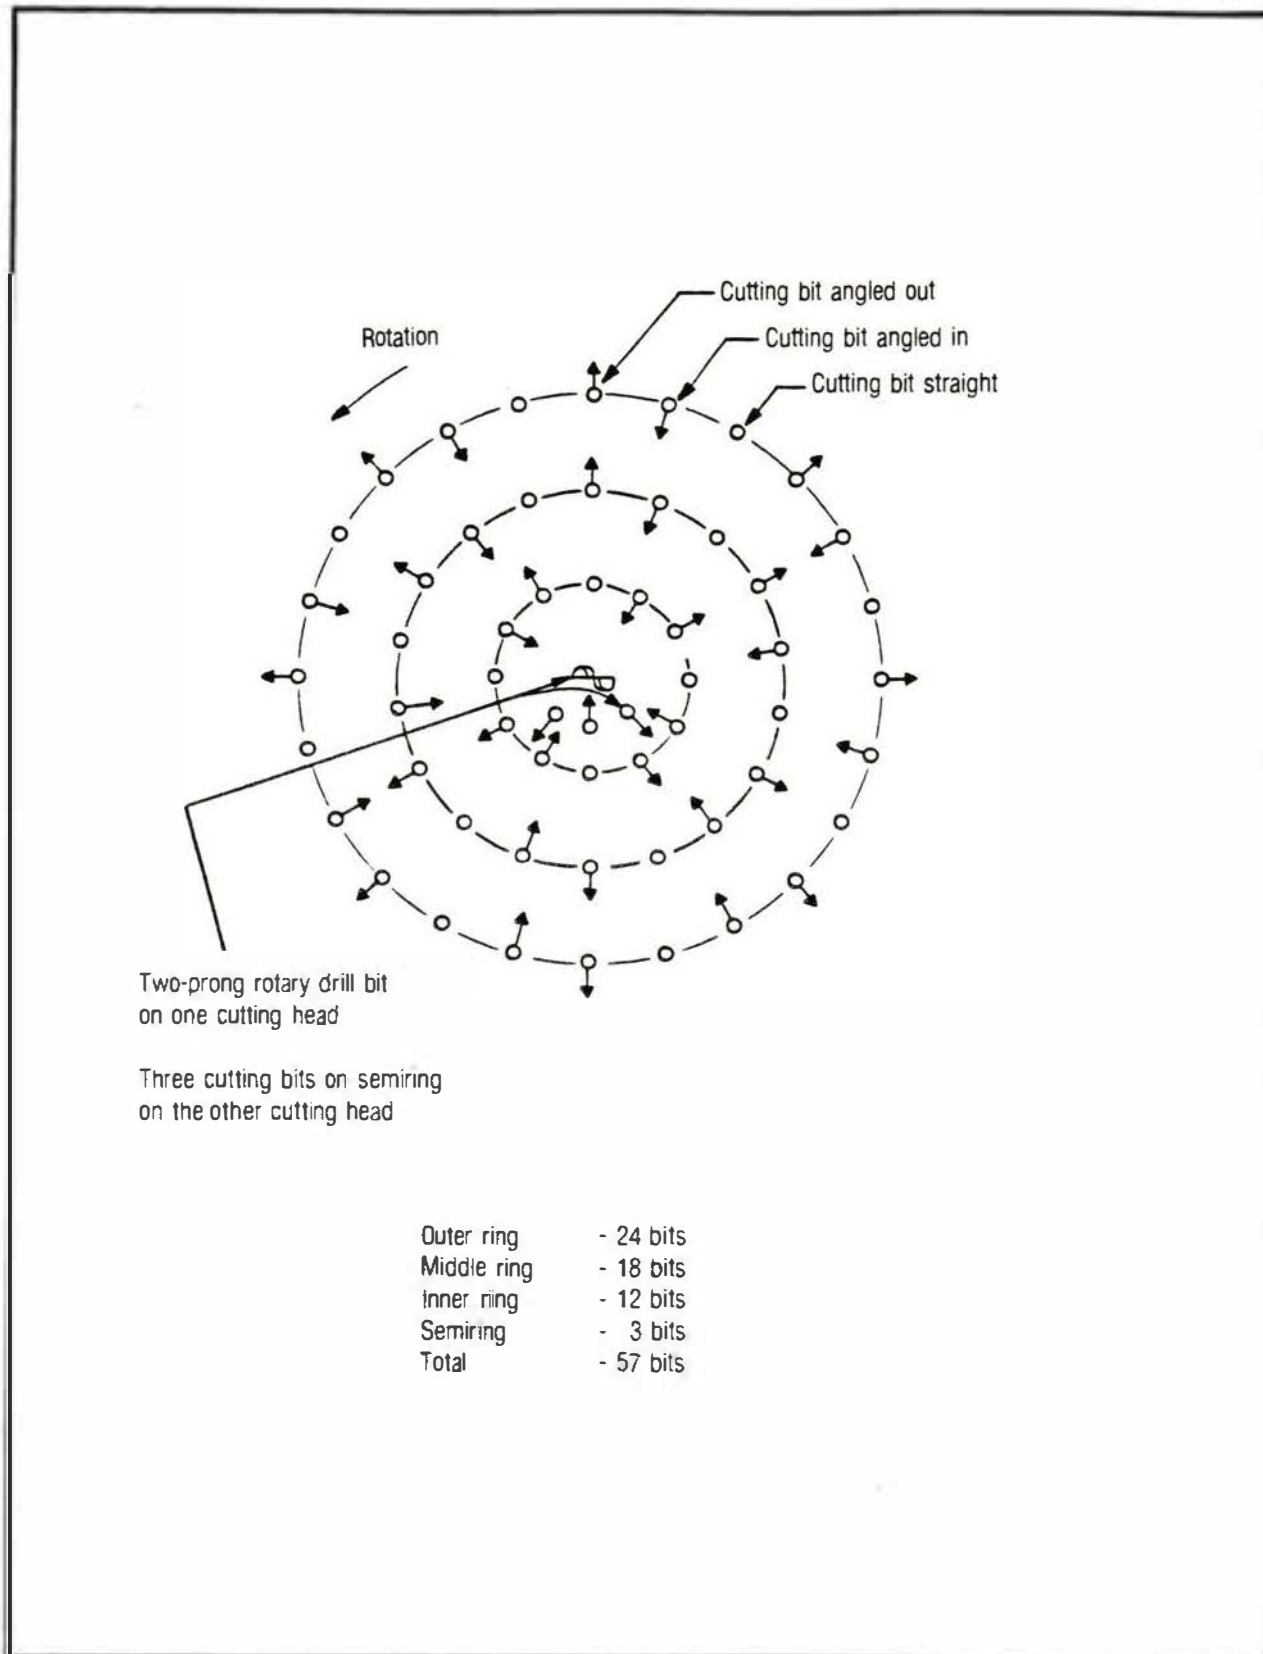
Figure 7 CUTTING HEAD BIT PATTERN

drill bit at the center of auger rotation, whereas the other auger has a semi-ring which holds three cutter bits (see Figure 7). A total of 57 mounting blocks (54 on the other auger) were provided.

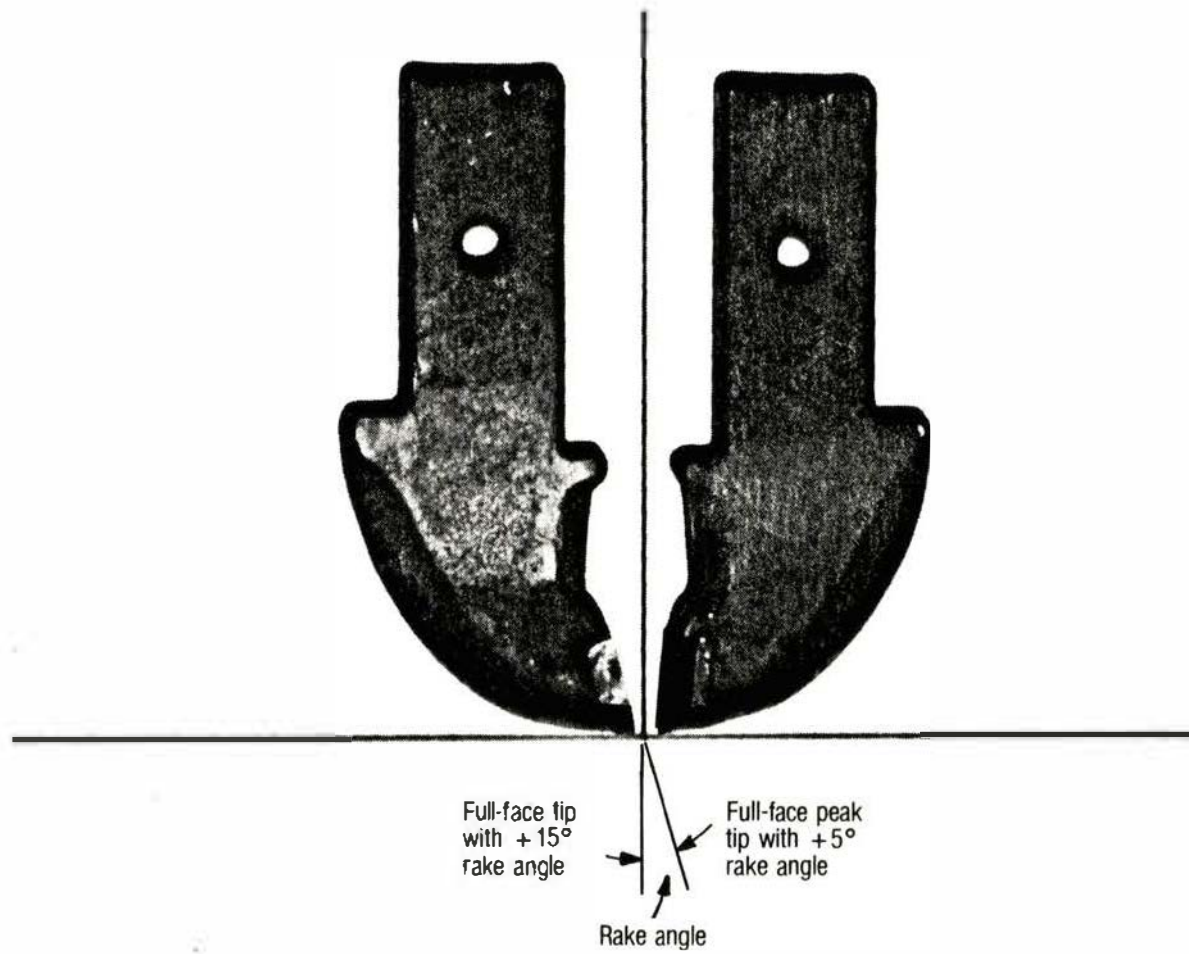
Figure 8 CUTTER BIT STYLES

For a brief period, full-face tip cutting bits were installed to see if a larger rake angle (see Figure 8) would increase cutting speed. No discernable difference could be observed. Otherwise, the full-face peak tip cutting bit was used throughout the demonstration.

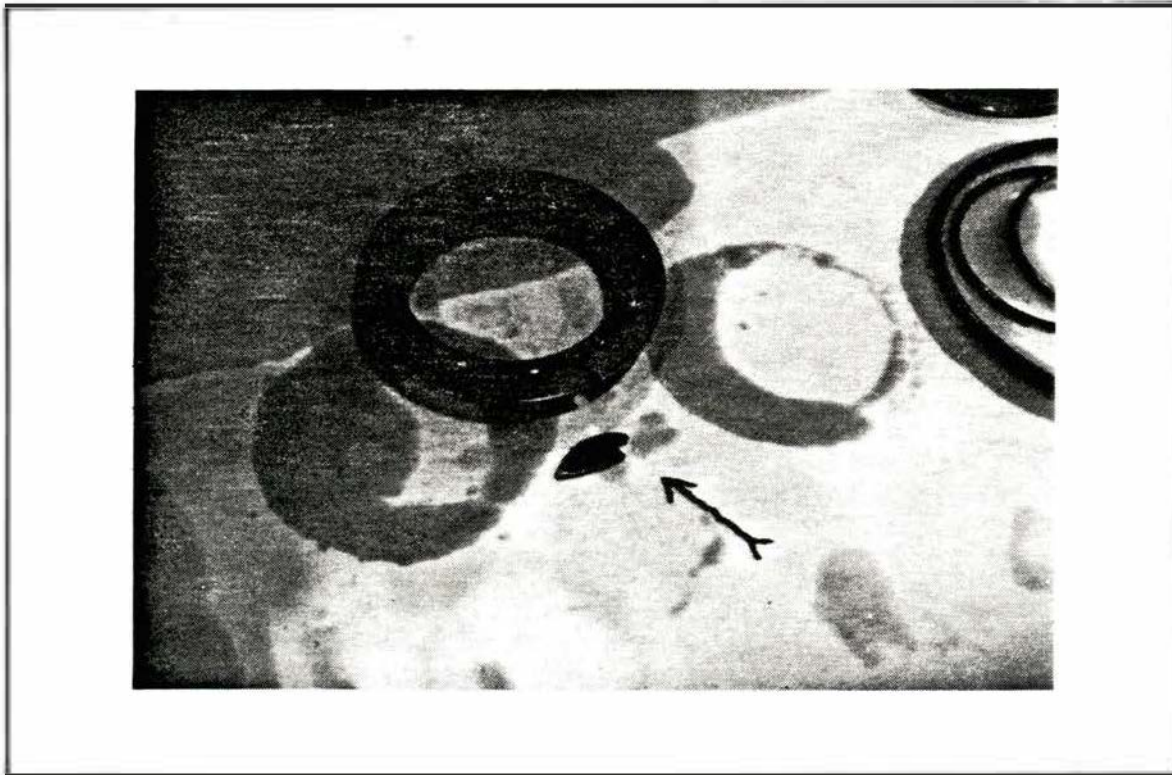
Figure 9 BROKEN PIECE FROM PREVIOUS FAILURE FOUND IN REPAIRED PUMP

The second failure of the pump was damage to the rotating part of the shaft seal and was caused by a piece of metal (see Figure 9) which was inadvertently left inside the pump during the first rebuild. This piece of metal was part of the flange of the stationary part of the original seal replaced when the pump was rebuilt.

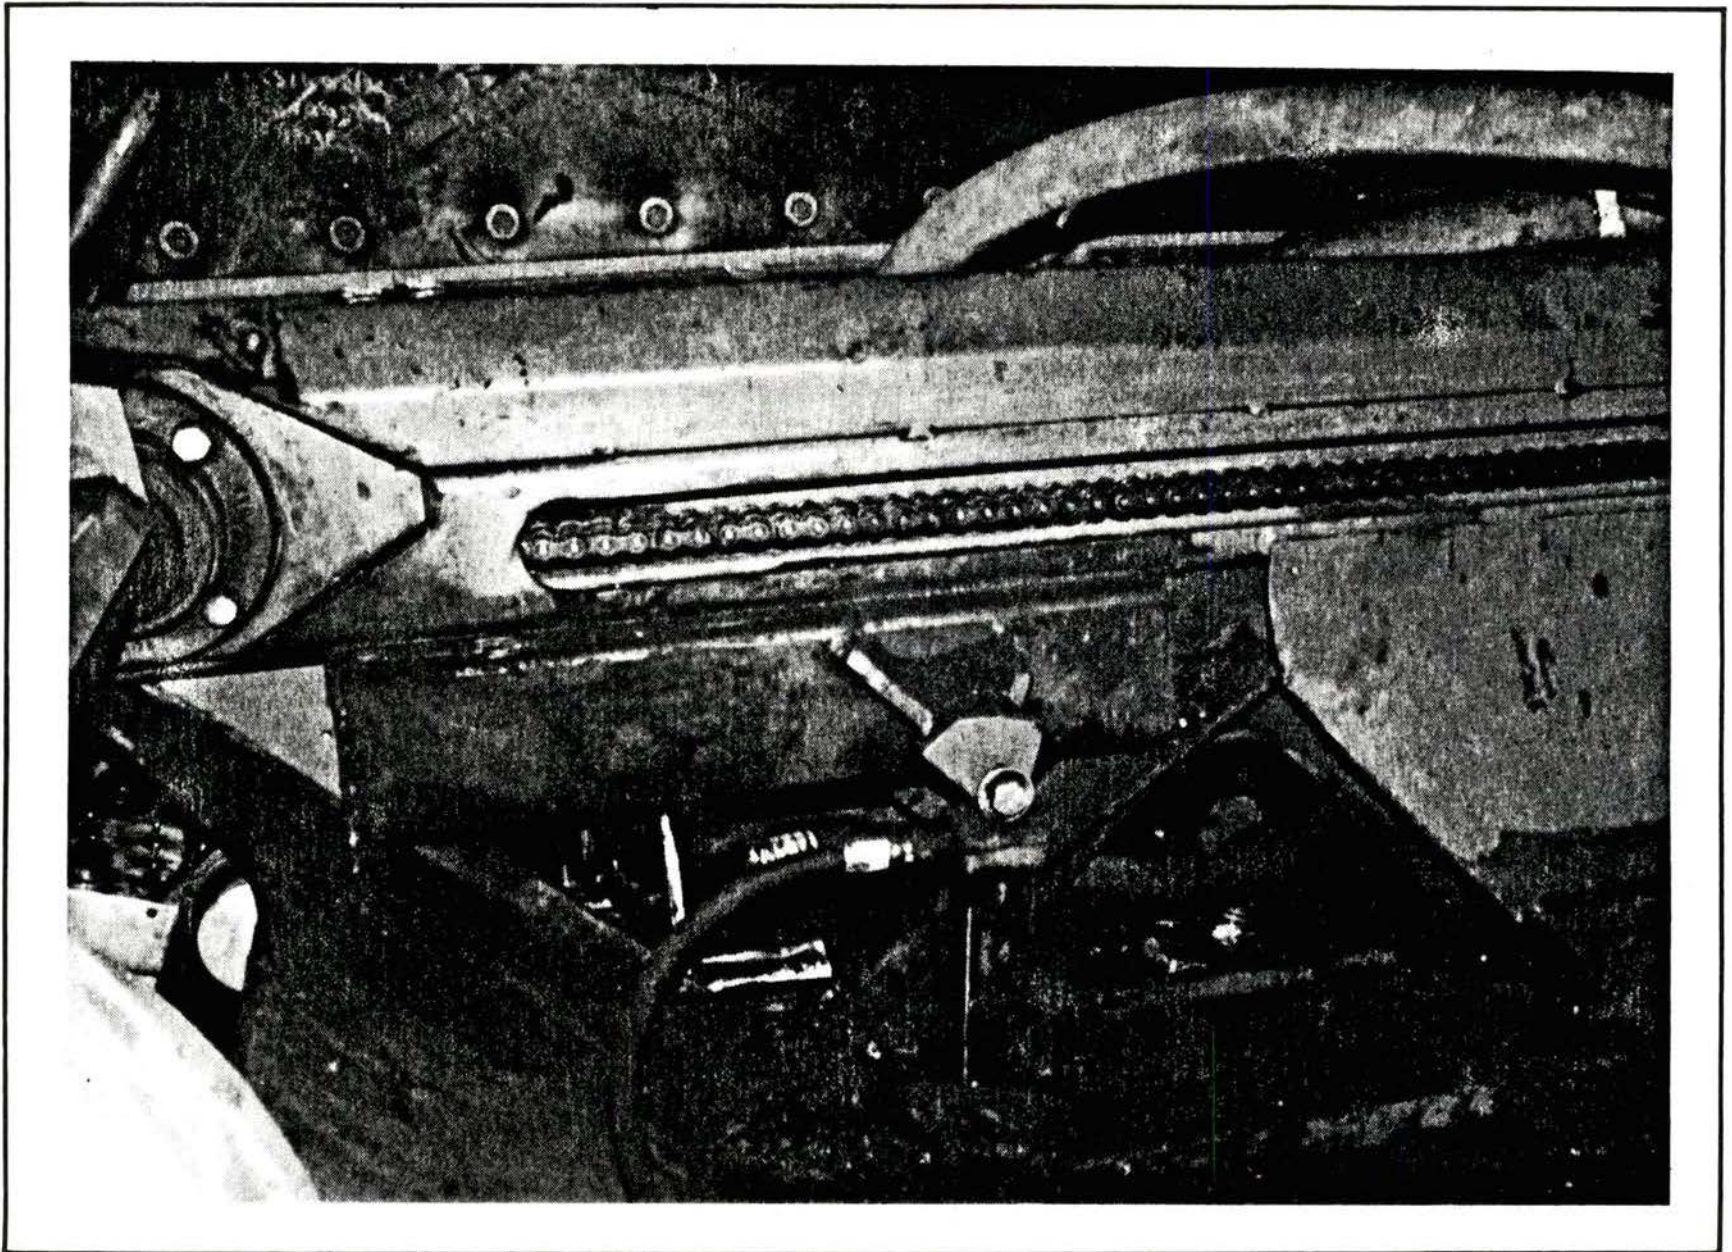
Figure 10 AUGER SUMP CHAIN BEHIND SLOT IN STRUCTURAL MEMBER

A pair of double-strand roller chains are used to sump the auger as it drills its hole. These chains lie inside structural members that are part of the upper edges of the auger trough. The side of each structural member facing an auger is slotted lengthwise to provide passage for the auger drive motor mounting yoke pin. This pin fits into a block that slides along the length of the structural member when pulled in either direction by the chain (see Figure 10).

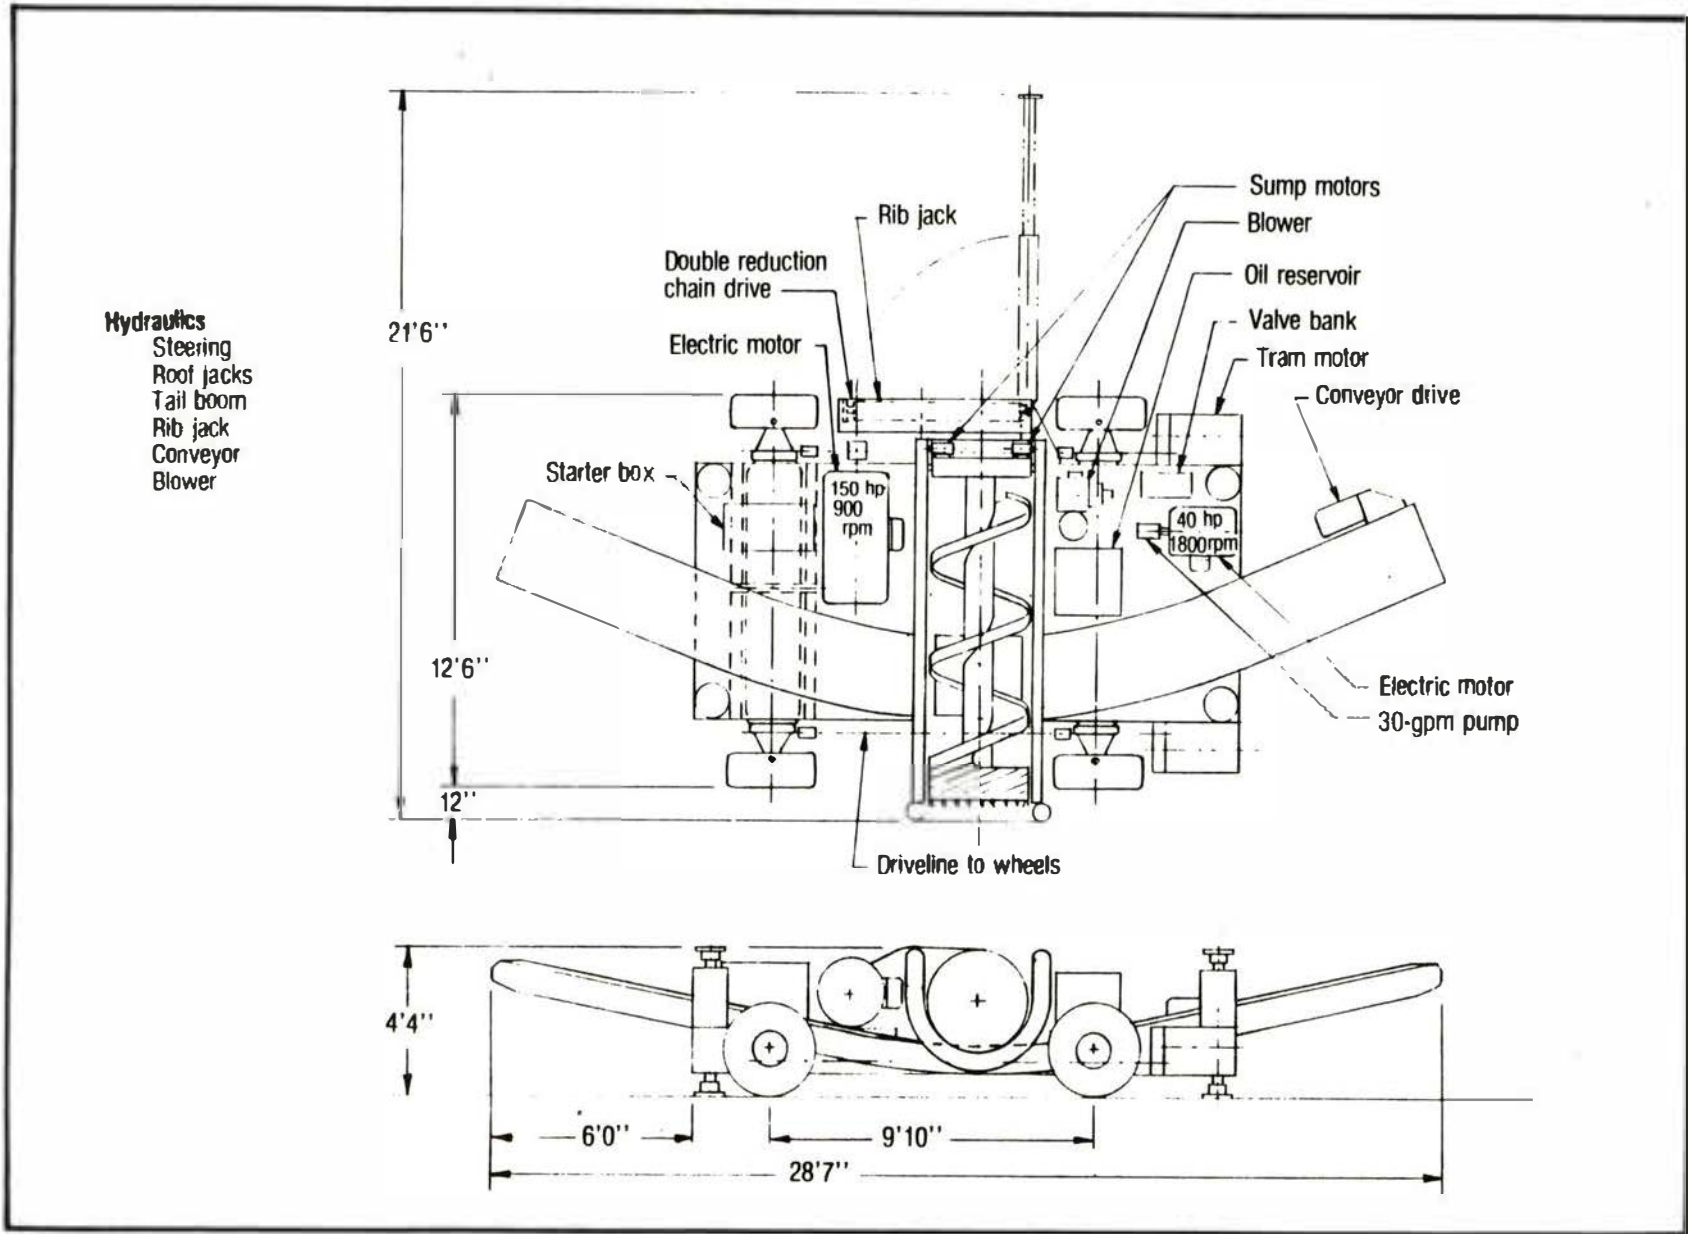
Figure 11 SINGLE AUGER CONCEPT

Figure 11 depicts an auger configuration that incorporates most of the recommended changes listed above. A pivoting beam axle has been incorporated to maintain four-wheel contact with the mine floor. Tram drive is by two DC electric motors connected by driveline to front and rear wheel gear reduction drives. Four-wheel and crab steer are provided as before. The auger is driven by a 150-horsepower 900-rpm electric motor through a double-reduction roller chain drive. Two high-torque low-speed gear-type hydraulic motors drive pinions on two inverted racks to sump (advance) the auger into the coal face. A rib jack, which can be pivoted about one end, is provided to react auger thrust into the opposite rib. Machine control, roof jacks, dust control (by water spray), and bore hole ventilation, are like those on the bidirectional auger. One 36-inch-diameter auger, rather than two 48-inch augers, is proposed to reduce machine cost, weight, and height. At an overall height of 52 inches, the auger should have a broader marketing potential for recovering coal from pillars. With the conveyor arranged for discharge at either end, the auger has capability to work pillars on both sides of an entry or crosscut.

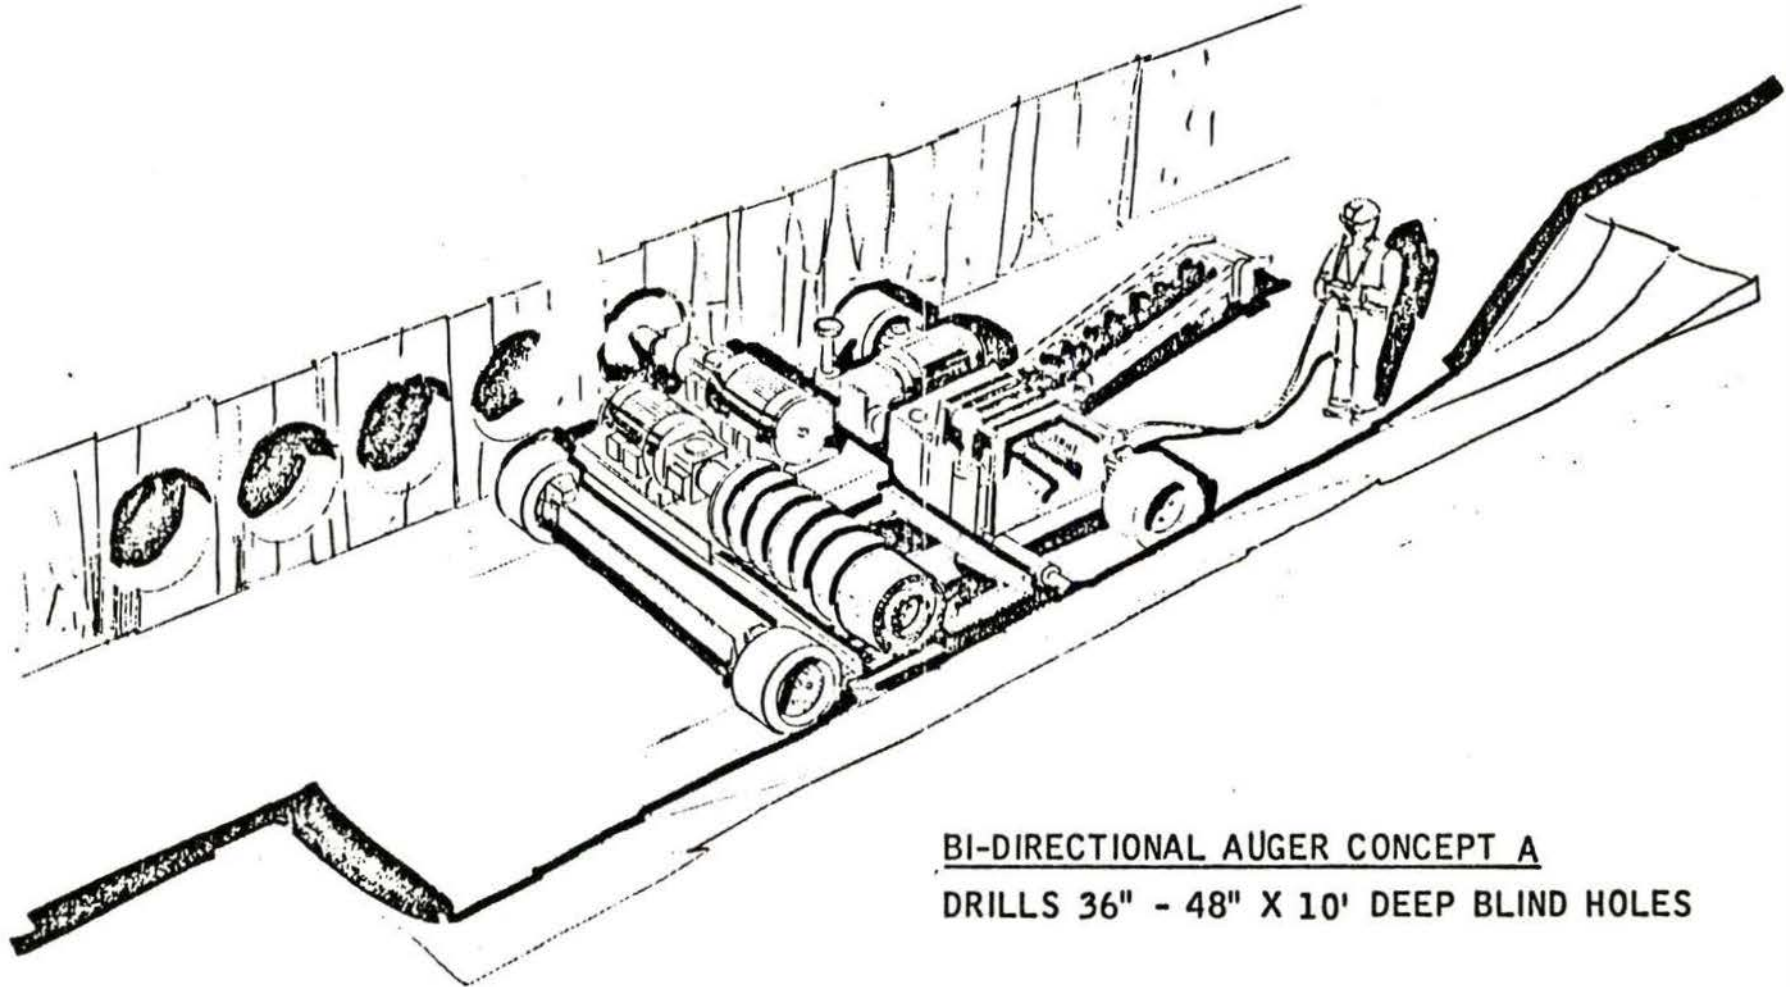
BI-DIRECTIONAL AUGER CONCEPT A
DRILLS 36" - 48" X 10' DEEP BLIND HOLES

- Upon evaluation of the time study data taken from the underground auger program in the Ireland Mine, two promising machine concepts have emerged (see attached illustrations). These machines will require further "brainstorming" in the areas of tramability, coal conveyance, and power requirements.

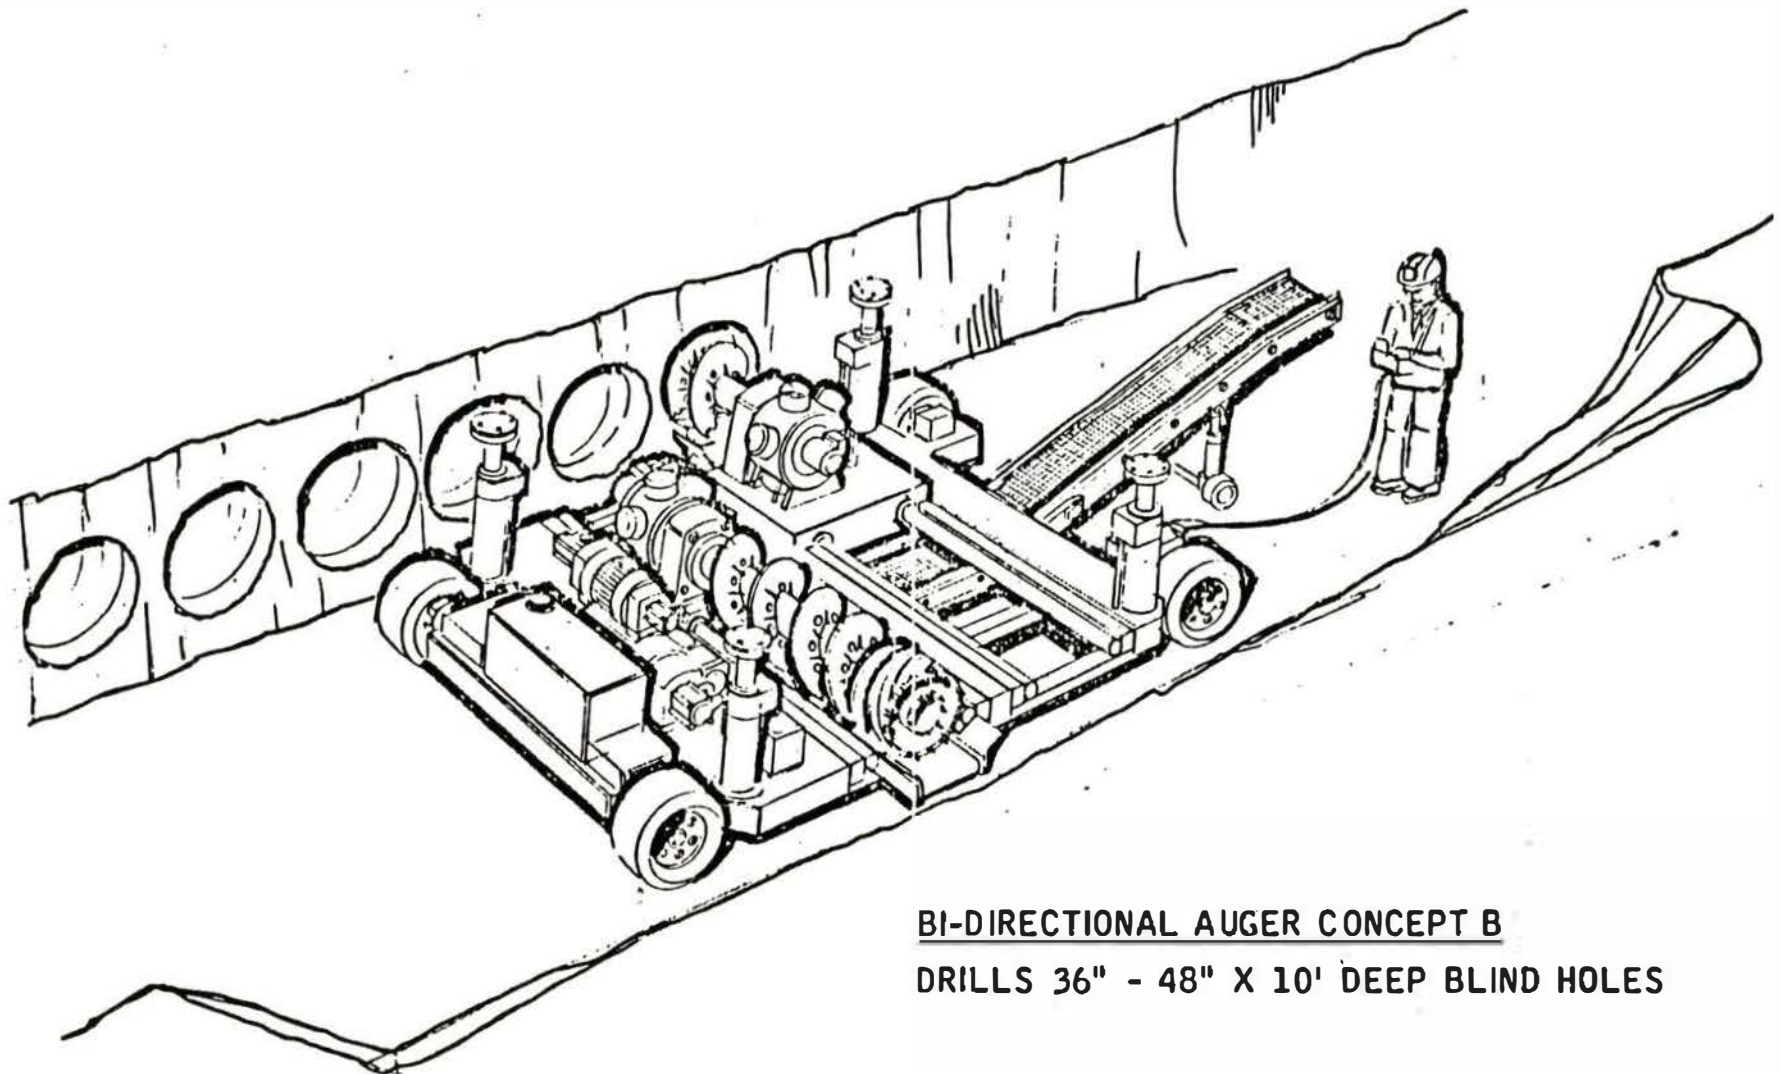
BI-DIRECTIONAL AUGER CONCEPT B
DRILLS 36" - 48" X 10' DEEP BLIND HOLES

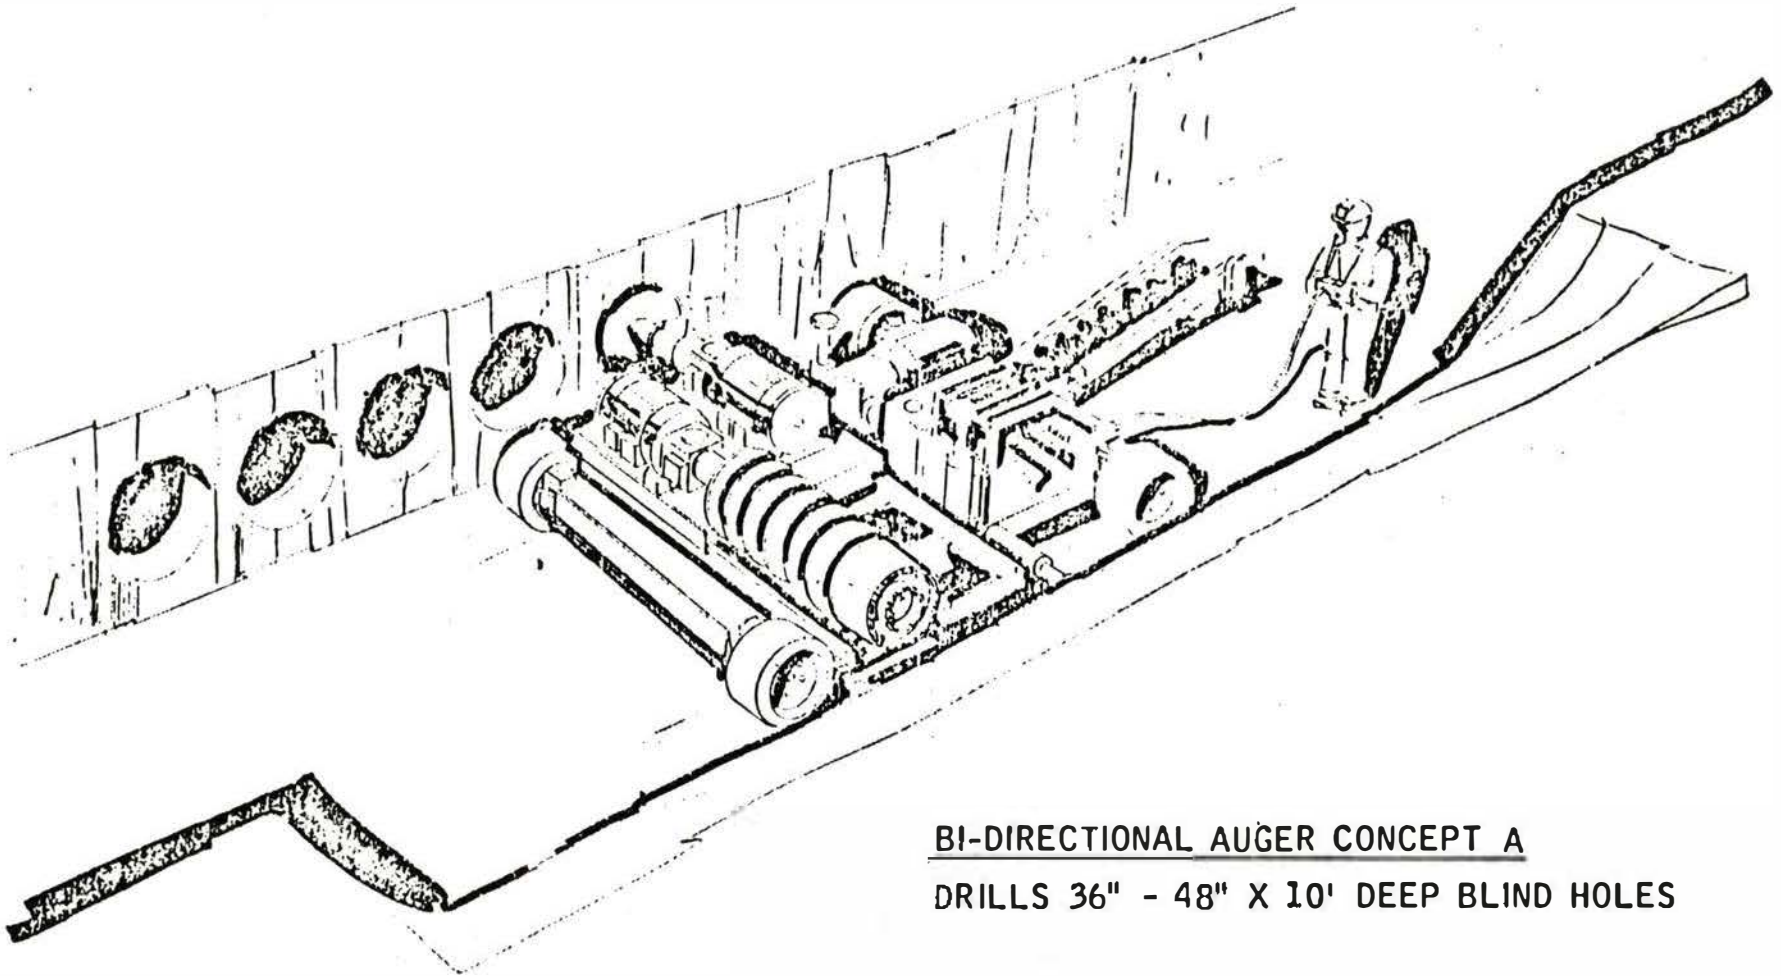
BI-DIRECTIONAL AUGER CONCEPT A
DRILLS 36" - 48" X 10' DEEP BLIND HOLES
