A mining research contract report
OCTOBER 1983

DESIGN, FABRICATION, AND TESTING OF A BIDIRECTIONAL AUGER

ESD Corporation

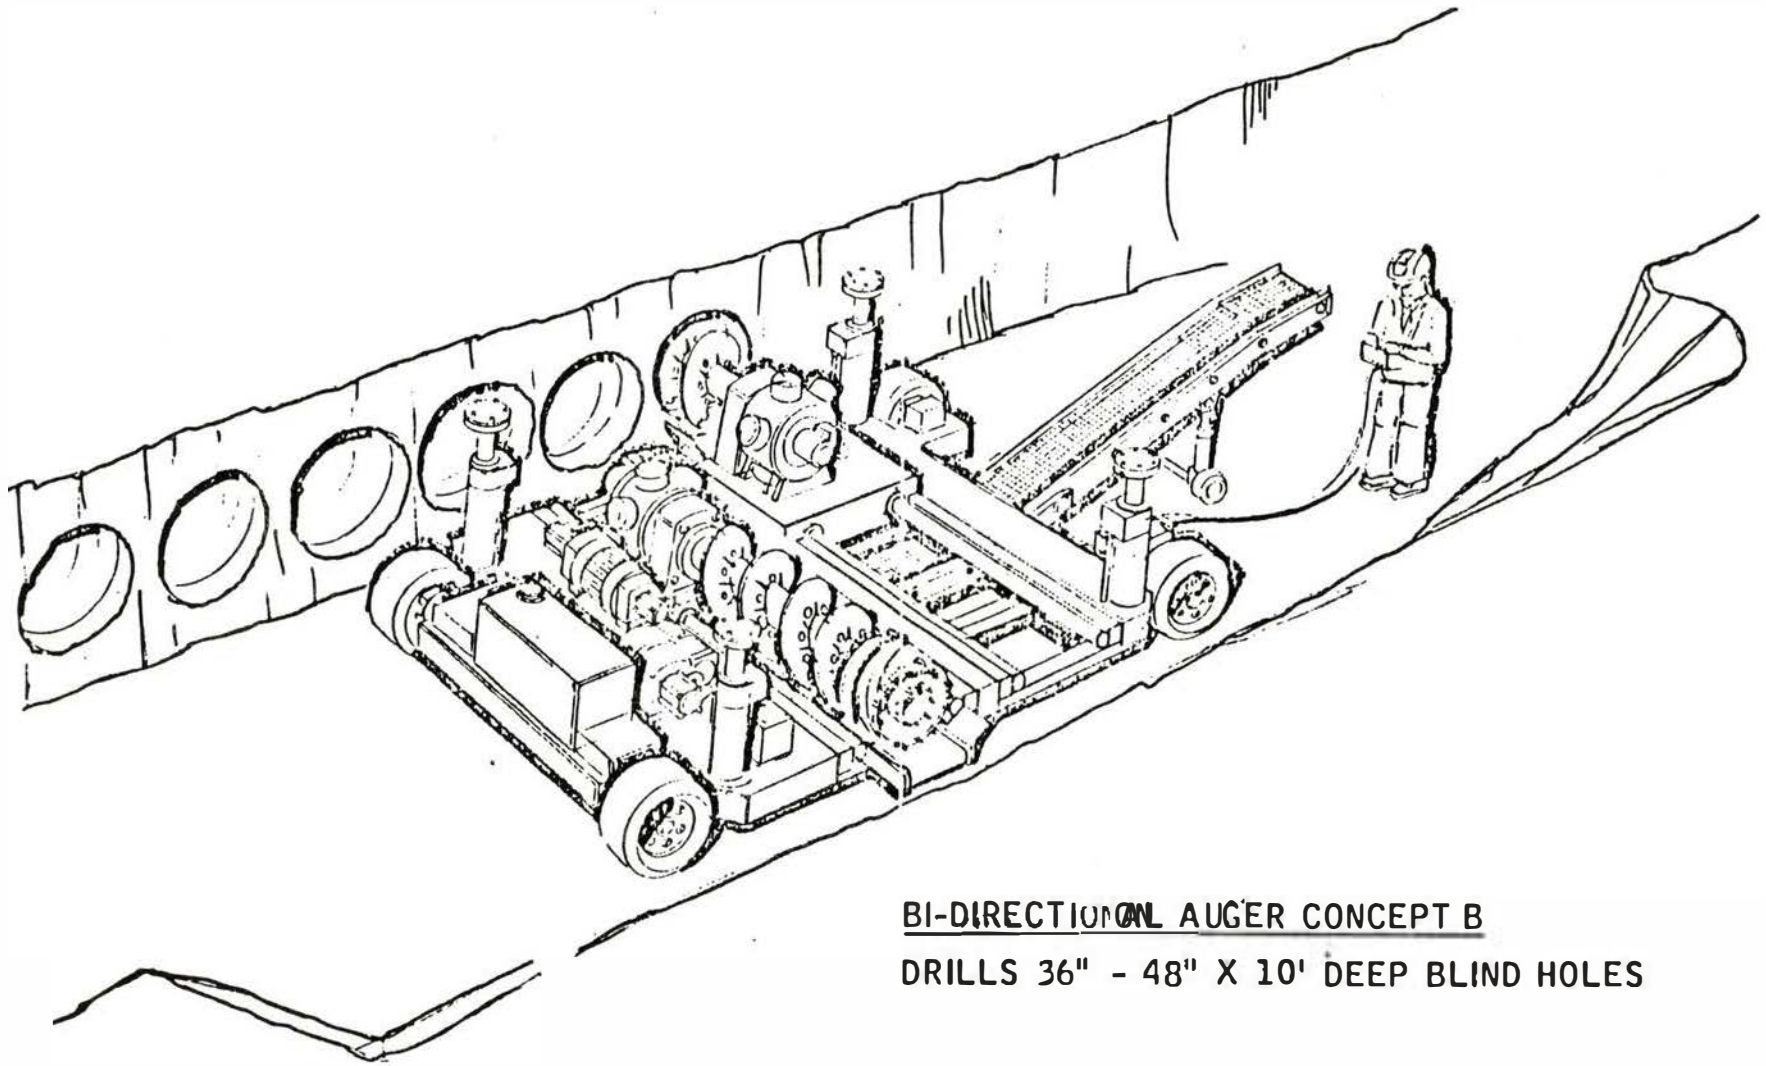
BI-DIRECTIONAL AUGER CONCEPT B
DRILLS 36" - 48" X 10' DEEP BLIND HOLES

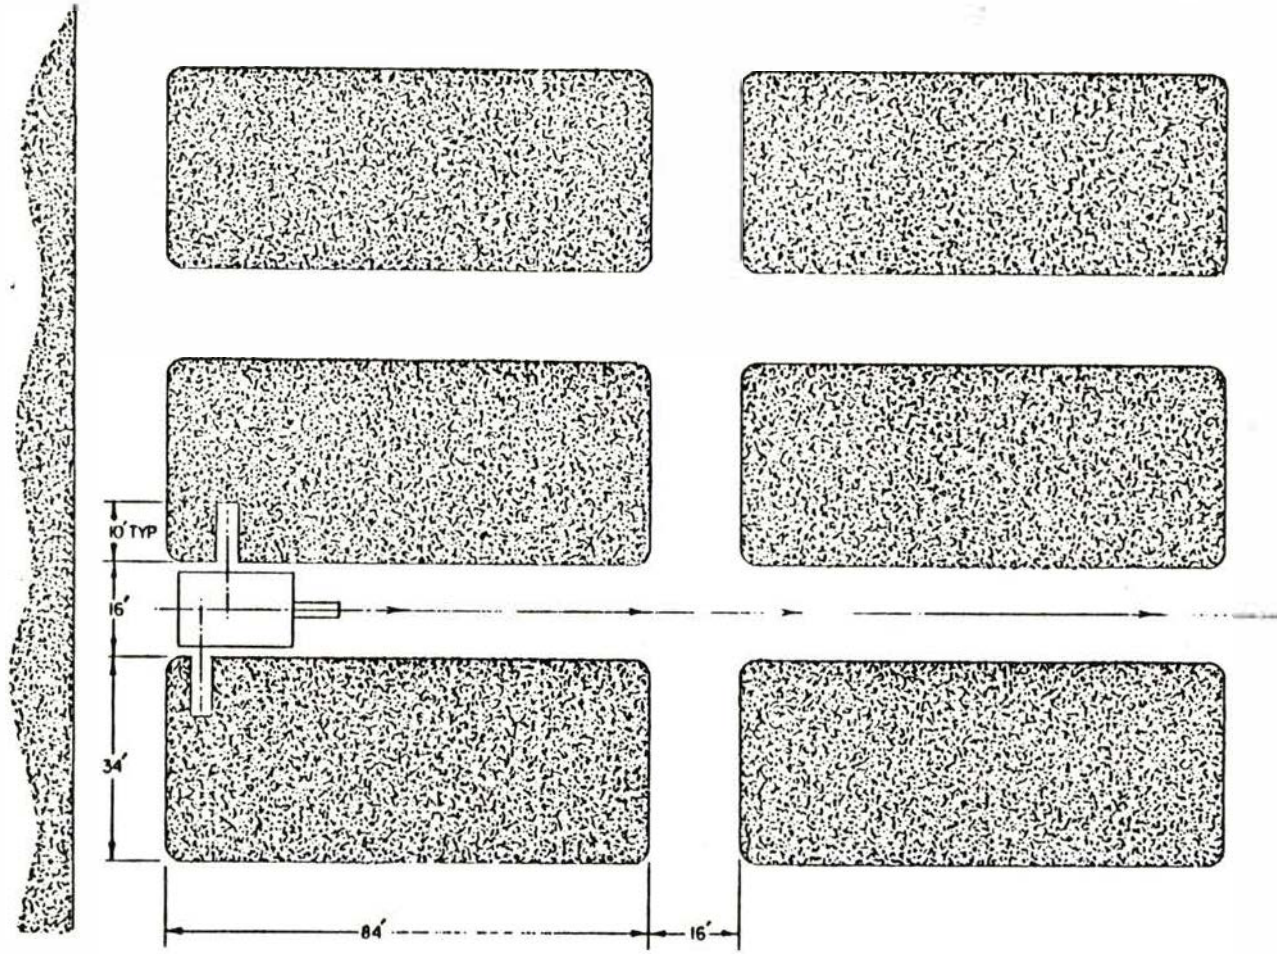
1 START OF PILLAR EXTRACTION, BOREHOLES DRILLED SEQUENTIALLY.

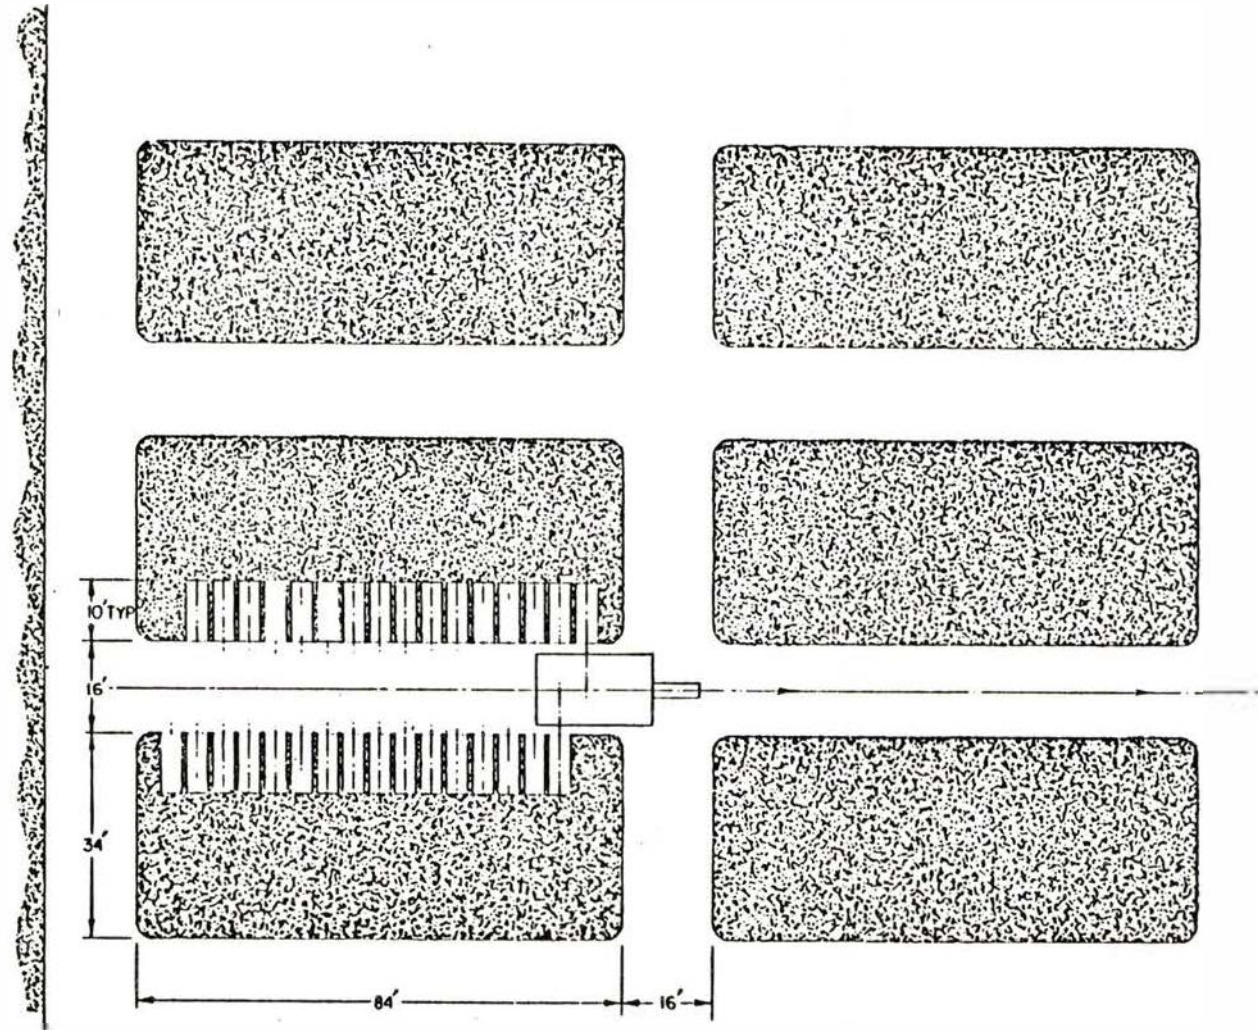
2 FIRST PAIR OF PILLARS TOTALLY DRILLED.
APPROXIMATELY FOUR TONS PER BOREHOLE.

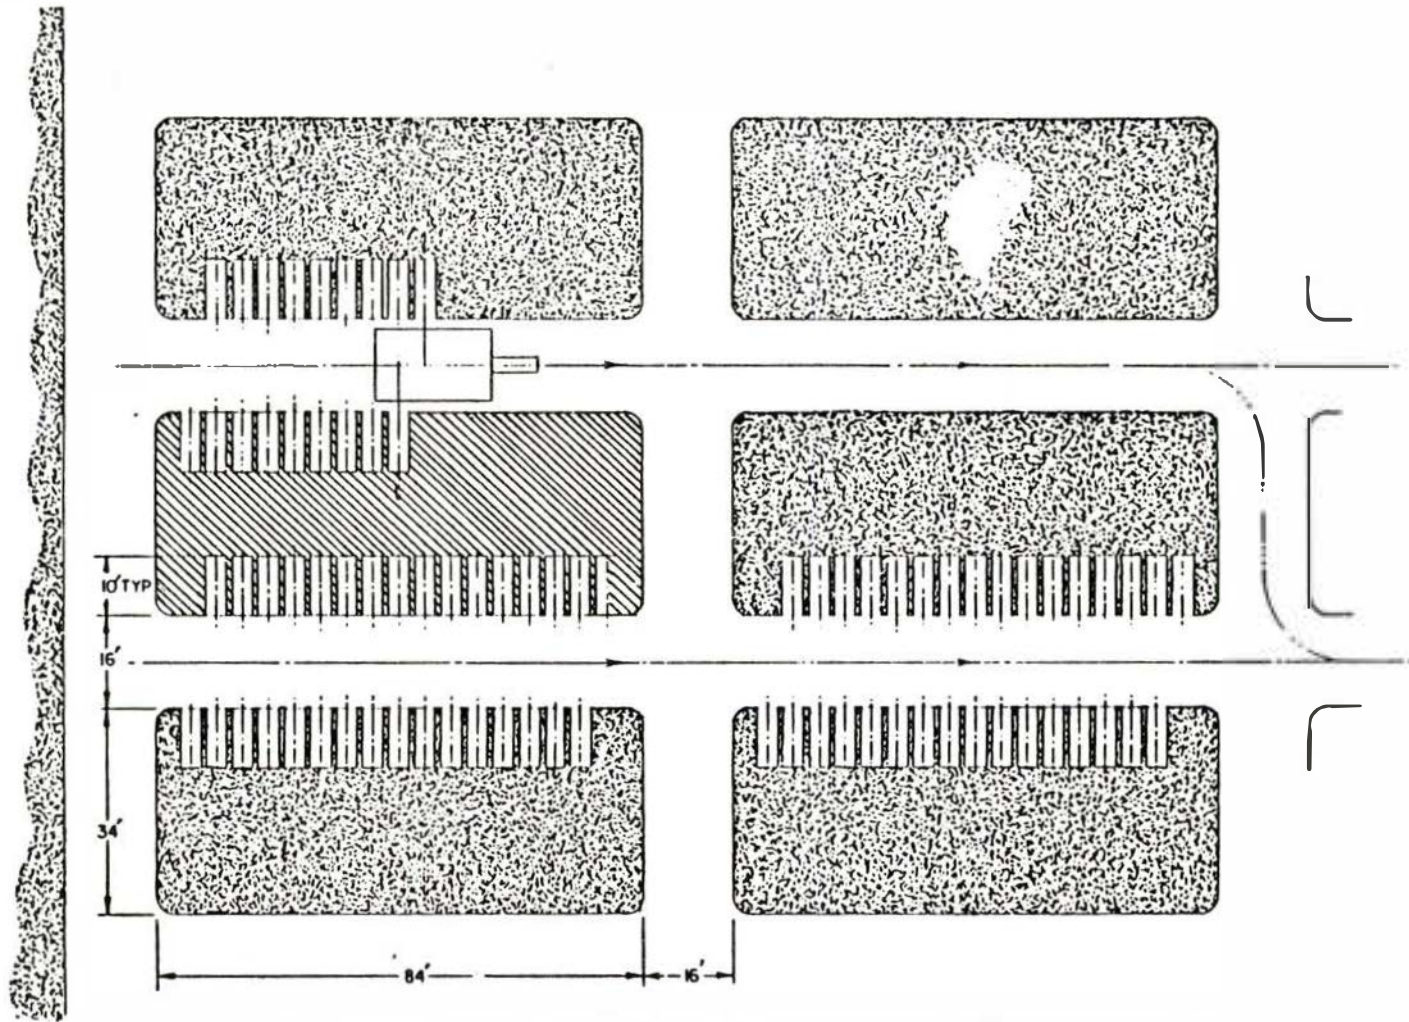
4 THIRD PAIR OF PILLARS BEING MINED. SHADED PILLAR WILL BE THE FIRST TO BE TOTALLY EXTRACTED.

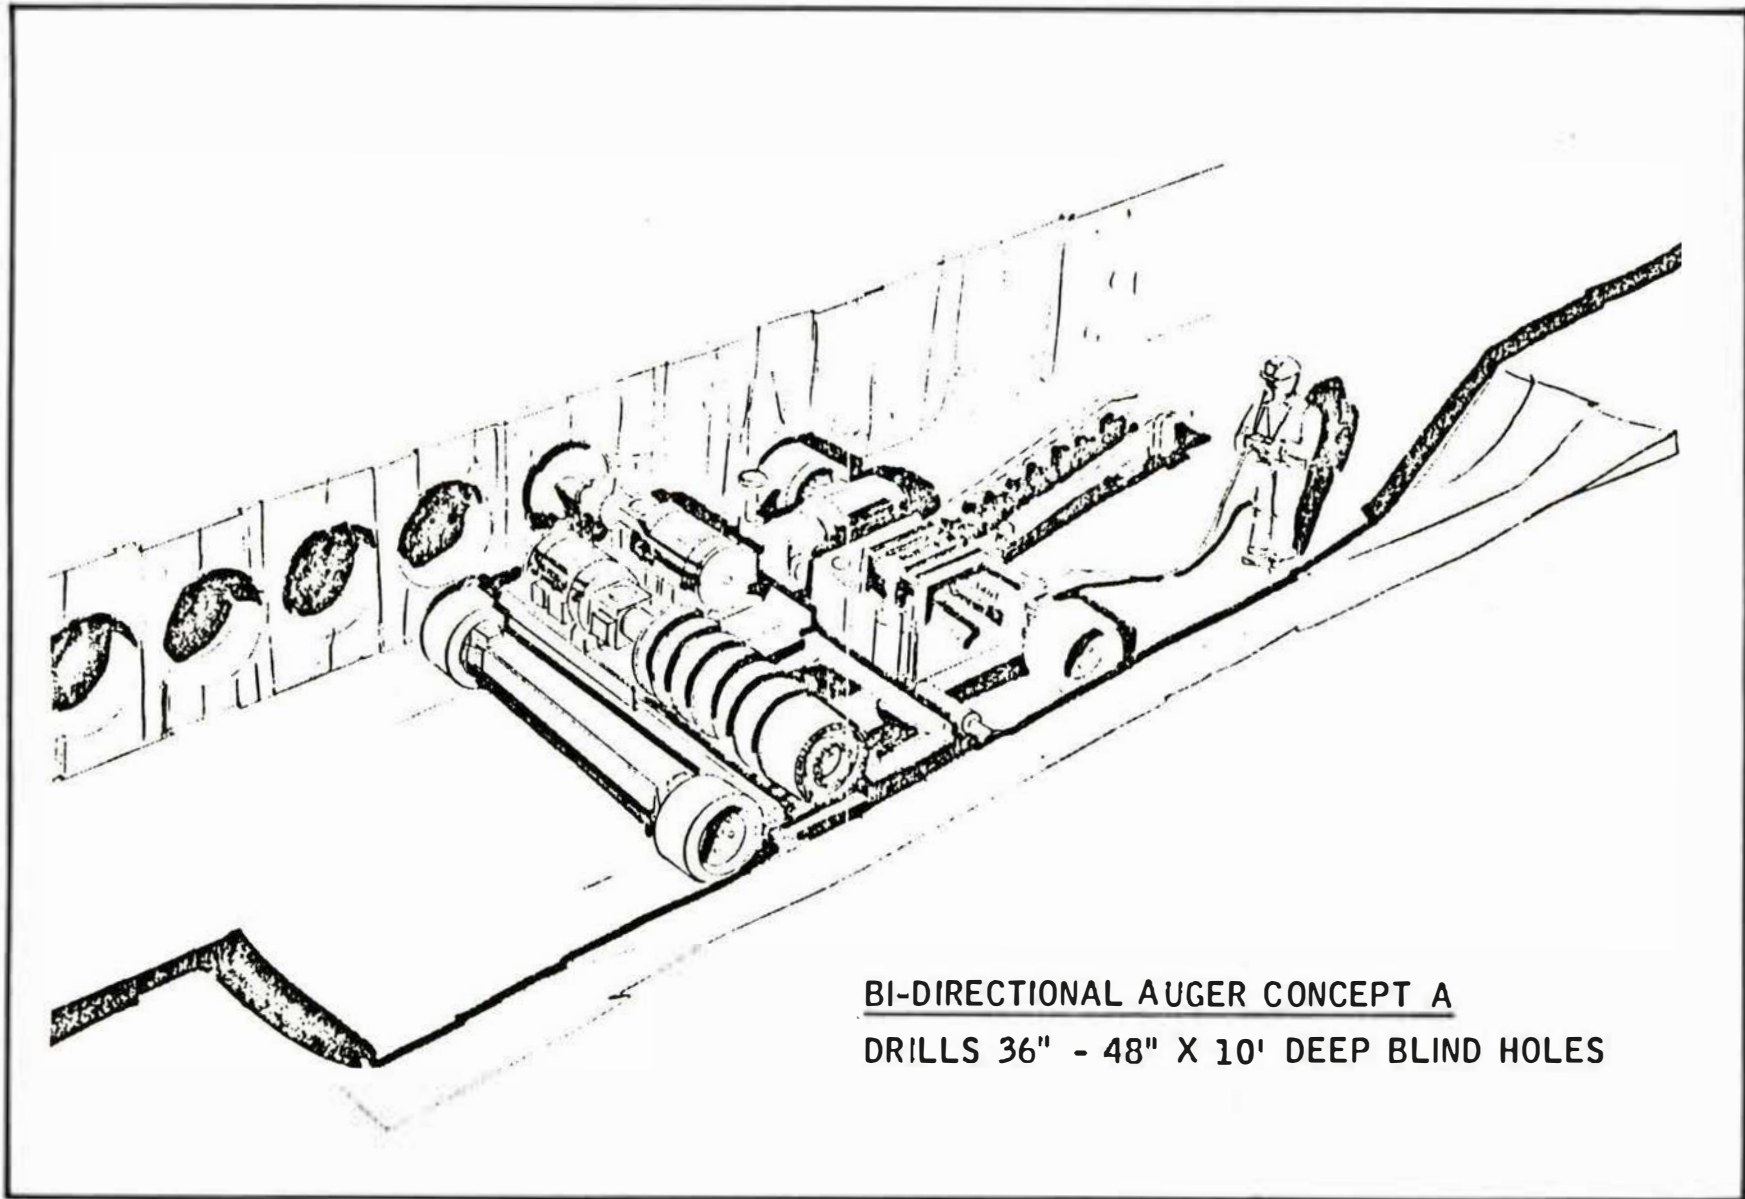
Figure 1 BIDIRECTIONAL AUGER, CONCEPT A

In March 1979 FMC hosted a concept review meeting with several MSHA staff members in attendance. At that meeting a concept of a single-chassis bidirectional auger which drilled boreholes only 10 feet deep was presented. FMC proposed that, for this short depth, the boreholes be unventilated during drilling. We proposed that the machine be remotely controlled, or as an option, the operator could be positioned under a canopy. Artist's renderings of these two concepts are shown in Figures 1 and 2.

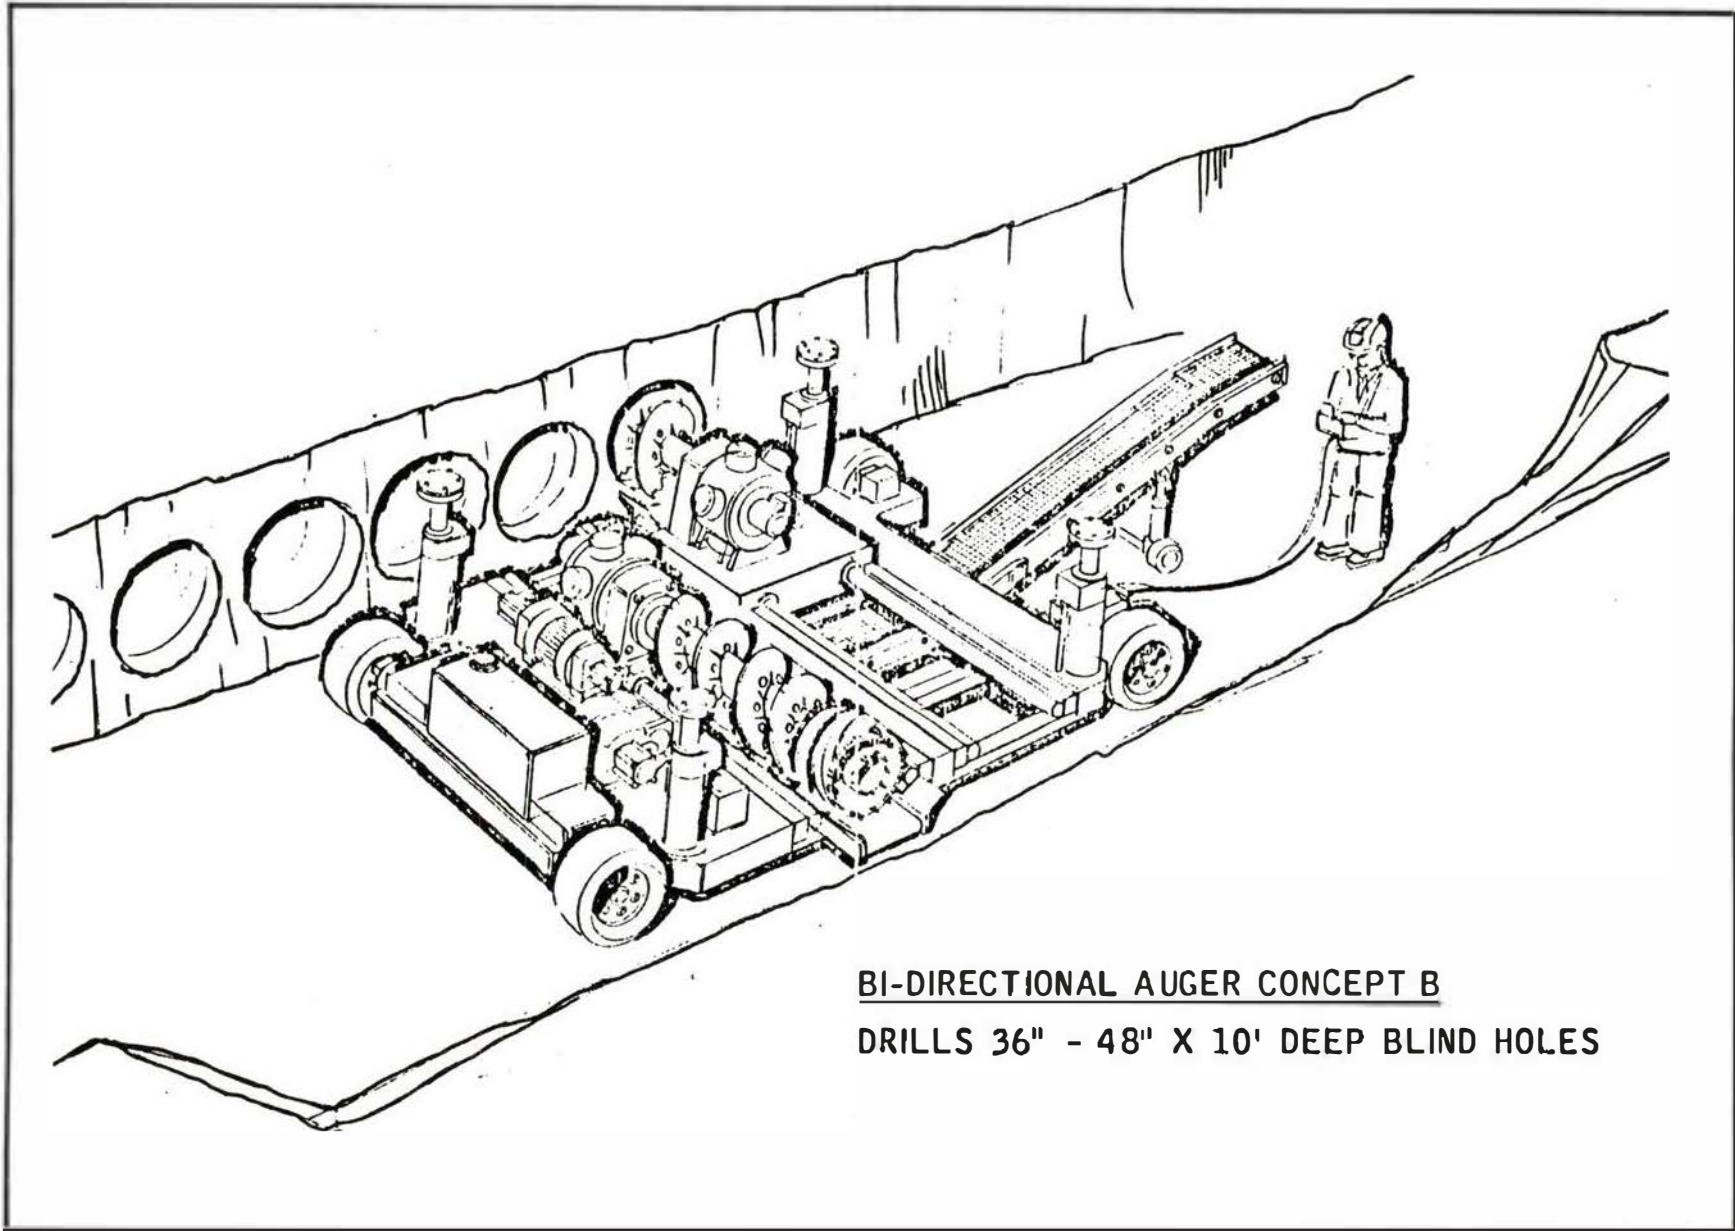
Figure 2 BIDIRECTIONAL AUGER, CONCEPT B
