Analysis of Safety Aspects And Mining Practices For Effective Ground Control in Surface Mining

Suresh K. Bhatt, *Mining Engineer*
Christopher Mark, *Supervisory physical scientist*
National Institute for Occupational Safety and Health
Pittsburgh Research Laboratory
Pittsburgh, PA.

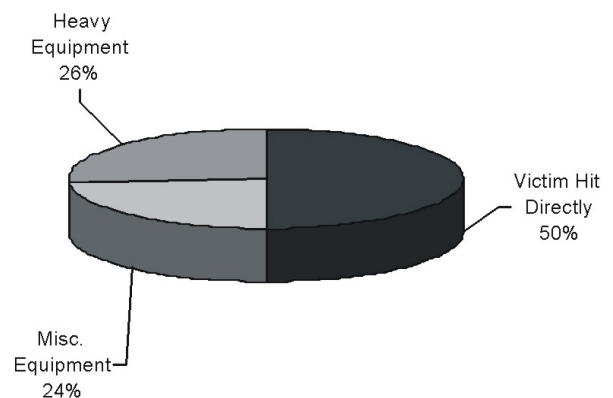
Approximately 26% of all accidents caused by highwall failure involved heavy earth moving equipment, such as the drill, front-end loader, dozer, shovel/dragline, and trucks. Approximately half of the injuries were caused when the failed material hit the victim directly. The remaining 24% involved miscellaneous equipment items (over 40). Figure 1 shows this breakdown.

Figure 1. Accidents by worker involvement

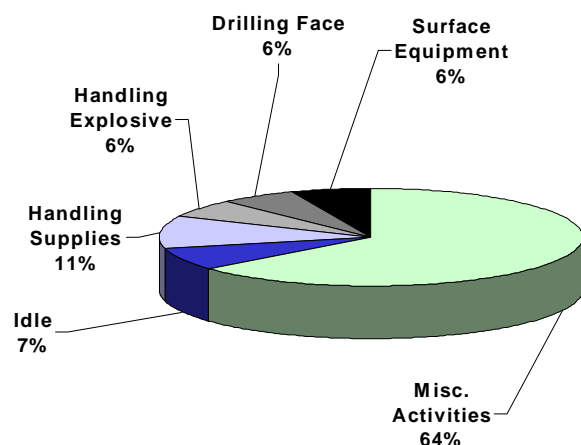
Handling supplies or material was found to be the single most frequent (11%) worker activity when injured, followed by idle category (7%). Handling explosives, drilling face, and surface equipment (not elsewhere classified) each represent about 6% of all accidents (18% total). The remaining 64% are distributed over 80 mine worker activities. Figure 2 shows this breakdown.

Figure 2. Accidents by worker activity

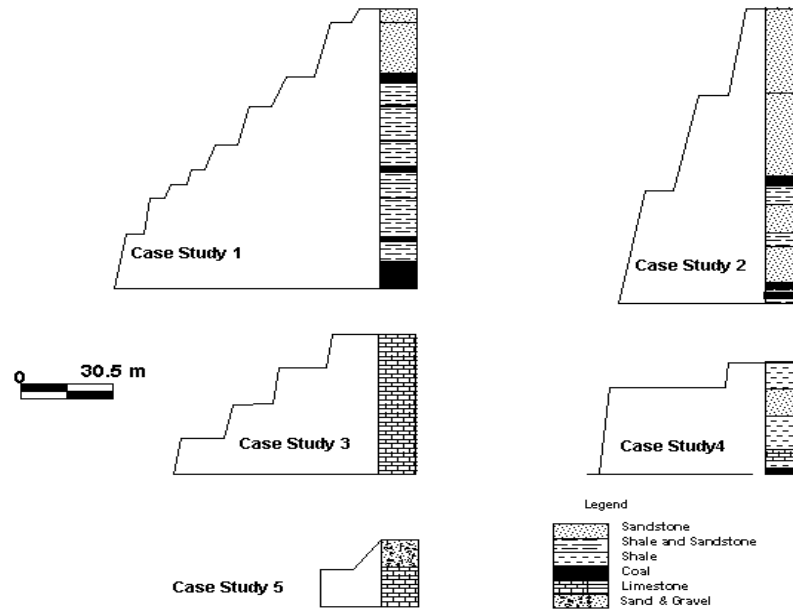
Figure 4. Geological settings and operational parameters

In addition to gathering information from the mine personnel, an operating surface mine was visited at each location. The mine visits covered parts of West Virginia, Pennsylvania, and Ohio. Materials mined include coal (anthracite and bituminous), limestone, and sandstone. Of the eleven mines, eight are coal, two limestone, and one sandstone. Figure 3 shows the general location of these mines in the eastern United States. Five case studies are provided to represent the mining practices and safety aspects of the study area. Typically, a case study addresses the geological setting and operational parameters (bench width, height, and slope angle) in a mining area for effective ground control. Figure 4 shows the geological settings and operational parameters for the five case studies.
