# NOISE AND VIBRATION REDUCTION OF A VIBRATING SCREEN

## Abstract

Workers in coal preparation plants, where vibrating screens are significant noise sources, are often exposed to sound levels exceeding 90 dB(A). The National Institute for Occupational Safety and Health, a major coal company, and a vibrating screen manufacturer conducted a cooperative study of vibrating screen noise. Rubber isolators reduced sound levels by 1 dB. Urethane screen panels did not reduce sound levels in this case. Drive noise was determined to be the dominant noise source on the screen. Damped side plates reduced vibration levels on the screen sides by 1 to 7 dB(A). Detailed results of the study are presented.

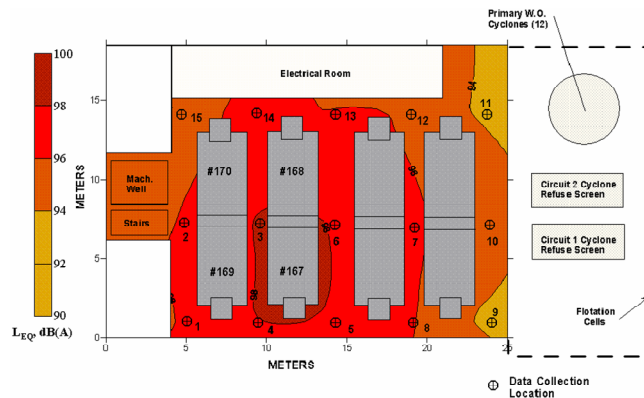
**Figure 1.** Contour plot of the A-weighted sound levels around a group of eight clean coal screens.

The consortium selected a coal preparation plant for the study based on its proximity to all of the involved researchers. In the selected plant, preliminary measurements were made in the area surrounding a group of eight horizontal vibrating screens used to process clean coal. These measurements indicated that the sound levels ranged from 94 to 98 dB(A) with the plant processing coal (see Figure 1) and from 89 to 97 dB(A) without the plant processing coal and the screens operating with vibration only. The sound levels decrease significantly with increasing distance from the screens, indicating that the

screens dominate the overall A-weighted sound level in this area of the preparation plant. In order to reduce the potential for overexposing preparation plant workers to noise, the collaborators agreed to test several commonly used engineering noise controls for vibrating screens. In addition, the collaborators initiated a research effort to rank the noise sources on one of the horizontal vibrating screens and to develop engineering noise controls to address the dominant noise sources.

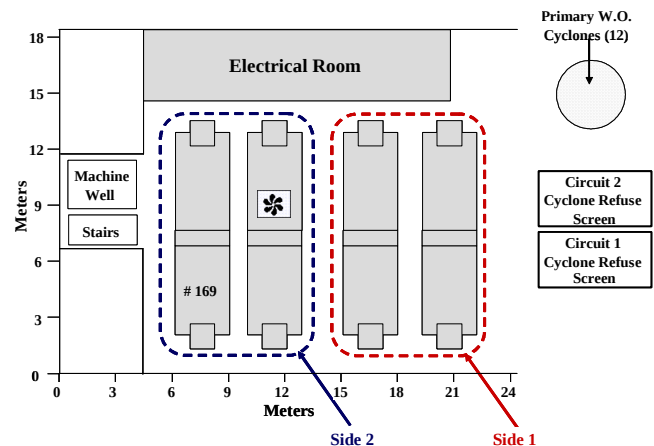
**Figure 2.** Overhead view of test area.

After the plant operation, test options, and available screens were discussed, a single 2.4 m x 4.9 m horizontal vibrating screen used to drain and rinse a 1 x 10 mesh cyclone clean coal product was selected as the test screen. The test screen, Screen #169, operates within a group of eight similar screens as shown in Figure 2. The plant is designed such that the eight screens are split into two groups of four screens, referred to as Side 1 and Side 2. The sound levels at any location within the test area are influenced by each of the eight screens. Ideally, the sound level around the test screen could be measured with only the test screen processing coal. However, the seven other screens cannot be turned off while processing coal on only the test screen. All of the screens from either Side 1 or Side 2 can be turned off while processing coal. In addition, one screen from Side 1 or Side 2 can be turned off while processing coal with the remaining screens. Therefore, without some means of reducing the contribution of the other screens to the sound level around the test screen, evaluating the sound levels due to the test screen and the noise reductions due to installing engineering controls would be impossible.

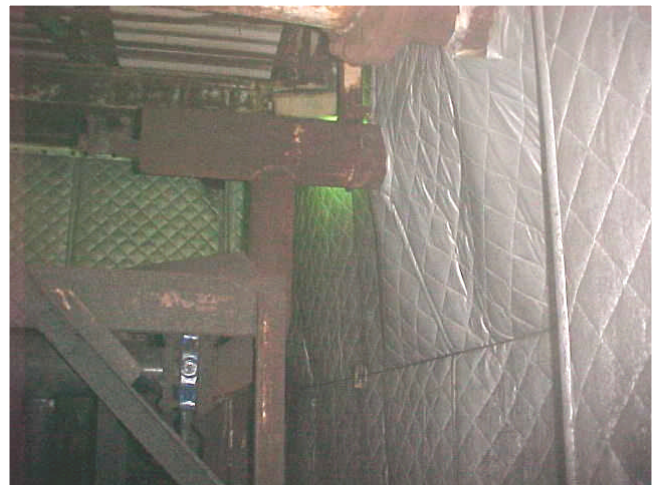
**Figure 3.** Barrier-absorber curtain between screen numbers 169 and 167 showing tight seal around piping.

In order to reduce the background sound levels around the test screen due to the nearby plant machinery, quilted barrier-absorbers consisting of two fiberglass layers with a loaded vinyl septum and covered in a nylon material were hung from the plant support beams around the test screen (see Figure 3). The barriers were attached to the support beams of the above floor with bolts through grommets. The barriers were sized such that they touched the floor when installed. The seams between individual barrier strips were sealed with Velcro, and gaps around pipe penetrations were kept to a minimum. The above steps were necessary to achieve the maximal reduction in the background noise near the test screen.

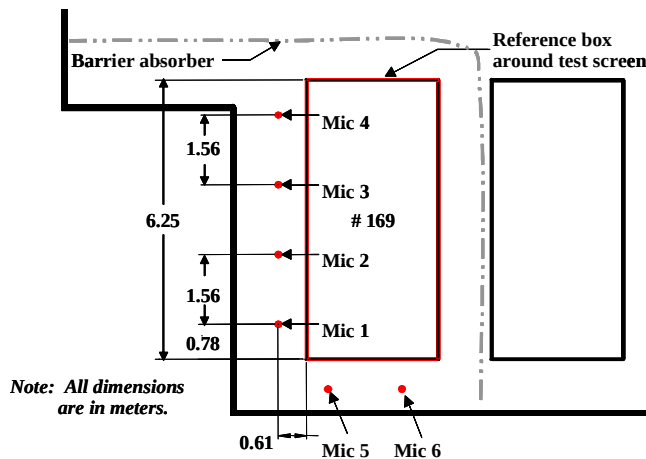
**Figure 4.** Overhead view of microphone positions around test screen (169) showing barrier-absorber curtain location.

Six microphones were positioned at a height of 1.5 meters and a distance of 0.6 meters from a reference box surrounding the test screen (see Figure 4). Four microphones were positioned along the left side of the test

screen with two microphones behind the feed chute. Due to the proximity of the barrier to the right side of the test screen, it was not possible to position microphones along the right side of the screen. Microphones could not be positioned at the discharge end of the screen between the test screen and Screen #170 due to the screen design. The data acquisition equipment was positioned in the corner of the building as shown in Figure 5.

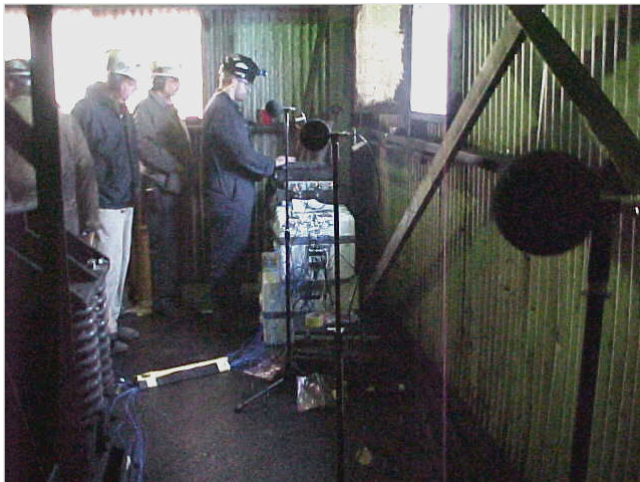
**Figure 5.** Data acquisition equipment location and microphones along left side of screen 169.

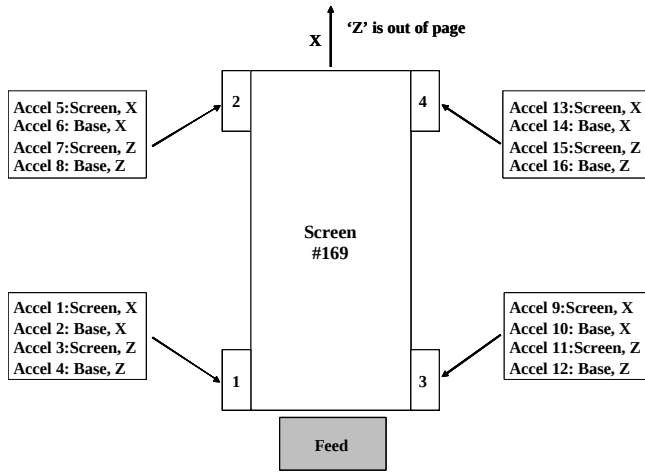
**Figure 6.** Accelerometer locations used during steel coil spring and rubber isolator testing.

After the barrier-absorber curtain was in place, sound level measurements were performed with new steel coil springs installed. To determine the effect of switching to rubber isolators on building vibration, accelerometers were attached to the screen at the steel coil spring locations on both the screen side and building side of the springs to measure accelerations in both the fore/aft (x) and vertical (z) directions as shown in Figure 6. Figure 7 shows the accelerometers at one mounting location with the steel coil springs (upper picture) and rubber isolators (lower picture).

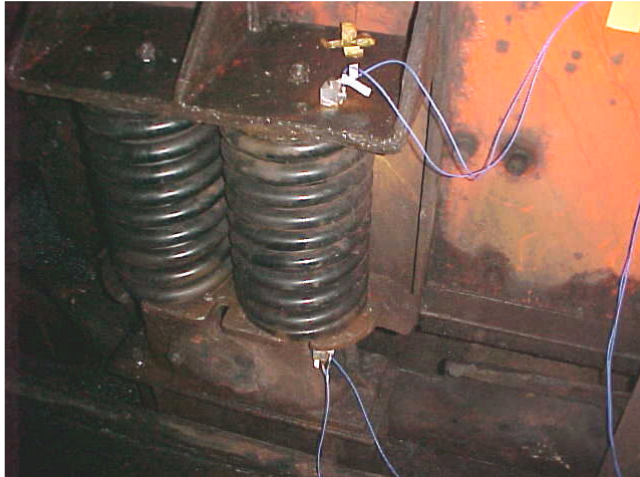
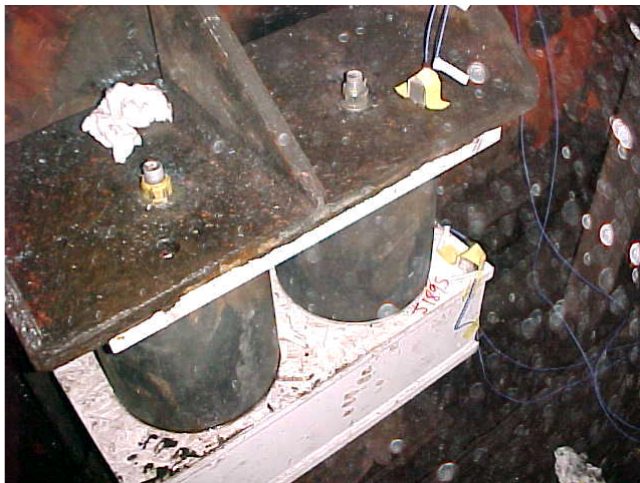
**Figure 7.** Accelerometers affixed to screen and base at isolator mount locations.

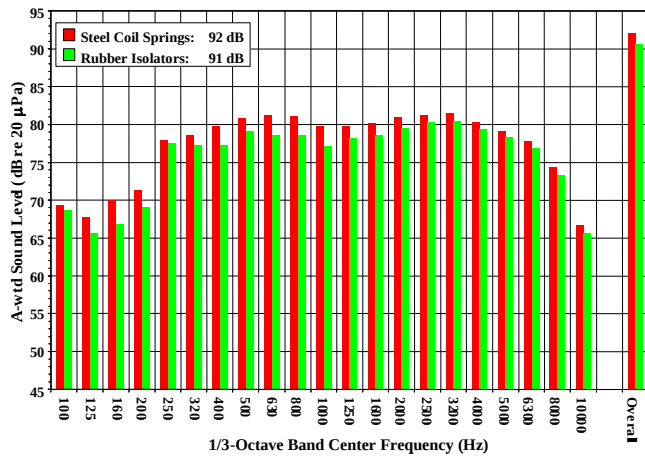
**Figure 8.** A-wtd 1/3-octave band sound levels for steel coil springs vs. rubber isolators, full operation.

Figures 8 and 9 show the background-noise-corrected A-weighted, 1/3-octave band sound levels due to the test screen for full operation and vibration only, respectively. The figures show that using rubber isolators reduced the overall sound level by 1 dB(A) for full operation and 2 dB(A) for vibration only operation. The figures show that small reductions occur throughout the 100 Hz to 10 kHz frequency range.

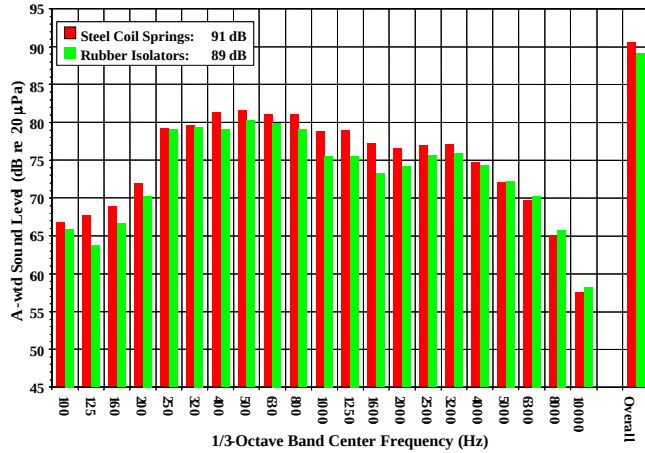
**Figure 9.** A-wtd 1/3-octave band sound levels for steel coil springs vs. rubber isolators, vibration only.

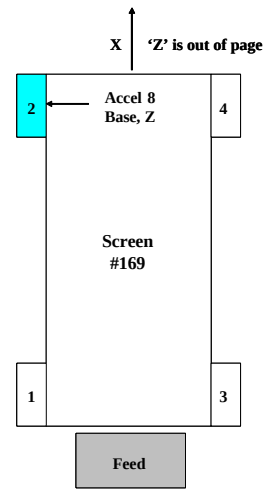
**Figure 10.** Location used to compare the acceleration time history with steel coil springs and rubber isolators.

To examine the vibration associated with noise radiation, the time waveform of the accelerometer signal on the building side of the mounting location highlighted in Figure 10 was compared for the steel coil springs and rubber isolators. Figure 11 shows the time waveform with the steel coil springs and with the rubber isolators. The

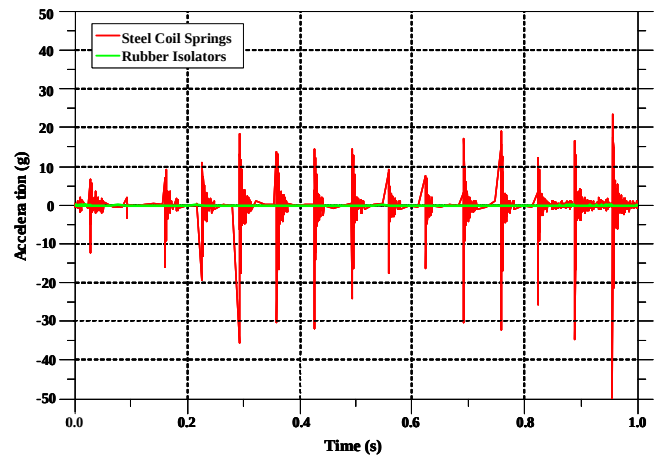
**Figure 11.** Acceleration in Z-direction at mount 2 with steel coil springs and rubber isolators.

figure shows that 15 impacts per second occurred with the steel coil springs. This impact rate corresponds with the rotation frequency of the vibration mechanisms. The impacts cause peak to peak high frequency vibrations on the order of 75 g at this location. Similar results were observed at the other mounting locations. The impacts could be due to contact between an inner and outer coil spring, a coil spring and its positioning disk, a friction check and the screen, or the screen and a fixed object such as a chute, pipe, or support structure. These impacts cause the screen and its support structure to vibrate and radiate noise. Therefore, these impacts must be eliminated to reduce screen noise in the most efficient manner.

Upon the re-installation of the steel coil springs, vibration measurements were taken at the spring mounting locations to determine the cause of the steel-on-steel impacts observed in the original data (refer to Figure 11). The steel-on-steel impacts were not observed at this time. It is possible that the original test data were influenced by an installation problem with the springs, which would increase the sound level around the screen. It is also possible that during the year that had passed any high spots on the gears in the rebuilt mechanisms had worn away resulting in smoother tooth engagement. In addition, with the rubber isolators, more vibration was transmitted to the building which could have increased the drive noise. Proper installation of the steel coil springs may have eliminated the steel-on-steel impacts and reduced the vibration transmitted to the building, thus decreasing the noise radiated by the screen and the building.

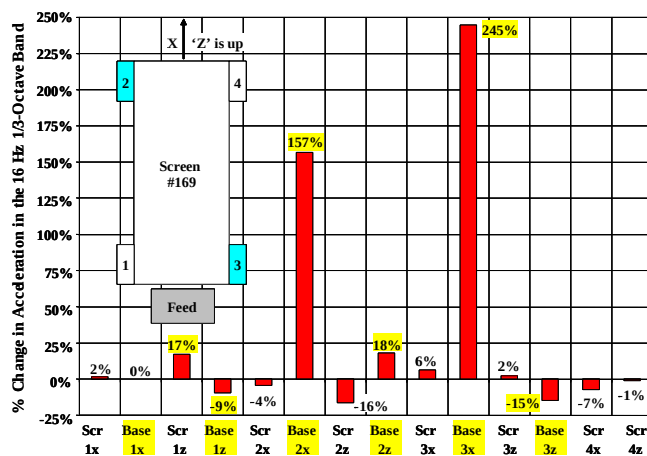
**Figure 12.** Percentage change in the acceleration in the 16 Hz 1/3-octave band due to replacing steel coil springs with rubber isolators.

rotation frequency. These low frequency vibrations can be a concern with respect to building vibration. Figure 12 shows the percentage change in the accelerations in the 16 Hz 1/3-octave band for the fore/aft (x) and vertical (z) directions on both the building (base) and screen side of each mount. The figure shows that the building vibration at the left mount on the discharge end and the right mount on the feed end of the screen increased substantially. Subjectively, an increase in the building vibration could be felt in the corner of the building where the acquisition equipment was located. The low frequency vibration with the rubber isolators was significantly higher than with the steel coil springs, even though the high frequency vibrations were lower with the rubber isolators.

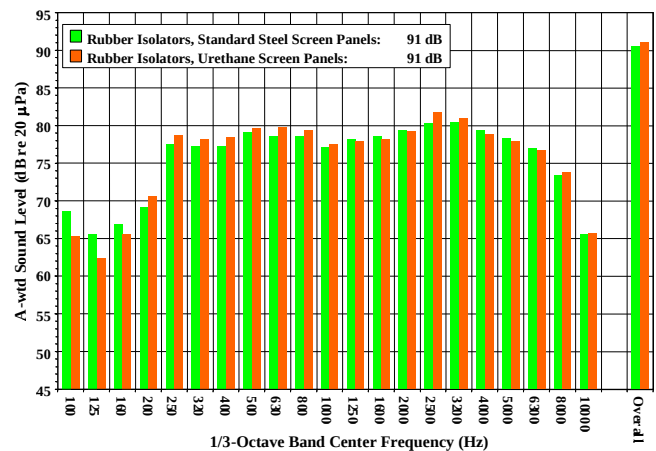
**Figure 13.** A-wtd 1/3-octave band sound levels for standard steel screen panels vs. urethane screen panels with rubber isolators, processing coal.

Following the tests with the rubber isolators, the steel screen panels were replaced with urethane screen panels. Sound level measurements were then performed with the screens processing coal. Figure 13 shows the background-noise-corrected A-weighted 1/3-octave band sound levels with the standard and urethane screen panels. A slight increase in sound level was observed. However, the increase was only a few tenths of a decibel, which is within measurement error. The figure indicates that the urethane screen panels did not reduce the sound level around the test screen in this case. These results are consistent with the findings of a 1977 report to the Bureau of Mines which states that particle size must ordinarily be greater than 12 mm diameter before coal impact noise exceeds 90 dB(A) near a screen (Rubin, 1997). Generally, coal flow noise is dominant in screens handling coarse coal, while noise due to the drive mechanism, which may be radiated by the screen body or mechanism housings, is the most significant noise source in screens handling finer coal (Ungar et al., 1976).

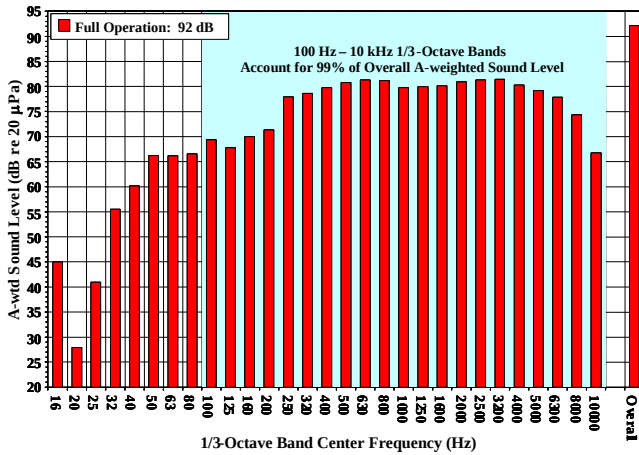
**Figure 14.** A-wtd 1/3-octave band sound levels for test screen while processing coal.

Figure 14 shows the A-weighted 1/3-octave band sound levels for the test screen with the steel coil springs and standard steel return deck while processing coal. The figure shows that the sound level in the 16 Hz 1/3-octave band, which contains the mechanism rotation frequency, is unimportant in terms of the overall A-weighted sound level. The 100 Hz through 10 kHz 1/3-octave bands, however, account for 99% of the overall A-weighted sound level under full operation. Therefore, emphasis was placed on this frequency range in determining the contributions of each noise source on the screen.

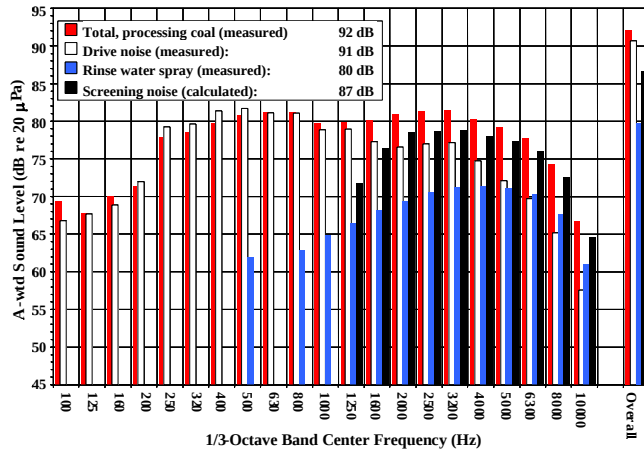
**Figure 15.** A-wtd 1/3-octave band sound levels for the total screen noise, drive noise, rinse water spray noise, and screening noise.

The A-weighted 1/3-octave band sound levels for the total screen noise, drive noise, rinse water spray noise, and screening noise are shown in Figure 15. The figure shows that drive noise is dominant in the 100 Hz through 1600 Hz 1/3-octave bands, whereas screening noise is dominant above the 1600 Hz 1/3-octave band. Therefore, the most effective approach to reduce the sound level around the screen would be to first address the drive noise in the 100 Hz through 1600 Hz 1/3-octave bands. Once the sound level due to drive noise is reduced to 87 dB(A), drive noise and screening noise would be equal contributors to the sound level around the screen during full operation. At this time, a decision would have to be made regarding which of these two noise sources would be most easily addressed to further reduce sound levels, if necessary.

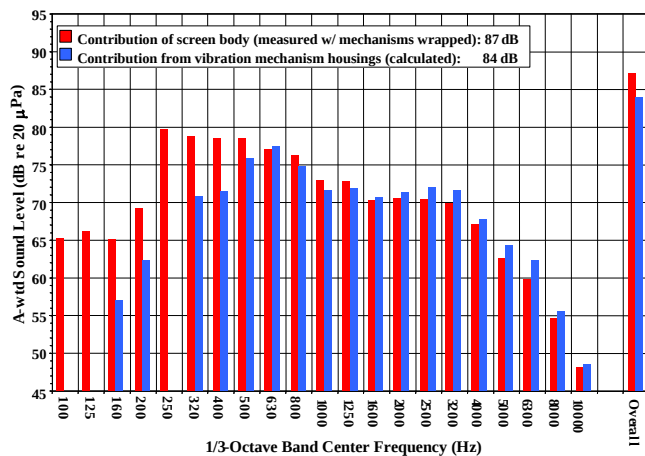
**Figure 16.** A-wtd 1/3-octave band sound levels for noise radiated by screen body and mechanism housings.

Figure 16 shows the A-weighted 1/3-octave band sound levels due to screen body and mechanism housing vibration. The sound levels due to screen body and mechanism housing vibration were found to be 87 dB(A) and 84 dB(A), respectively. Since a 3-dB difference in levels indicates a doubling of energy, screen side vibration can be said to have twice the significance of mechanism housing vibration in terms of drive noise. The spectra indicate that the noise radiated by the screen body is dominant in the 100 through 500 Hz 1/3-octave bands. The screen sides account for 83% of the sound energy for this band. In the 630 Hz through 1600 Hz 1/3-octave bands, the figure shows that the screen sides and mechanism housings generate similar sound levels with each contributing approximately 50% to the drive noise in this frequency range. In the 2 kHz through 10 kHz 1/3-octave bands, the sound levels due to mechanism housing vibration are higher than those associated with screen side vibration. Mechanism housing vibration accounts for 58% of the drive noise sound level in this frequency range.

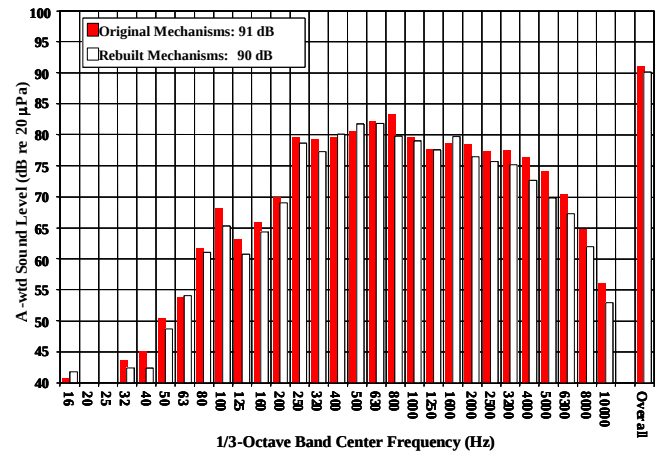
**Figure 17.** A-wtd 1/3-octave band sound levels for vibration only operation with original and rebuilt mechanisms.

Baseline sound levels were measured with the existing set of mechanisms, the rubber isolators, and the urethane screen panels installed on the test screen with the plant shut down and the test screen operating with vibration only. The mechanisms were then replaced with rebuilt mechanisms and the measurements were repeated. Figure 17 shows the 1/3-octave band sound levels with the original and rebuilt mechanisms. The figure indicates that installing the rebuilt mechanisms reduced the overall A-weighted sound level by 1 dB. According to the screen manufacturer and the coal company, installing rebuilt mechanisms costs

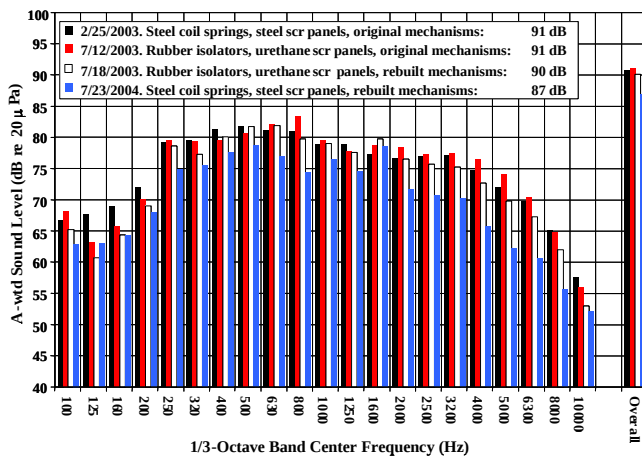
**Figure 18.** Comparison of sound levels with original or rebuilt mechanisms, steel coil springs or rubber isolators, and steel or urethane screen panels for several test dates.

Due to the increased building vibration with the rubber isolators, the mounts were switched back to the steel coil springs. In addition, the urethane screen panels were removed and standard steel screen panels were installed since the urethane screen panels did not reduce the sound levels and were prone to plugging. After approximately one year, a new set of measurements was performed to establish the baseline sound levels for the screen operating with vibration only with the steel coil springs and steel deck. The measurements were performed on a maintenance day with the plant shut down. At this time, an unexpected result was observed. The vibration only sound levels for the test screen with the steel coil springs and rebuilt mechanism decreased to 87 dB(A), a 4-dB reduction compared to the original measurements from February 25, 2003. Figure 18 shows a comparison of the vibration only sound levels with (1) steel coil springs, steel screen panels, and the original mechanisms, (2) rubber isolators, urethane screen panels, and the original mechanisms, (3) rubber isolators, urethane screen panels, and the rebuilt mechanisms, and (4) steel coil springs, steel screen panels, and the rebuilt mechanisms. The test dates for these data were February 25, 2003, July 12, 2003, July 18, 2003, and July 23, 2004, respectively.

The figure shows that the average sound level measured on February 25, 2003, with new coil springs, the steel return deck, and the original mechanisms was 91 dB(A). When testing was conducted within a 1-week period (July 12, 2003, and July 18, 2003) with the original versus rebuilt mechanisms with rubber isolators and urethane screen panels, the sound levels were 91 and 90 dB(A), respectively. However, after the steel coil springs replaced the rubber isolators and the steel screen panels replaced the urethane screen panels and one year had passed since the installation of the rebuilt mechanisms, the sound level for vibration only operation was 87 dB(A).

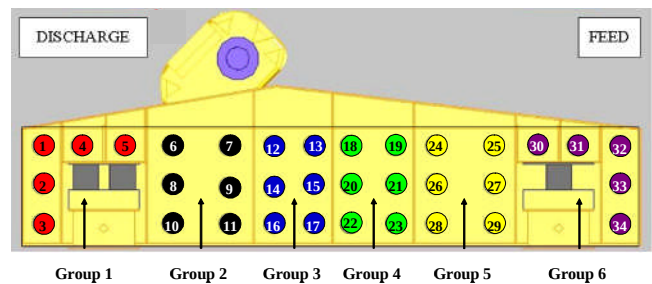
**Figure 19.** Approximate accelerometer locations used for vibration measurements on the left side of the screen.

Prior to constructing the damped side plates, a series of vibration measurements was performed on the left side of the screen to determine the relative vibration levels along the side of the screen. The goal was to determine if constrained layer damping was necessary on the entire side plate or if some areas, which had insignificant vibration levels, could be left untreated. The left side was divided into six areas and a group of accelerometers was attached to each area as shown in Figure 19.

To evaluate the effects of the damping treatment on the screen side vibration, the average A-weighted vibration velocity levels for the left and right sides of the screen were calculated from the measured accelerations at the locations shown in Figure 21. Although the aforementioned problems with the screen installation would tend to increase the radiated noise, it was thought that the damping treatment would still reduce the screen side vibration. This is because both of the installation problems would tend to cause additional noise to be radiated from the building and from local areas more than from the screen sides. Figures 23 and 24 show the A-weighted 1/3-octave band vibration levels on the left and right sides of the screen, respectively. Figure 23 shows reductions in the A-weighted velocity levels on the left screen side ranging from 2 to 7 dB in the 200 Hz through 5 kHz 1/3-octave bands with the damped sides. For the right screen side, Figure 24 indicates reductions of 1 to 6 dB in the 200 Hz through 5 kHz 1/3-octave bands. In the 200 Hz through 630 Hz 1/3-octave bands, the A-weighted vibration levels were reduced by 3 dB on the left side and 4 dB on the right side. The A-weighted vibration levels in the 800 Hz through 5 kHz 1/3-octave bands were reduced by 6 dB on the left side and 3 dB on the right side. With these substantial reductions, the A-weighted sound levels should have been reduced by 3 dB or more. More research should be performed to evaluate the effects of mechanism covers and the damped sides on the radiated sound levels.

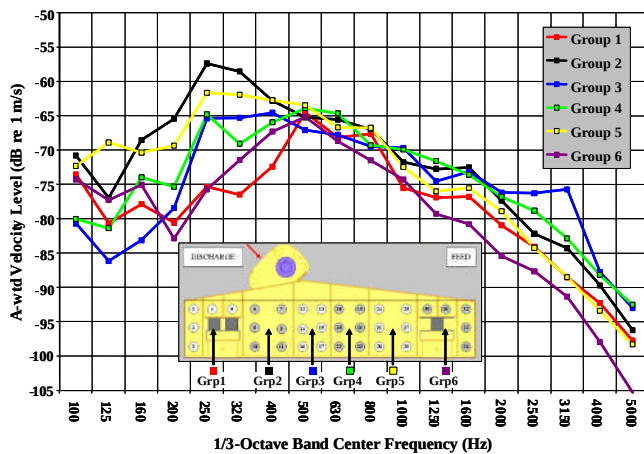
**Figure 20.** A-weighted surface-averaged velocity levels.

The test screen was operated with vibration and without coal. Since noise radiation is directly related to the surface-averaged velocity, the resulting 1/3-octave band accelerations were integrated to yield vibratory velocities, and the surface-averaged A-weighted velocity levels for the six areas were calculated (see Figure 20). A-weighting was applied to the vibratory velocities to deemphasize low frequency vibration, which is not a significant contributor to the A-weighted sound level in this case. The figure shows that the velocity levels are highest in the 100 Hz through 400 Hz 1/3-octave bands for the Group 2 and Group 5 accelerometers. However, above the 500 Hz 1/3-octave band, the variation in vibration levels from group to group is generally less than 10 dB. Therefore, each area is a significant contributor to the drive noise radiated by the screen sides and should be treated.

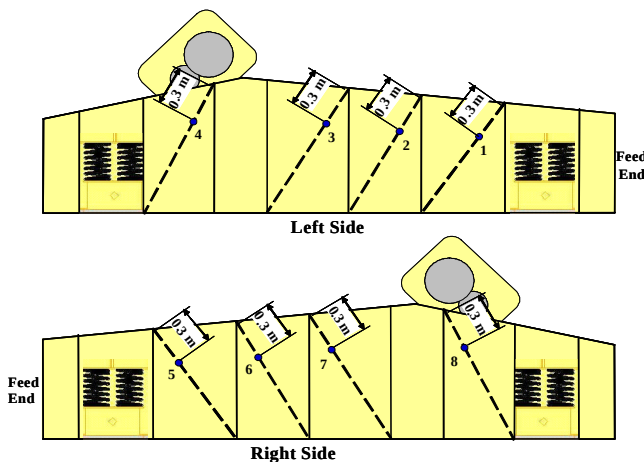
**Figure 21.** Accelerometer locations used to evaluate the effects of installing constrained layer damped side plates.

Constrained layer damped side plates were constructed by bonding a layer of viscoelastic damping material to new side plates using epoxy. A 1/8-inch-thick layer of steel was then attached to the viscoelastic material with epoxy to complete the construction. Mechanism covers were fabricated from a barrier-absorber material similar to the material used to exclude background noise from the test area during the initial tests. Prior to installing the damped side plates, baseline sound level measurements were taken during miner's vacation with the plant shut down and the test screen operating with vibration only. In addition, acceleration measurements were taken on the sides of the screen at the locations shown in Figure 21.

mechanism covers were then removed and the measurements were repeated. In addition, acceleration measurements were performed at the locations shown in Figure 21 for comparison with the baseline vibration measurements collected in July.

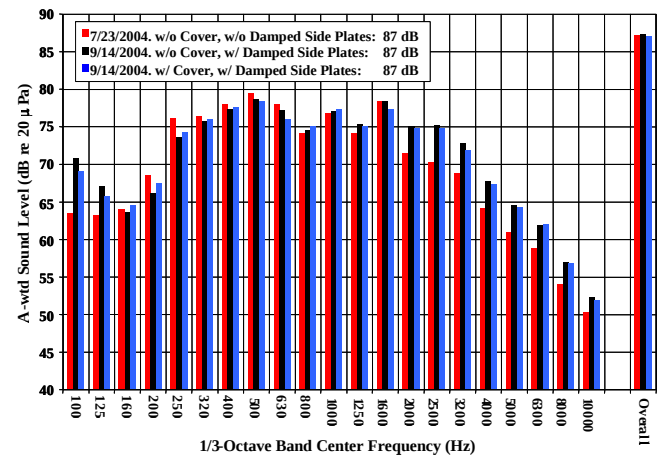
**Figure 22.** A-wtd 1/3-octave band sound levels with vibration only operation for mechanism cover and damped side plate tests.

Figure 22 shows the A-weighted 1/3-octave band sound levels for baseline conditions and with the engineering noise controls installed. As the figure shows, neither the damped side plates alone nor the damped side plates and mechanism covers reduced the overall A-weighted sound level. It was expected that the sound level would be reduced by 3 dB or more. The figure shows that the sound levels in the 200 Hz through 630 Hz 1/3-octave bands were reduced by 1 to 2 dB with the damped side plates. With the damped sides and mechanism covers, the reductions in this band were again 1 to 2 dB. In the 800 Hz through 10 kHz 1/3-octave bands, the sound levels measured with the engineering controls installed increased from 83 dB(A) to 84 dB(A). Since it is unlikely that installing these noise controls would increase the sound levels in these bands, something must have changed with the vibrating screen during the period between baseline testing in July, 2004, and the testing with the noise controls in September, 2004.

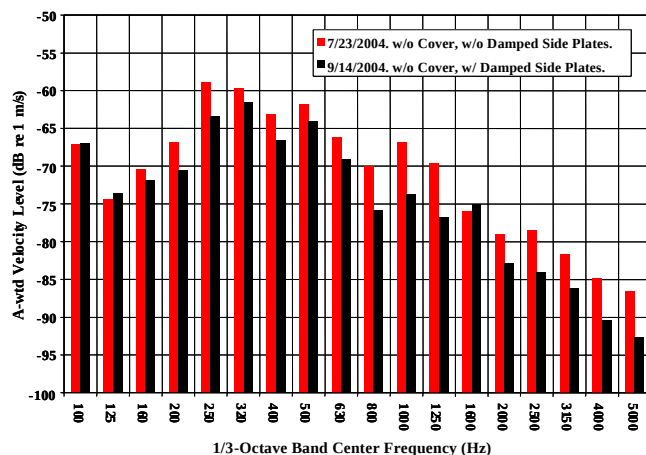
**Figure 23.** A-weighted average velocity on left side of the screen without and with damped sides.

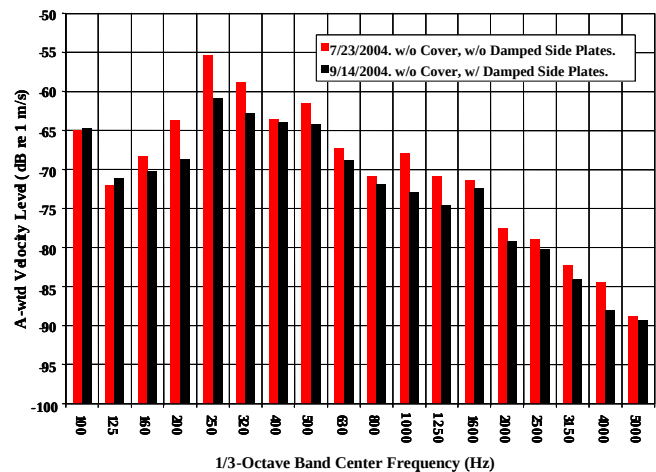
**Figure 24.** A-weighted average velocity on right side of the screen without and with damped sides.
