# From Scotia to Brookwood, fatal US underground coal mine explosions ignited in intake air courses

Thomas H. Dubaniewicz, Jr.\*

*National Institute for Occupational Safety and Health, Pittsburgh Research Laboratory, P.O. Box 18070, Pittsburgh, PA 15236*

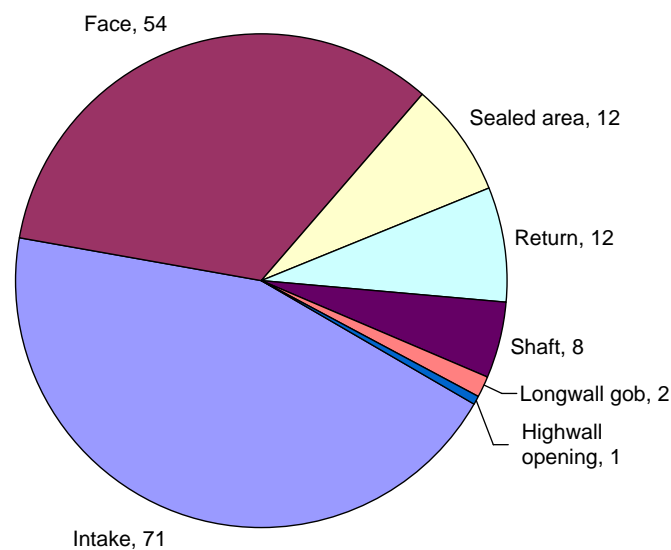
Fig. 1. 160 methane and/or coal dust explosion fatalities by location of the ignition source in underground or high wall coal mines from 1976 to 2006. Numbers of fatalities per location were weighted by the location uncertainty of the 1989 Pyro No. 9 disaster.

Using Table A1 data, Figs. 1–5 show fatalities linked to different locations and ignition sources. In Fig. 1, the numbers of fatalities per location were weighted by the uncertainty of the location of the 1989 Pyro No. 9 disaster. Of the ten 1989 Pyro fatalities, 5 were attributed to a face ignition and 5 were attributed to an intake air entry ignition. 71 of 160 fatalities were linked to intake air courses using this weighting method (Fig. 1). Considering all fatalities from the 1989 Pyro disaster, 76 fatalities were linked to intake air courses. In Fig. 2, numbers of fatalities per category were weighted by ignition source uncertainties of the 1989 Pyro No. 9 disaster and 1987 Double R explosion. In Fig. 3, numbers of fatalities per category were weighted by ignition source uncertainties of the 1989 Pyro No. 9 disaster and 1987 Double R explosion. In Fig. 4, numbers

Fig. 1 shows that many US explosion fatalities since 1976 can be linked to ignition sources in intake air courses. In all of these accidents, the ventilation system failed or was found to be inadequate. These fatalities suggest intake air courses of gassy underground coal mines should be considered Class I Division 2 or Zone 2 locations at a minimum, i.e. locations in which flammable gases or vapors are normally prevented by positive mechanical ventilation, and which might become hazardous through failure or abnormal operation of the ventilating equipment (NEC 500.5 (b) (2); 505.5 (b) (3)).

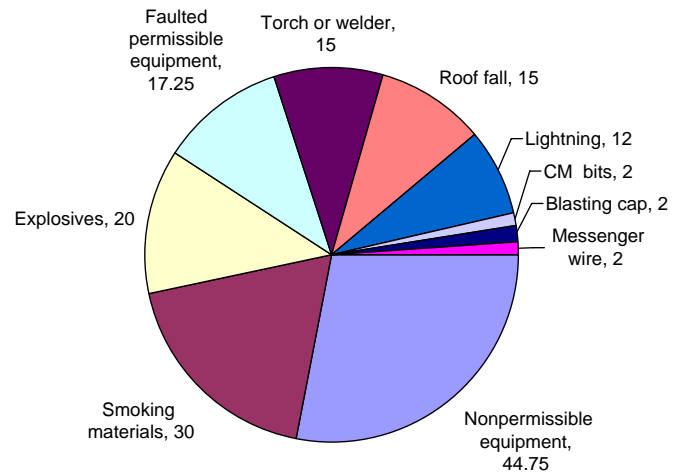
Fig. 2. Ignition sources linked to 160 methane and/or coal dust explosion fatalities in underground and high wall coal mines from 1976 to 2006. Numbers of fatalities per category were weighted by ignition source uncertainties of the 1989 Pyro No. 9 disaster and 1987 Double R explosion.

Figs. 2 and 3 show that nonpermissible equipment can be linked to more explosion fatalities than any other ignition source category, for all locations, and especially in intake air courses. Fig. 5 shows this trend continues to recent times. All of the nonpermissible equipment ignition sources linked to explosion fatalities were located in intakes. Fig. 4 shows that nonpermissible vehicles (battery and trolley powered) were linked to most intake explosion fatalities. Today, several underground vehicle manufacturers offer explosion protected locomotives and personnel carriers, track or tire, battery or diesel. Given the history of vehicle ignited fatal explosions and the availability of explosion protected vehicles, use of explosion protected vehicles in intake air courses of gassy underground coal mines is recommended to reduce this hazard.

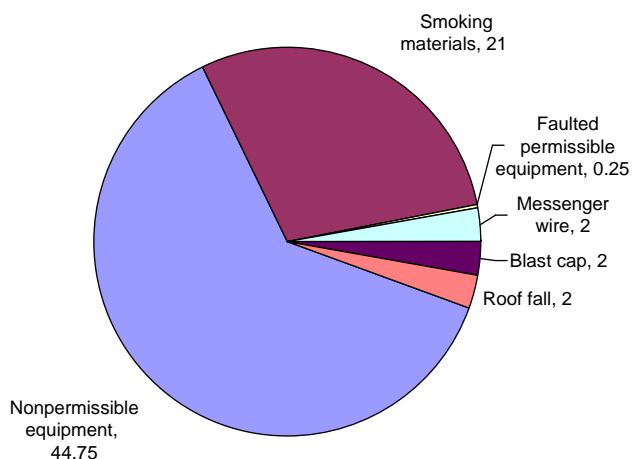
**Fig. 3.** Methane and methane plus coal dust explosion fatalities linked to ignition sources in intake air courses of underground coal mines from 1976 to 2006. Numbers of fatalities per category were weighted by ignition source uncertainties of the 1989 Pyro No. 9 disaster and the 1987 Double R explosion.

Most fatalities linked to cigarette lighters occurred when the miner was lighting up in intake air courses (Fig. 3). Smoking materials are prohibited in underground coal mines (30 CFR 75.1702). The smoking related fatal explosions emphasize the hazard of open ignition sources located in intake air courses of gassy mines should the ventilation system fail or become inadequate. The use of explosion protected electrical equipment in intakes of gassy mines may make the miner more aware of ignition hazards in these areas, including smoking materials.

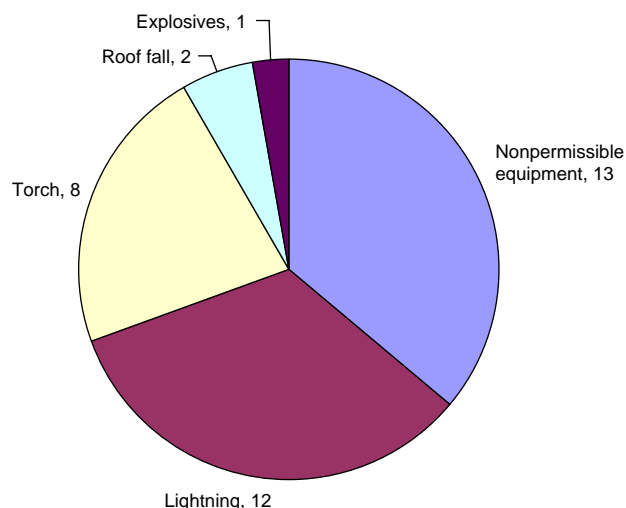
**Fig. 5.** Most likely ignition sources identified by MSHA for 36 fatalities from methane and methane plus coal dust explosions in underground coal mines from 2000 to 2006.

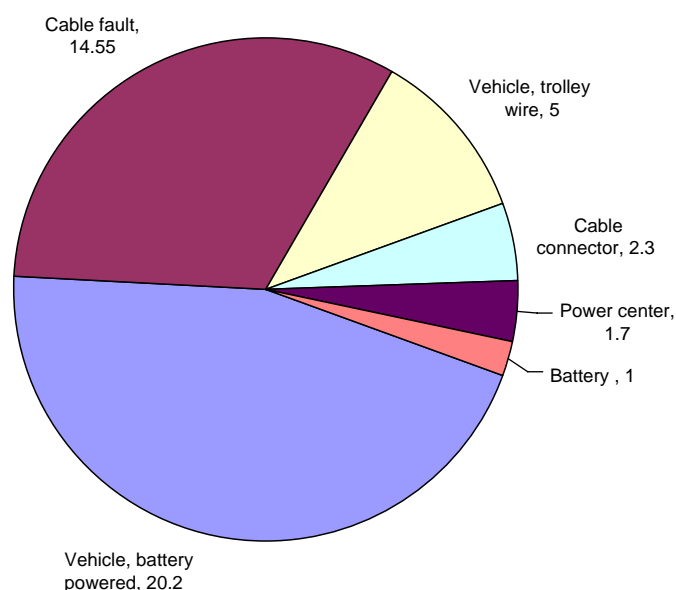
**Fig. 4.** Methane and methane plus coal dust explosion fatalities linked to non-permissible electrical equipment in intake air courses from 1976 to 2006. Numbers of fatalities per category were weighted by ignition source uncertainties of the 1983 McClure disaster and the 1987 Double R explosion.

of fatalities per category were weighted by ignition source uncertainties of the 1983 McClure disaster and the 1987 Double R explosion.

Twelve of the cable fault fatalities (Fig. 4) can be linked to the damaged block light cable igniting the second massive Brookwood explosion. The block light system was not required to be designed to prevent methane ignition as it was installed in an intake air entry. The description of the block light circuit (MSHA, 2002) suggests the block light installation may not have met several requirements for flexible cords in Class I Hazardous Locations (2005 NEC 501.140; 505.17)<sup>2</sup>. Potential violations involved: lack of a separate grounding conductor, cord not listed for extra hard usage, cord not protected from damage by location or suitable guard. Compliance with these NEC<sup>®</sup> and OSHA requirements might have prevented the 2nd 2001 Brookwood explosion (Dubaniewicz, 2007).
