Bureau of Mines Report of Investigations/ 1973

Geologic Factors Causing Roof Instability and Methane Emission Problems

The Lower Kittanning Coalbed, Cambria County, Pa.

Report of Investigations 7769

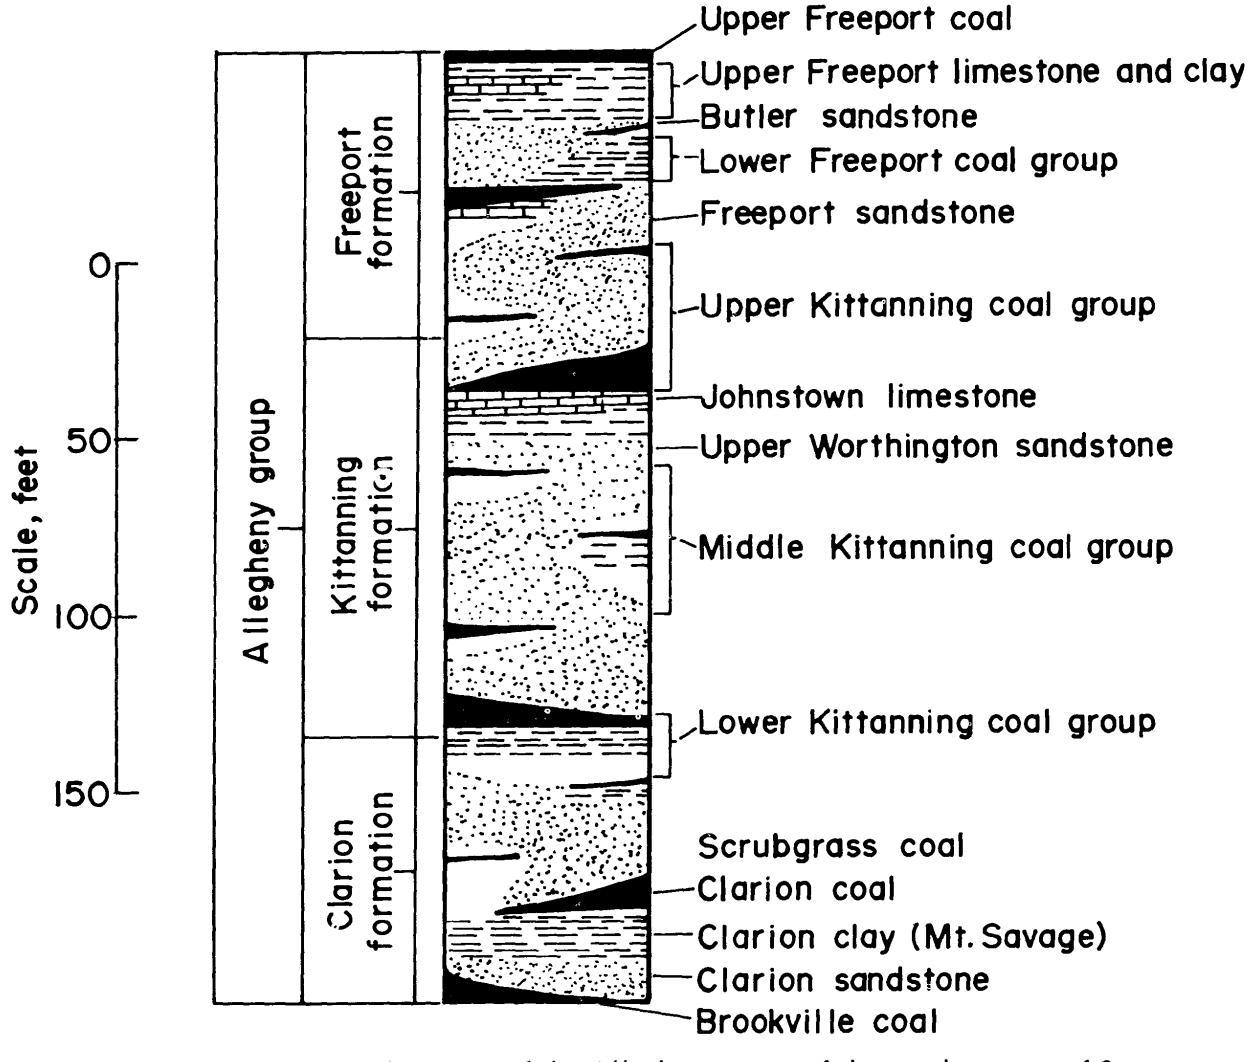
FIGURE 1. - Generalized section of the Allegheny group of the southern part of Somerset County, Pa.

Of the two stratigraphic columns shown, the first (fig. 1) is the "generalized section of the Allegheny group of southern Somerset County, Pa." ($\underline{8}$). A stratigraphic column of the Kittanning formation of the area considered in this report (fig. 2) has been drawn from core hole data and underground fall areas observed in the mines; this uses Flint's terminology.

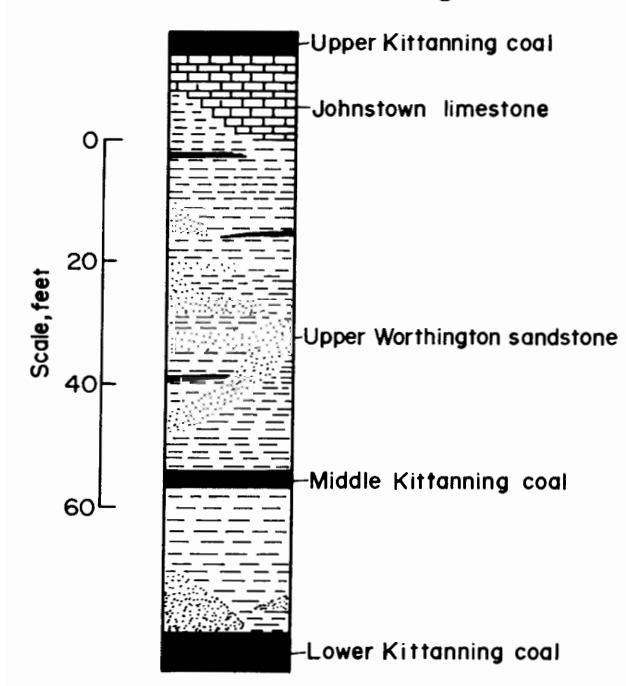
FIGURE 2. - Generalized section of the Kittanning formation of central Cambria County, Pa. These features are part of the Allegheny Mountain section of the Appalachian Plateaus province and trend northeastward.

"strata between the base of the underclay beneath the upper coalbed of the Lower Kittanning coal group and the top of the lower bench of the Upper Kittanning coal group." The average thickness of this sequence determined from the core hole data in this report is 106 feet. The persistent sandstone that overlies the Lower Kittanning coalbed is the Worthington Sandstone (14).

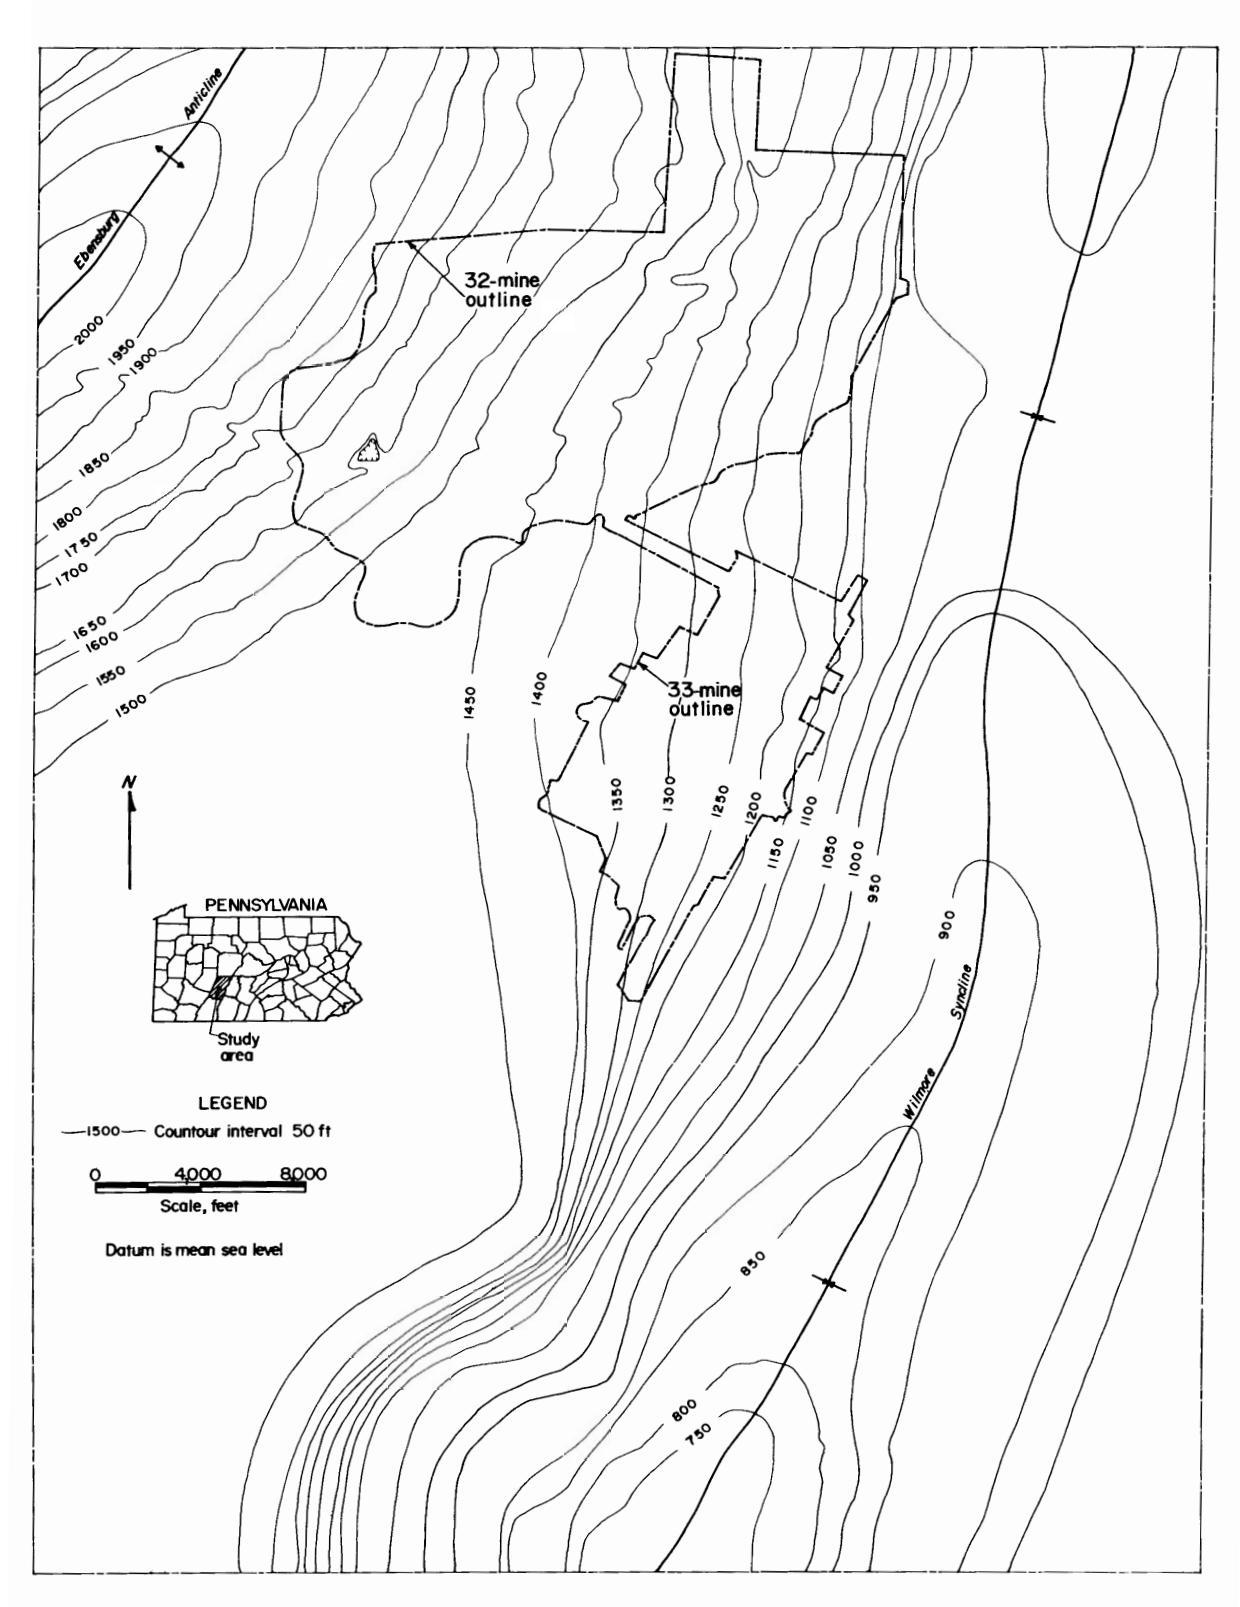
FIGURE 3. - Generalized structural contour map of area around Cambria Nos. 32 and 33 mines.

The Cambria Nos. 32 and 33 mines are located in the area where the main structures are the Ebensburg anticline and the Wilmore syncline (fig. 3).

The structural contours in figure 3 were drawn on the bottom of the Lower Kittanning coalbed from mine and core hole data.

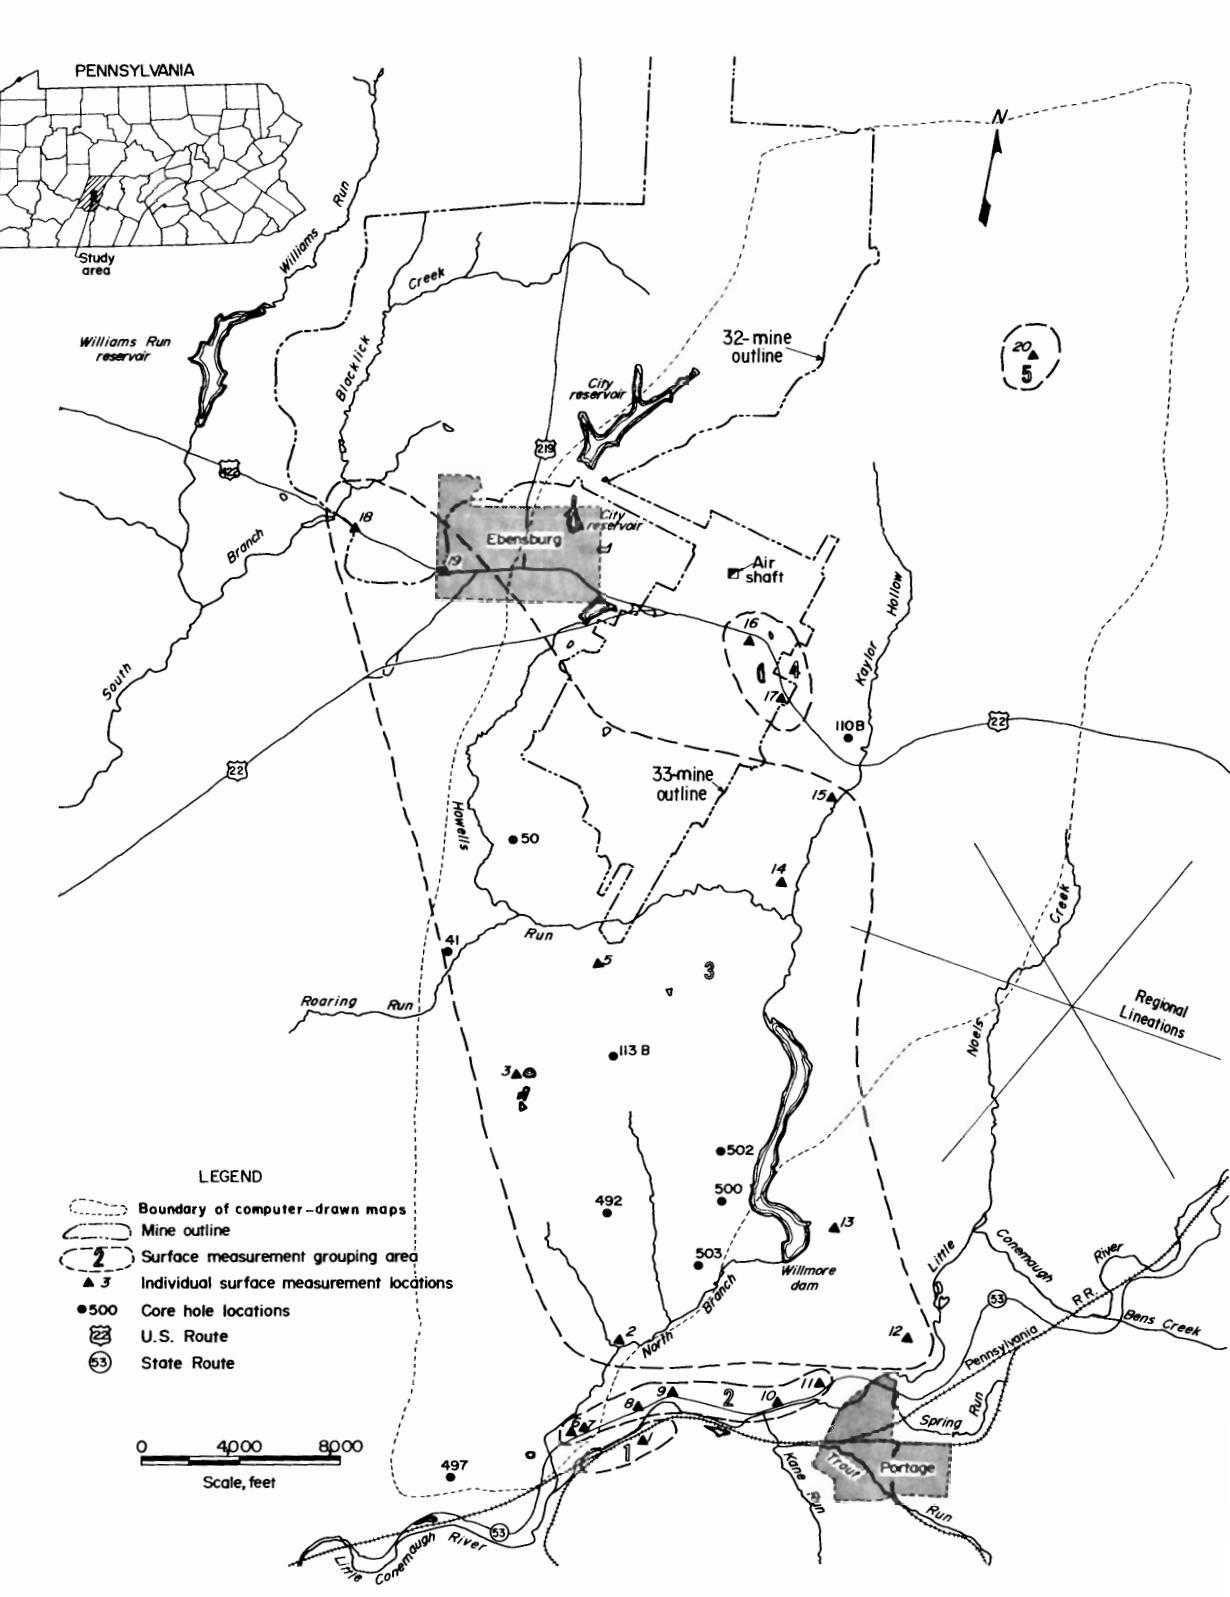
FIGURE 4. - Index map of surface joint sampling locations.

SLAR imagery of Cambria County, Pa., was studied for this report. Three prominent directions of lineations were observed on the SLAR imagery; these are (1) N 39° E, (2) N 31° W, and (3) N 70° W. These directions are indicated on figure 4.

The general locations of surface joint measurements are shown in figure 4.

¹Number in parentheses corresponds to position on index map. All are ±2° compass directions.

Number in parentheses corresponds to location on index map. All are $\pm 2^{\circ}$ compass directions.

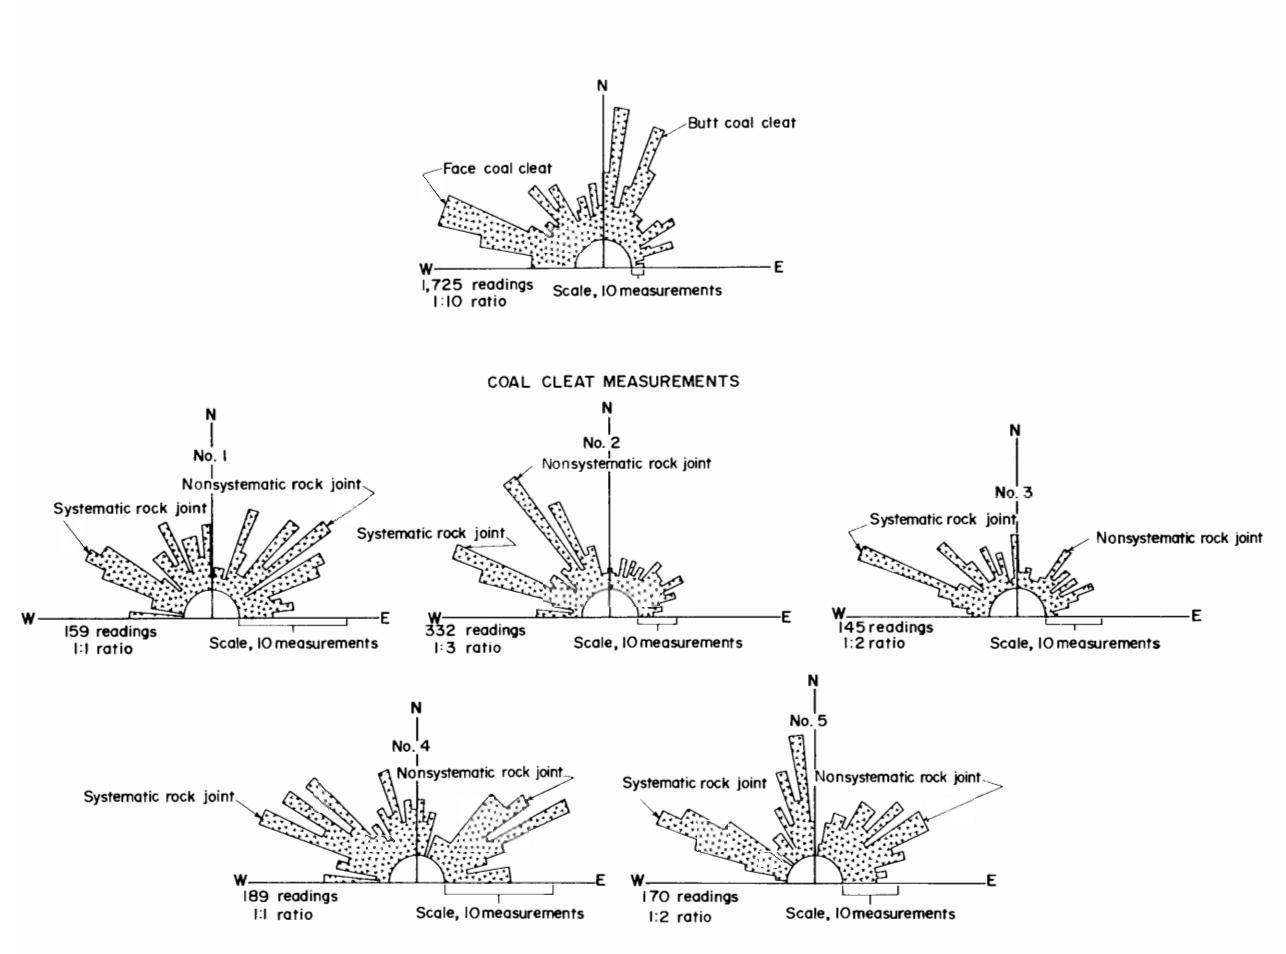
FIGURE 5. - Strike of coal cleats and rock joints.

The strike and dip of the coal cleats and the surface rock joints were measured. The orientations of the various cleat and fundamental joint system directions are shown in figure 5. Nickelson (13) divided the fundamental joint system into two parts: (1) systematic joints and (2) nonsystematic joints.

From table 1 the average strike for the face cleats of the coal is N 69° W, whereas the average strike for the systematic surface rock joint is N 67° W, including the measurements of rock joints at location 4 in figure 4. The strikes of the two features are about the same, suggesting that there is a relationship between the strike of the systematic rock joints and the coal face cleats.

Measurements at location 4 were made at sites where we found later there had been major surficial dislocation either by slumping due to erosion of adjacent stream valleys or to caving of underground workings. Comparing figure 4 with figure 6, it can be observed that "individual surface measurement locations" 16 and 17 are directly over areas where roof falls have occurred, supporting the idea that caving may be a factor in the deviation of these measurements from the norm. The computer program used to treat these data selected the center of a trimodal distribution as the strong direction rather than one of the extremes. Figure 5 illustrates the trimodal distribution at location 4. It appears that the lower of the three northwest lobes is the stronger but the difference is small. Field checks show that the most prominent direction is the one designated at location 4 as being the "systematic rock joint," N 68° W, very close in direction to the other four areas of surface measurement, but the other two lobes indicate some change or rotation and contribute to making the average direction N 58° W.

From table 2 the average strike for the butt cleat is N 19° E, and the average strike for the nonsystematic rock joint is N 04° W. As can be seen from the data, the variations in the nonsystematic joint measurements are too great to have any significance; this was also supported by the computer program printout.

- 1. Strike of face coal cleat--N 69° W.
- 2. Strike of systematic surface rock joint--N 67° W.
- 3. Strike of butt coal cleat--N 19° E.
- 4. Strike of nonsystematic surface rock joint -- N 04° W.

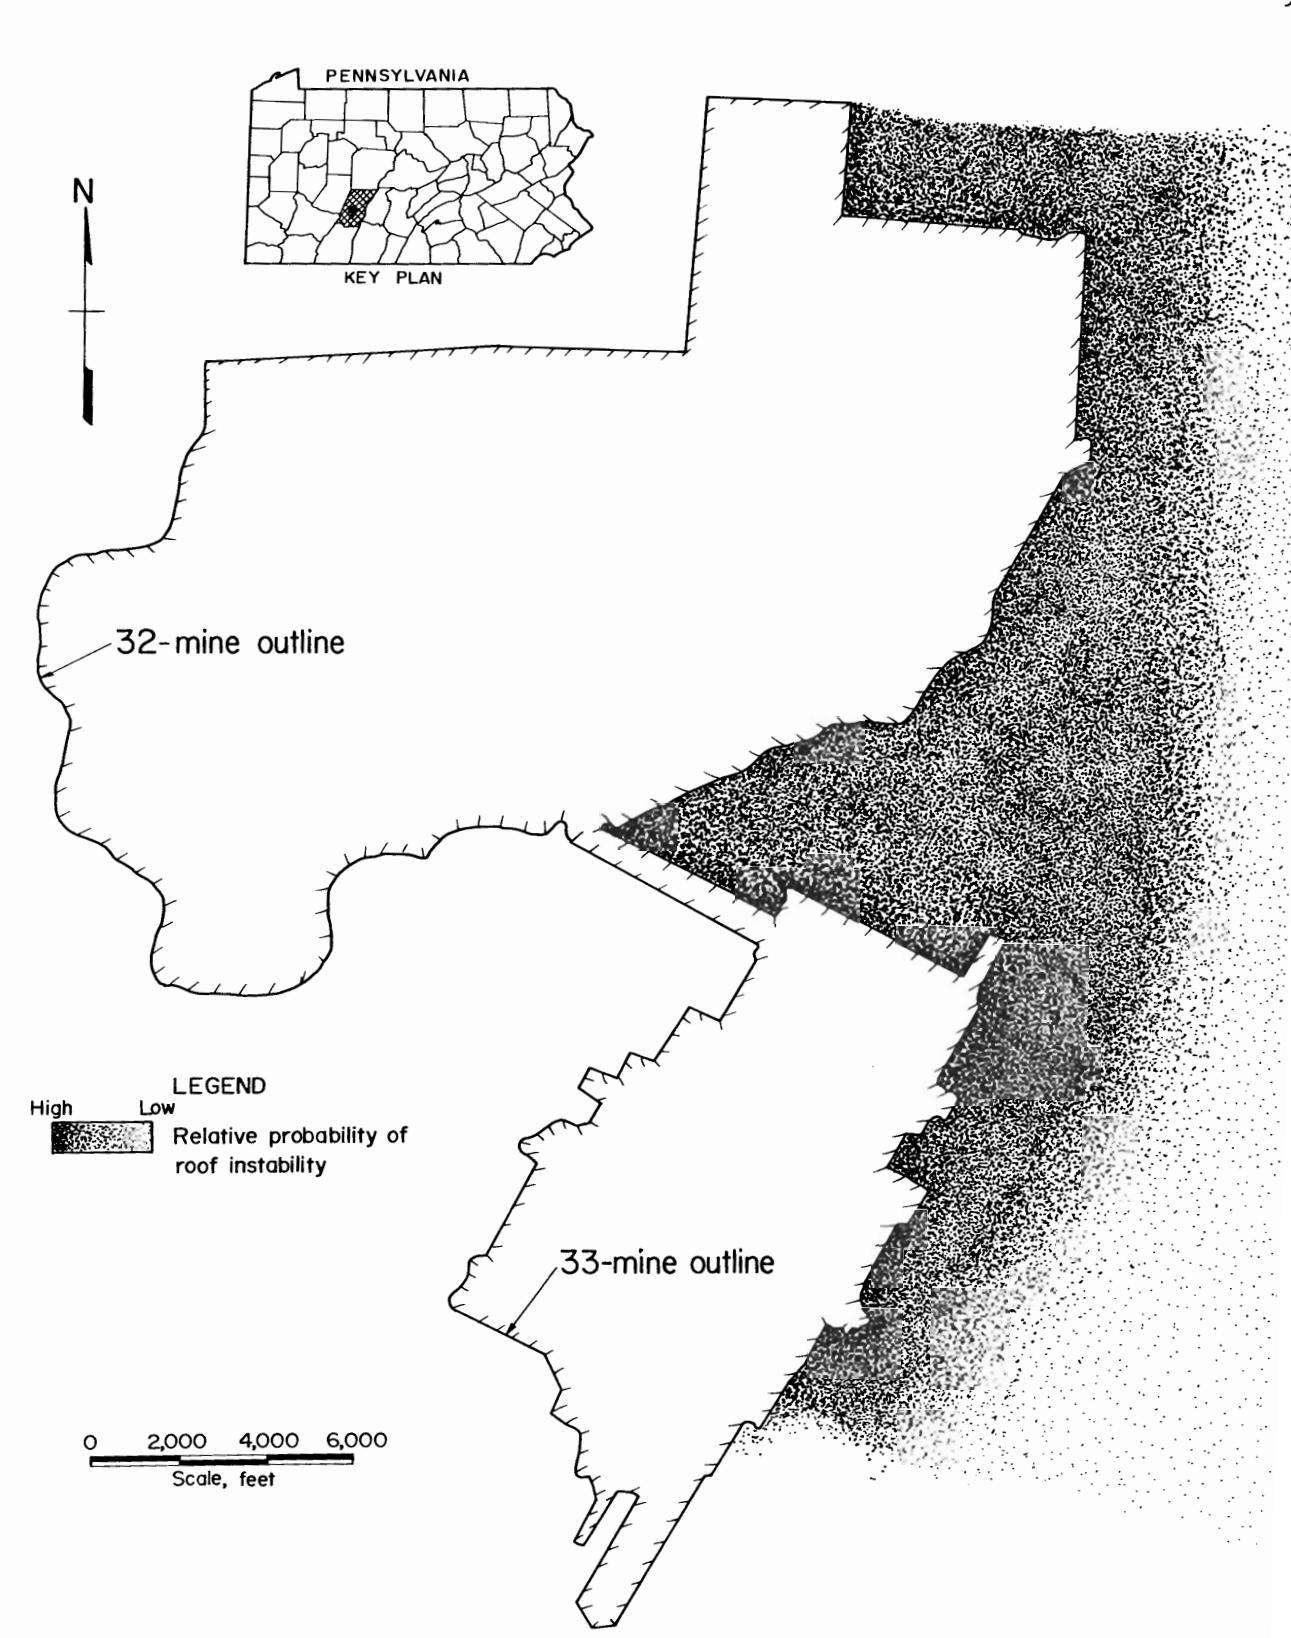
FIGURE 6. - Sketch map showing where unstable roof is likely to occur.

On June 23, 1972, after the main theme of this report had been developed, a plan view of the two mines was received from the Bethlehem Mines Corp. showing areas of unstable roof. This map (fig. 15) was then reduced in size to overlay it on the panel diagram (or fence diagram) and the other maps used in this study. By comparing the map of unstable roof areas with the maps drawn by us, it became apparent that falls most commonly occur along the roofmargins of the channel fill sandstones which parallel the eastern boundary of both the Cambria 32 and 33 present mine workings. From these data we compiled a map (fig. 6) that shows where unstable roof is likely to occur in the future.

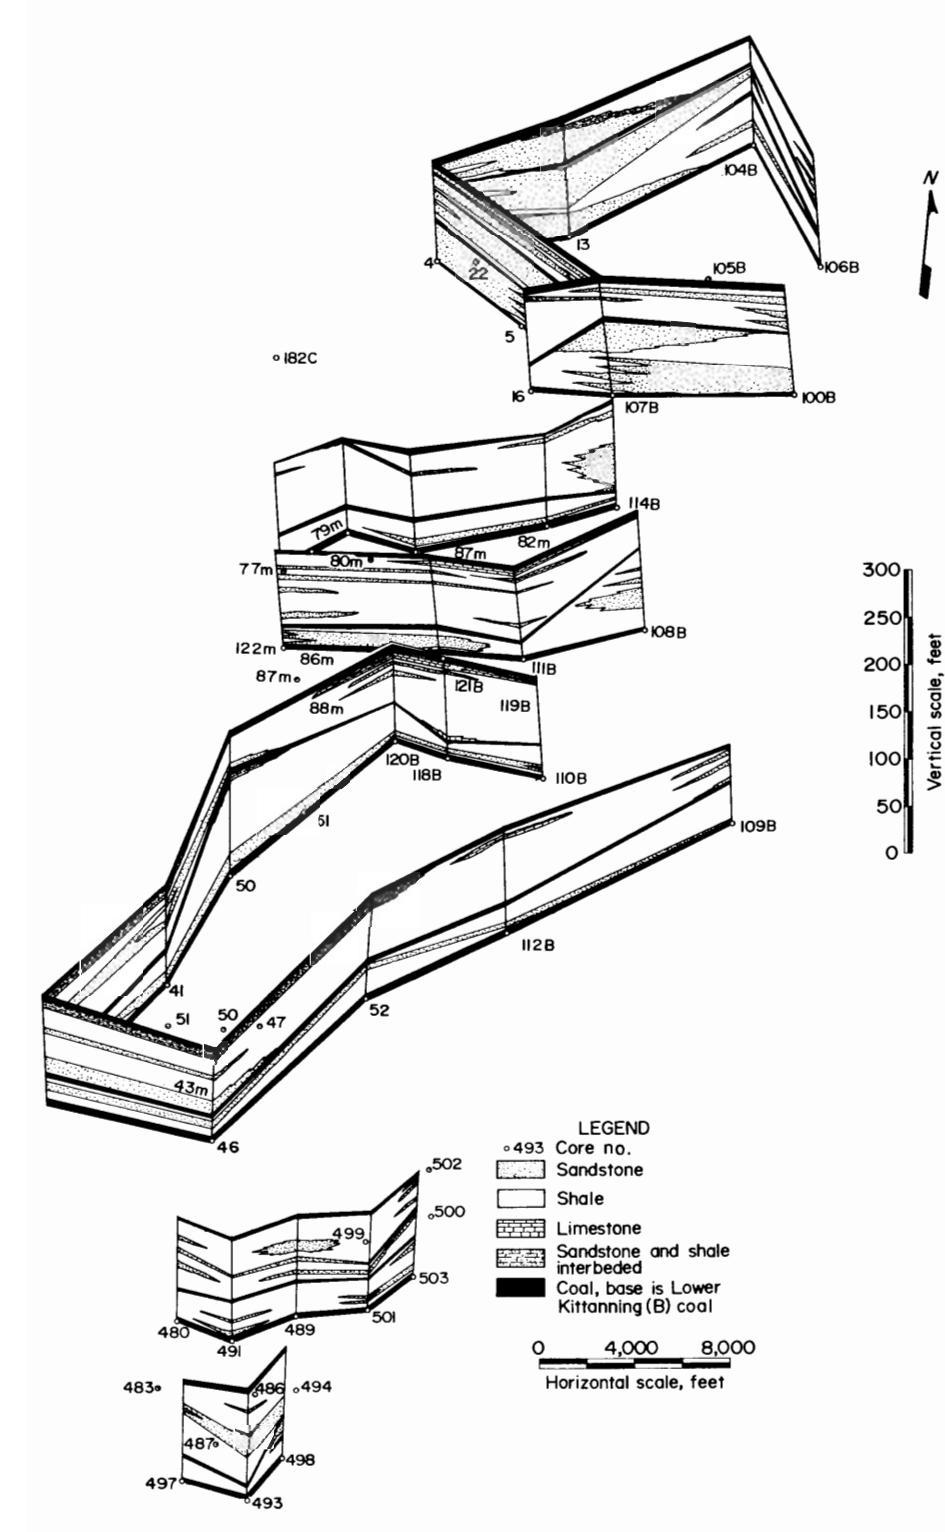
To display the lithologic variability of this area, a panel diagram (fig. 7) was prepared from core logs using the interval between the Lower and Upper Kittanning coalbeds. In the north, sandstone is the predominant rock; southward, the shale becomes dominant. The panel diagram shows a channel area along the

east margin of the mine that eventually broadens to form a sheetlike structure to the south and west.

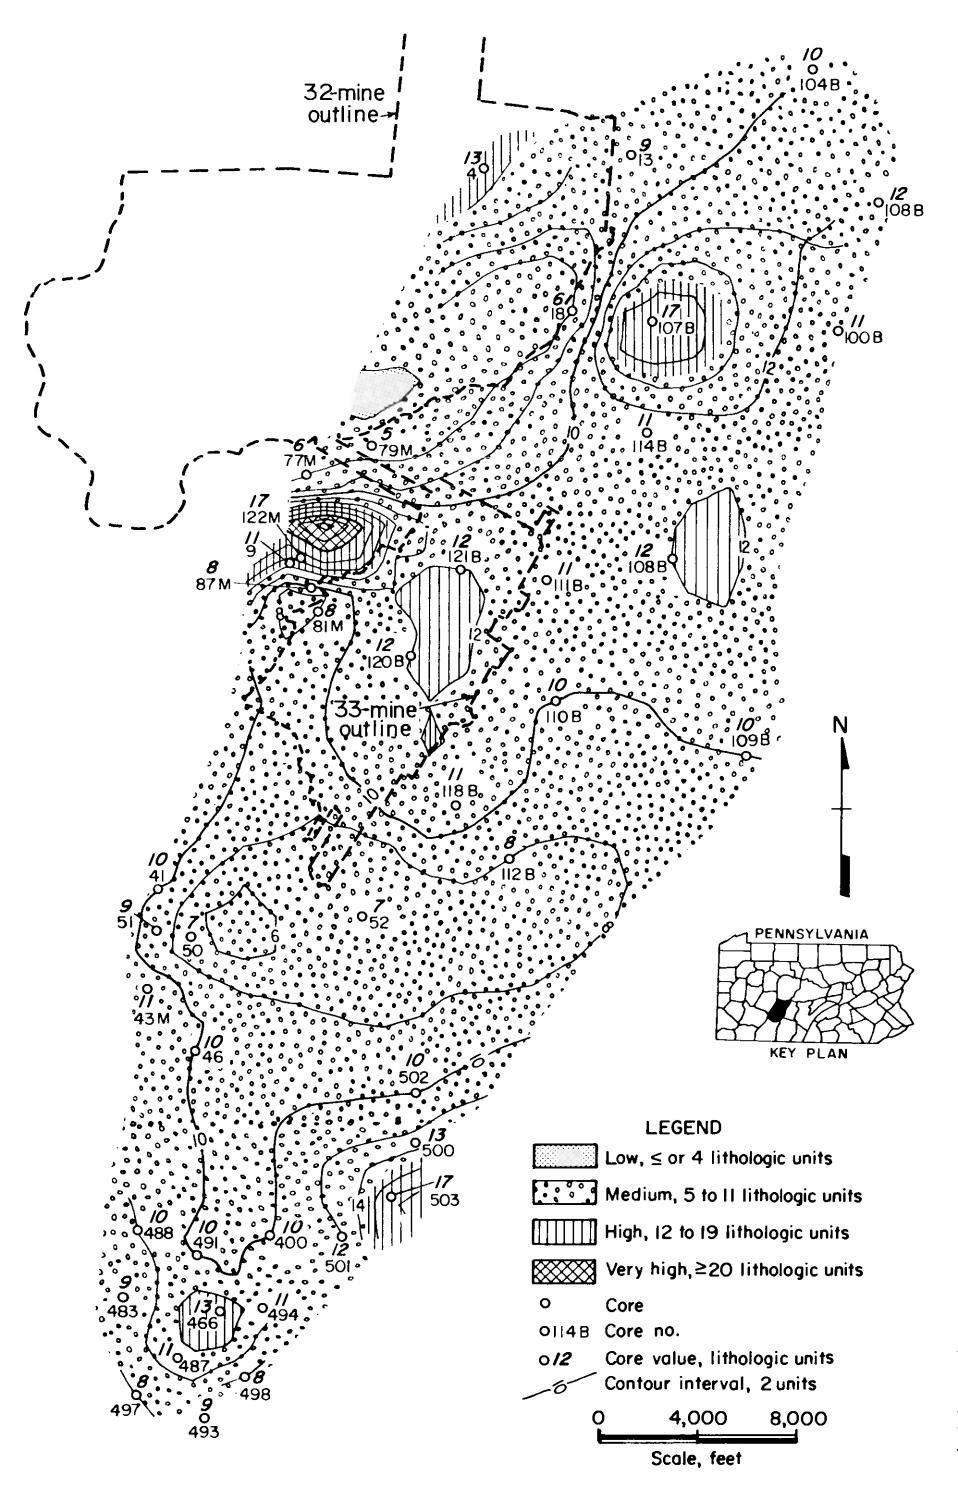
FIGURE 8. - Lithologic frequency map of interval between Lower and Upper Kittanning coalbeds.

A lithologic frequency map (fig. 8) shows the number of separate lithologic units for a given interval. The interval is arbitrarily selected depending on the information to be illustrated. This lithologic frequency map was drawn using as contours the number of lithologic units occurring in the approximately 100-foot interval between the Upper and Lower Kittanning coalbeds. The number ranges from four to 24 lithologic units. A lithologic unit is defined here as any thickness greater than 0.5 foot in thickness.

One area showing an extremely large number of lithologic units, more than 20, and two other areas showing more than 15, were found. These areas coincide with known areas of roof instability in the mine. When conducting underground surveys in these areas of roof instability, it was noted that the joints in the roof were closely spaced and that the distance to the next coal above the Lower Kittanning was less than 32 feet wherever the roof had fallen. In contrast, a smaller number of thicker lithologic units would indicate relatively stable roof conditions.

The close proximity of zone of a very high and low number of lithologic units is an indication of rapid sedimentational changes and a site of potentially unstable roof.

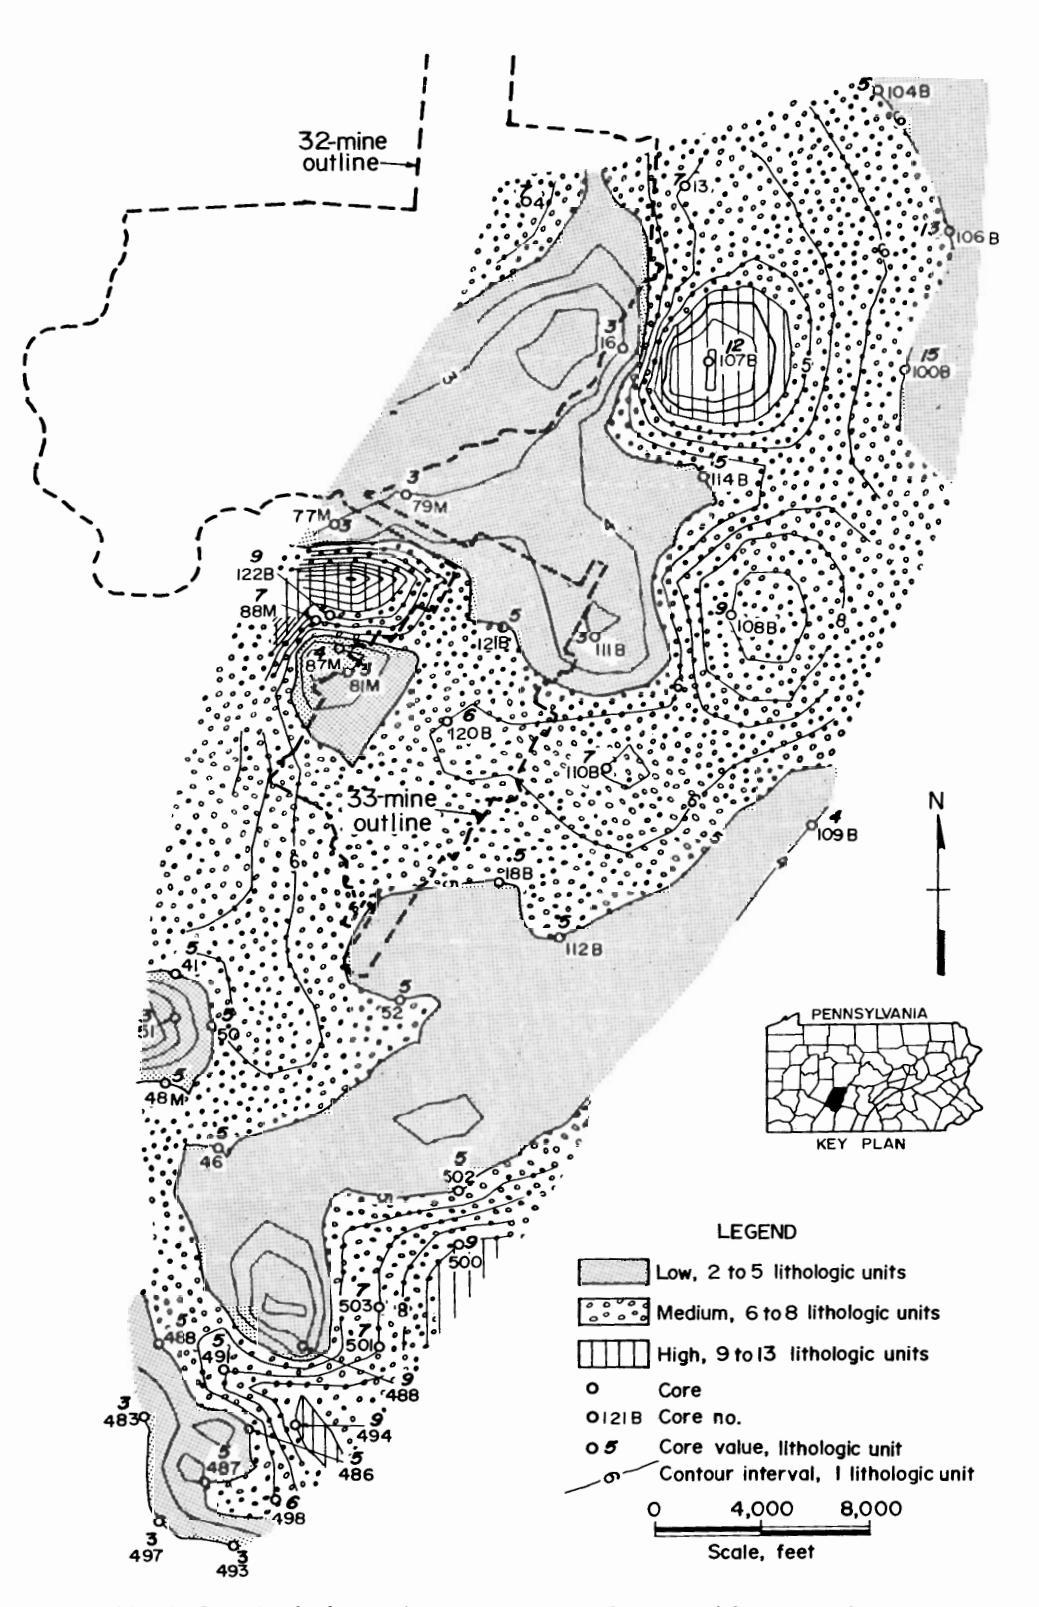
FIGURE 9. - Lithologic frequency map of interval between Lower Kittanning coalbed and next higher coalbed.

A low lithologic frequency indicates areas where relatively stable roof <u>rock</u> can be expected. Areas of intermediate lithologic frequency may or may

not present a problem: Other factors that contribute to roof instability are a small vertical distance to the next higher coal and close joint spacing. A large distance to the next coal and wide joint spacing would greatly increase the probability of stable roof. Figure 9 is similar to the other lithologic frequency map (fig. 8) except that a variable coal-to-coal interval is involved. The interval now is from 20 to 55 feet, depending on where the next coal above the Lower Kittanning coal appears. There is a marked similarity between these two maps, especially in the northwestern part where there is rapid transition from less than five lithologic units to more than nine lithologic units in a horizontal distance of 2,000 feet. The interval between the Lower Kittanning and the next higher coal (whether the Middle Kittanning or a wild coal) was selected because,

as was stated earlier, it was observed underground that the upper extent of most roof falls was the bottom of the coal directly above the Lower Kittanning coalbed.

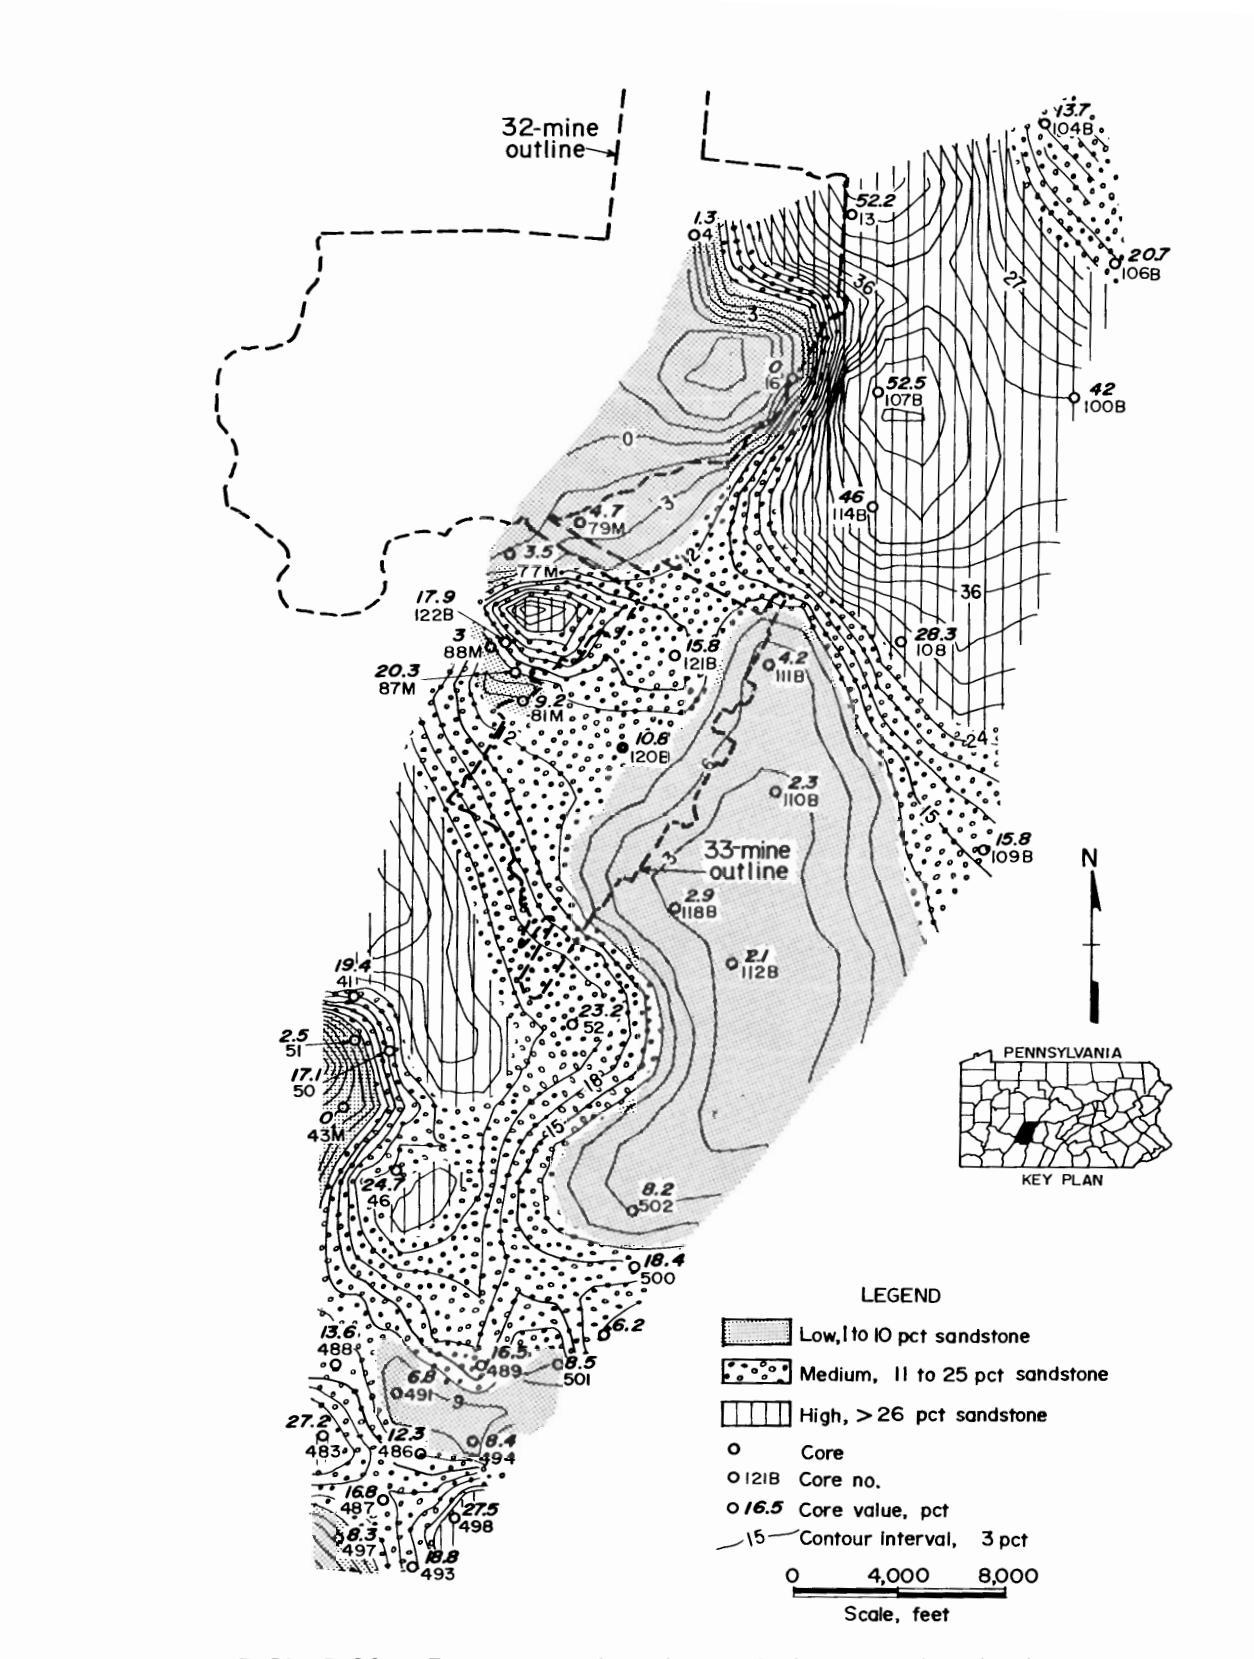
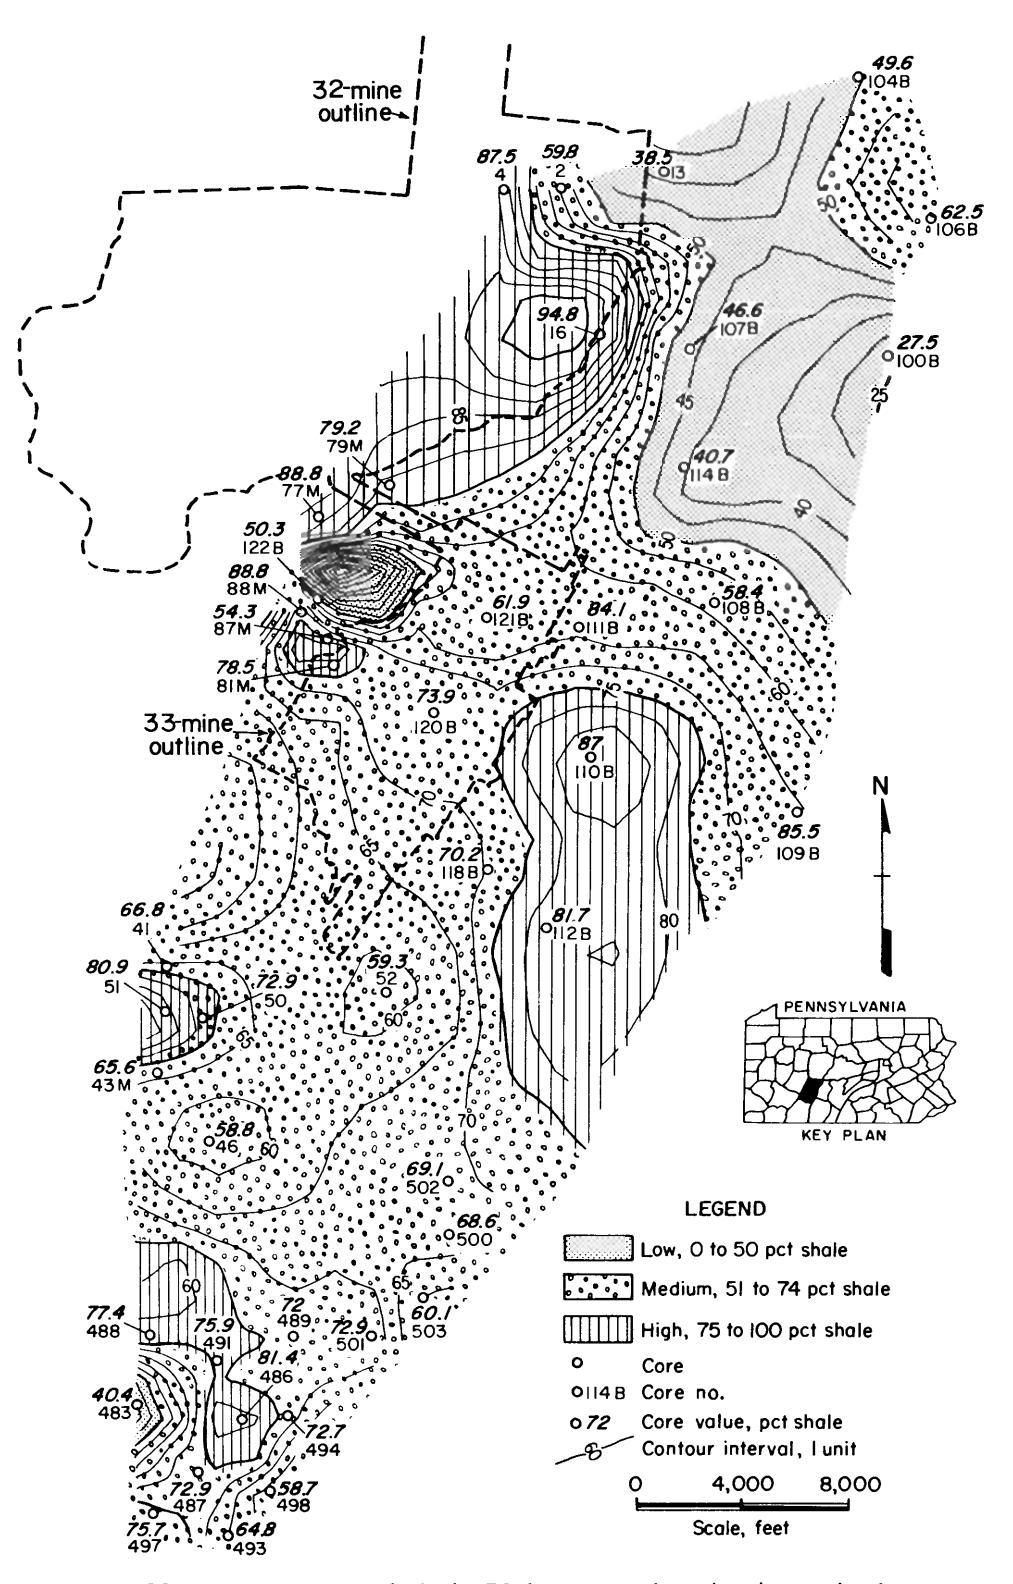
The maps showing the percentage of sandstone and the percentage of shale (figs. 10-11) outline a channel. In preparing these maps, the interval used was the 50 feet immediately above the Lower Kittanning coalbed. These maps show a high percentage of sandstone and a low percentage of shale, which define the channel area. Outside the channel there are, conversely, high shale and low sandstone percentages.

FIGURE 10. - Percentage of sandstone 50 feet immediately above the Lower Kittanning coalbed.

FIGURE 11. - Percentage of shale 50 feet immediately above the Lower Kittanning coalbed.

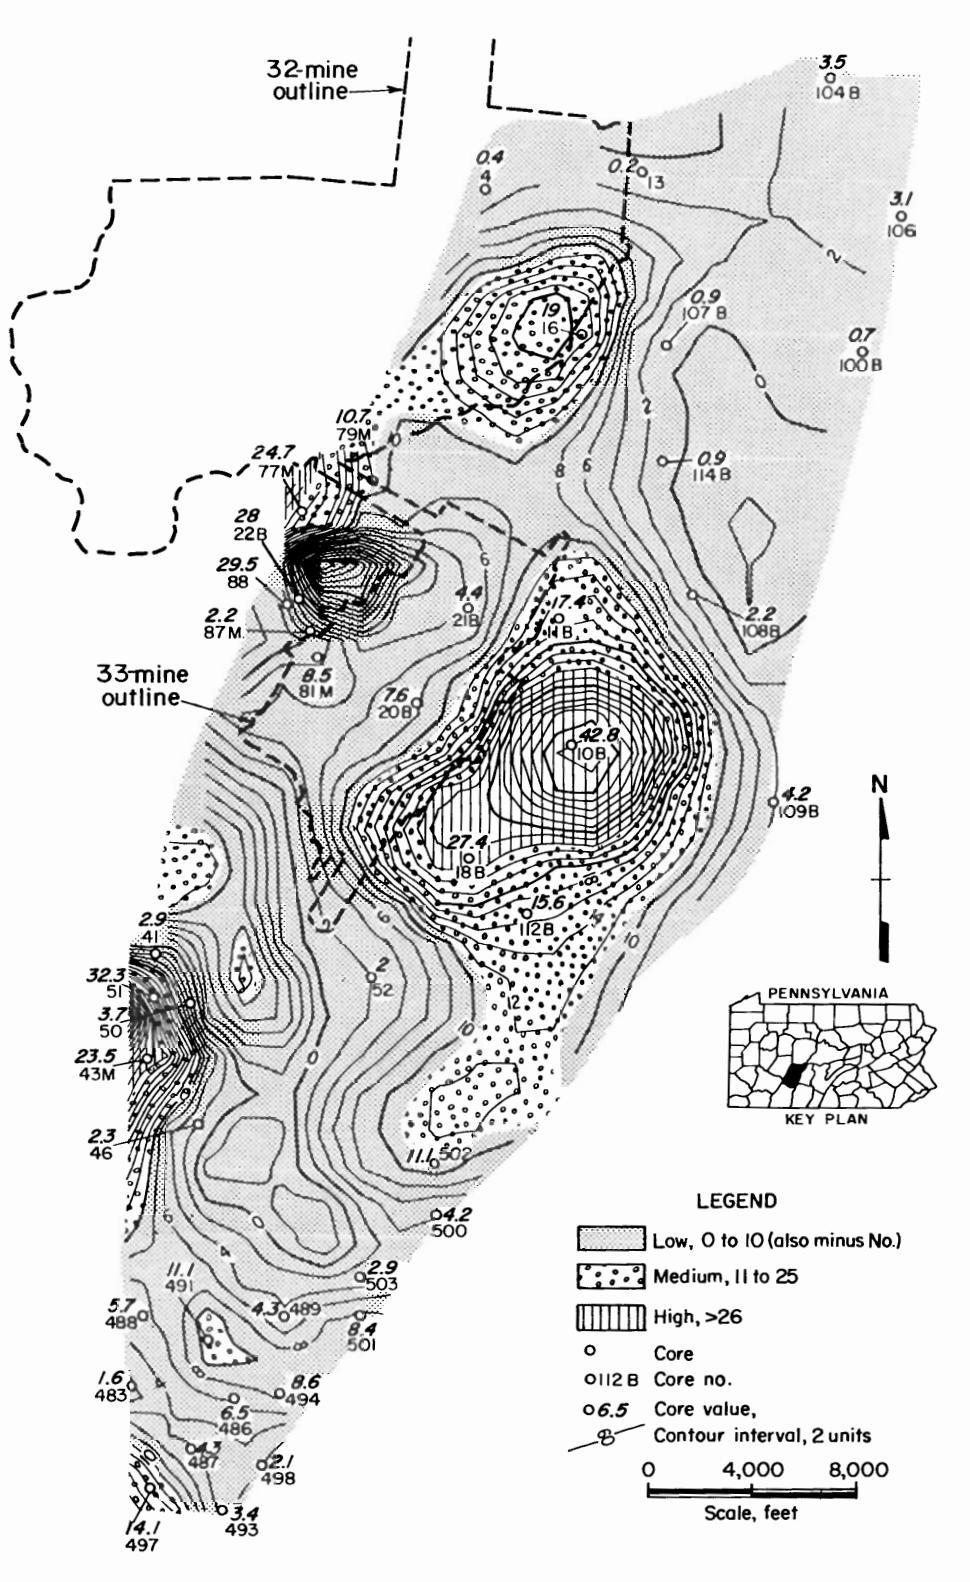
FIGURE 12. - Map of shale plus limestone to sandstone ratio.

Study of figure 12 substantiates the existence of a channel. A relatively large ratio number indicates a small percentage of sandstone in relation to shale and limestone. The small ratio numbers, representing sandstone-rich zones, can be followed through the middle of the map, indicating channel and sheetlike sandstone deposits. At the southern end, no definite sandstone pattern can be detected. The trend of the channel as inferred from this study is shown in figure 13. This shows that the inferred boundary between the channel sandstone deposit and shale follows the trend of known roof instability in the mines.

A channel sandstone deposit occurs immediately above the Lower Kittanning coalbed along the eastern part of the present No. 32 workings and extends over much of the No. 33 mine (fig. 12); this sedimentational feature is the cause of some of the mining problems encountered.
