Bureau of Mines Report of Investigations/ 1973

Geologic Factors Causing Roof Instability and Methane Emission Problems

The Lower Kittanning Coalbed, Cambria County, Pa.

Report of Investigations 7769

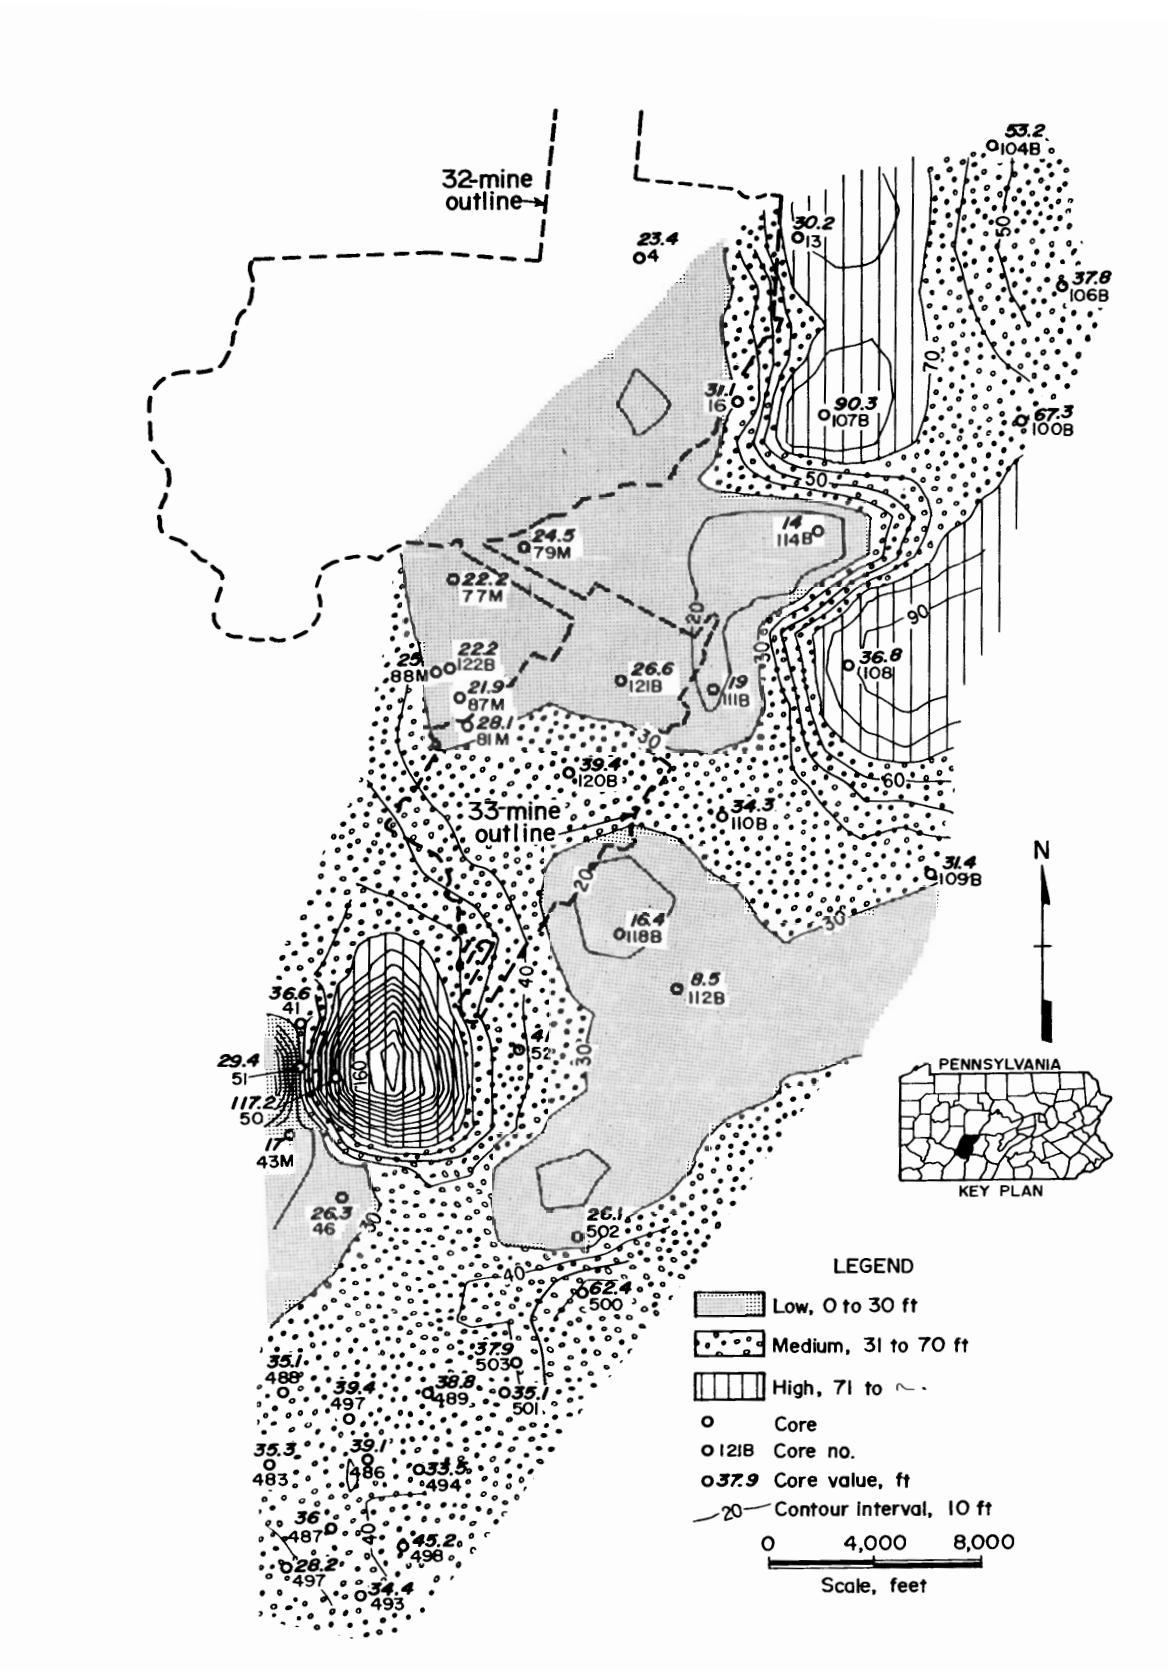
FIGURE 14. - Isopach map of interval between Lower Kittanning coalbed and next higher coalbed.

The interval between the Lower Kittanning coal and the next higher coal is critical because the uppermost plane along which the roof tends to separate is the bottom of the coalbed immediately above (whether a wild coal or the Middle Kittanning coalbed). From falls observed underground and related to this map (fig. 14) we find a correlation between roof instability and a thin zone, less than 30 feet (vertically) between the upper coal and the Lower Kittanning coalbed, especially where the roof strata are well jointed. Where this interval is more than 50 feet, the probability of roof instability is greatly decreased. The areas of highest occurrence of roof falls correlate with the thin areas of this interval on the isopach map and the areas of high frequency of lithologic units.

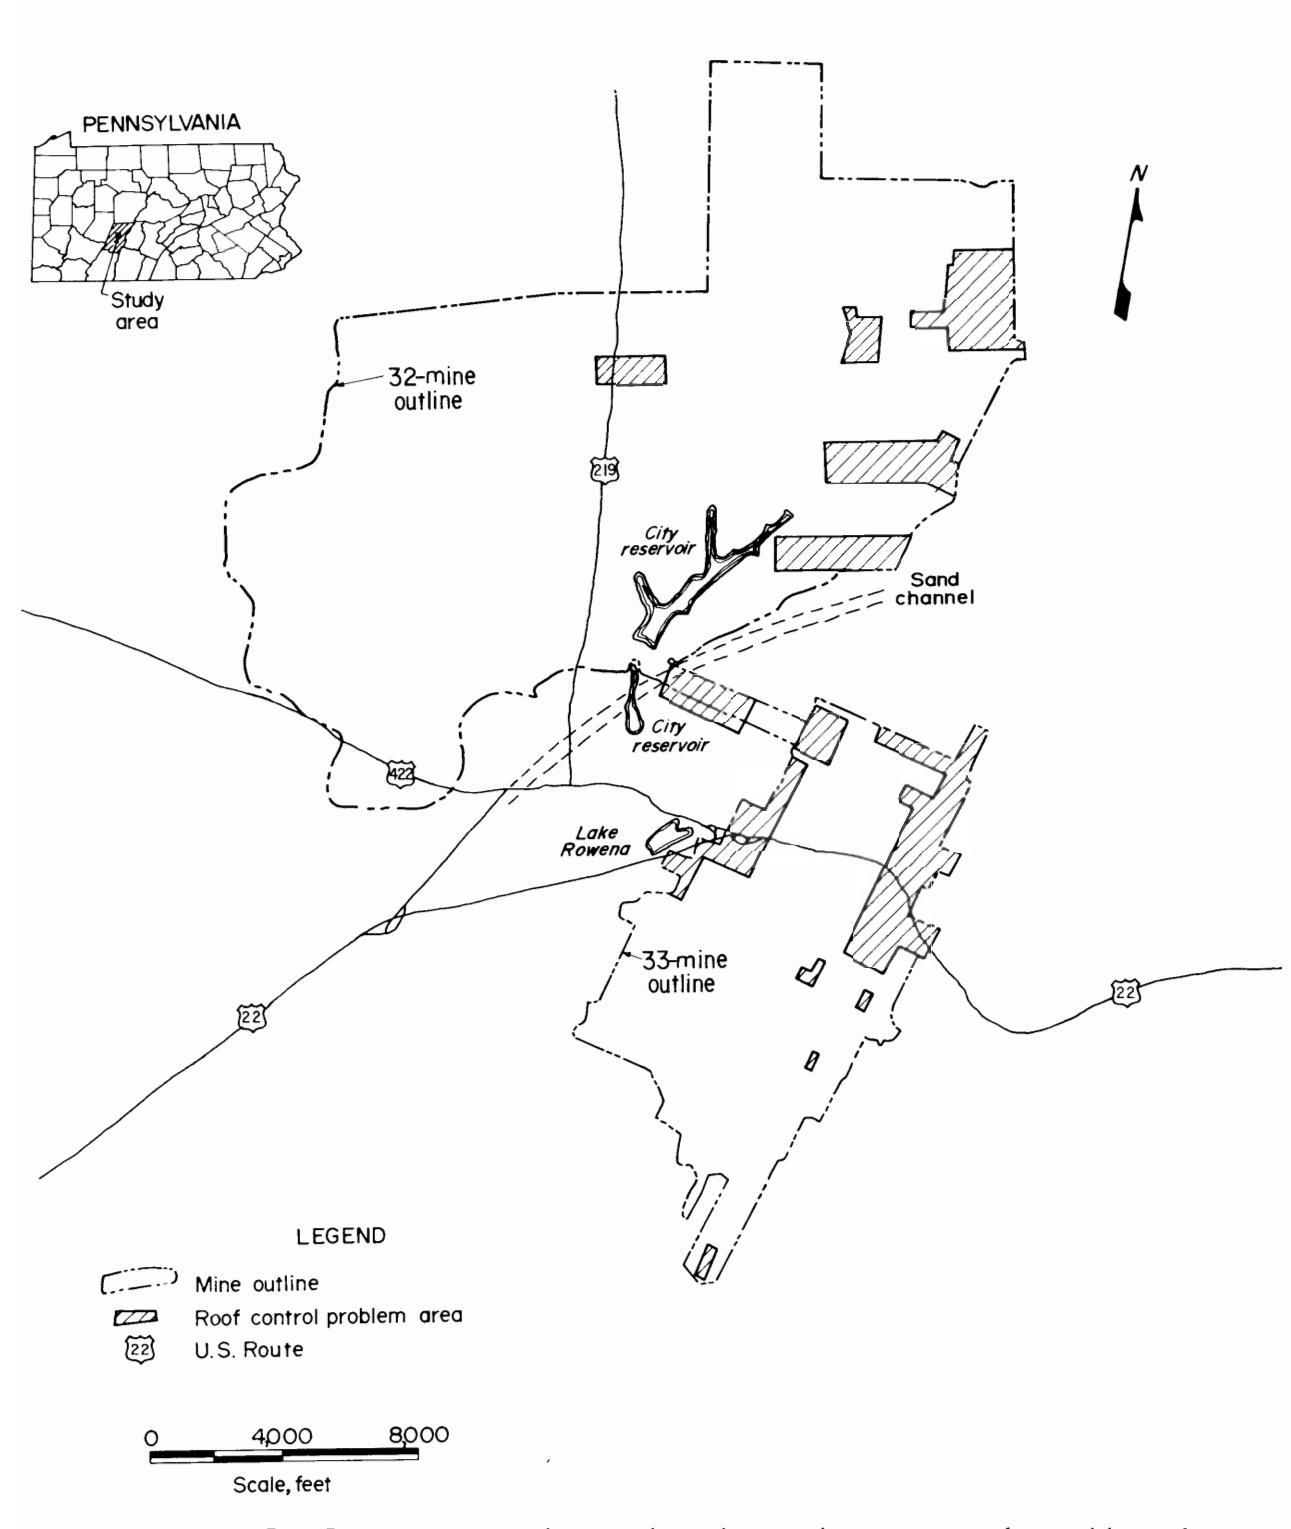
FIGURE 15. - Present mine working outline showing known areas of unstable roof.

On June 23, 1972, after the main theme of this report had been developed, a plan view of the two mines was received from the Bethlehem Mines Corp. showing areas of unstable roof. This map (fig. 15) was then reduced in size to overlay it on the panel diagram (or fence diagram) and the other maps used in this study. By comparing the map of unstable roof areas with the maps drawn by us, it became apparent that falls most commonly occur along the roofmargins of the channel fill sandstones which parallel the eastern boundary of both the Cambria 32 and 33 present mine workings. From these data we compiled a map (fig. 6) that shows where unstable roof is likely to occur in the future.
