Detection and Control of Spontaneous Heating in Coal Mine Pillars—A Case Study

Report of Investigations 9553

By Robert J. Timko and R. Lincoln Derick

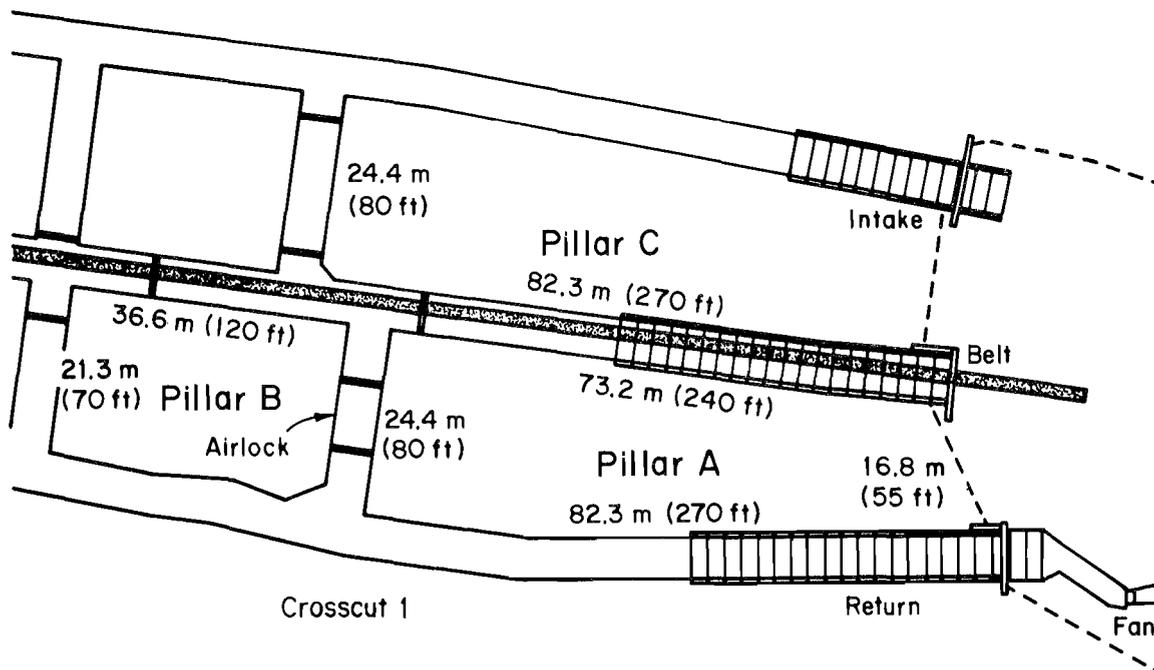
Figure 1

The three pillars examined in this study and their associated dimensions are seen in figure 1. Two pillars, A and B, were located between the belt and the return entries and were subjected to differential pressures of 175 Pa (0.7 in H₂O) across them. Pillar C was separated by intake and belt entries and, since both entries were on intake air, had no measurable differential pressure across it.

Plan view of the three pillars evaluated.

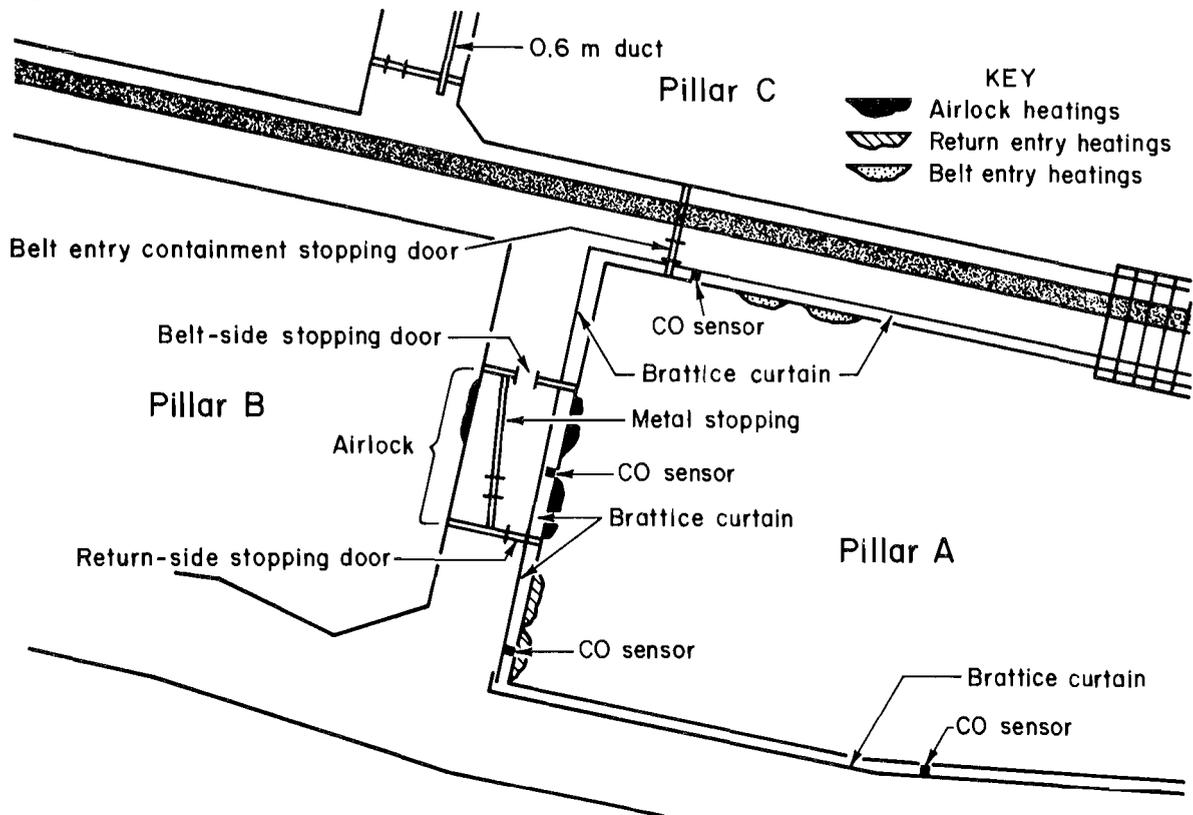
Figure 2

During a routine survey with the infrared camera, elevated surface temperatures were discovered along the pillar A rib in the crosscut 1 airlock (figure 2). Further investigations found heatings within the airlock along pillars A and B. A Magnehelic-type device found that pressure fell 175 Pa (0.7 in H₂O) from the belt side to the return side of the crosscut 1 airlock. Since air was flowing through the pillar and then into the airlock, the pillar A heating could have occurred anywhere along a line roughly paralleling the coal cleat between the belt-entry pillar rib and the crosscut 1 rib. Conversely, the heating along the pillar B rib had to be near the surface because air was flowing into the pillar at that location.

Detection of spontaneous heating episodes and resulting control measures implemented.

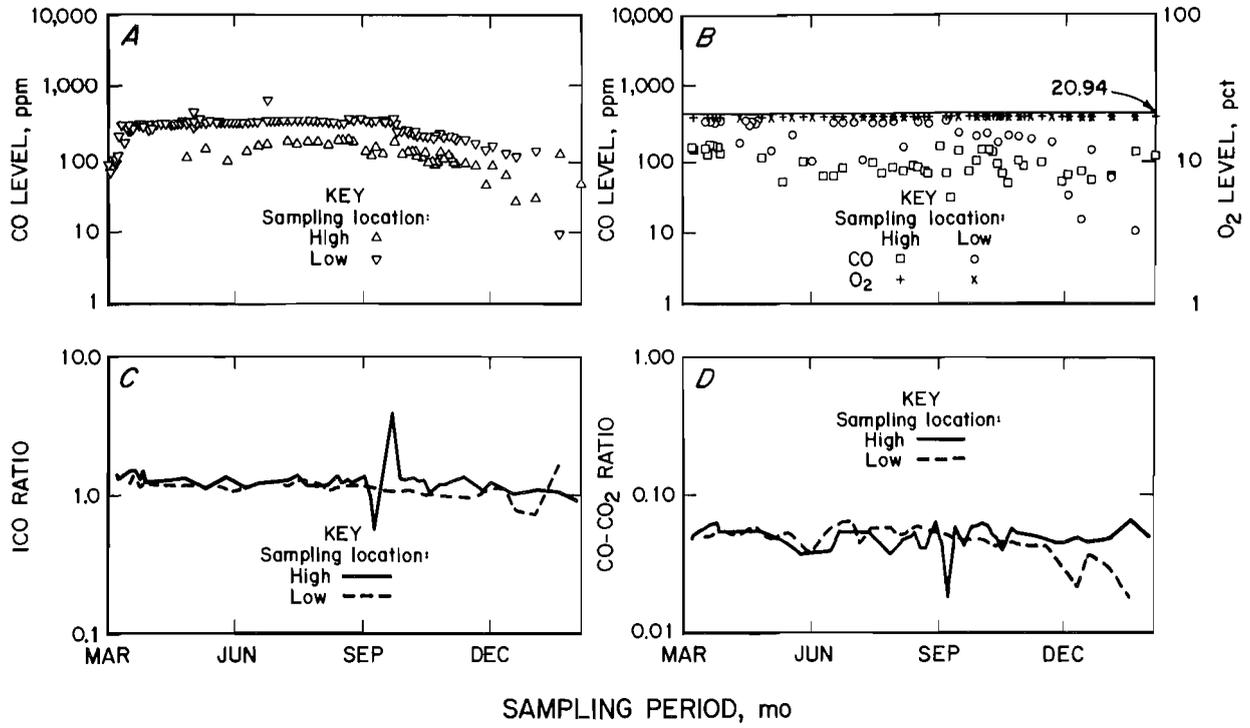
Figure 3

Handheld CO values are shown in figure 34. Even though these results remained relatively stable throughout the evaluation, the presence of CO in the atmosphere indicated that some level of oxidation was taking place within pillar A and was being vented to the atmosphere in the airlock.

Gas chromatographic analyses of airlock samples (figure 3B) found CO in conjunction with below-ambient oxygen concentrations (less than 20.94 pct O₂), indicating that oxygen was being consumed by the oxidation reaction. ICO and CO-CO₂ results at both the high and low sampling locations (figures 3C and 3D) remained stable with the exception of the large fluctuations in September.

Crosscut 1 airlock. A, Handheld results; B, gas chromatography data; C, ICO; and D, CO-CO₂ ratio.

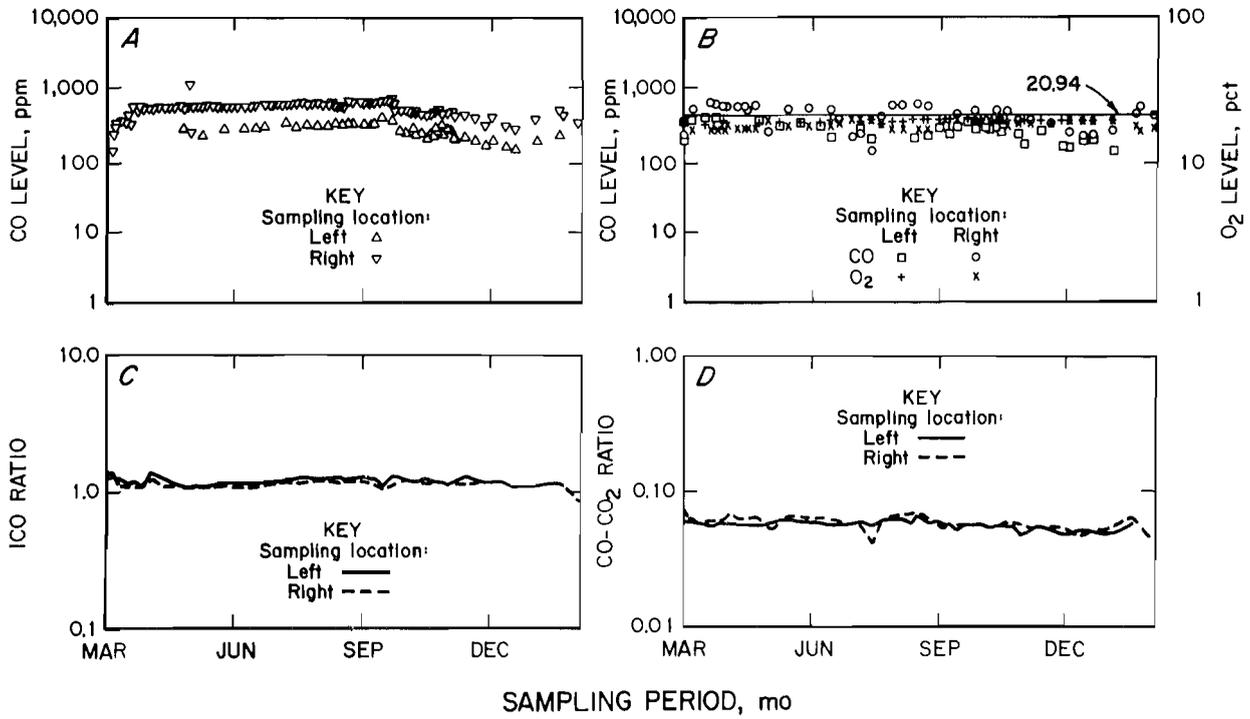
Figure 4

Handheld results (figure 44) showed that CO values at the right location were consistently higher. Chromatographic results (figure 4B) paralleled those CO values found with the handheld instruments. Depleted oxygen levels reinforced the theory that oxidation was taking place somewhere in pillar A. Conversely, both ICO and

Crosscut 1 return. A, Handheld results; B, gas chromatography data; C, ICO; and D, CO-CO₂ ratio.

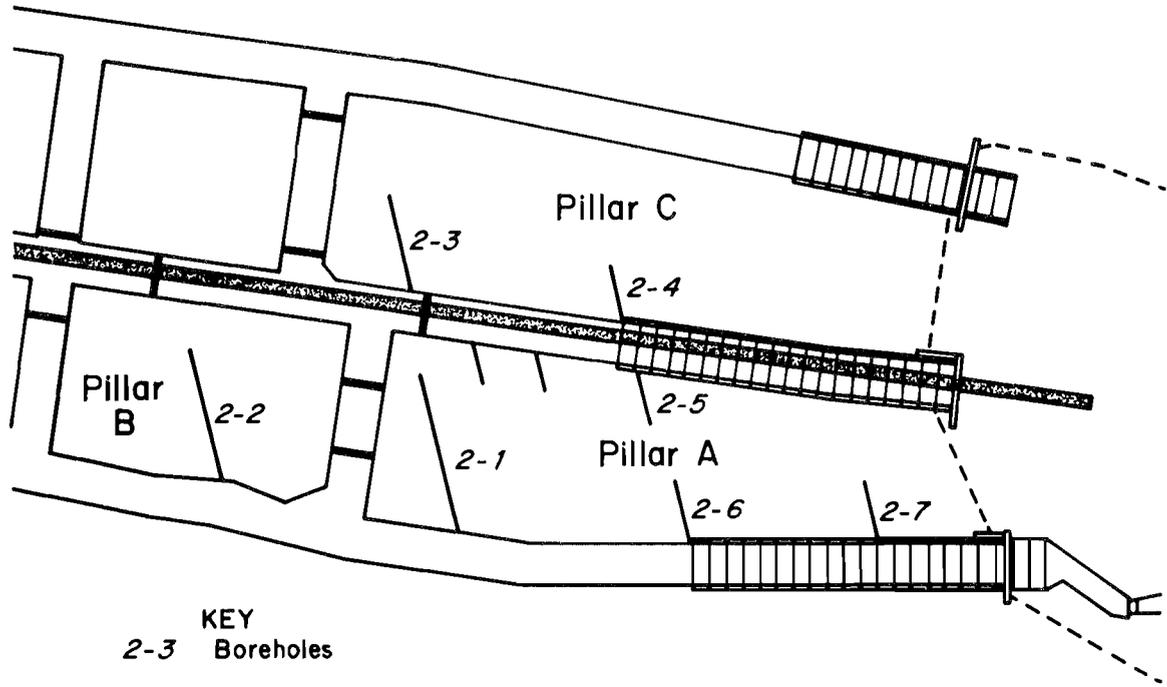
Figure 7

Locations of pillar boreholes.

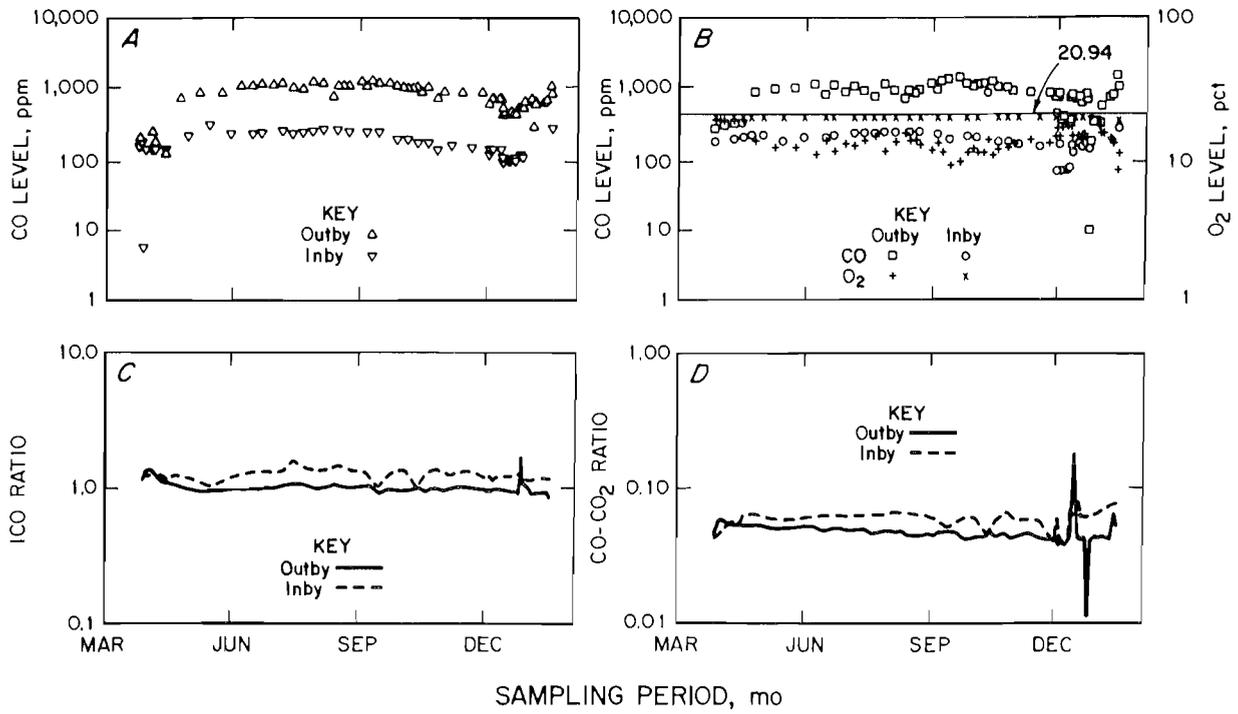
Figure 8

Borehole 2-1. A, Handheld results; B, gas chromatography data; C, ICO; and D, CO-CO₂ ratio.

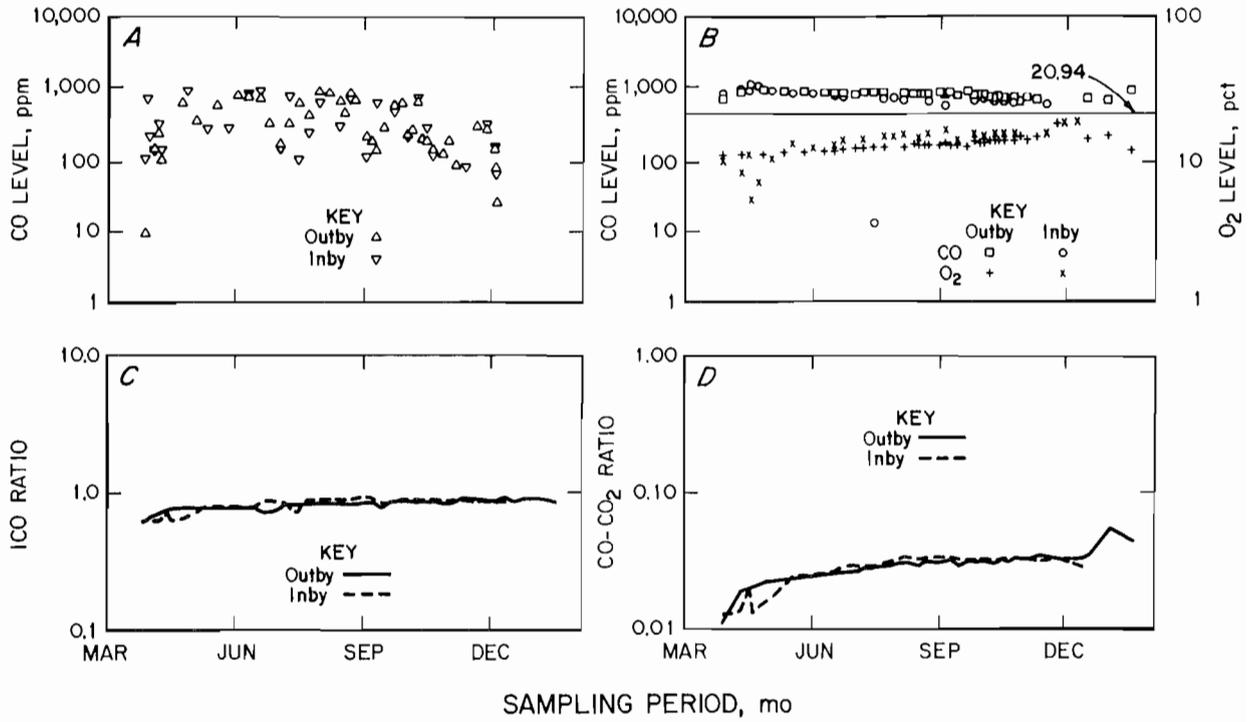
Figure 9

Borehole 2-2. A, Handheld results; B, gas chromatography data; C, ICO; and D, CO-CO₂ ratio.

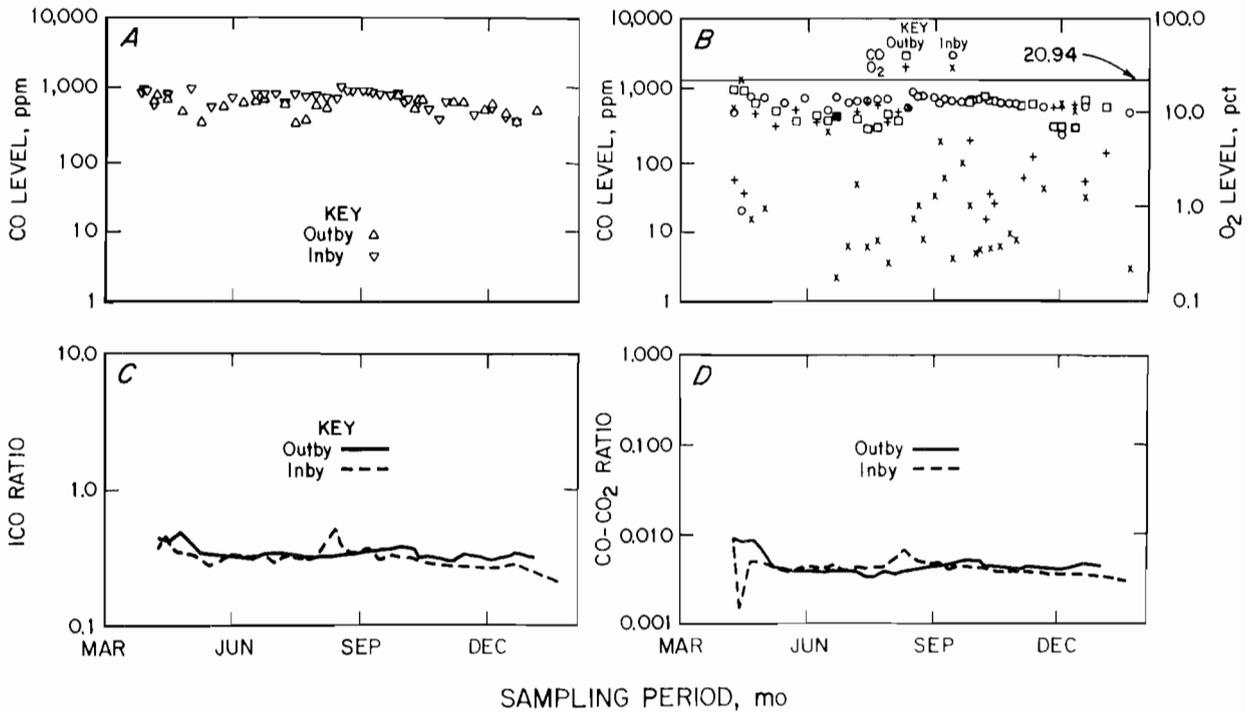
Figure 10

Handheld results (figure 10A) showed that CO levels remained elevated and stable throughout the evaluation, with both inby and outby locations having similar results. Gas chromatographic data (figure 10B) found that inby and outby CO values paralleled the handheld results. Levels of O₂ remained below ambient; there was no explanation for the fluctuations.

ICO and CO-CO₂ results (figures 10C and 10D) remained stable and below values found at the other test hole locations. These results were believed to be a signature of normal oxidation within coal pillars having no differential pressure, and thus no appreciable airflow, through them.

Borehole 2-3. A, Handheld results; B, gas chromatography data; C, ICO; and D, CO-CO₂ ratio.

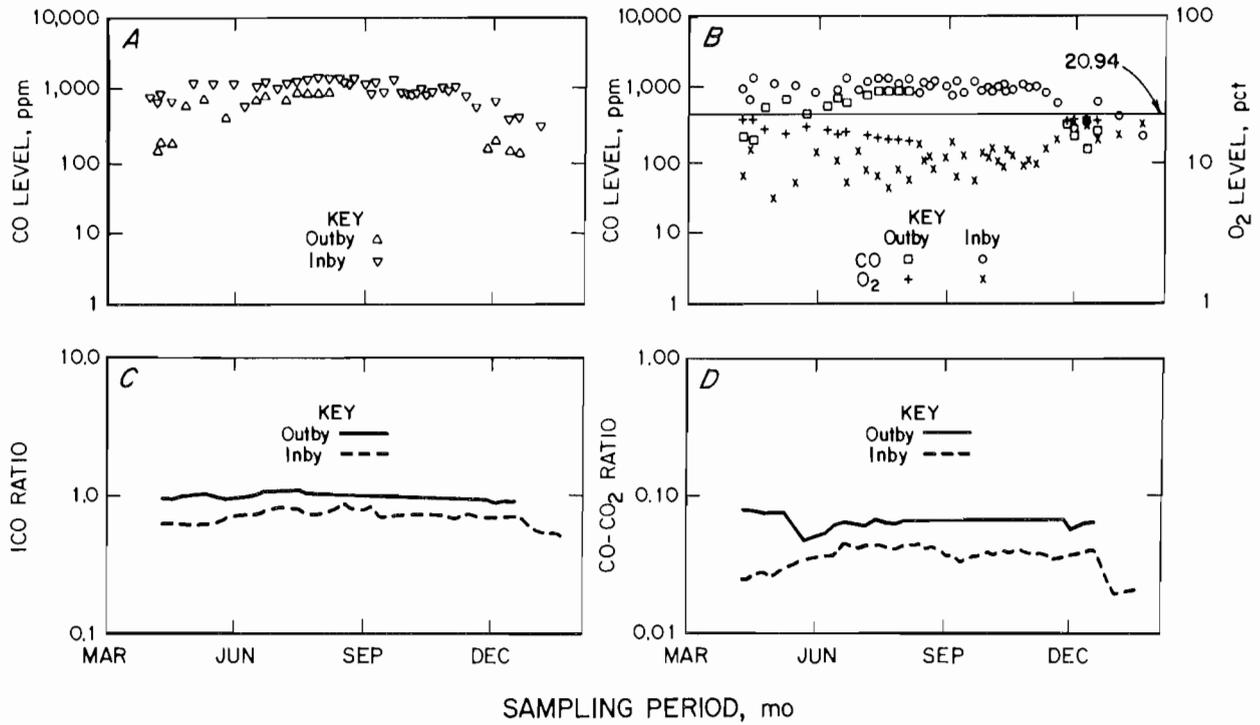
Figure 11

A second borehole, designated test hole 2-4, was drilled into pillar C. This borehole was 9.1 m (30 ft) deep. Handheld CO values (figure 11A) and gas chromatographic results (figure 11B) from both the inby and outby sampling positions correlated well with each other and with those values found at test hole 2-3. Based on comparative results between boreholes 2-3 and 2-4, internal pillar CO values near 1,000 ppm as well as O₂ levels of about 10 pct were considered indicative of the oxidation rate in the D seam.

ICO and CO-CO₂ results from test hole 2-4 (figures 11C and 11D) were more similar to borehole 2-1 data than to borehole 2-3. This apparent inconsistency was probably caused by the proximity of test hole 2-4 to the coal burn line.

Borehole 2-4. A, Handheld results; B, gas chromatography data; C, ICO; and D, CO-CO₂ ratio.

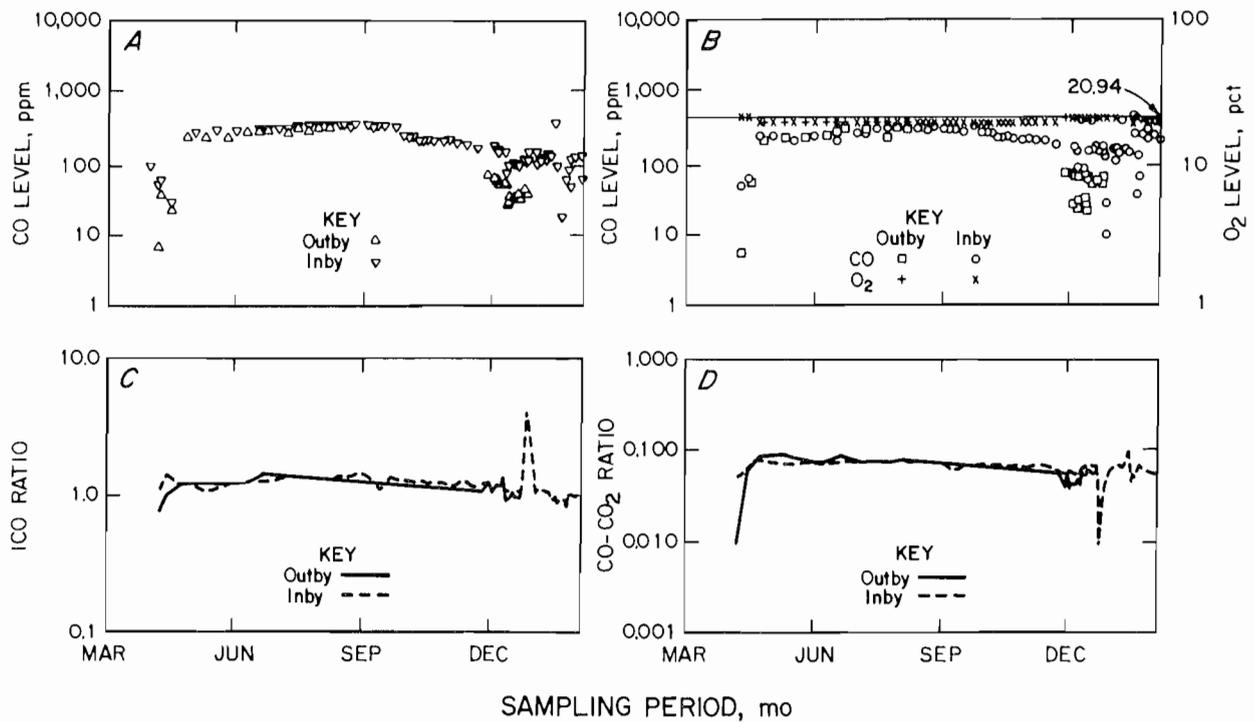
Figure 12

Chromatographic CO values (figure 12B) closely paralleled handheld concentrations. The O₂ levels at both the inby and outby positions remained close to ambient. ICO and CO-CO₂ results (figures 12C and 12D) were unchanged until the fire. The only indication of fire at borehole 2-5 was a slight increase in the ICO and a

Borehole 2-5. A, Handheld results; B, gas chromatography data; C, ICO; and D, CO-CO₂ ratio.

corresponding decrease in CO-CO₂. The fluctuations that followed the initial changes were believed to be caused by efforts to control the fire, rather than being indicative of the fire itself.

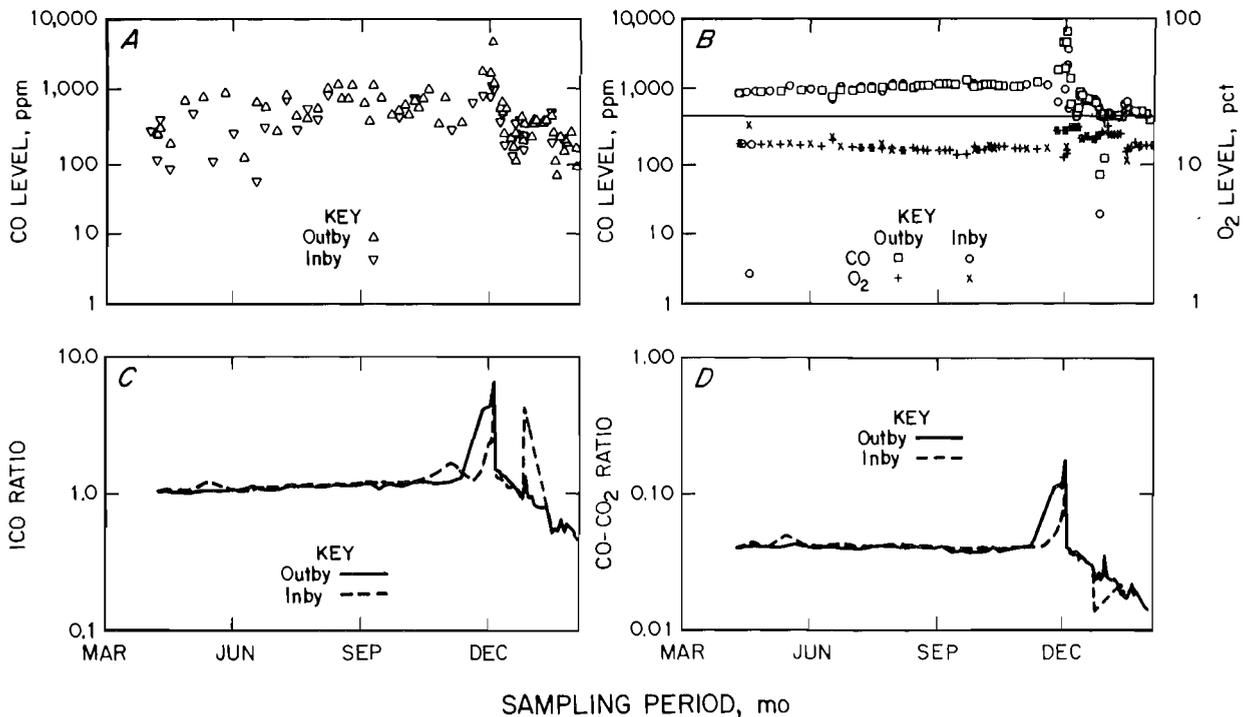
Figure 13

As the trend began to change, a thorough investigation of pillar A was performed with the infrared camera. An area of glowing coal was discovered behind the tunnel liner in the pillar A rib, upstream of borehole 2-6 and between the borehole and the mine portal. The burn zone extended into the pillar rib about 0.3 m (1 ft). It was extinguished by extracting the burning coal and saturating it and the remaining in situ pillar coal with water.

Borehole 2-6. A, Handheld results; B, gas chromatography data; C, ICO; and D, CO-CO₂ ratio.

different coal pillars just inby the mine portals. In hole 2-6, following three consecutive samples with increasing CO concentrations and corresponding decreases in O₂, researchers concluded that the oxidation process was accelerating and increased sampling frequency with handheld instruments and gas chromatography. Shortly thereafter a fire was found just upstream of this borehole.

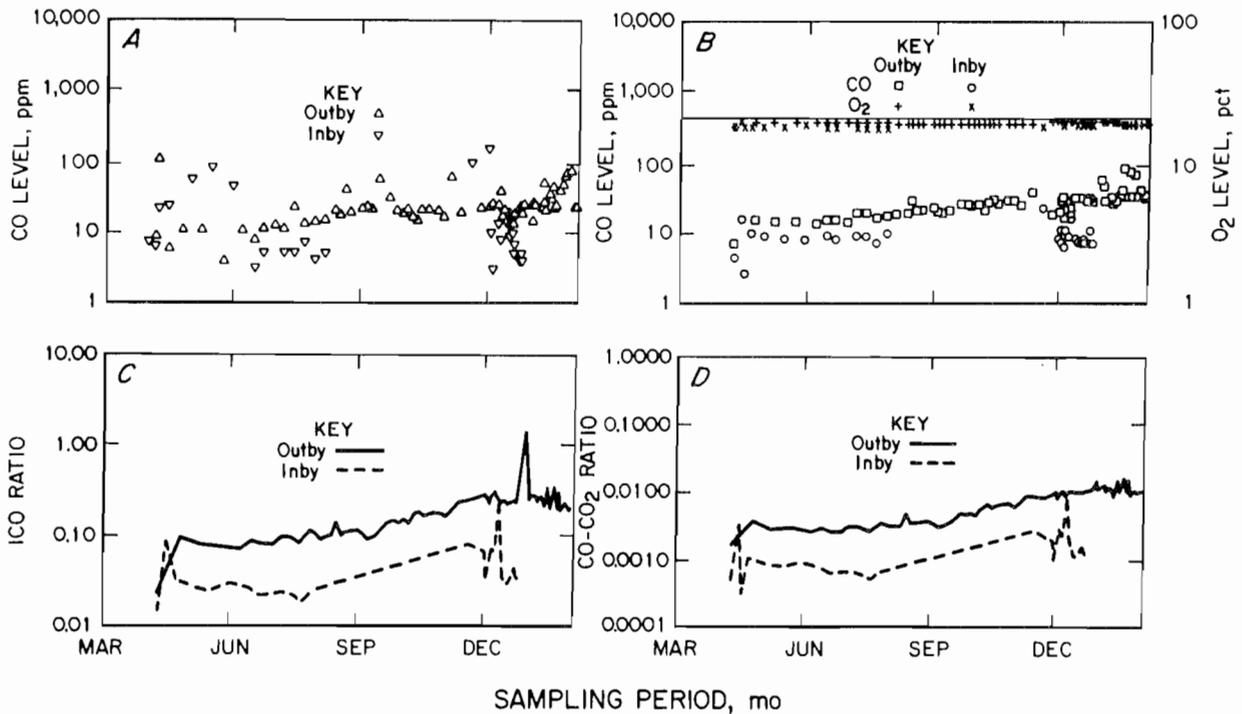
Figure 14

Borehole 2-7 was 9.1 m (30 ft) deep. Inby and outby values of handheld CO (figure 14A) were less than those levels found at the other holes. Chromatographic CO samples (figure 14B), while exhibiting a very gradual increase over time, were below the values found at all other locations. The O₂ values were unchanged but slightly below ambient throughout the study.

ICO and CO-CO₂ results exhibited a continual increase (figures 14C and 14D) even though they were below values found at other locations. If an increasing trend alone was regarded as a predictor of spontaneous heating, looking at this data could lead one to infer that a heating was taking place upstream of borehole 2-7 in pillar A even though no heating was ever located. These indications could have been from the pillar A belt-entry fire or from residual heating in the coked material outby the borehole.

Borehole 2-7. A, Handheld results; B, gas chromatography data; C, ICO; and D, CO-CO₂ ratio.

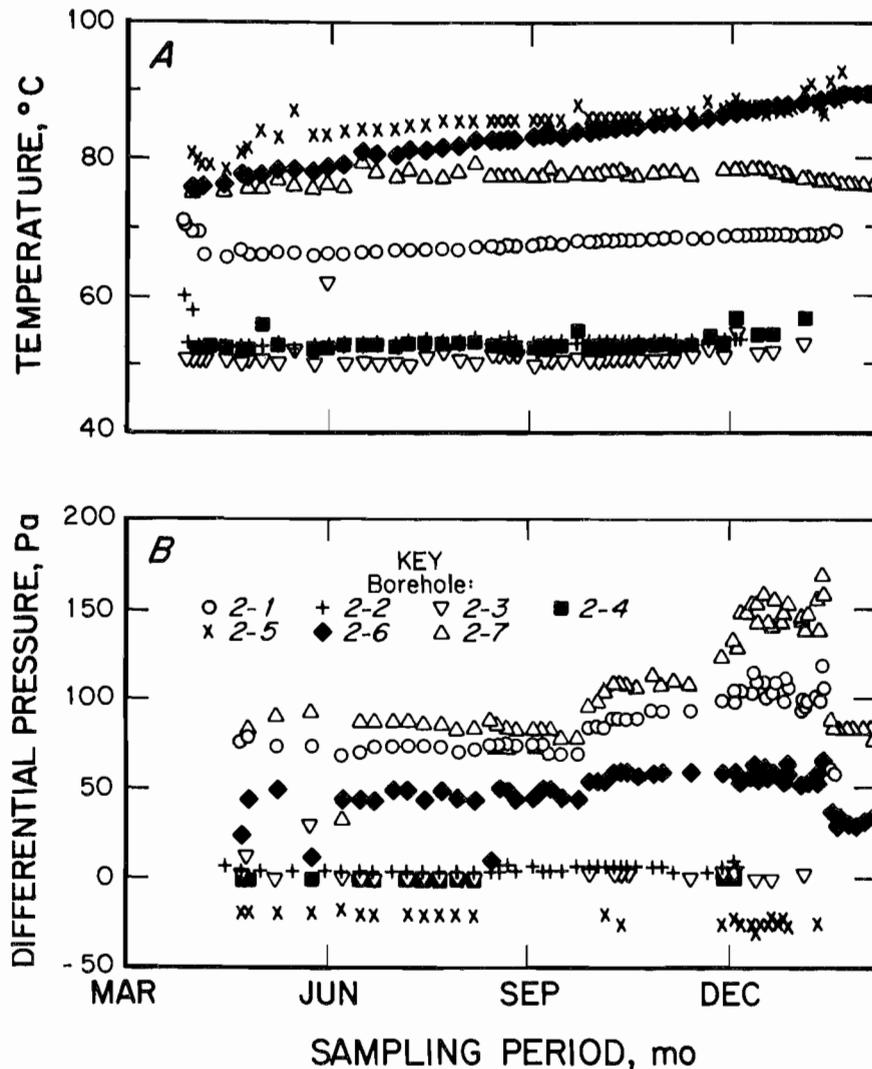
Figure 15

A correlation existed between borehole pressure and temperature. If a pressure differential existed within the hole, that borehole also had elevated and increasing temperatures. Temperature and pressure data reinforced the premise that some level of spontaneous heating was constantly occurring in pillar A.

Borehole measurements. A, Temperatures; B, pressures.
