REPORT OF INVESTIGATIONS/1993

Strength Characteristics and Air-Leakage Determinations for Alternative Mine Seal Designs

By E. S. Weiss, N. B. Greninger, C. R. Stephan, and J. R. Lipscomb

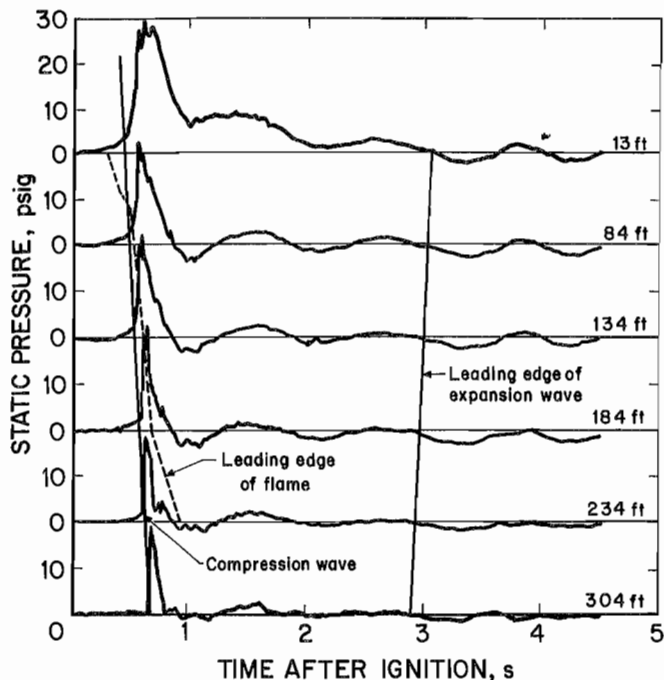
Figure 3.—Computer data from 20-psig pressure pulse in C drift.

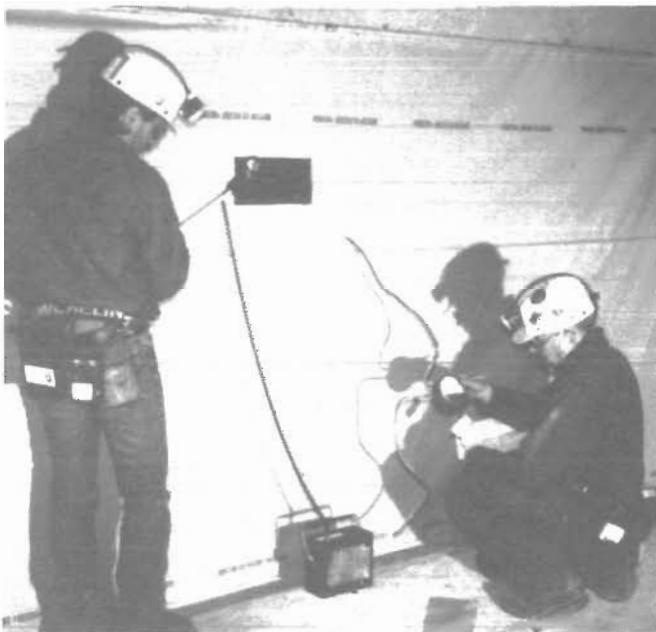
Figure 6.—Monitoring of air flow through test seal.

As the ventilation fan speed was increased, the pressures and the air flows through each seal were recorded (fig. 6). Based on data collected during the testing program (3, 4) with solid-concrete-block and cementitious

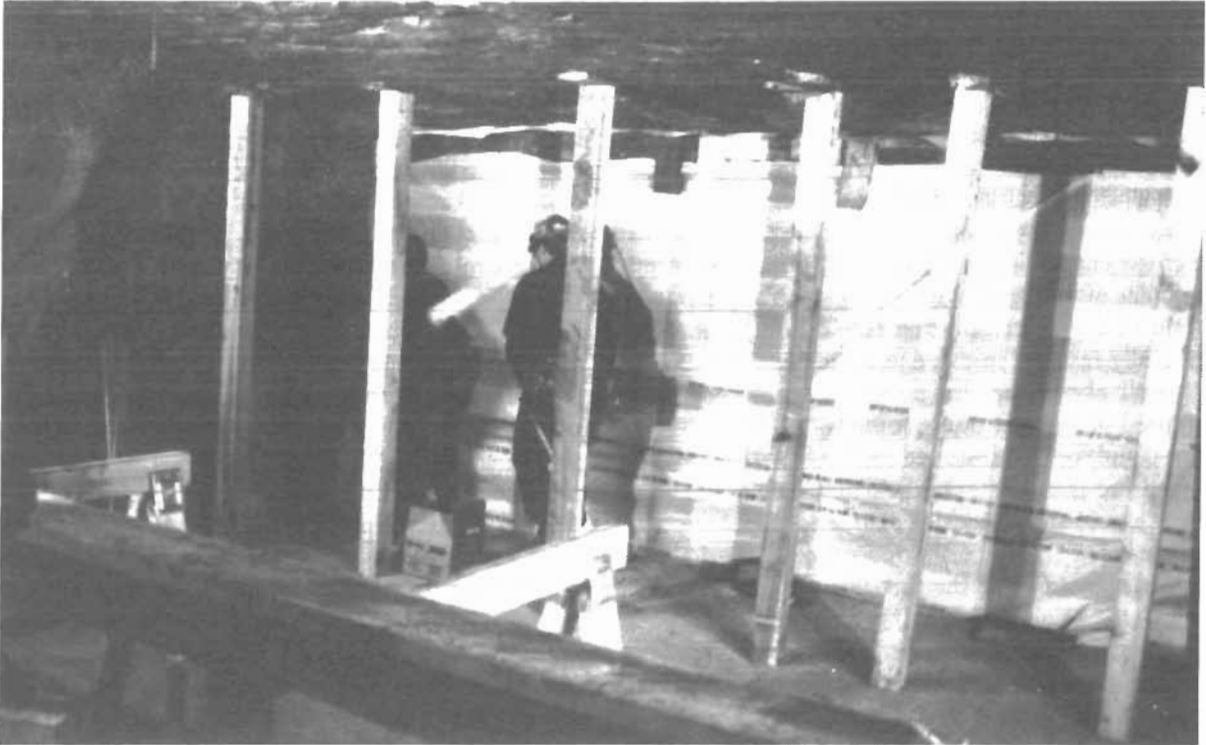
Figure 8.—Wooden framework for cementitious foam seal.

The wooden framework with attached brattice cloth used to contain the cementitious slurry was similar to that used during the first test series (3). No simulated keying with a steel angle was used with these seal designs. Figures 8 and 9 show two phases of the lumber and brattice framework construction. A copper tube was positioned through the middle of each seal (fig. 9), prior to the slurry injection, for monitoring the pressure differential across each seal during the leakage tests. Thermocouples were attached to the tubing to monitor the reaction temperatures of the cementitious slurry during the curing period.

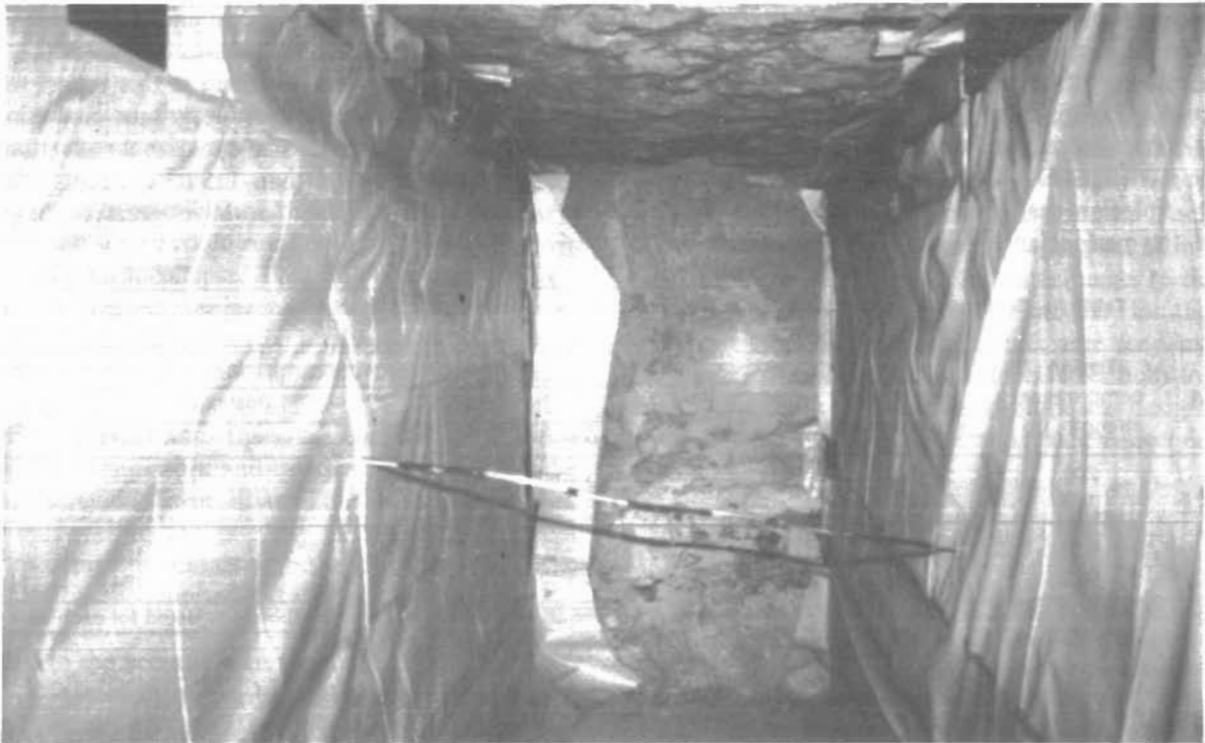
Figure 9.—Brattice liner attached to framework used to contain the cementitious foam slurry. Note copper tubing through the middle of the seal.

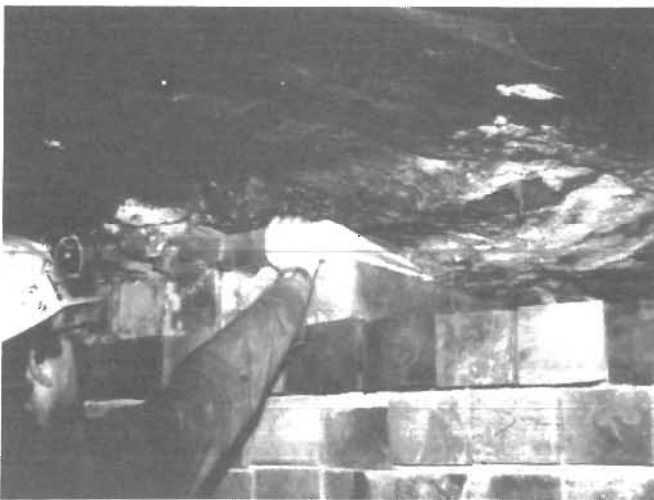
Figure 12.—Wedging of wood blocks to mine roof.

the crosscut ribs, with the square ends facing out toward B and C drifts. A 0.25- to 0.5-in-thick layer of rock dust was placed between the timber rows (or courses) to level and fill void spaces between crib blocks and to reduce air leakage through the seal (fig. 11). The seal was constructed to make solid contact with the roof, floor, and ribs. Voids around the perimeter of the seal were filled with wood pieces and the timber rows then were wedged solidly against both ribs. This procedure was followed for each row until the last full row reached the mine roof. Once the mine roof height was reached, any space remaining that was too small for a full timber was filled with a taper-cut timber. The top course of these crib blocks was installed solidly against the mine roof using wood wedges on both sides of the seal (fig. 12).

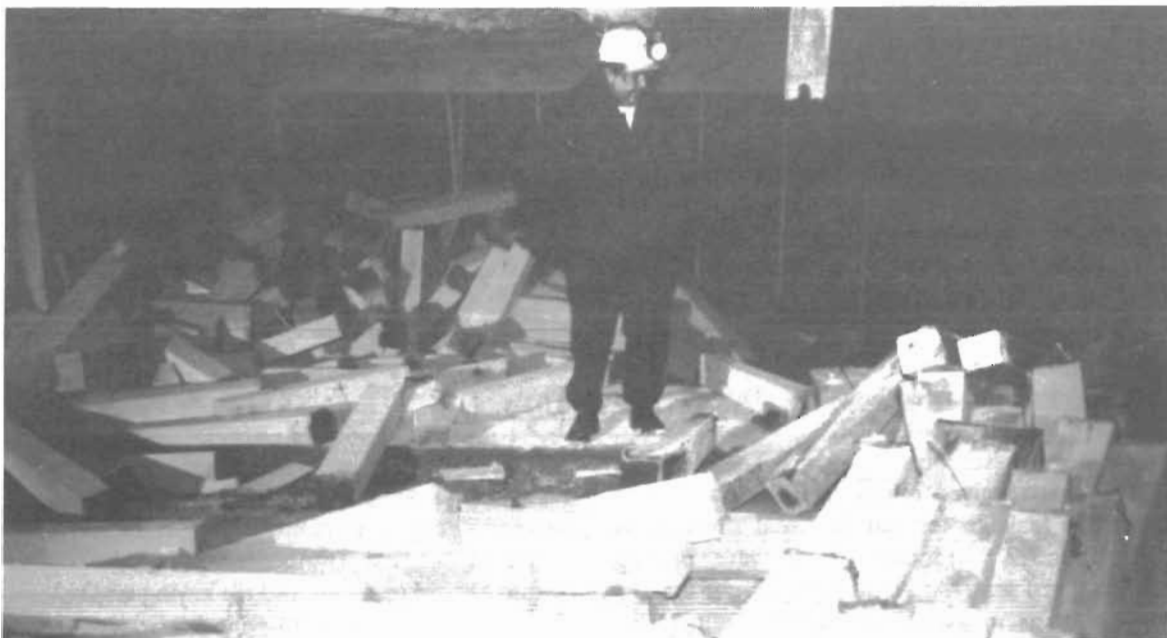
Figure 14.—Damage to typical wood-block seal when subjected to 20-psig pressure pulse.

Cover Photographs: Top, U.S. Bureau of Mines Lake Lynn experimental mine. Mine seals constructed in the crosscuts between B and C drifts; Bottom, Damage to typical wood-block seal when subjected to 20-psig pressure pulse.

The crib-block and rock-dust seal in crosscut 2 was demolished totally by the 22-psi level pressure wave (fig. 14). Note that the 3/4-in-diam bolts used to secure the steel-angle simulated hitching were not damaged and were of sufficient strength, in this instance, to hold the angle in place. Crib-block and rock-dust seals, as currently constructed in operating mines, will not withstand a 20-psig explosion prior to being subjected to mine convergence.

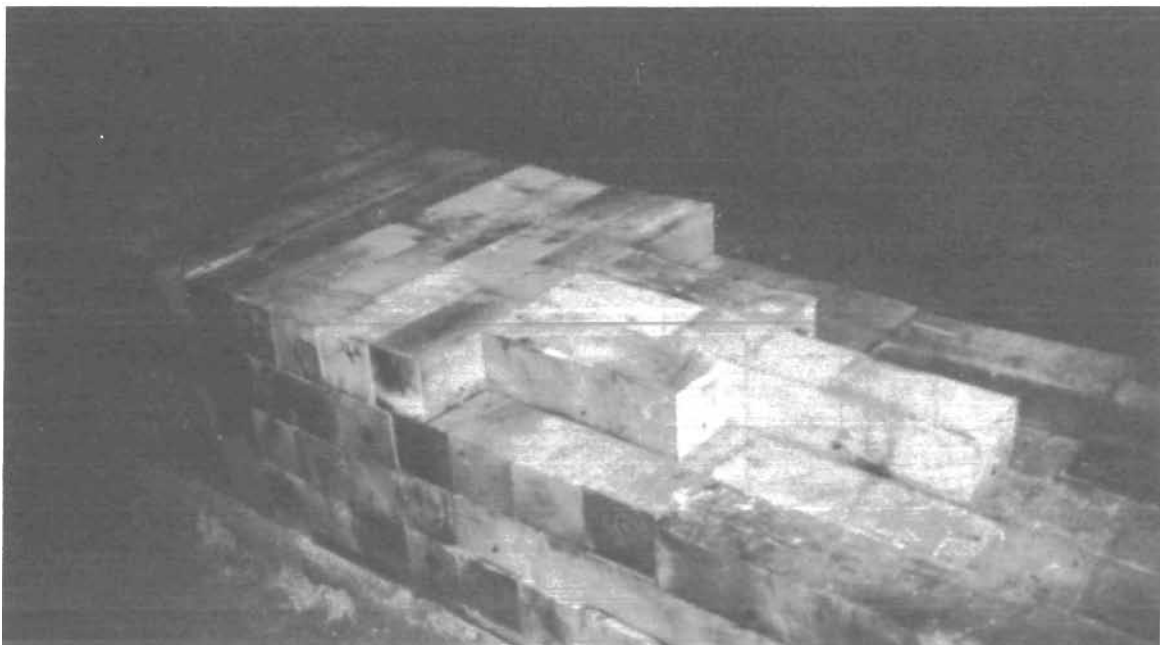
Figure 16.—Staggered wood-block joints.
