Bureau of Mines Report of Investigations/1983

Concrete Crib Design and Field Testing

By T. W. Smelser and L. N. Henton

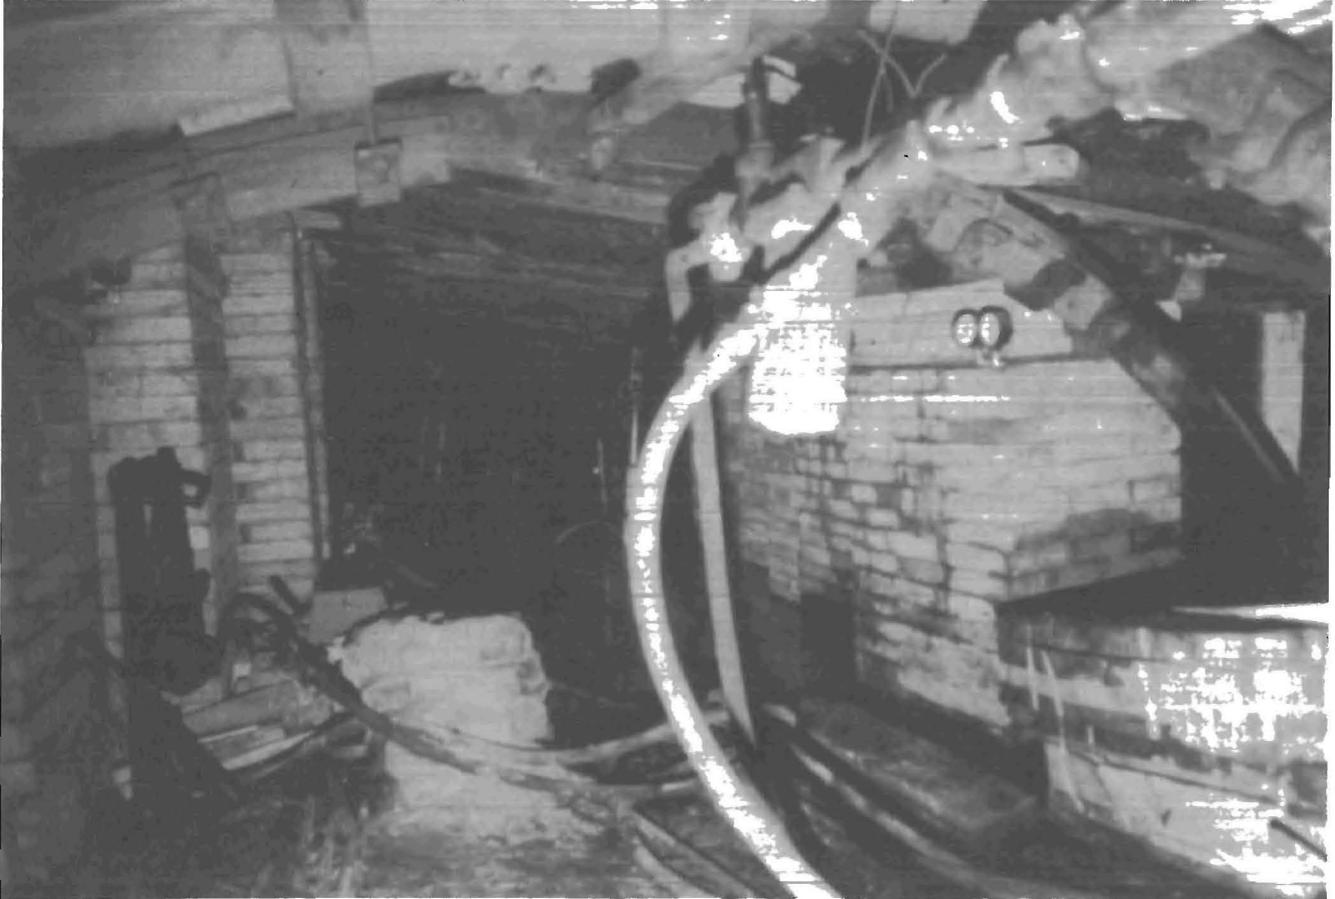
FIGURE 1. - Panel 10 left advancing tailgate. Foreground is previous yielding arch. Background is SFC crib demonstration.

Paired continuous walls of design 2 SFC solid cribs placed "skin-to-skin" were installed in the advancing tailgate of the retreating 10 left longwall panel (fig. 1). The walls demonstrated application 3, support of an advancing tailgate. The panel had about 2,000 ft of cover. The demonstration was not completed because the panel was stopped for production reasons not related to the concrete cribs. It was stopped with

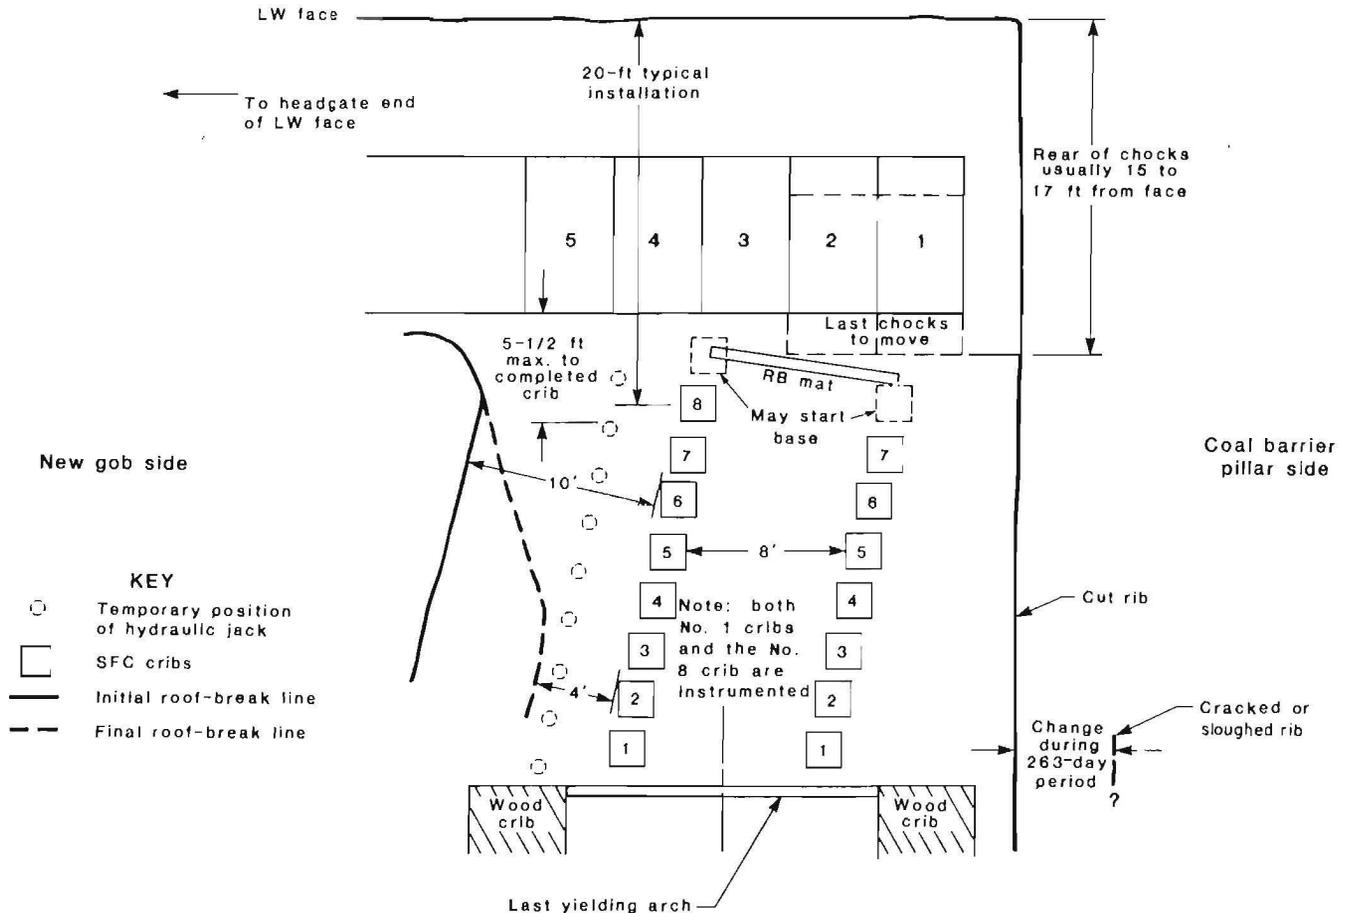
FIGURE 2. - Panel 10 left demonstration actual layout.

The standard advancing tailgate of the 10 left longwall consisted of yielding arches prior to the start of the SFC test section (fig. 2). Sixteen-foot-diameter semicircular arches on 3-ft centers had wood cribbing on both sides. Floor heave and punching into the floor caused loss of tailgate entry clearance, necessitating floor removal. Initial 7-ft clearance at the center of the arches closed to 4 ft or less at some places. The actual layout of the demonstration is shown in figure 2.

Individual cribs with dimensions of 30 by 30 by 72 in consisted of concrete members plus 1/2 to 1 ft of wood wedging and blocking. Most blocking was at the top of the cribs. Only enough wood wedges were used on the bottom to fill in and level the base. The cribs consisted of solid layers with members crosswise to members in the layers above and below. Each individual design 2 member measured 30 by 3 by 10 in.

Construction started with the first pair of cribs. Subsequent crib pairs were offset to the right until the desired location closer to the remaining coal pillar was obtained (fig. 2). A space of 5-1/2 ft was maintained from the rear of the chock to a completed crib. Roof-bolt mats were installed on 4-ft

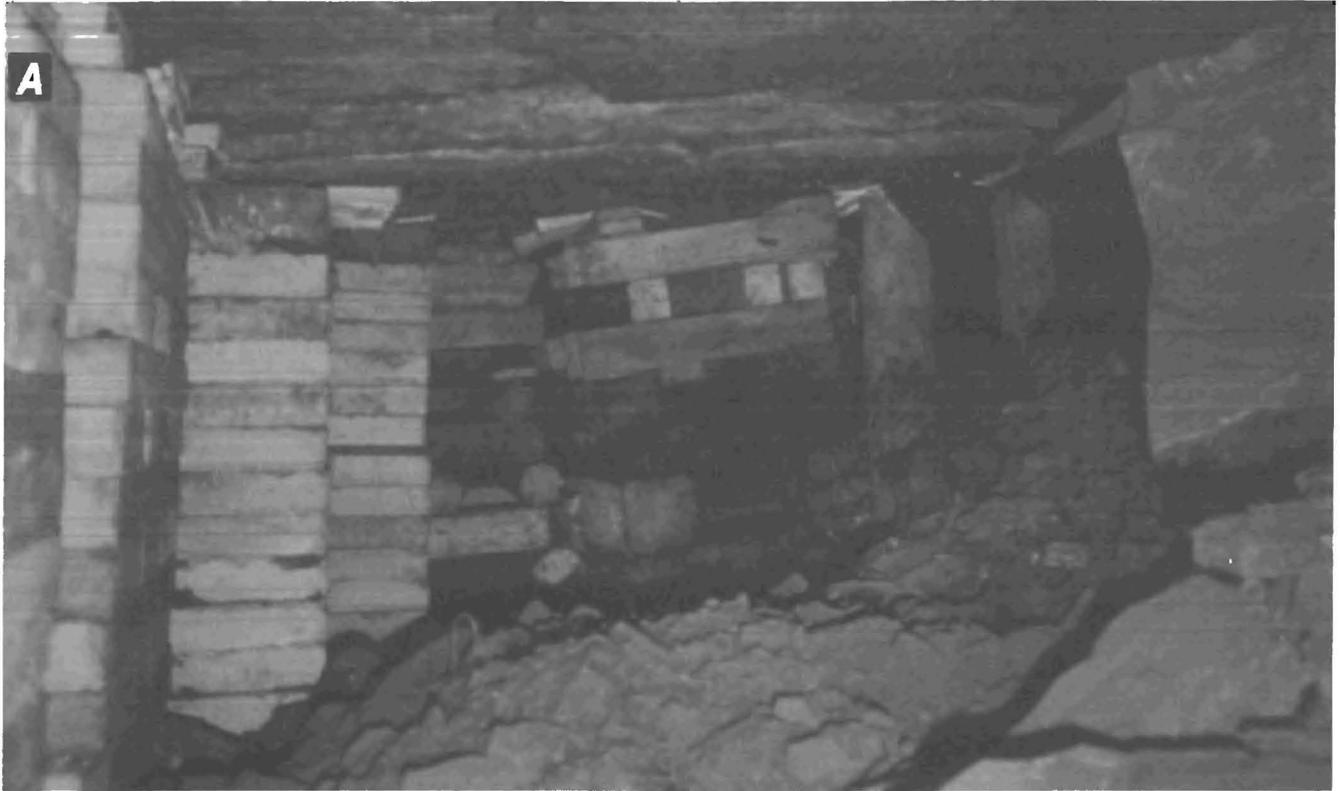
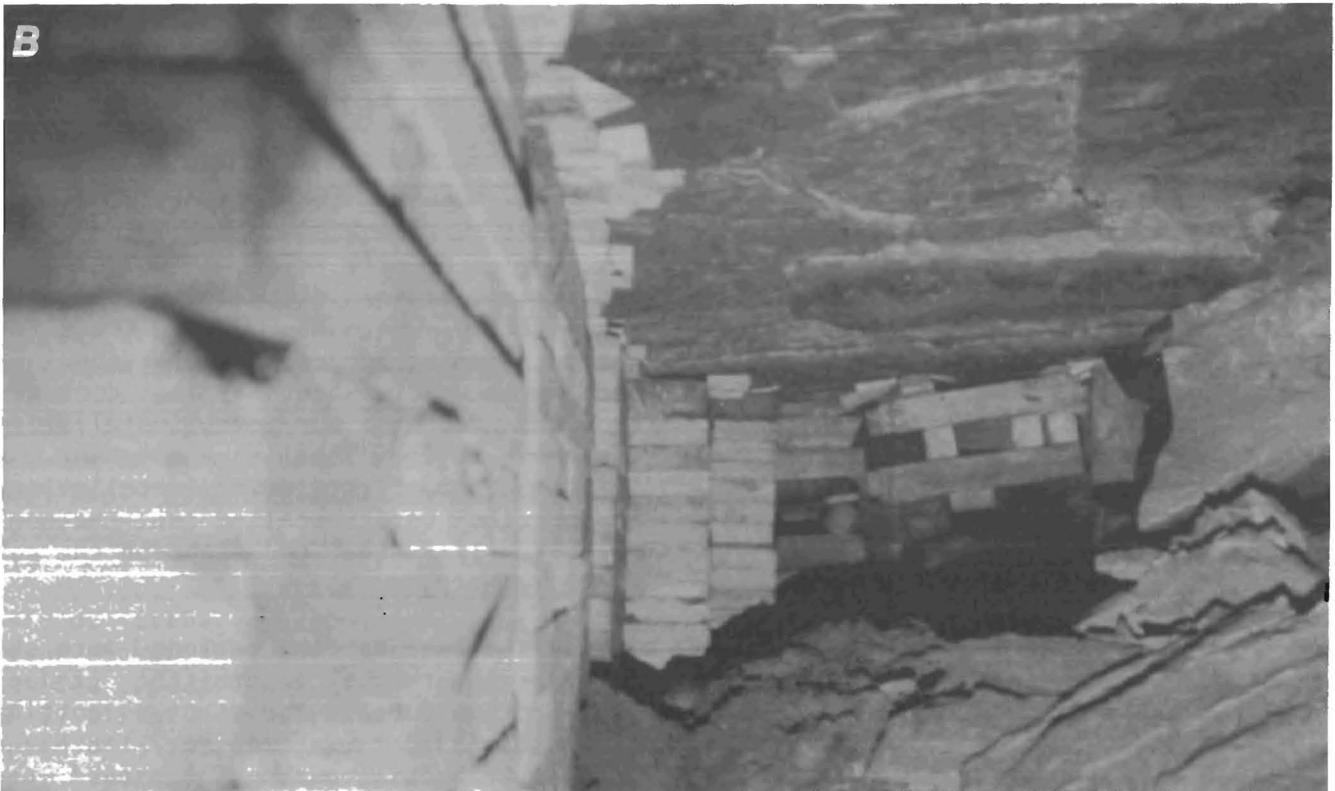
FIGURE 3. - Panel 10 left gob relation to gob side of cribs. *A*, Gob shortly after installation; *B*, gob long after installation.

centers before crib construction and spanned the 8-ft clearance between crib walls. A hydraulic jack behind longwall chock 5, on the gob side of the SFC crib, provided insurance against premature caving into the crib construction area. The gob-roof break line did not approach closer than 4 ft to the gob-side crib at a distance of 15 to 20 ft behind the chock at the slowest average rates of advance. At faster advance rates, the gob-roof break line lagged even farther behind before coming within 4 ft of the crib. At the point of crib construction, the gob-roof break line was normally about 10 ft from the gob-side crib (fig. 3A). When the panel stood for a month with no advance, small pieces of gob had piled against the side of the cribs (fig. 3B).

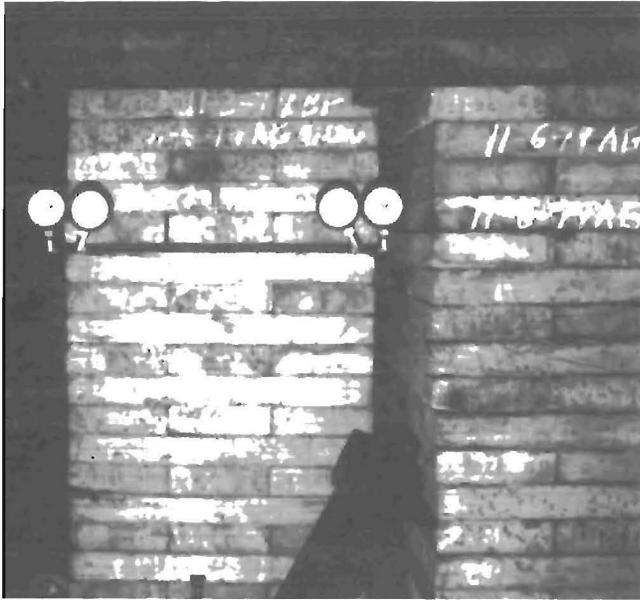
FIGURE 4. - Panel 10 left instrumentation layer installed in first SFC crib.

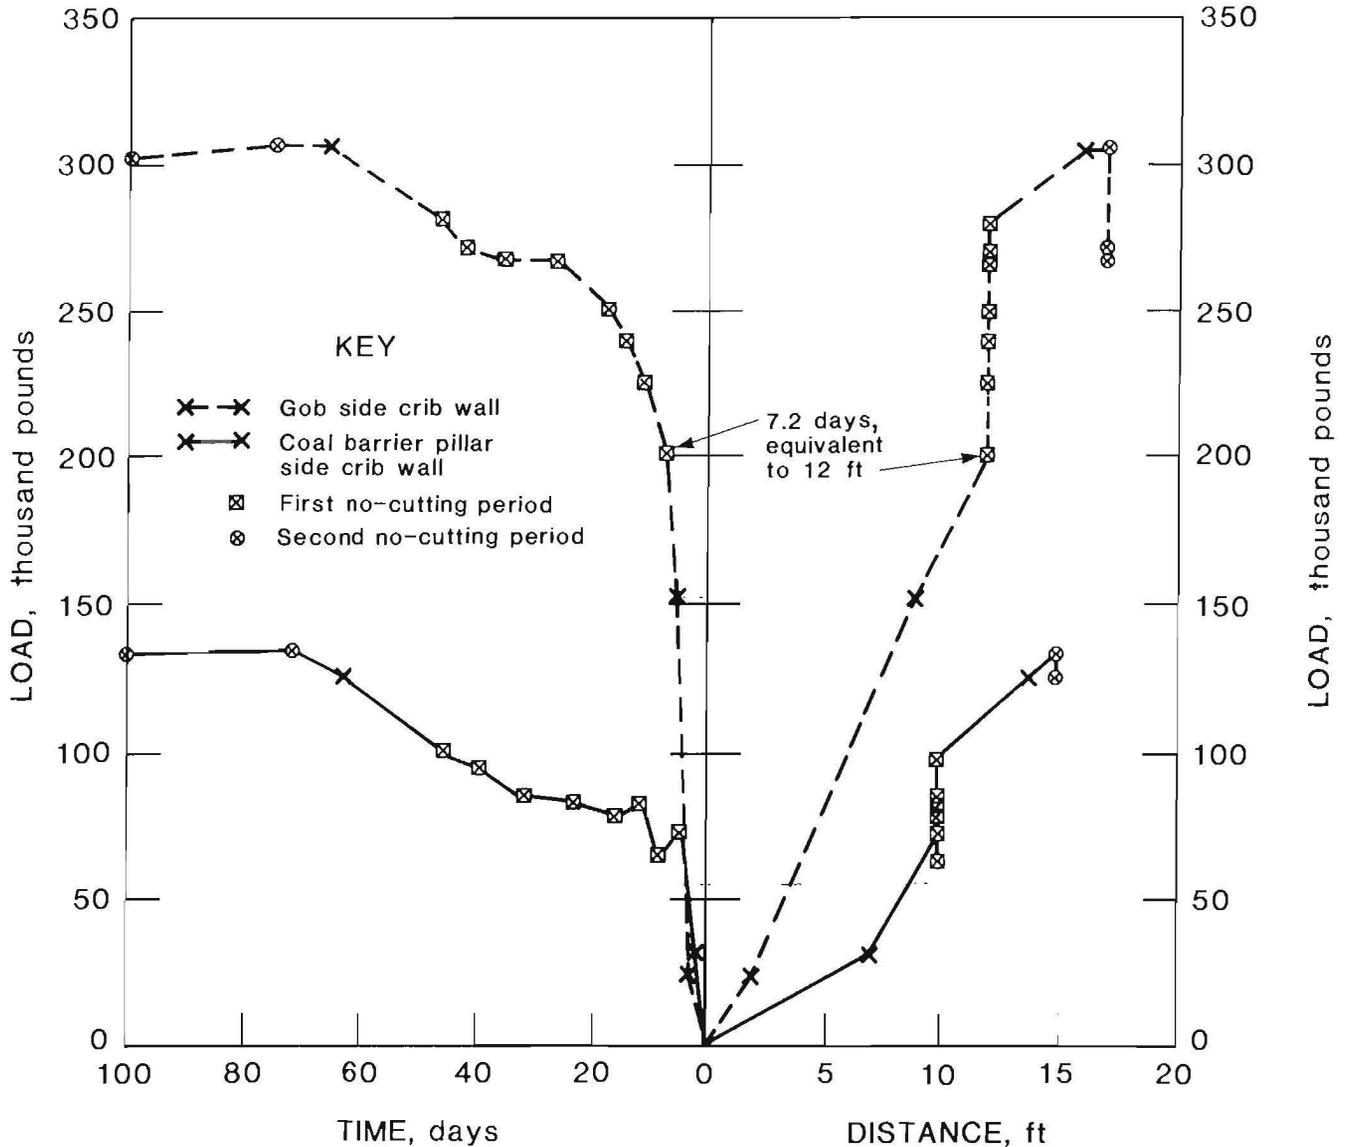
FIGURE 5. - Panel 10 left plot of each crib load versus time and distance of face movement since crib installation. Dotted line: first gob-side crib. Solid line: first coal-barrier pillar side crib. Zero is each crib installation.

Figure 5 shows the data plots of the first two instrumented cribs. The total load on each crib is shown versus time and face movement distance after crib installation. Note that during the first 7 days, loading increased proportional to face movement distance. Typical distance from the face to any crib installation was about 20 ft. Total face movement was 17 ft after first crib installation. Seven cribs were installed on the coal barrier pillar side, and eight on the gob side.

Two interesting time periods were observed owing to the intermittent production of this panel. The first no-cutting period of 39 days showed an increased load on both crib rows. The second no-cutting period of 239 days showed slow unloading.

Assuming the higher loads of the gob-side crib row to be most indicative of rock mass behavior, fast loading occurred with fast cutting, slower loading occurred with slower cutting, and slower or no loading occurred during the first no-cutting period. During the second no-cutting period of 239 days, unloading appeared only slightly faster near the end of the period and there may not be a significant difference. Information recorded here showed increased load during successive coal excavations. The maximum crib load during the demonstration was 305,000 lb, or 340 psi on the first gob-side crib. The other instrumented gob-size crib No. 8 at the rear of the chocks, never changed from the zero reading. The maximum crib load on the pillar side was 135,000 lb, or 150 psi on the first crib, the only instrumented crib on that side. The load per linear foot of entry was 109,000 lb on the gob side and 48,000 lb on the pillar side, or a total of 157,000 lb/lin ft of entry. The integrity of the tailgate entry was maintained at these loads. Cribs were still intact with no cracks, had maintained their shape, and were not punching the roof or floor. Wood blocking and

Total load on a crib was about proportional to the distance from the barrier pillar. During the 239-day no-cutting period, the gob-side load was decreasing four times as fast as the pillar-side load, when the data from the two instrumented cribs were analyzed. This trend was attributed to (1) lessening of the cantilevered gob-roof load as the cave line progressed closer to the gob-side crib wall, (2) support of the remaining cantilevered gob roof by the accumulating caved gob, and (3) sloughing out and cracking of the coal pillar, tending to equalize the distances from the pillar to both crib rows.

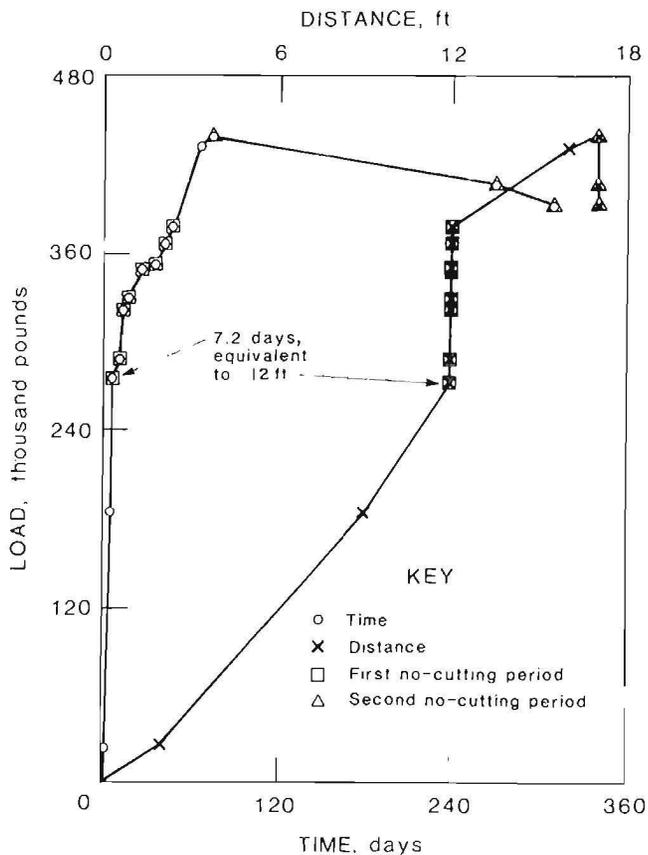
FIGURE 6, - Panel 10 left, two-crib total load versus time and distance of face movement since crib installation. Zero is gob-side crib installation.

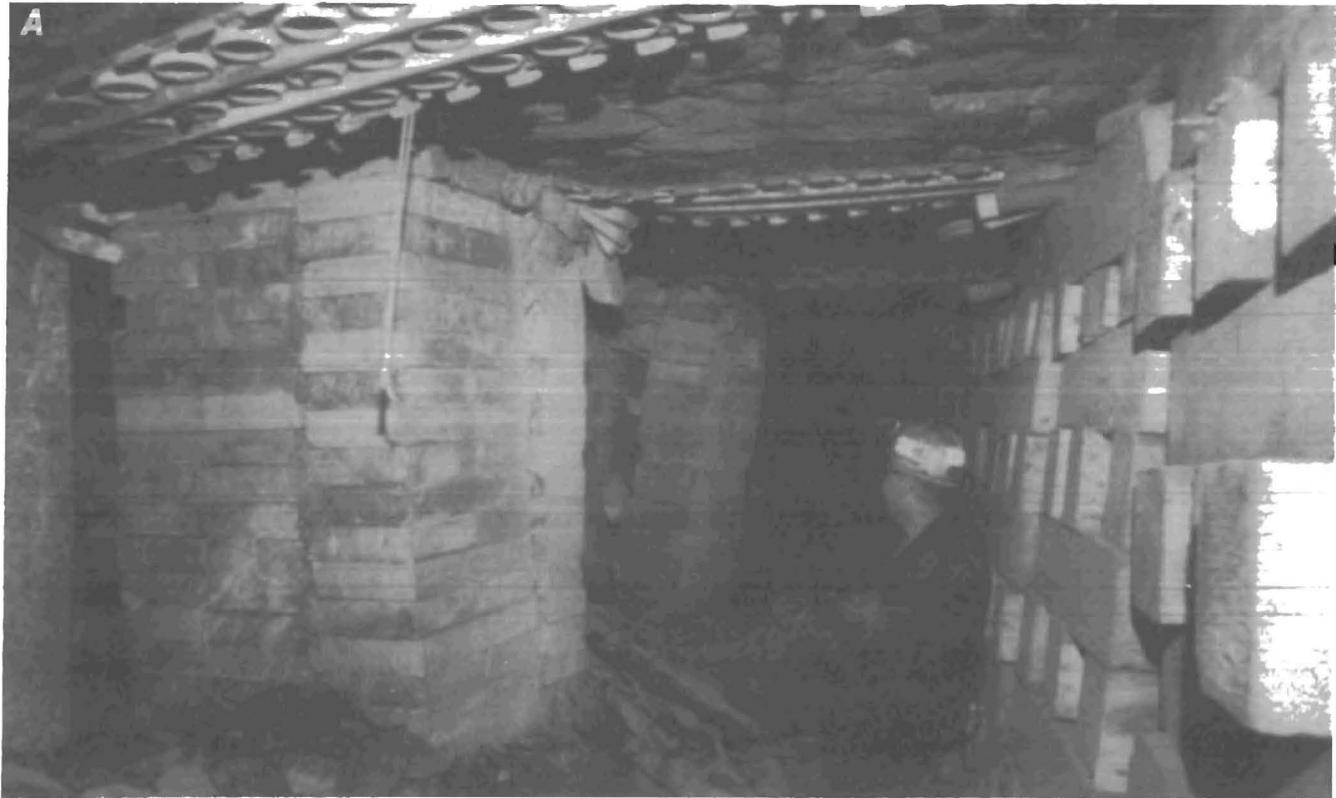
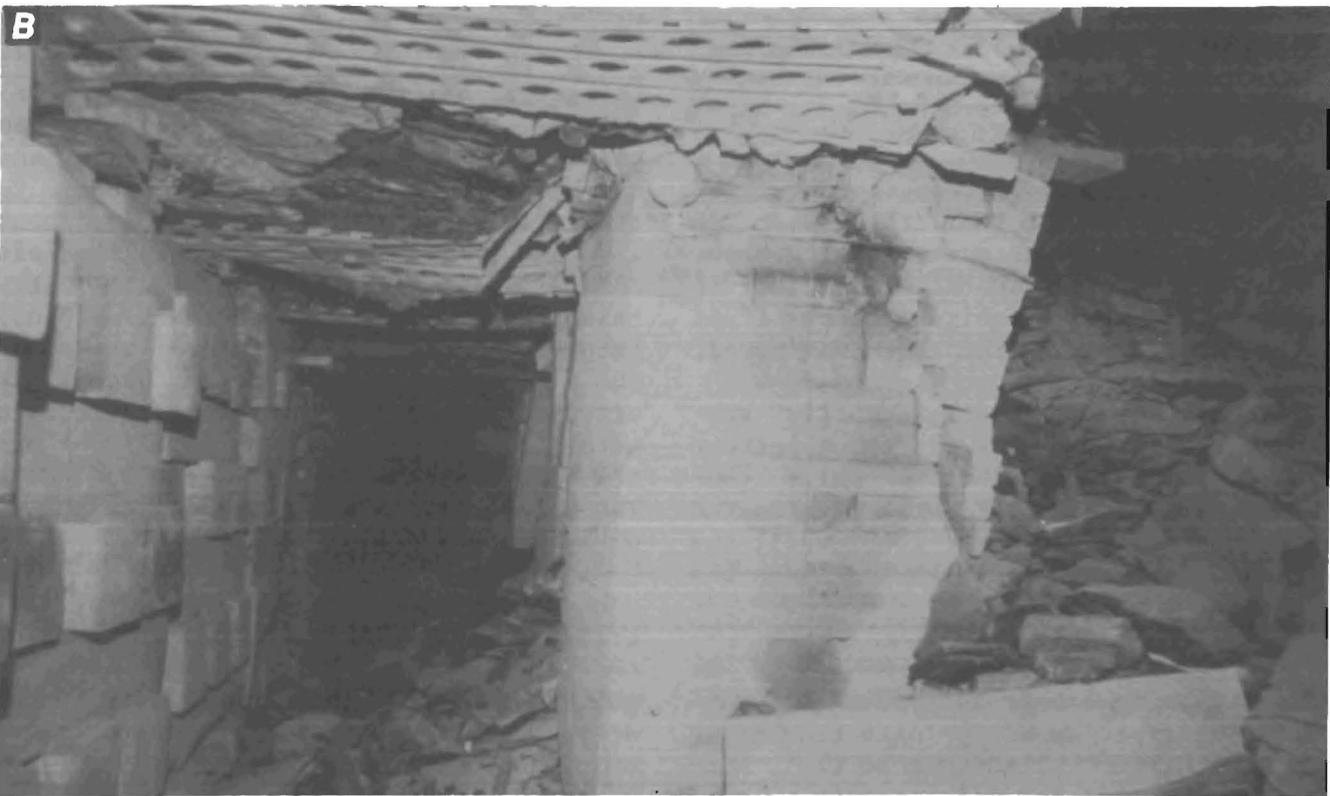
FIGURE 7. - Panel 17 left outside double-entry tailgate demonstration 1, after the second longwall face had passed. *A*, Gob-side SFC cribs at left, center solid wood cribs at right; *B*, chain pillar-side SFC cribs at right, center wood cribs at left.

As seen in figure 7A on the center rear crib, most vertical joint cracks in the SFC cribs were parallel to the tailgate entry. There were three times as many parallel cracks as there were perpendicular. Each crack was three times as wide at the top as at the bottom of a crib. Maximum separation observed at the top was 12 in when the 17 left face had passed the crib by 135 ft, contrasted with 6 in when the face had gone by

71 ft. These cracked cribs were functioning as three minicribs after the 17 left face had passed by 135 ft.

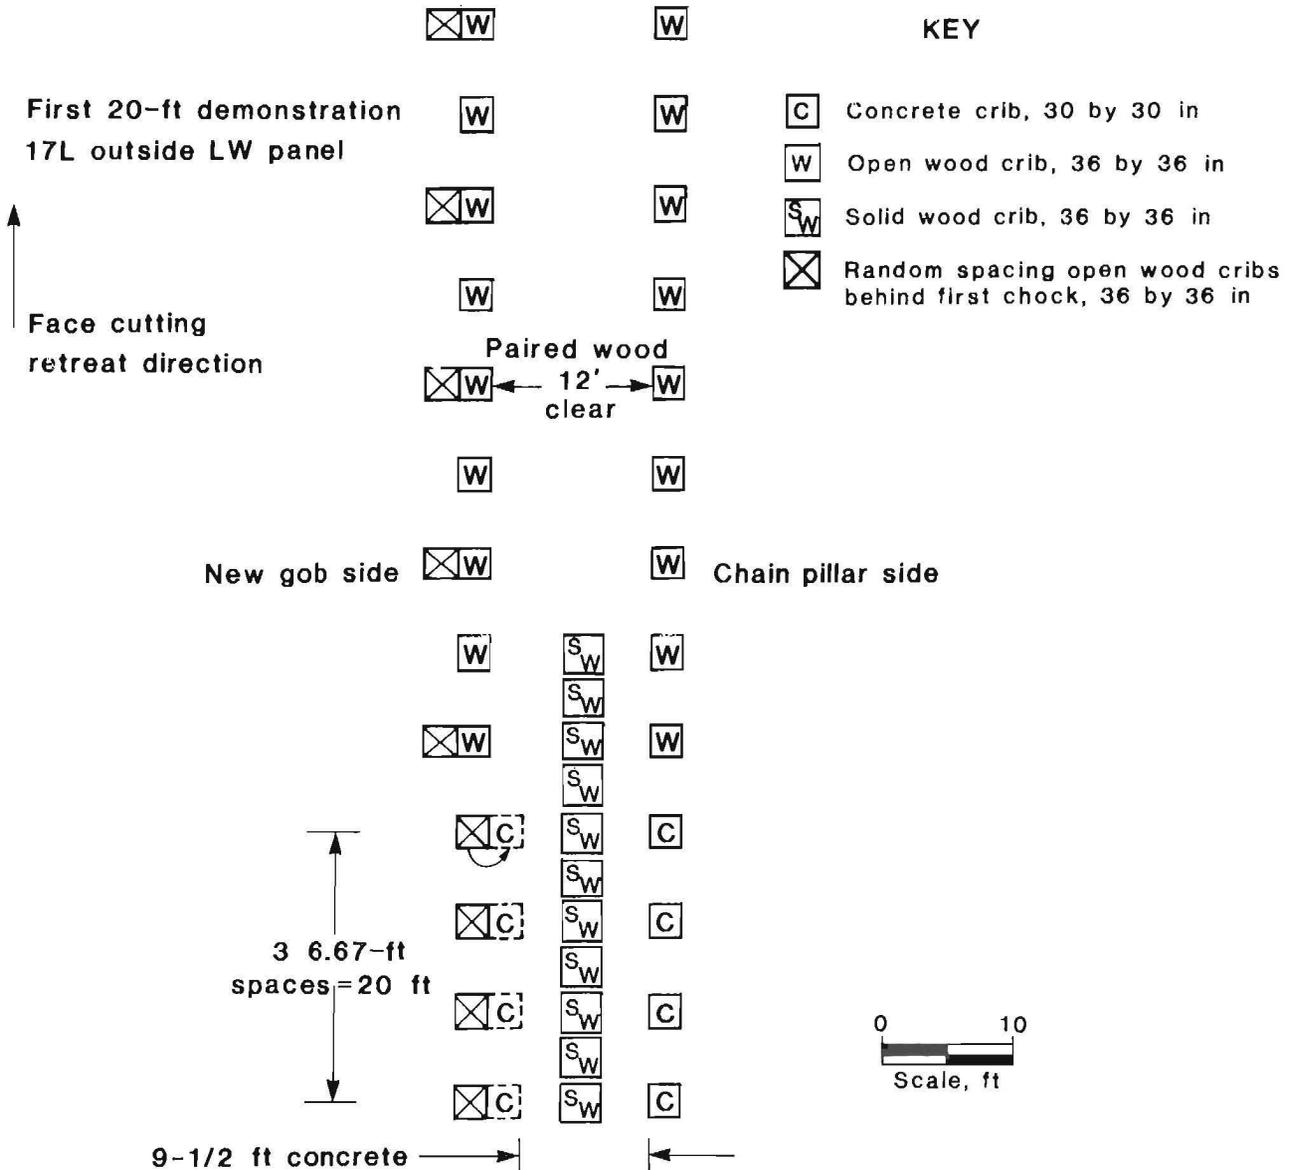
FIGURE 8. - Panel 17 left outside demonstration 1 actual layout plan.

Compared with the wood crib system, the gob-side concrete crib row was offset away from the face so the shearer would not have to cut it as sometimes occurred with the wood cribs on the gob side. There were 270 sq in of SFC crib support-bearing surface per linear foot of entry length.

A 12-ft clearance between paired wood cribs was maintained. Hydraulic jacks, occasional wood posts, and occasional wood cribs were added in the tailgate entry about 50 ft ahead of the longwall face. Mine experimentation with

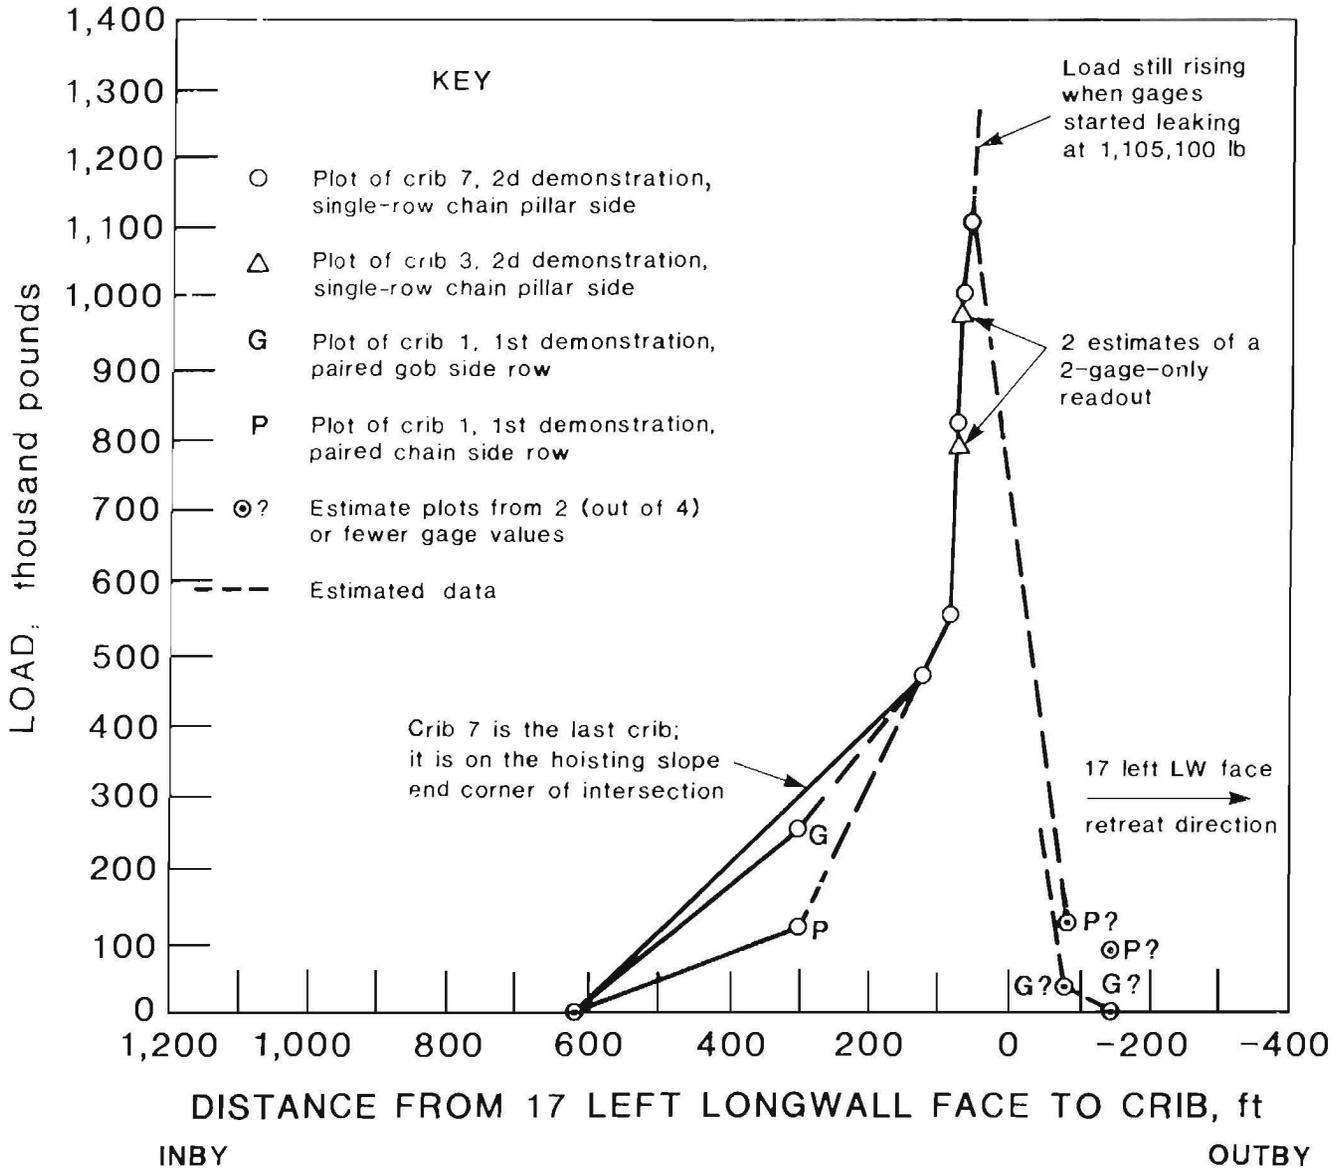
FIGURE 9. - Panel 17 left combined plot of demonstrations 1 and 2. When LW face is inby the zero crib location distances are plus, outby minus.

Figure 9 shows crib load versus distance from the 17 left face for demonstrations 1 and 2. The limited instrument information from the first demonstration, indicated by "G" and "P" on the plot, was in general agreement with the more plentiful information from demonstration 2 and was therefore combined with it. Note that the 2:1 load ratio for the gob-side crib loads compared with coal pillar-side crib loads, as was observed in the 10 left advancing tailgate, was also observed immediately at 300 ft in the first demonstration in 17 left. It was estimated, if gages had been read more often, loading would have started about 450 ft prior to arrival of the 17 left face.

Figure 9 shows the combined information of both demonstrations. Loads were rapidly increasing when the gages began leaking, so loads much higher than recorded were probable. Loads at the two intersection corners, cribs 3 and 7, were in agreement. The last recorded reading on crib 7 was 1,105,000 lb, or 1,230 psi, when the 17 left face was 52 ft from arriving at crib 7.

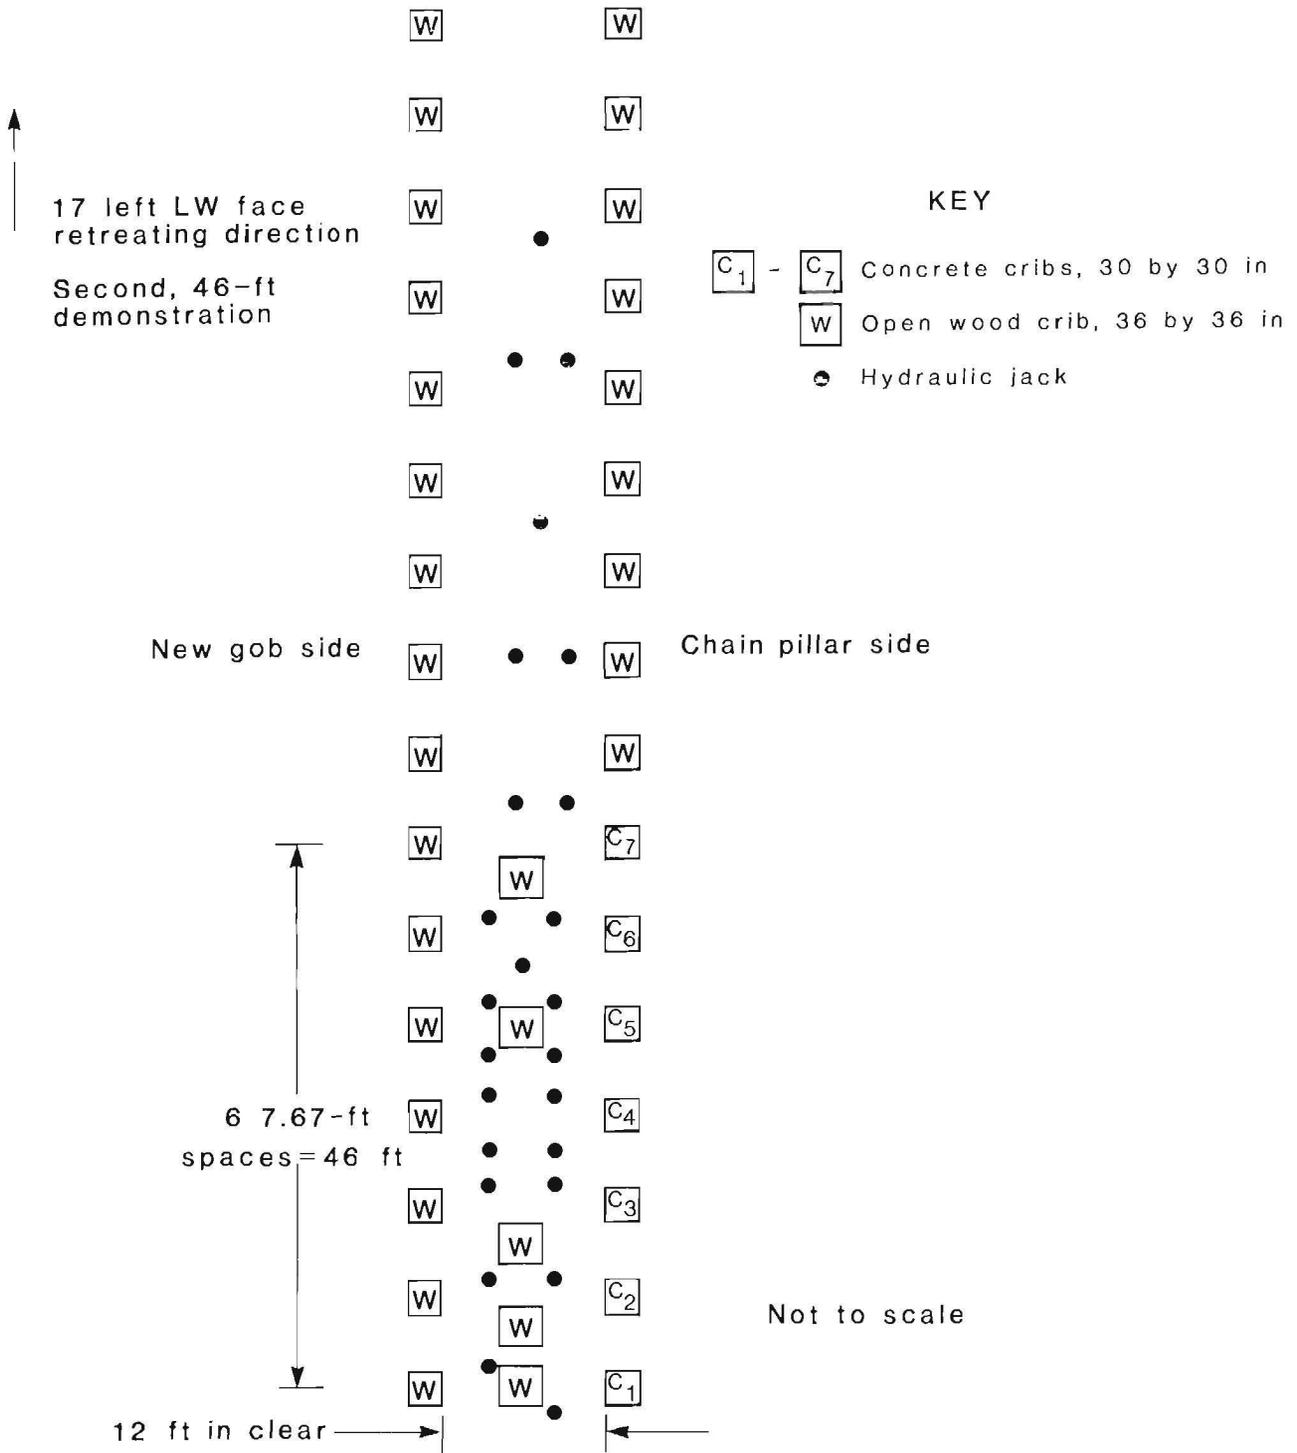
FIGURE 10. - Panel 17 left demonstration 2 actual layout plan.

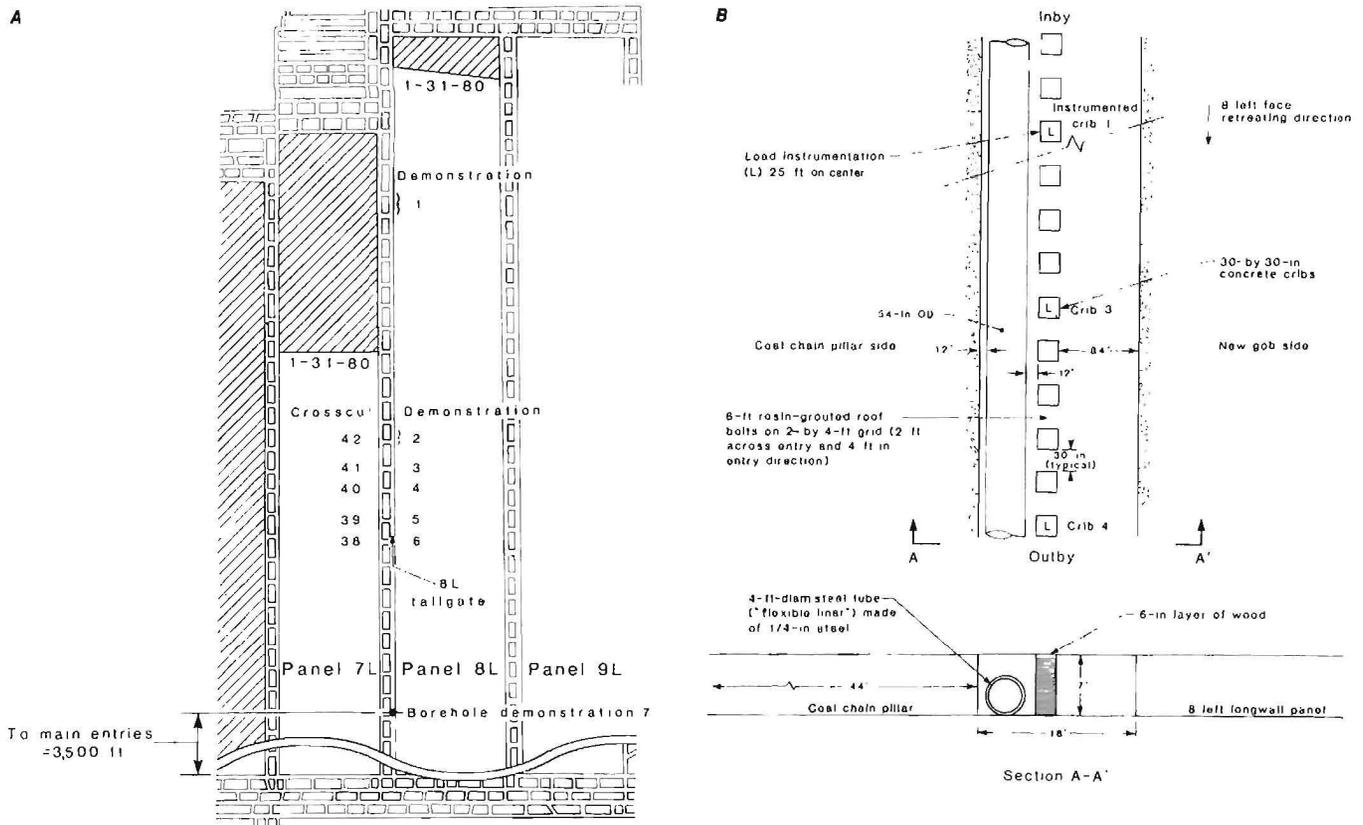
FIGURE 11. - Panel 8 left demonstration layout. A, In relation to panels; B, detail of 8 left demonstration.

consisted of a single row of spaced SFC cribs in approximately the center of the entry. On the chain pillar side of the single crib row, a 4-ft-diam steel tube was installed to maintain a return exhaust escapeway free from debris, which was the long-term application 2. The basic tailgate support during development was roof-bolted mat on 4-ft centers with a number of intersections and weaker areas having beams across them with post or crib support at the ends. Highly faulted areas had yielding arches and/or roof-bolted beams.

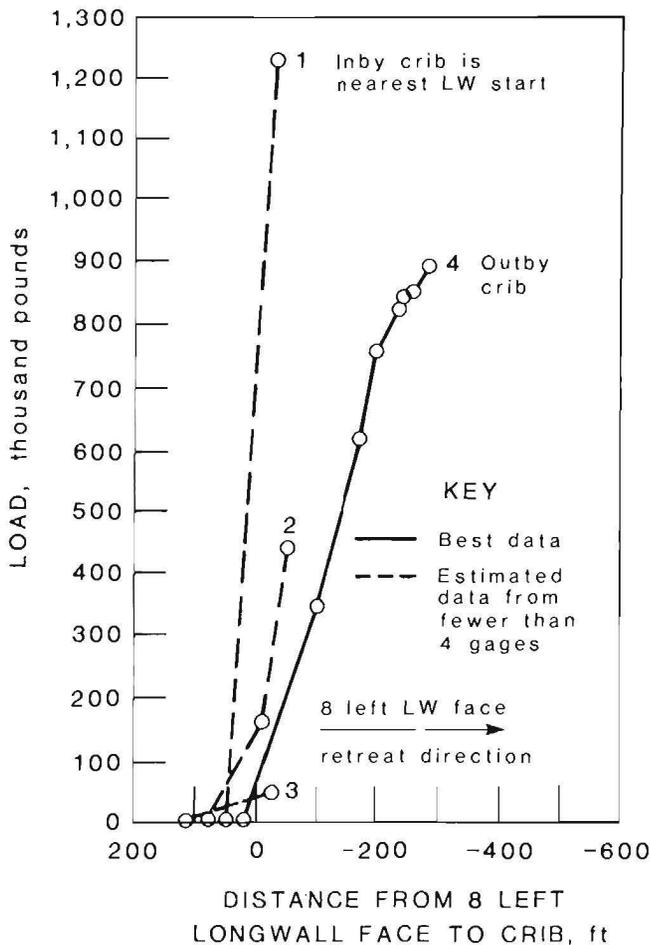
FIGURE 12. - Panel 8 left first demonstration crib plots. When LW face is inby the zero crib location distances are plus, outby minus.

Figure 12 shows instrumentation results for crib load versus longwall face position. No loads were observed until after the 8 left panel face passed. Crib 1, the first inby 30- by 30-in SFC crib, had an estimated maximum load of 1,223,000 lb, or 1,360 psi.

Cribs 2 and 3 provided limited information because the pressure gages were vandalized before peak loads were reached. Instrumentated crib 4 was 107 ft into the demonstration section at about two-thirds the distance from the starting end of the section. It was a 30- by 20-in crib. The maximum recorded load of 885,000 lb, or 1,480 psi, was increasing when the gages failed. It was believed loads were eventually much higher. When last observed in May 1980, the stiffer SFC cribs were maintaining the tailgate in a condition that would last the life of the 8 left panel as desired (application 2). There was less closure than with the wood crib sections and insignificant SFC crib damage (figs. 13A-C). Panel-end-support effects, shallow cover, and good ground conditions apparently delayed loading until after the 8 left face had passed. Later demonstrations showed loading from 900 ft prior to arrival of the 8 left face.

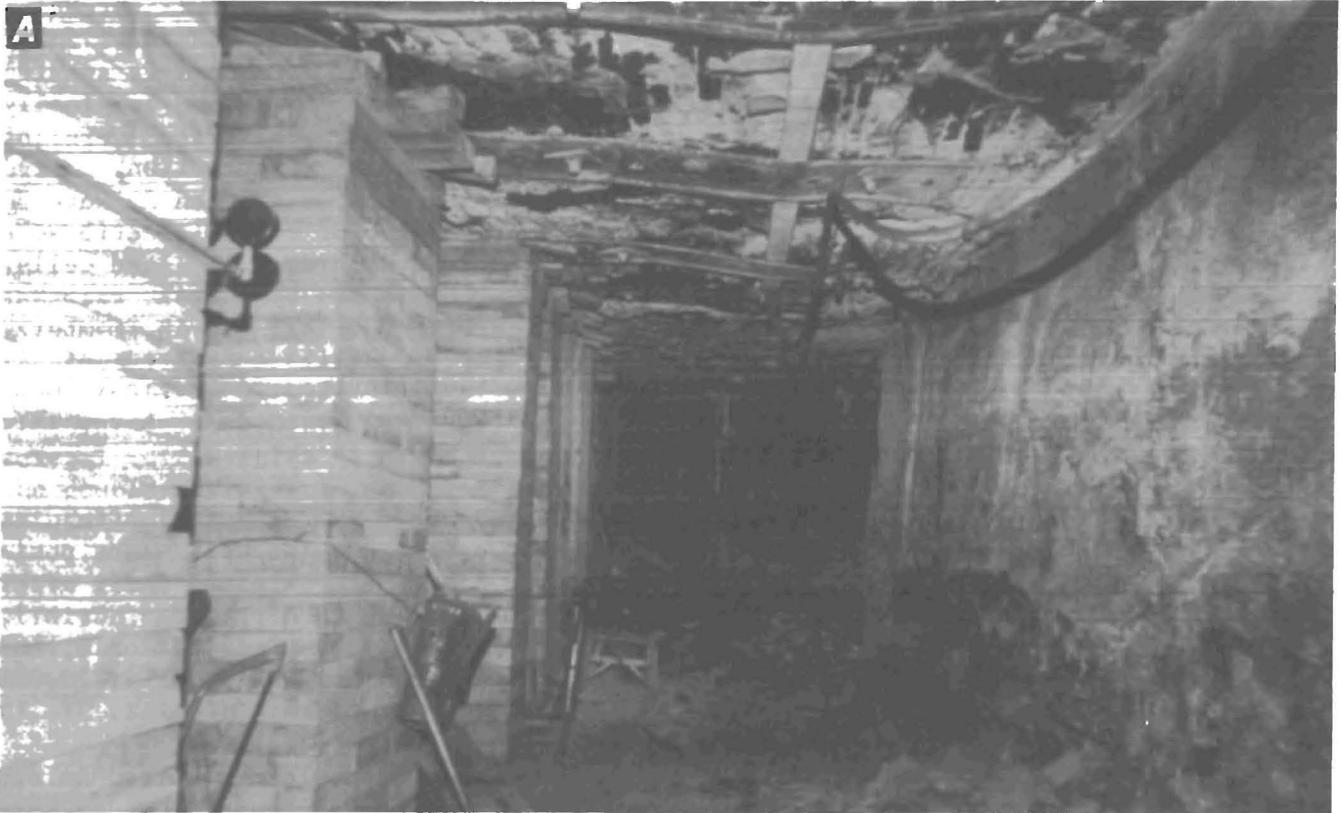
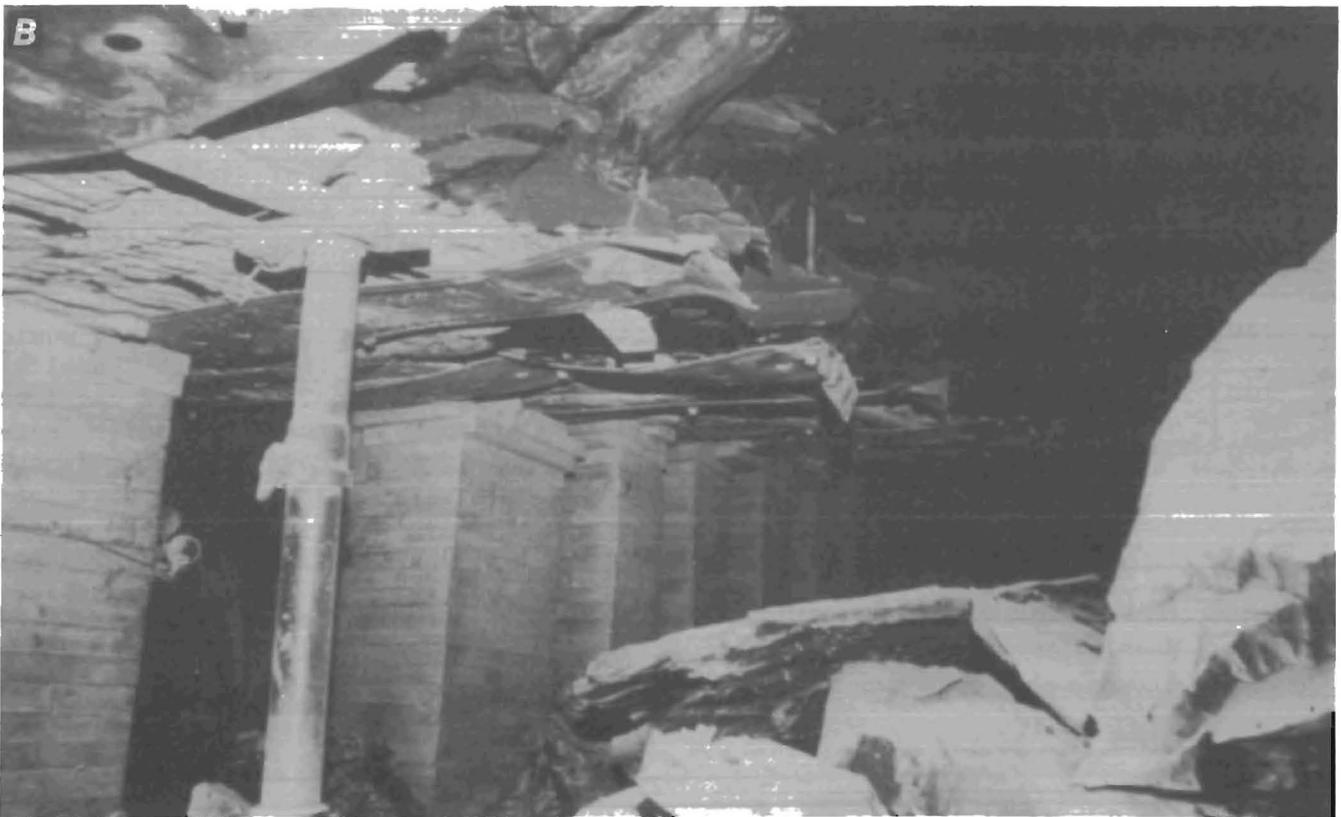
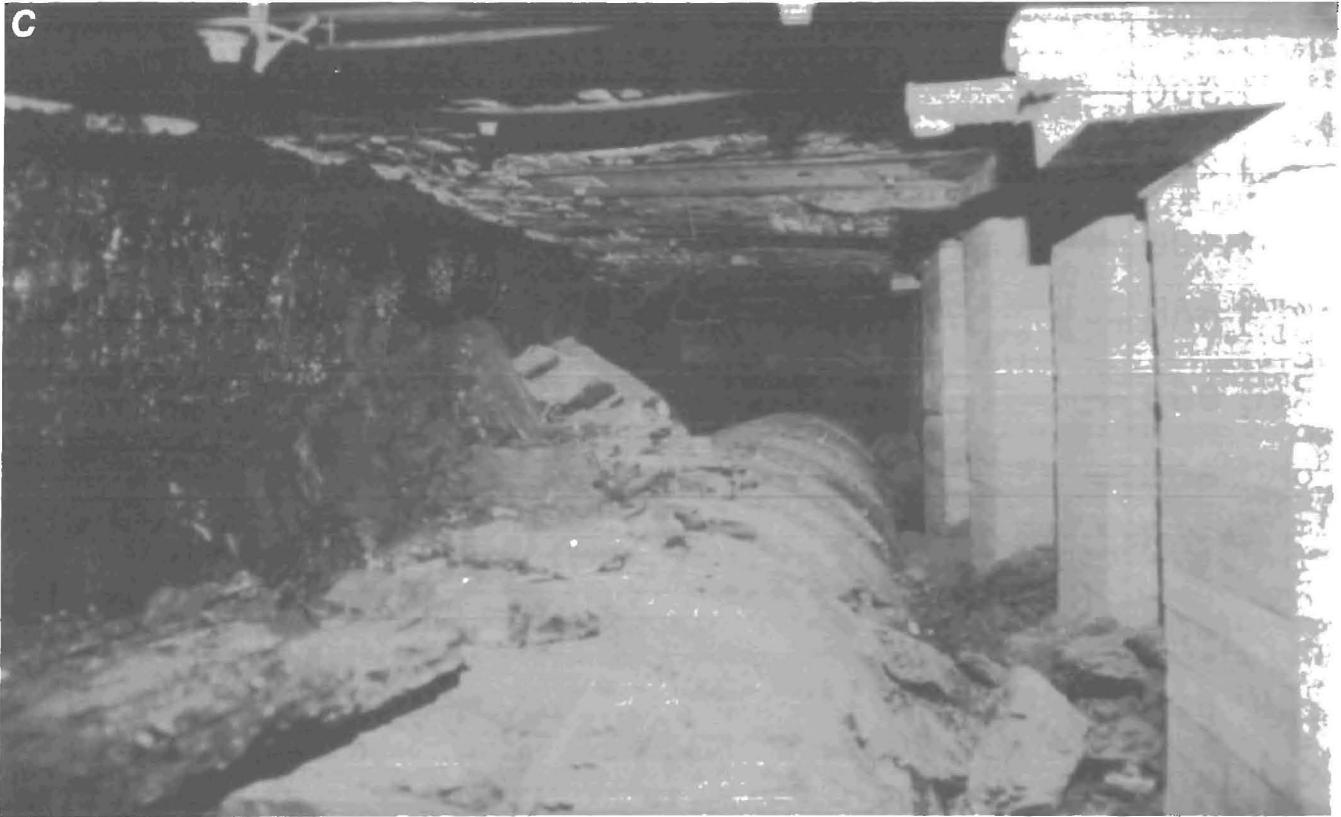
FIGURE 13. - Panel 8 left first demonstration. *A*, Gob side before longwall face arrived; *B*, gob side after longwall face had passed.

FIGURE 13. - Panel 8 left first demonstration—Continued. C, Chain pillar side after longwall face had passed.

condition that would last the life of the 8 left panel; the wood crib system definitely was not, with closure up to 2 ft. Damage to the SFC cribs, and closure around them, was insignificant (figs. 13A-13C). In poor ground with 600 ft of cover, the slower closing SFC system was punching the floor and roof rather than the cribs disintegrating. At last observation, 50 to 100 ft behind the face, the punching SFC cribs had not yet destroyed the integrity of the roof opposite the cribs, although the roof supported with wood cribs between SFC crib locations was disintegrating into small debris. It was also clear that the wood crib system with steel beams and yielding arches was about to close the tube from above because ground movement was continuing at 130 ft behind the face. At least a continuous solid SFC crib wall with tube would have been needed in that location to provide enough bearing surface to reduce the punching, prevent disintegration of roof between individual cribs, and control the small-coal debris from the chain pillar. The SFC design stiffness and strength range were good for all applications except this one; a demonstration with more bearing surface is needed for application 2.
