Bureau of Mines Report of Investigations/1983

Concrete Crib Design and Field Testing

By T. W. Smelser and L. N. Henton

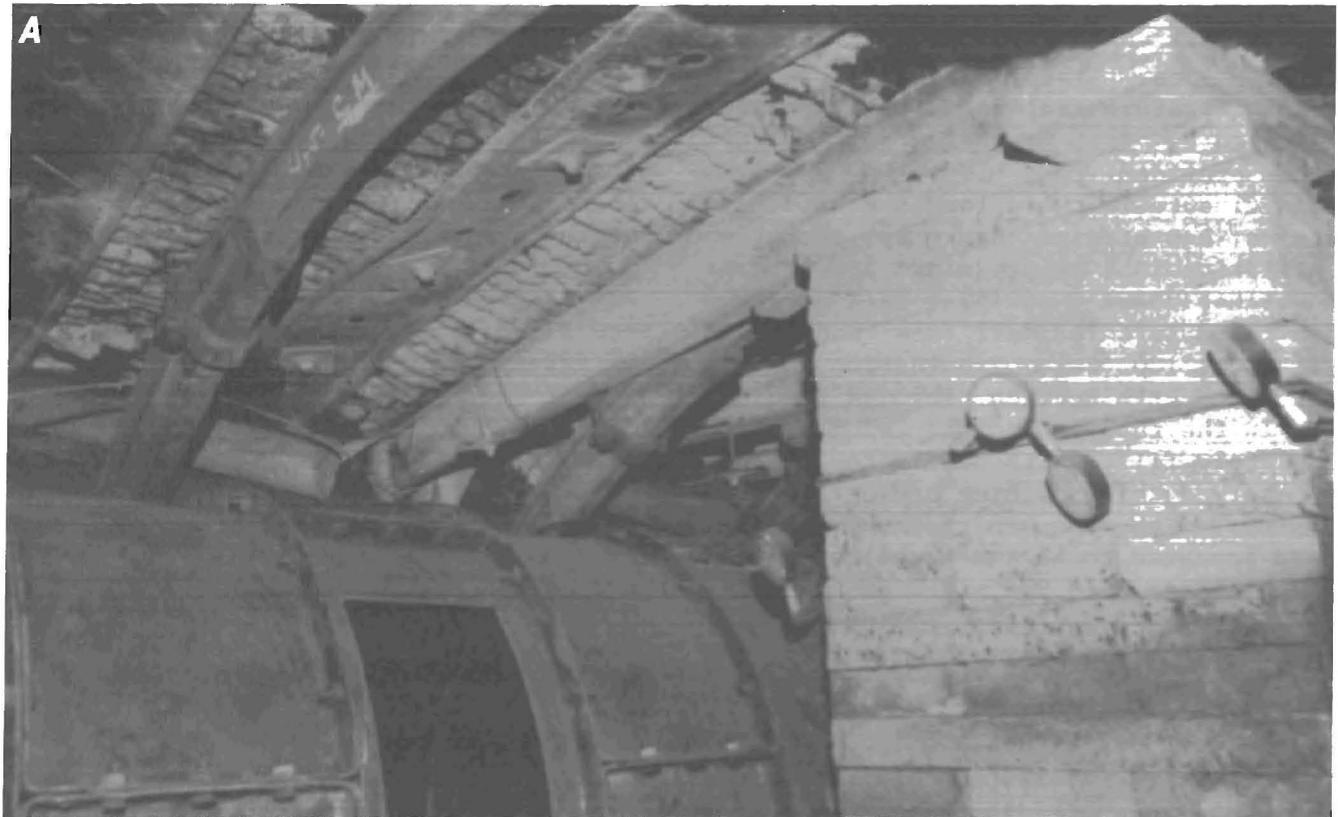
FIGURE 15. - Panel 8 left second demonstration. *A*, Instrumented SFC crib near tube access door; *B*, SFC cribs sometimes under steel beams and arches.

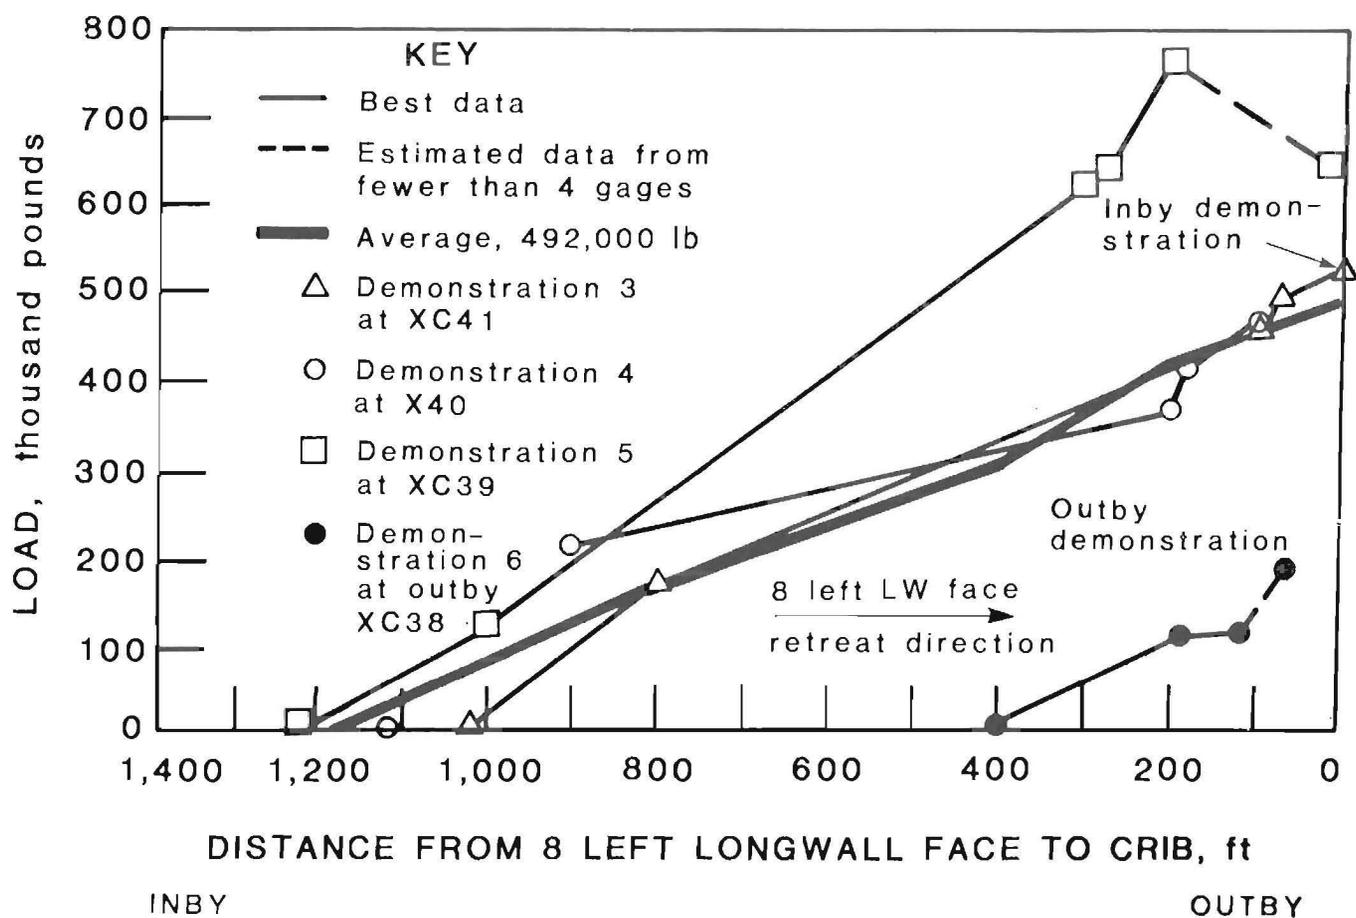
FIGURE 16. - Panel 8 left plots of four short intersection demonstrations and their average. Demonstrations 3, 4, 5, and 6 at crosscuts 41, 40, 39, and 38.

As shown in figure 16, loading started at 1,000 ft or more before the 8 left longwall face arrived at the instrumentation. The load is generally proportional to distance between the longwall face and the crib support in all four demonstrations, with an increasing load of about 430 lb/lin ft of retreat. This represents a 0.5-psi pressure increase per foot of retreat for each crib bearing surface. The average of the four intersections was 492,000 lb per crib when all were projected to zero distance. This was nearly equal to the crib load at the third demonstration, crosscut 41, which was actually measured at zero distance. The crosscut 41 load was 524,000 lb of total crib load, 580 psi of bearing surface, or 87,000 lb/lin ft of entry.

be more satisfactorily supported with the SFC cribs than the average intersection was supported with wood cribs. As the face approached crosscut 41, the wood-supported section between crosscut 42 and crosscut 41 was closing such that several steel beams in the area were on the top of the tube. A new row of wood cribs that was added on the gob side had already crushed and deformed ahead of the face, so that travel between the two rows of wood cribs was no longer possible. Travel to the face was only possible through the tube. The wood crib section between crosscut 42 and crosscut 41 offered marginal support at best. Superior results at the four short intersection demonstrations were similar to the superior results at demonstration 2.

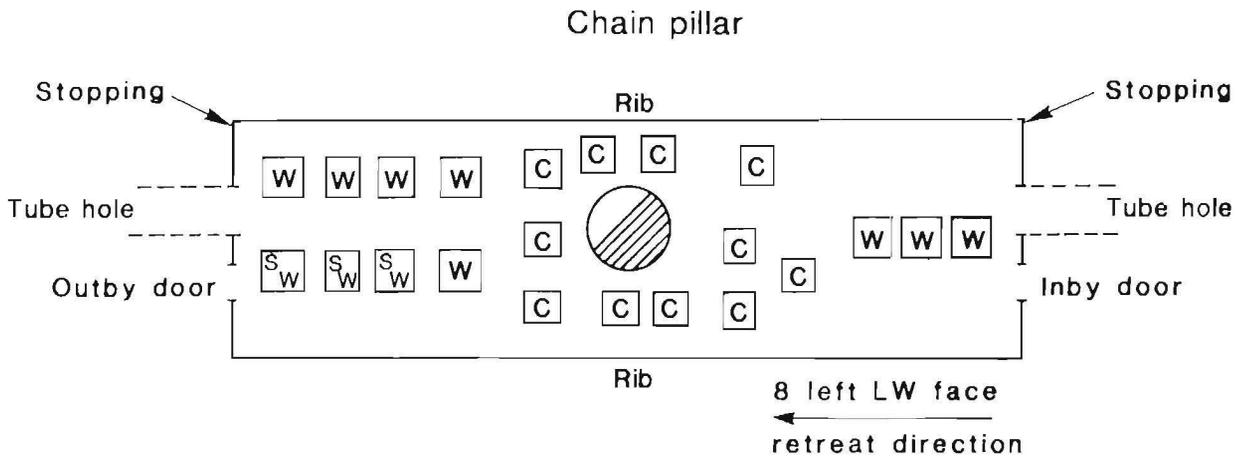
FIGURE 17. - Panel 8 left demonstration 7-layout installed.

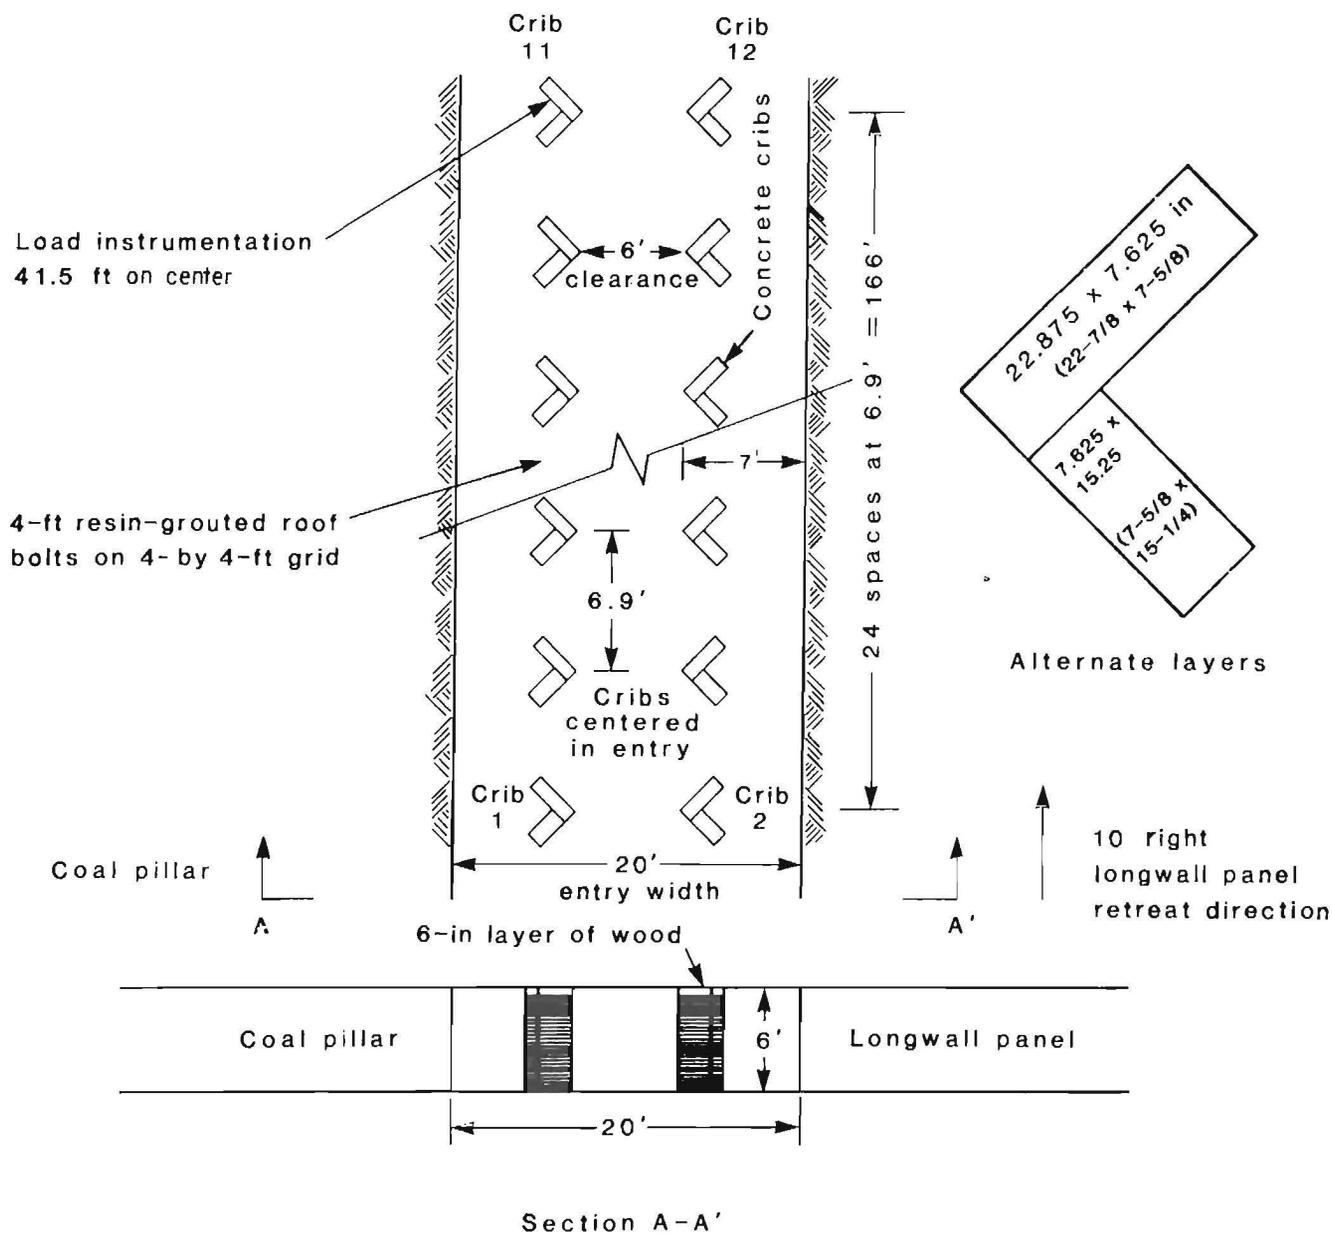
FIGURE 18. - Panel 10 right demonstration layout plan.

At the time of strain-gage installation on the SFC cribs, the 9 right longwall face was 70 ft in by the first pair of SFC cribs. Figure 18 shows the demonstration layout of SFC cribs.

Twenty-five pairs of cribs on 6.9-ft centers along the entry, with 6 ft of clearance across the entry, made up the system. Cribs were built L-shaped with the point toward the center of the entry. The SFC cribs were placed between previously installed open wood cribs. The blocking at the top of the wood cribs was removed after the SFC cribs were finished and instrumented with strain gages.

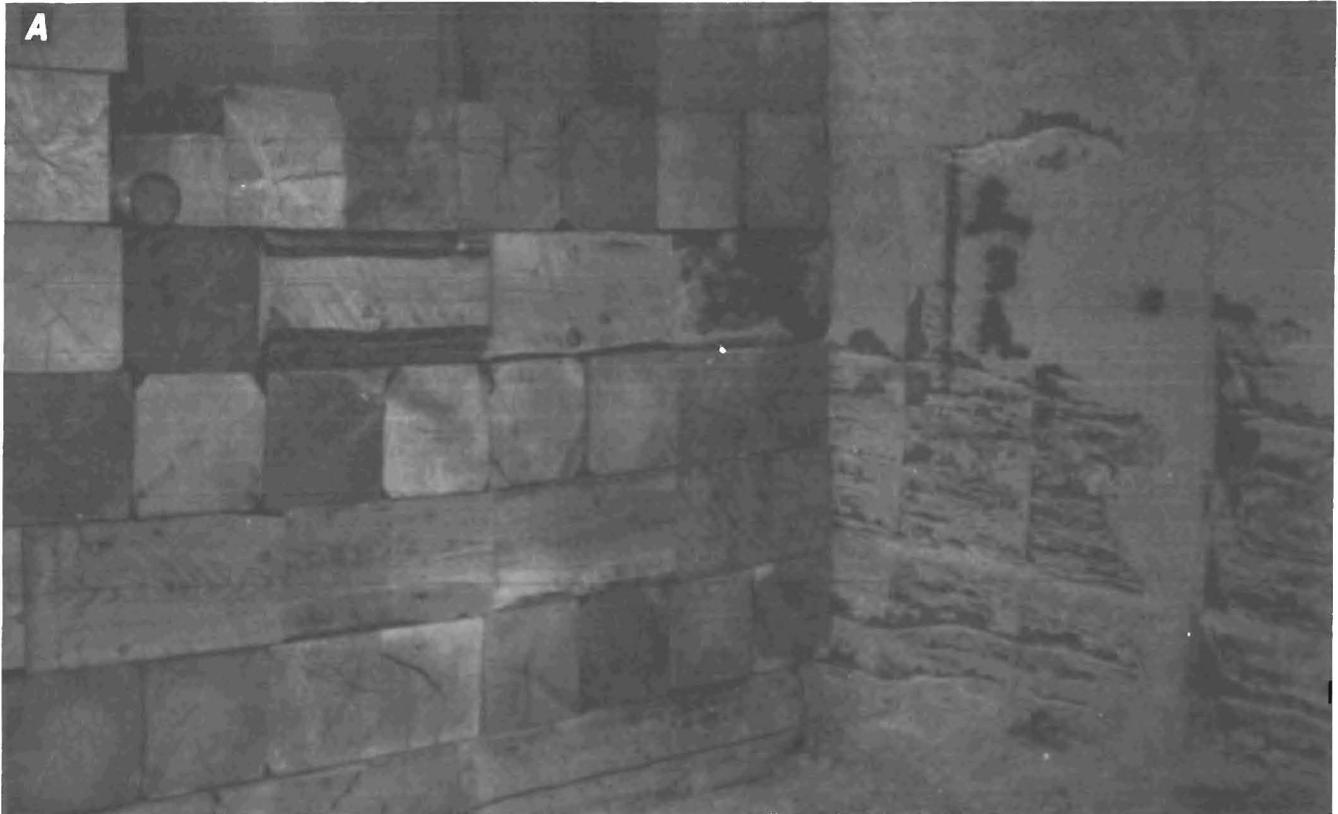
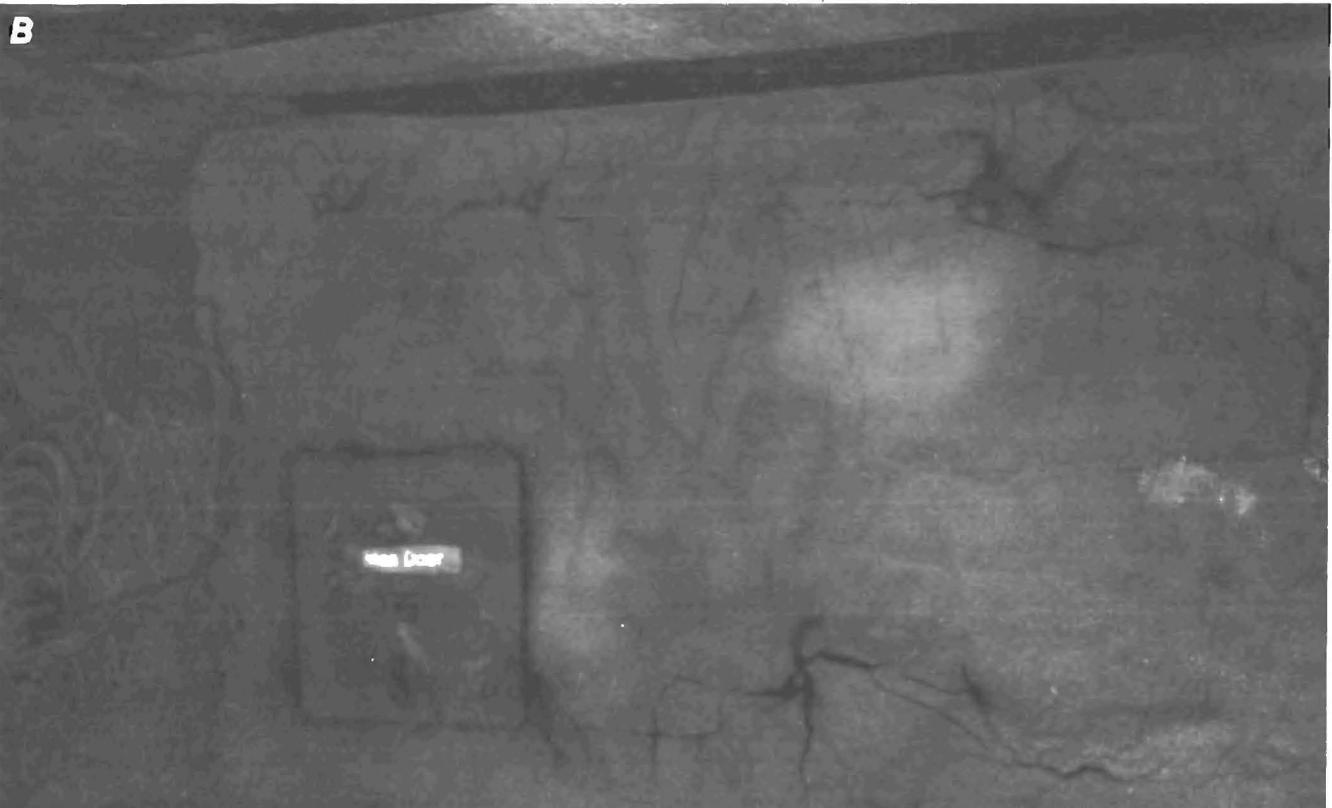
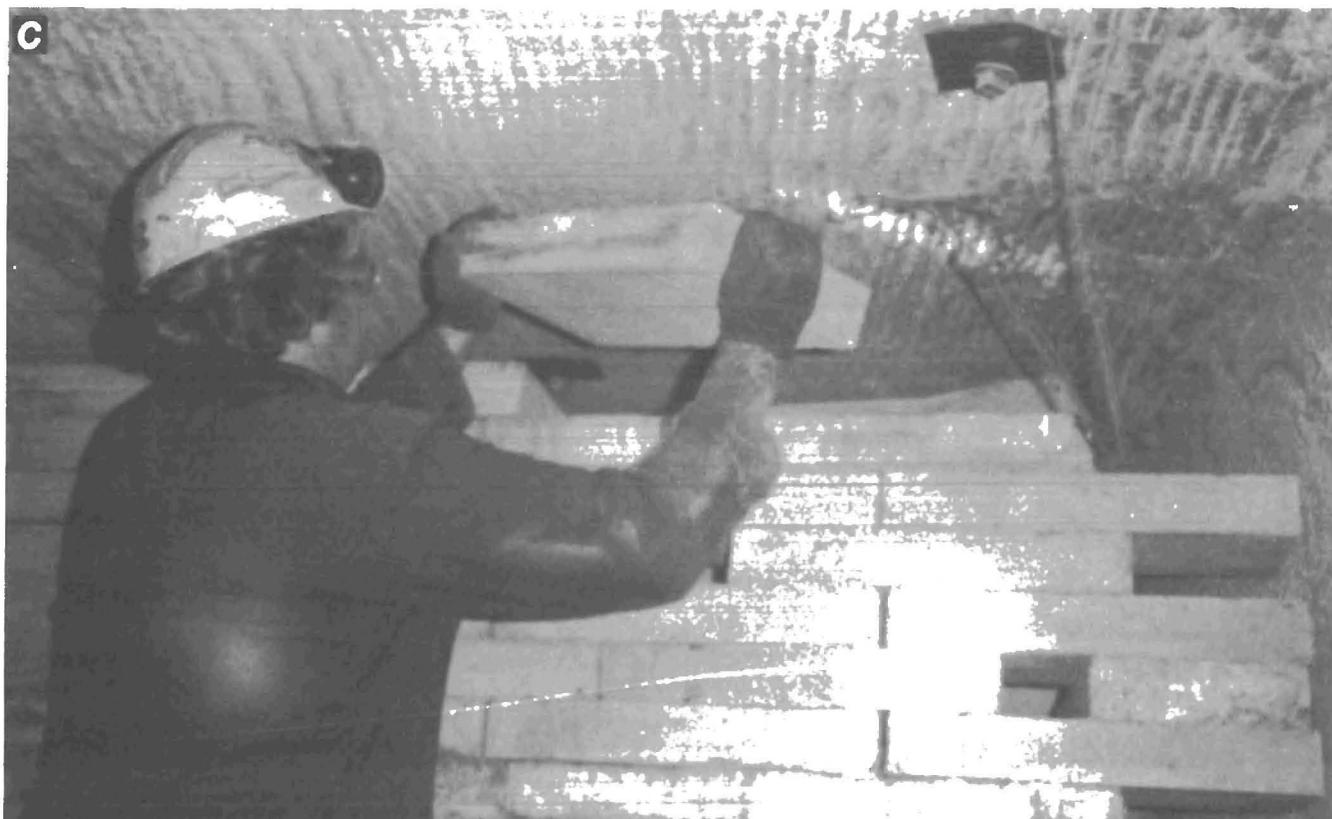
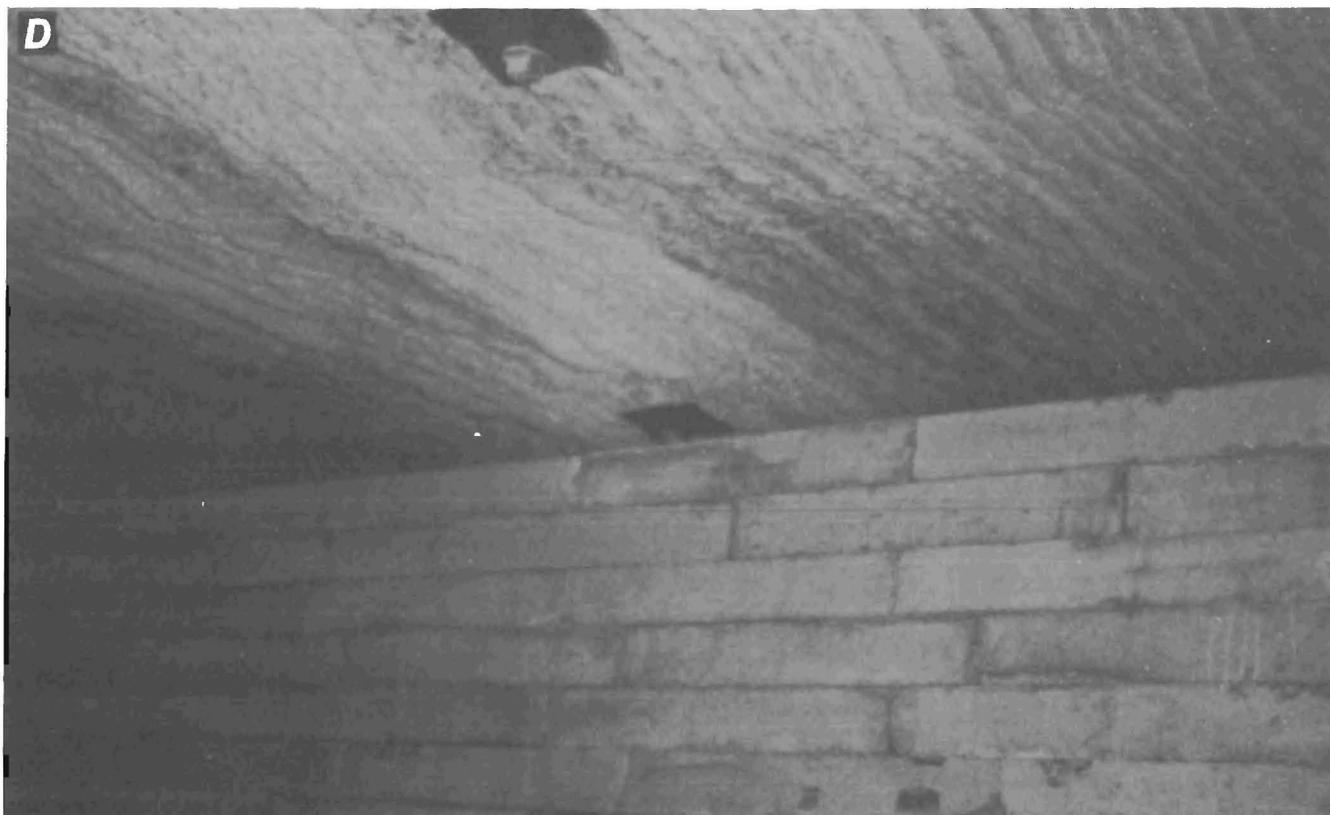
FIGURE 19. - Permanent stopping. *A*, Present wood block construction; *B*, cracks in air seal of wood construction.

FIGURE 19. - Permanent stopping—Continued. *C*, Design 2 stopping construction; *D*, design 2 stopping wedged at top with a minimum amount of wood, later sealed.

Because installation was in an area of the mine with little roof loading, proof of favorable results will require several years at least. See figures 19A to 19D for construction of the present wood stoppings, cracking of the seal on the wood stoppings, and construction of the design 2 SFC member stopping.

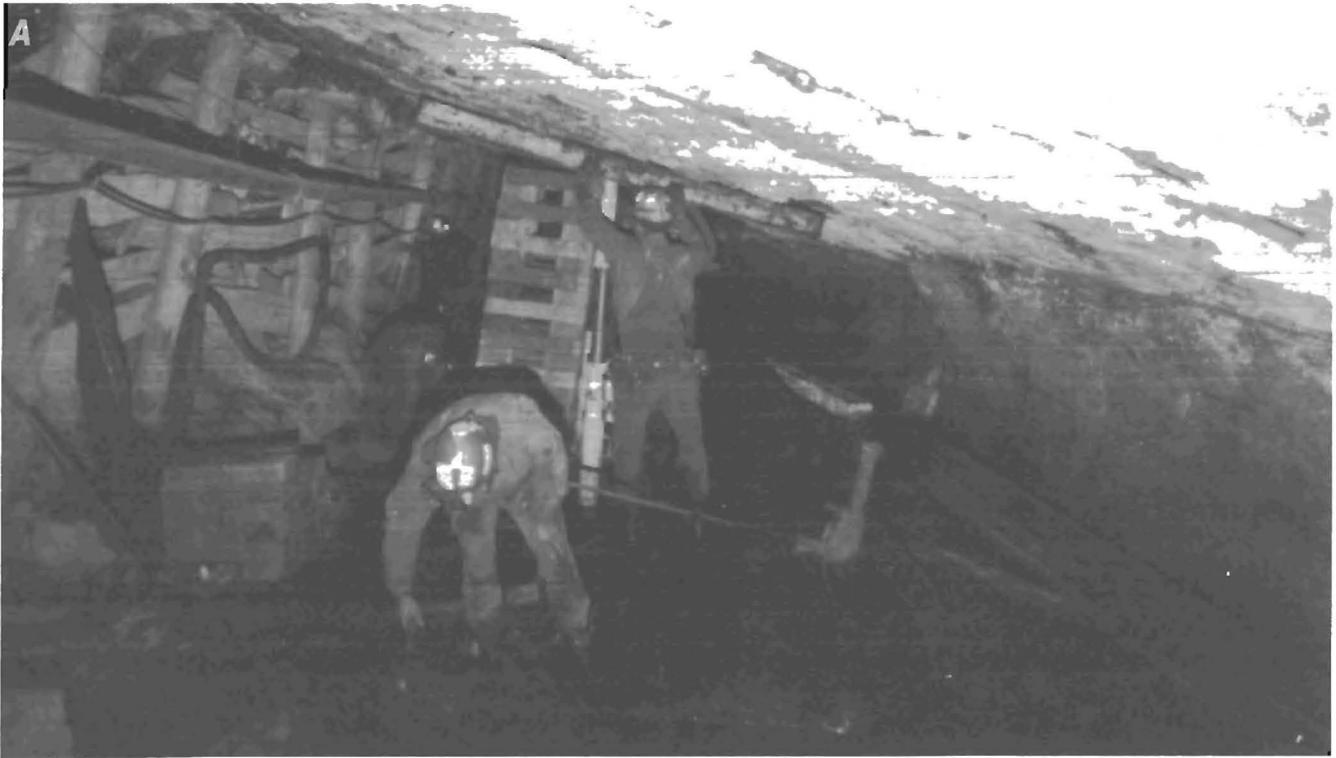
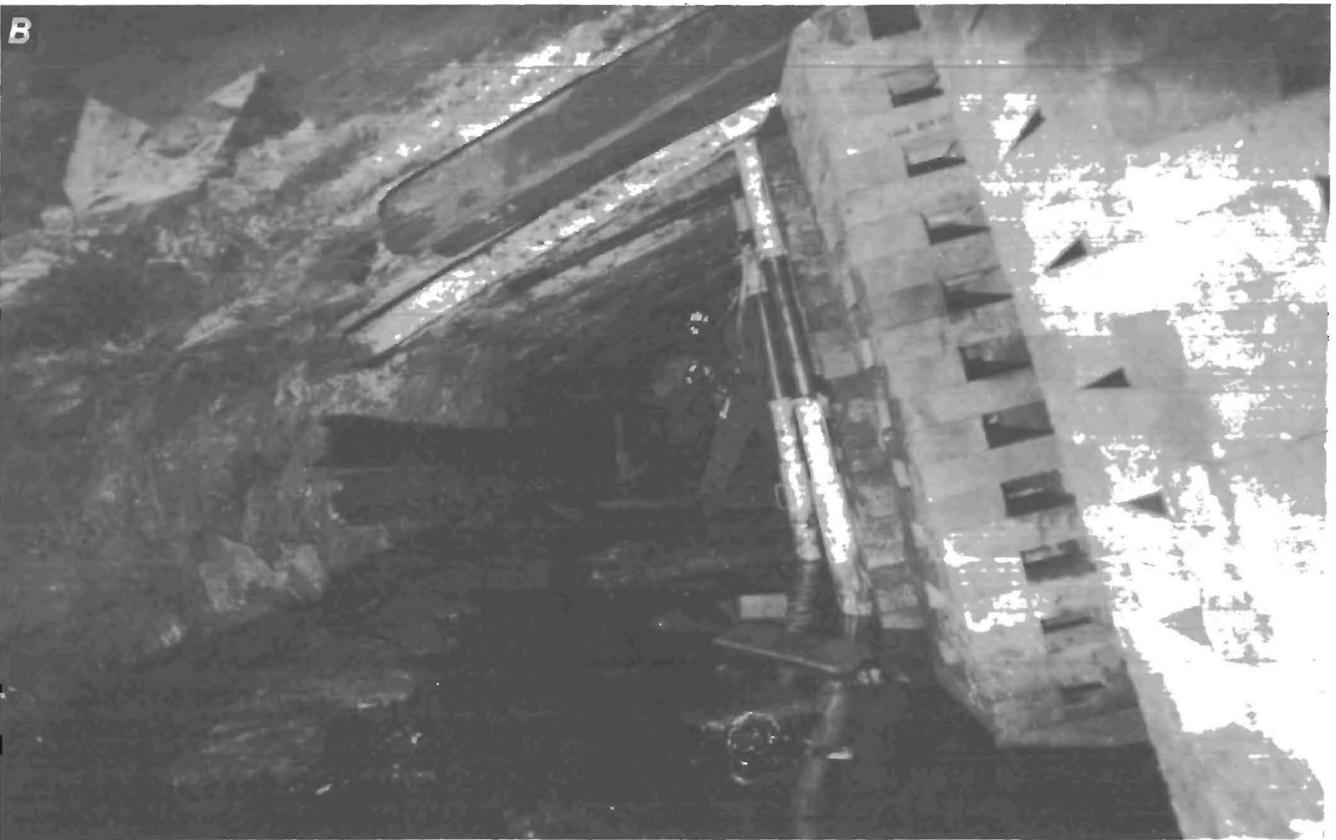
FIGURE 20. - Thompson Creek No. 1 Mine, underground construction of design 3 SFC cribs *A*, Looking to inby of panel 1-2 tailgate; *B*, looking to outby of panel 1-2 tailgate.

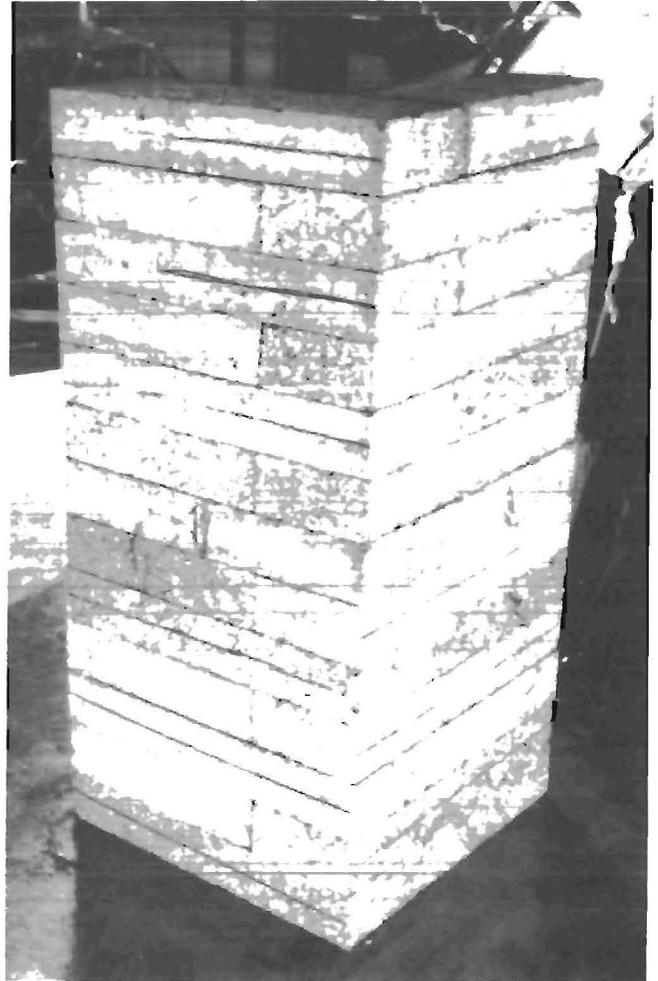
FIGURE 21. - Design 3 SFC members.
