**RI 9231**

# In Situ Measurements and Preliminary Design Analysis for Deep Mine Shafts in Highly Stressed Rock

By M. P. Board and M. J. Beus

BUREAU OF MINES

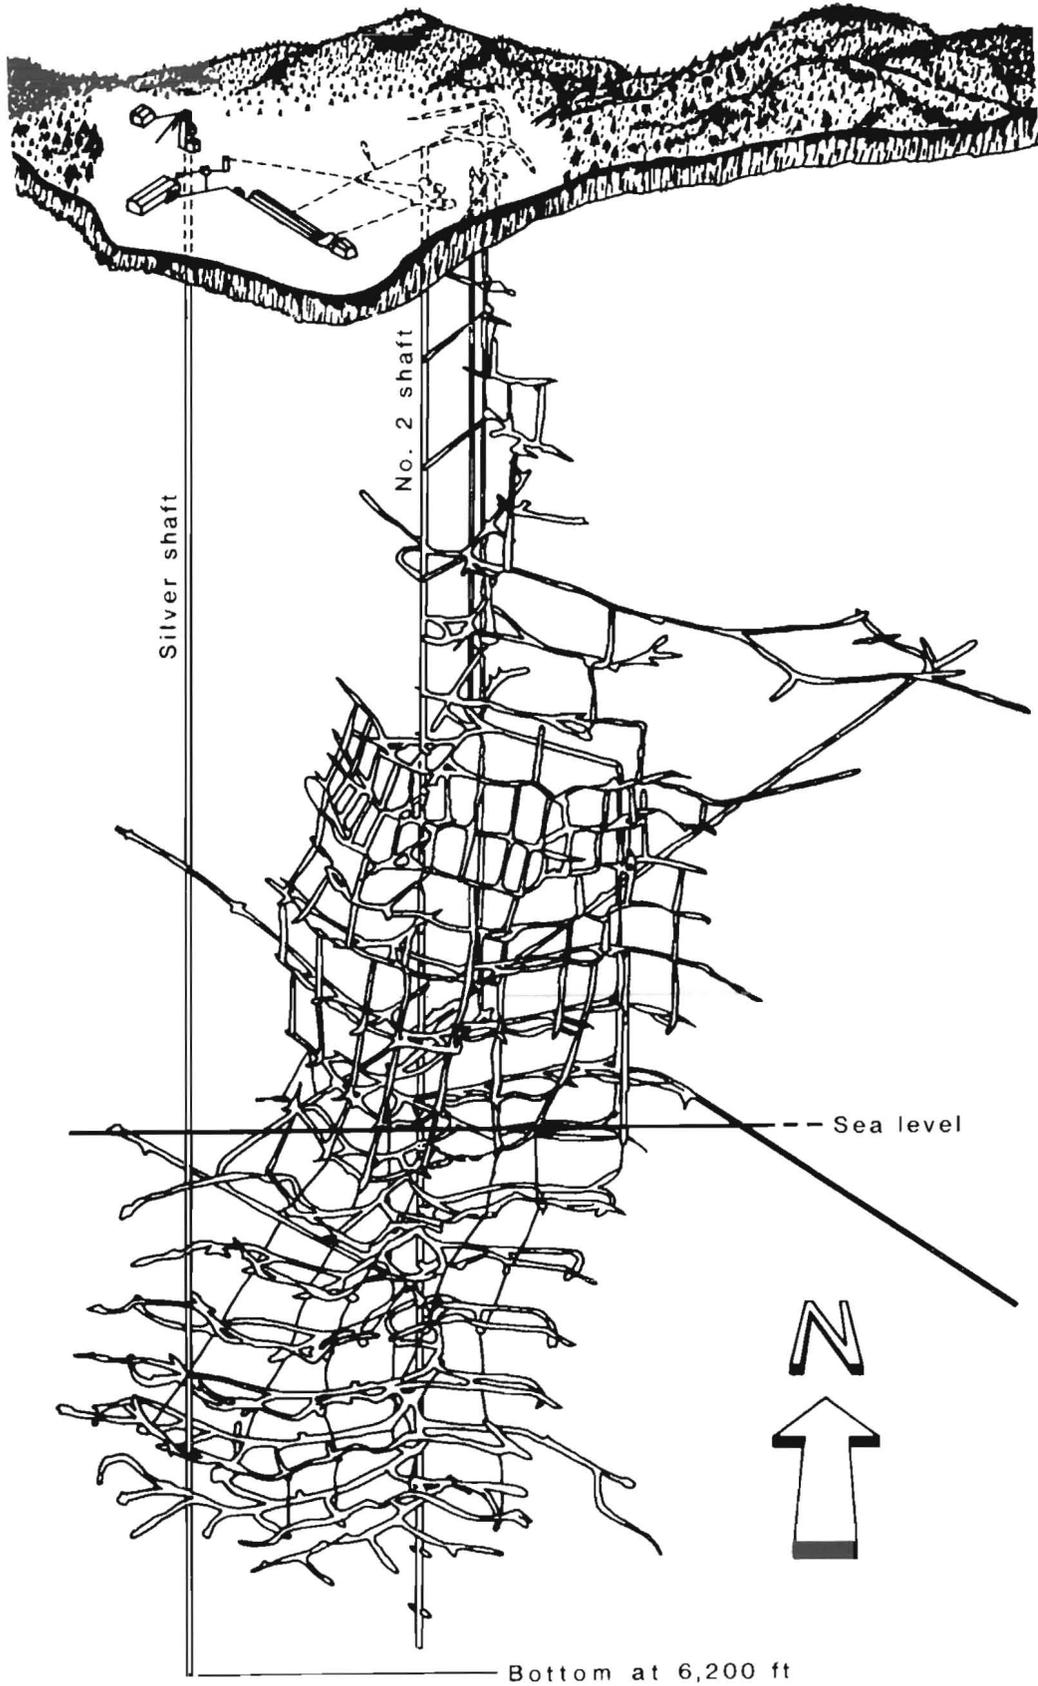
Figure 2.—Lucky Friday Mine and existing shafts and workings.

Three significant geologic features that can have significant effects on the mechanical response of the rock mass are evident in the shaft: (1) Distinct, continuous bedding surfaces, (2) two sets of semicontinuous cross joints, and (3) shear zones that may or may not be conformable with bedding surfaces. The bedding represents a distinct set of parallel, continuous features. The spacing of the bedding planes averages about 0.5 to 1.5 ft at all horizons, with occasional thick (2 ft) or very thin (<6 in) beds. The strike of the bedding is consistent from level to level, averaging N 40° to 60° W with dips varying from about 60° to 80° SW. The bedding planes are cut by two sets of semicontinuous cross joints, which create a blocky appearance of the shaft walls. The first set strikes approximately S 70° to 90° W, dipping at 60° to 70° N, and has a spacing of about 6 in and a mean length of 10 to 20 in. The second set strikes 0° to 10° W, dipping 60° E to 80° W, and has similar spacing and length. Thus, there are three distinct discontinuities; however, only bedding is continuous over extended lengths.

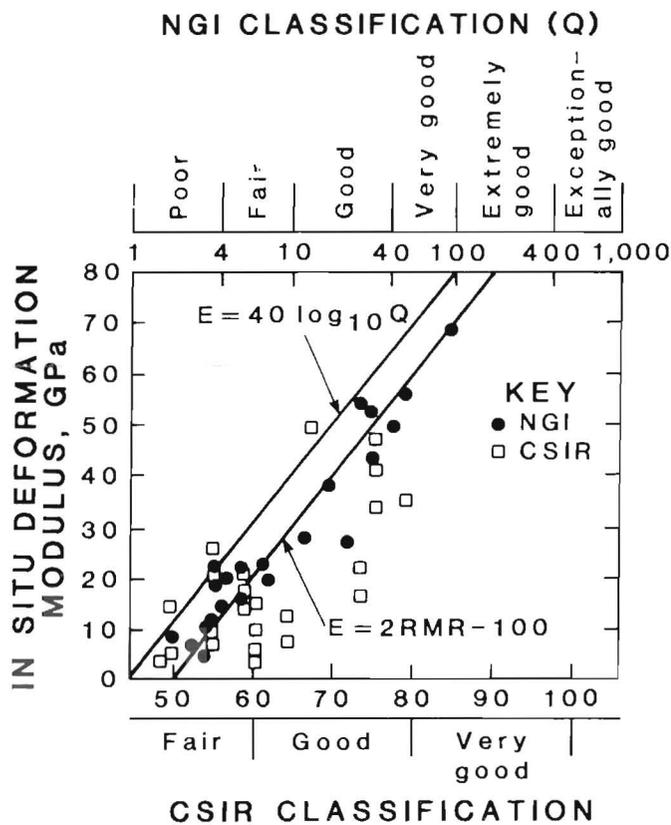
Figure 3.—Estimation of in situ modulus of deformation from Norwegian Geotechnical Institute (NGI) and Council for Scientific and Industrial Research (CSIR) classification methods.

A rock mass classification was performed at each level as a means of estimating the engineering properties. The in situ deformation modulus was estimated with the NGI Q-system. The relation of the Q-value as well as the Council for Scientific and Industrial Research (CSIR) rock mass rating (RMR) system (5) to deformation modulus is shown in figure 3. The Q-classification is estimated from the rock quality designation (RQD), number of joint sets, the ratio of rock stress to strength, and the degree of weathering of the weakest set. In this case, the Q-value ranges from approximately 2 for the argillitic zone of thin beds to 10 to 15 for the massive quartzites. The modulus of deformation estimates for the rock mass vary distinctly with orientation because of the direction and intensity of jointing. The estimated values are summarized in table 1. These values reflect the orientation and distribution of fractures in directions perpendicular and parallel to the bedding structure. Further detail on each classification, Q-ratings, level geology, and rock strength is presented in appendix A.

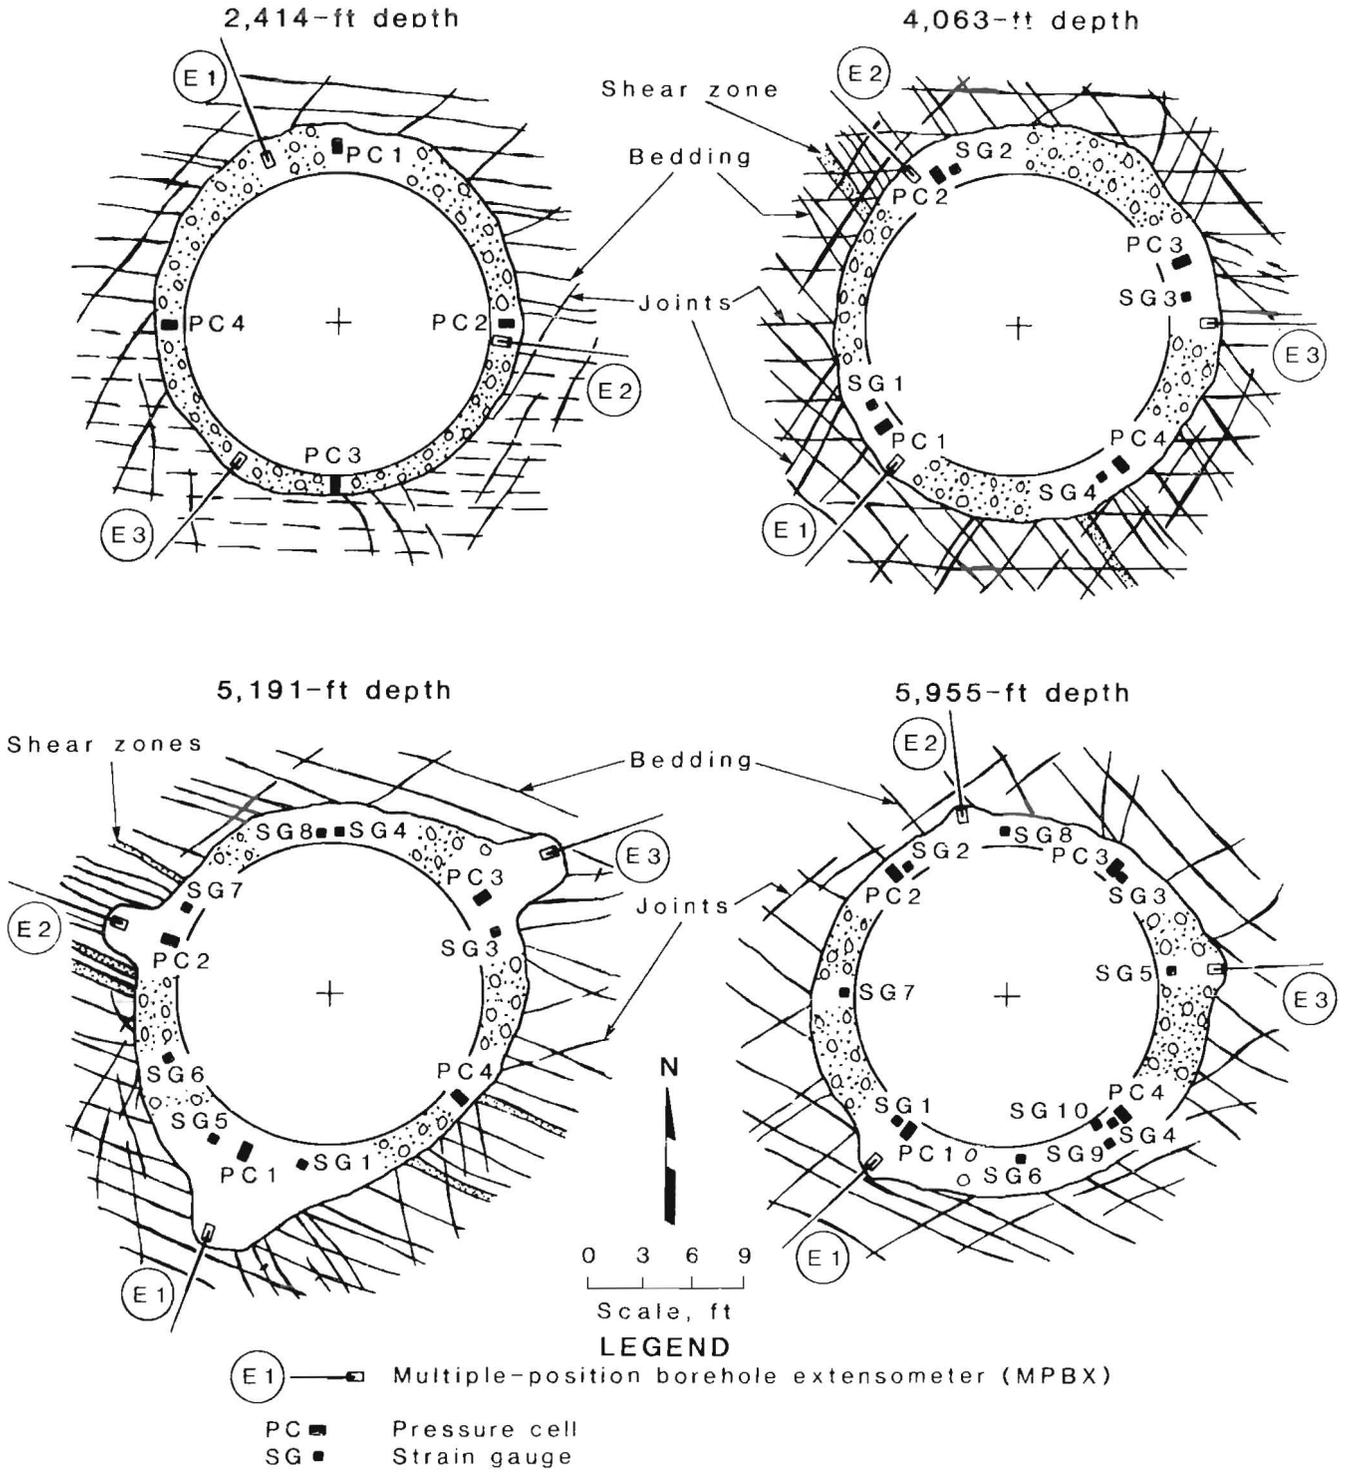
Figure 4.—Shaft test sites and instrument location, orientation, and rock profile.

Strain in the liner was monitored with the concrete embedment SG's used at the 4,063-, 5,191-, and 5,955-ft-depth test sites. They were placed at 45° intervals and were oriented to measure tangential strain. Thermistors were also installed at the 2,414- and 4,063-ft-depth sites to determine the temperature distribution in the concrete and rock (see appendix B).

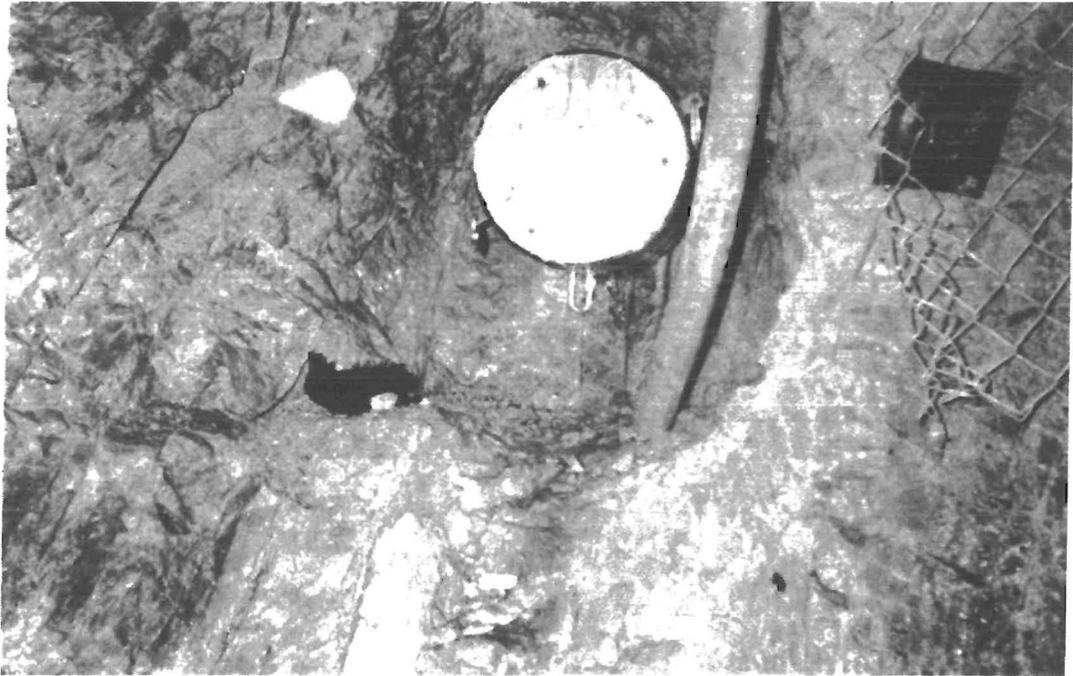
Figure 5.—MPBX E2 instrument head recessed flush with shaft wall.

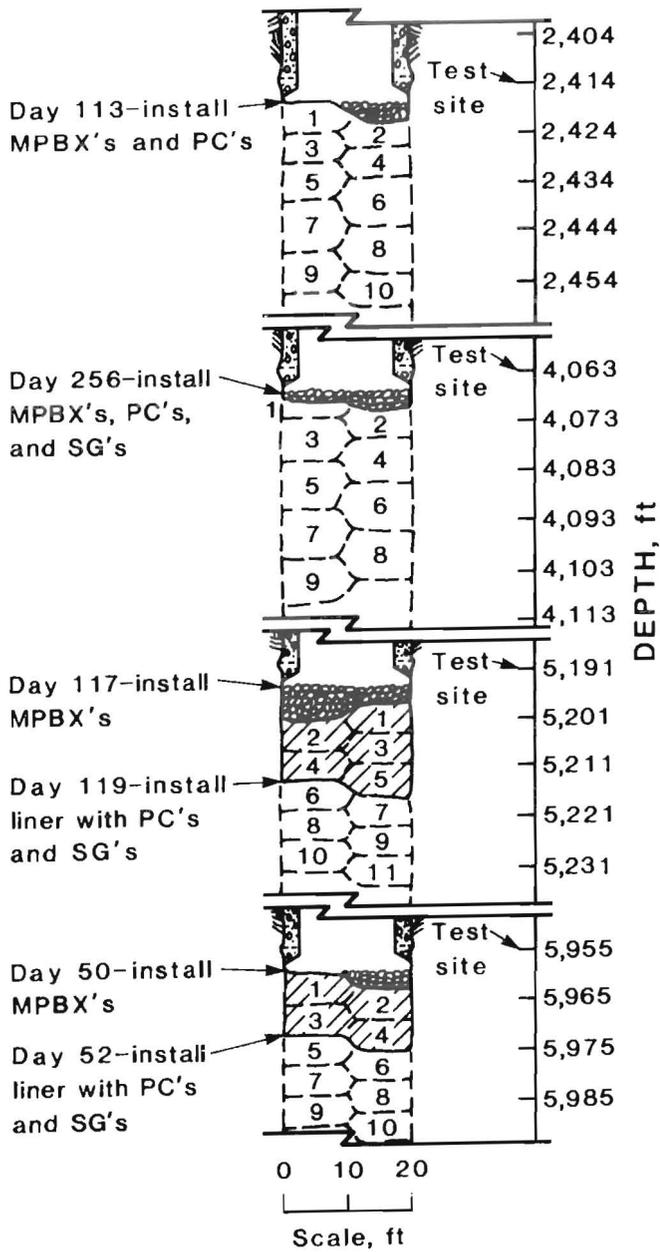
Figure 6.—Vertical profile of four test sites and installation and excavation schedule.

the same shaft depth once the concrete forms reached that level. Figure 6 shows a section through the shaft and the four test sites. Table 3 summarizes these installation activities and the time required for each installation.

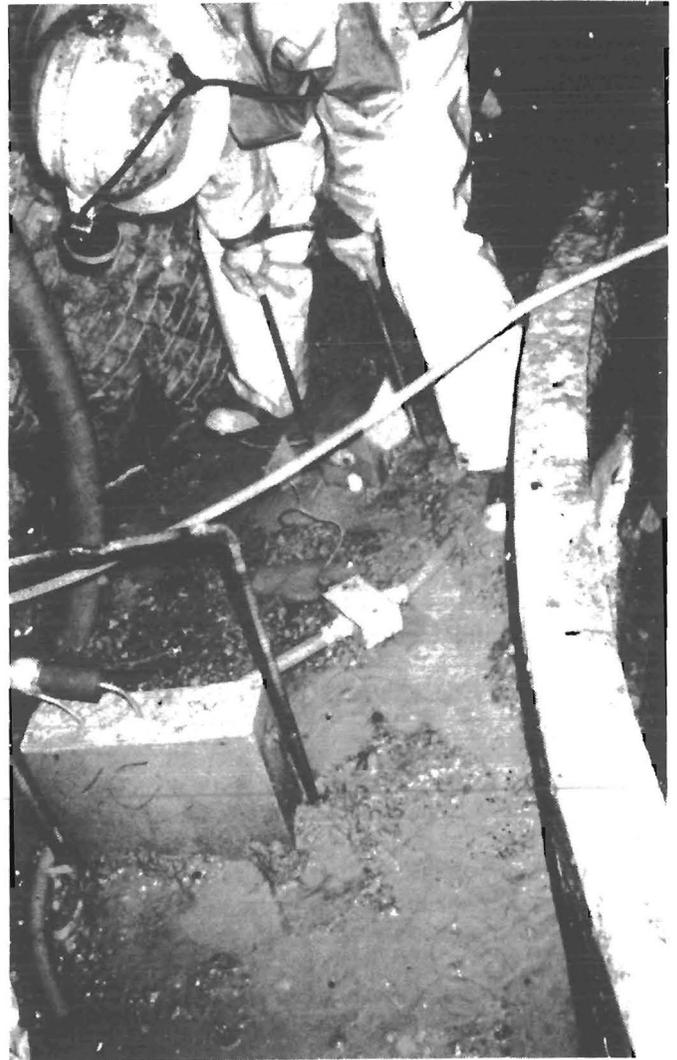
Figure 7.—Pressure cell and strain gauge briquettes being installed in kerb ring.

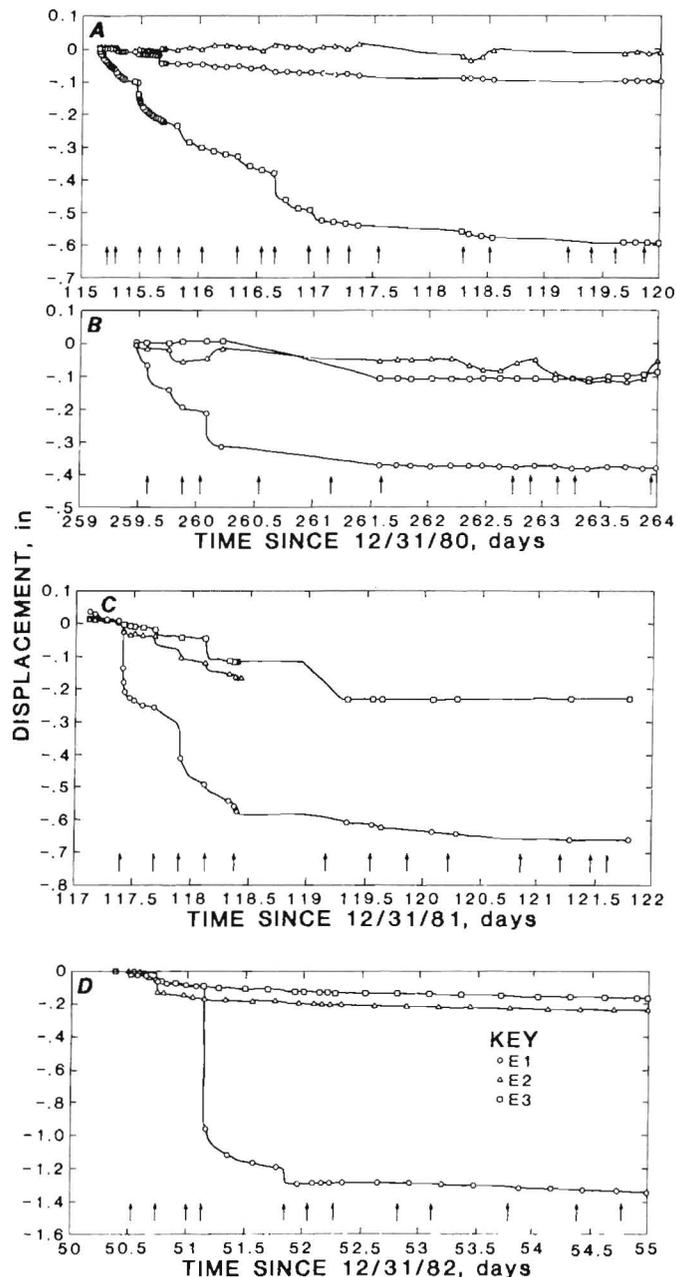
Figure 8.—Shaft wall displacements measured by MPBX E-1-E-3 over initial 5-day interval. A, 2,414-ft depth; B, 4,063-ft depth; C, 5,191-ft depth; D, 5,955-ft depth.

The maximum displacement on all instruments was measured at the collar of the borehole on the shaft wall. At the 2,414- and 4,063-ft-depth sites, where the MPBX heads were located in the concrete liner, the indicated movement was actually less than that shown by the shallow anchors located in the rock. Figure 8 shows 5-day shaft wall displacements over a specific interval of elapsed time at each test site for each MPBX location, during which face advance was equivalent to approximately two to three shaft diameters. The exact blasting times are indicated by arrows. Appendix D lists the actual blast schedule for each test site. With the exception of the 2,414-ft depth, the orientation of the MPBX's to bedding followed a consistent pattern, i.e., E1-normal, E2-parallel, and E3-45°. At the 2,414-ft depth, the instruments were located 120° apart, with one parallel (E2) and two at 45° (E1 and E3) to the bedding strike.

Displacement normal to bedding was several times greater than that measured 45° or parallel to the bedding. The ratio of maximum to minimum shaft wall displacement is 6:1 at the 2,414- and 5,955-ft depths and 3:1 at the other two depths. The high ratio at the 2,414- and 5,955-ft depths is probably the result of shear zones that crossed the MPBX holes at locations near the shaft wall (see appendix A for details).

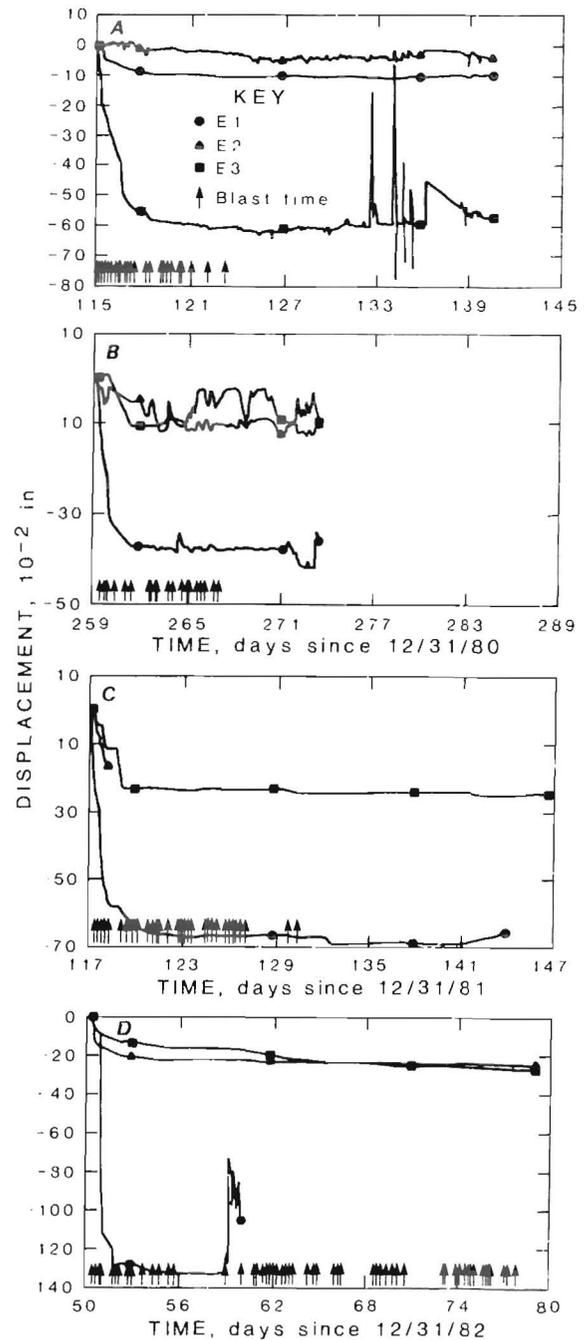
Figure 9.—Shaft wall displacements for 30 days' elapsed time. A, 2,414-ft depth; B, 4,063-ft depth; C, 5,191-ft depth; D, 5,955-ft depth.

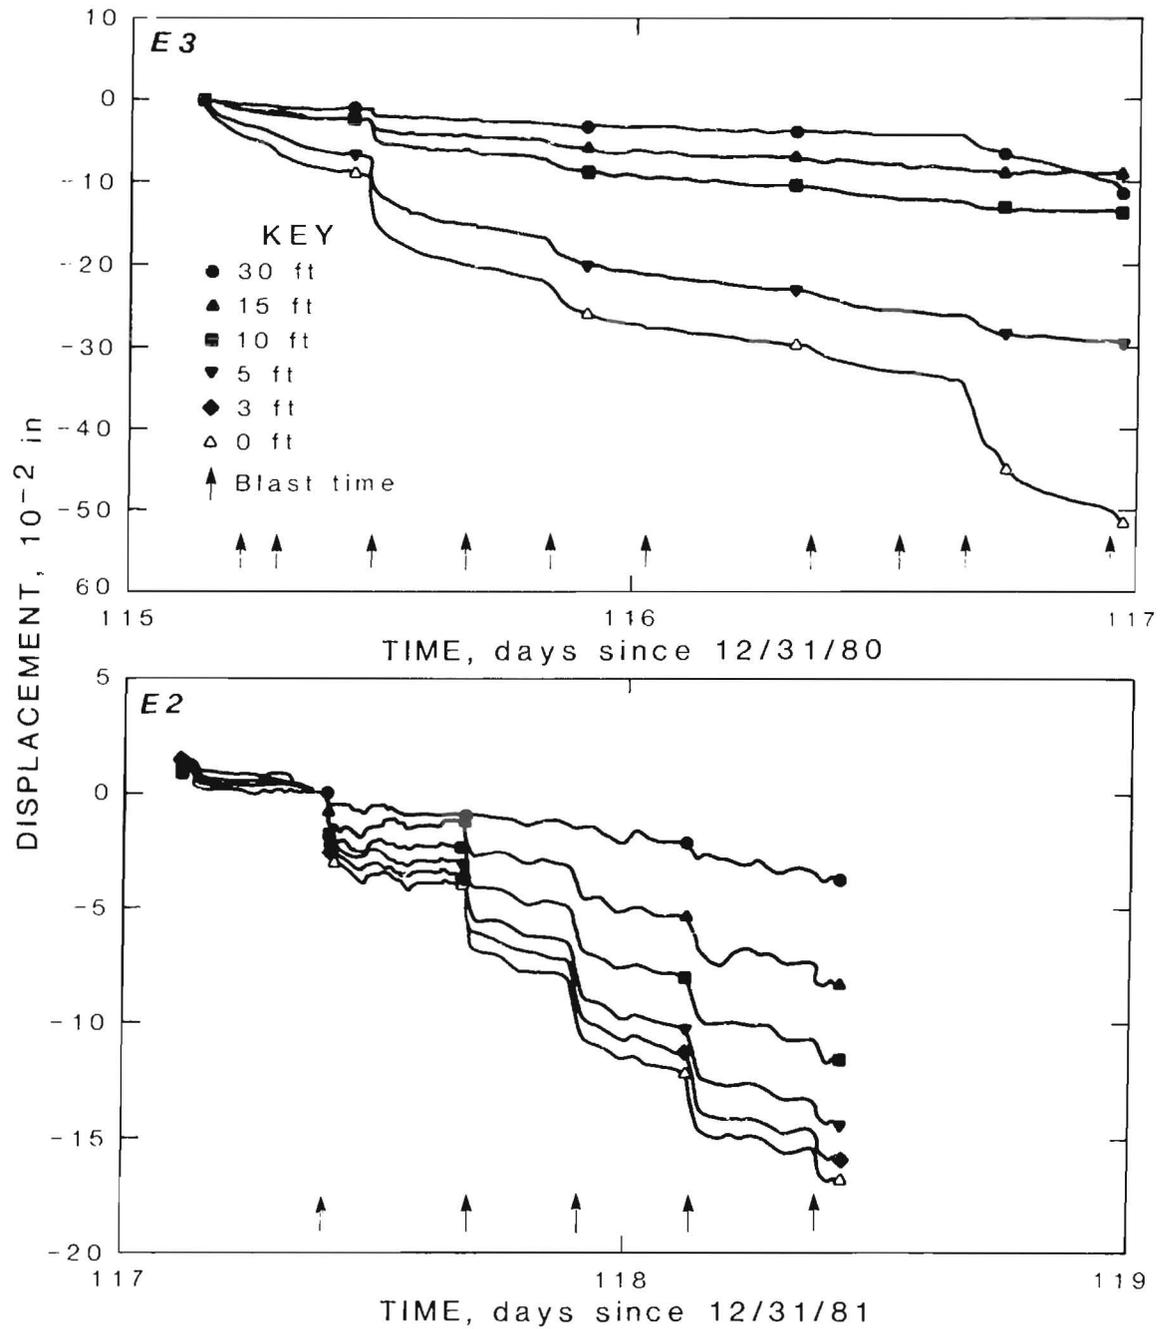
Figure 10.—Typical response characteristics at indicated hole depth for MPBX E3 at 2,414 ft for the first 10 blasts and MPBX E2 at 5,191 ft for the first 5 blasts.

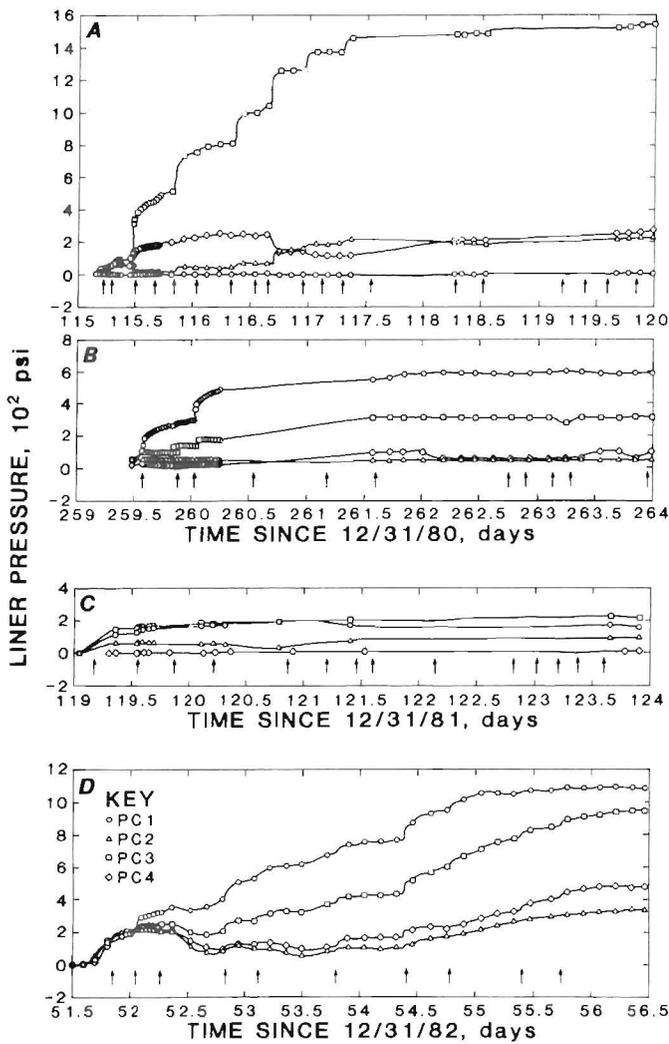
Figure 11.—Liner pressure developed over 5-day interval following installation. A, 2,414-ft depth; B, 4,063-ft depth; C, 5,191 ft depth; D, 5,955-ft depth.

The PC's and SG's were oriented to measure tangential stress near the neutral axis of the unreinforced liner. This location in the liner was selected to minimize the effects of liner bending on the measured stress. Figures 11 and 12 show the 5-day responses of the PC's and SG's, respectively. Times of individual blasts again are indicated

by arrows. For the 2,414- and 4,063-ft levels, the liner was installed to the shaft bottom. On the 5,191- and 5,955-ft levels, the liner was installed in the normal fashion, 18 to 20 ft above the shaft bottom. As with the movement of the shaft wall rock (as indicated by the MPBX's), the PC's and SG's indicated discrete jumps at each blast. In addition, there was a significant creep component between blasts, due largely to curing of the concrete, particularly during the first 24 h following installation.

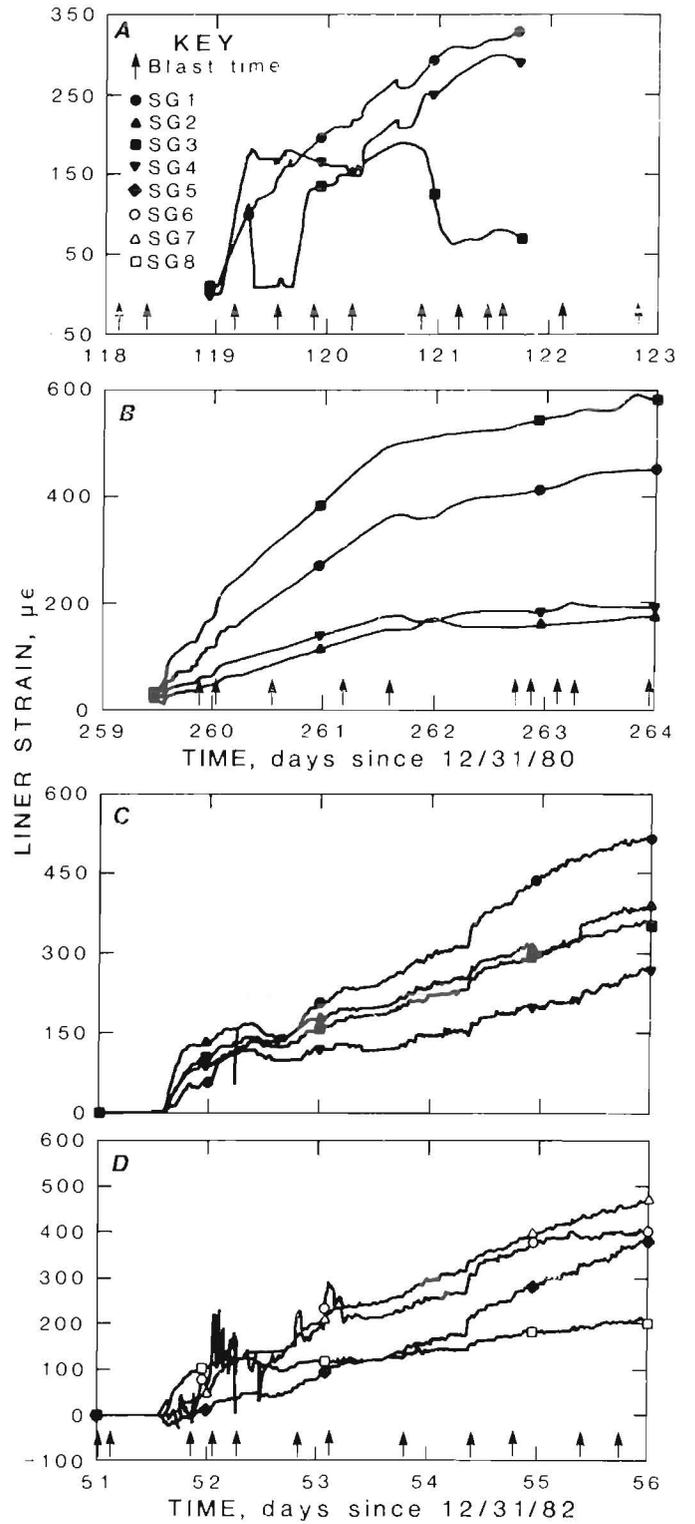
Figure 12.—Liner strain developed over 5-day interval following installation. A, 4,063-ft depth; B, 5,191-ft depth; C-D, 5,955-ft depth.

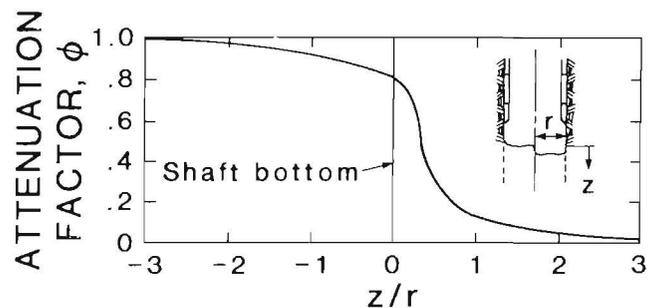
Figure 13.—Effects of support delay showing attenuation factor  $\phi$ , the factor used to reduce calculated values so they agree with measured values, as a function of ratio between measurement distance above shaft bottom  $z$  and shaft radius  $r$ .

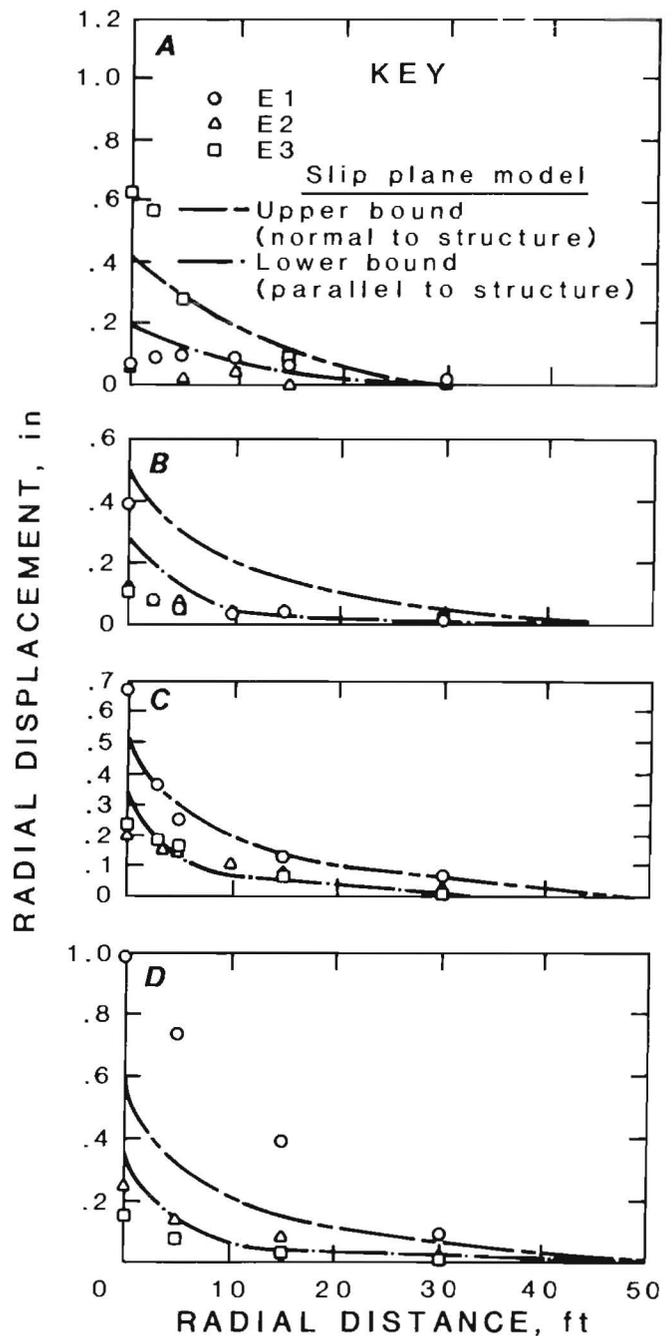
Figure 14.—Measured versus calculated radial displacement plotted as a function of radial distance for each MPBX location (E-1—E-3) at each site. A, 2,414-ft depth; B, 4,063-ft depth; C, 5,191-ft depth; D, 5,955-ft depth.

The model reasonably reproduces the measured data from all four sites. The model is able to produce the important feature of a large displacement contrast between the direction normal and parallel to structure. An approximately elastic response is seen at the parallel and 45° MPBX (E-2, E-3) locations.

The poorest correlation occurs at the collar anchors on the perpendicular MPBX's (E1) from the 2,414- and 5,955-ft depths and can be related to geologic conditions unique to both test sites. At the 2,414-ft depth, a conformable contact between a soft, thinly bedded argillite and a hard, medium-bedded quartzite roughly separate the northern and southern halves of the shaft. The collar of MPBX E3 was located in the soft argillite, which was unconsolidated enough to be removed fairly easily with a pickax. At the 5,955-ft depth, a clay gouge zone was encountered 2 ft into the hole at being drilled for MPBX E1. In both of these cases, the ratio of maximum (normal) to minimum (parallel and 45°) displacement was approximately 6:1, whereas it was about 3:1 at the 4,063- and 5,191-ft test site depths.

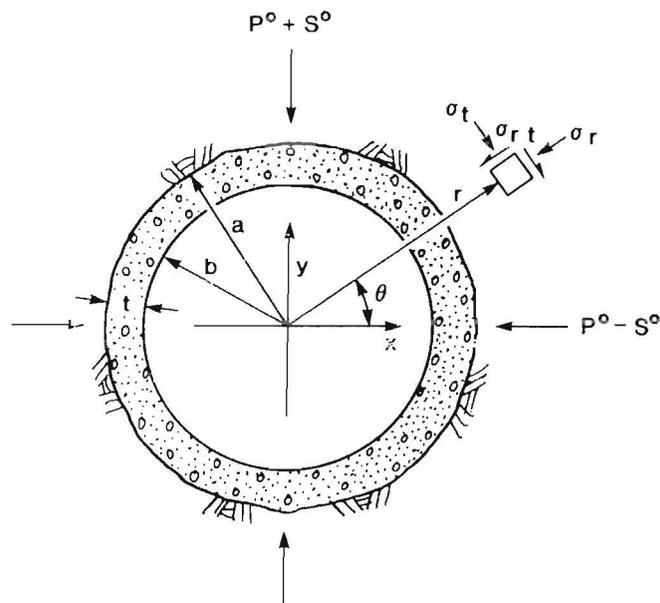
Figure 15.—Geometry of concrete liner modeled as a thick elastic ring embedded in elastic rock mass with no-slip interface.

The problem of a thick elastic ring embedded in an elastic rock mass with a no-slip interface was examined. The geometry of this problem is illustrated in figure 15. Excavation and support installation are assumed to occur simultaneously and rock reinforcement, such as a Split Set or grouted bolts, is not considered. The solution for liner tangential stresses is presented as a function consisting of components proportional to the hydrostatic,  $P^\circ$ , and deviatoric,  $S^\circ$ , stress components:

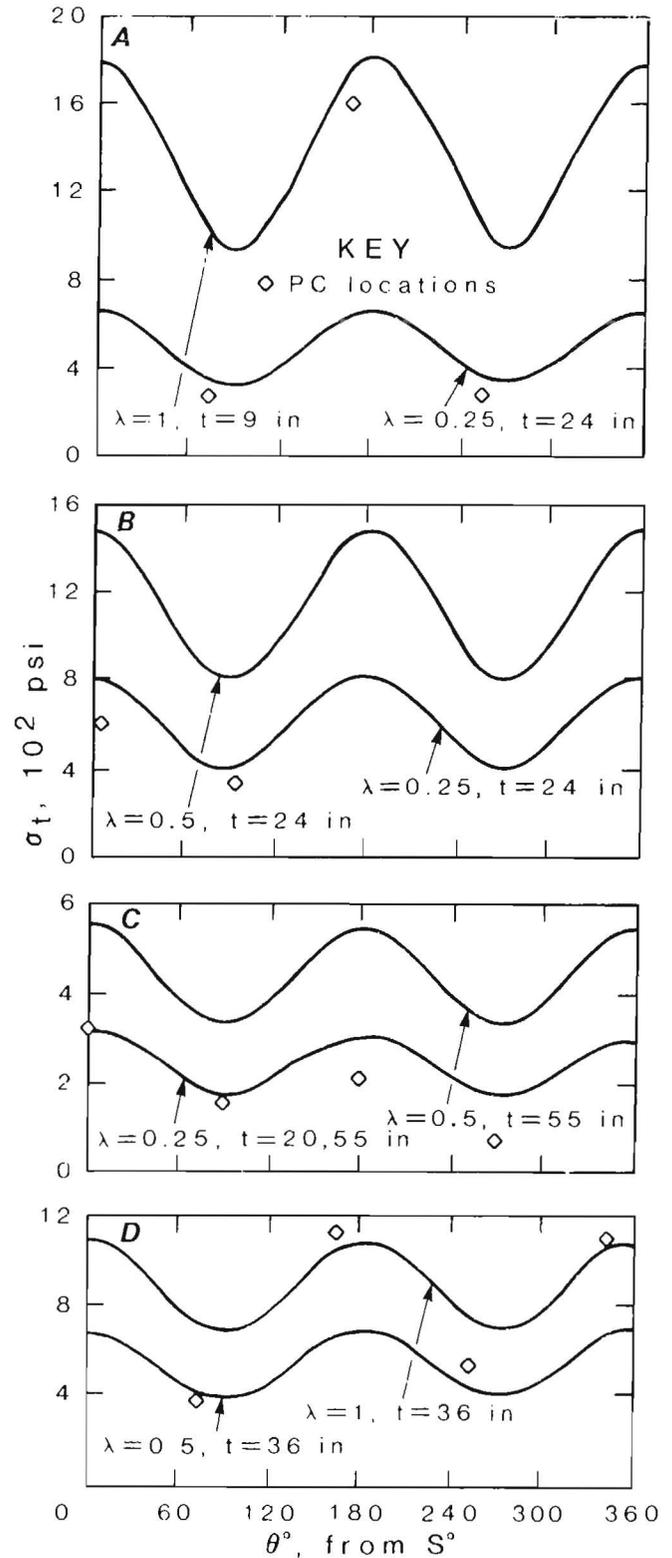
Figure 16.—Measured versus calculated tangential liner stress at each site (shear modulus ratio,  $\lambda$ ; liner thickness,  $t$ ). A, 2,414-ft depth; B, 4,063-ft depth; C, 5,191-ft depth; D, 5,955-ft depth.

A parameter study was conducted to compare measured tangential liner stress to stress calculated by equation 5. Two parameters have the most important effect on tangential stress: the shear modulus, ratio,  $\lambda$ , and the ratio of liner thickness to outer radius,  $t/a$  (table 4). The effects of the  $\lambda$  variation are fairly obvious; however, the parameters  $t$  and  $a$  can cause opposite variation in  $\sigma_t$ ; e.g., a

It is possible that nonuniform loading of the liner from rock mass structural variations resulted in larger induced stresses, as was previously shown (13). A larger component of deviatoric in situ stress would also result in more rapid change in the tangential component with angular distance around the shaft, but this would be expected on the basis of data from the other two test sites (4,063- and 5,191-ft depths) where a smooth variation was seen.

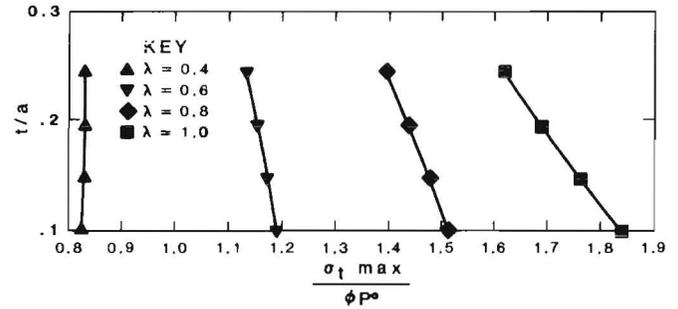
Figure 17.—Effect of normalized liner thickness  $t/a$  to normalized tangential stress  $\sigma_t(\max)/\phi P^\circ$  for various shear modulus ratios ( $\lambda$ ).

The primary design criteria of interest are (1) what minimum nominal liner thickness can be used and (2) how far behind the face can the liner be carried while maintaining a reasonable factor of safety against liner failure. A parameter study was conducted using the solution of equation 5 and various values of support delay, liner thickness, and concrete-to-rock mass shear modulus ratio ( $\lambda$ ). A general plot illustrating the relation of  $t/a$  to the normalized average tangential stress at its maximum position ( $\sigma_t(\max)/\phi P^\circ$ ) for various values of the shear modulus ratio is given in figure 17. For a given hydrostatic stress component,  $P^\circ$ , support delay factor,  $\phi$  (from fig. 13), and shear modulus ratio,  $\lambda$ , the required liner thickness can be calculated. Thus, for general design purposes, the value of  $\sigma_t(\max)$  can be calculated and compared to the concrete liner strength (assuming that no tensile stress exists) with any desirable factor of safety.

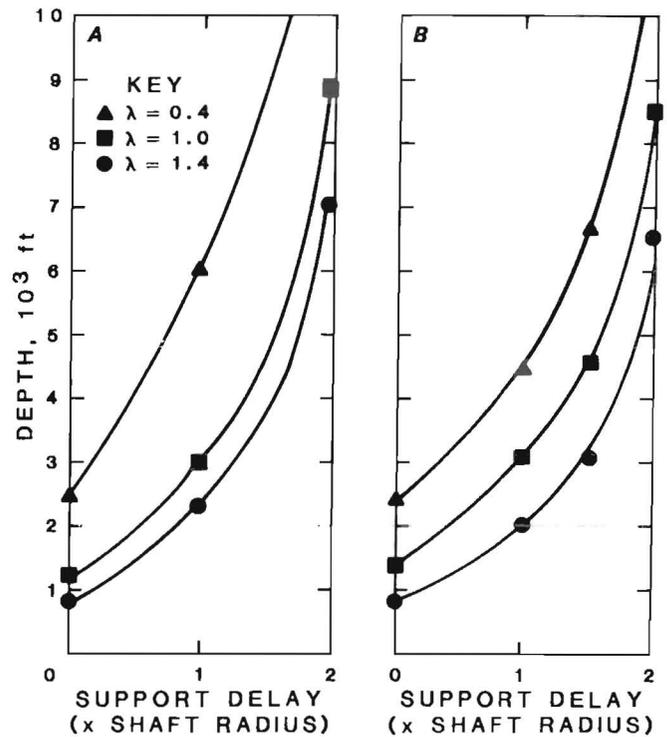
Figure 18.—Required support delay as a function of shaft depth for various shear modulus ratios ( $\lambda$ ). A,  $t/a = 0.2$ ; B,  $t/a = 0.1$ .

For the specific case of the Silver shaft, plots have been developed that illustrate the required support delay in terms of shaft radius as a function of depth for various ratios of  $t/a$  and  $\lambda$  (fig. 18). These plots assume a 4,000-psi compressive strength concrete and a factor of safety of 2.0. The bounding value of  $\lambda = 1.0$  shows that for a support delay of two shaft radii, the maximum shaft depth before liner failure is about 8,000 ft. During construction, the shaft bottom reached 6,200 ft with one diameter delay with no liner stability problems.

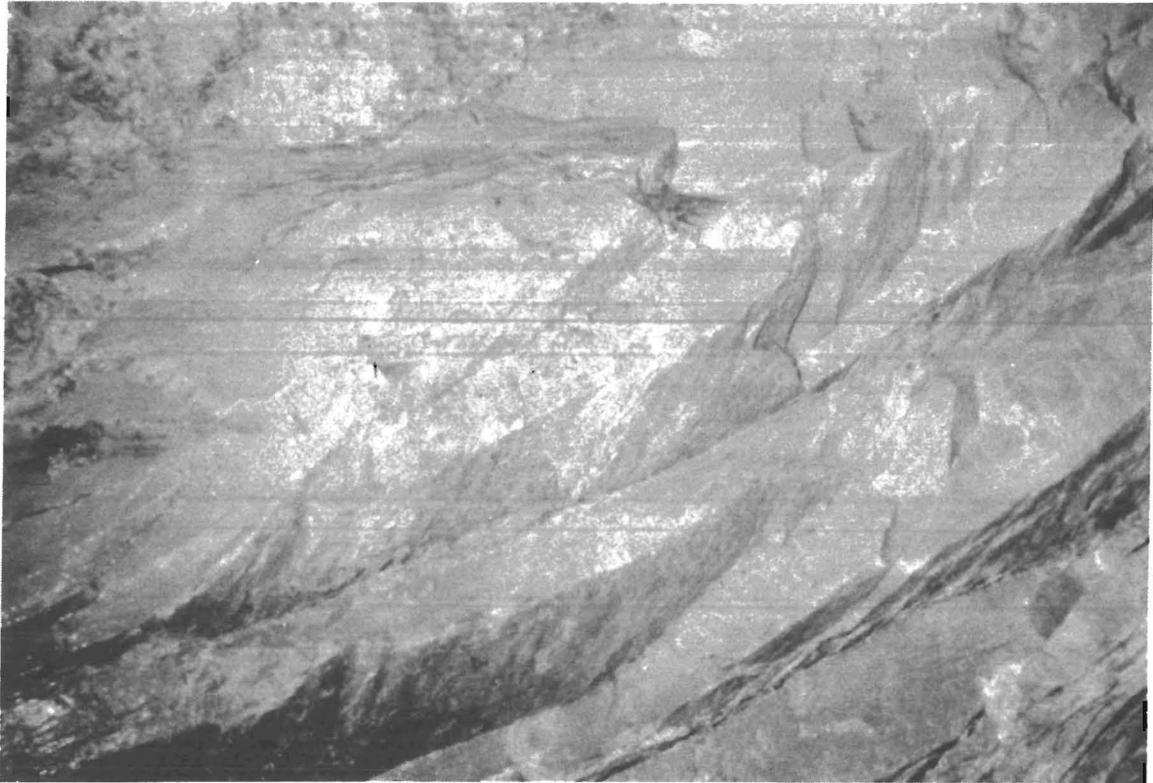
**Figure A-1.—Wedge-shaped overbreak features on northeast side of shaft.**

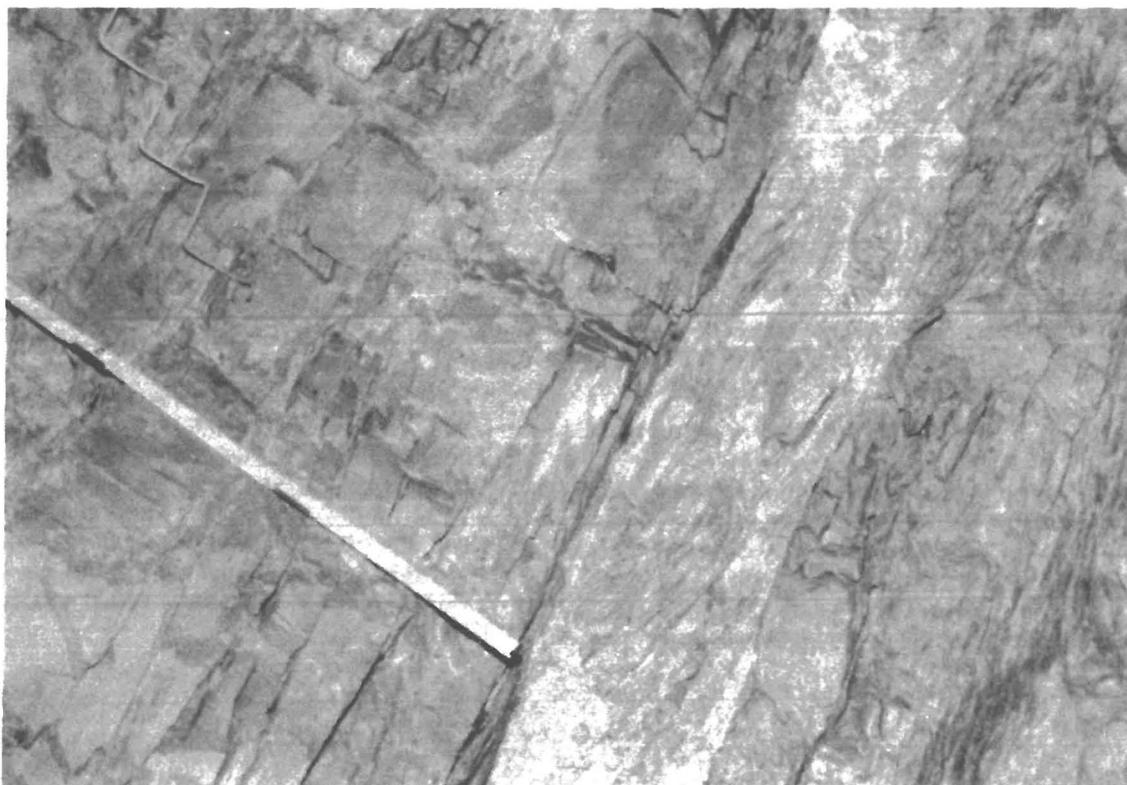
Figure A-2.—Northwest-southeast-trending shear zone containing crushed quartzite and fine gouge paralleling beds.

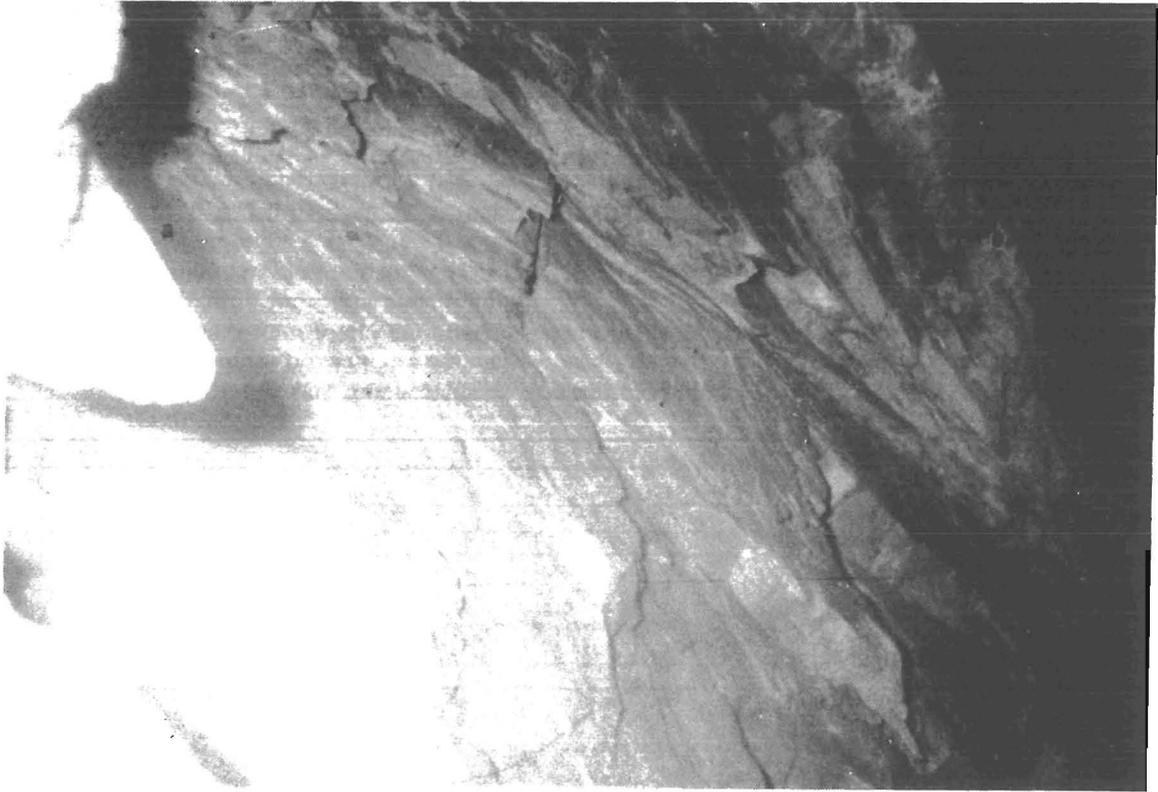
**Figure A-3.—Bedding joints dipping toward observer with slickensides on exposed surface.**

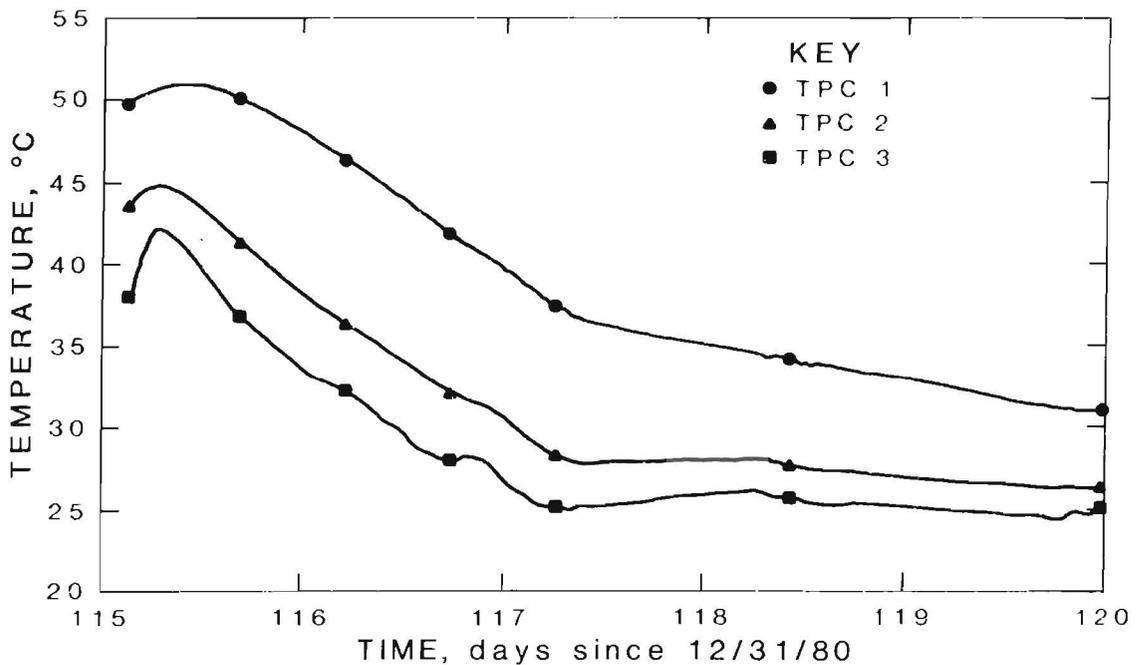
Figure B-1.—Temperature versus time for thermistors at PC 1, PC 2, and PC 3 for the first 5 days after installation at 2,414-ft depth.

The extensometer thermistors showed that a temperature gradient of less than 1° C existed between the 5- and 20-ft radial distances. The rock mass temperature increased by about 0.5° to 1° C because of the presence of the liner. The rock temperatures equilibrated at 27° C after approximately one-half day. In addition, the measurements indicated little, if any, thermal gradient in the shaft. One important result of the temperature measurements was that no temperature correction to the MPBX displacements was required.
